***WASTEWATER DISPOSAL REPORT***

***WINSOME FILING NO. 3***

**SOIL, GEOLOGY, AND GEOLOGIC HAZARD STUDY  
WINSOME SUBDIVISION – FILING NO. 3  
PORTIONS OF PARCEL NOS. 51000-00-497 & 51000-00-510  
17480 MERIDIAN ROAD NORTH  
EL PASO COUNTY, COLORADO**

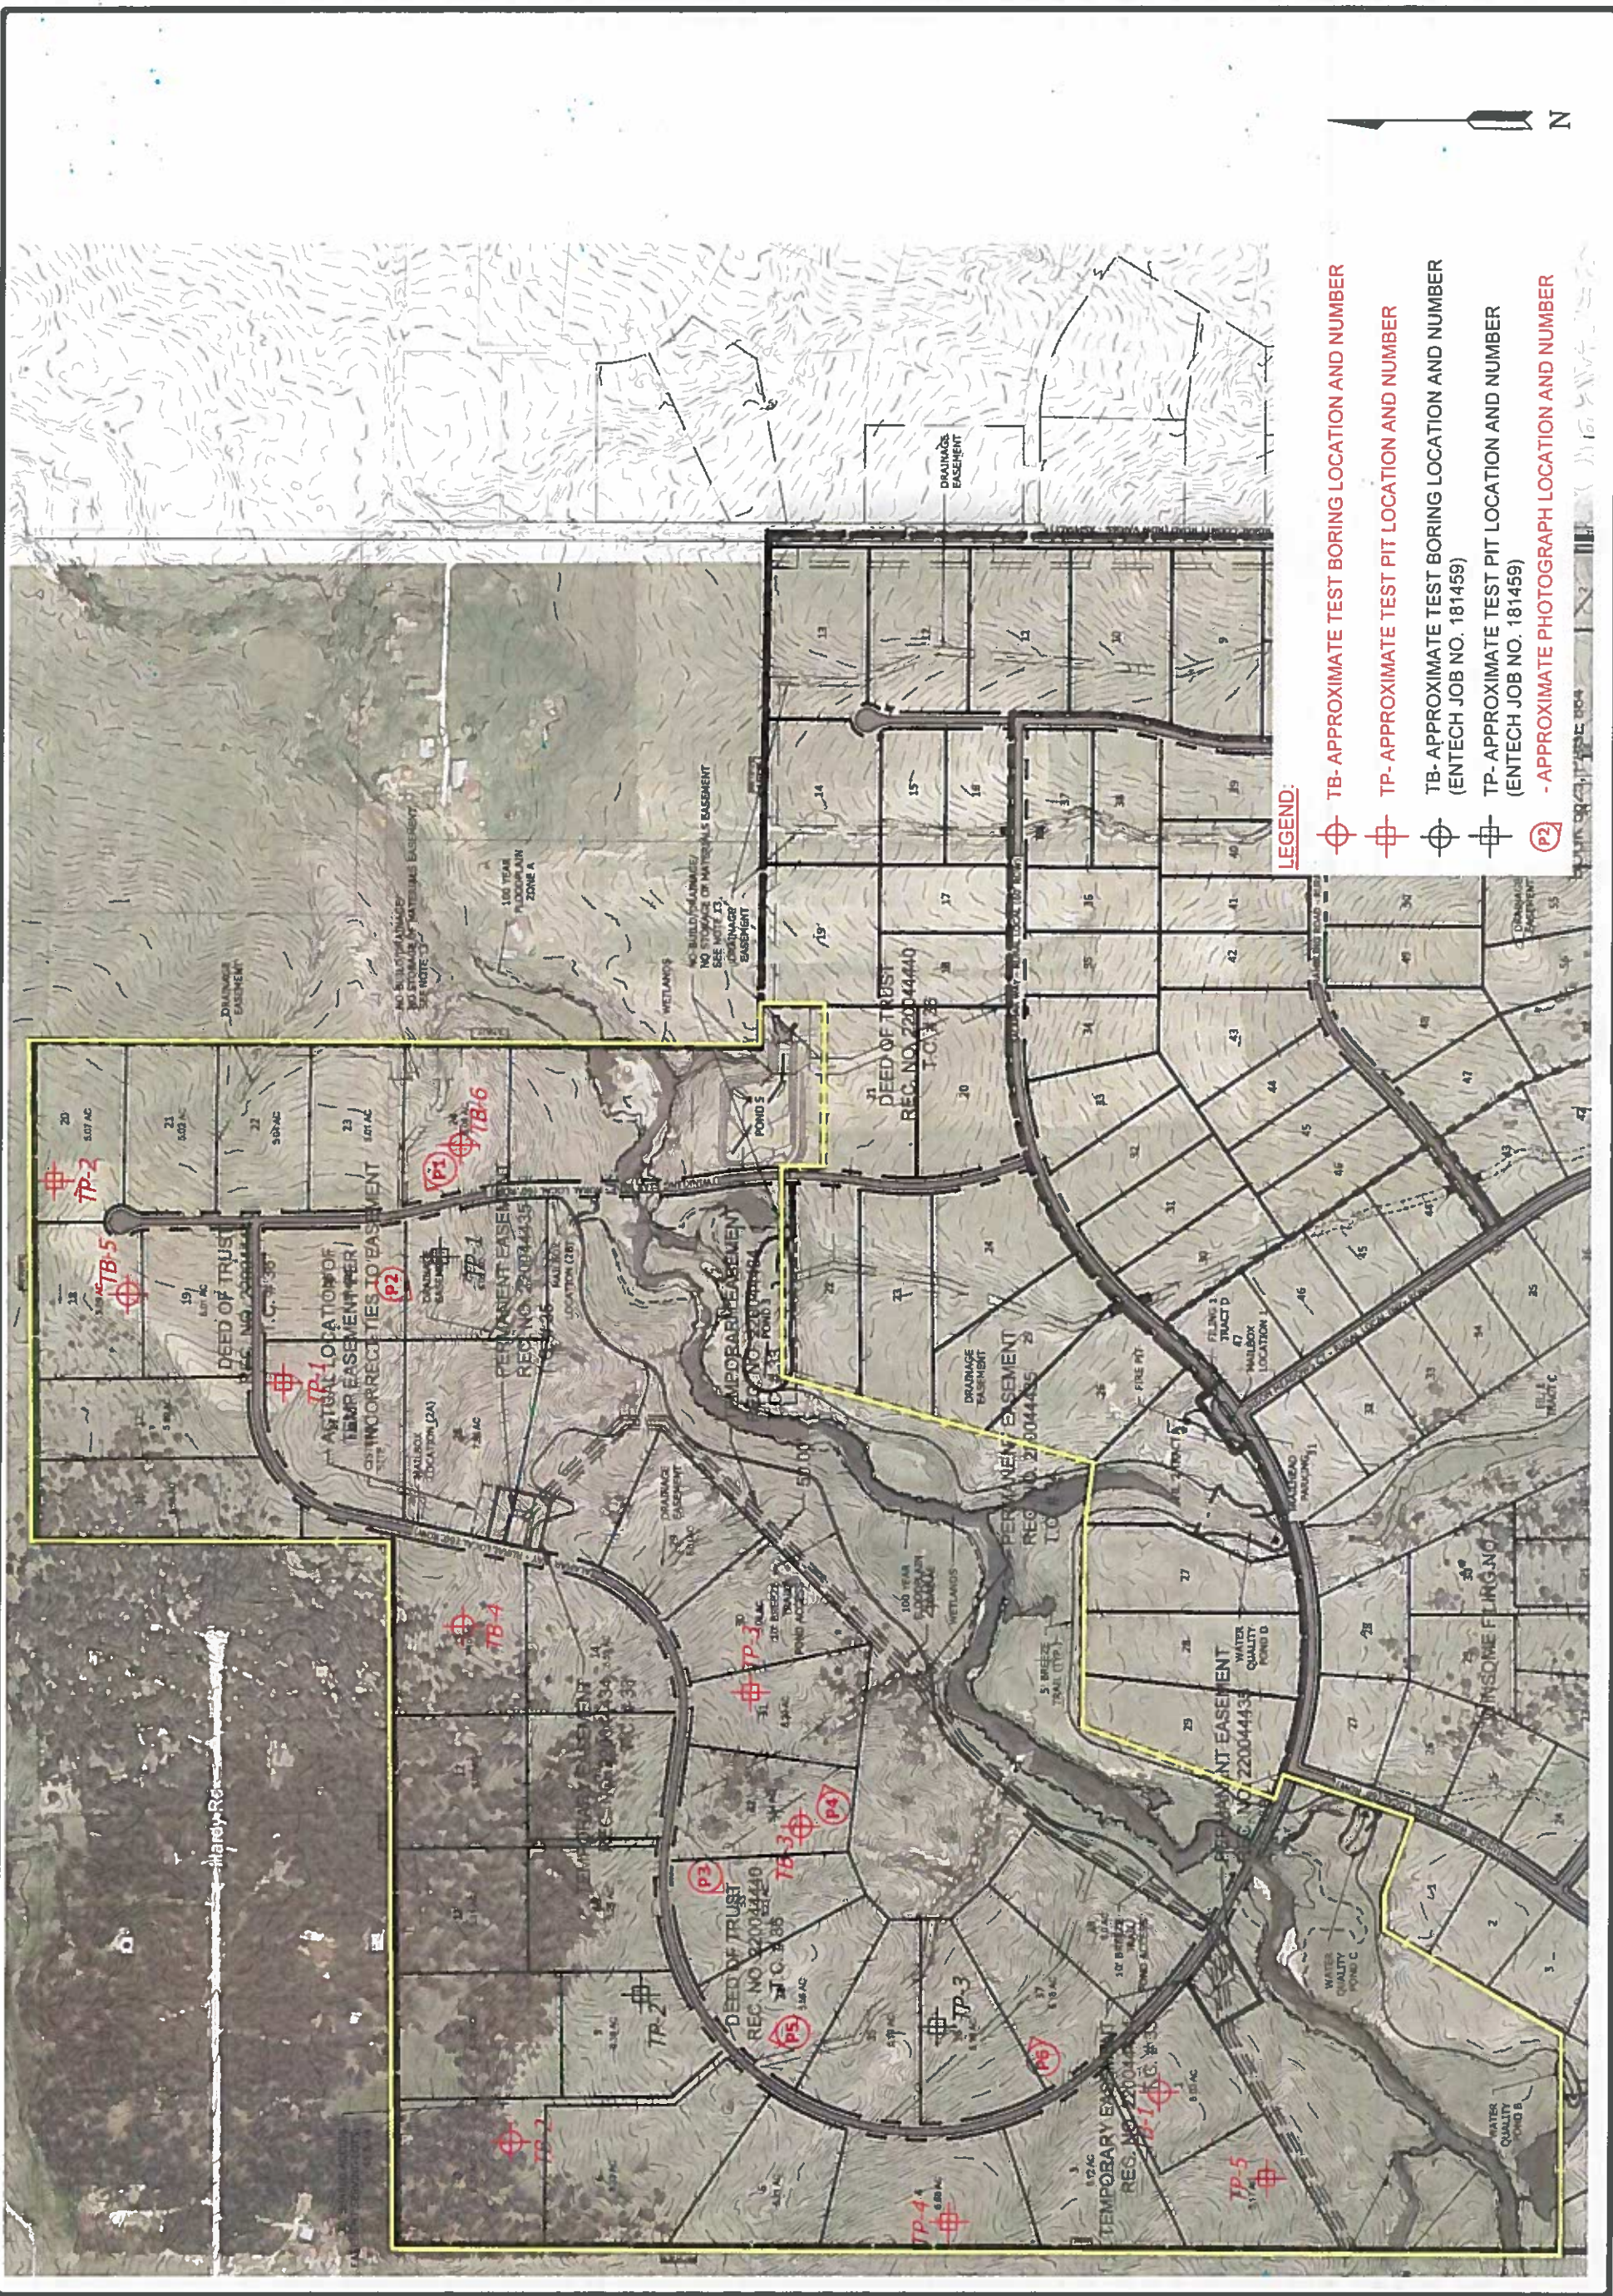
**SITE PLAN/TESTING LOCATION MAP**  
WINSOME SUBDIVISION - FILING NO. 3  
HODGEN ROAD & MERIDIAN ROAD  
EL PASO COUNTY, CO.  
FOR: WINSOME, LLC

The site was previously investigated as part of a Preliminary Soils, Geology, Geologic Hazard and Wastewater Study, Entech Job No. 181459 (Reference 1). Five (5) test borings, and ten (10) tactile test pits were performed on the site to determine general suitability of the site for the use of on-site wastewater treatment systems. The previous report/investigation was used as part of this investigation. More specifically previous Test Pit Nos. (TP-1, TP-2 and TP-3) were used as part of the Winsome Subdivision Filing No. 3 investigation.

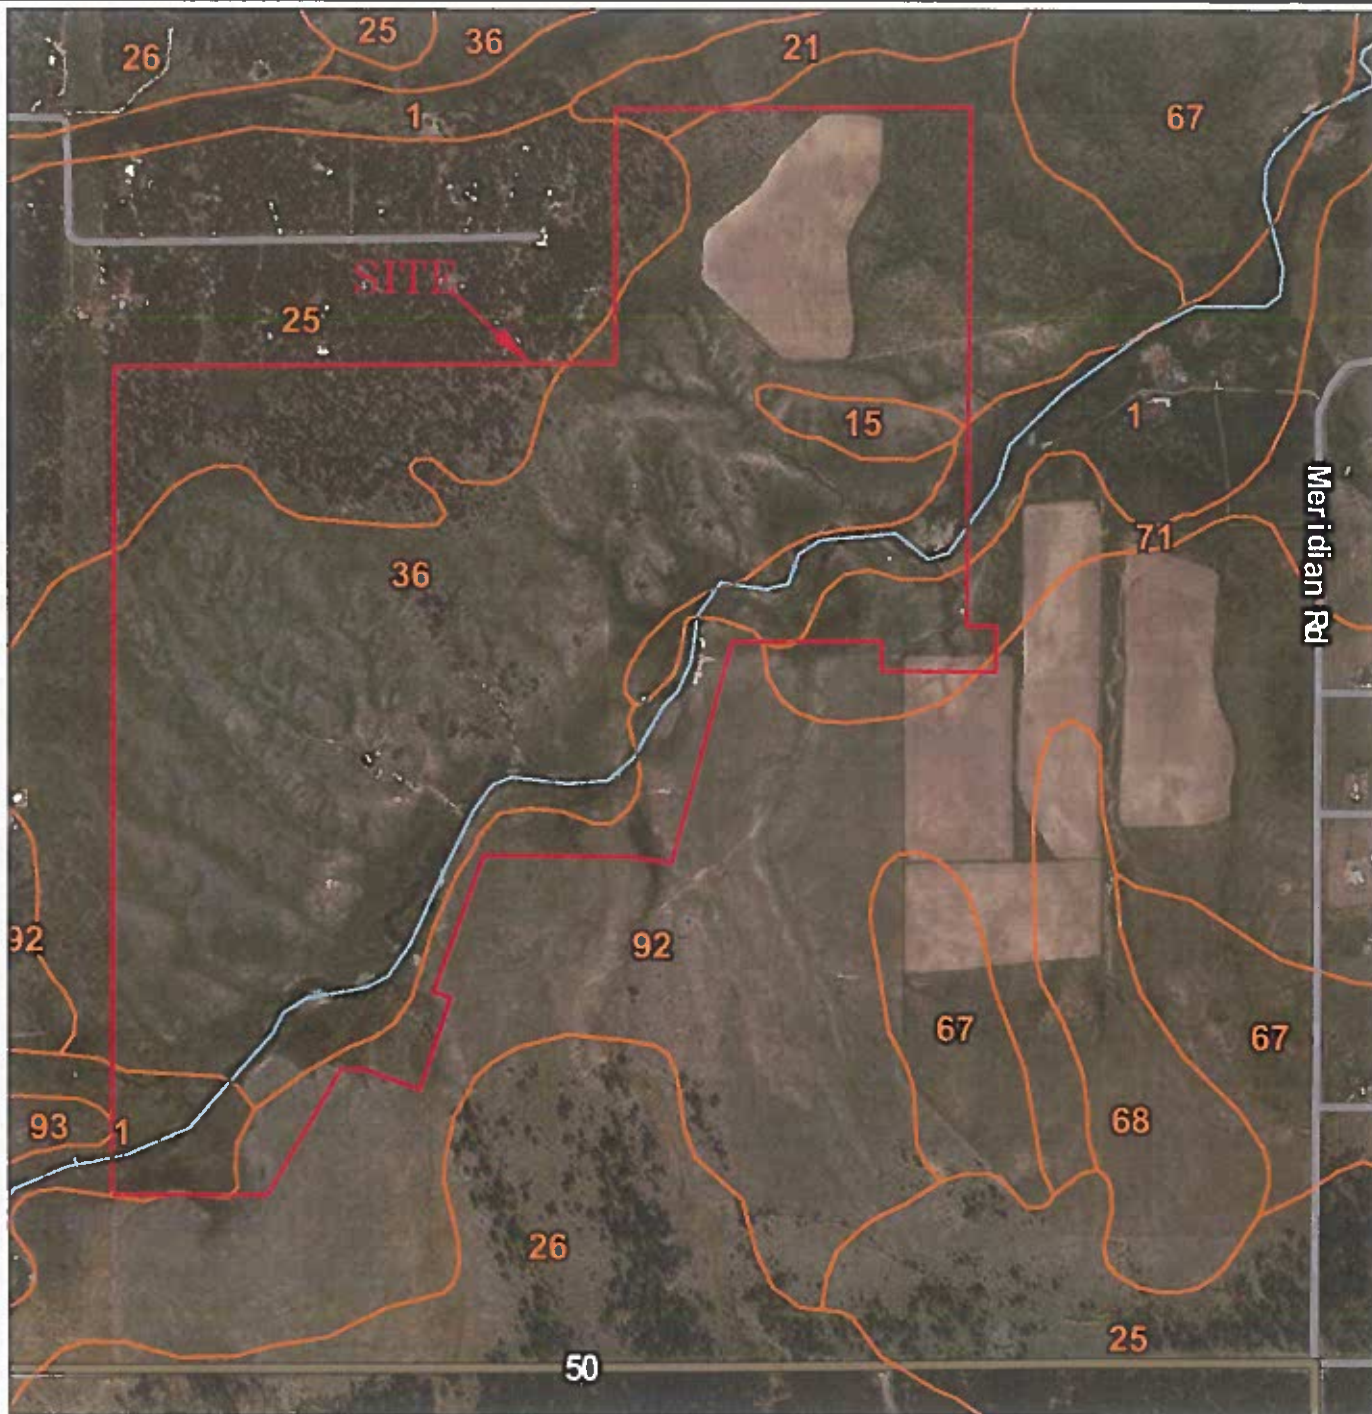
FIG NO.:  
4

SOIL SURVEY MAP  
WINSOME SUBDIVISION - FILING NO. 3  
HODGEN ROAD & MERIDIAN ROAD  
EL PASO COUNTY, CO.  
FOR: WINSOME, LLC

Complete descriptions of each soil type are presented in Appendix D. The soils have generally been described to typically have slow to rapid permeabilities. The majority of the soils have moderate permeabilities. Limitations described for the soils include shrink-swell potential on Soil Type Nos. 25. Roads may need to be designed to minimize frost-heave potential. Possible hazards with soil erosion are present on the site. The erosion potential can be controlled with vegetation. The majority of the soils have been described to have moderate erosion hazards.

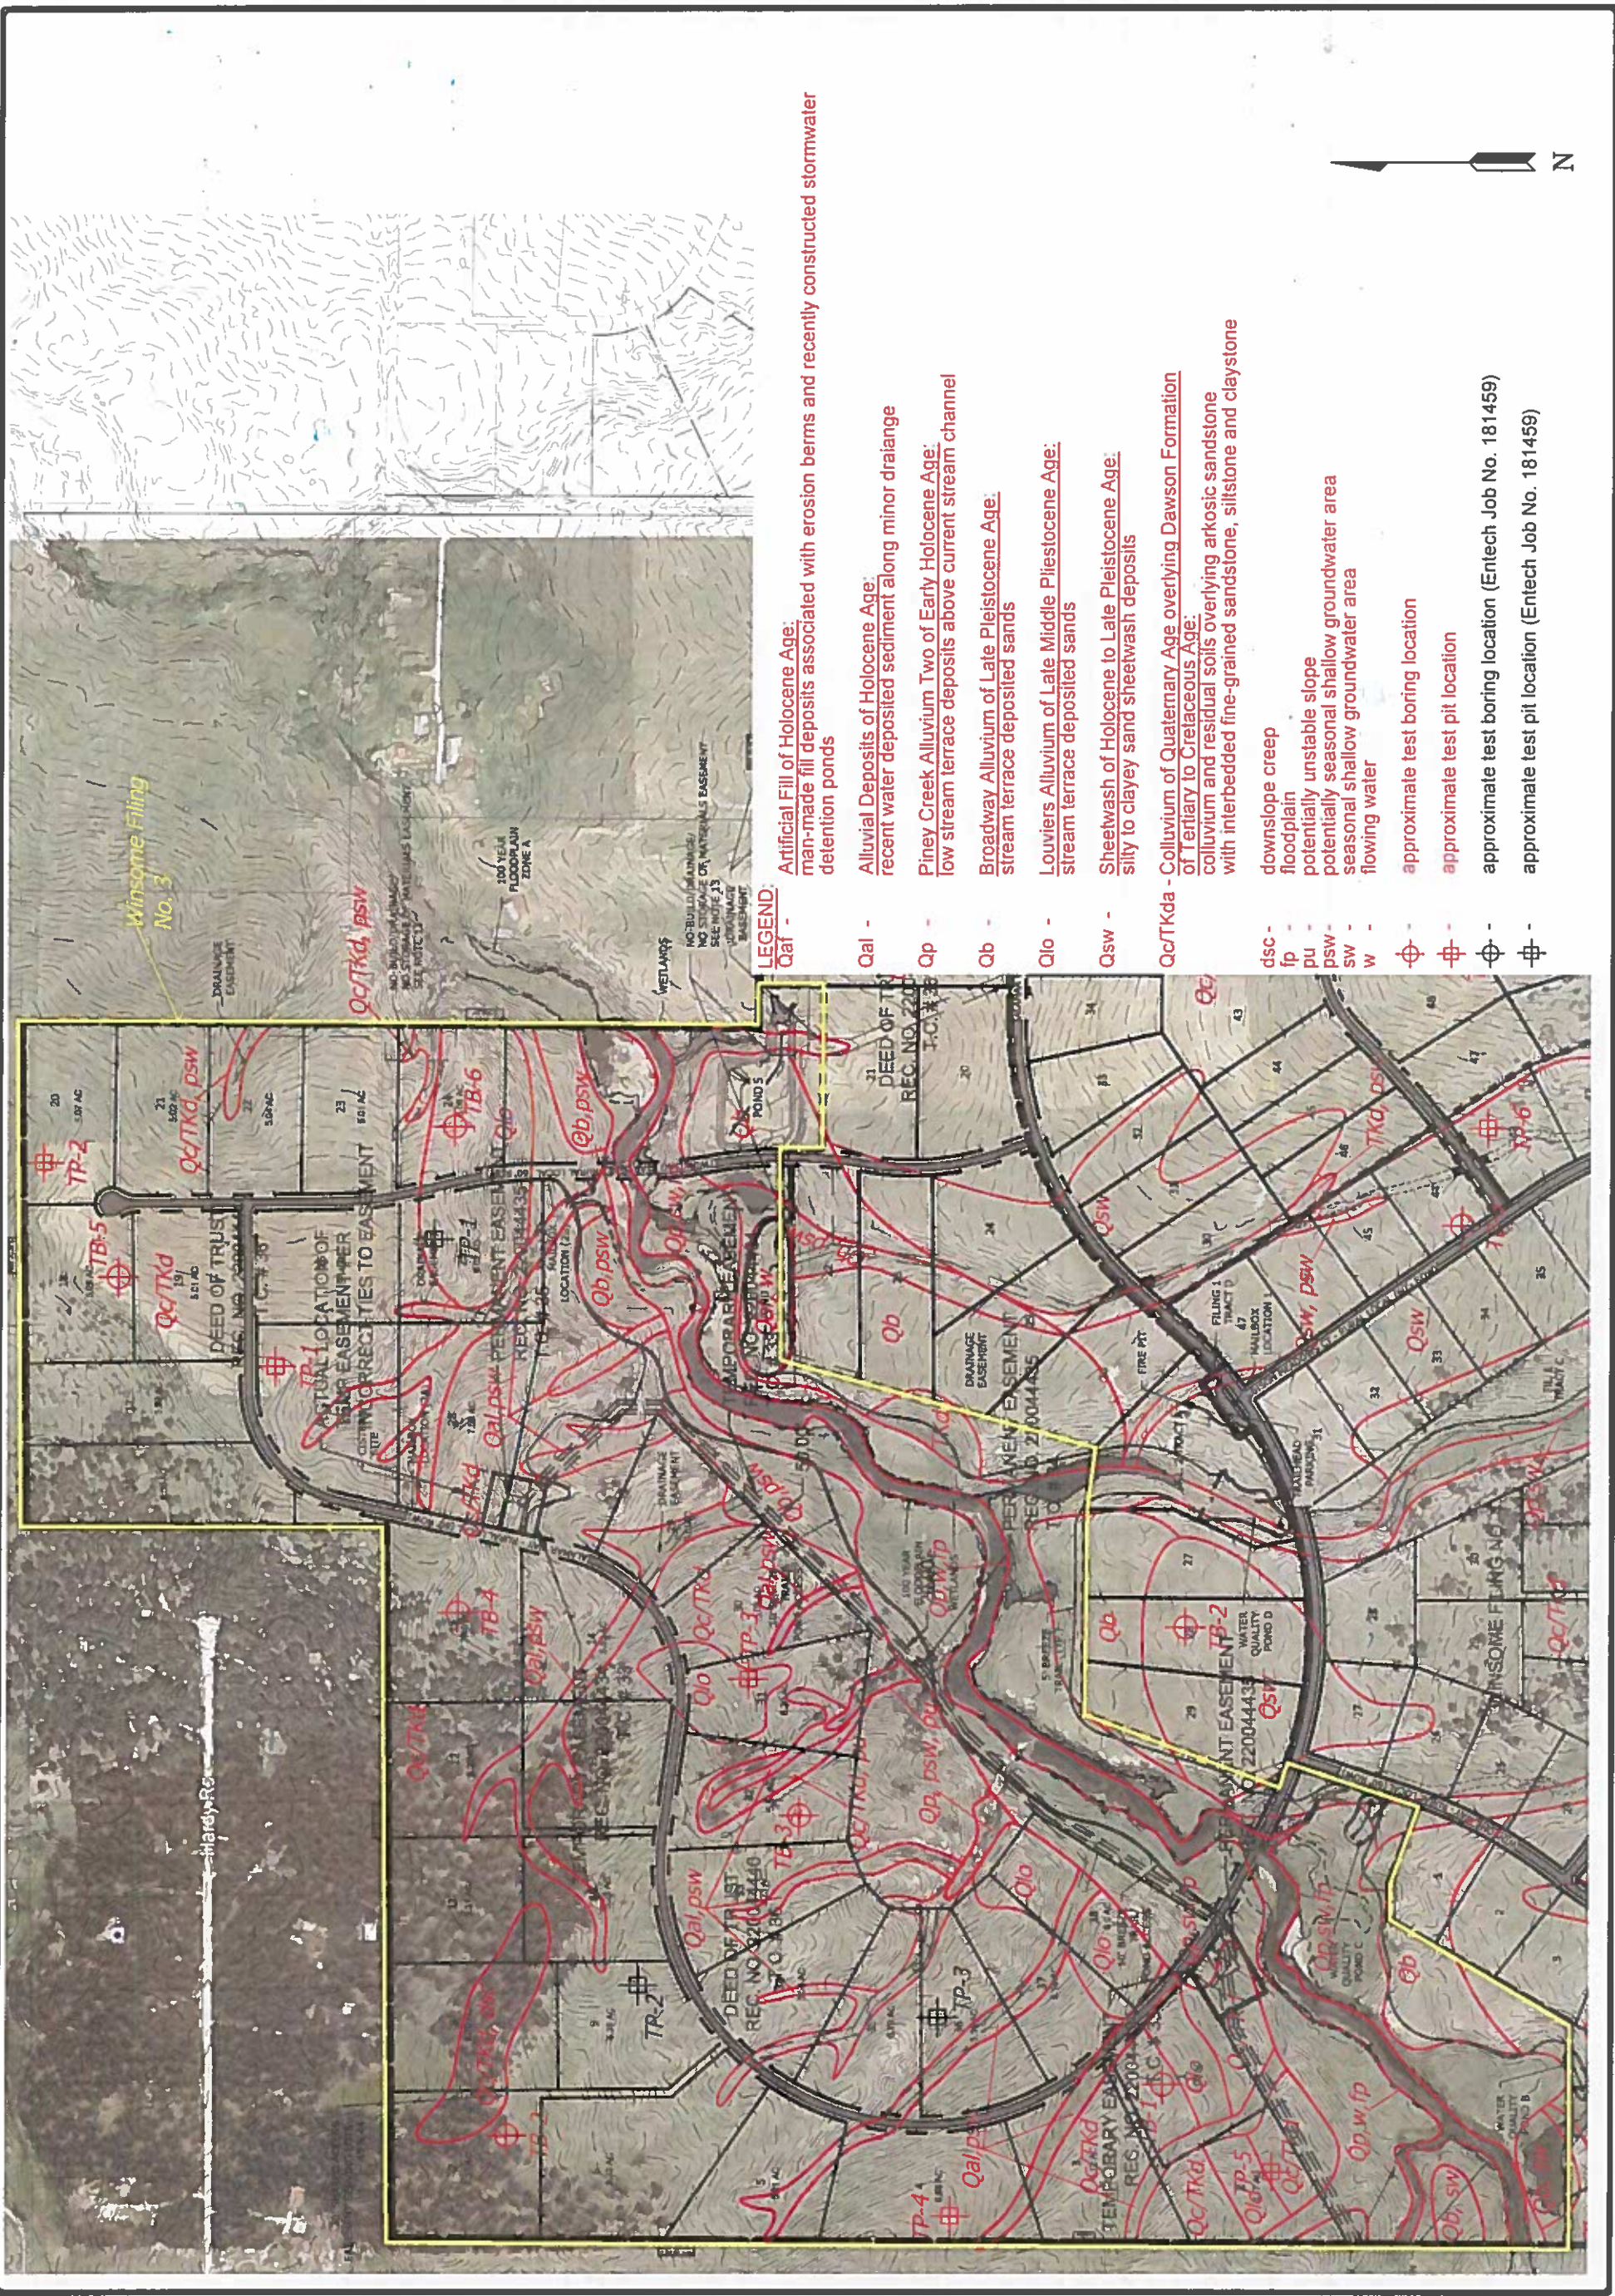
DATE	5/18/21
SHEET	AS SHOWN
JOB NO.	210539
FIGURE NO.	9
DRAWN	LL
CHECKED	LL

GEOLOGY/ENGINEERING GEOLOGY MAP  
WINSOME SUBDIVISION - FILING NO. 3  
HODGEN ROAD & MERIDIAN ROAD  
EL PASO COUNTY, CO.  
FOR: WINSOME, LLC

As mentioned previously, detailed mapping has been performed on this site to produce a Geology/Engineering Geology Map (Figure 6). This map shows the location of various geologic conditions of which the developers should be cognizant during the planning, design and construction stages of the project. These hazards and the recommended mitigation techniques are as follows:

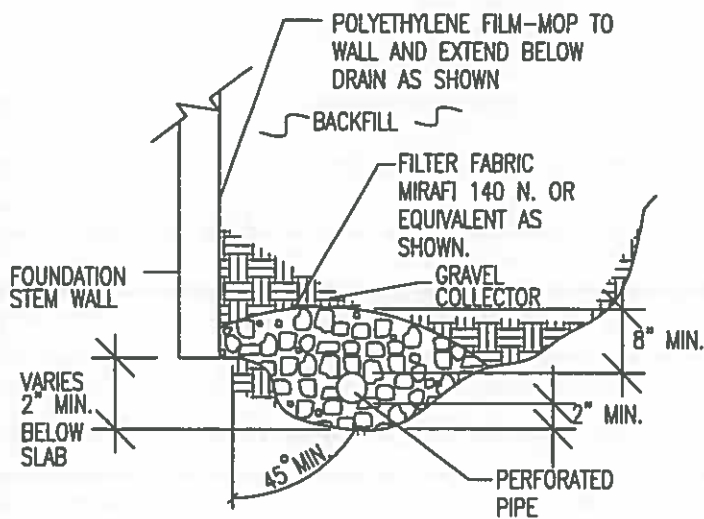
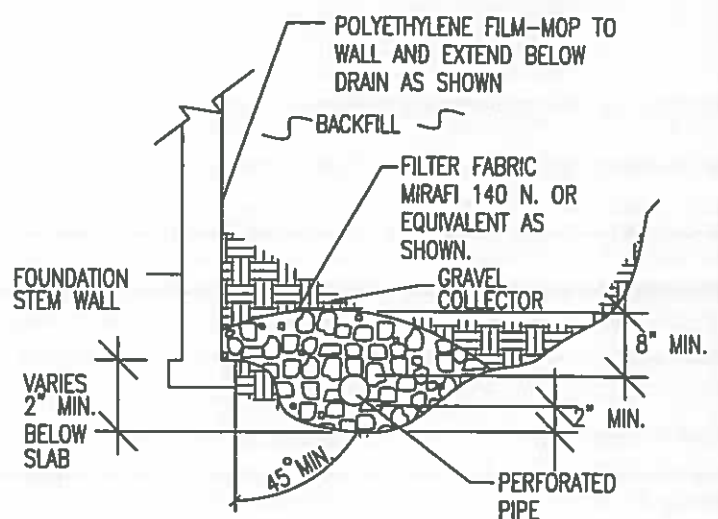
-GRAVEL SIZE IS RELATED TO DIAMETER OF PIPE PERFORATIONS-85% GRAVEL GREATER THAN 2x PERFORATION DIAMETER.

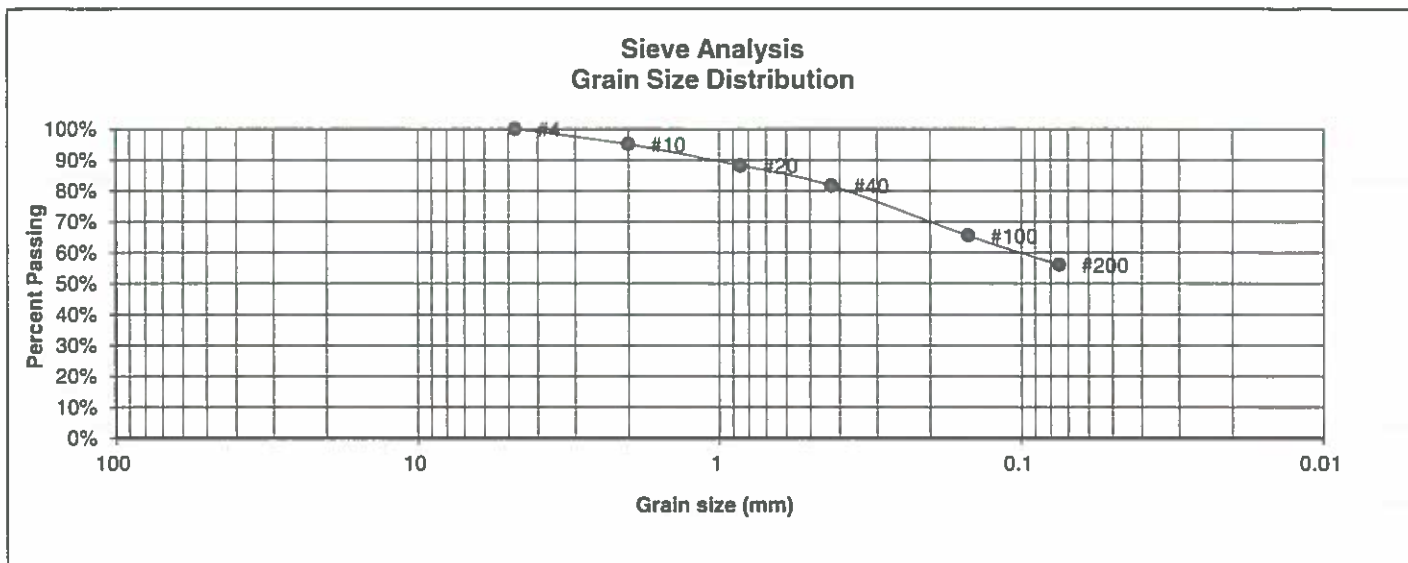
FIG NO.:  
C-1

<u>UNIFIED CLASSIFICATION</u>	CL	<u>CLIENT</u>	WINSOME, LLC
<u>SOIL TYPE #</u>	1	<u>PROJECT</u>	HODGEN AND MERIDIAN
<u>TEST BORING #</u>	4	<u>JOB NO.</u>	210539
<u>DEPTH (FT)</u>	10	<u>TEST BY</u>	BL

<u>U.S. Sieve #</u>	<u>Percent Finer</u>
3"	
1 1/2"	
3/4"	
1/2"	
3/8"	
4	100.0%
10	95.1%
20	88.2%
40	81.7%
100	65.5%
200	56.1%

Soil Type 1 is a sandy clay (CL). This material was encountered in all of the test borings. The sand was encountered at the existing surface and extended to depths ranging from 1 to 4 feet, and to the termination of Test Boring No. 4 (20 feet). These soils were encountered at firm to very stiff consistencies and at moist conditions. Samples tested had 56 to 87 percent of the soil sized particles passing the No. 200 Sieve. Swell/Consolidation Testing resulted in a volume change of 2.9 percent, which indicates a moderate to high expansion potential.

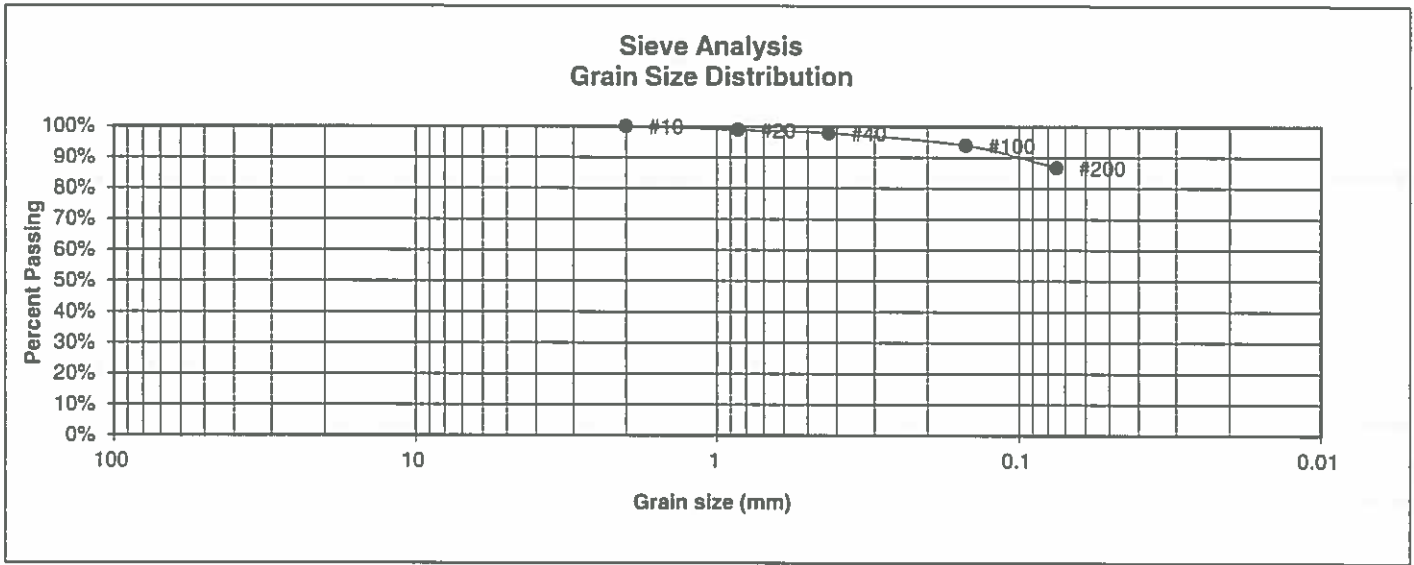
<u>UNIFIED CLASSIFICATION</u>	CL	<u>CLIENT</u>	WINSOME, LLC
<u>SOIL TYPE #</u>	1	<u>PROJECT</u>	HODGEN AND MERIDIAN
<u>TEST BORING #</u>	6	<u>JOB NO.</u>	210539
<u>DEPTH (FT)</u>	2-3	<u>TEST BY</u>	BL

<u>U.S. Sieve #</u>	<u>Percent Finer</u>
3"	
1 1/2"	
3/4"	
1/2"	
3/8"	
4	
10	100.0%
20	98.8%
40	97.8%
100	93.9%
200	86.7%

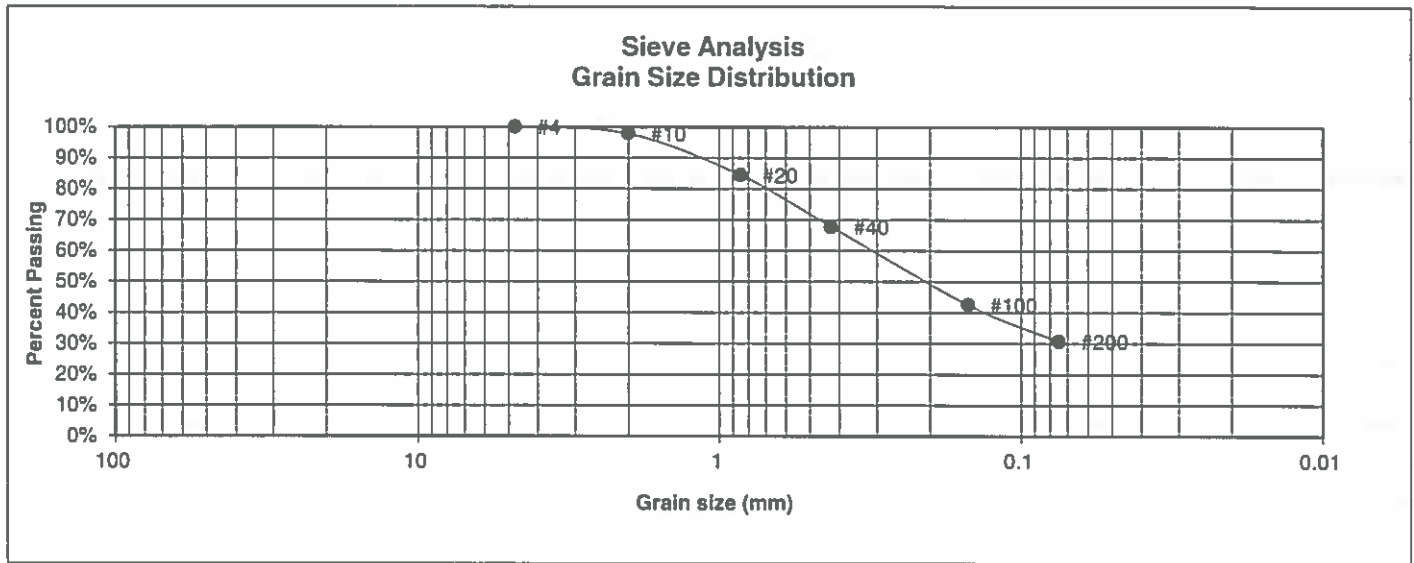
<u>UNIFIED CLASSIFICATION</u>	SC	<u>CLIENT</u>	WINSOME, LLC
<u>SOIL TYPE #</u>	2	<u>PROJECT</u>	HODGEN AND MERIDIAN
<u>TEST BORING #</u>	1	<u>JOB NO.</u>	210539
<u>DEPTH (FT)</u>	2-3	<u>TEST BY</u>	BL

<u>U.S. Sieve #</u>	<u>Percent Finer</u>
3"	
1 1/2"	
3/4"	
1/2"	
3/8"	
4	100.0%
10	97.9%
20	84.5%
40	67.7%
100	42.6%
200	30.7%

<u>Atterberg Limits</u>	
Plastic Limit	15
Liquid Limit	25
Plastic Index	10

Soil Type 2 is a silty to clayey sandstone (SM, SM-SW, SC). This material was encountered in five of the test borings at depths ranging from 2 to 8 feet extending to depths ranging from 15 to 20 feet. The sandstone was encountered at dense to very dense states and moist conditions. Samples tested had 23 to 48 percent of the soil sized particles passing the No. 200 sieve. Atterberg Limits Testing on samples of the sandstone resulted in a liquid limit of 25 and a plastic index of 10, and non-plastic results. Swell/Consolidation Testing resulted in a consolidation of 1.4 percent, indicating a low consolidation potential. Highly expansive clayey sandstone and claystone are commonly interbedded in the sandstone in the area. Sulfate testing on the

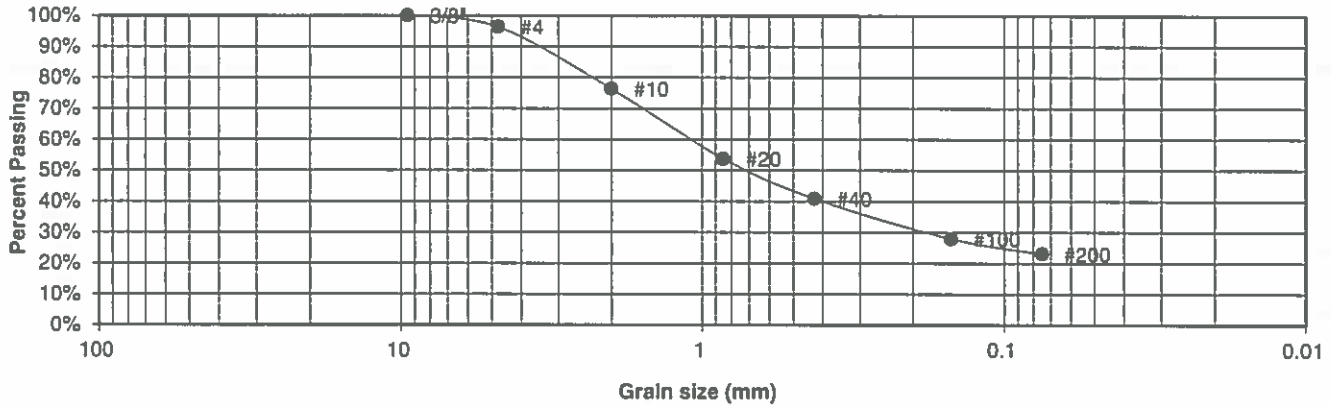
FIG NO.:  
C-4

### Sieve Analysis Grain Size Distribution

<u>U.S. Sieve #</u>	<u>Percent Finer</u>
3"	
1 1/2"	
3/4"	
1/2"	
3/8"	100.0%
4	96.4%
10	76.4%
20	53.7%
40	40.8%
100	27.9%
200	23.1%

<u>Atterberg Limits</u>	
Plastic Limit	NP
Liquid Limit	NV
Plastic Index	NP

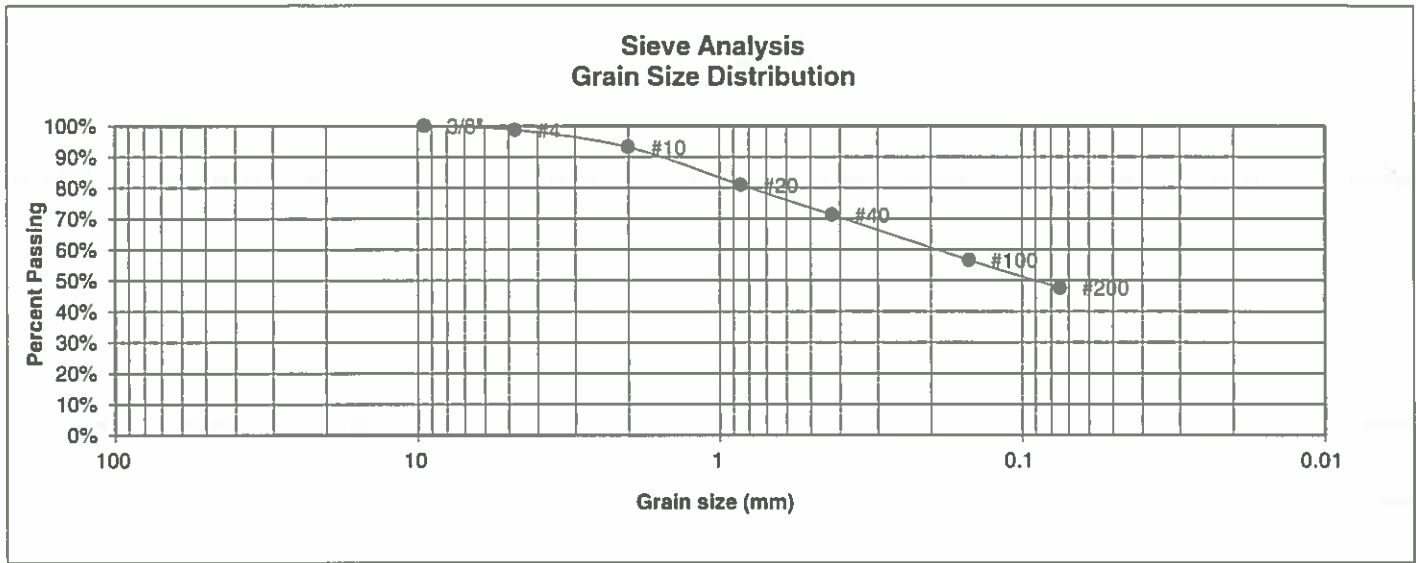
FIG NO.:  
C-5

<u>UNIFIED CLASSIFICATION</u>	SC	<u>CLIENT</u>	WINSOME, LLC
<u>SOIL TYPE #</u>	2	<u>PROJECT</u>	HODGEN AND MERIDIAN
<u>TEST BORING #</u>	5	<u>JOB NO.</u>	210539
<u>DEPTH (FT)</u>	20	<u>TEST BY</u>	BL

<u>U.S. Sieve #</u>	<u>Percent Finer</u>
3"	
1 1/2"	
3/4"	
1/2"	
3/8"	100.0%
4	98.7%
10	93.1%
20	80.9%
40	71.2%
100	56.6%
200	47.6%

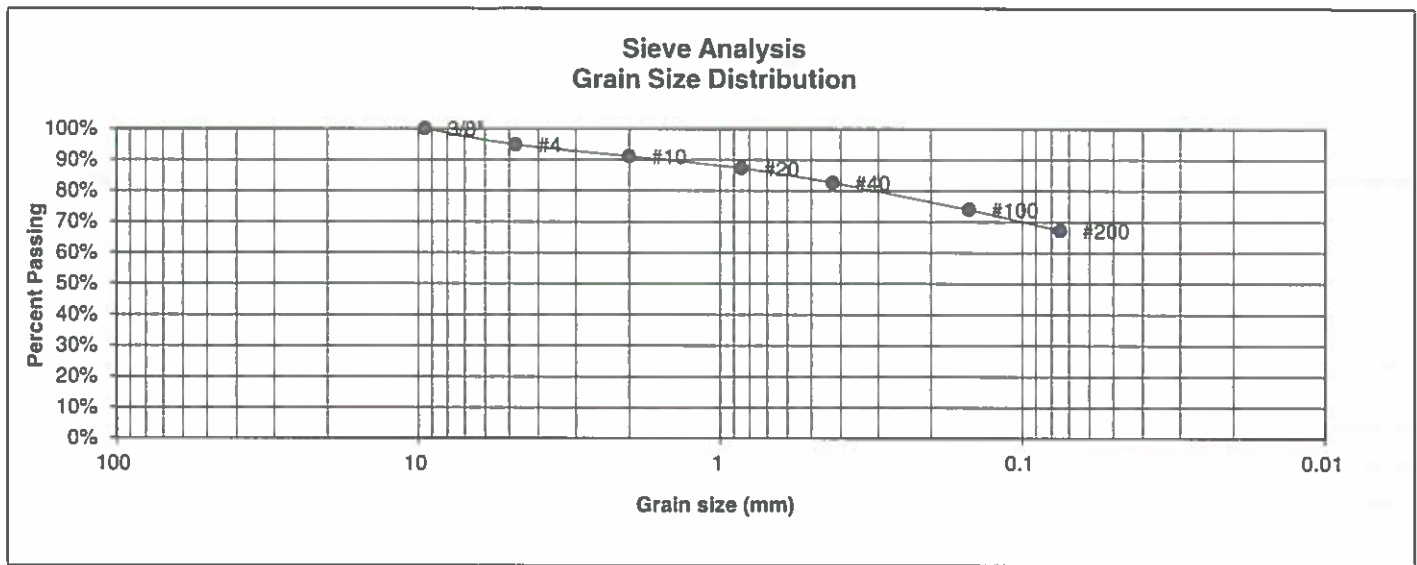
FIG NO.:  
C-6

<u>UNIFIED CLASSIFICATION</u>	CL	<u>CLIENT</u>	WINSOME, LLC
<u>SOIL TYPE #</u>	3	<u>PROJECT</u>	HODGEN AND MERIDIAN
<u>TEST BORING #</u>	2	<u>JOB NO.</u>	210539
<u>DEPTH (FT)</u>	10	<u>TEST BY</u>	BL

<u>U.S. Sieve #</u>	<u>Percent Finer</u>
3"	
1 1/2"	
3/4"	
1/2"	
3/8"	100.0%
4	94.8%
10	91.1%
20	87.3%
40	82.6%
100	74.0%
200	67.3%

<u>Atterberg Limits</u>	
Plastic Limit	17
Liquid Limit	32
Plastic Index	15

Soil Type 3 is a sandy claystone (CL). This material was encountered Test Boring No. 1 at 14 feet bgs and extended to the termination of the boring (20 feet). The claystone was encountered at hard consistencies and moist conditions. Samples tested had 64 to 67 percent of the soil sized particles passing the No. 200 sieve. Atterberg Limits Testing resulted in a liquid limit of 32 and a plastic index of 15. FHA Swell Testing resulted in an expansion pressure of 430 psf. Swell/Consolidation Testing resulted in a volume change of 2.5 percent. These results indicated low, and moderate to high expansion potentials.

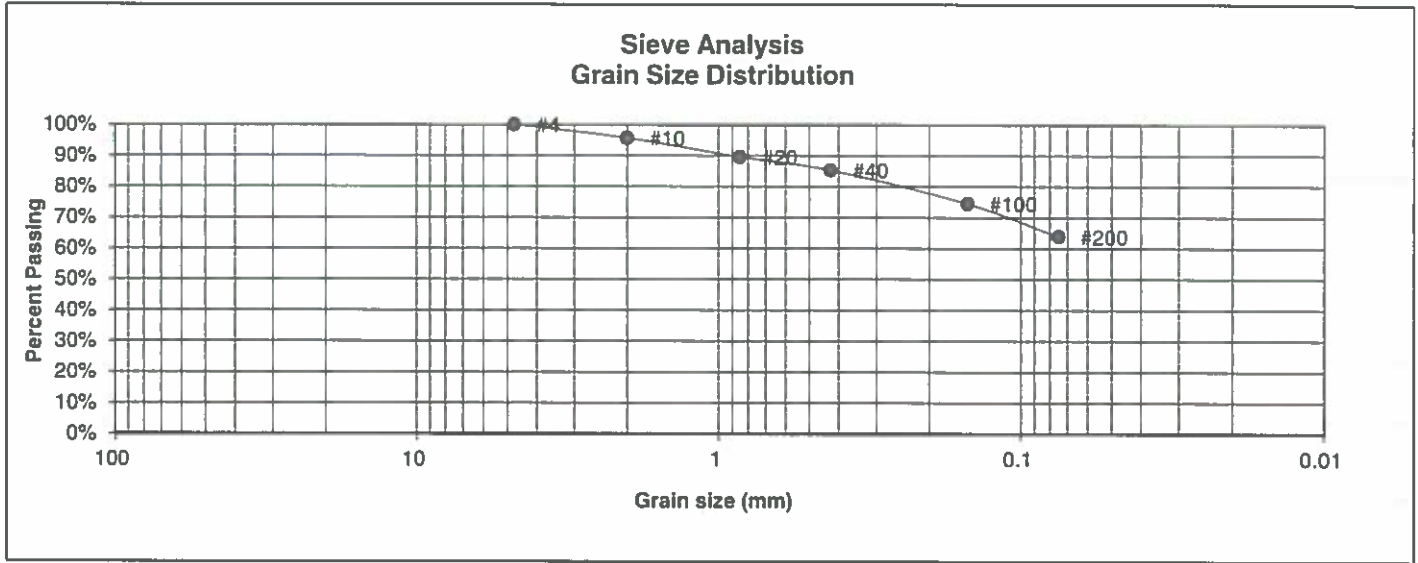
<u>UNIFIED CLASSIFICATION</u>	CL	<u>CLIENT</u>	WINSOME, LLC
<u>SOIL TYPE #</u>	3	<u>PROJECT</u>	HODGEN AND MERIDIAN
<u>TEST BORING #</u>	3	<u>JOB NO.</u>	210539
<u>DEPTH (FT)</u>	2-3	<u>TEST BY</u>	BL

<u>U.S. Sieve #</u>	<u>Percent Finer</u>
3"	
1 1/2"	
3/4"	
1/2"	
3/8"	
4	100.0%
10	95.7%
20	89.6%
40	85.3%
100	74.5%
200	63.9%

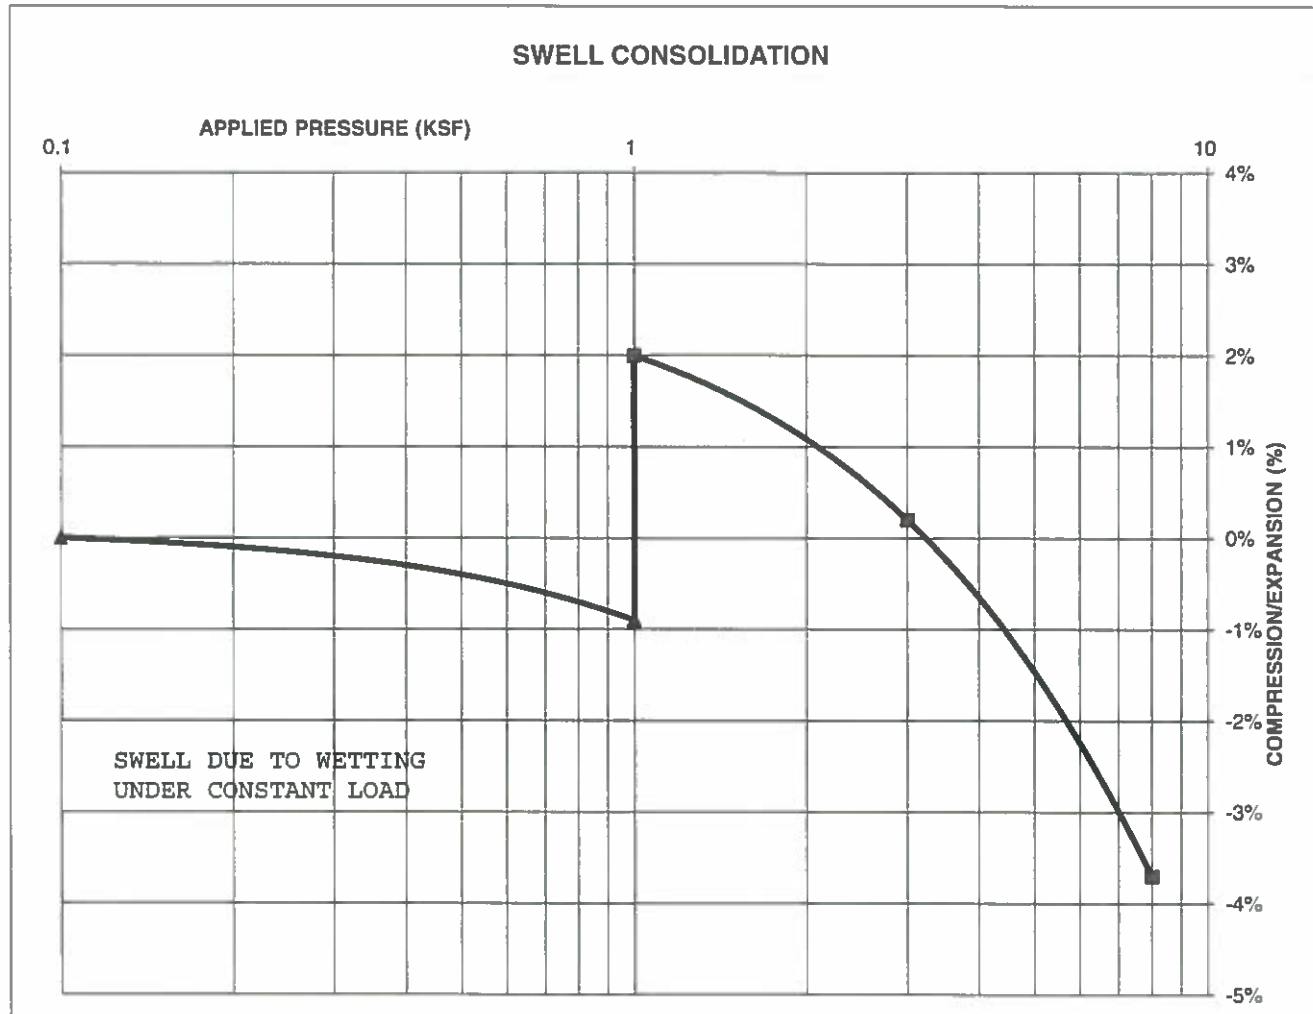
TEST BORING #	6	DEPTH(ft)	2-3
DESCRIPTION	CL	SOIL TYPE	1
NATURAL UNIT DRY WEIGHT (PCF)			108
NATURAL MOISTURE CONTENT			9.7%
SWELL/CONSOLIDATION (%)			2.9%

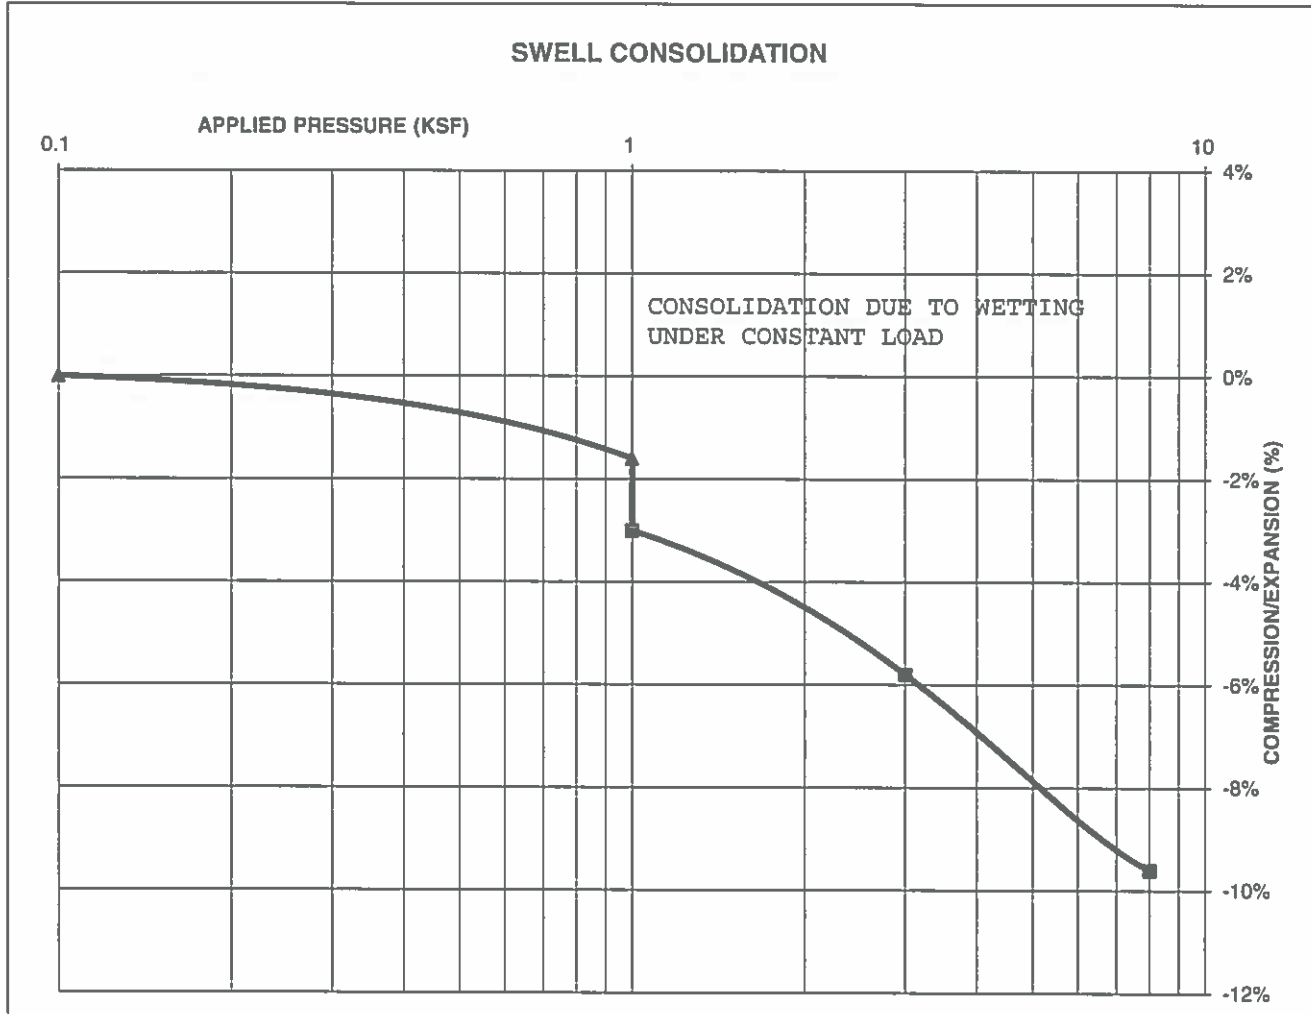
TEST BORING #	1	DEPTH(ft)	2-3
DESCRIPTION	SC	SOIL TYPE	2
NATURAL UNIT DRY WEIGHT (PCF)	106		
NATURAL MOISTURE CONTENT	9.1%		
SWELL/CONSOLIDATION (%)	-1.4%

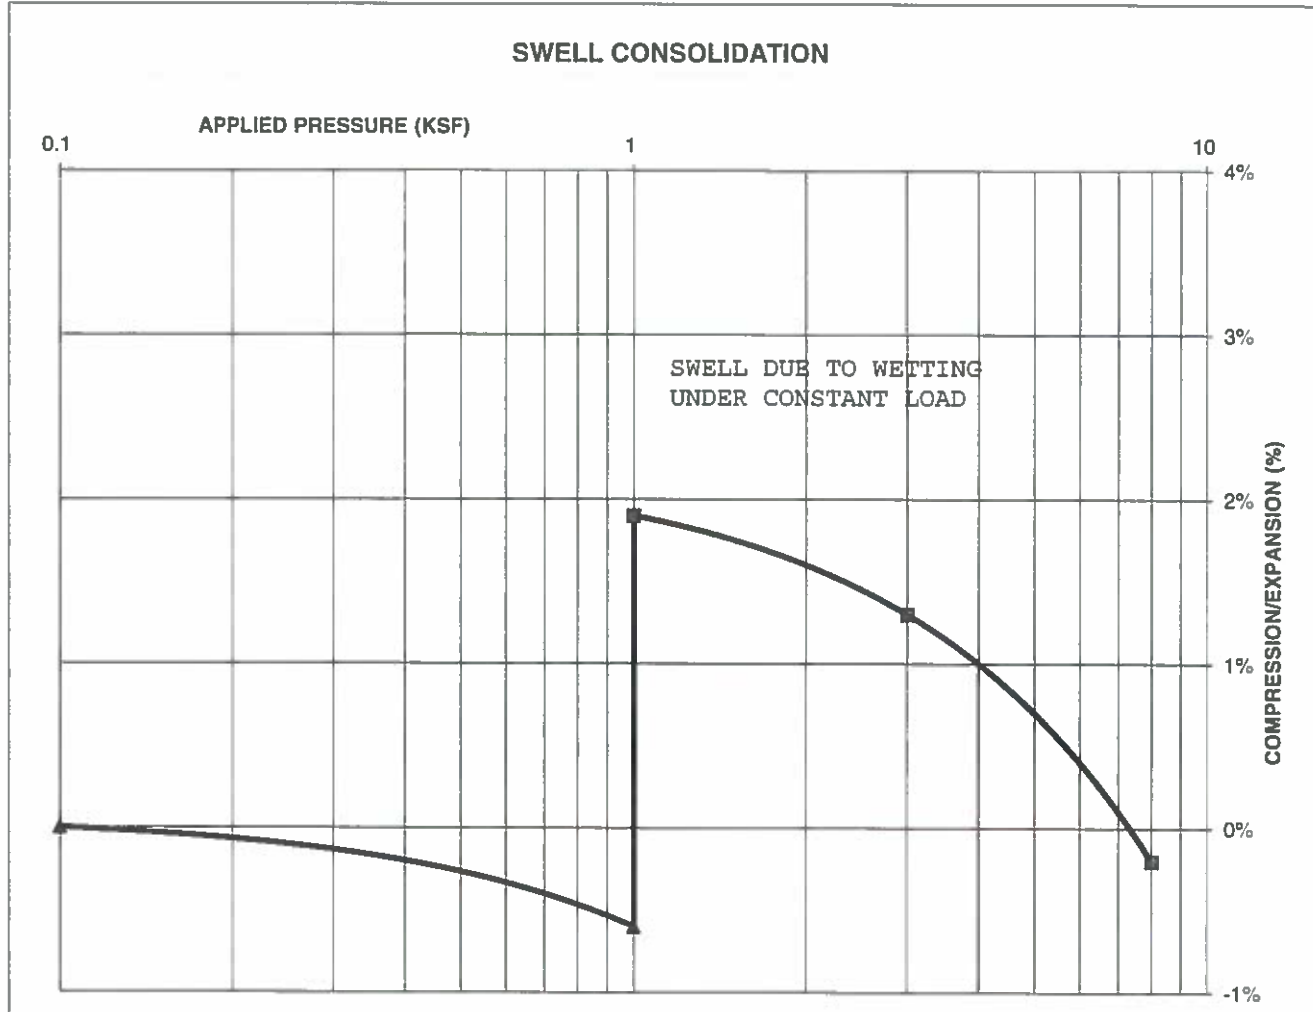
TEST BORING #	2	DEPTH(ft)	10
DESCRIPTION	CL	SOIL TYPE	3
NATURAL UNIT DRY WEIGHT (PCF)	126		
NATURAL MOISTURE CONTENT	10.4%		
SWELL/CONSOLIDATION (%)	2.5%
