***WASTEWATER DISPOSAL REPORT***

***WINSOME FILING NO. 3***

**SOIL, GEOLOGY, AND GEOLOGIC HAZARD STUDY  
WINSOME SUBDIVISION – FILING NO. 3  
PORTIONS OF PARCEL NOS. 51000-00-497 & 51000-00-510  
17480 MERIDIAN ROAD NORTH  
EL PASO COUNTY, COLORADO**

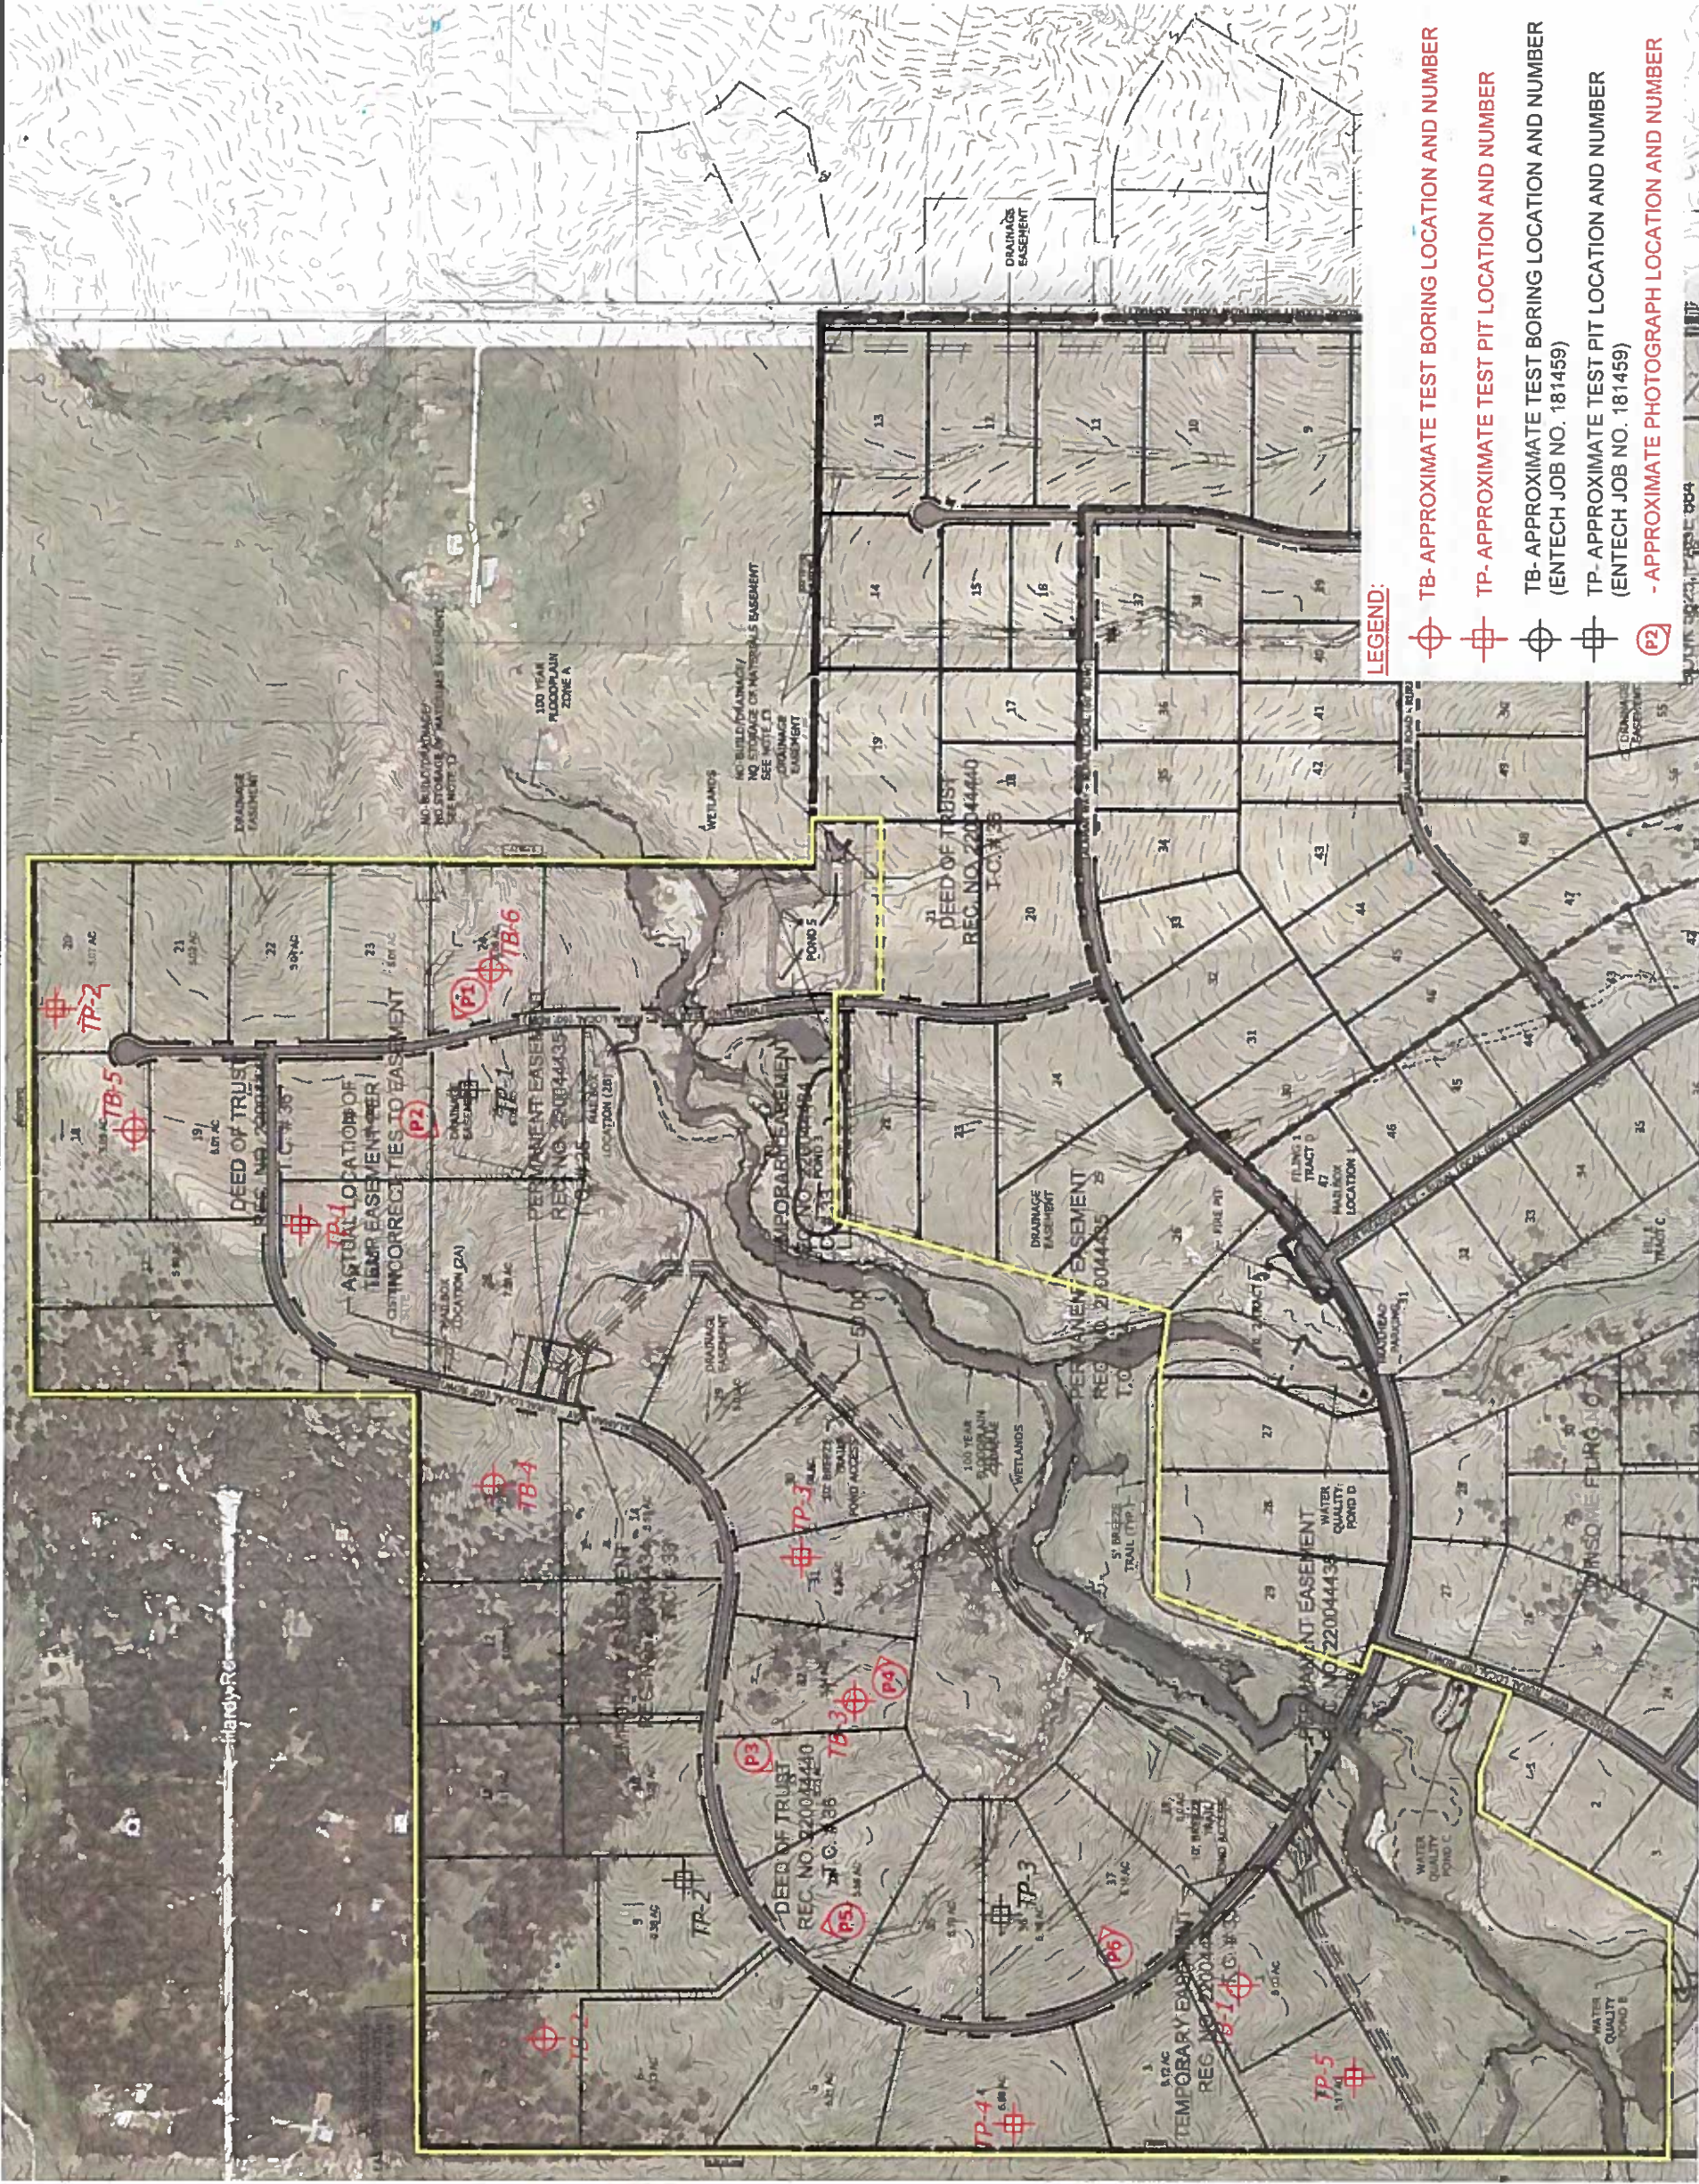
SITE PLAN/TESTING LOCATION MAP  
WINSOME SUBDIVISION - FILING NO. 3  
HODGEN ROAD & MERIDIAN ROAD  
EL PASO COUNTY, CO.  
FOR: WINSOME, LLC

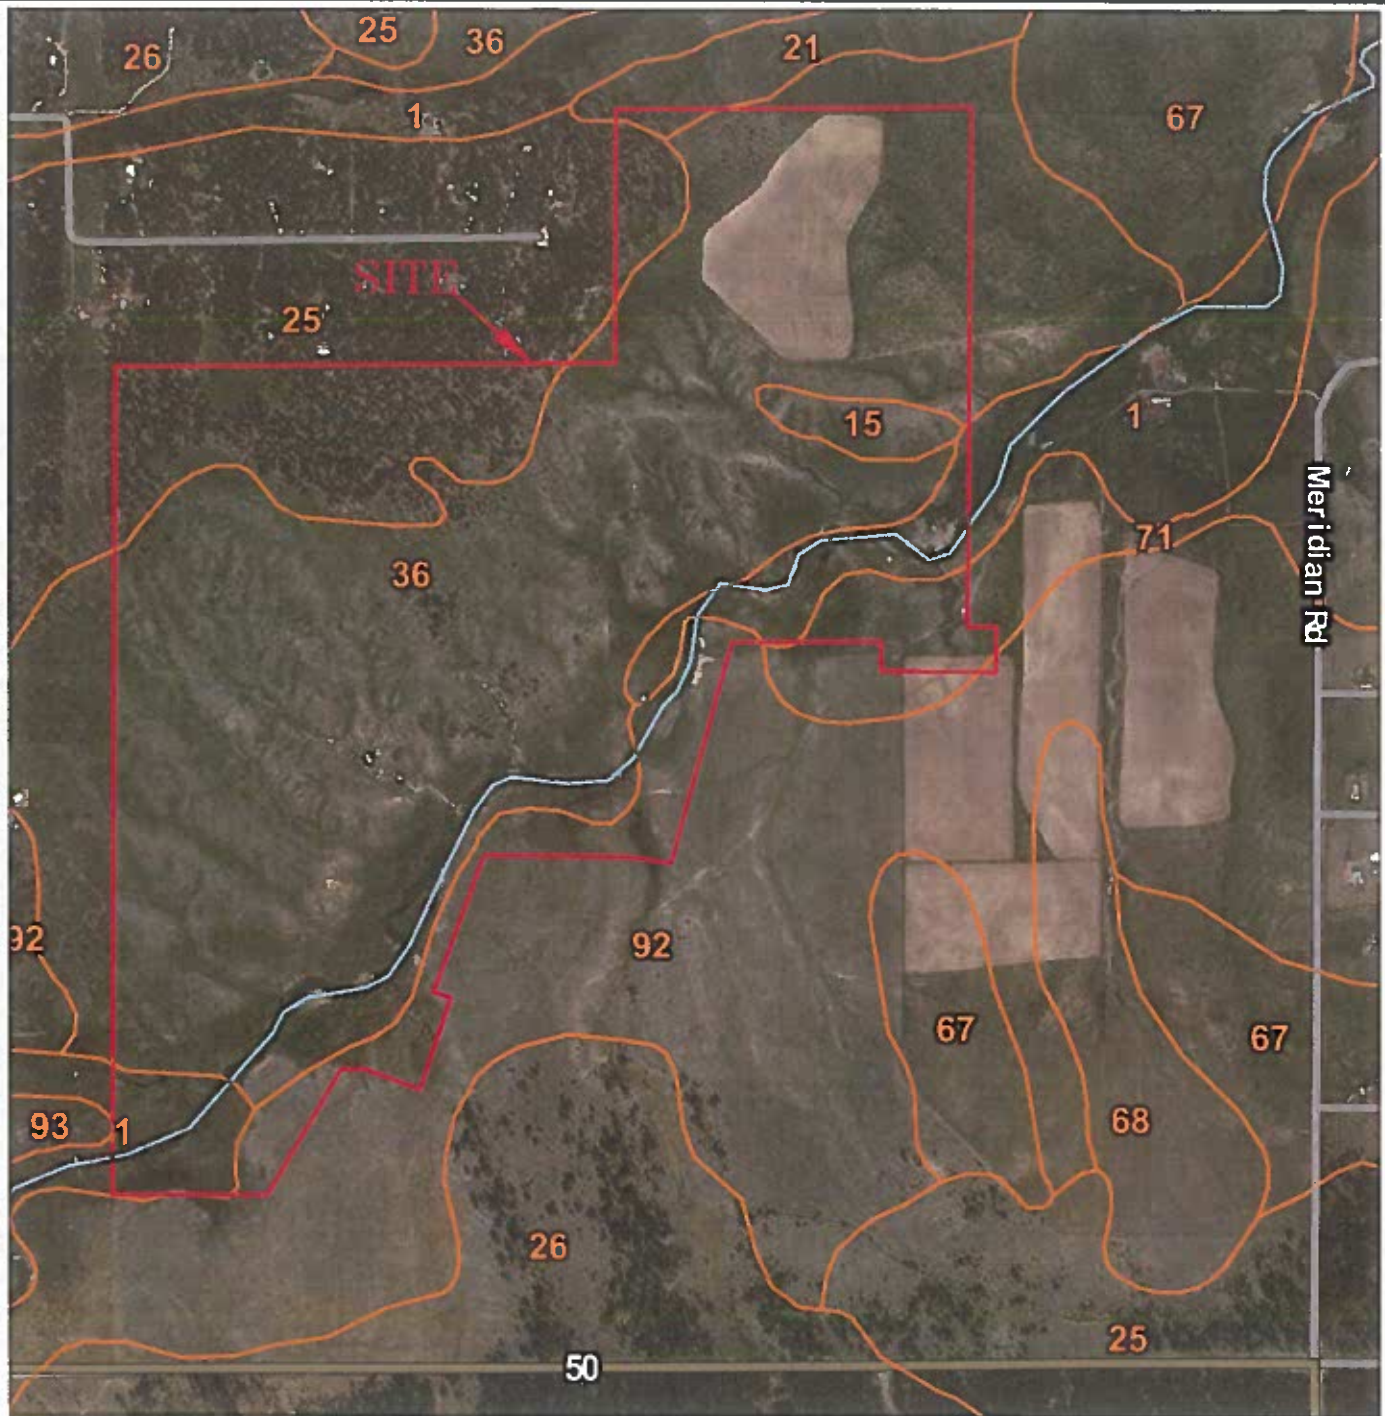
SOIL SURVEY MAP  
WINSOME SUBDIVISION - FILING NO. 3  
HODGEN ROAD & MERIDIAN ROAD  
EL PASO COUNTY, CO.  
FOR: WINSOME, LLC

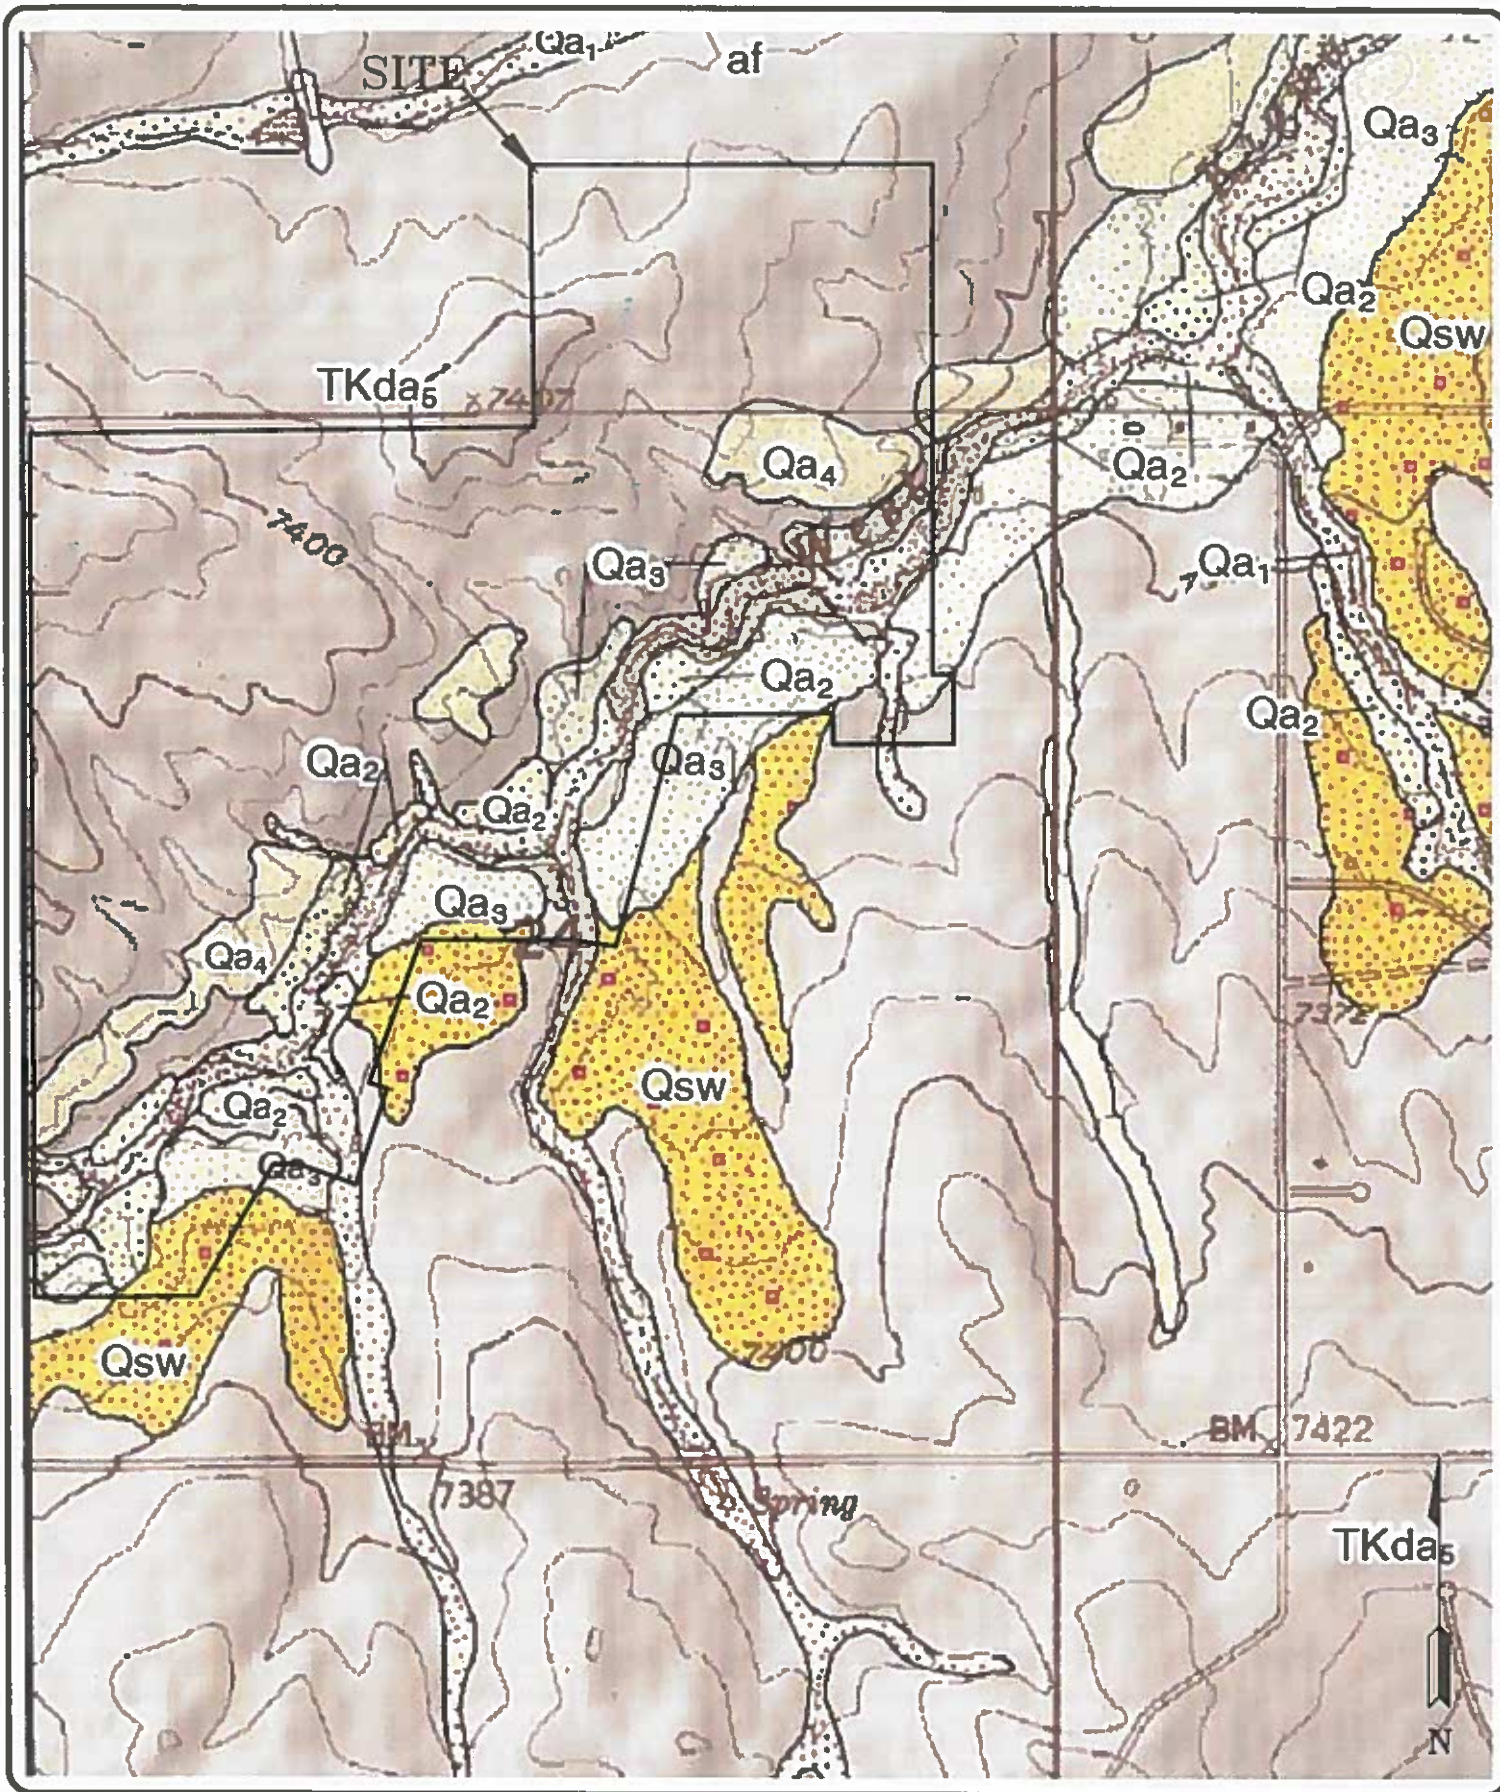
FIG NO.:  
4

EASTONVILLE QUADRANGLE GEOLOGIC MAP  
WINSOME SUBDIVISION - FILING NO. 3  
HODGEN ROAD & MERIDIAN ROAD  
EL PASO COUNTY, CO.  
FOR: WINSOME, LLC

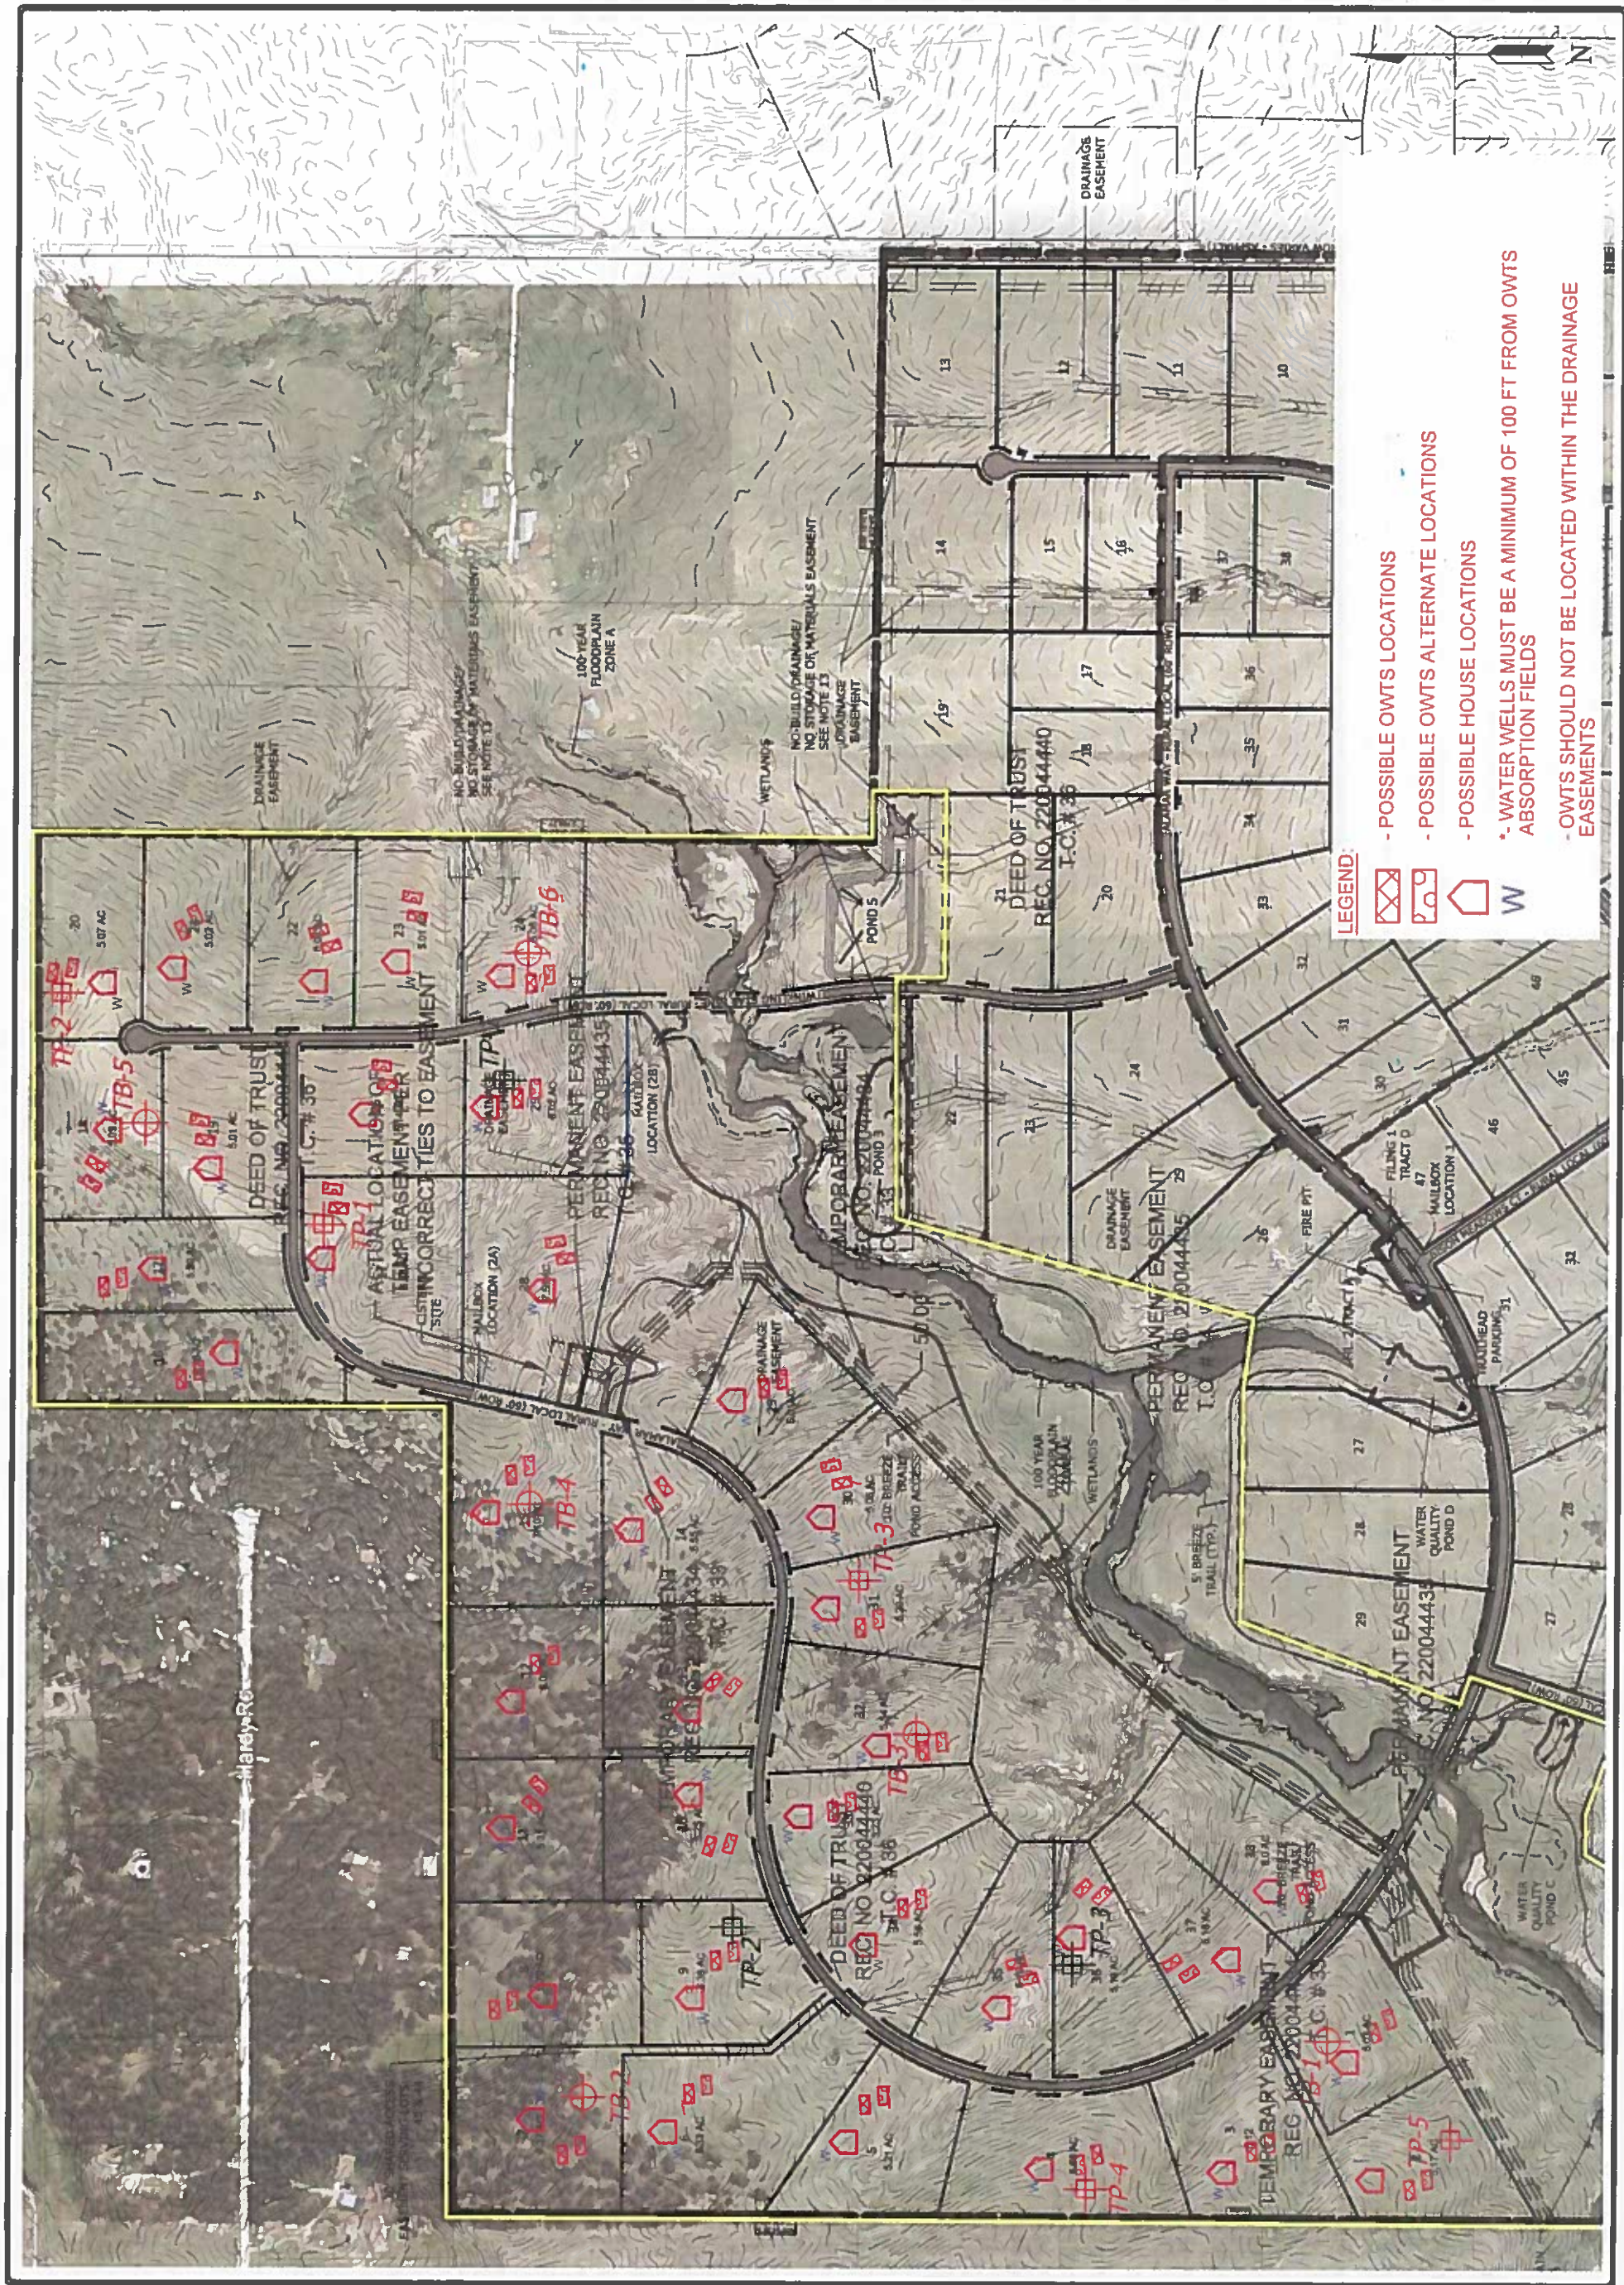
DOWN	DATE	AS SHOWN	FIGURE NO.
111.	5/21/21	JOB NO.	8
CHECKED	SUP	210539

SEPTIC SUITABILITY MAP  
WINSOME SUBDIVISION - FILING NO. 1  
HODGEN ROAD & MERIDIAN ROAD  
EL PASO COUNTY, TC.  
FOR: WINSOME, LTC

bedrock (less than 5 feet) was encountered in four of the test pits. The limiting layers encountered in the test pits are sandy clay loam (Soil Type 3A), sandy clay (Soil Types 3 and 4), silty to clayey sandstone (Soil Types 3A and 4A), and sandy claystone (Soil Type 4A), which correspond to LTAR values ranging from 0.35 to 0.15 gallons per day per square foot. The conditions encountered in the test pits excavated in Filing No. 3 will require designed systems. Additional investigation may identify areas where suitable conventional systems could be used on the lots.

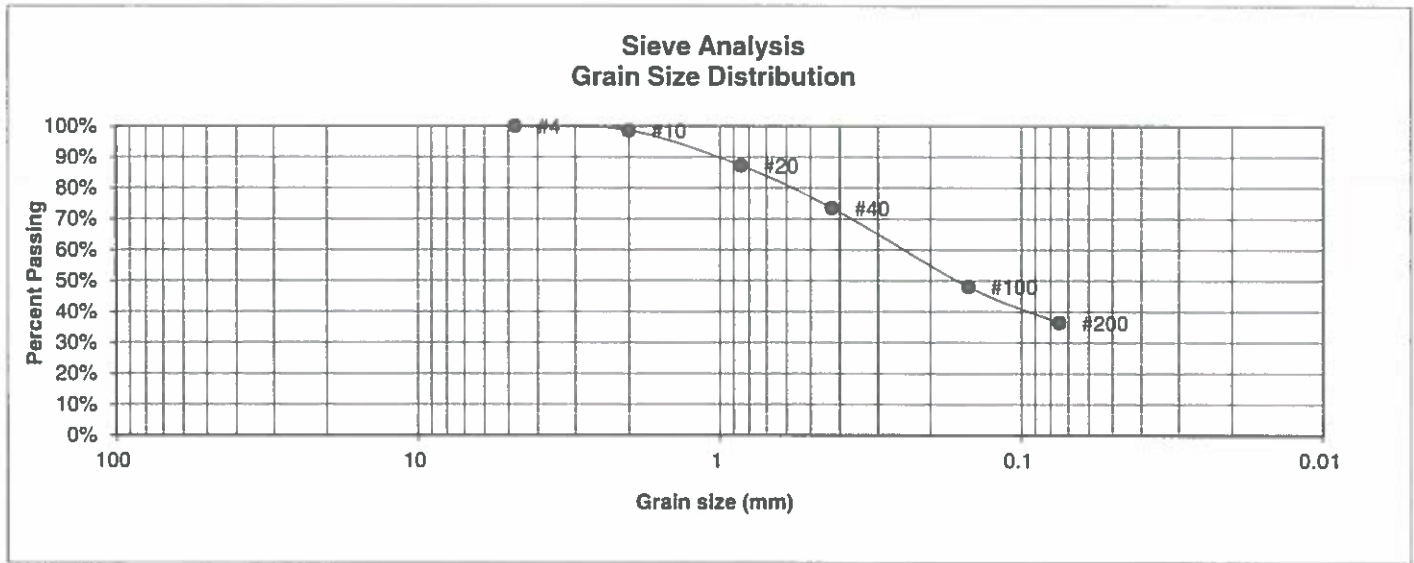
FIG NO.:  
B-1

<u>UNIFIED CLASSIFICATION</u>	SC	<u>CLIENT</u>	WINSOME, LLC
<u>SOIL TYPE #</u>	1	<u>PROJECT</u>	WINSOME SUBDIVISION
<u>TEST BORING #</u>	TP-1	<u>JOB NO.</u>	210539
<u>DEPTH (FT)</u>	1 - 2	<u>TEST BY</u>	BL

<u>U.S. Sieve #</u>	<u>Percent Finer</u>
3"	
1 1/2"	
3/4"	
1/2"	
3/8"	
4	100.0%
10	98.6%
20	87.2%
40	73.5%
100	48.1%
200	36.5%

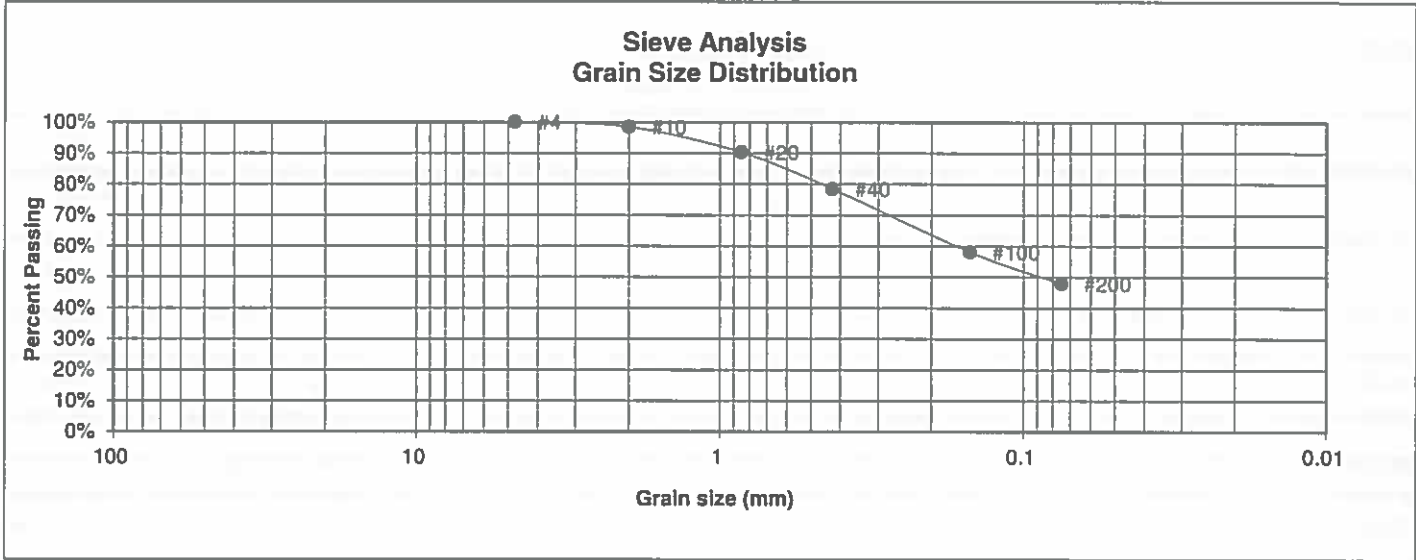
FIG NO.:  
B-2

<u>UNIFIED CLASSIFICATION</u>	SC	<u>CLIENT</u>	WINSOME, LLC
<u>SOIL TYPE #</u>	1	<u>PROJECT</u>	WINSOME SUBDIVISION
<u>TEST BORING #</u>	TP-2	<u>JOB NO.</u>	210539
<u>DEPTH (FT)</u>	1-3	<u>TEST BY</u>	BL

<u>U.S. Sieve #</u>	<u>Percent Finer</u>
3"	
1 1/2"	
3/4"	
1/2"	
3/8"	
4	100.0%
10	98.5%
20	90.3%
40	78.5%
100	58.1%
200	47.9%

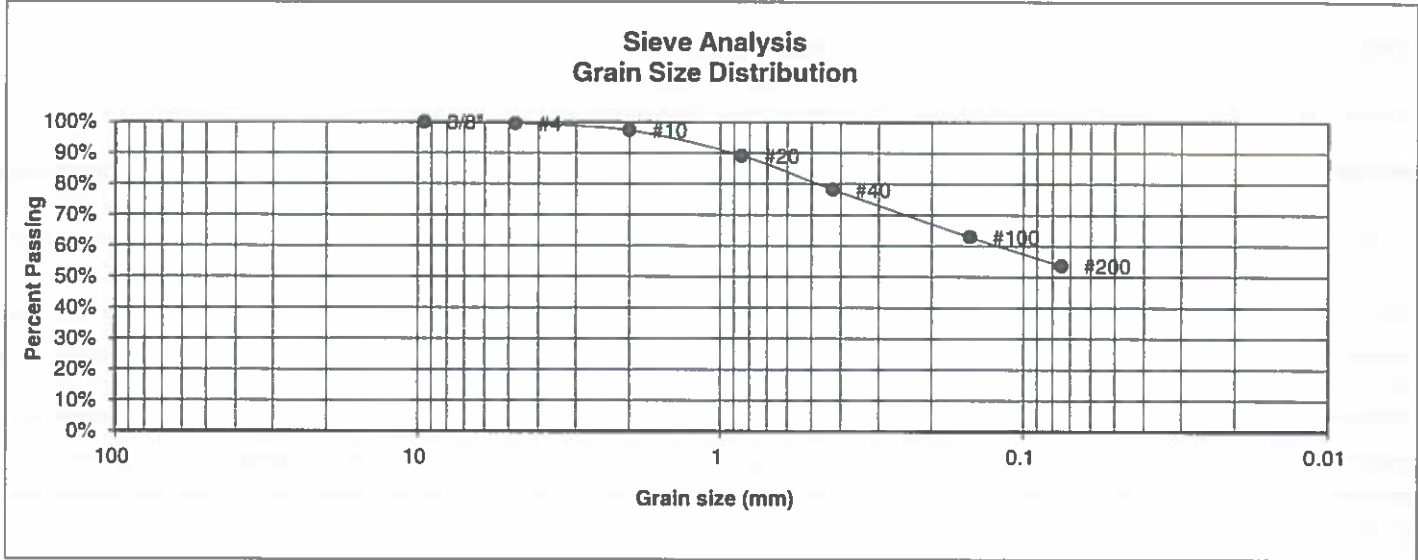
FIG NO.:  
B-3

<u>UNIFIED CLASSIFICATION</u>	CL	<u>CLIENT</u>	WINSOME, LLC
<u>SOIL TYPE #</u>	2	<u>PROJECT</u>	WINSOME SUBDIVISION
<u>TEST BORING #</u>	TP-2	<u>JOB NO.</u>	210539
<u>DEPTH (FT)</u>	3-4	<u>TEST BY</u>	BL

<u>U.S. Sieve #</u>	<u>Percent Finer</u>
3"	
1 1/2"	
3/4"	
1/2"	
3/8"	100.0%
4	99.5%
10	97.3%
20	89.2%
40	78.2%
100	62.9%
200	53.7%

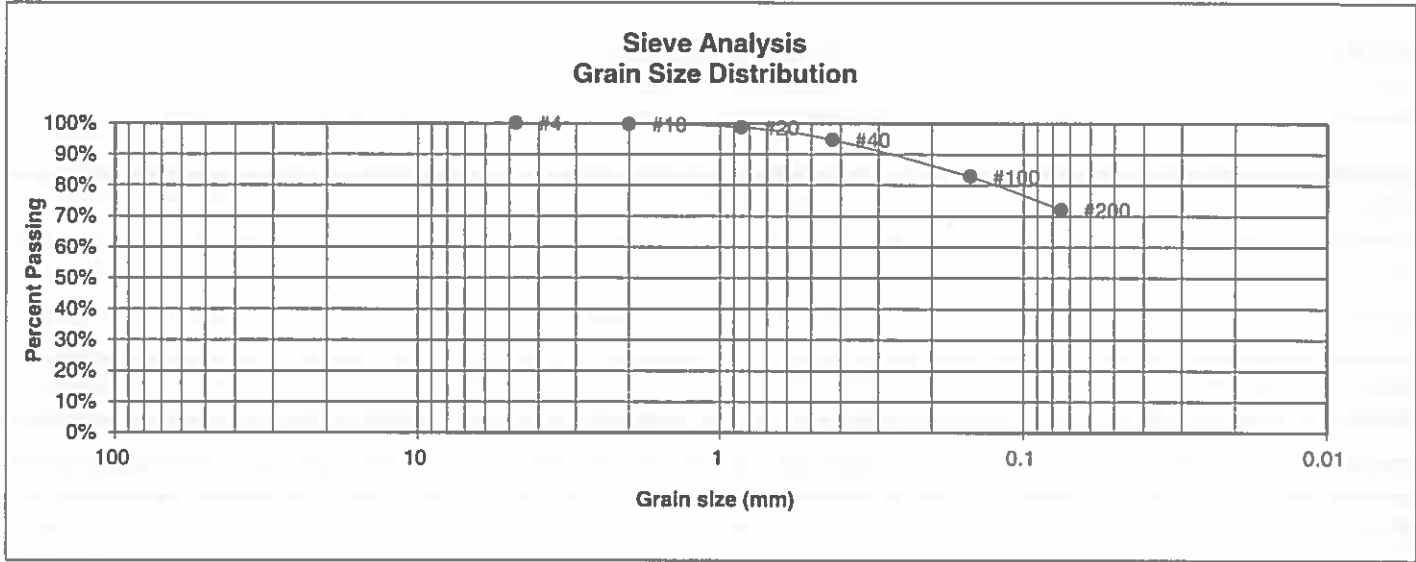
<u>UNIFIED CLASSIFICATION</u>	CL	<u>CLIENT</u>	WINSOME, LLC
<u>SOIL TYPE #</u>	2	<u>PROJECT</u>	WINSOME SUBDIVISION
<u>TEST BORING #</u>	TP-3	<u>JOB NO.</u>	210539
<u>DEPTH (FT)</u>	2-3	<u>TEST BY</u>	BL

<u>U.S. Sieve #</u>	<u>Percent Finer</u>
3"	
1 1/2"	
3/4"	
1/2"	
3/8"	
4	100.0%
10	99.7%
20	98.7%
40	94.7%
100	82.8%
200	72.1%

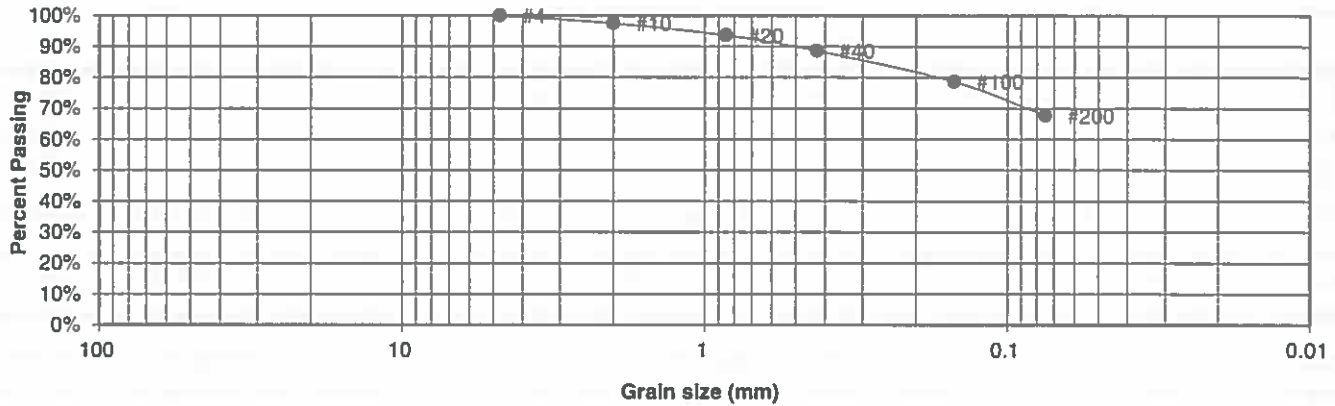
**Sieve Analysis  
Grain Size Distribution**

<u>U.S. Sieve #</u>	<u>Percent Finer</u>
3"	
1 1/2"	
3/4"	
1/2"	
3/8"	
4	100.0%
10	97.5%
20	93.6%
40	88.6%
100	78.7%
200	67.7%

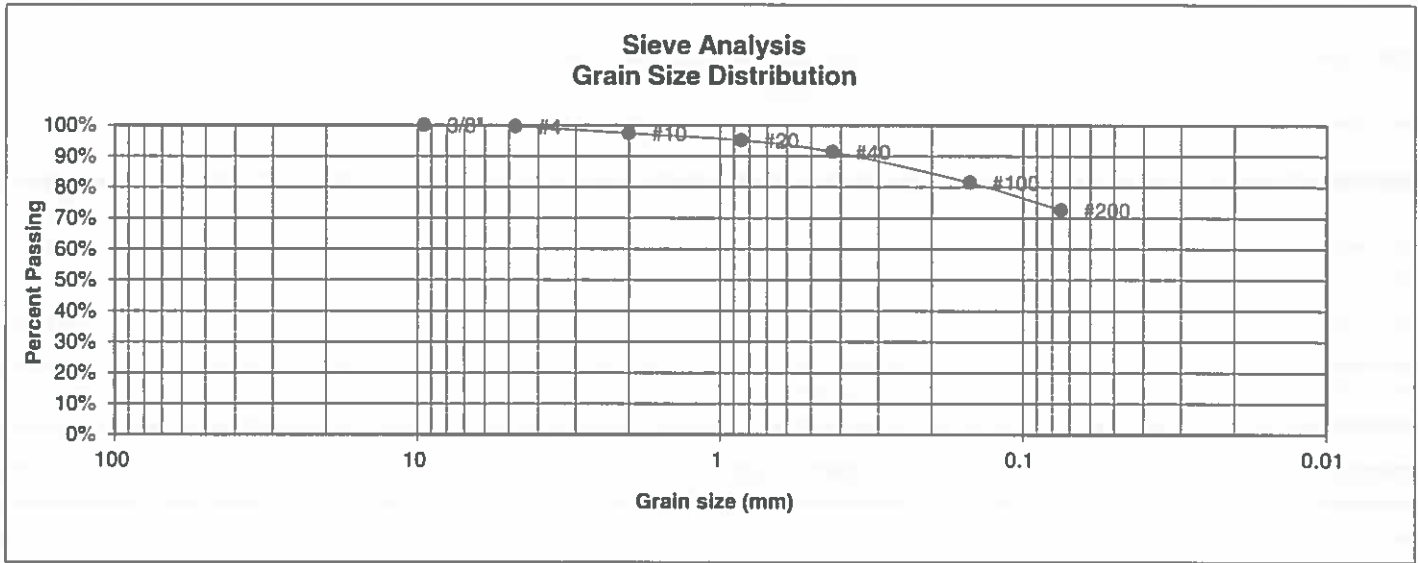
<u>UNIFIED CLASSIFICATION</u>	CL	<u>CLIENT</u>	WINSOME, LLC
<u>SOIL TYPE #</u>	2	<u>PROJECT</u>	WINSOME SUBDIVISION
<u>TEST BORING #</u>	TP-5	<u>JOB NO.</u>	210539
<u>DEPTH (FT)</u>	1	<u>TEST BY</u>	BL

<u>U.S. Sieve #</u>	<u>Percent Finer</u>
3"	
1 1/2"	
3/4"	
1/2"	
3/8"	100.0%
4	99.6%
10	97.4%
20	95.1%
40	91.4%
100	81.5%
200	72.6%

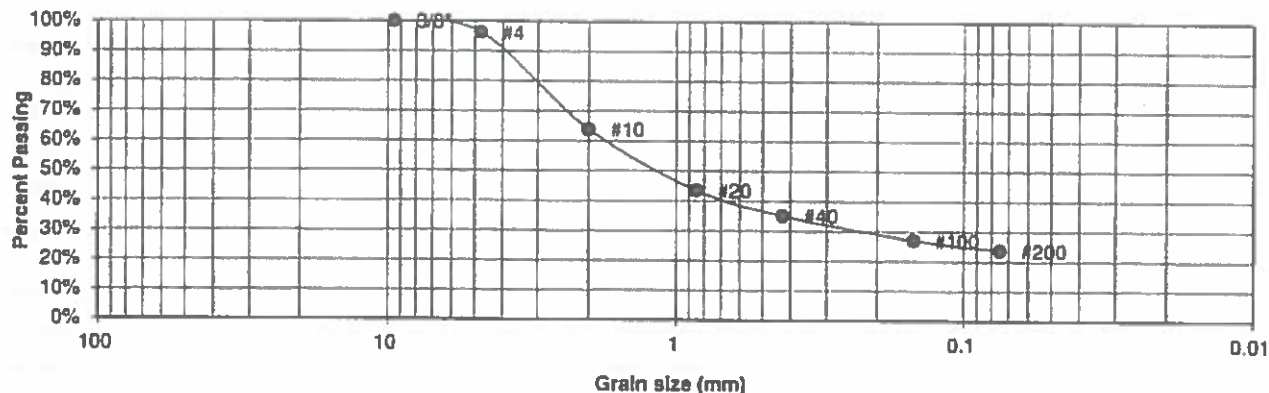
<b>UNIFIED CLASSIFICATION</b>	SM	<b>CLIENT</b>	PROTERRA PROPERTIES
<b>SOIL TYPE #</b>	1	<b>PROJECT</b>	WINSOME SUBDIVISION
<b>TEST BORING #</b>	TP-3	<b>JOB NO.</b>	181459
<b>DEPTH (FT)</b>	2-3	<b>TEST BY</b>	BL

### Sieve Analysis Grain Size Distribution

U.S. Sieve #	Percent Finer
3"	
1 1/2"	
3/4"	
1/2"	
3/8"	100.0%
4	96.3%
10	63.9%
20	43.5%
40	35.2%
100	27.0%
200	23.7%

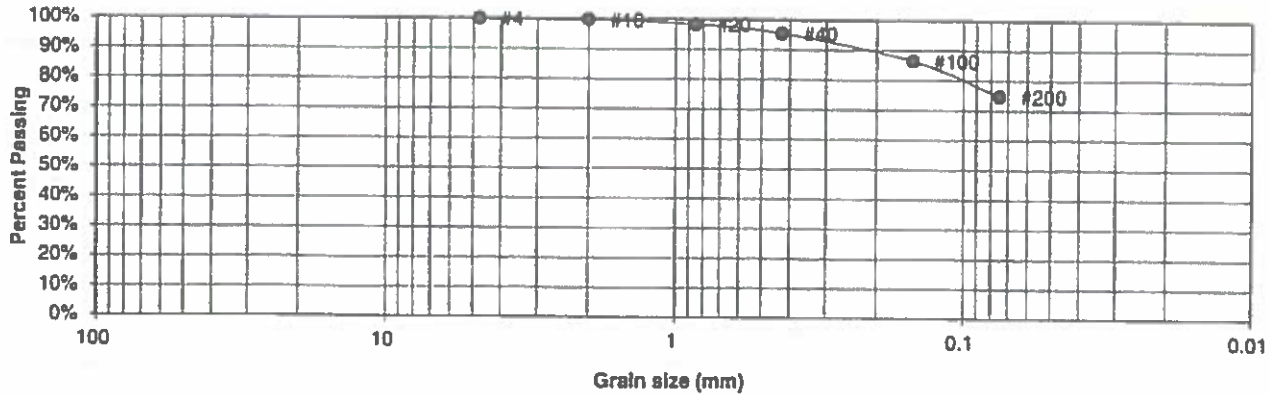
Sieve Analysis  
 Grain Size Distribution

U.S. Sieve #	Percent Finer
3"	
1 1/2"	
3/4"	
1/2"	
3/8"	
4	100.0%
10	99.8%
20	98.4%
40	95.4%
100	86.5%
200	74.8%

Atterberg  
Limits  
 Plastic Limit 20  
 Liquid Limit 30  
 Plastic Index 10

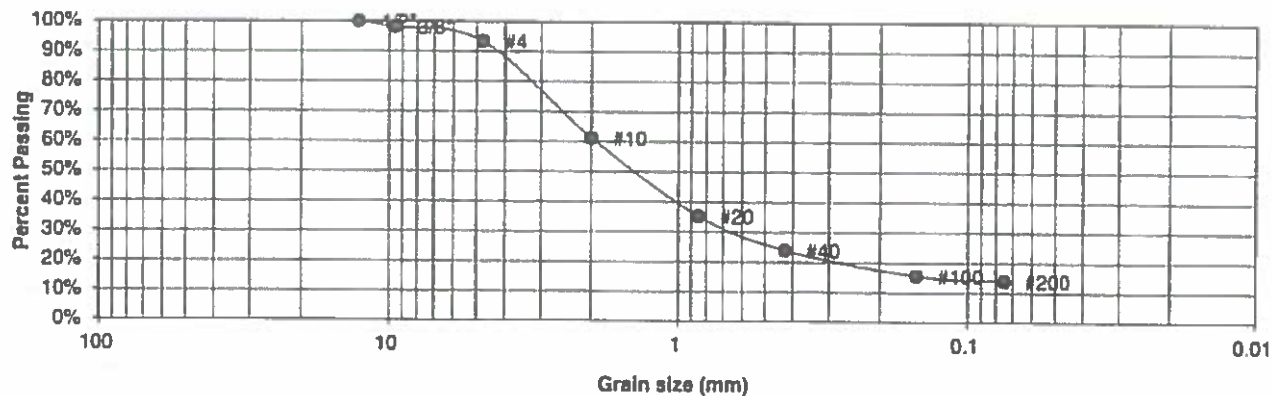
### Sieve Analysis Grain Size Distribution

U.S. Sieve #	Percent Finer
3"	
1 1/2"	
3/4"	
1/2"	100.0%
3/8"	98.2%
#4	93.4%
#10	61.2%
#20	35.3%
#40	24.0%
#100	15.6%
#200	14.0%

**Atterberg**  
**Limits**  
 Plastic Limit 21  
 Liquid Limit 30  
 Plastic Index 9
