**ENTECH**  
ENGINEERING, INC.

**SOILS AND GEOLOGY STUDY  
FLYING HORSE NORTH – FILING NO. 9  
EL PASO COUNTY, COLORADO**

Entech Job No. 260456

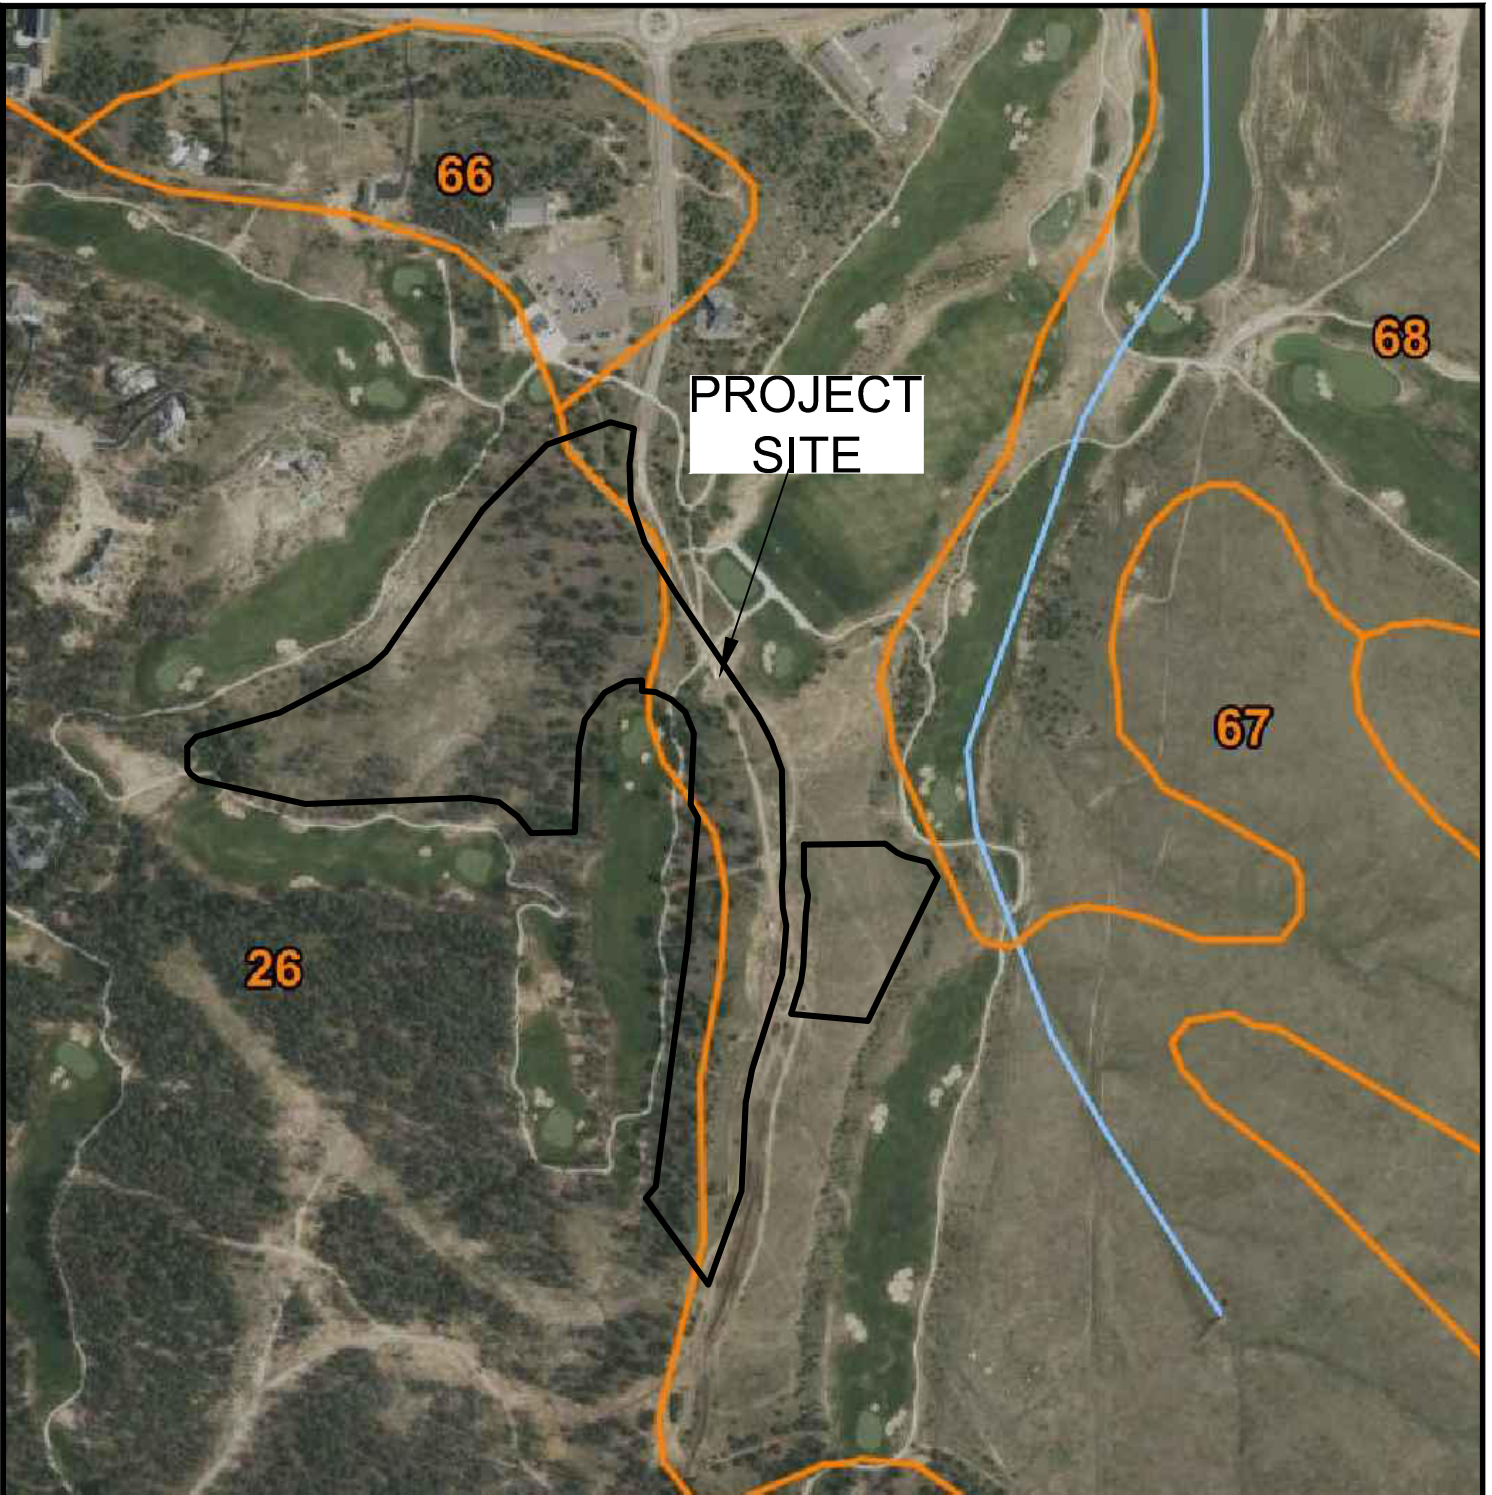
**FIG. 4**

**SOIL SURVEY MAP**

The Natural Resource Conservation Service (Reference 11), previously the Soil Conservation Service (Reference 12) has mapped two soil types on the site (Figure 4). In general, they vary from sandy loam to loam with subsoils of clay loam. The soils are described in exhibit 1 below.

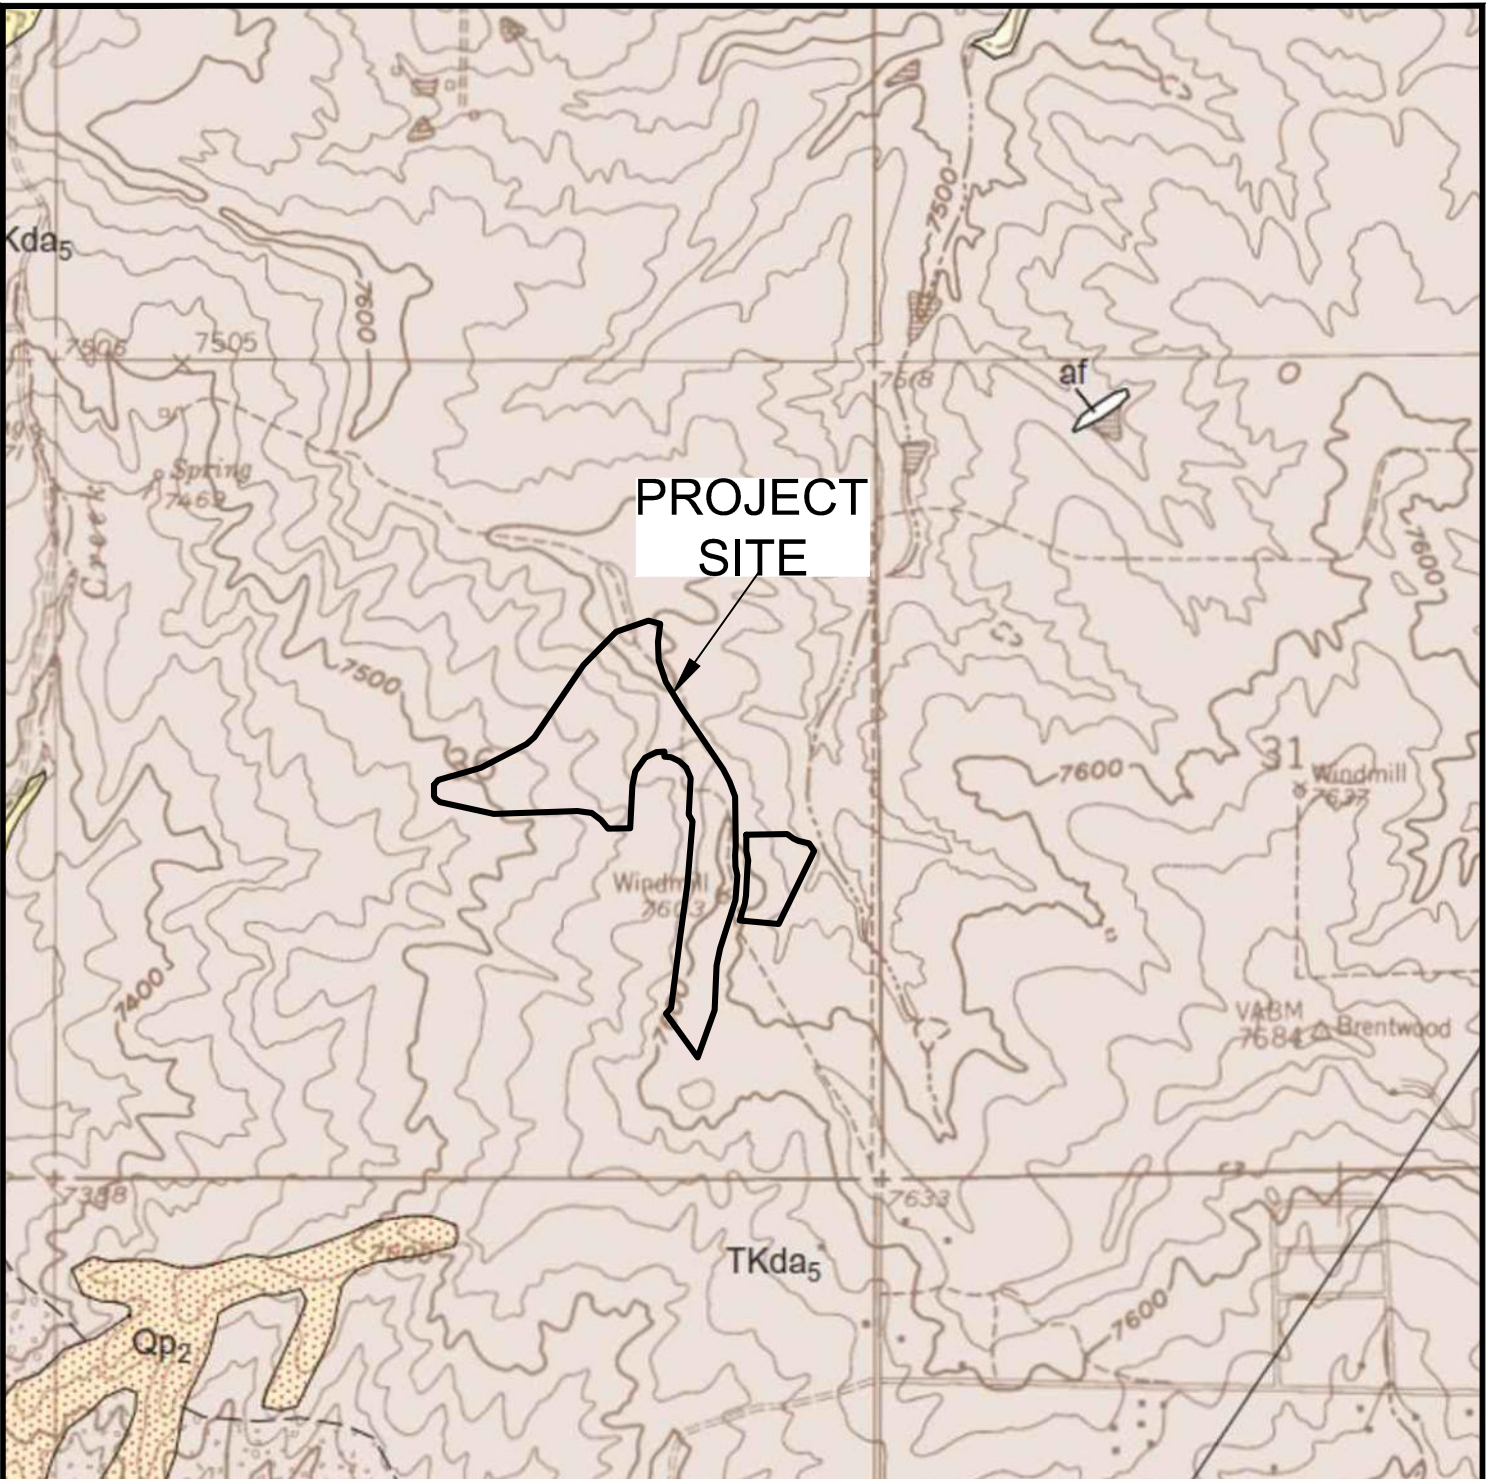
**FIG. 5**

**GEOLOGIC MAP OF THE  
BLACK FOREST QUADRANGLE**  
FLYING HORSE NORTH - FILING NO. 9  
FLYING HORSE NORTH, LLC

The Geologic Map of the Black Forest Quadrangle showing the site is presented in Figure 5 (Reference 13). The Geology/Engineering Geology Map prepared for the site is presented in Figure 6. One mappable unit was identified on this site which is described as follows:

The soils listed above were mapped from site-specific mapping, the *Geologic Map of the Black Forest Quadrangle* distributed by the Colorado Geological Survey in 2003 (Reference 14), the *Geologic Map of the Colorado Springs-Castle Rock Area*, distributed by the US Geological Survey in 1979 (Reference 15), and the *Geologic Map of the Denver 1° x 2° Quadrangle*, distributed by the US Geological Survey in 1981 (Reference 16). The Test Borings and Test Pit Logs used in evaluating the site are included in Appendix B. The Geology Map prepared for the site is presented in Figure 6.

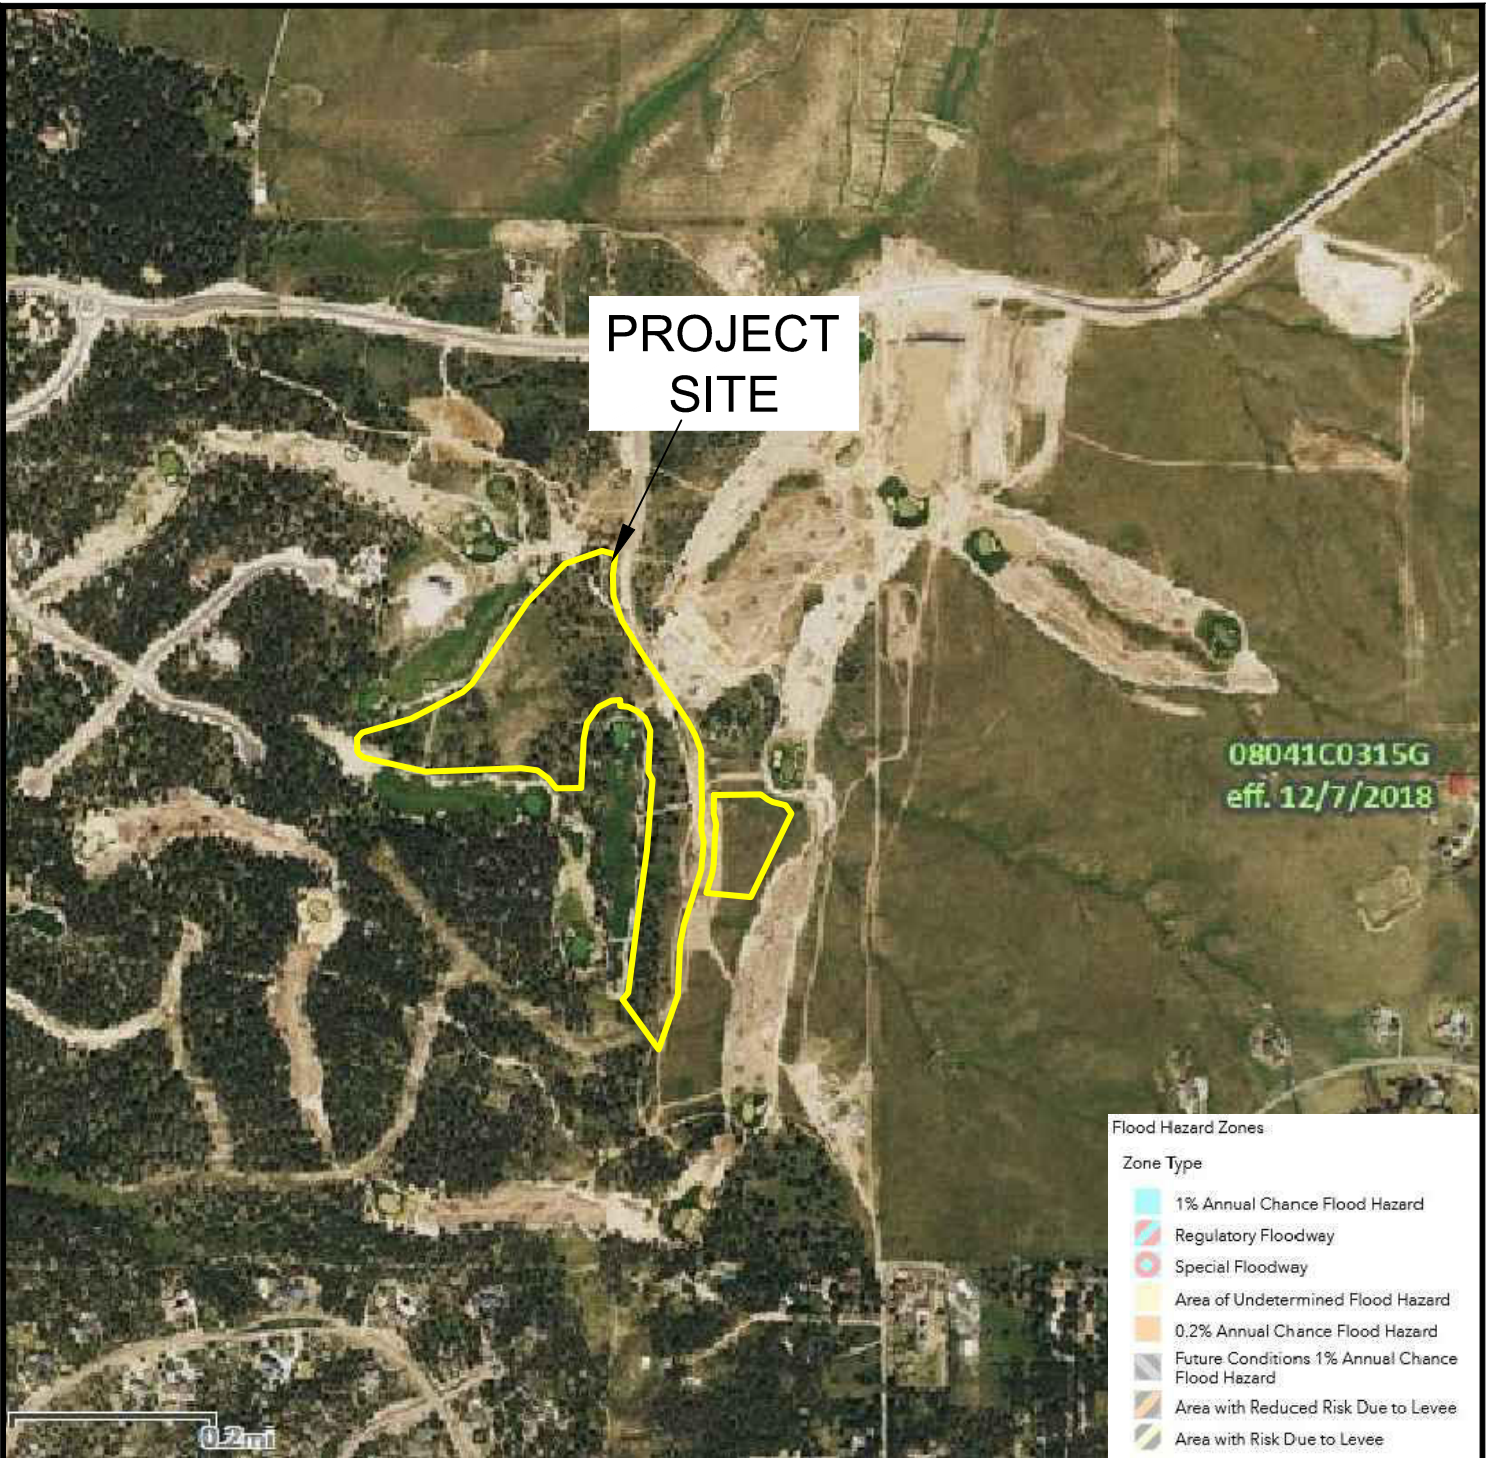
**FIG. 7**

**FEMA FLOODPLAIN MAP**

Filing No. 9 does not lie within any floodplain zones according to the FEMA Map No.08041CO315G, dated December 7, 2018 (Figure 7, Reference 17). The exact locations of floodplain and specific drainage studies are beyond the scope of this report. Additionally, Filing No. 9 has not been included in any mapped wetlands according to National Wetland Inventory (Reference 18). Minor drainage swales were observed in the western portion of Filing No. 9 on portions of Lots 2 – 6 and the detention pond tract. Water was not observed flowing in the minor drainage swales at the time of this investigation, however, these areas have been identified as potential seasonally shallow groundwater areas and have identified on the Geology/Engineering Geology Map, Figure 6.

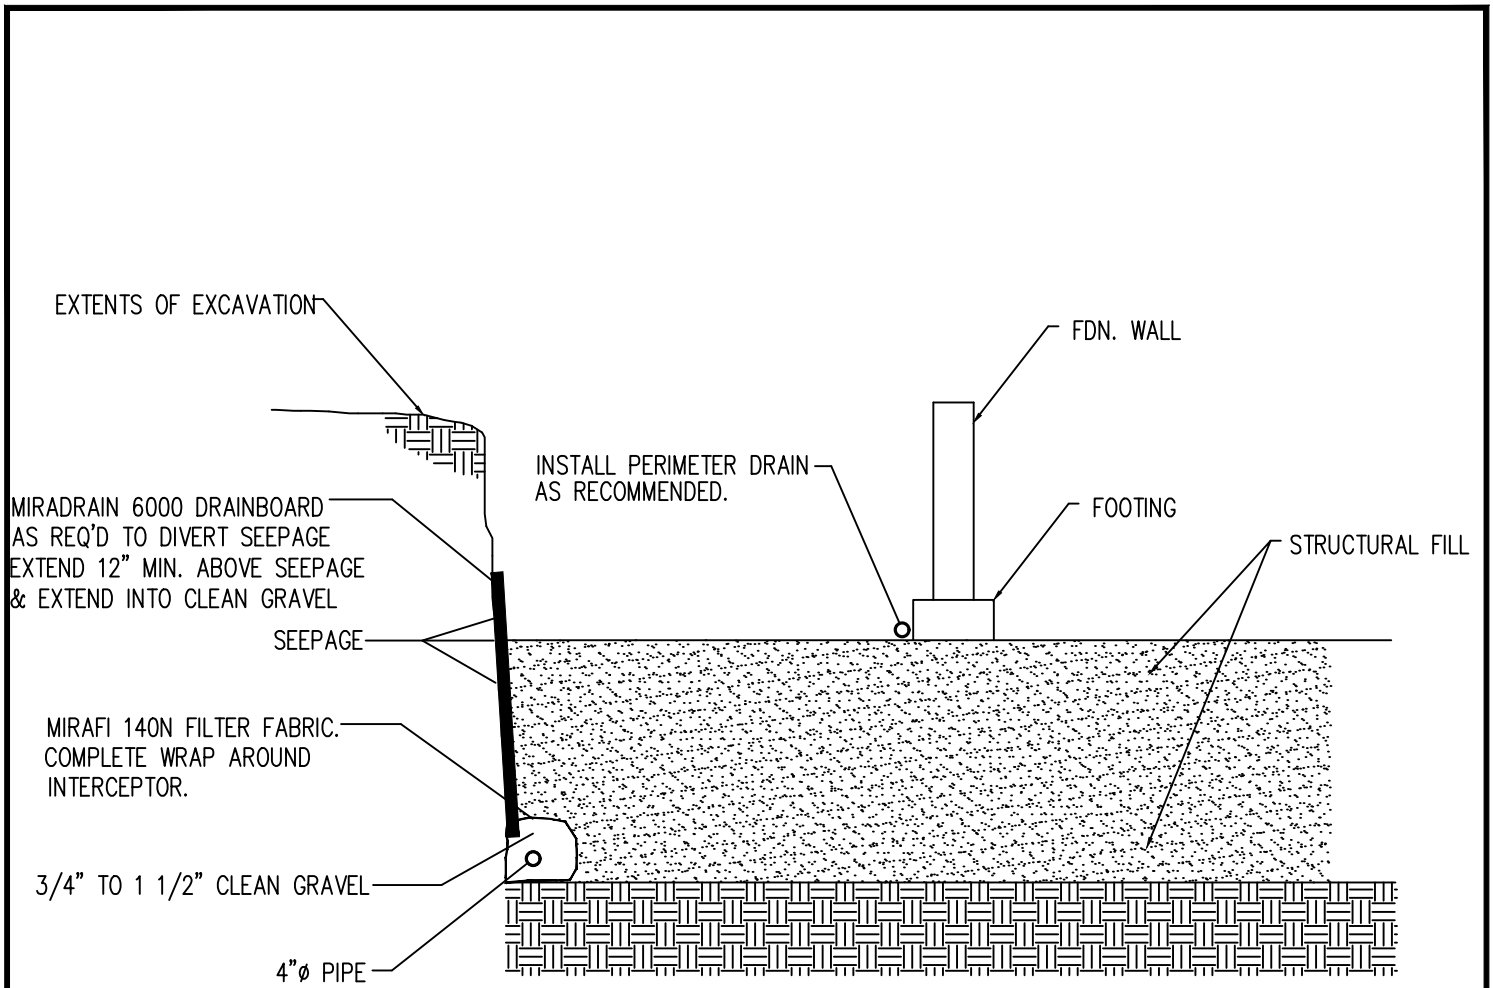
**FIG. 9**

NOTE:  
 EXTEND INTERCEPTOR DRAIN TO UNDERDRAIN OR TO SUMP.  
 BENCH DRAIN INTO NATIVE SOILS 12 INCHES MINIMUM.

## INTERCEPTOR DRAIN DETAIL

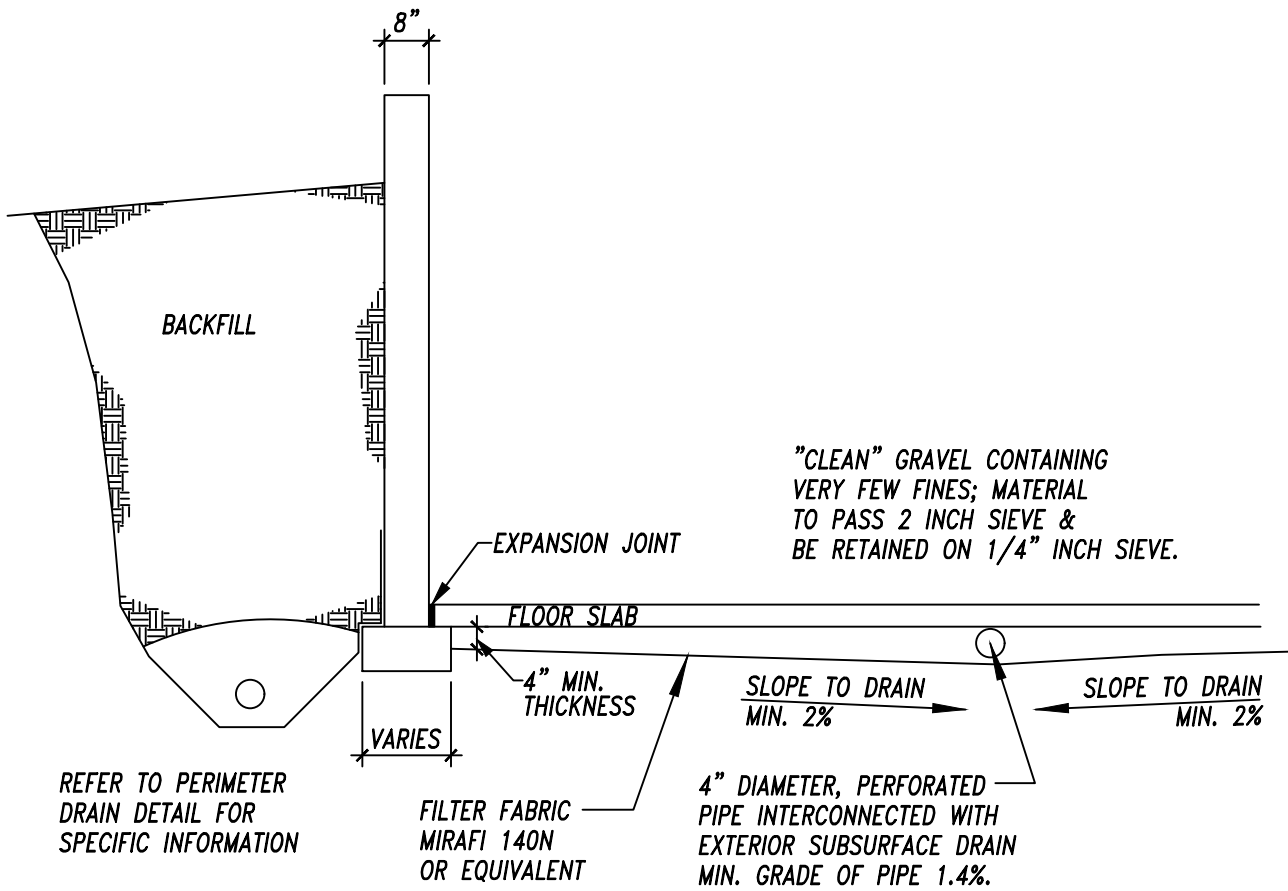
**FIG. 10**

**TYP. UNDERSLAB DRAINAGE LAYER  
(CAPILLARY BREAK)**  
FLYING HORSE NORTH - FILING NO. 9  
FLYING HORSE NORTH, LLC

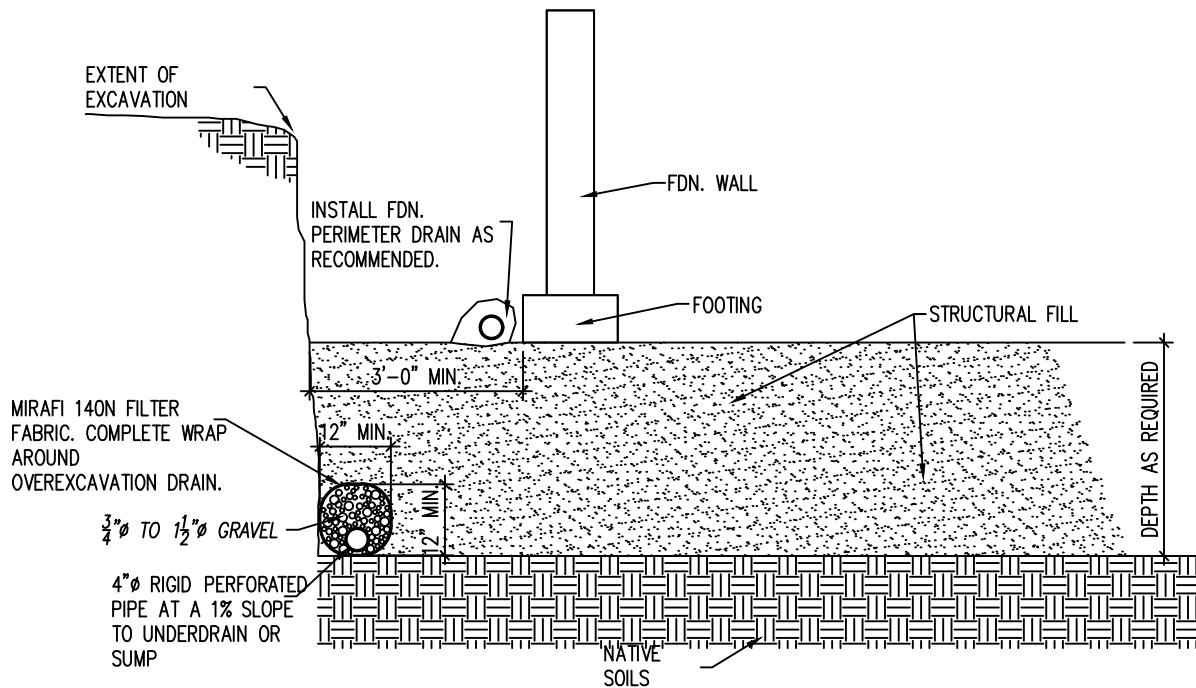
**FIG. 11**

## OVEREXCAVATION DRAIN DETAIL

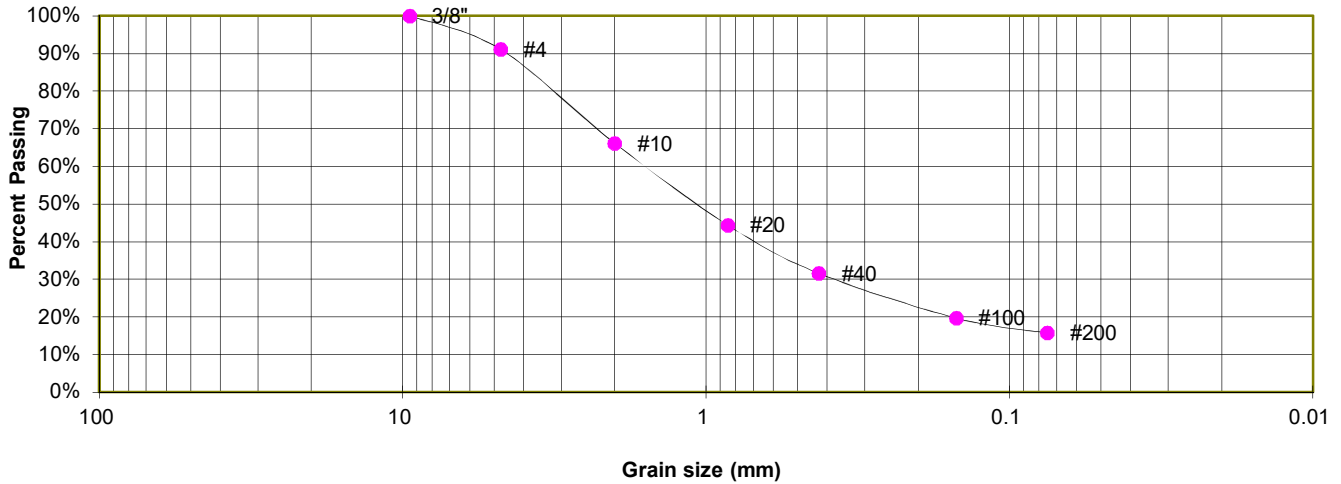
SOIL DESCRIPTION SAND, SILTY  
 SOIL TYPE 1

**GRAIN SIZE ANALYSIS**

U.S. Sieve #	Percent Finer
3"	
1 1/2"	
3/4"	
1/2"	
3/8"	100.0%
4	91.1%
10	66.1%
20	44.4%
40	31.6%
100	19.7%
200	15.7%

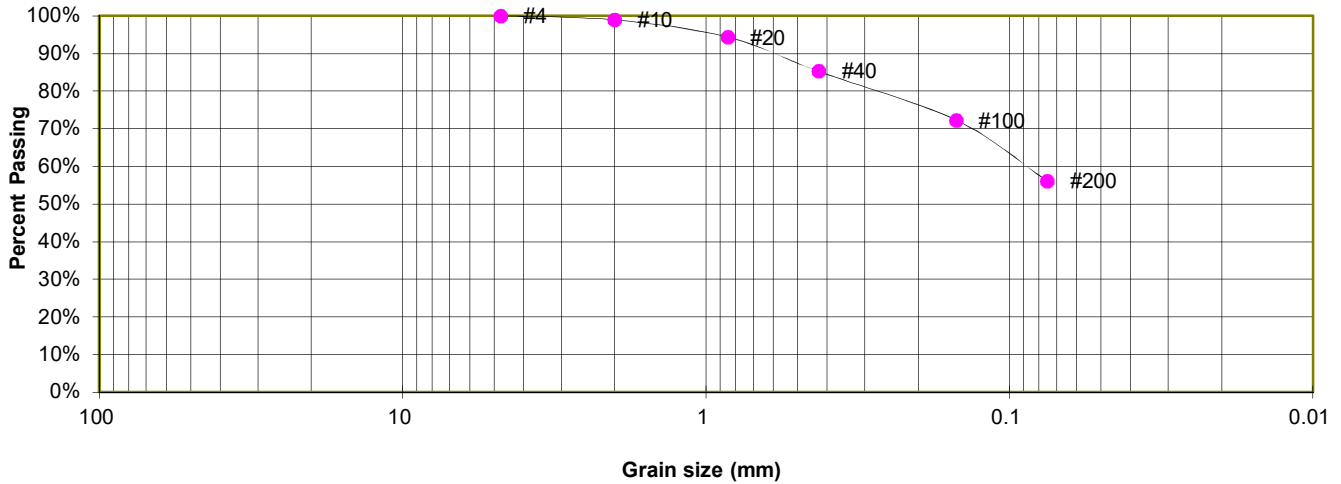
SOIL DESCRIPTION CLAY, SANDY  
 SOIL TYPE 2

**GRAIN SIZE ANALYSIS**

U.S. Sieve #	Percent Finer
3"	
1 1/2"	
3/4"	
1/2"	
3/8"	
4	100.0%
10	98.9%
20	94.4%
40	85.3%
100	72.3%
200	56.2%

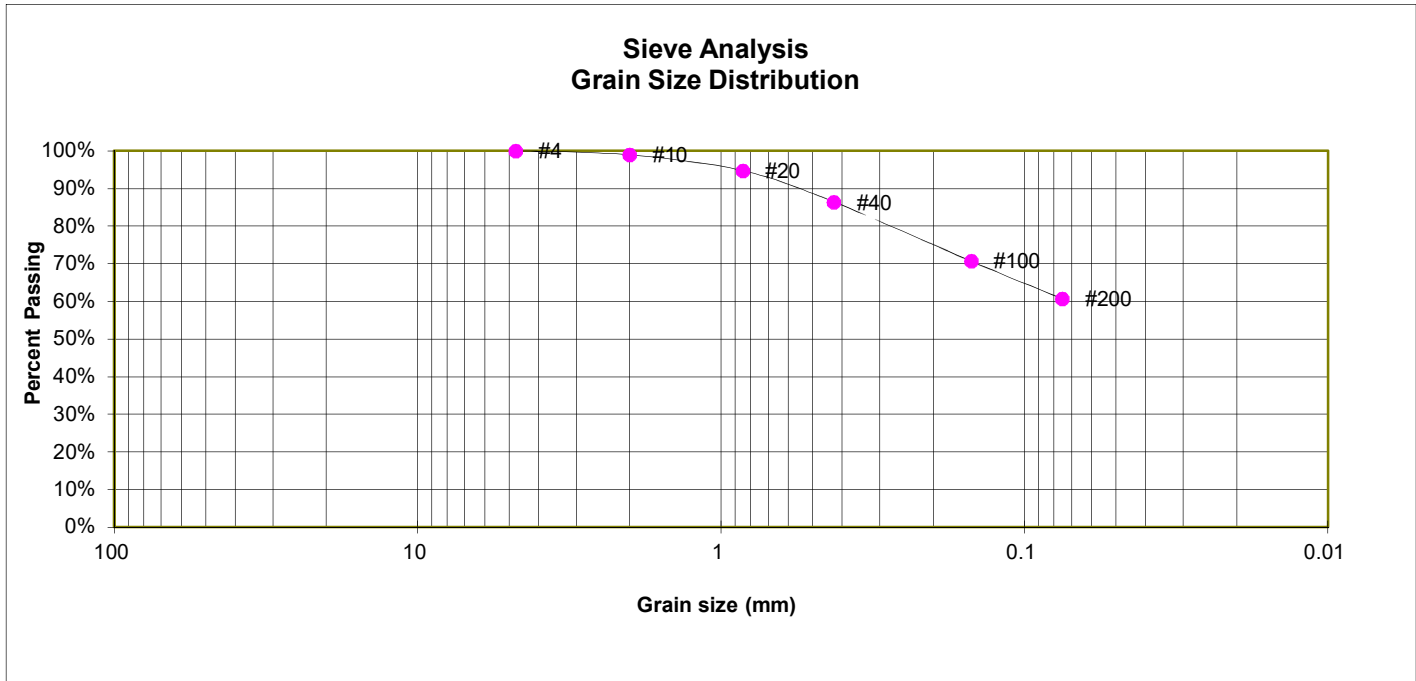
TEST BORING 1  
 DEPTH (FT) 5

SOIL DESCRIPTION CLAY, SANDY  
 SOIL TYPE 2

**GRAIN SIZE ANALYSIS**

U.S. Sieve #	Percent Finer
3"	
1 1/2"	
3/4"	
1/2"	
3/8"	
4	100.0%
10	98.9%
20	94.8%
40	86.4%
100	70.7%
200	60.7%

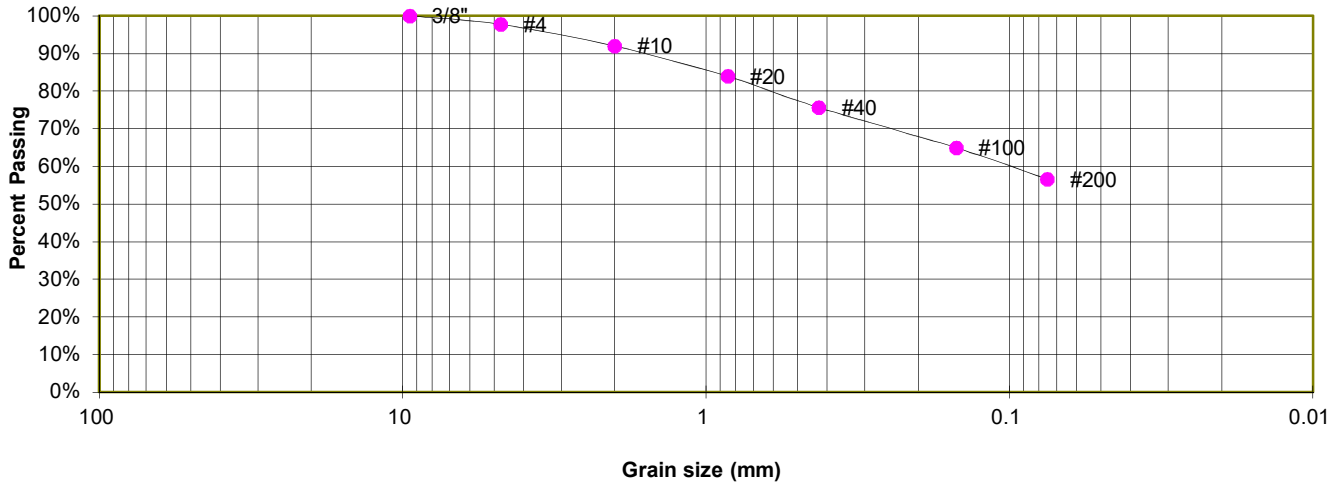
SOIL DESCRIPTION CLAY, SANDY  
 SOIL TYPE 2

**GRAIN SIZE ANALYSIS**

U.S. Sieve #	Percent Finer
3"	
1 1/2"	
3/4"	
1/2"	
3/8"	100.0%
4	97.7%
10	92.0%
20	83.9%
40	75.6%
100	65.0%
200	56.6%

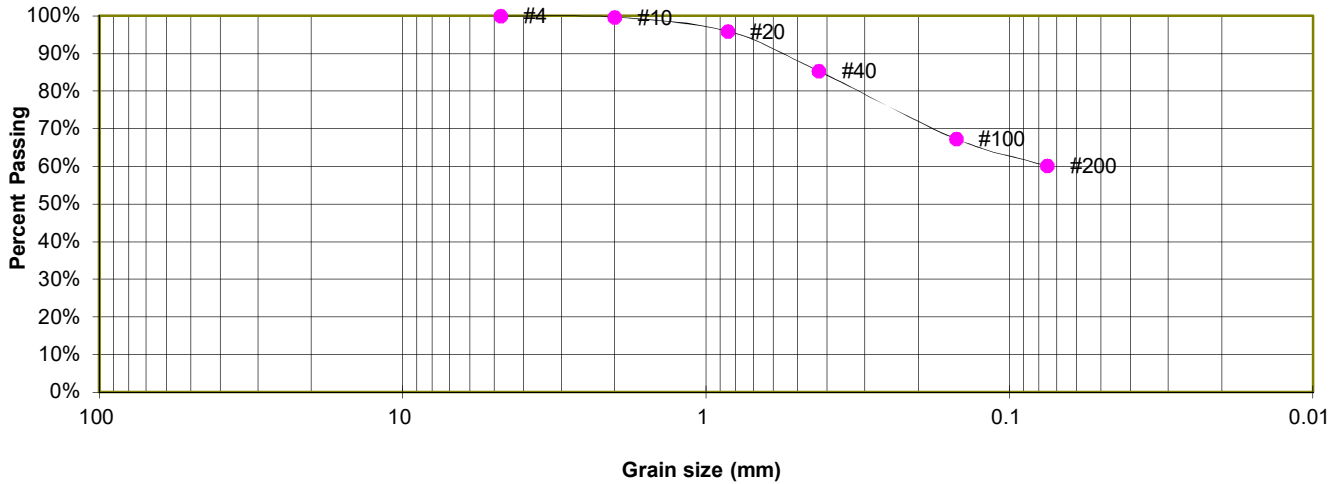
SOIL DESCRIPTION CLAY, SANDY  
SOIL TYPE 2

#### **GRAIN SIZE ANALYSIS**

U.S. Sieve #	Percent Finer
3"	
1 1/2"	
3/4"	
1/2"	
3/8"	
4	100.0%
10	99.7%
20	96.0%
40	85.3%
100	67.3%
200	60.1%

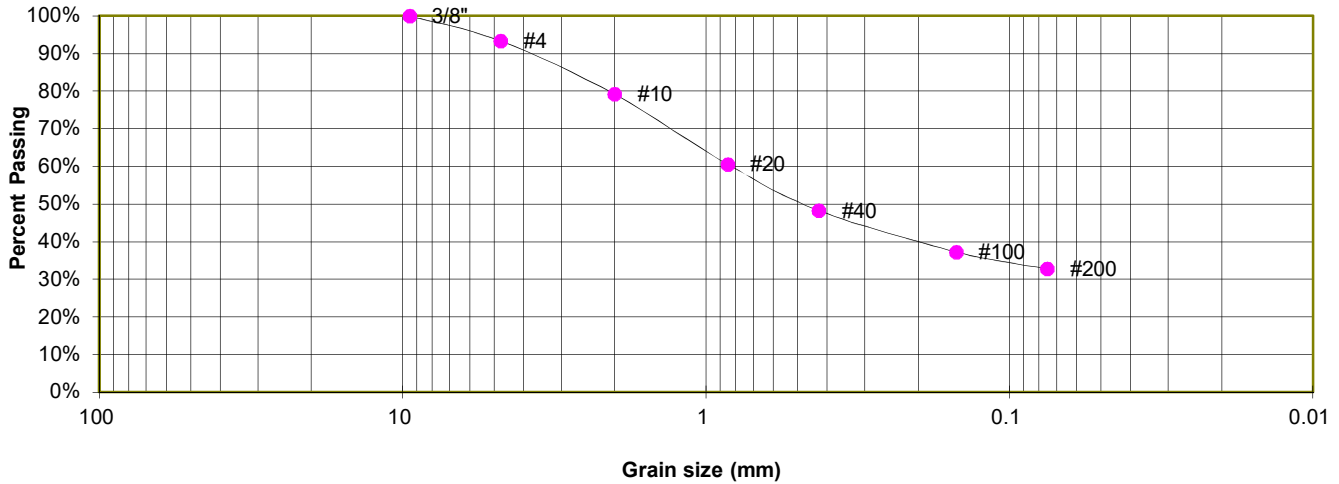
SOIL DESCRIPTION SANDSTONE (SAND, CLAYEY)  
 SOIL TYPE 3

**GRAIN SIZE ANALYSIS**

U.S. Sieve #	Percent Finer
3"	
1 1/2"	
3/4"	
1/2"	
3/8"	100.0%
4	93.3%
10	79.2%
20	60.6%
40	48.3%
100	37.3%
200	32.7%

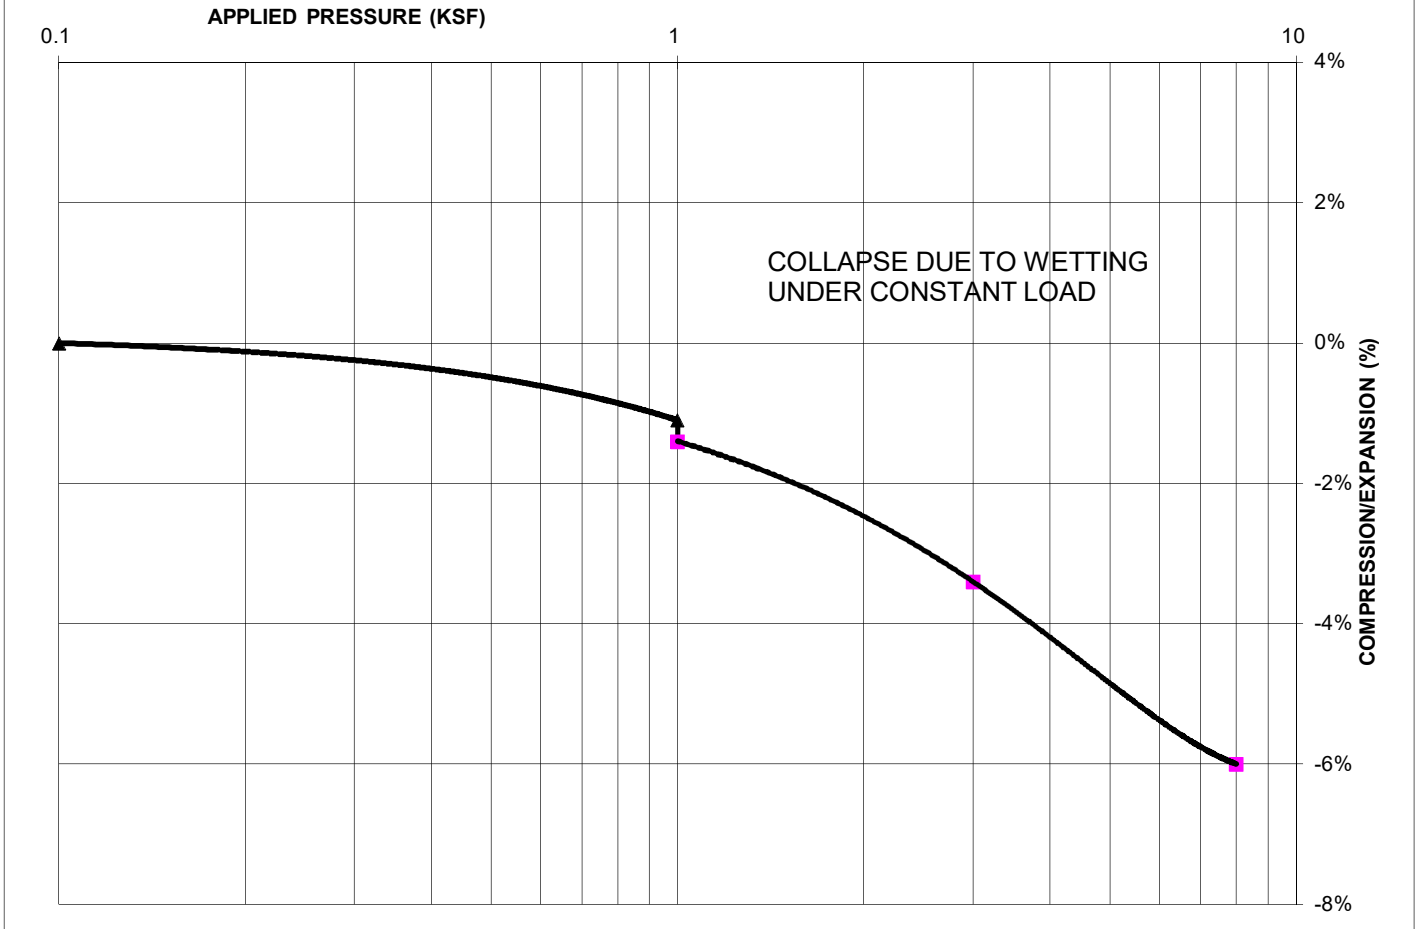
SOIL DESCRIPTION CLAY, SANDY  
SOIL TYPE 2

### SWELL CONSOLIDATION

#### **SWELL/COLLAPSE TEST RESULTS**

NATURAL UNIT DRY WEIGHT (PCF): 114  
NATURAL MOISTURE CONTENT: 10.1%  
SWELL/COLLAPSE (%): -0.3%

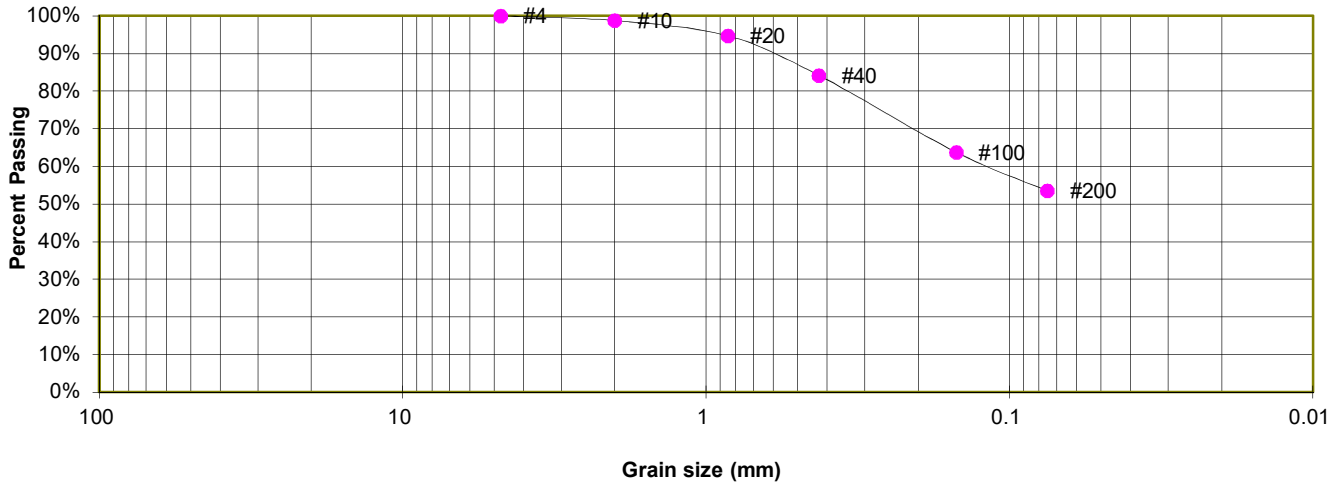
SOIL DESCRIPTION CLAY, SANDY

**GRAIN SIZE ANALYSIS**

U.S. Sieve #	Percent Finer
3"	
1 1/2"	
3/4"	
1/2"	
3/8"	
4	100.0%
10	98.8%
20	94.7%
40	84.2%
100	63.8%
200	53.5%

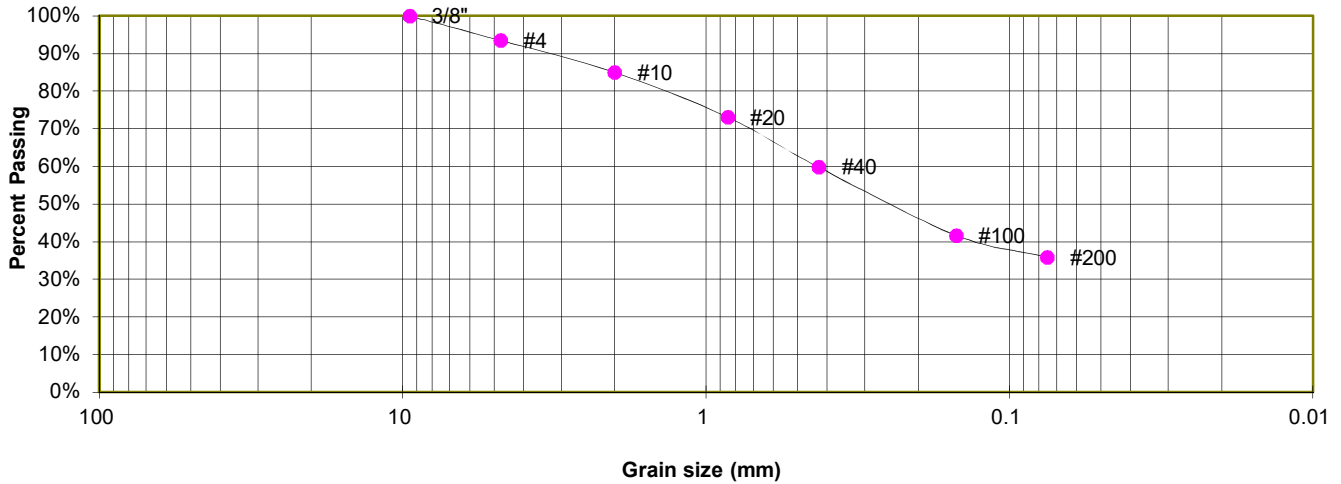
SOIL DESCRIPTION SAND, CLAYEY

**GRAIN SIZE ANALYSIS**

U.S. Sieve #	Percent Finer
3"	
1 1/2"	
3/4"	
1/2"	
3/8"	100.0%
4	93.5%
10	85.0%
20	73.1%
40	59.8%
100	41.7%
200	35.8%

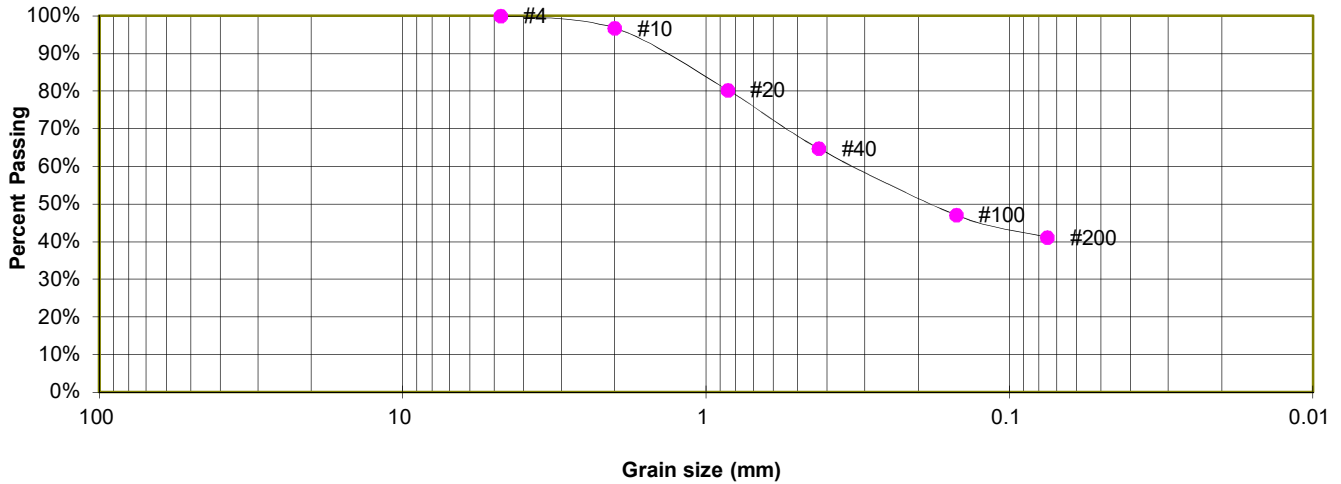
SOIL DESCRIPTION SAND, CLAYEY

**GRAIN SIZE ANALYSIS**

U.S. Sieve #	Percent Finer
3"	
1 1/2"	
3/4"	
1/2"	
3/8"	
4	100.0%
10	96.8%
20	80.3%
40	64.8%
100	47.1%
200	41.1%

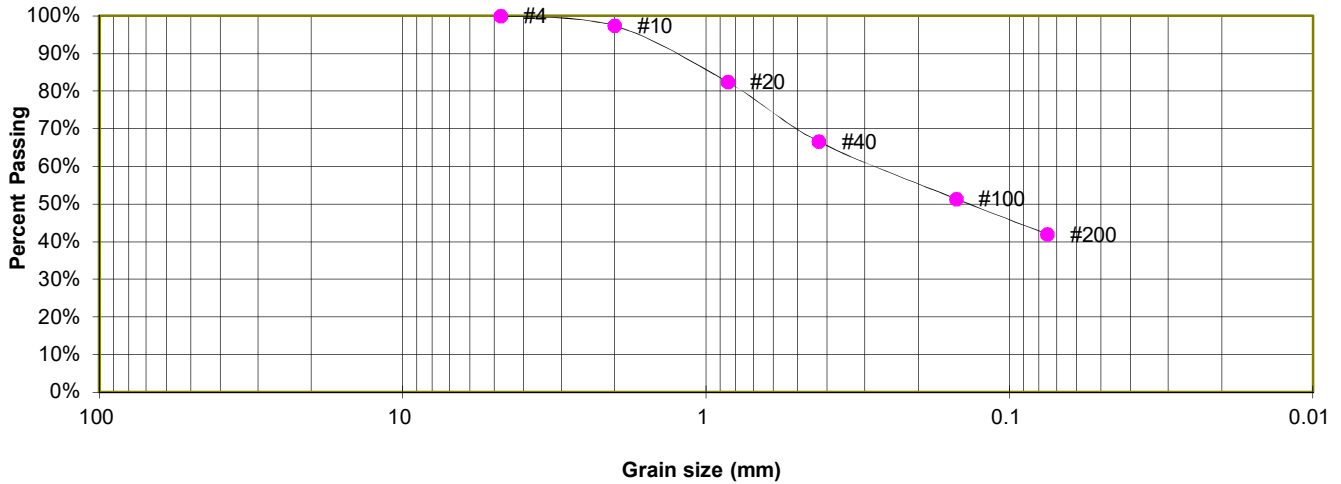
SOIL DESCRIPTION SAND, CLAYEY

**GRAIN SIZE ANALYSIS**

U.S. Sieve #	Percent Finer
3"	
1 1/2"	
3/4"	
1/2"	
3/8"	
4	100.0%
10	97.4%
20	82.4%
40	66.6%
100	51.4%
200	42.0%

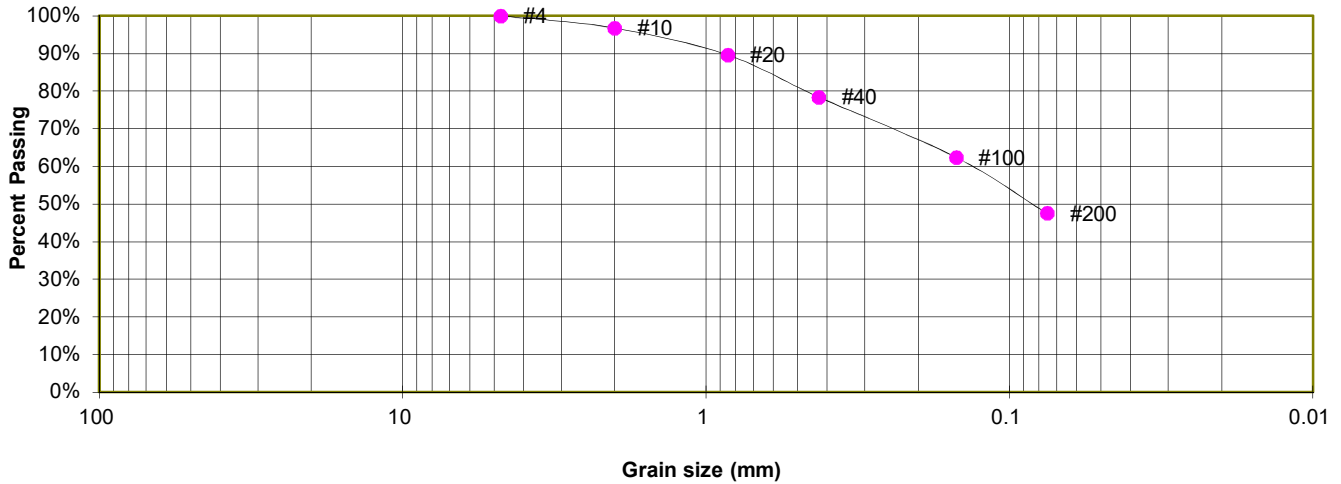
SOIL DESCRIPTION SAND, CLAYEY

**GRAIN SIZE ANALYSIS**

U.S. Sieve #	Percent Finer
3"	
1 1/2"	
3/4"	
1/2"	
3/8"	
4	100.0%
10	96.8%
20	89.6%
40	78.4%
100	62.4%
200	47.5%

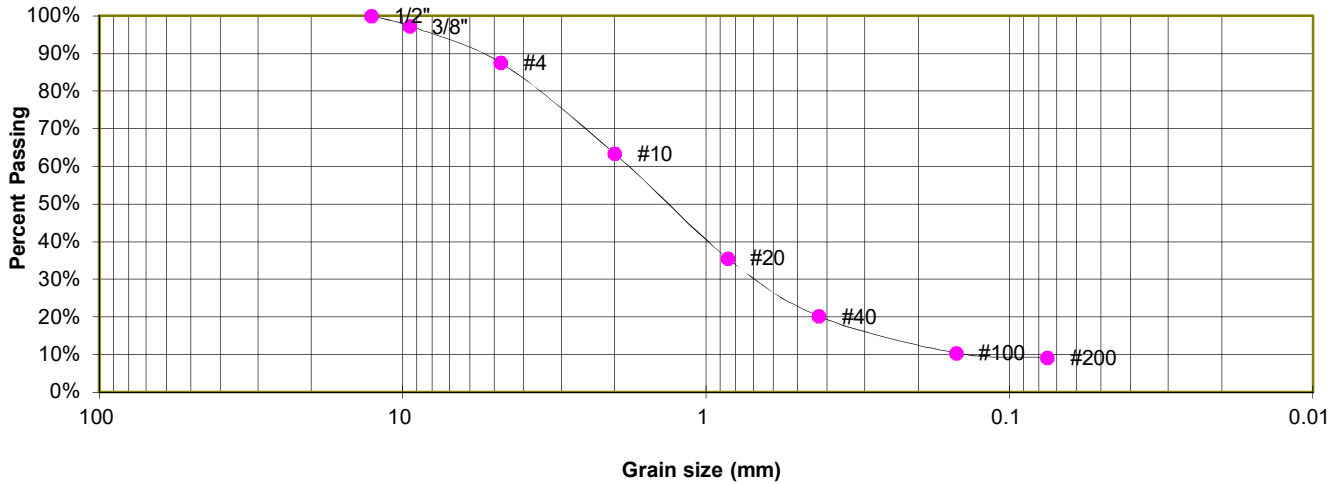
SOIL DESCRIPTION SAND, WITH SILT

**GRAIN SIZE ANALYSIS**

U.S. Sieve #	Percent Finer
3"	
1 1/2"	
3/4"	
1/2"	100.0%
3/8"	97.3%
4	87.5%
10	63.4%
20	35.6%
40	20.2%
100	10.4%
200	9.2%

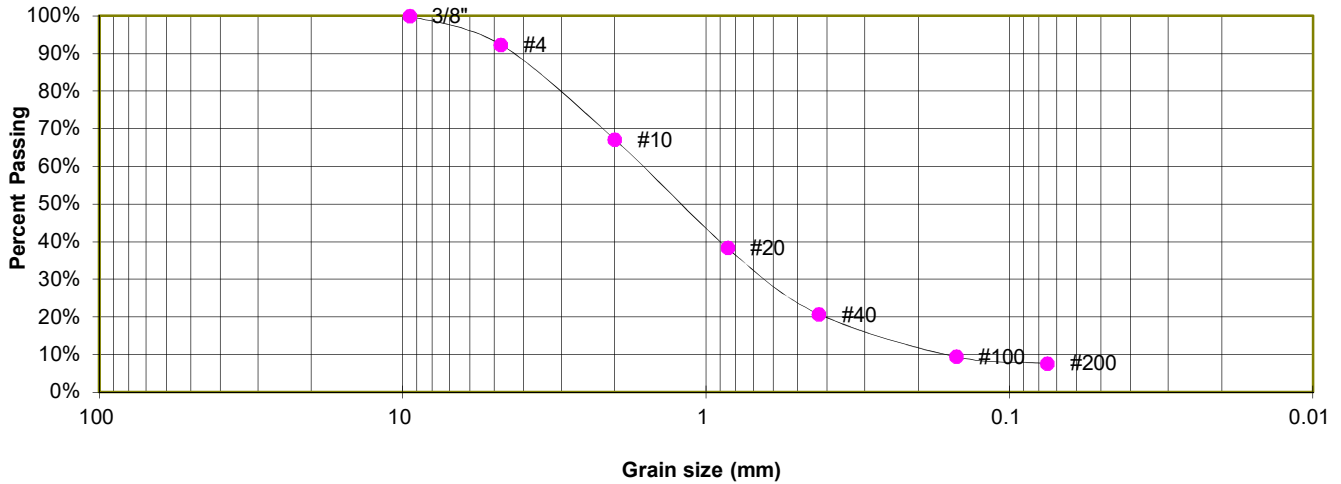
SOIL DESCRIPTION SAND, WITH SILT

#### GRAIN SIZE ANALYSIS

U.S. Sieve #	Percent Finer
3"	
1 1/2"	
3/4"	
1/2"	
3/8"	100.0%
4	92.4%
10	67.2%
20	38.3%
40	20.7%
100	9.4%
200	7.7%
