Re: Soil, Geology and Geologic Hazard Evaluation  
Lot 2, Appaloosa Hwy 24 Subdivision Filing  
El Paso County, Colorado

Platte Valley, LLC  
Soil, Geology and Geologic Hazard Evaluation  
Lot 2, Appaloosa Hwy 24 Subdivision Filing No. 2  
El Paso County, Colorado

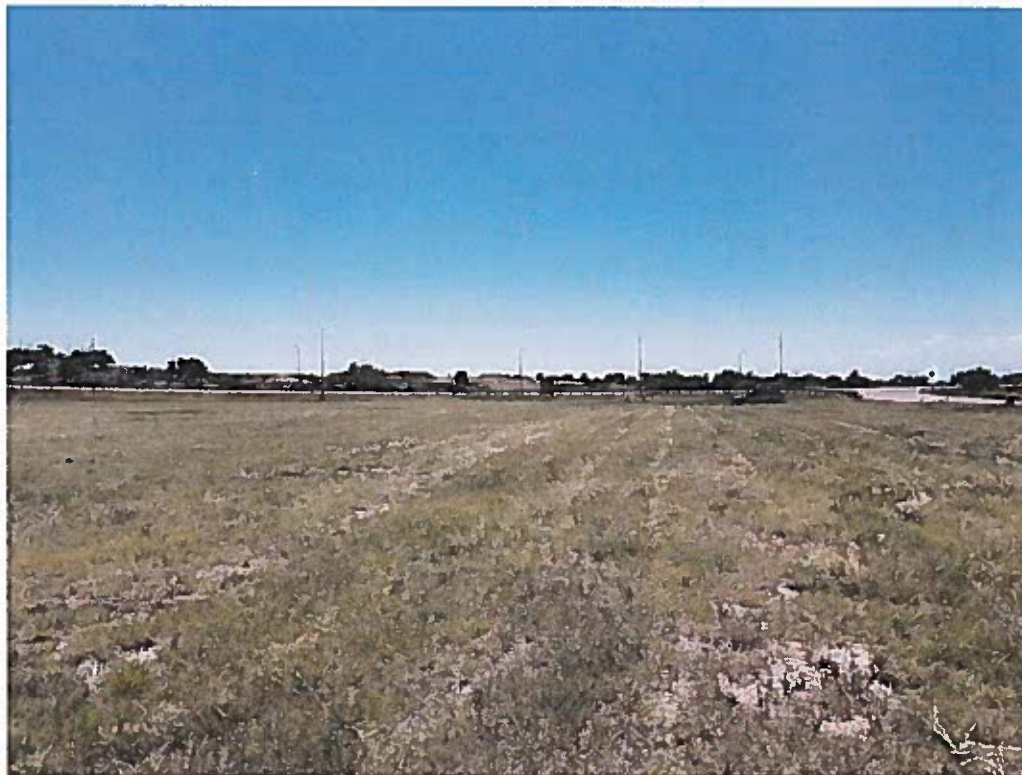
**Looking south from  
the northwestern  
portion of the site.**

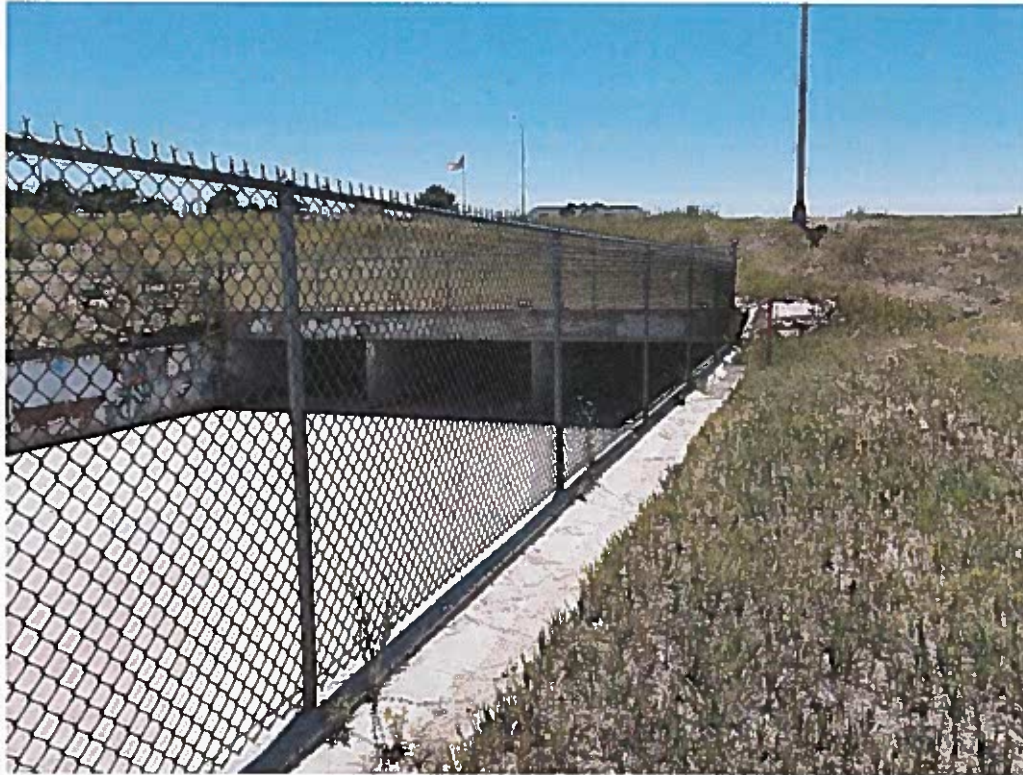
**Looking east at  
concrete drainage way  
along the southeast  
boundary of site.**

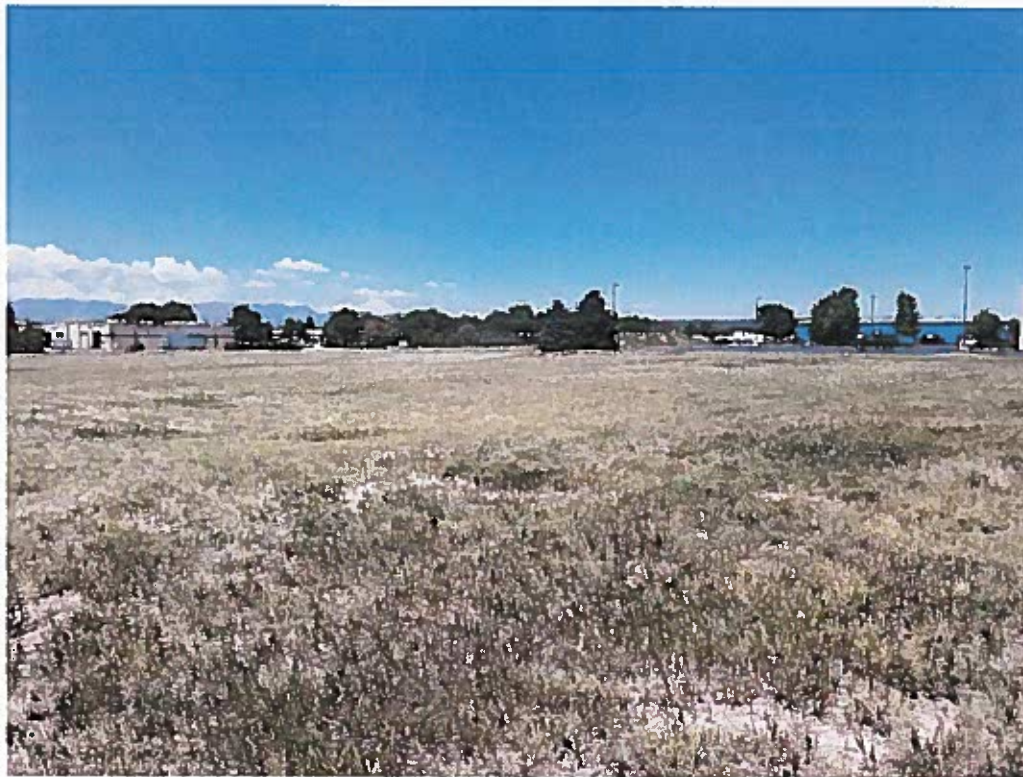
**Looking northwest  
from the southeastern  
portion of the site.**
