Subject: Response to Review Comments
Solace Apartment Complex
Powers Boulevard and Galley Road
Colorado Springs, Colorado
CTLT Project Nos CS19163.001-125 L2

**GEOLOGIC HAZARDS EVALUATION AND
PRELIMINARY GEOTECHNICAL INVESTIGATION
POWERS APARTMENT COMPLEX
POWERS BOULEVARD AND GALLEY ROAD
EL PASO COUNTY, COLORADO**

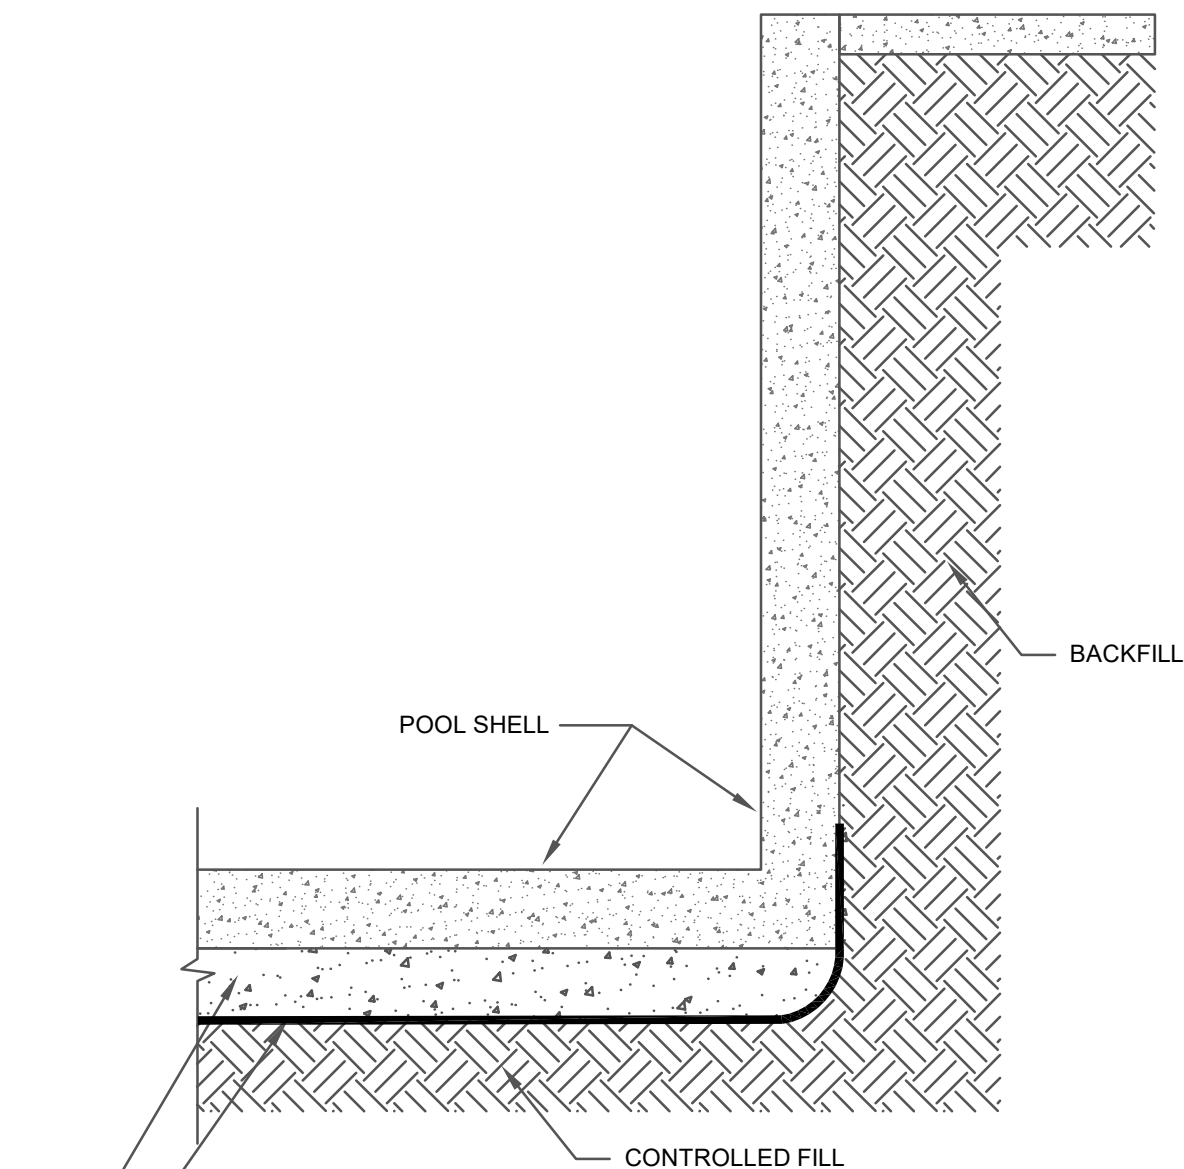
Recommended Pool Drain Detail

IMPERVIOUS PLASTIC MOISTURE BARRIER INSTALLED IMMEDIATELY AFTER EXCAVATION (20 MIL. PVC SHEETING GLUED AT SEAMS).

4 TO 6-INCHES OF WASHED 3/4-INCH TO NO. 4 CONCRETE AGGREGATE WITH A MAXIMUM OF 3 PERCENT PASSING NO. 200 SIEVE. (SLOPE TO DRAIN)

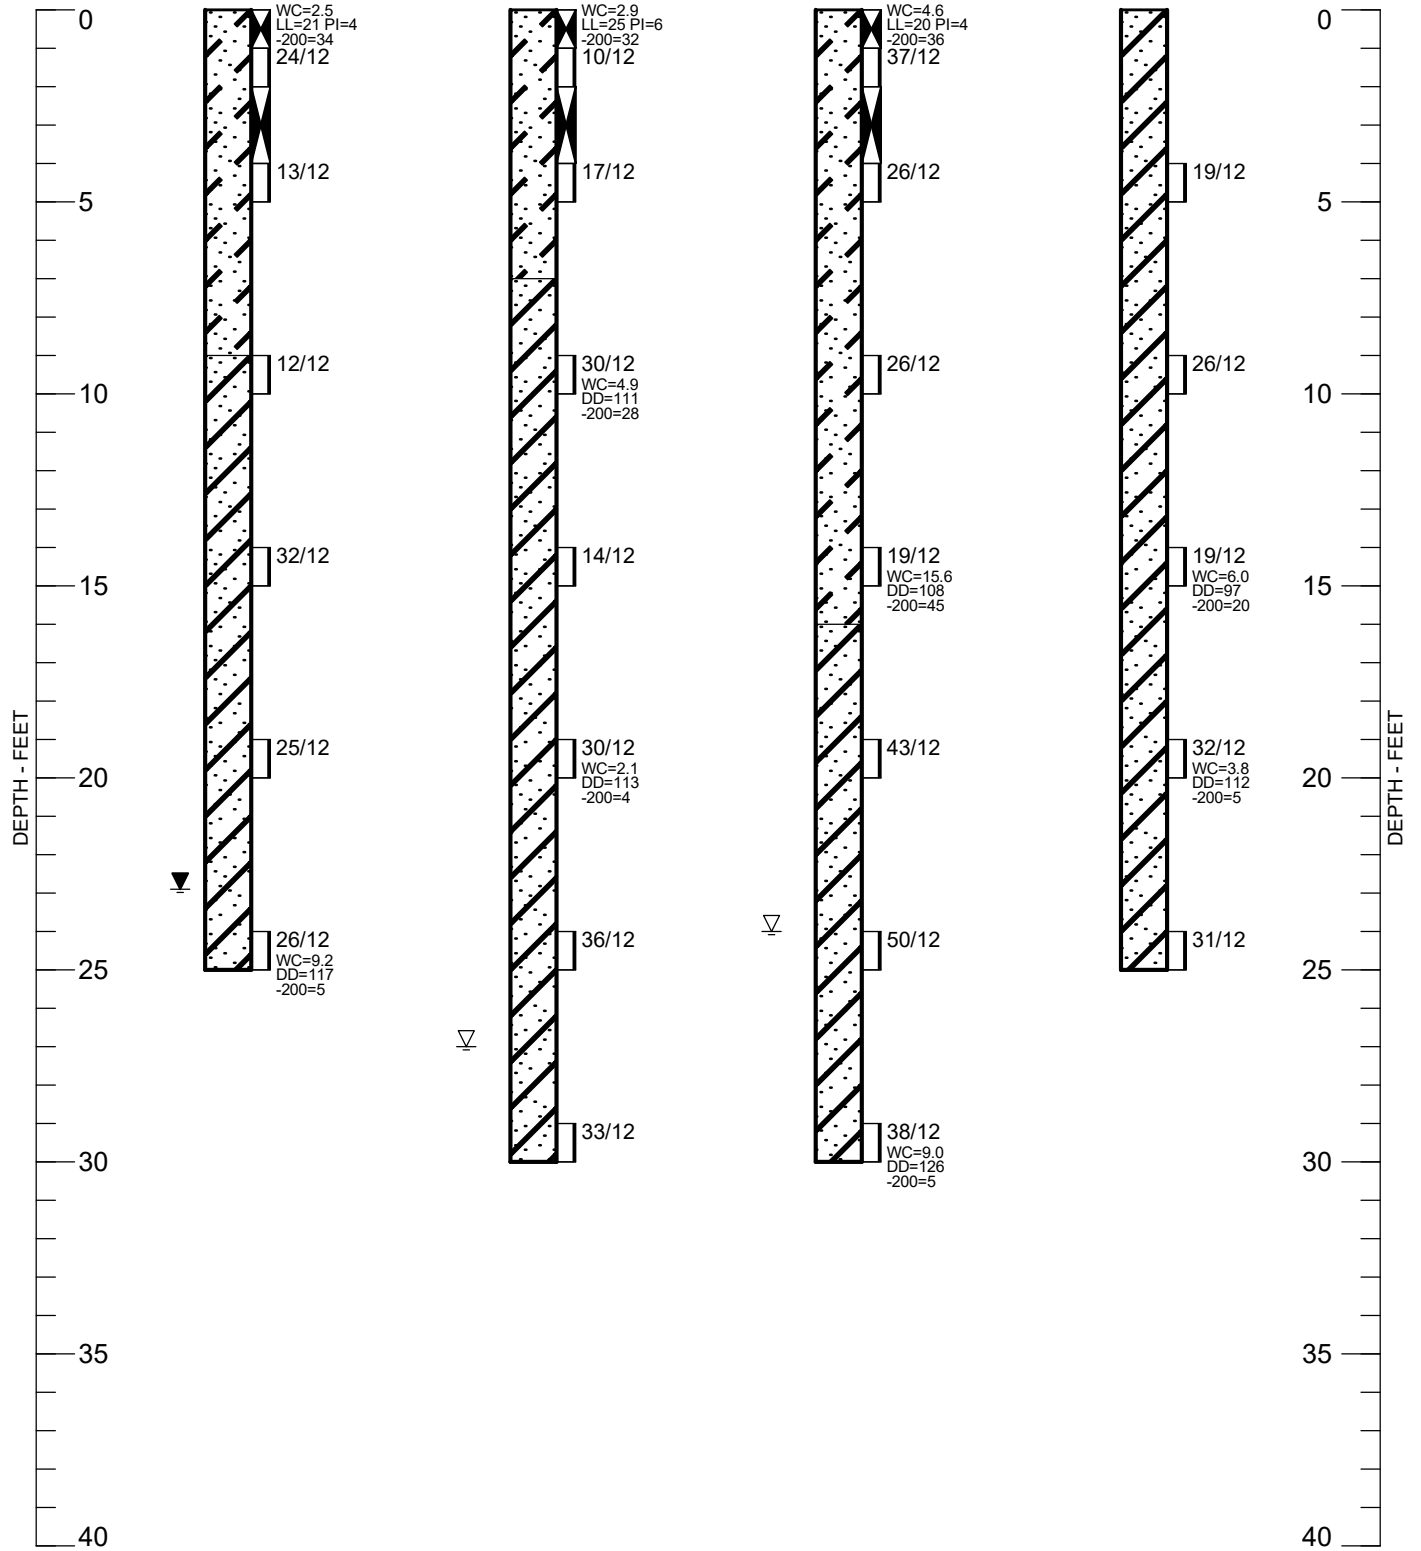
SUMMARY LOGS OF EXPLORATORY BORINGS

TH-103

TH-104

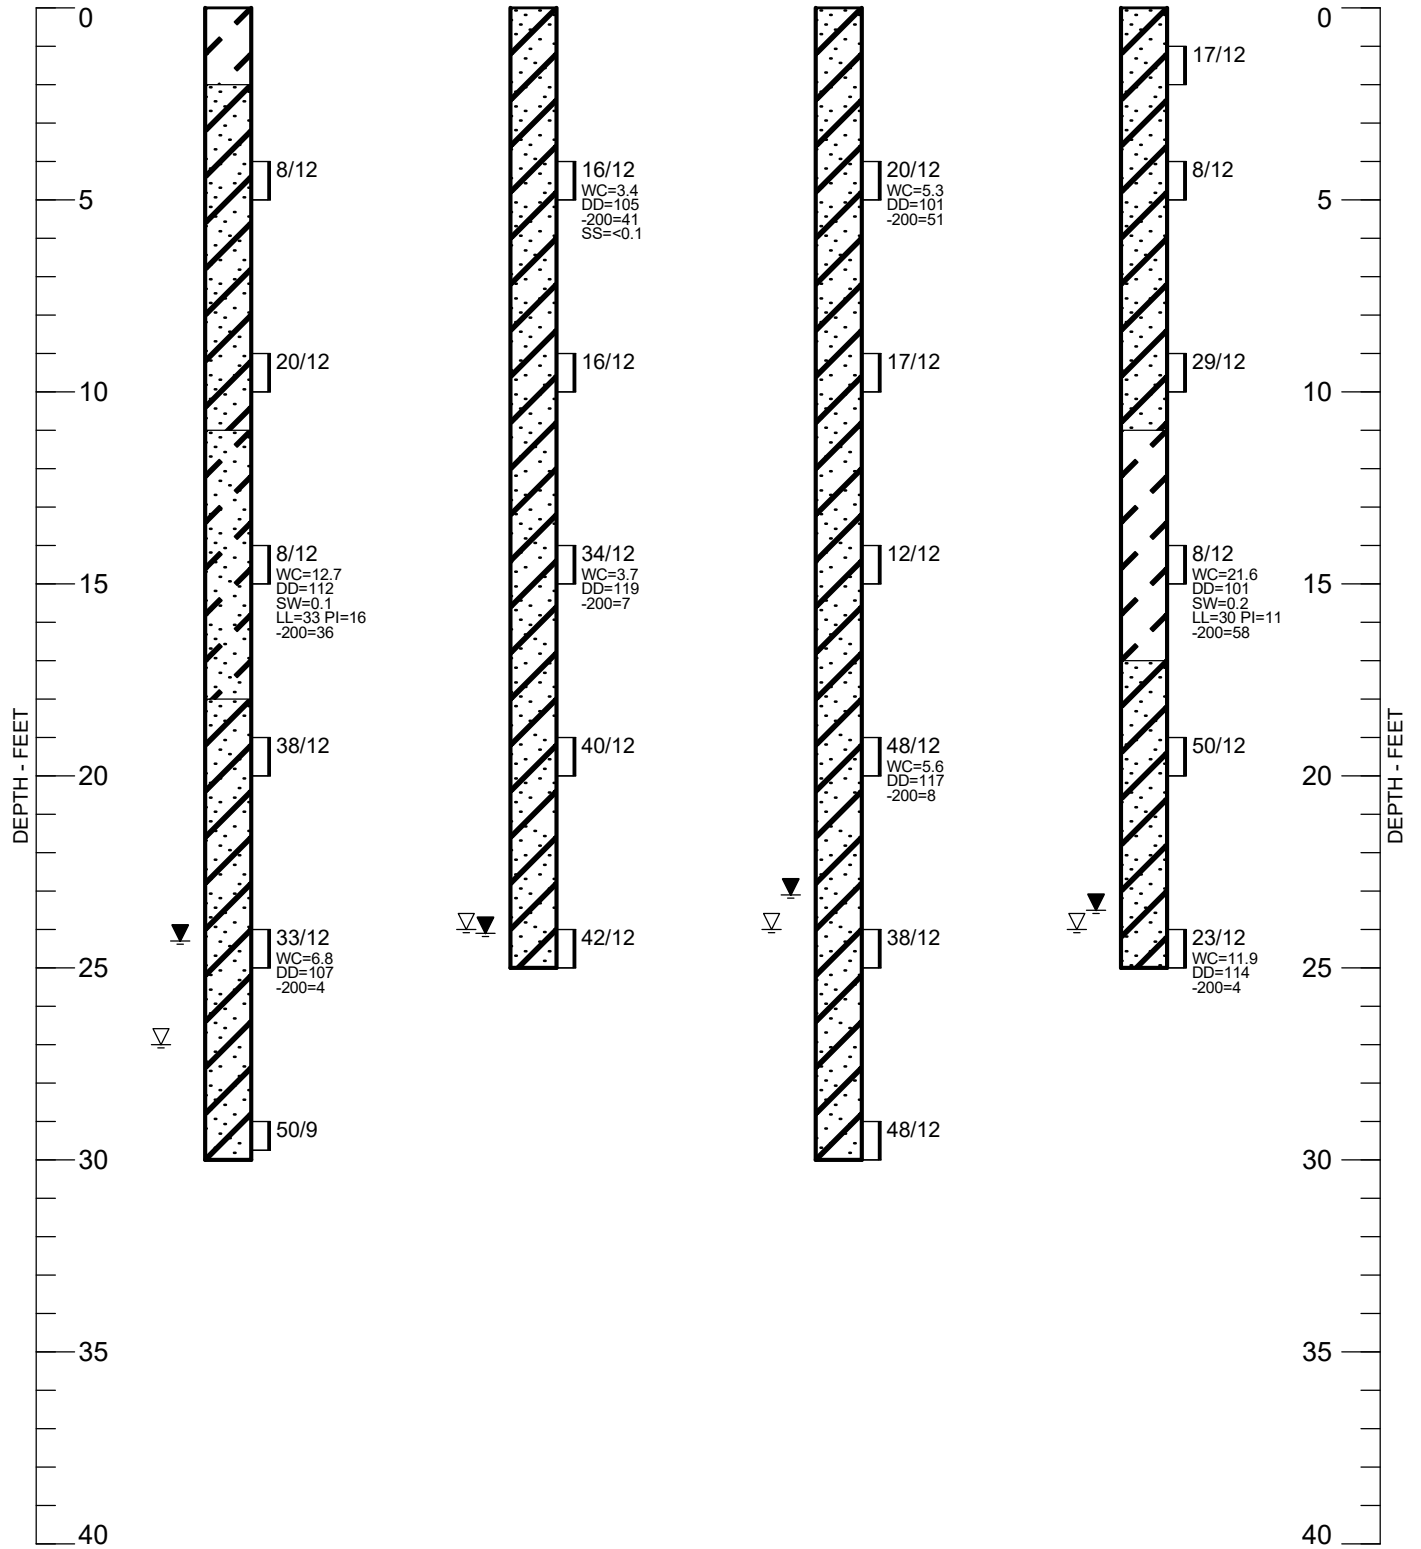
SUMMARY LOGS OF EXPLORATORY BORINGS

TH-107

TH-108

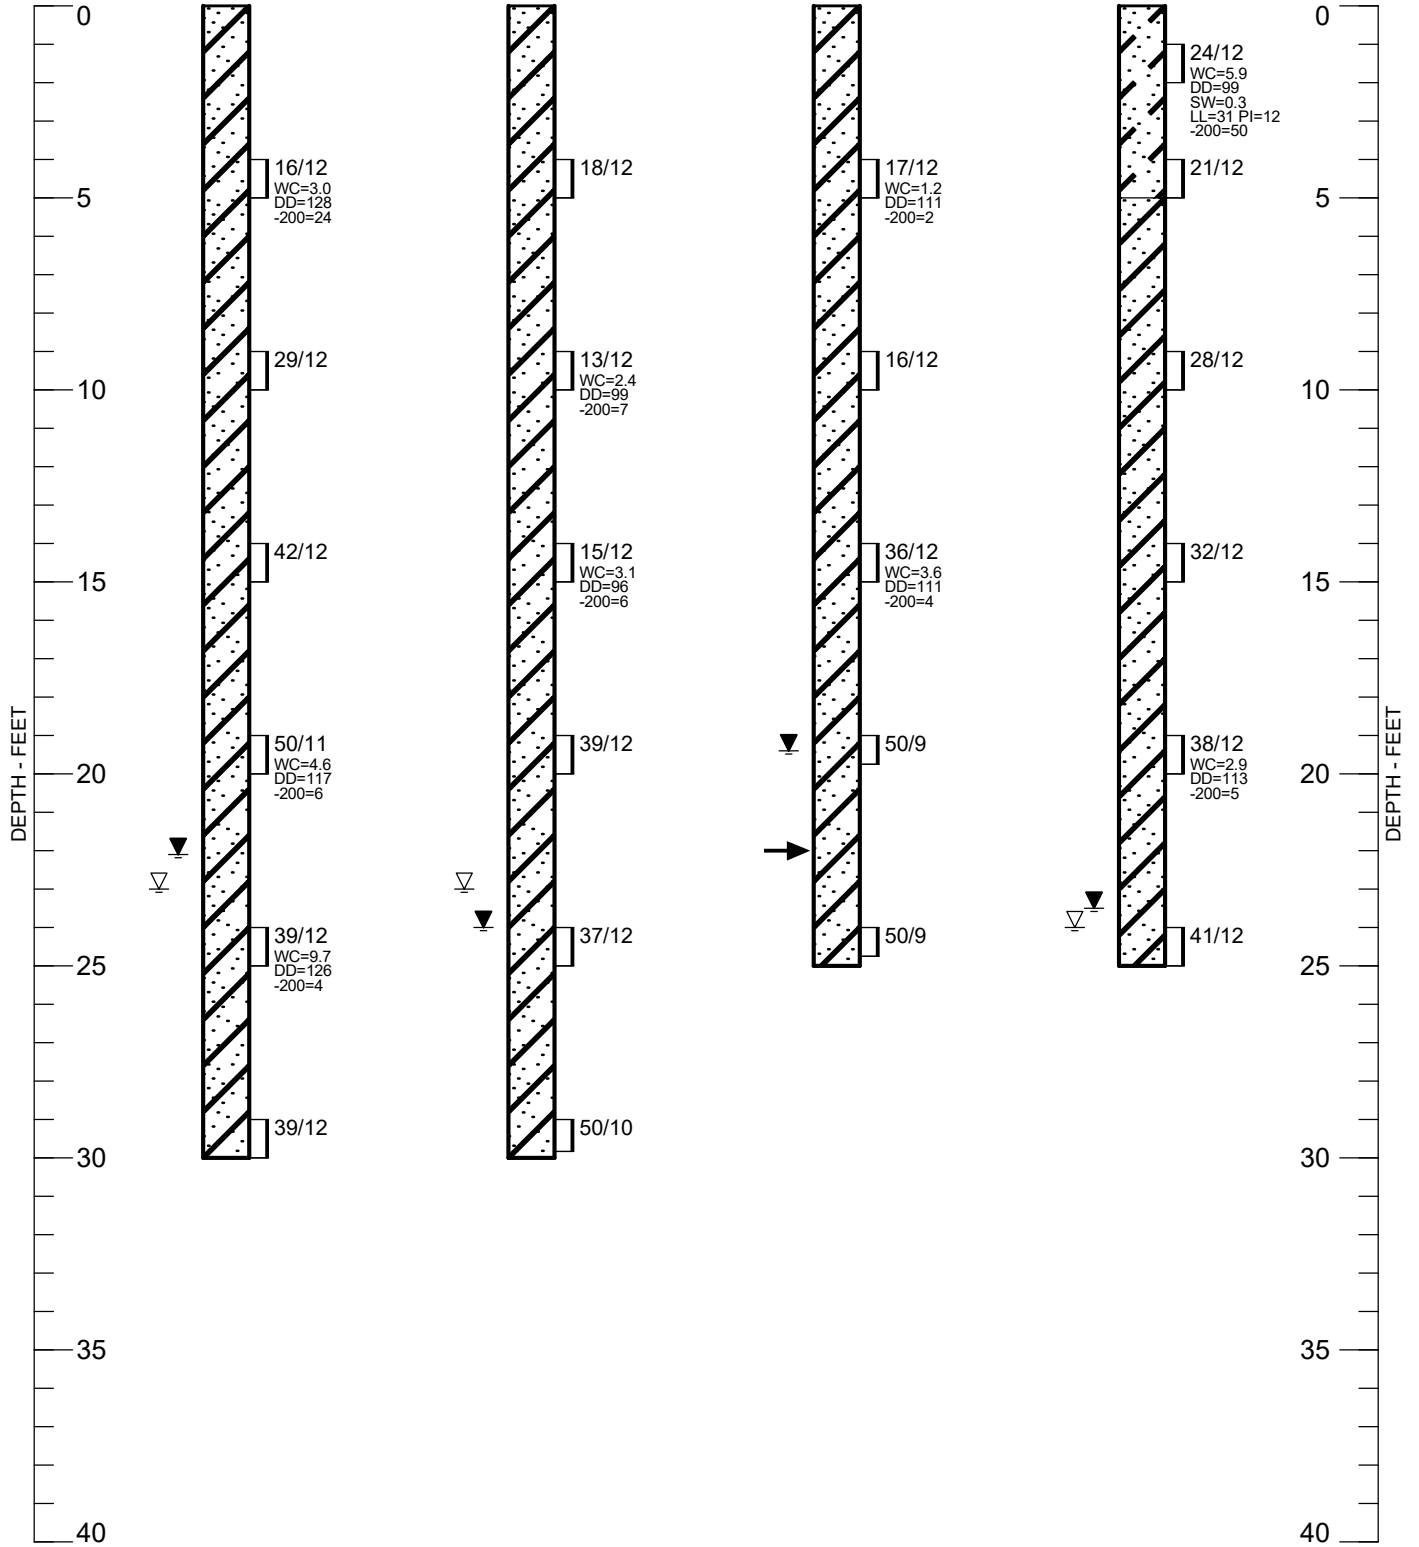
SUMMARY LOGS OF EXPLORATORY BORINGS

TH-115

TH-116

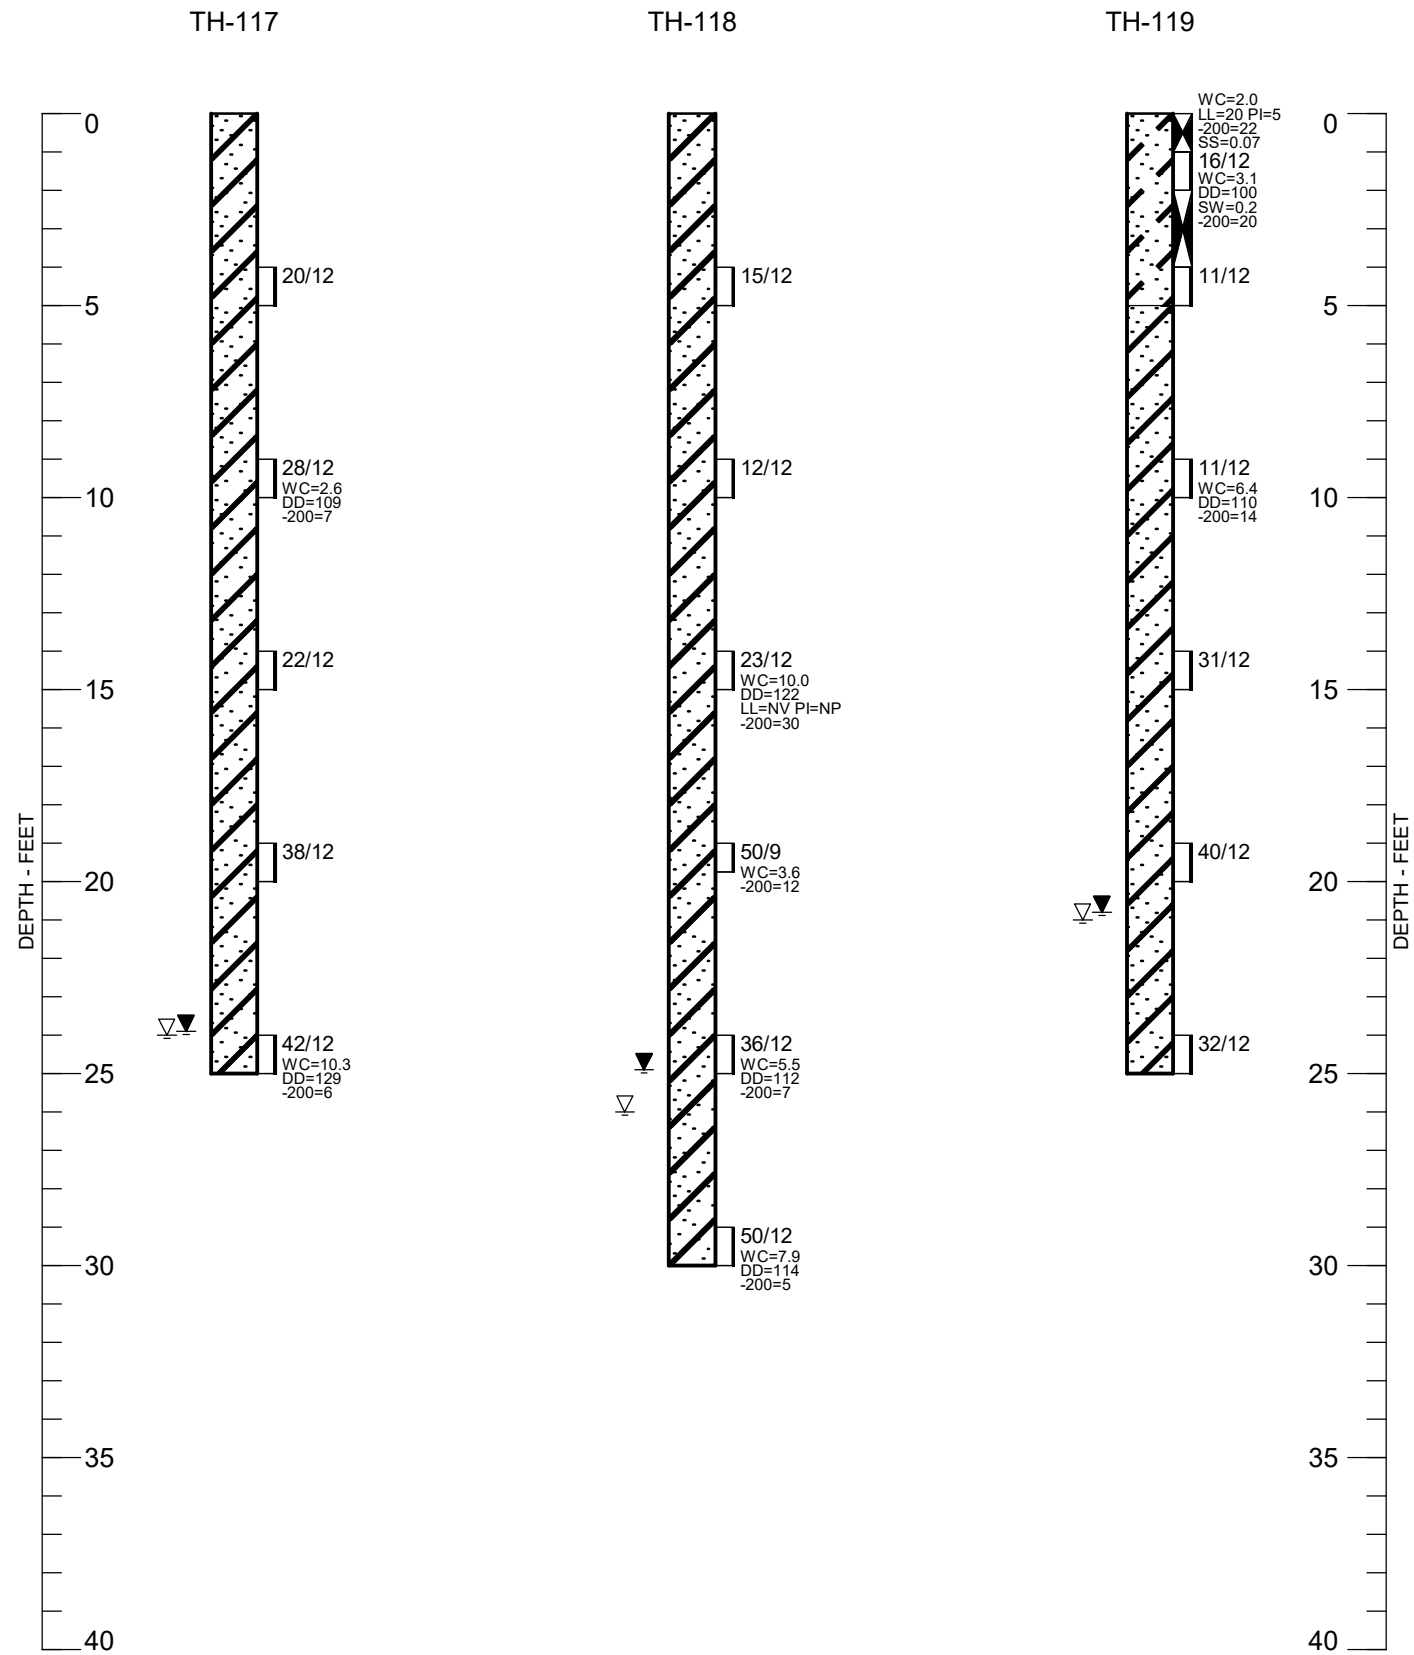
LEGEND:

SAND, CLEAN TO VERY SILTY, LOOSE TO DENSE, SLIGHTLY MOIST TO WET, LIGHT TO MEDIUM BROWN, LIGHT GRAY (SP, SP-SM, SW-SM, SM).
-

CLAY, SANDY TO VERY SANDY, STIFF, VERY MOIST, GRAY, BROWN (CL).
-

1. THE BORINGS WERE DRILLED ON SEPTEMBER 28 AND 29, 2020 USING 4-INCH DIAMETER, CONTINUOUS-FLIGHT SOLID-STEM AUGER AND TRUCK-MOUNTED CME-45 DRILL RIG.
2. WC - INDICATES MOISTURE CONTENT (%).
 DD - INDICATES DRY DENSITY (PCF).
 SW - INDICATES SWELL WHEN WETTED UNDER APPLIED PRESSURE (%).
 COM - INDICATES COMPRESSION WHEN WETTED UNDER APPLIED PRESSURE (%).
 LL - INDICATES LIQUID LIMIT.
 PI - INDICATES PLASTICITY INDEX.
 -200 - INDICATES PASSING NO. 200 SIEVE (%).
 SS - INDICATES WATER-SOLUBLE SULFATE CONTENT (%).
3. THESE LOGS ARE SUBJECT TO THE EXPLANATIONS, LIMITATIONS AND CONCLUSIONS CONTAINED IN THIS REPORT.

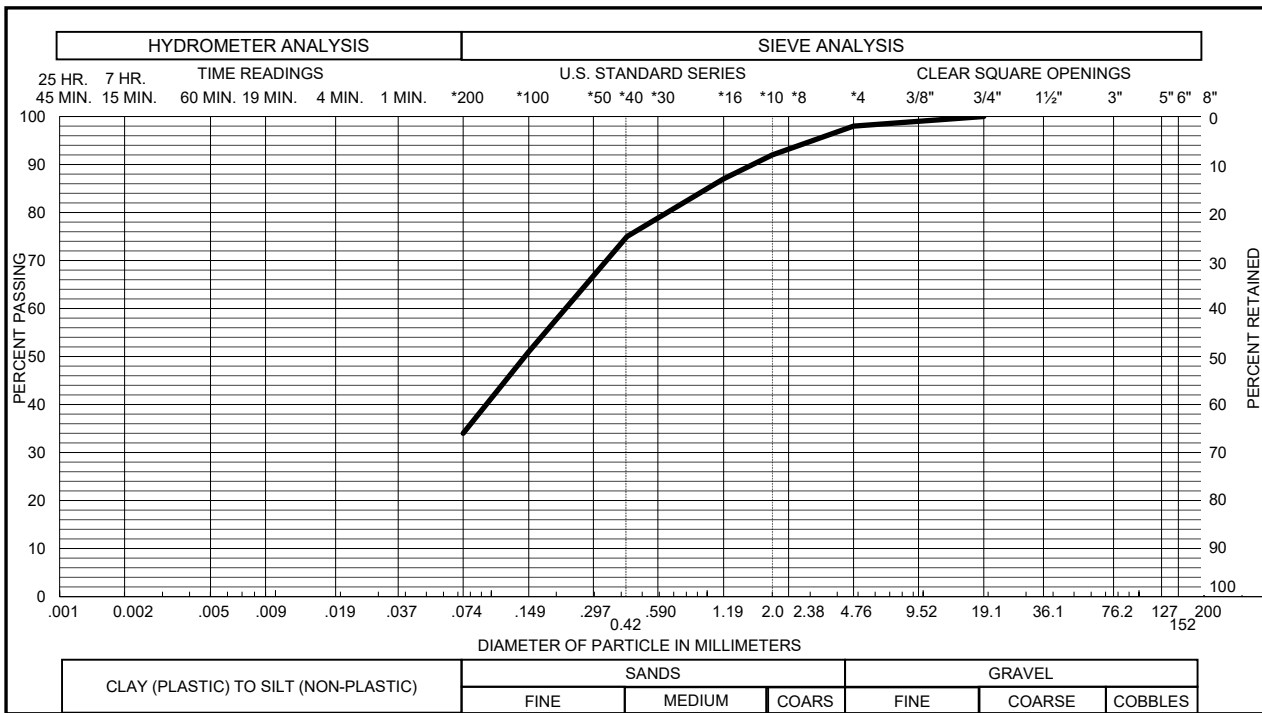
Sample of SAND, CLAYEY AND SILTY (SC-SM) GRAVEL 2 % SAND 64 %
 From TH - 101 AT 0-4 FEET SILT & CLAY 34 % LIQUID LIMIT 21 %
 PLASTICITY INDEX 4 %

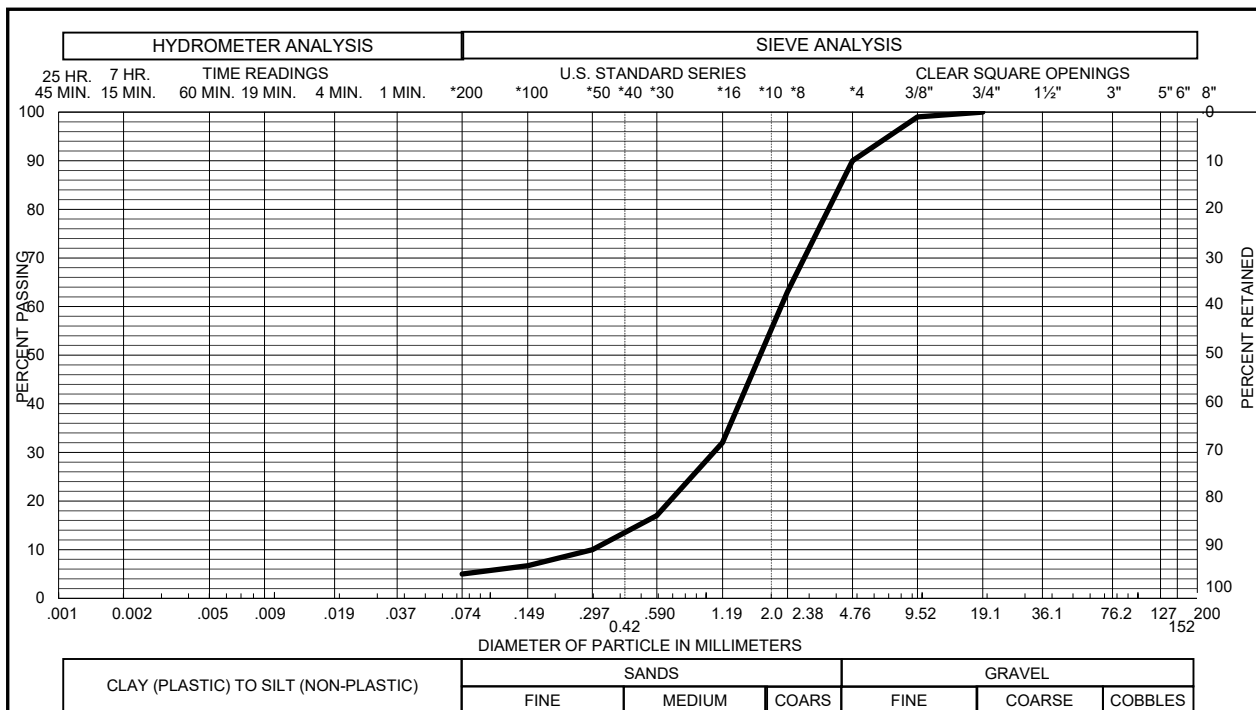
Sample of SAND, SLIGHTLY SILTY (SW-SM) GRAVEL 10 % SAND 85 %
 From TH - 101 AT 24 FEET SILT & CLAY 5 % LIQUID LIMIT %
 PLASTICITY INDEX %

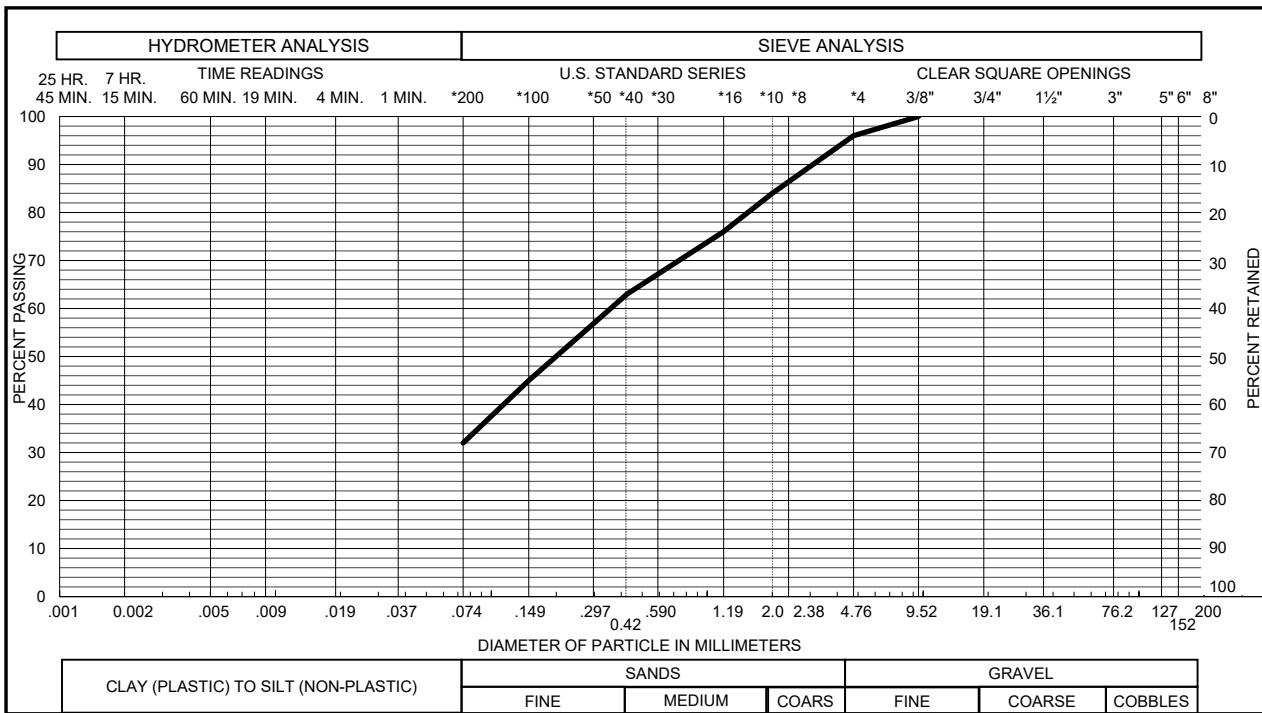
Sample of SAND, CLAYEY AND SILTY (SC-SM) GRAVEL 4 % SAND 64 %
 From TH - 102 AT 0-4 FEET SILT & CLAY 32 % LIQUID LIMIT %
 PLASTICITY INDEX %

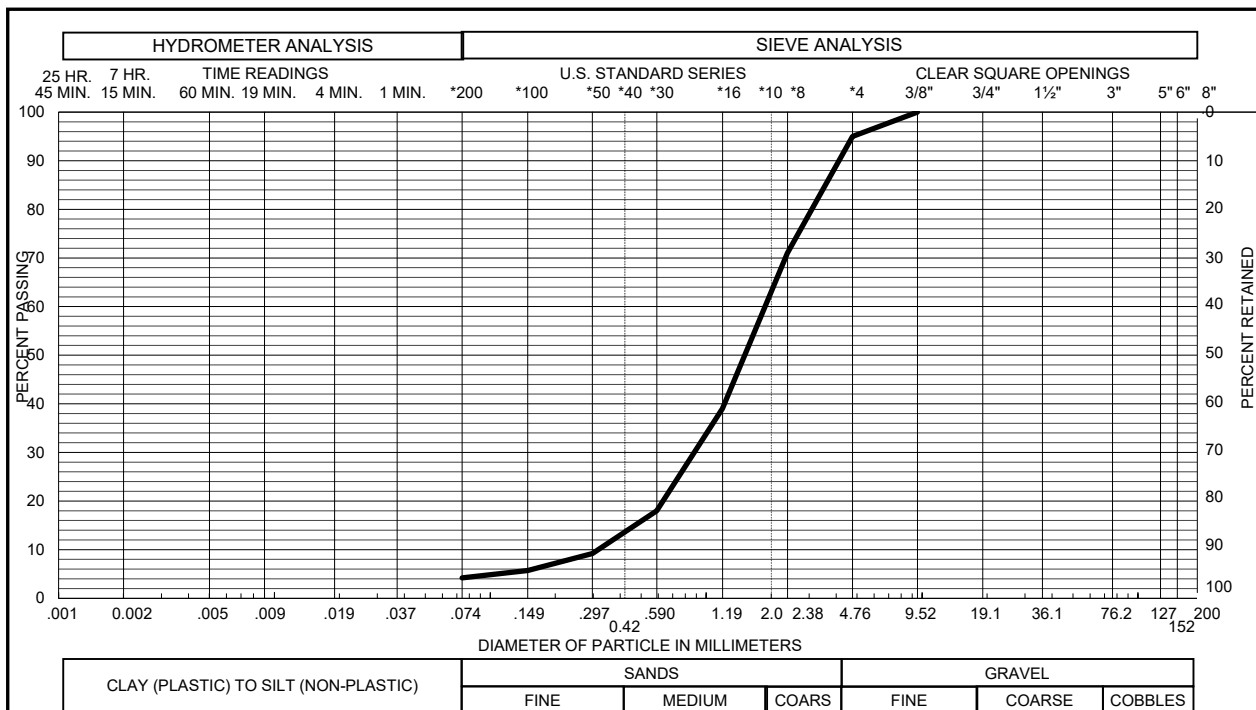
Sample of SAND (SP) GRAVEL 5 % SAND 91 %
 From TH - 102 AT 19 FEET SILT & CLAY 4 % LIQUID LIMIT %
 PLASTICITY INDEX %

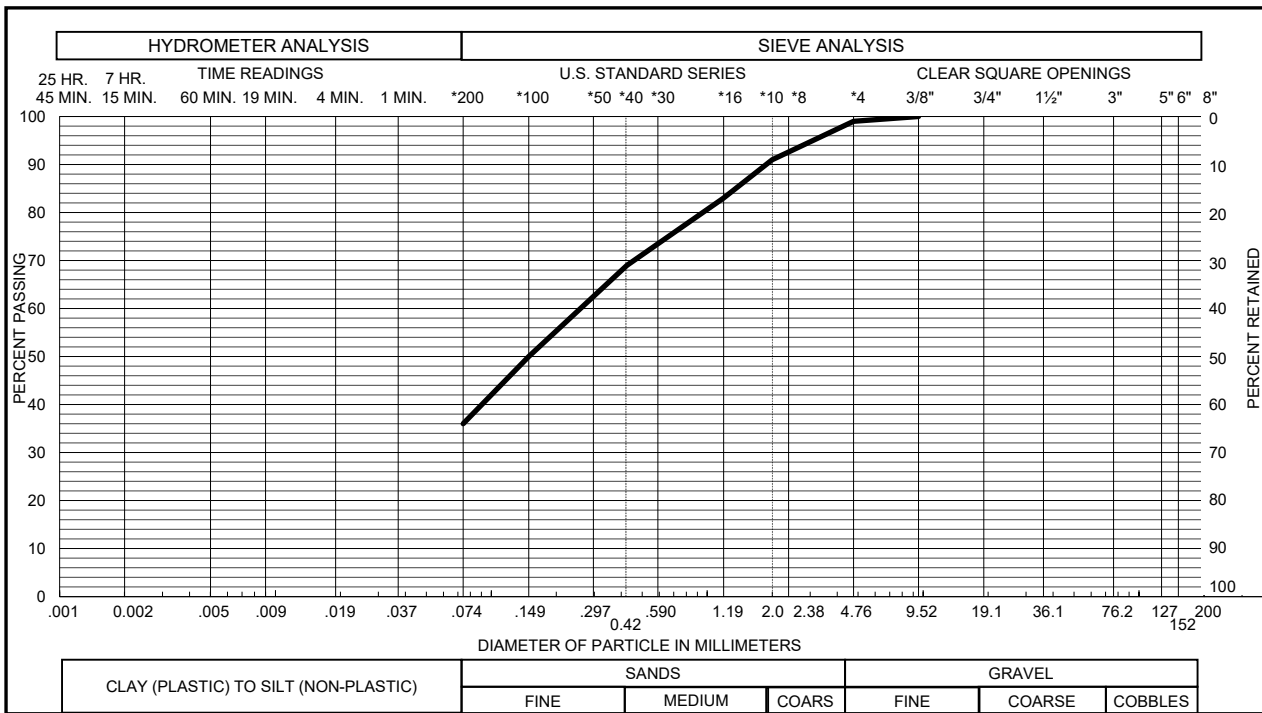
Sample of SAND, CLAYEY AND SILTY (SC-SM) GRAVEL 1 % SAND 63 %
 From TH - 103 AT 0-4 FEET SILT & CLAY 36 % LIQUID LIMIT 20 %
 PLASTICITY INDEX 4 %

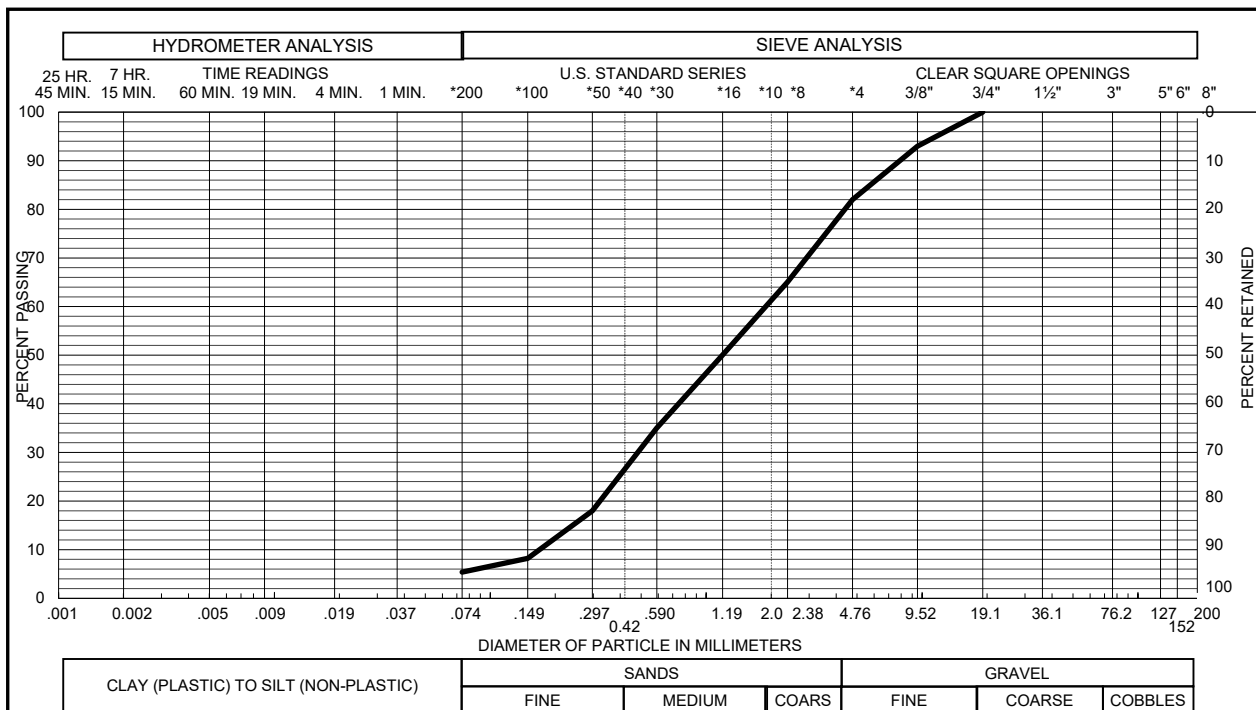
Sample of SAND, SLIGHTLY SILTY (SP-SM) GRAVEL 18 % SAND 77 %
 From TH - 103 AT 29 FEET SILT & CLAY 5 % LIQUID LIMIT %
 PLASTICITY INDEX %

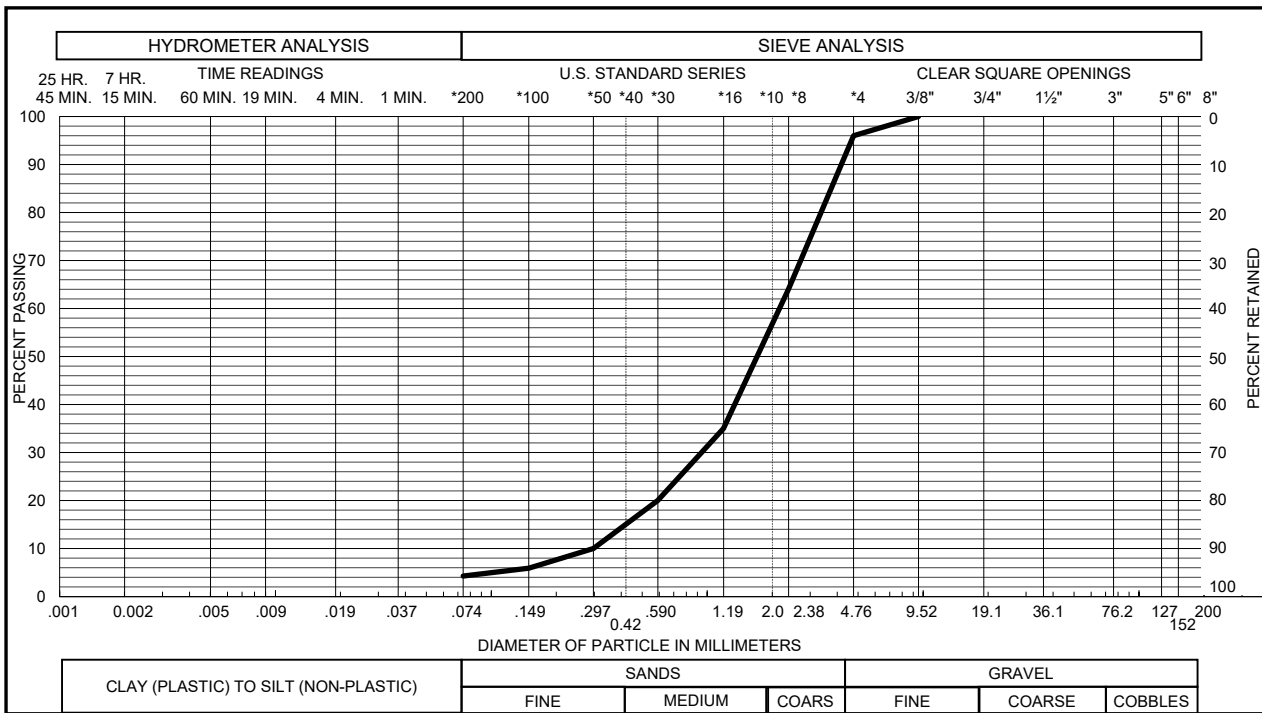
Sample of SAND (SW) GRAVEL 4 % SAND 92 %
 From TH - 105 AT 24 FEET SILT & CLAY 4 % LIQUID LIMIT %
 PLASTICITY INDEX %

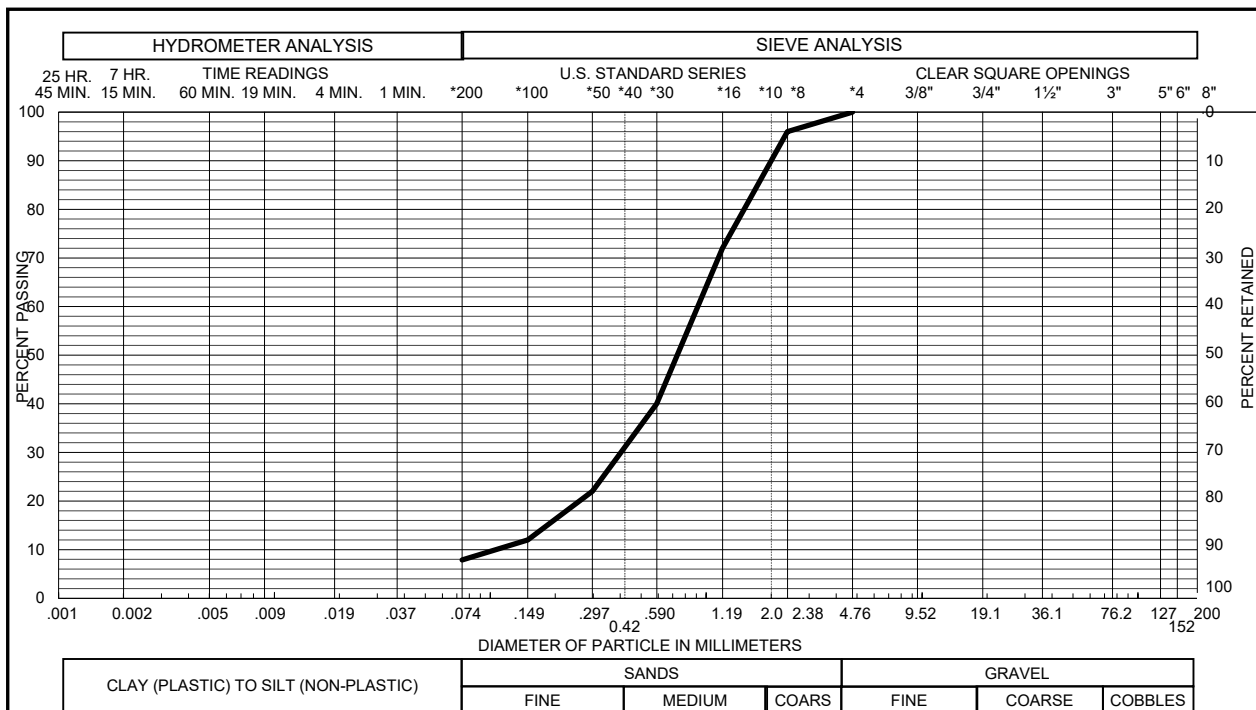
Sample of SAND, SLIGHTLY SILTY (SP-SM) GRAVEL 0 % SAND 92 %
 From TH - 107 AT 19 FEET SILT & CLAY 8 % LIQUID LIMIT %
 PLASTICITY INDEX %

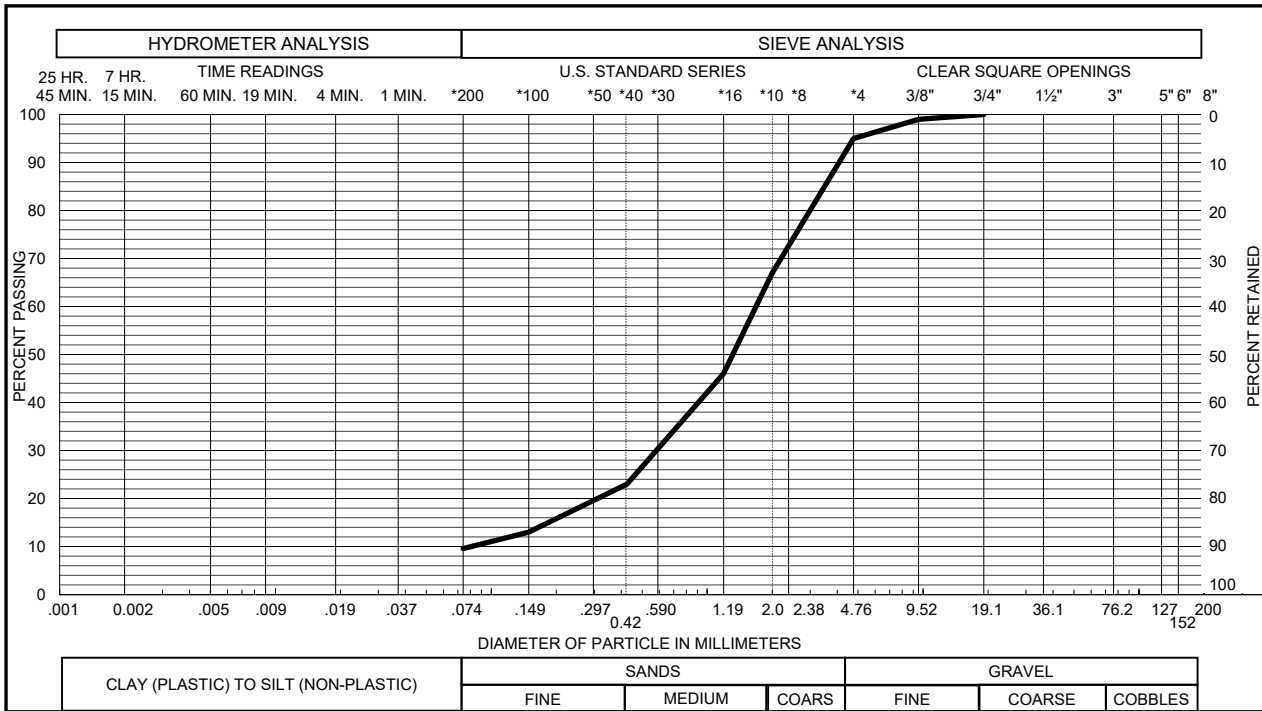
Sample of SAND, SLIGHTLY SILTY (SP-SM) GRAVEL 5 % SAND 85 %
 From TH - 108 AT 0-4 FEET SILT & CLAY 10 % LIQUID LIMIT %
 PLASTICITY INDEX %

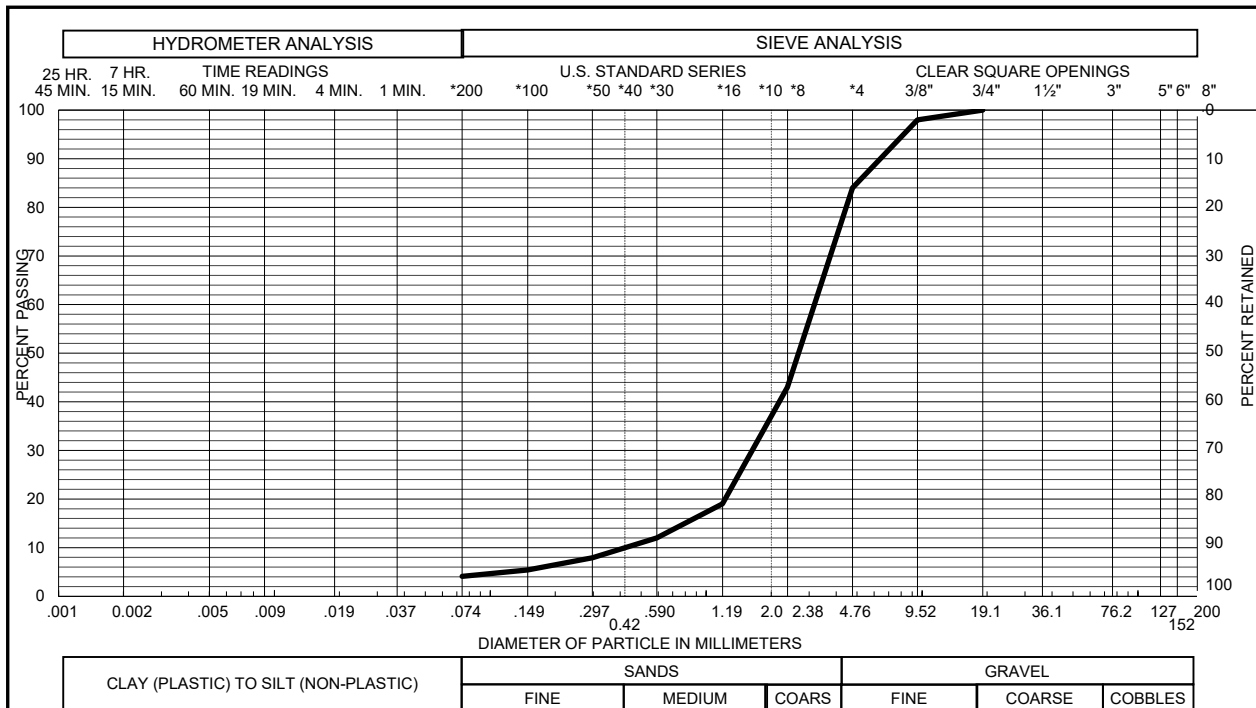
Sample of SAND (SW) GRAVEL 16 % SAND 80 %
 From TH - 108 AT 24 FEET SILT & CLAY 4 % LIQUID LIMIT %
 PLASTICITY INDEX %

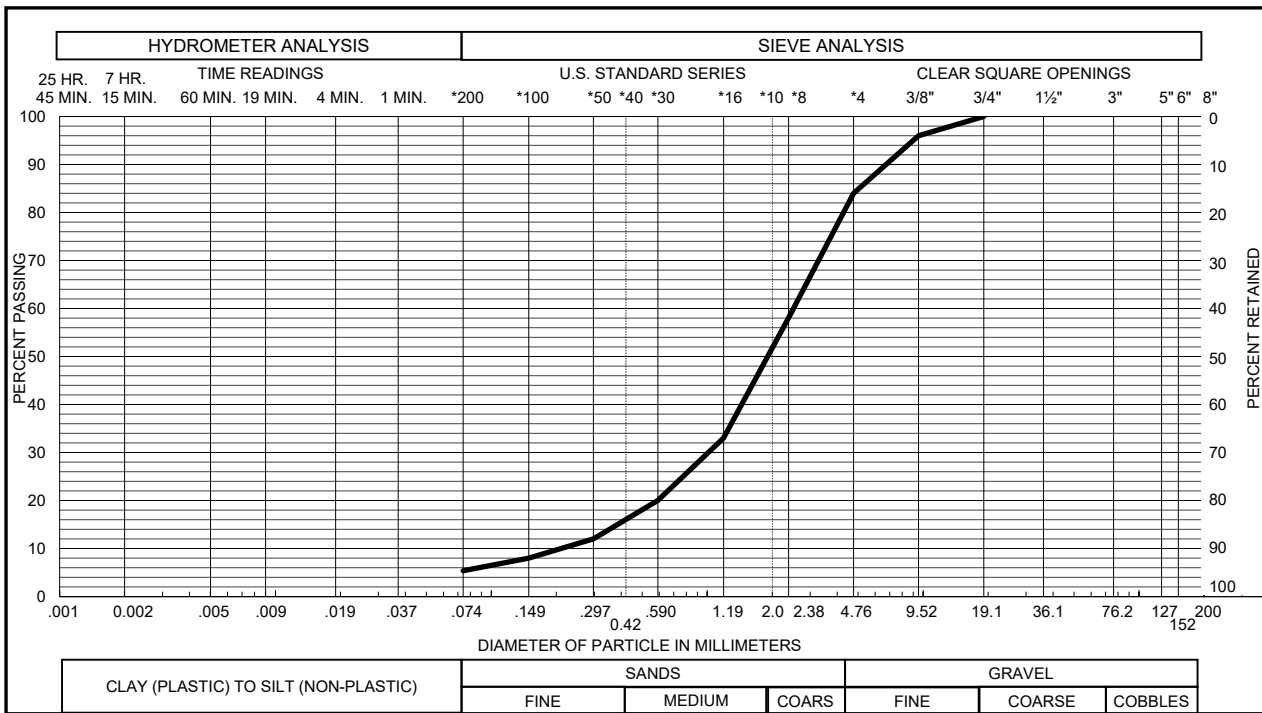
Sample of SAND, SLIGHTLY SILTY (SP-SM) GRAVEL 16 % SAND 79 %
 From TH - 109 AT 24 FEET SILT & CLAY 5 % LIQUID LIMIT %
 PLASTICITY INDEX %

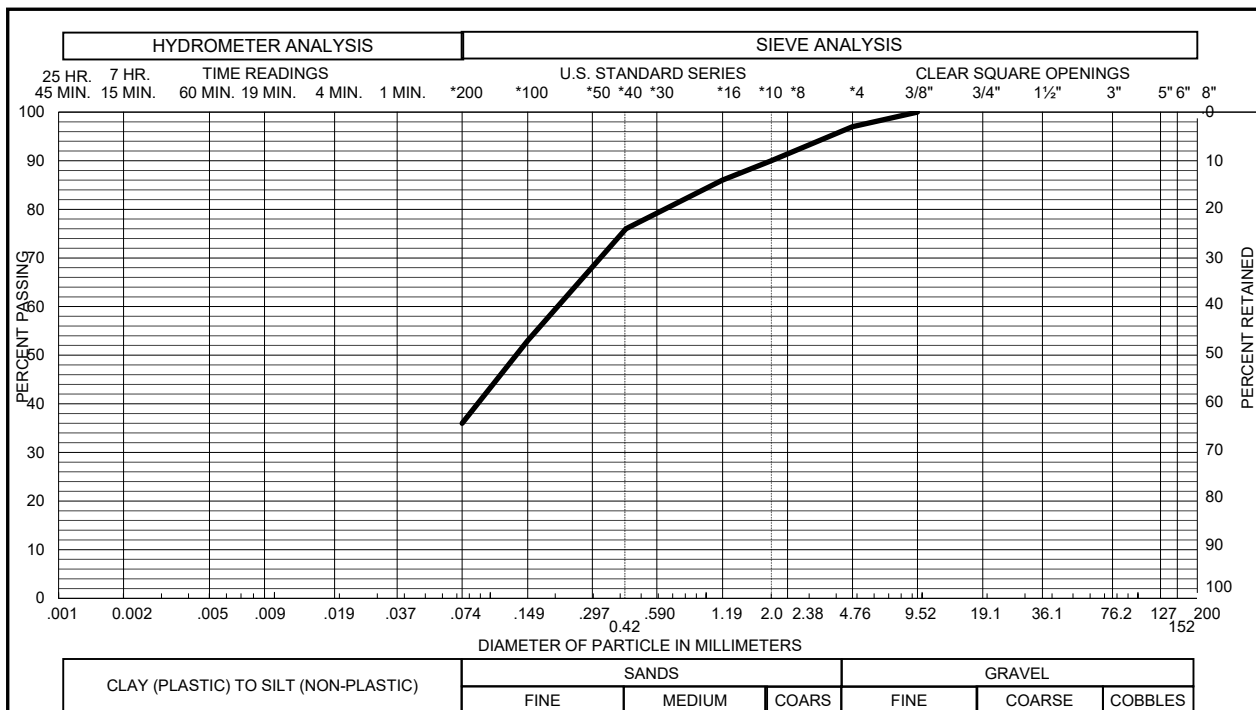
Sample of SAND, CLAYEY AND SILTY (SC-SM) GRAVEL 3 % SAND 61 %
 From TH - 110 AT 1-4 FEET SILT & CLAY 36 % LIQUID LIMIT %
 PLASTICITY INDEX %

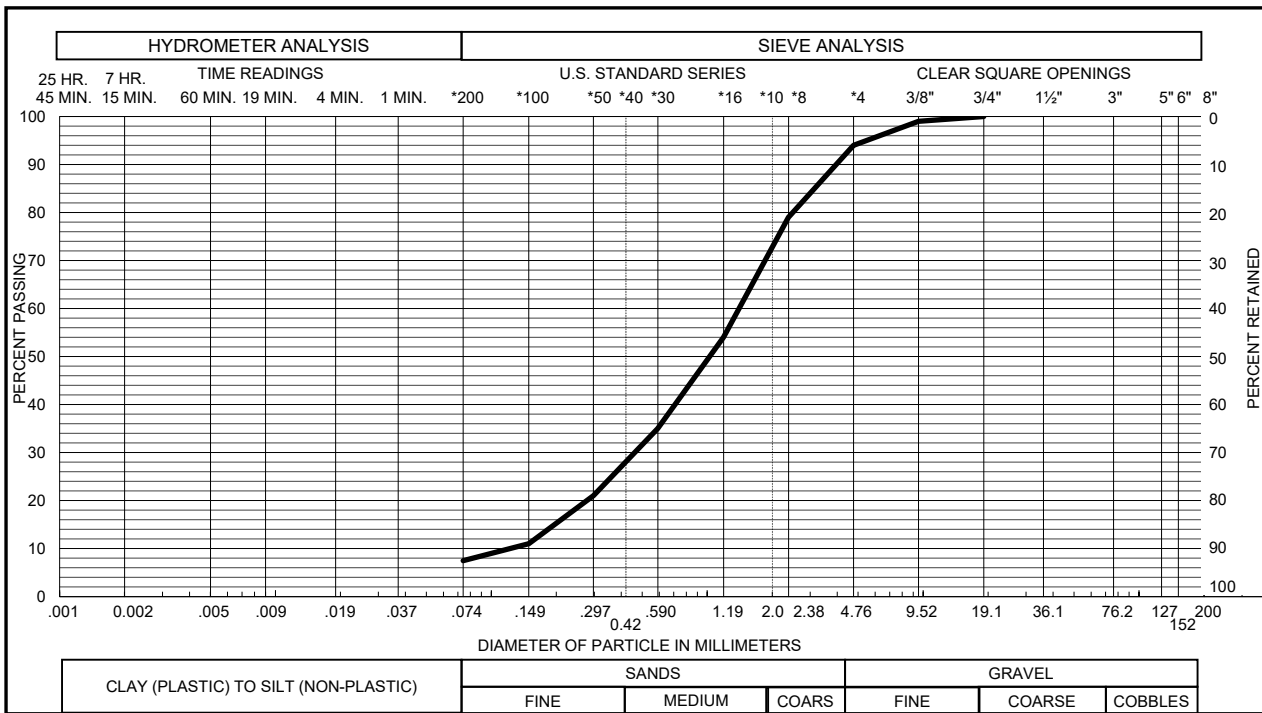
Sample of SAND, SLIGHTLY SILTY (SP-SM) GRAVEL 6 % SAND 86 %
 From TH - 111 AT 4 FEET SILT & CLAY 8 % LIQUID LIMIT _____ %
 PLASTICITY INDEX _____ %
