Subject: Response to Review Comments
Solace Apartment Complex
Powers Boulevard and Galley Road
Colorado Springs, Colorado
CTLT Project Nos CS19163.001-125 L2

**GEOLOGIC HAZARDS EVALUATION AND
PRELIMINARY GEOTECHNICAL INVESTIGATION
POWERS APARTMENT COMPLEX
POWERS BOULEVARD AND GALLEY ROAD
EL PASO COUNTY, COLORADO**

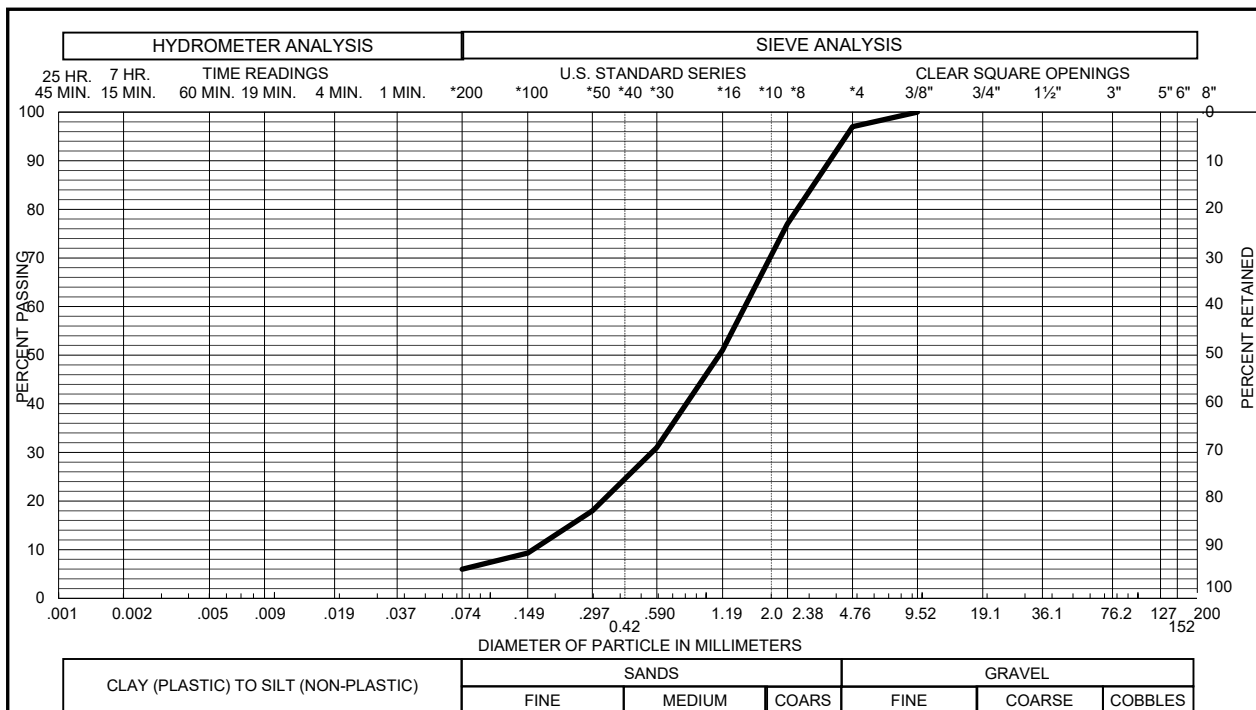
Sample of SAND, SLIGHTLY SILTY (SP-SM) GRAVEL 3 % SAND 91 %
 From TH - 113 AT 19 FEET SILT & CLAY 6 % LIQUID LIMIT _____ %
 PLASTICITY INDEX _____ %

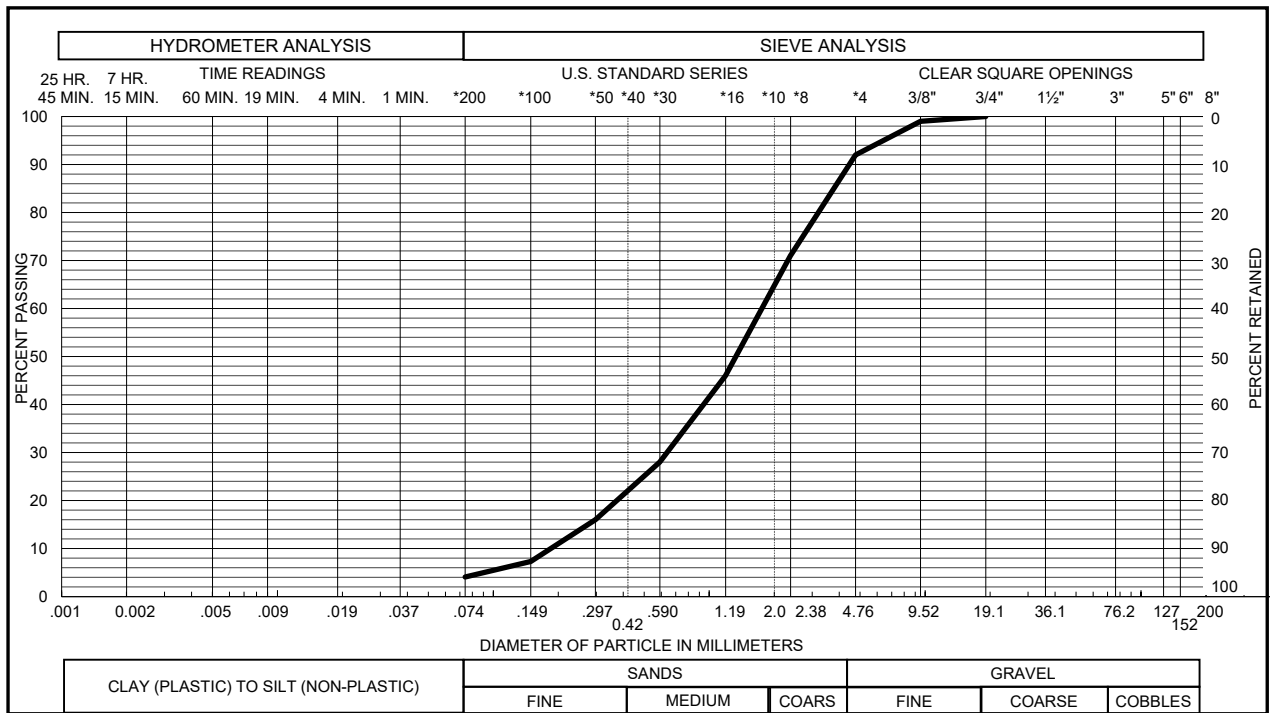
Sample of SAND (SW) GRAVEL 8 % SAND 88 %
 From TH - 113 AT 24 FEET SILT & CLAY 4 % LIQUID LIMIT %
 PLASTICITY INDEX %

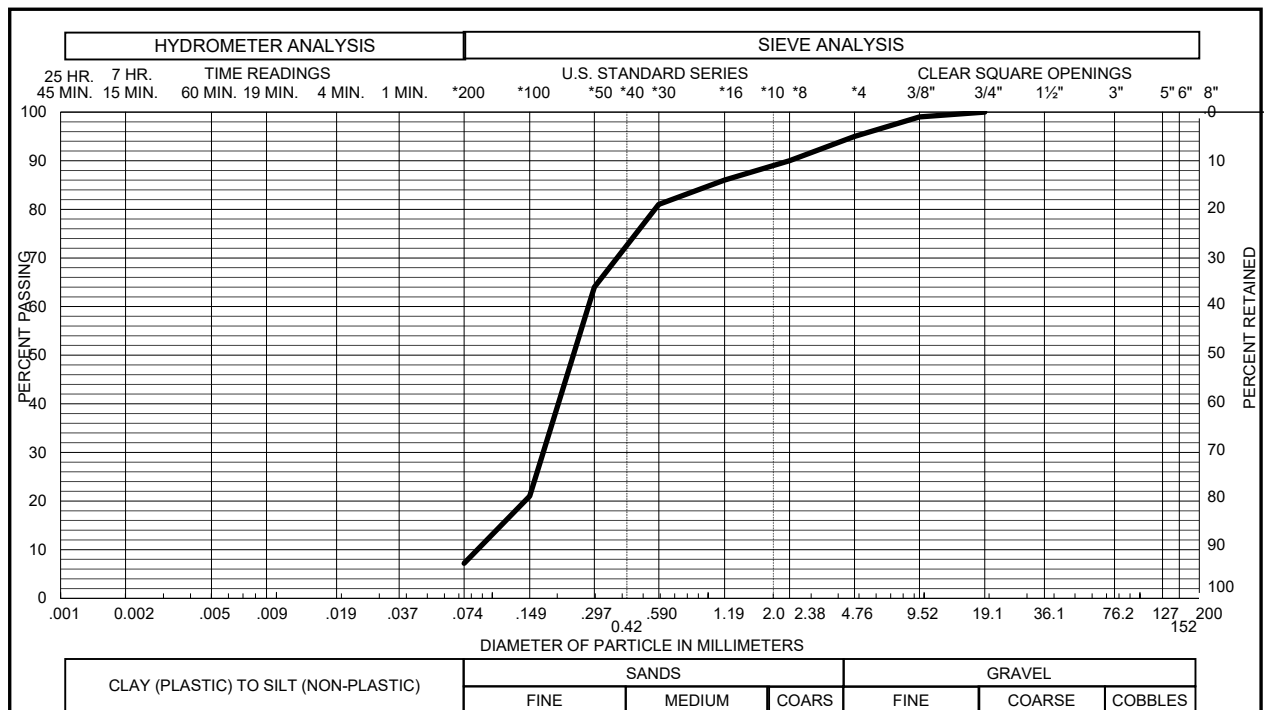
Sample of SAND, SLIGHTLY SILTY (SP-SM) GRAVEL 5 % SAND 88 %
 From TH - 114 AT 9 FEET SILT & CLAY 7 % LIQUID LIMIT %
 PLASTICITY INDEX %

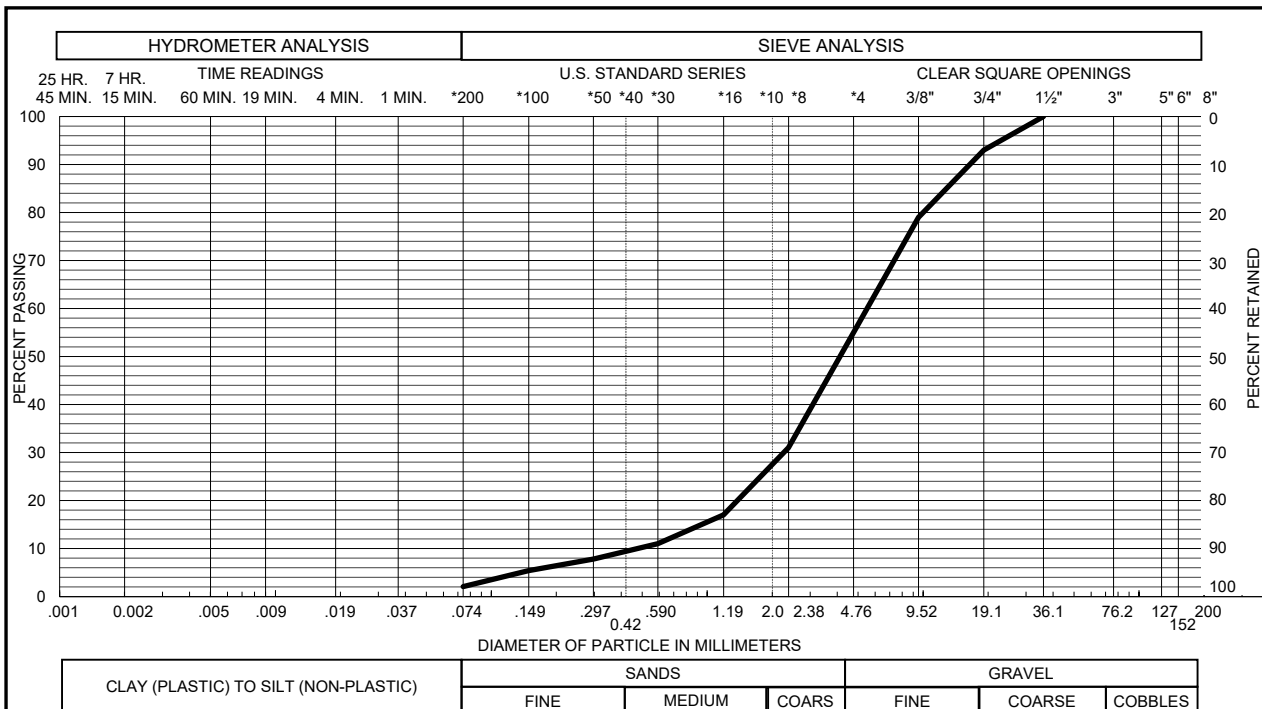
Sample of SAND (SW) GRAVEL 45 % SAND 53 %
 From TH - 115 AT 4 FEET SILT & CLAY 2 % LIQUID LIMIT %
 PLASTICITY INDEX %

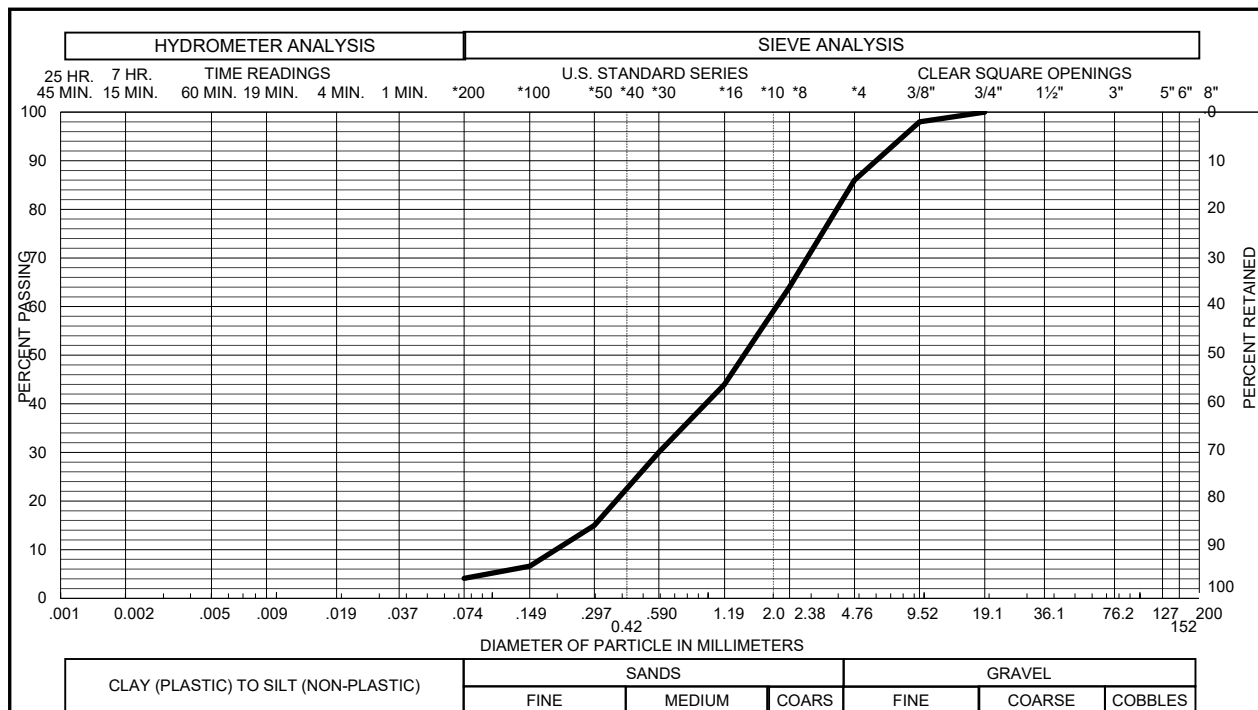
Sample of SAND (SP) GRAVEL 14 % SAND 82 %
 From TH - 115 AT 14 FEET SILT & CLAY 4 % LIQUID LIMIT %
 PLASTICITY INDEX %

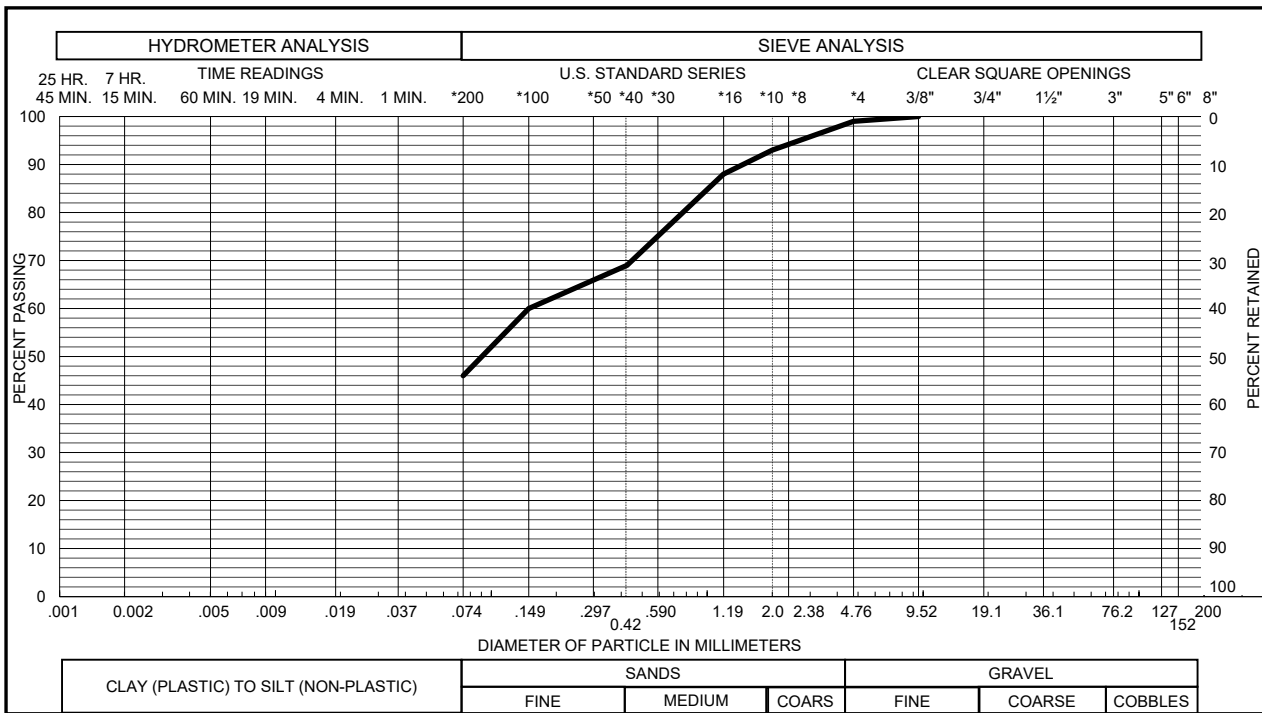
Sample of SAND, CLAYEY AND SILTY (SC-SM) GRAVEL 1 % SAND 53 %
 From TH - 116 AT 0-4 FEET SILT & CLAY 46 % LIQUID LIMIT 27 %
 PLASTICITY INDEX 7 %

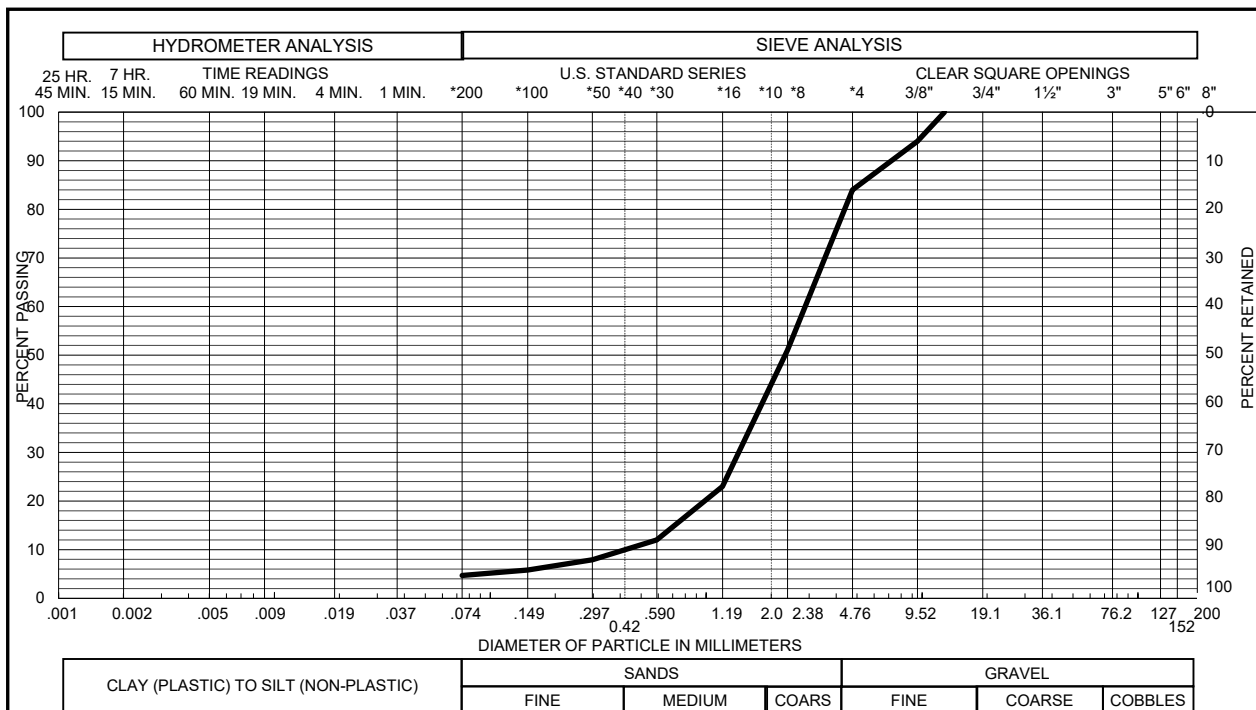
Sample of SAND, SLIGHTLY SILTY (SP-SM) GRAVEL 16 % SAND 79 %
 From TH - 116 AT 19 FEET SILT & CLAY 5 % LIQUID LIMIT %
 PLASTICITY INDEX %

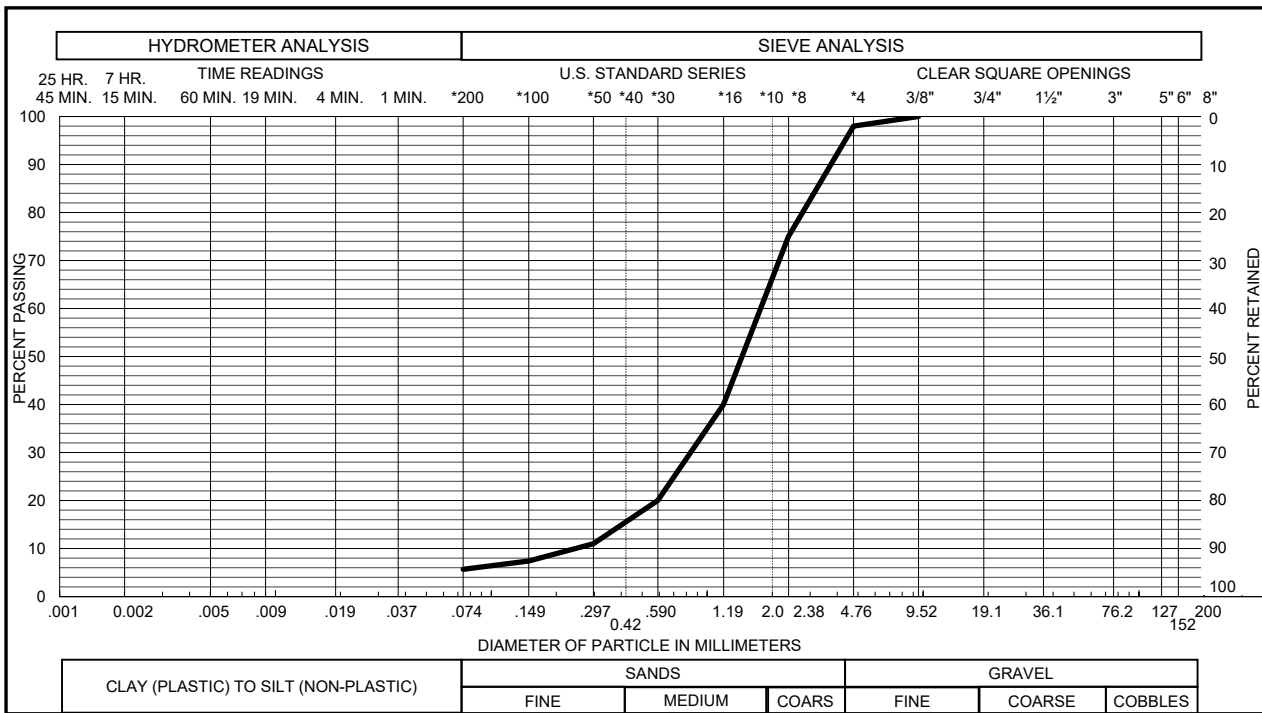
Sample of SAND, SLIGHTLY SILTY (SP-SM) GRAVEL 2 % SAND 92 %
 From TH - 117 AT 24 FEET SILT & CLAY 6 % LIQUID LIMIT %
 PLASTICITY INDEX %

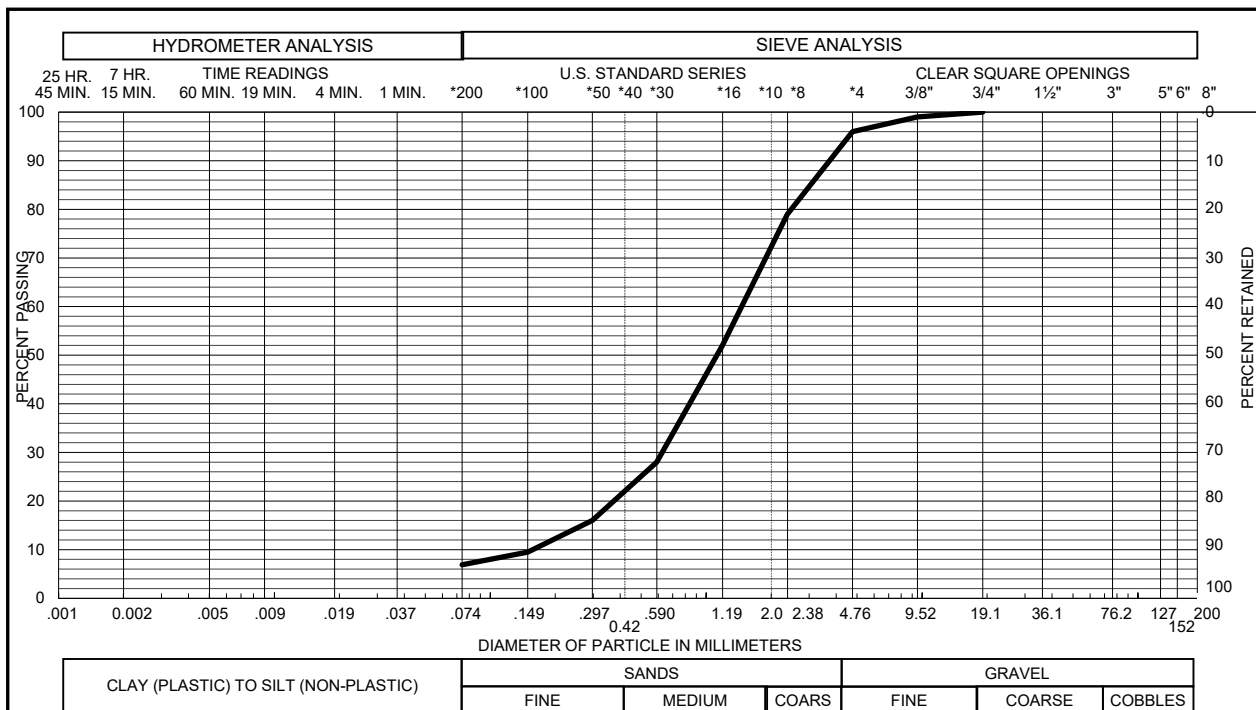
Sample of SAND, SLIGHTLY SILTY (SP-SM) GRAVEL 4 % SAND 89 %
 From TH - 118 AT 24 FEET SILT & CLAY 7 % LIQUID LIMIT %
 PLASTICITY INDEX %

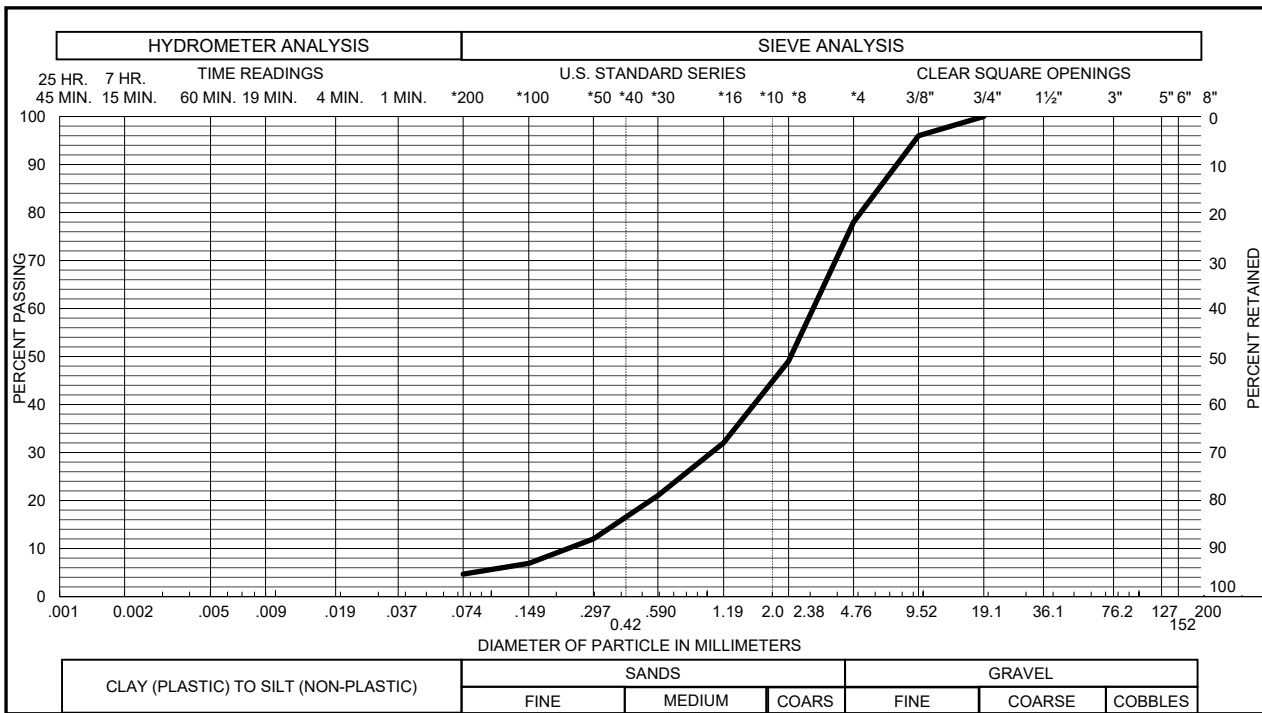
Sample of SAND, SLIGHTLY SILTY (SP-SM) GRAVEL 22 % SAND 73 %
 From TH - 118 AT 29 FEET SILT & CLAY 5 % LIQUID LIMIT %
 PLASTICITY INDEX %

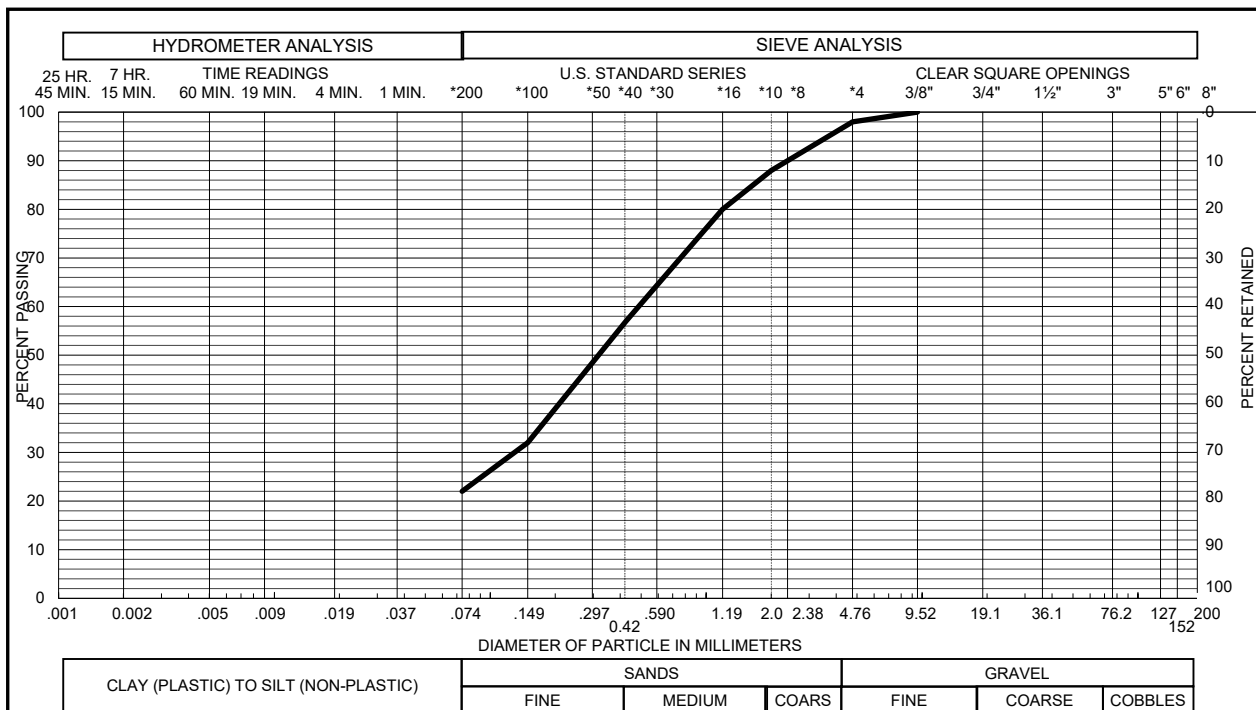
Sample of SAND, CLAYEY AND SILTY (SC-SM) GRAVEL 2 % SAND 76 %
 From TH - 119 AT 0-4 FEET SILT & CLAY 22 % LIQUID LIMIT %
 PLASTICITY INDEX %

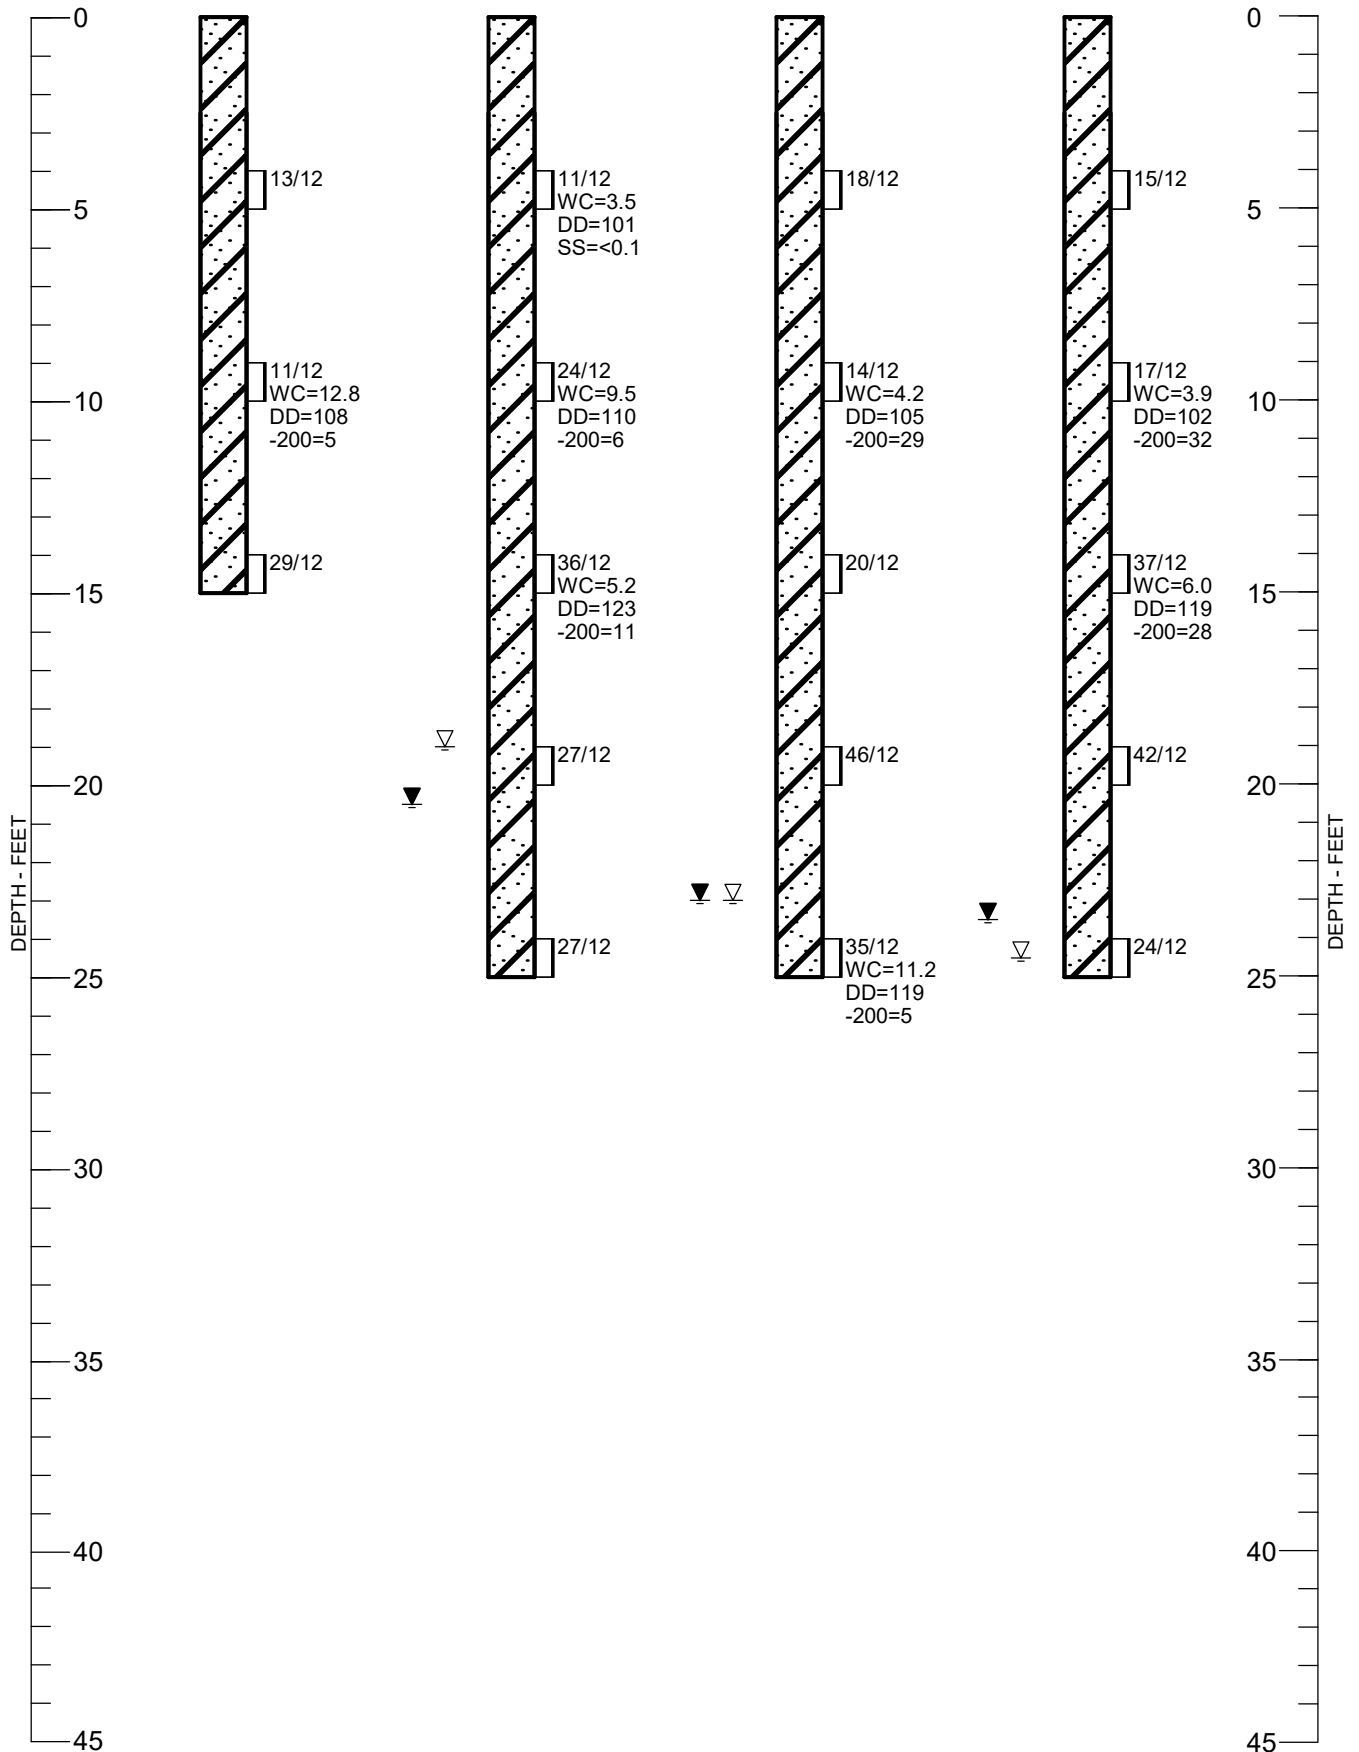
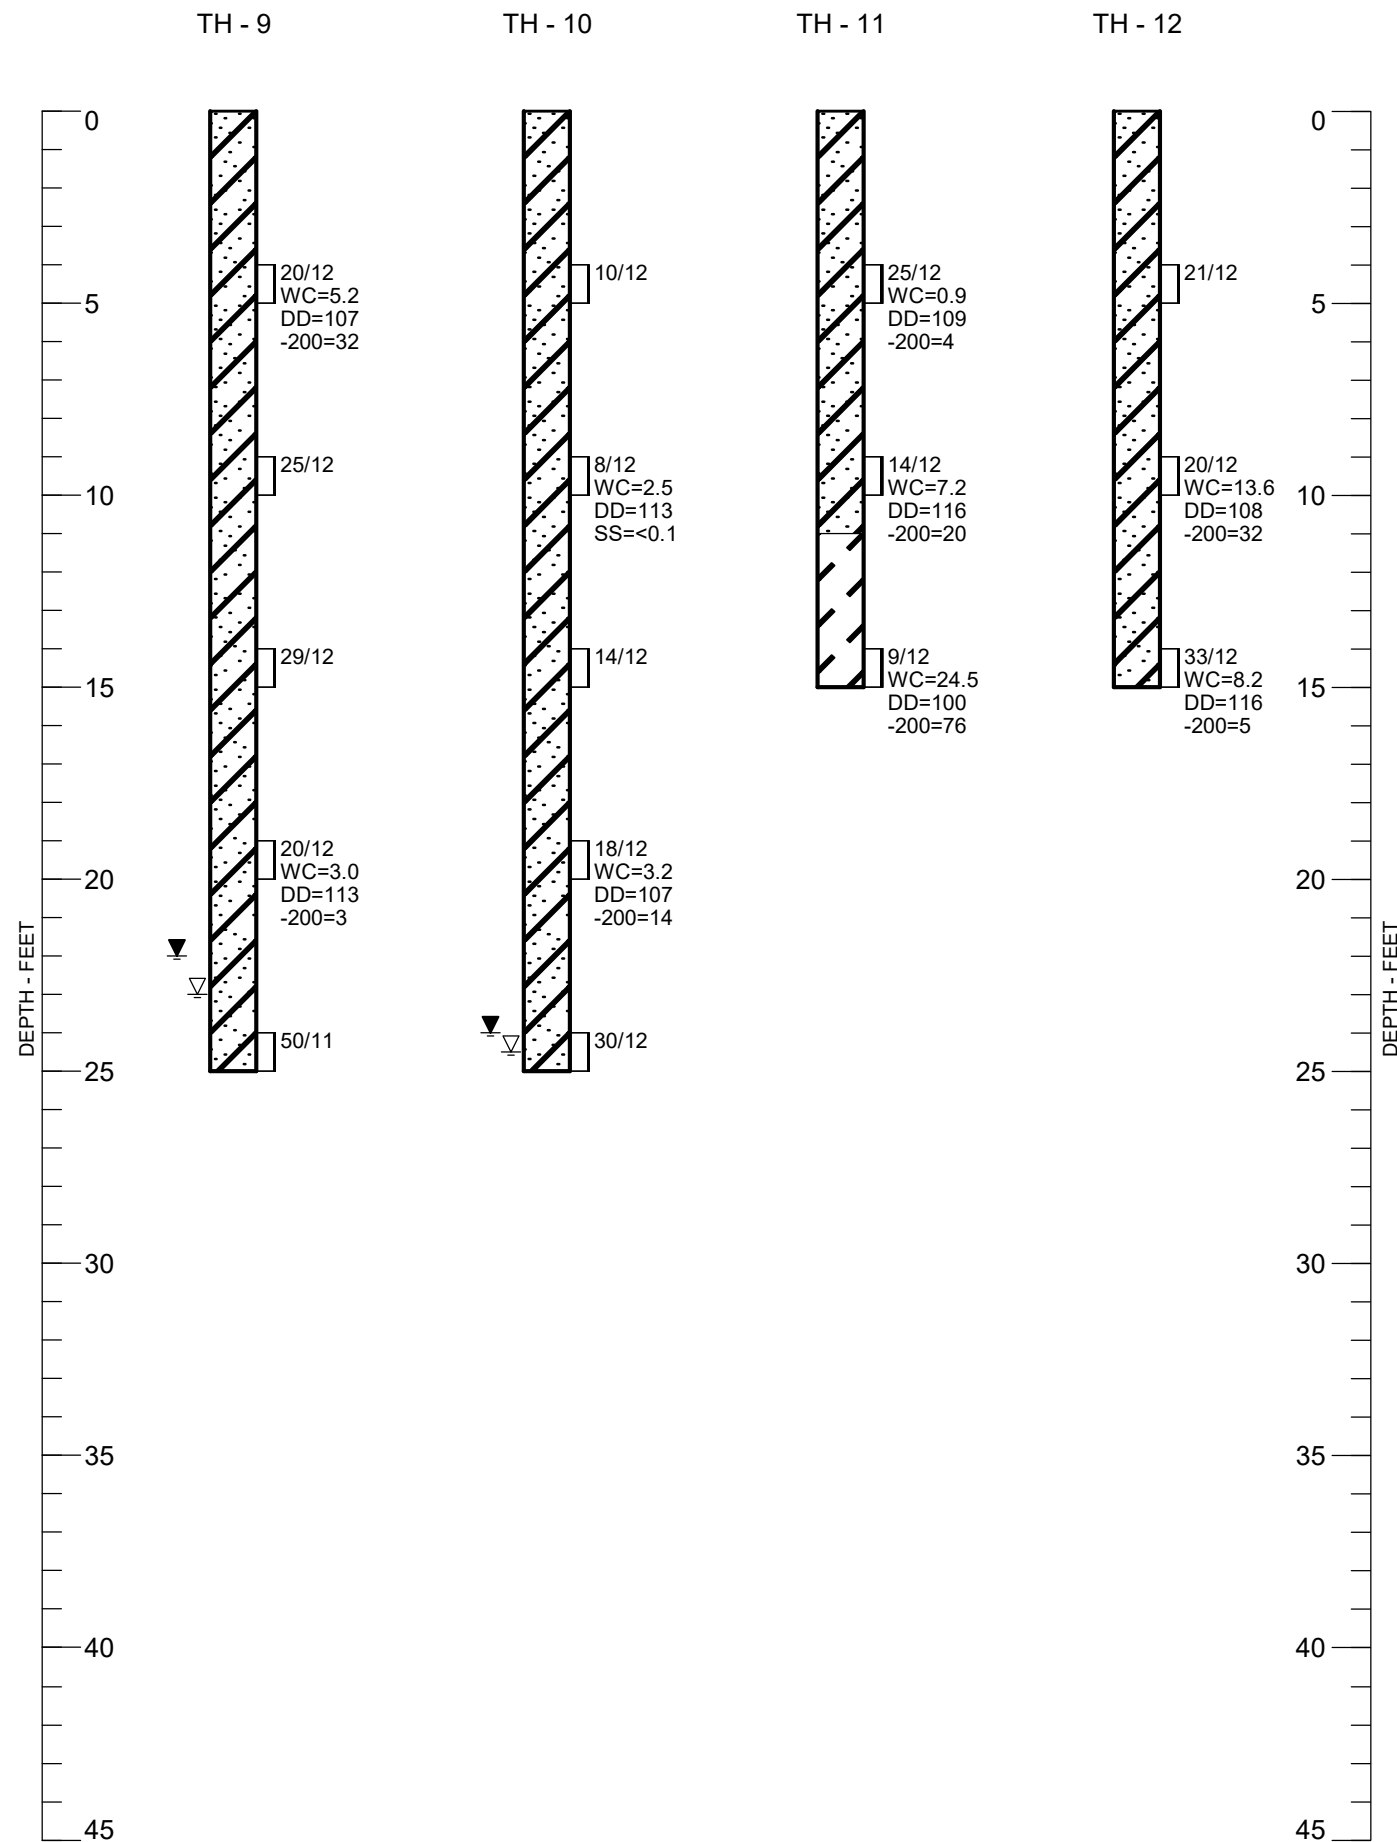
1. THE BORINGS WERE DRILLED OCTOBER 10 AND 17, 2019 USING A 4-INCH DIAMETER, CONTINUOUS-FLIGHT AUGER AND A CME-55, TRUCK-MOUNTED DRILL RIG.
2. THESE LOGS ARE SUBJECT TO THE EXPLANATIONS, LIMITATIONS, AND CONCLUSIONS AS CONTAINED IN THIS REPORT.
3. WC - INDICATES MOISTURE CONTENT. (%)
 DD - INDICATES DRY DENSITY. (PCF)
 -200 - INDICATES PASSING NO. 200 SIEVE. (%)
 SS - INDICATES WATER-SOLUBLE SULFATE CONTENT. (%)

- SAND, CLEAN TO SILTY, LOOSE TO DENSE, SLIGHTLY MOIST TO WET, LIGHT TO MEDIUM BROWN, LIGHT GRAY. (SP, SP-SM, SW-SM, SM)
- SAND, CLAYEY, MEDIUM DENSE, MOIST, DARK BROWN. (SC)
- CLAY, SANDY, STIFF, VERY MOIST, GRAY BROWN. (CL)
- DRIVE SAMPLE. THE SYMBOL 14/12 INDICATES 14 BLOWS OF A 140-POUND HAMMER FALLING 30 INCHES WERE REQUIRED TO DRIVE A 2.5-INCH O.D. SAMPLER 12 INCHES.
- GROUNDWATER LEVEL MEASURED AT TIME OF DRILLING.
- GROUNDWATER LEVEL MEASURED SIX DAYS AFTER DRILLING.
- INDICATES DEPTH WHERE THE TEST HOLE CAVED DURING DRILLING.

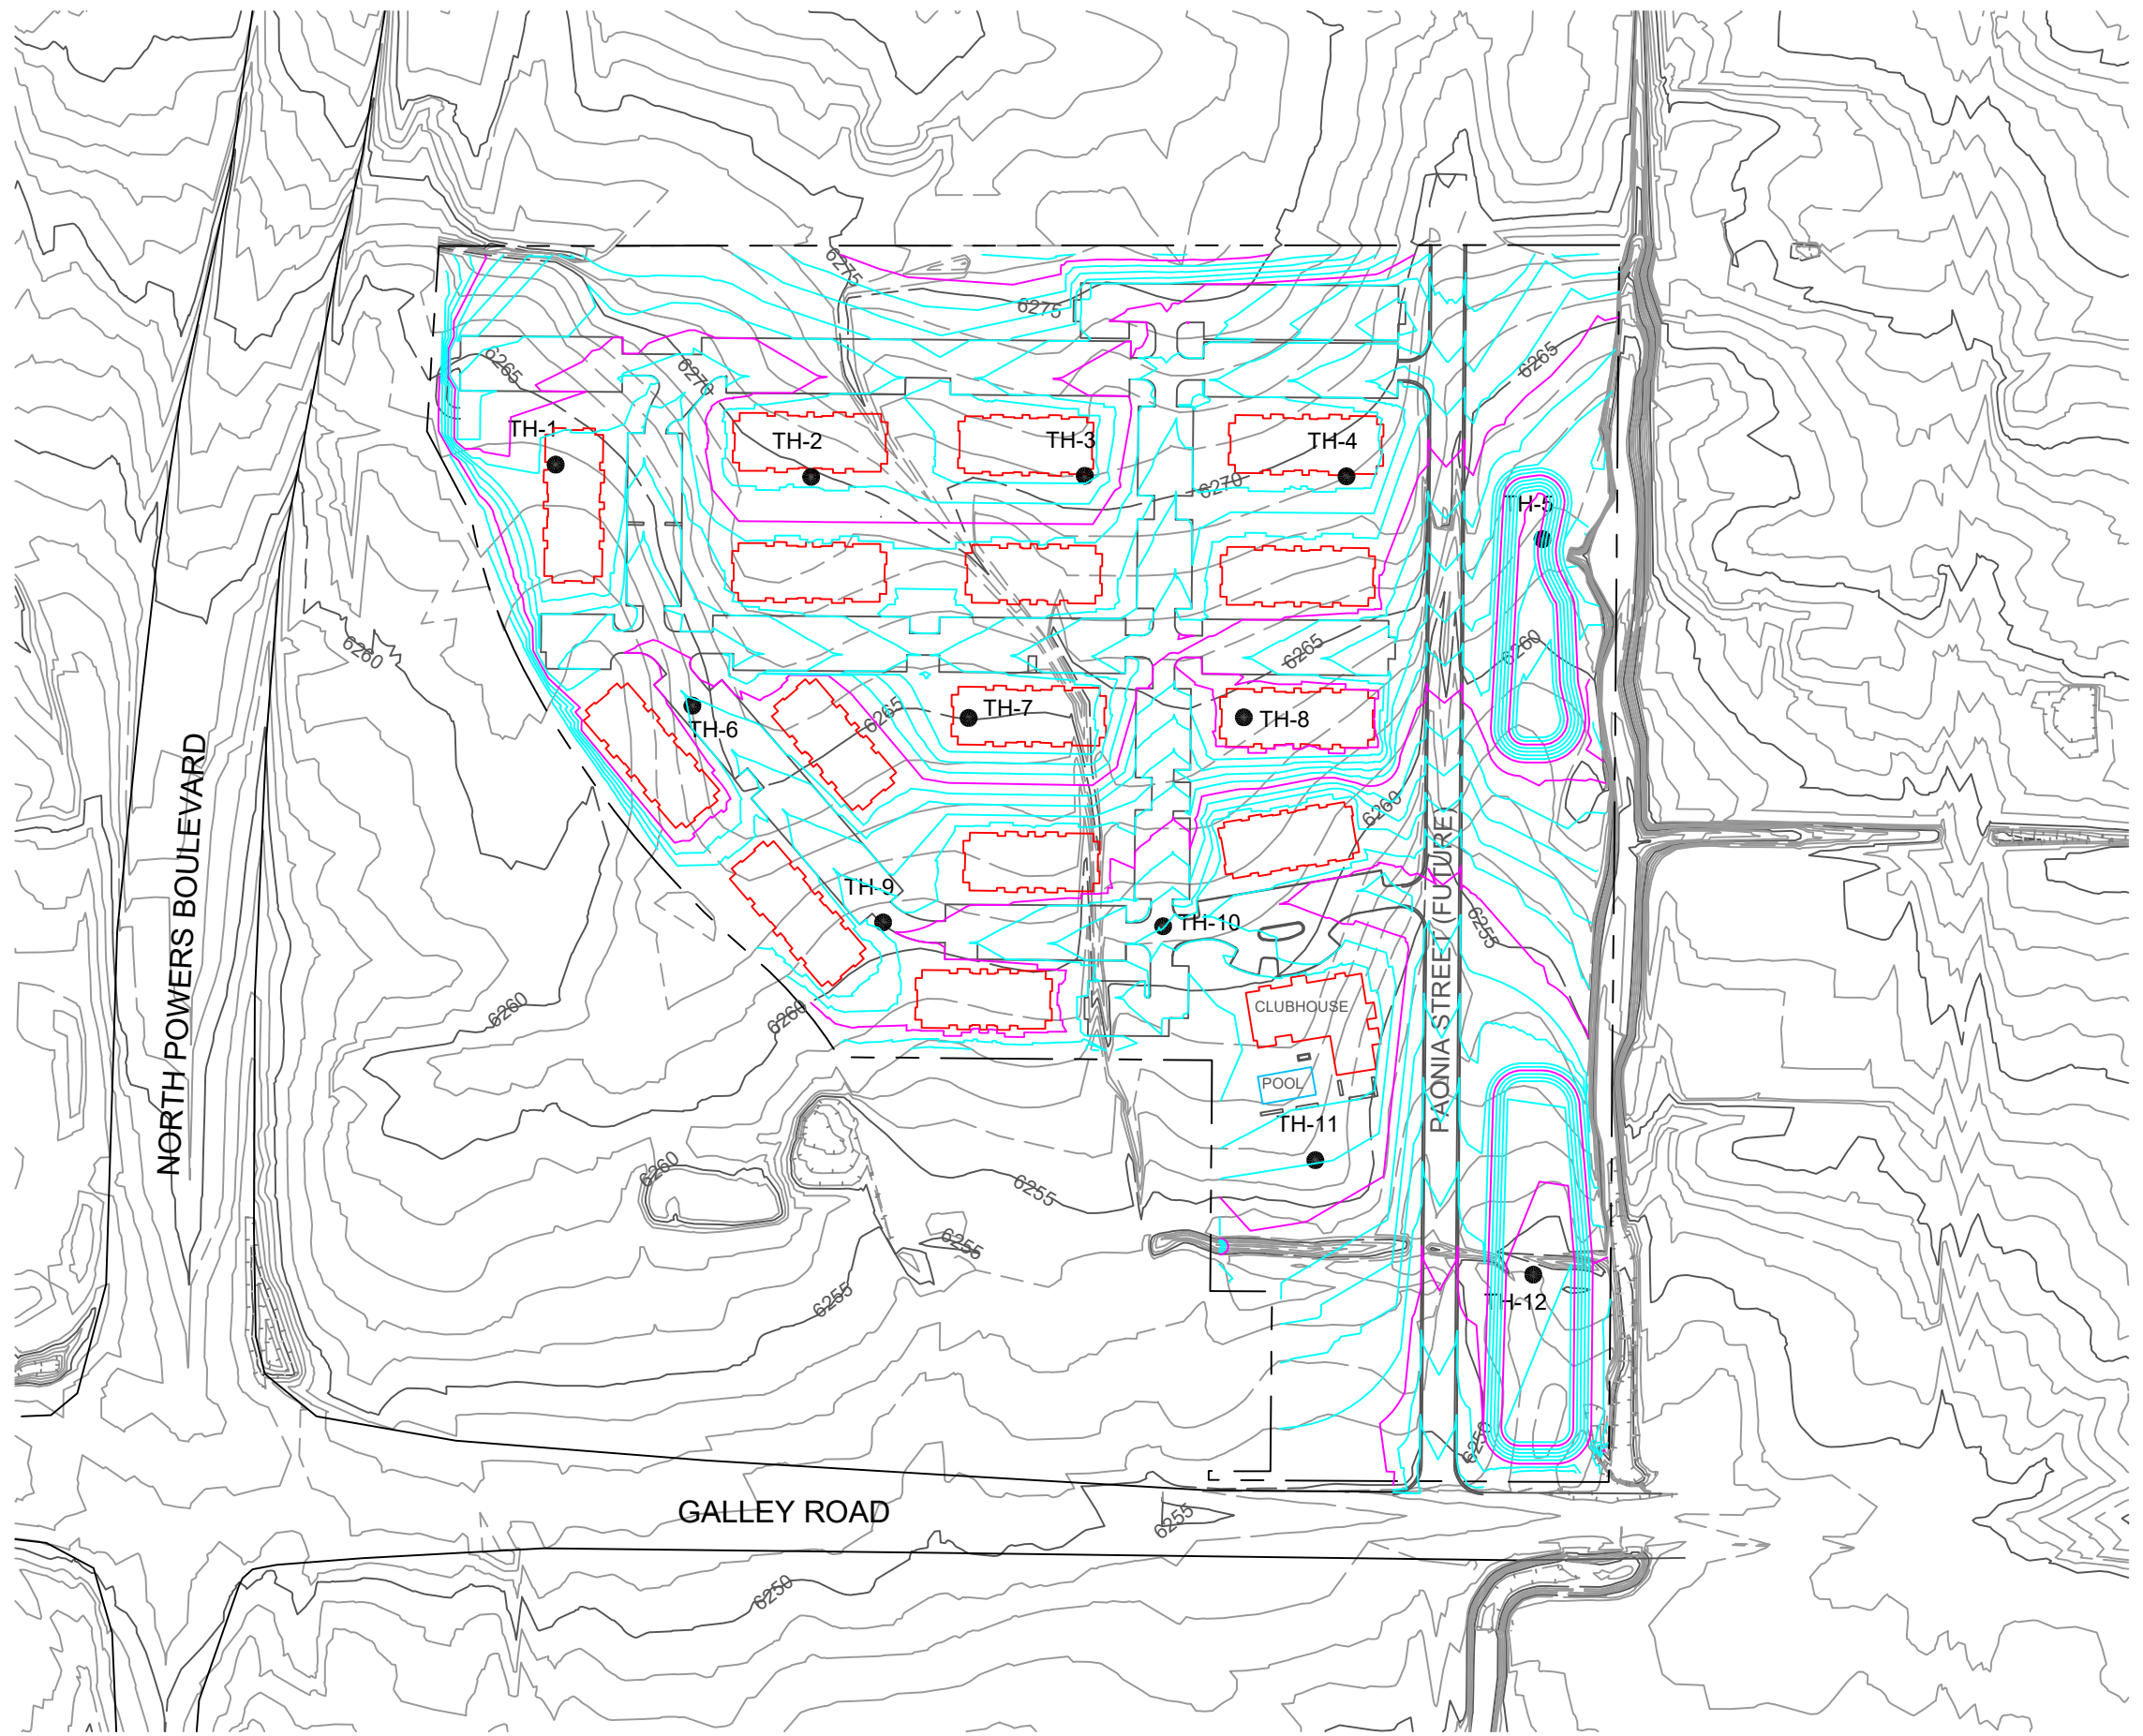
- TH-1 APPROXIMATE LOCATION OF EXPLORATORY BORING.
- PROJECT BOUNDARY
- LOCATION OF PROPOSED BUILDING FOOTPRINT.
- ≡≡≡ EXISTING TOPOGRAPHY
- ≡≡≡ PROPOSED GRADING CONTOURS

NOTE:
 BASE DRAWING WAS PROVIDED BY NES IN AN EMAIL DATED
 DECEMBER 4, 2019.
