Subject: Response to Review Comments
Solace Apartment Complex
Powers Boulevard and Galley Road
Colorado Springs, Colorado
CTLT Project Nos CS19163.001-125 L2

**GEOLOGIC HAZARDS EVALUATION AND
PRELIMINARY GEOTECHNICAL INVESTIGATION
POWERS APARTMENT COMPLEX
POWERS BOULEVARD AND GALLEY ROAD
EL PASO COUNTY, COLORADO**

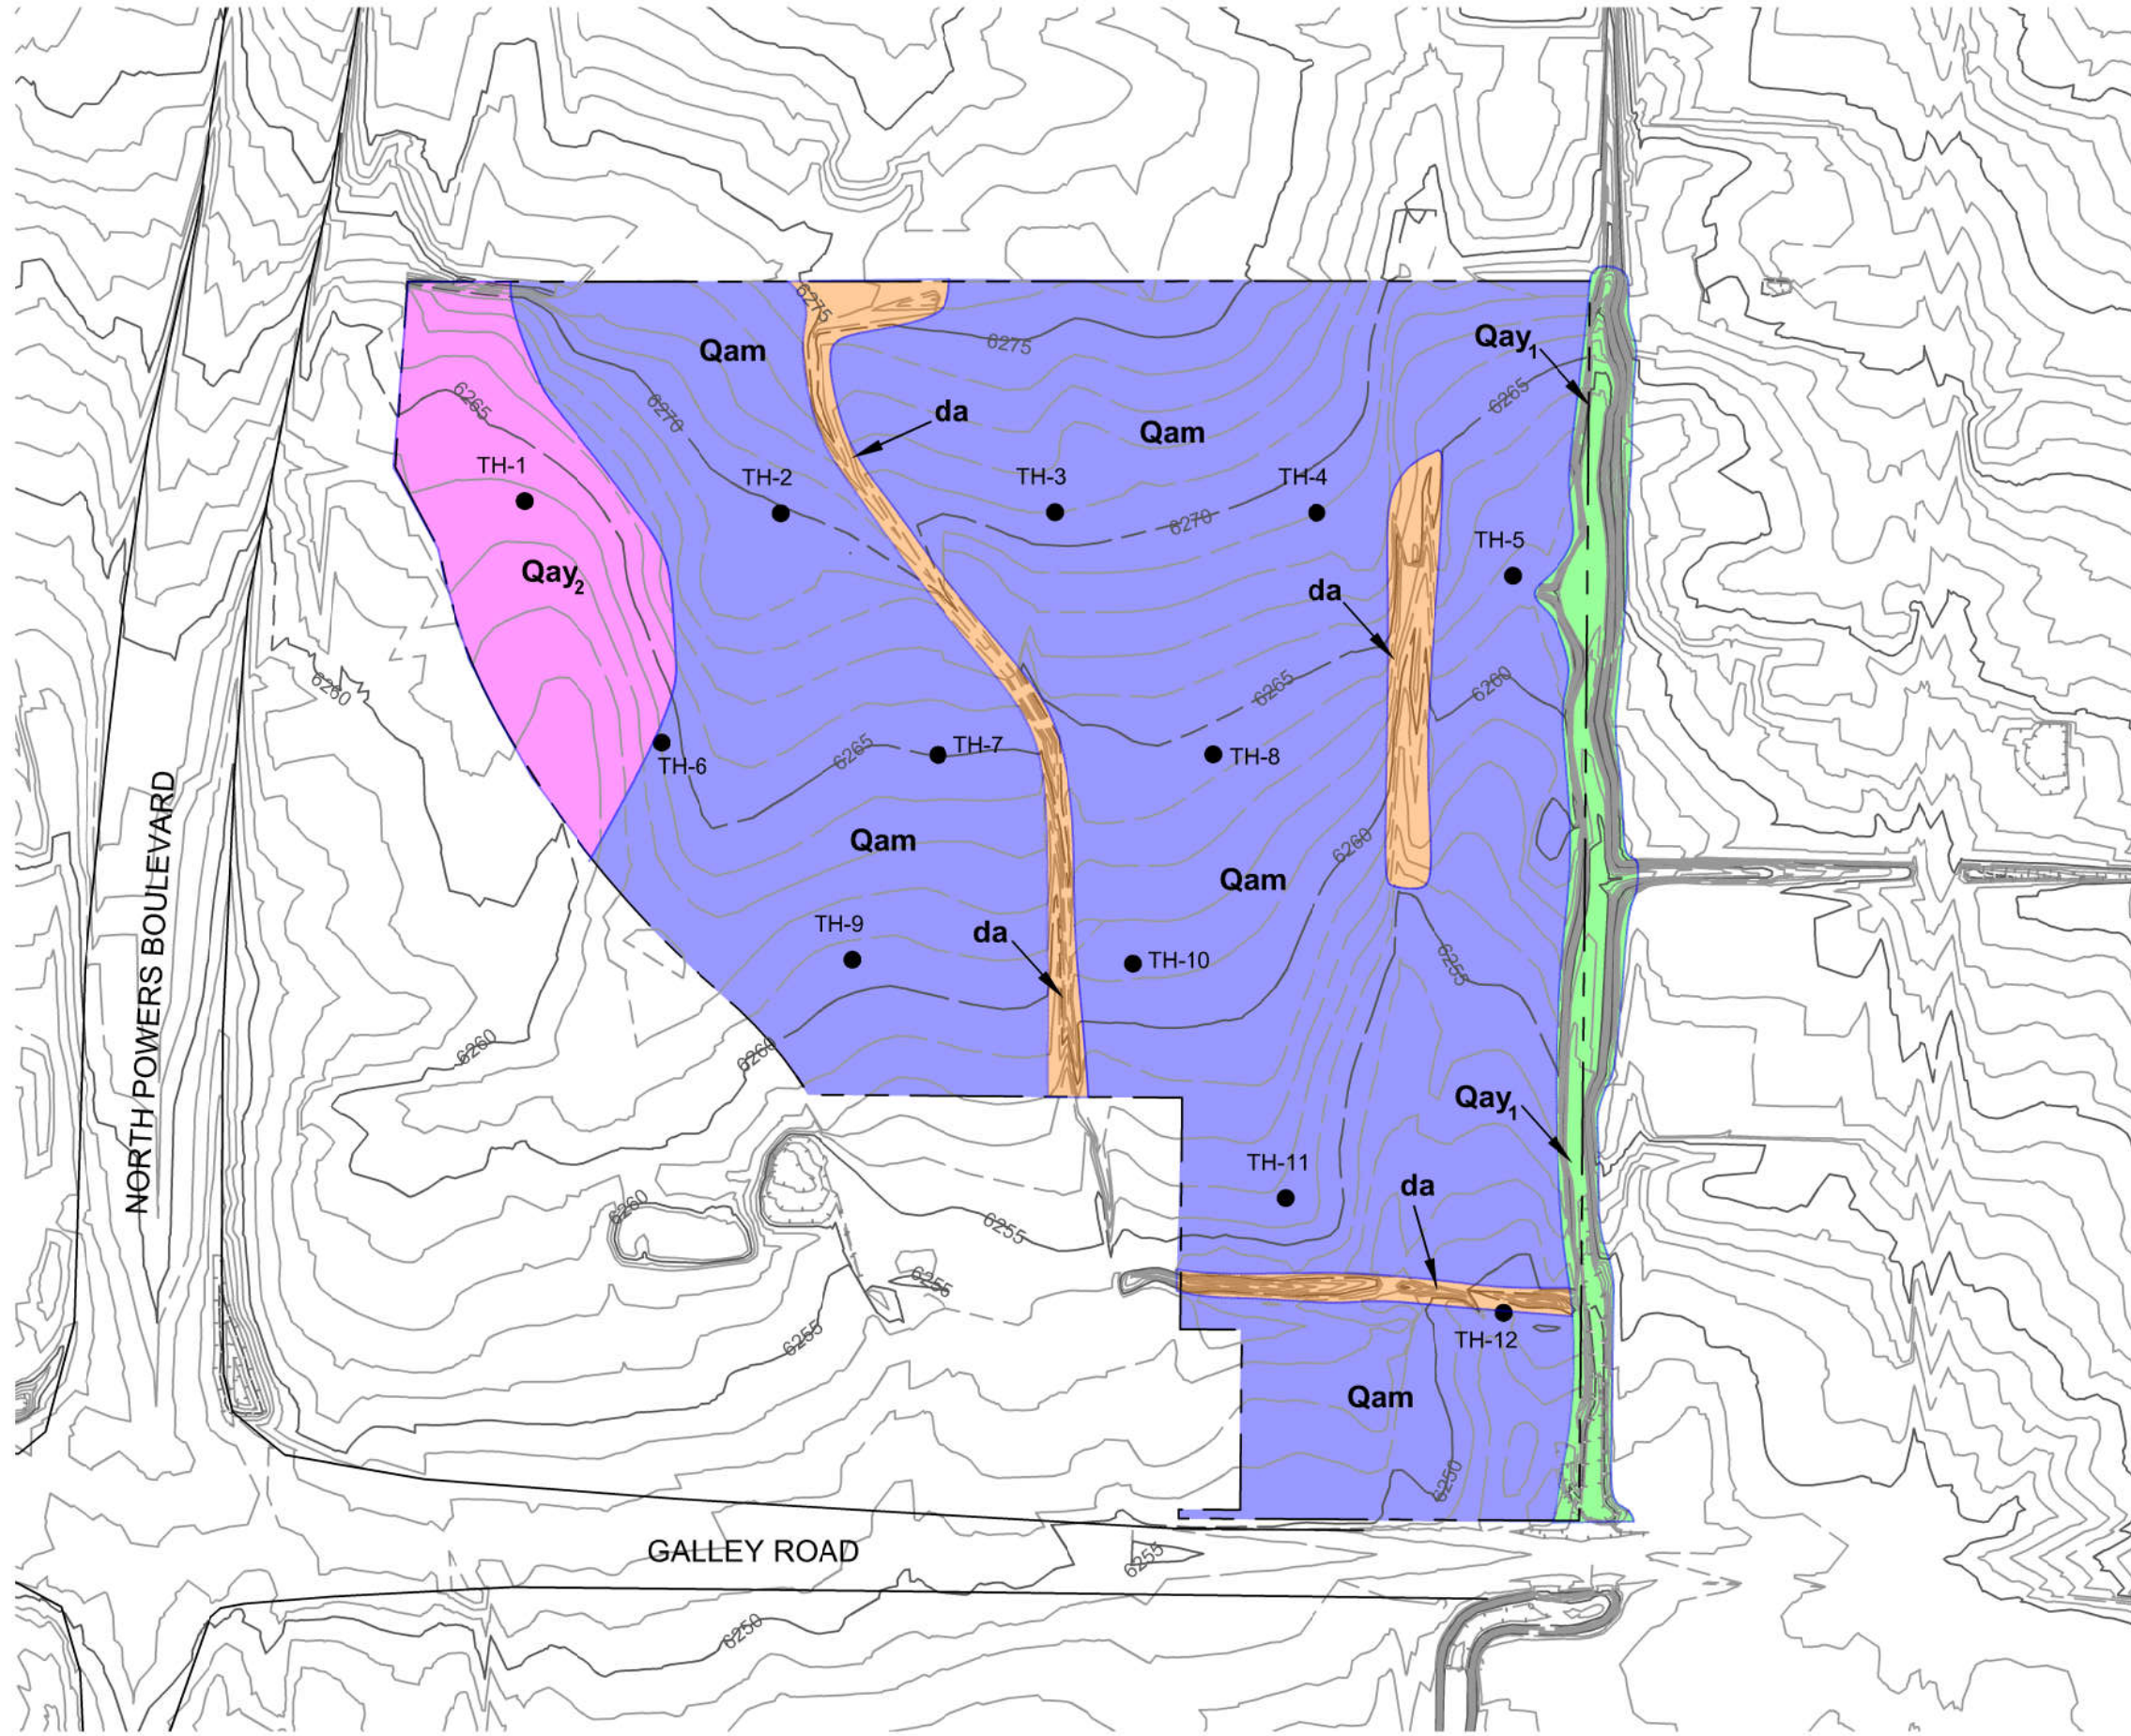
TH-1 ● APPROXIMATE LOCATION OF EXPLORATORY BORING.

Qay₁ YOUNG ALLUVIUM ONE, LATE HOLOCENE, POORLY-SORTED, SILTY SANDS TYPICALLY FOUND IN NARROW FLOOD PLAINS AND THE FLOORS OF STREAM CHANNELS.

Qay₂ YOUNG ALLUVIUM TWO, LATE AND MIDDLE HOLOCENE, POORLY-SORTED, SILTY SANDS TYPICALLY FOUND IN BROAD VALLEY FLOORS.

Qam MIDDLE ALLUVIUM, LATE PLEISTOCENE, POORLY-SORTED SANDS.

da DISTURBED AREA

1. BASE DRAWING WAS PROVIDED BY NES IN AN EMAIL DATED NOVEMBER 21, 2019.
2. ALL BOUNDARIES SHOWN SHOULD BE CONSIDERED APPROXIMATE. THEY ARE BASED UPON A SUBJECTIVE INTERPRETATION OF PUBLISHED MAPS, AERIAL PHOTOGRAPHS AND AN INITIAL FIELD RECONNAISSANCE. CHANGES IN THE MAPPED BOUNDARIES SHOWN ARE POSSIBLE AND SHOULD BE EXPECTED WITH MORE DETAILED WORK AND FURTHER INFORMATION. ALL INTERPRETATIONS AND CONDITIONS SHOWN ARE PRELIMINARY AND FOR LAND-USE PLANNING ONLY.

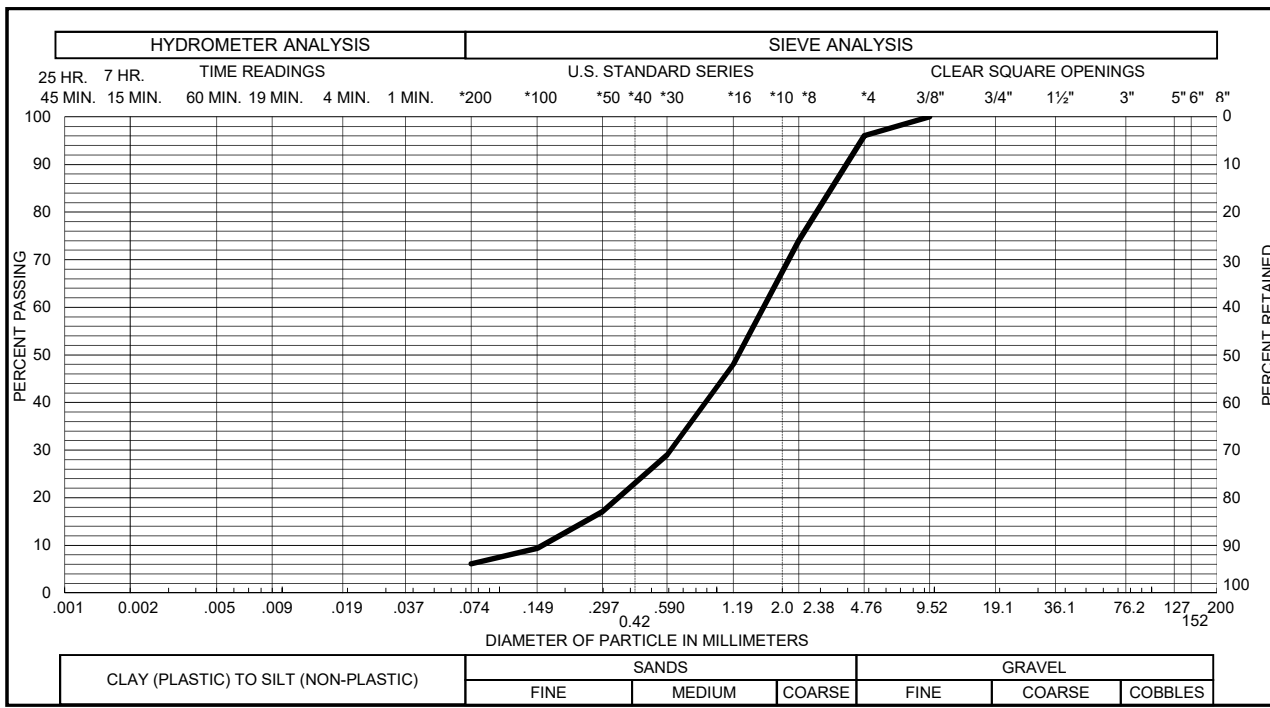
Sample of **SAND, SLIGHTLY SILTY (SW-SM)** GRAVEL 4 % SAND 90 %
 From **TH - 1 AT 19 FEET** SILT & CLAY 6 % LIQUID LIMIT _____ %
 PLASTICITY INDEX _____ %

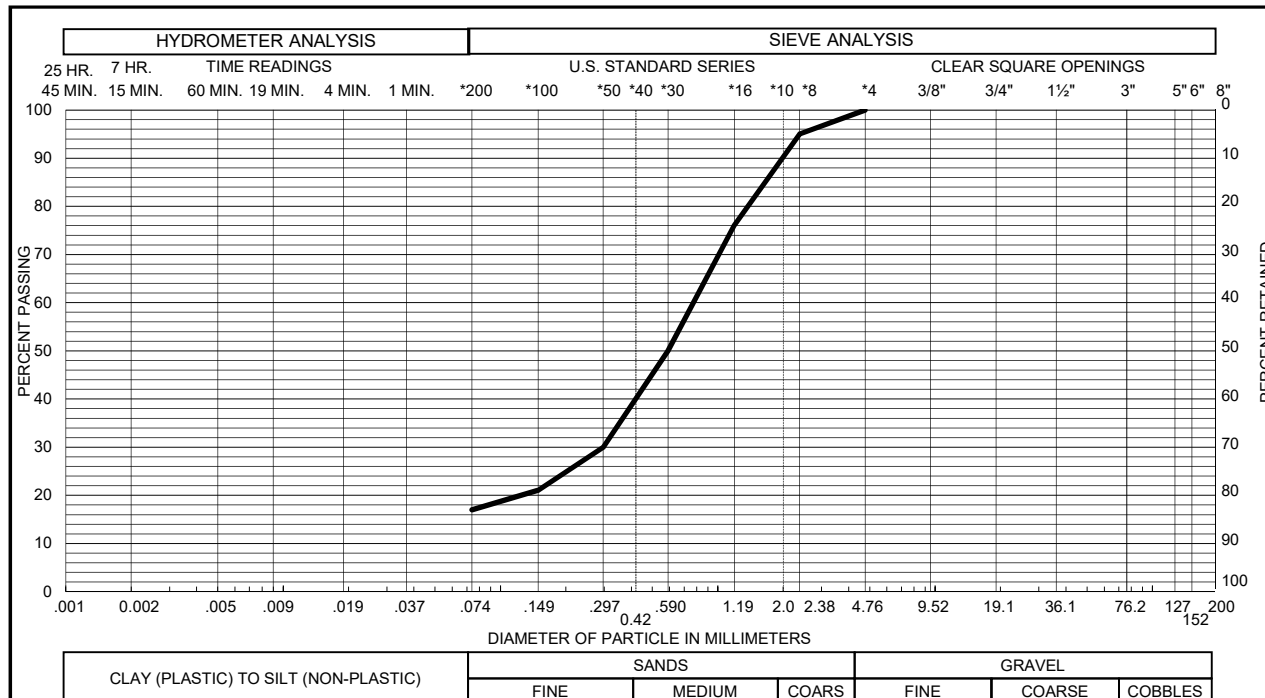
Sample of **SAND, SILTY (SM)** GRAVEL 0 % SAND 83 %
 From **TH - 2 AT 4 FEET** SILT & CLAY 17 % LIQUID LIMIT _____ %
 PLASTICITY INDEX _____ %

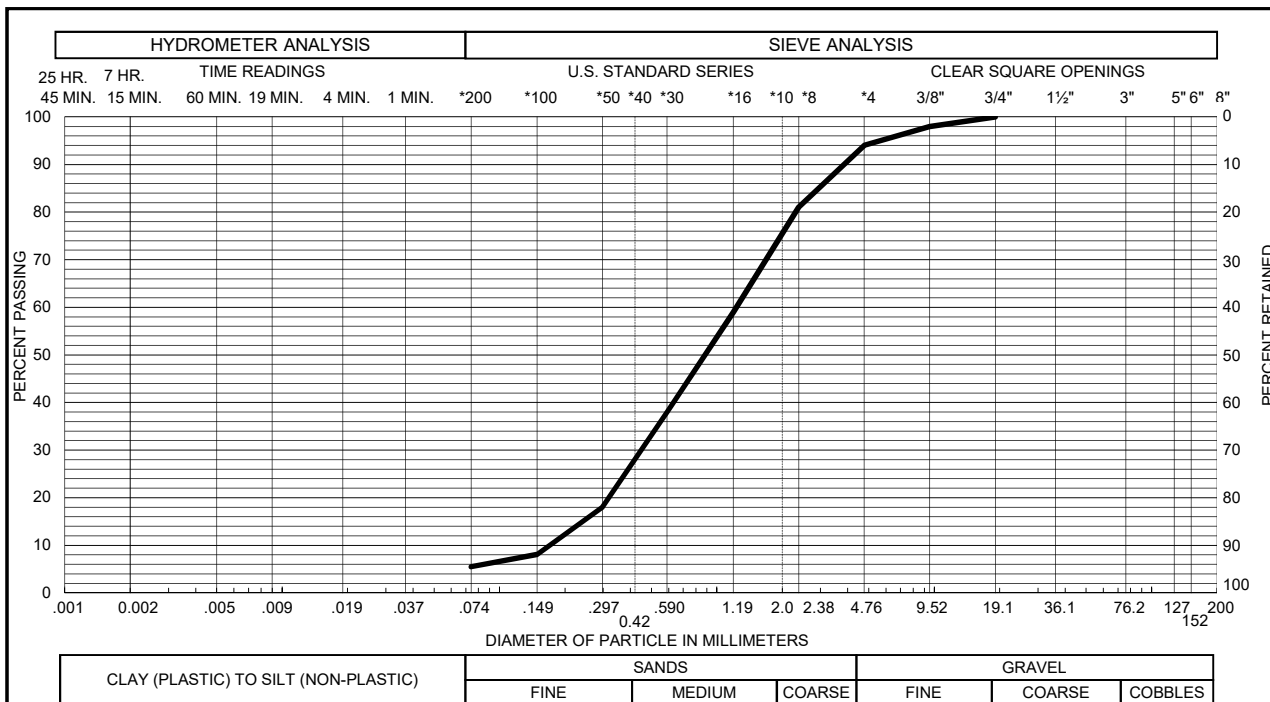
Sample of **SAND, SLIGHTLY SILTY (SP-SM)** GRAVEL **6 %** SAND **88 %**
 From **TH - 6 AT 9 FEET** SILT & CLAY **6 %** LIQUID LIMIT **%
 PLASTICITY INDEX **%****

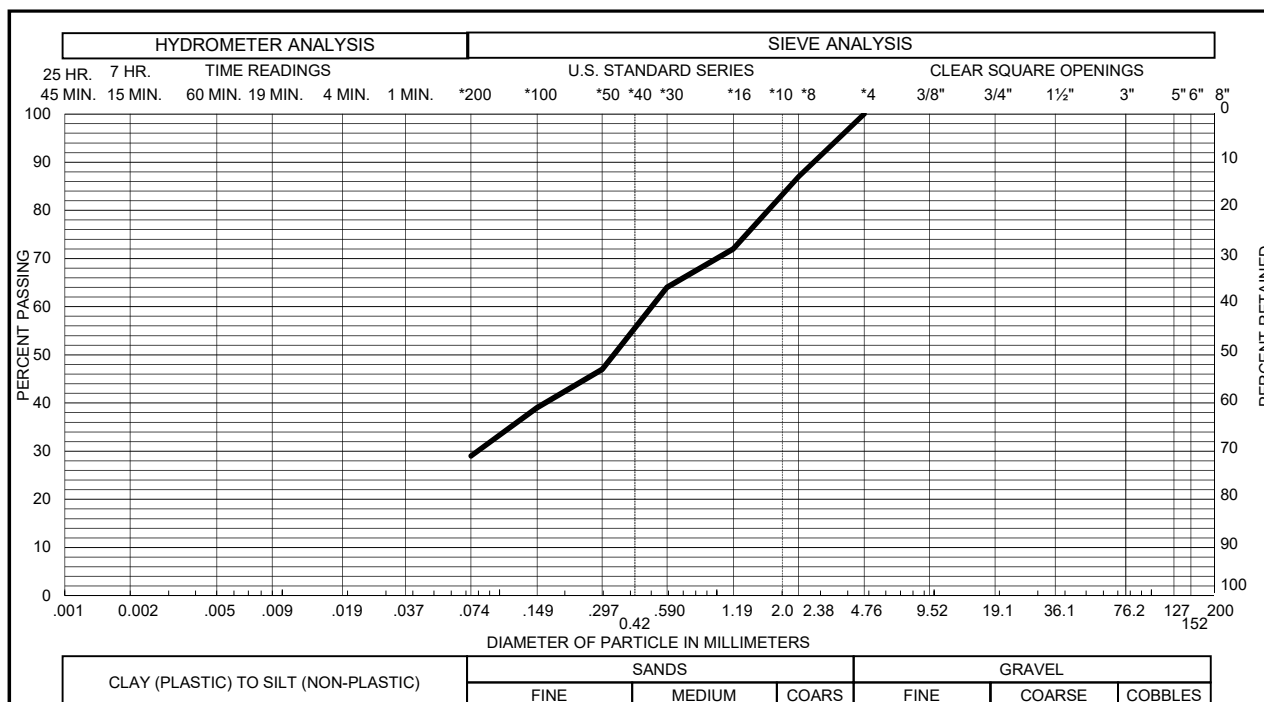
Sample of **SAND, SILTY (SM)** GRAVEL **0 %** SAND **71 %**
 From **TH - 7 AT 9 FEET** SILT & CLAY **29 %** LIQUID LIMIT **%
 PLASTICITY INDEX **%****

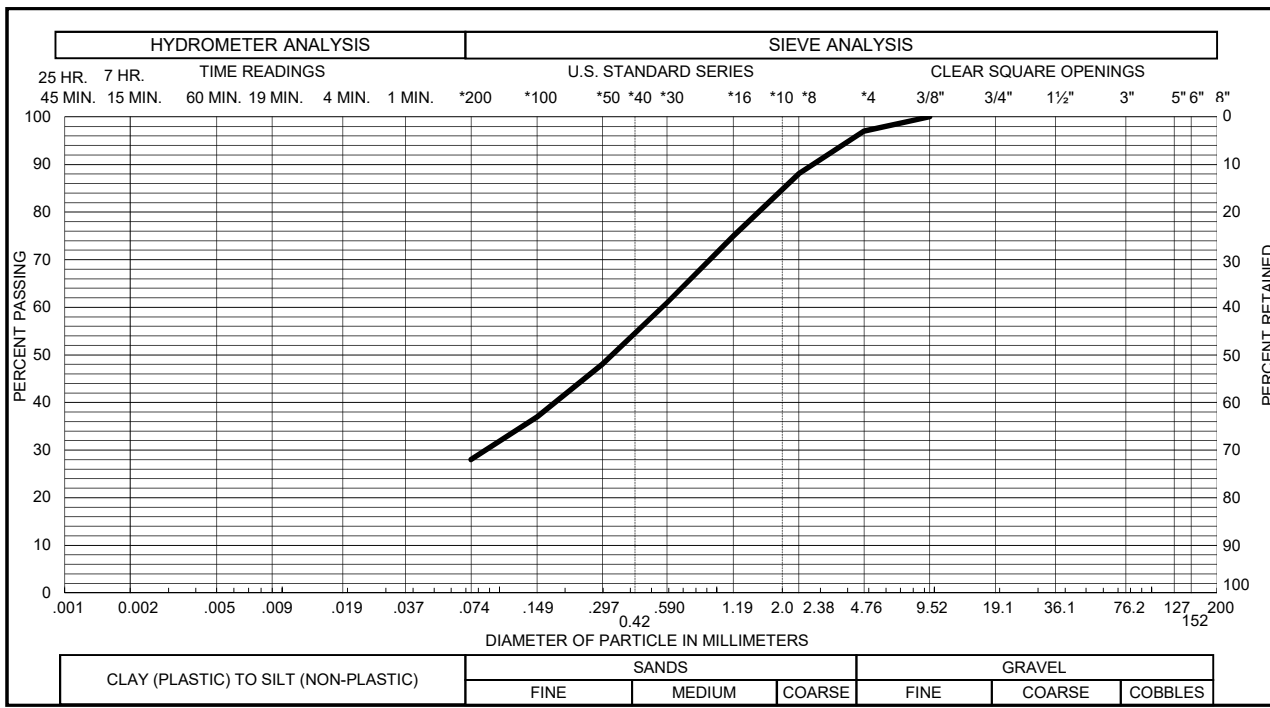
Sample of **SAND, SILTY (SM)** GRAVEL **3 %** SAND **69 %**
 From **TH - 8 AT 14 FEET** SILT & CLAY **28 %** LIQUID LIMIT **%
 PLASTICITY INDEX **%****

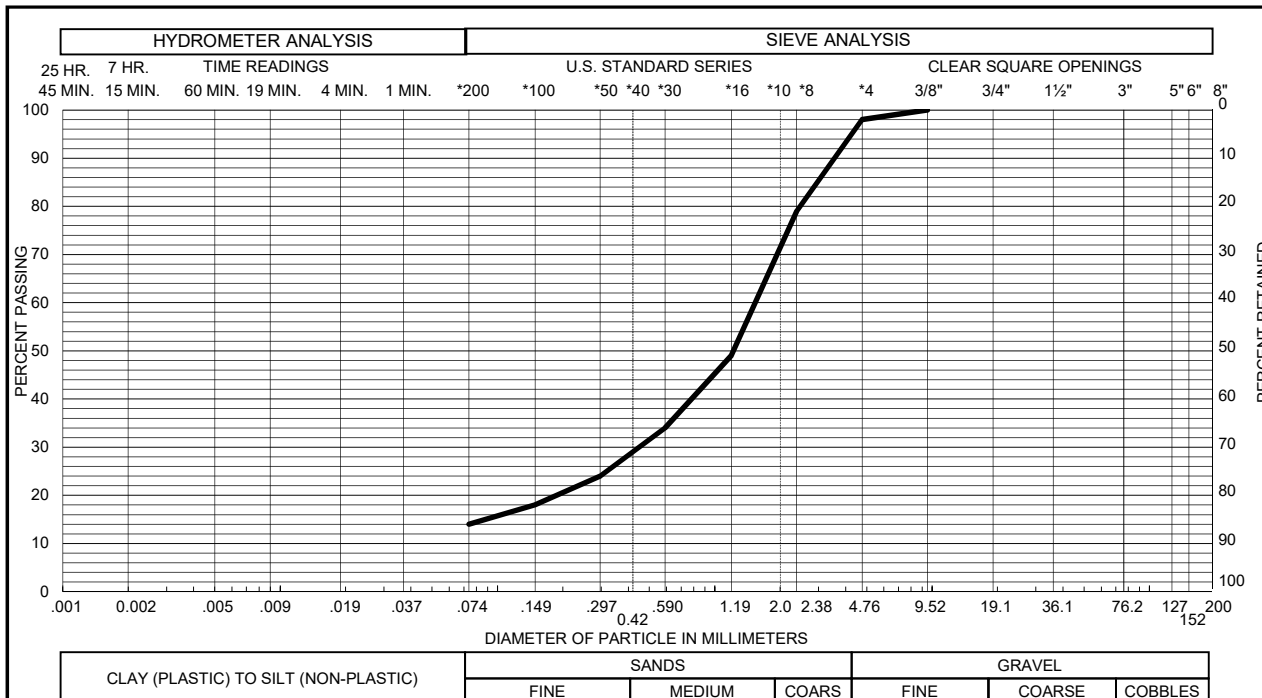
Sample of **SAND, SILTY (SM)** GRAVEL **2 %** SAND **84 %**
 From **TH - 10 AT 19 FEET** SILT & CLAY **14 %** LIQUID LIMIT **%
 PLASTICITY INDEX **%****

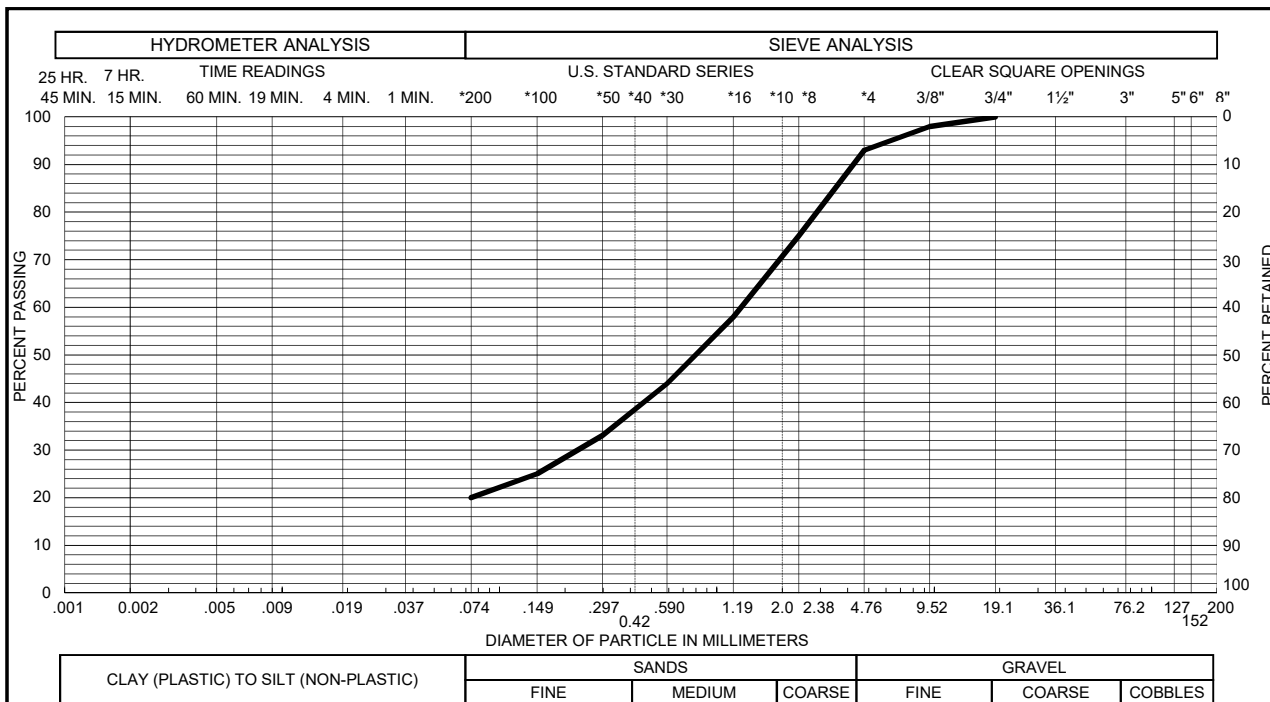
Sample of **SAND, SILTY (SM)** GRAVEL 7 % SAND 73 %
 From TH - 11 AT 9 FEET SILT & CLAY 20 % LIQUID LIMIT _____ %
 PLASTICITY INDEX _____ %
