Job No. 185466

Re: Response to:  
Colorado Geological Survey Review Comments, dated June 6, 2022 and  
El Paso County Planning and Community Development Comments, dated June 1, 2017.

RMG - Rocky Mountain Group prepared the "*Soils and Geology Study*" (RMG Job No. 185466, amended August 8 2022) for the proposed minor subdivision to comprise three single-family residential lots on approximately 61.55 acres. The report was reviewed by personnel of the Colorado Geological Survey (CGS). The purpose of this letter is to provide our response to the CGS and El Paso County Planning & Community Development review comments. The responses and modifications noted herein have been incorporated into our amended report.

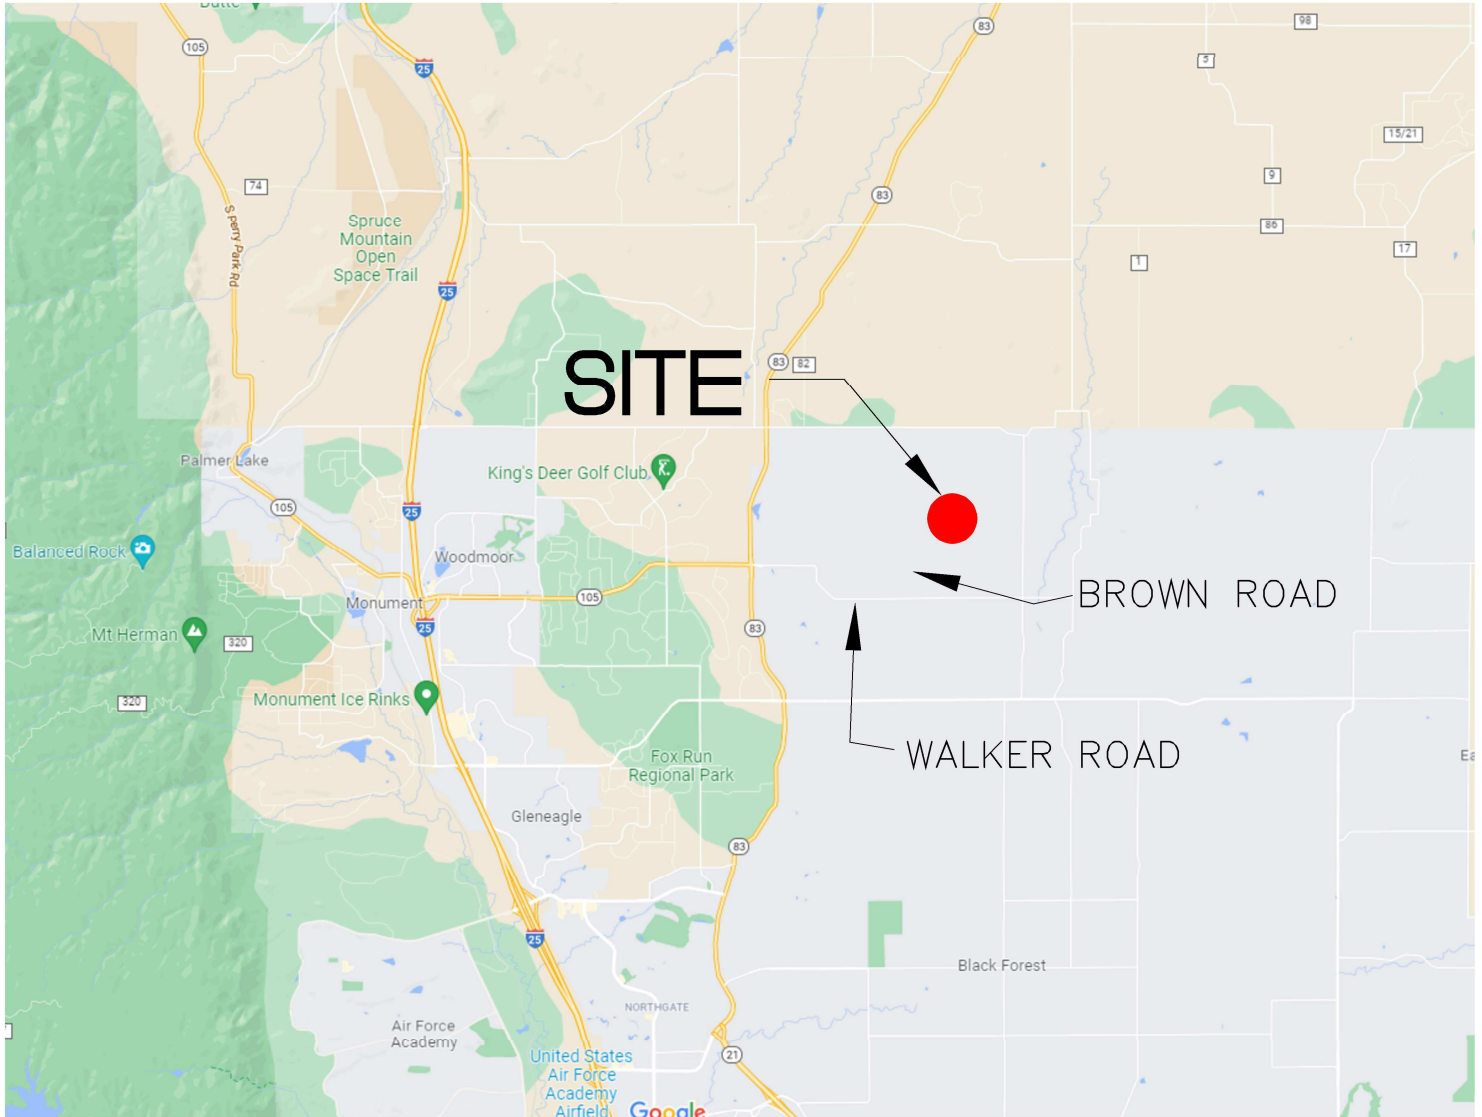
FIG No. 1

The project lies in part of the north ½ of lot 2 of the SW ¼ of Section 7, Township 11 South, Range 65 West of the 6<sup>th</sup> Principal Meridian in El Paso County, Colorado, and is generally located northwest of the intersection of Walker Road and Brown Road. The approximate location of the site is shown on the Site Vicinity Map, Figure 1.

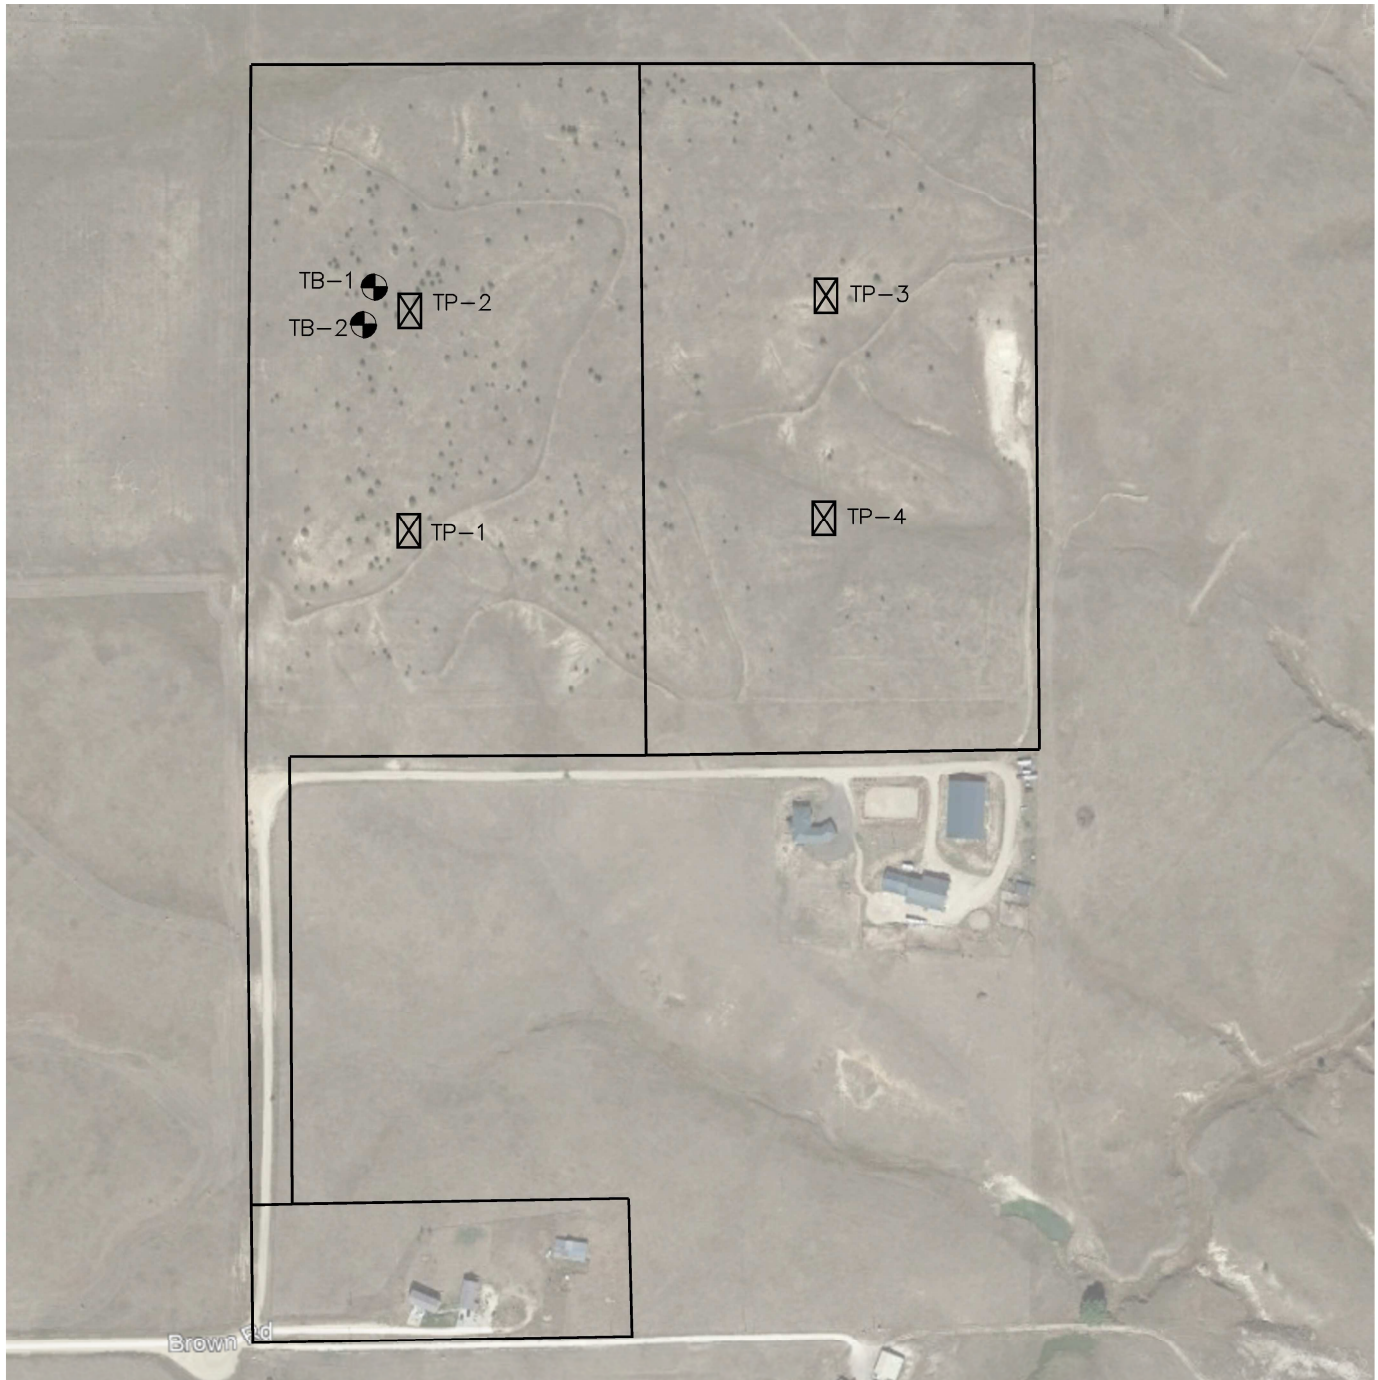
The site consists of approximately 61.55 acres (noted as 61.949 acres on the referenced plat) and is partially developed. An existing two-story agricultural residence is located on the southwest corner of the property. Two one-story barns are located east of the residence. It is our understanding the existing 61.55 acres is to be subdivided into a total of two lots. As denoted on the Final Plat prepared by SMH Consultants, dated May 2022, Lot 1 is to consist of approximately 21.9 acres and Lot 2 is to consist of approximately 40 acres. Lot 2, is to retain the existing residence, well and septic. No additional residences are currently proposed on Lot 2. Based on conversations with the owner, a single family residence, well and septic is proposed for Lot 1. The remaining 35 acres, east of Lot 1 are not included in this subdivision. Lot 1 is to be accessed from Brown Road. The Proposed Lot Layout is presented in Figure 2.

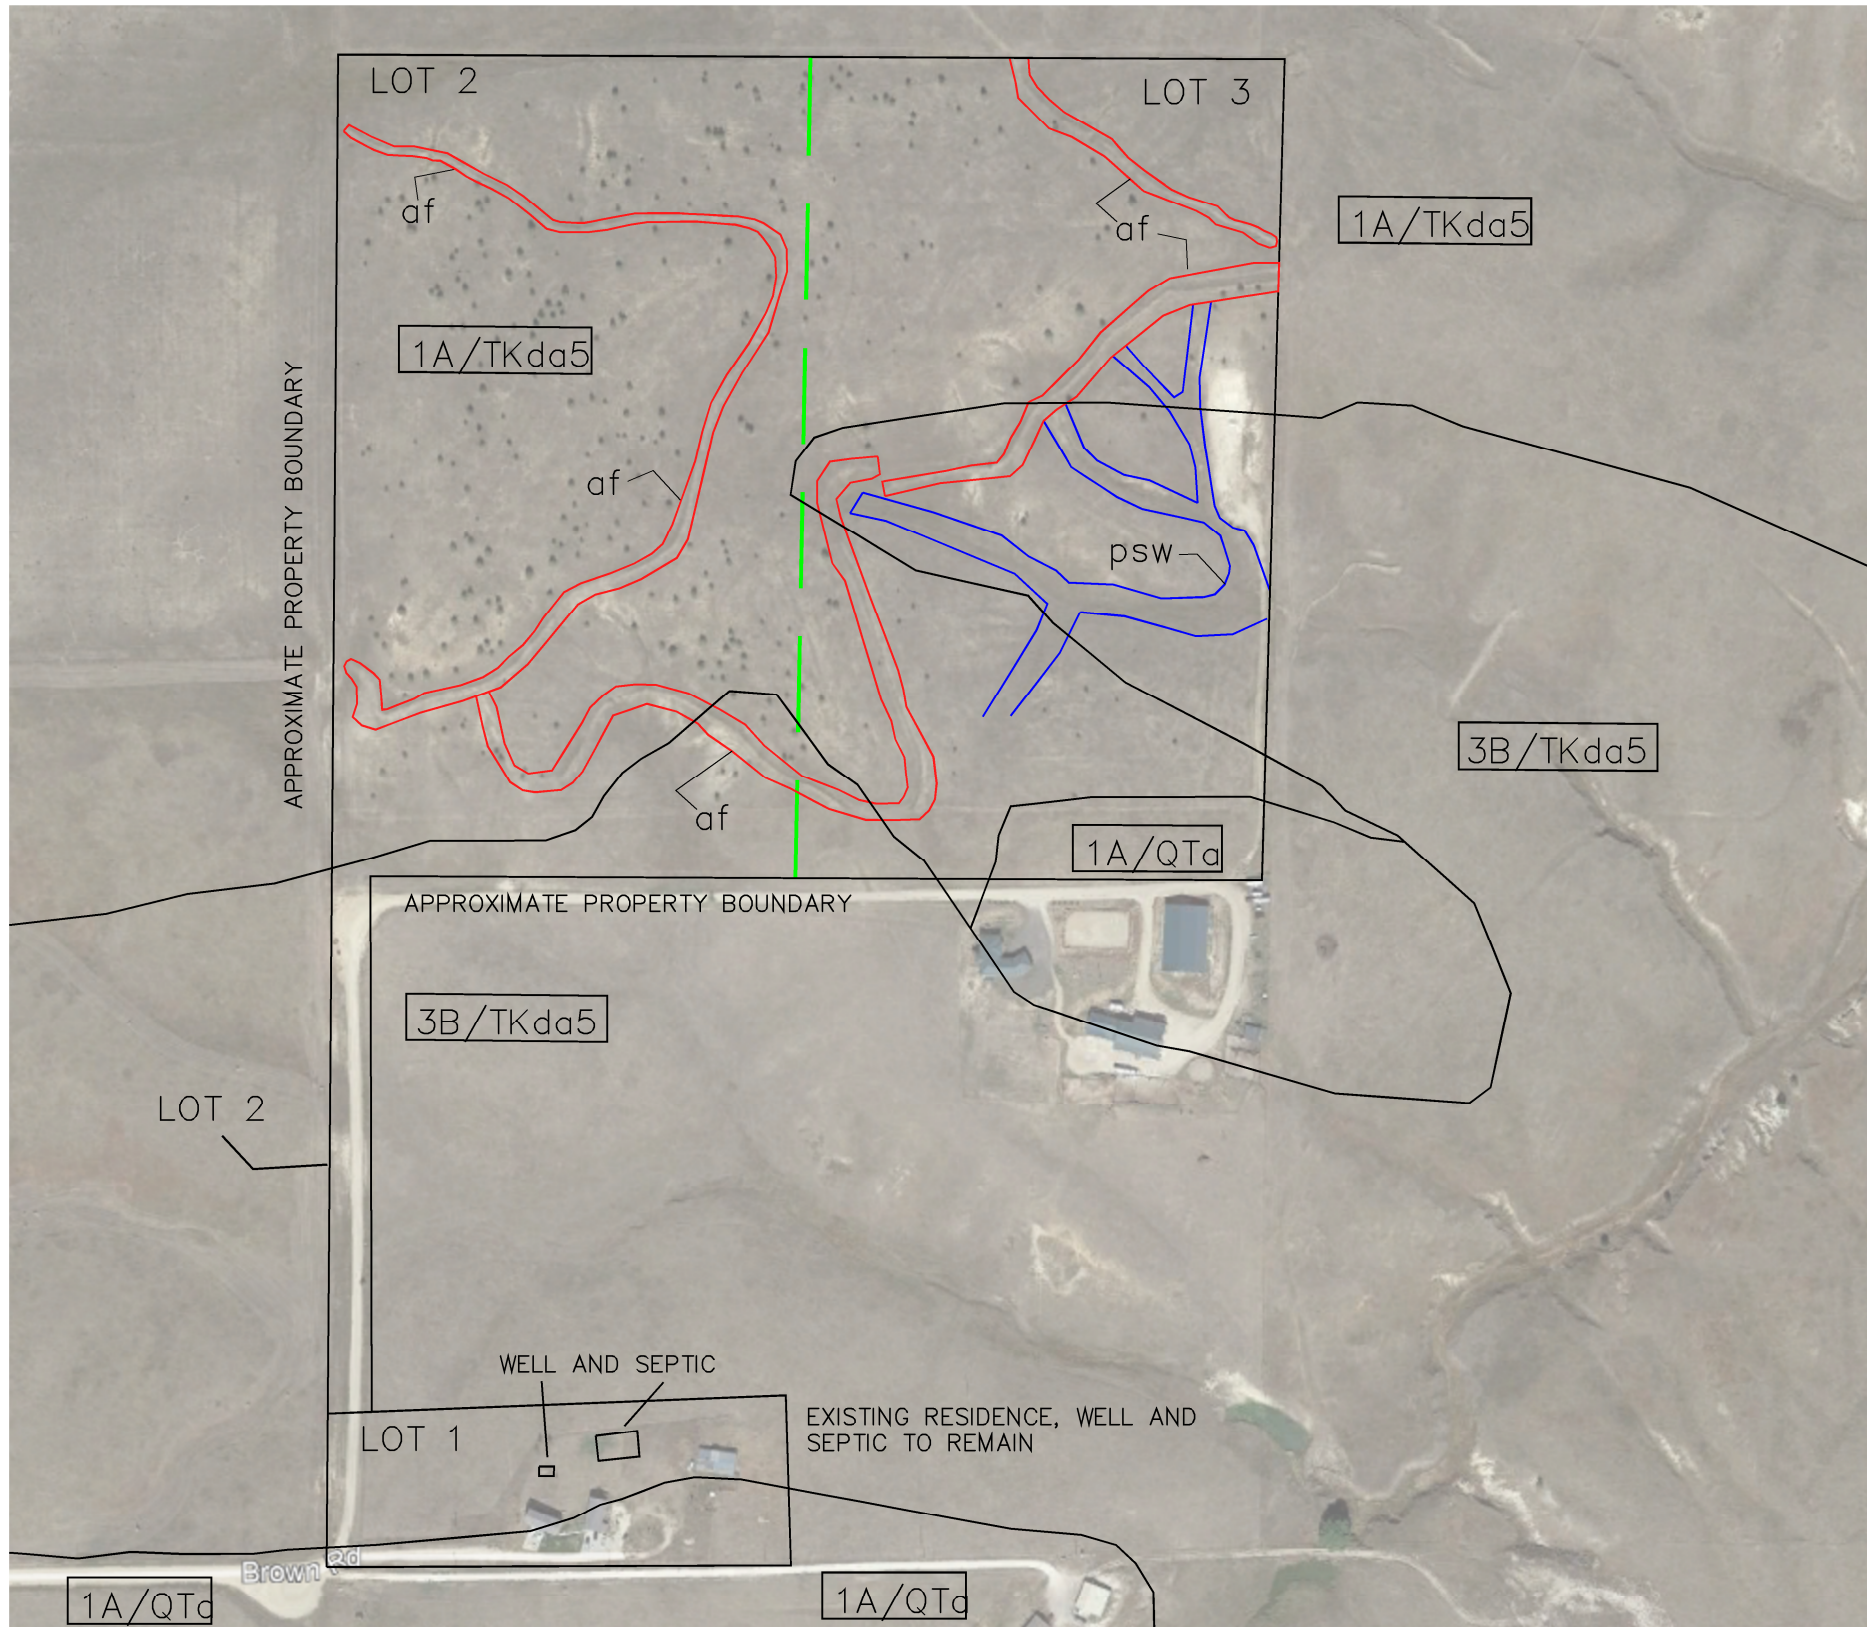
- TKda5 – Dawson Formation, facies unit three (early to middle Eocene) – Unit is estimated to be about 500 feet thick
- QTa – Alluvium of Palmer Divide (early Pleistocene or Pliocene) – Unit is up to 30 feet thick
- af – Artificial Fill Area – Artificial fill placed between 1955 and 1960 for the creation of irrigation ditches throughout the property
- psw – Potentially Seasonally Wet Area

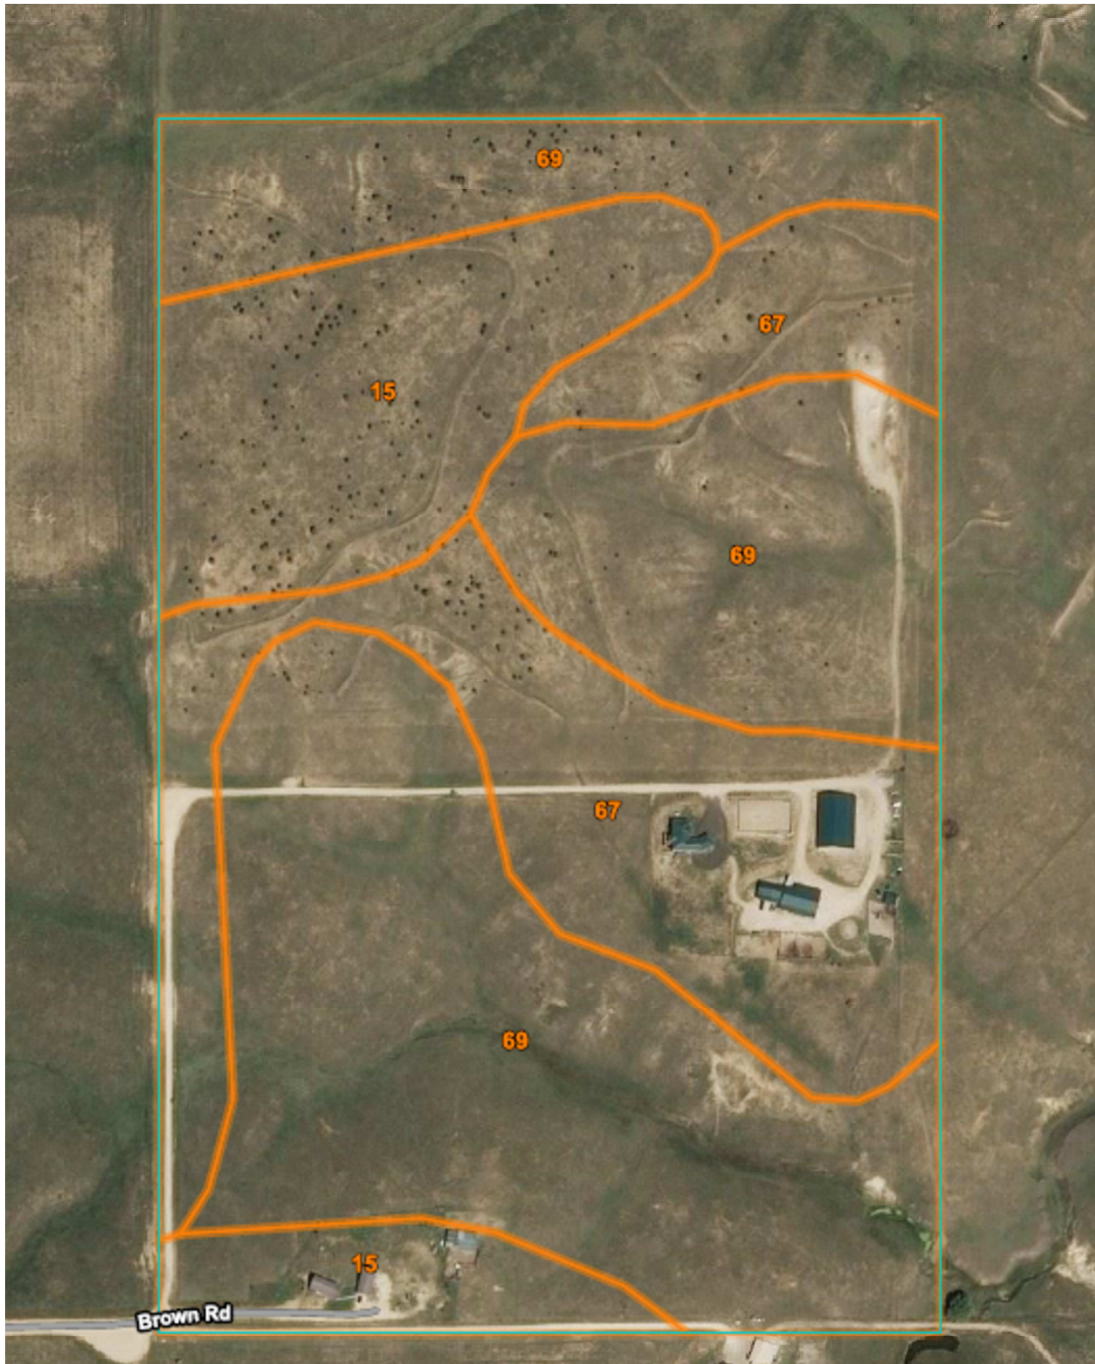
FIG No. 6

- 15 – BRUSSETT LOAM, 3 TO 5 PERCENT SLOPES
- 67 – PEYTON SANDY LOAM, 5 TO 9 PERCENT SLOPES
- 69 – PEYTON-PRING COMPLEX, 8 TO 15 PERCENT SLOPES

The USDA Soils Survey Map is presented in Figure 6.

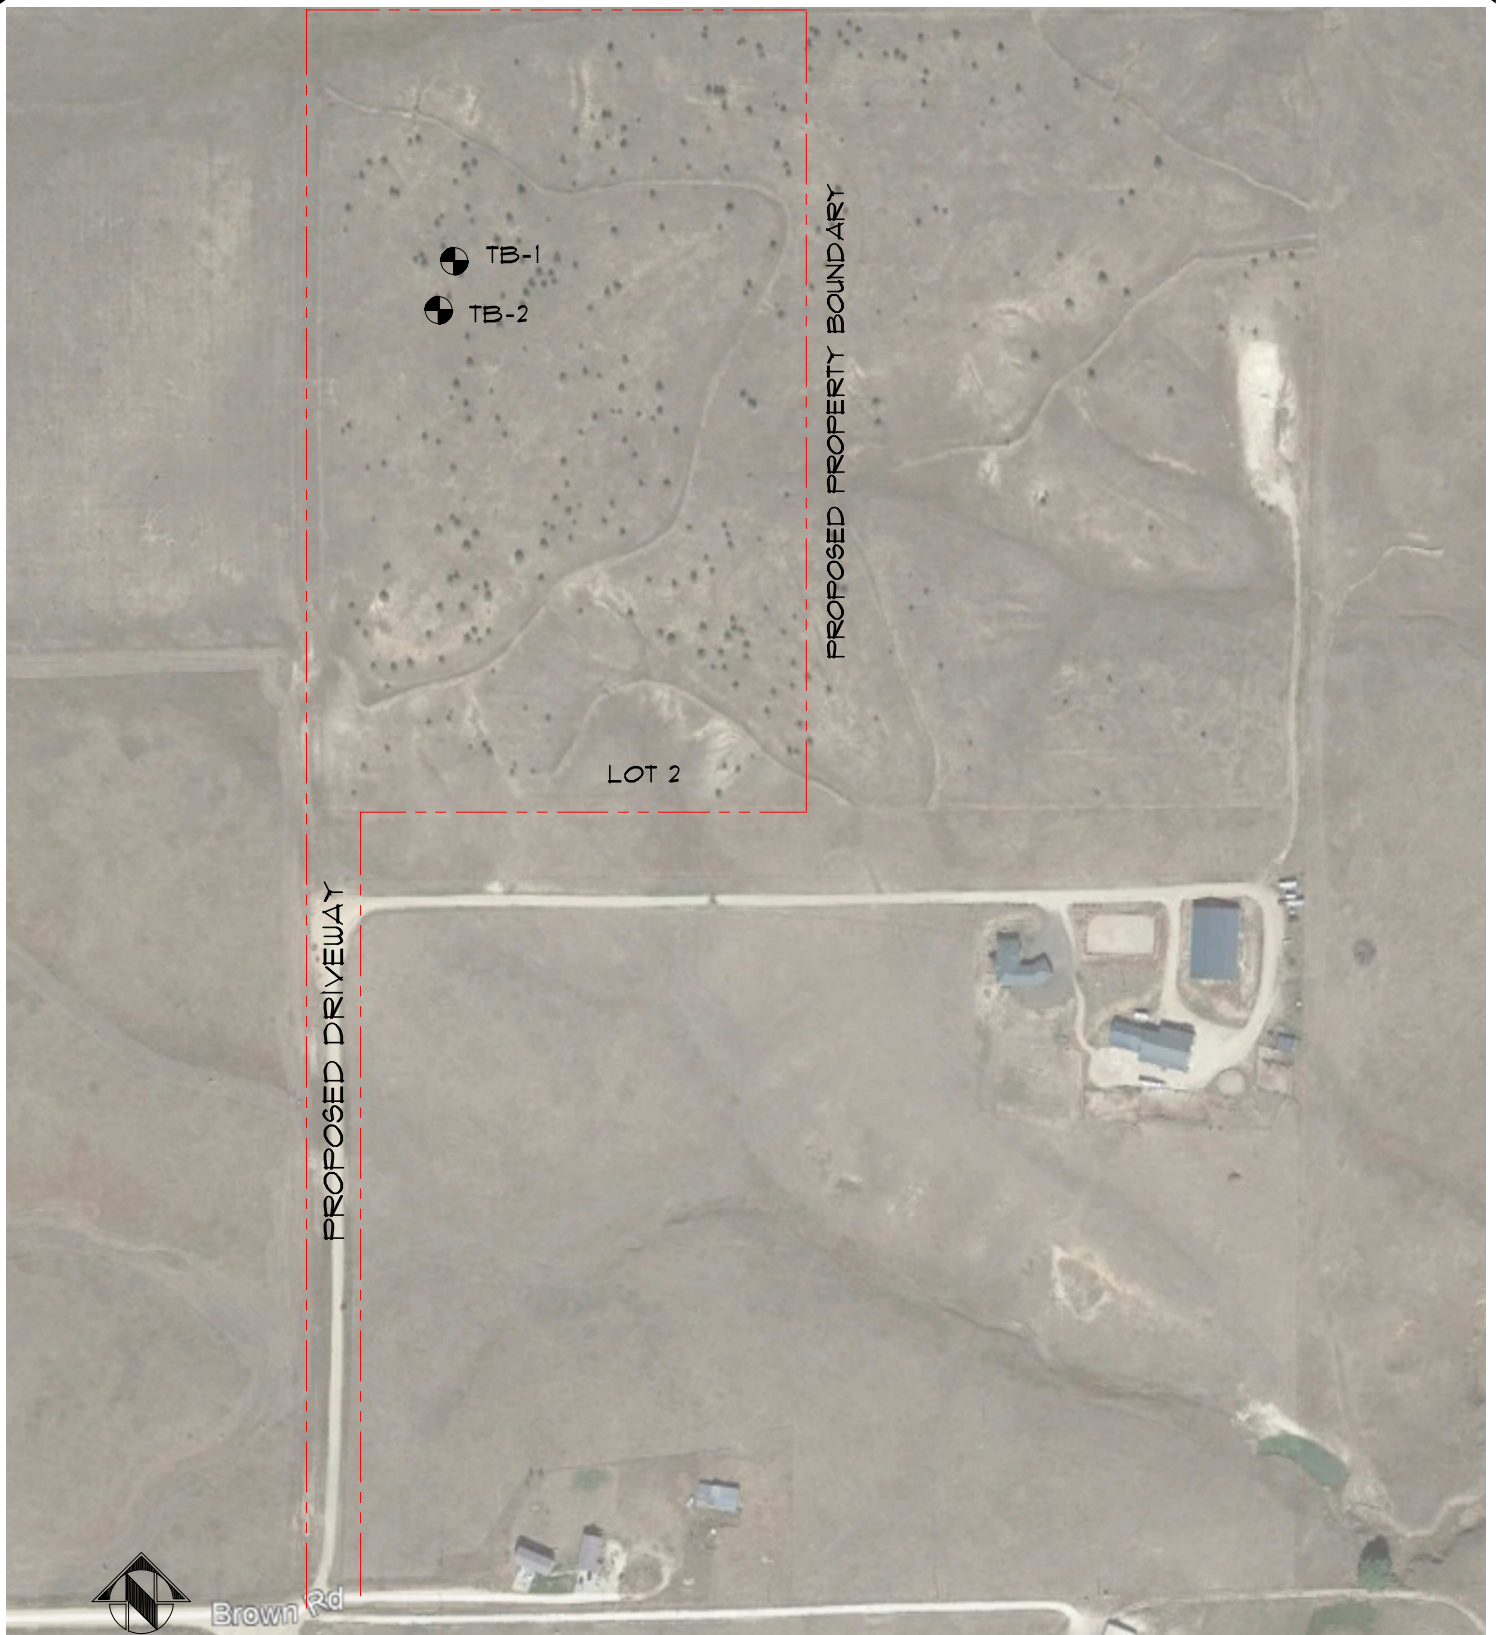
⊕ DENOTES APPROXIMATE  
LOCATION OF TEST BORINGS

RMG – Rocky Mountain Group drilled two test borings for the proposed single family residence at the above-referenced address on July 11, 2022. It is our understanding the parcel is to be subdivided into 3 lots. Once the subdivision is approved, each new lot is to be assigned a new address. This soils investigation was completed for the proposed construction on Lot 2, which currently has not been assigned a new address. A Site Vicinity Map and Test Boring Location Plan are presented in Figures 1 and 2, respectively. Our findings, conclusions and recommendations are provided in this report.
