GEOLOGY AND SOILS REPORT

**Parcel No.s 512300013 and 5123000014
El Paso County, Colorado**

JOB NO. 167392

January 16, 2019

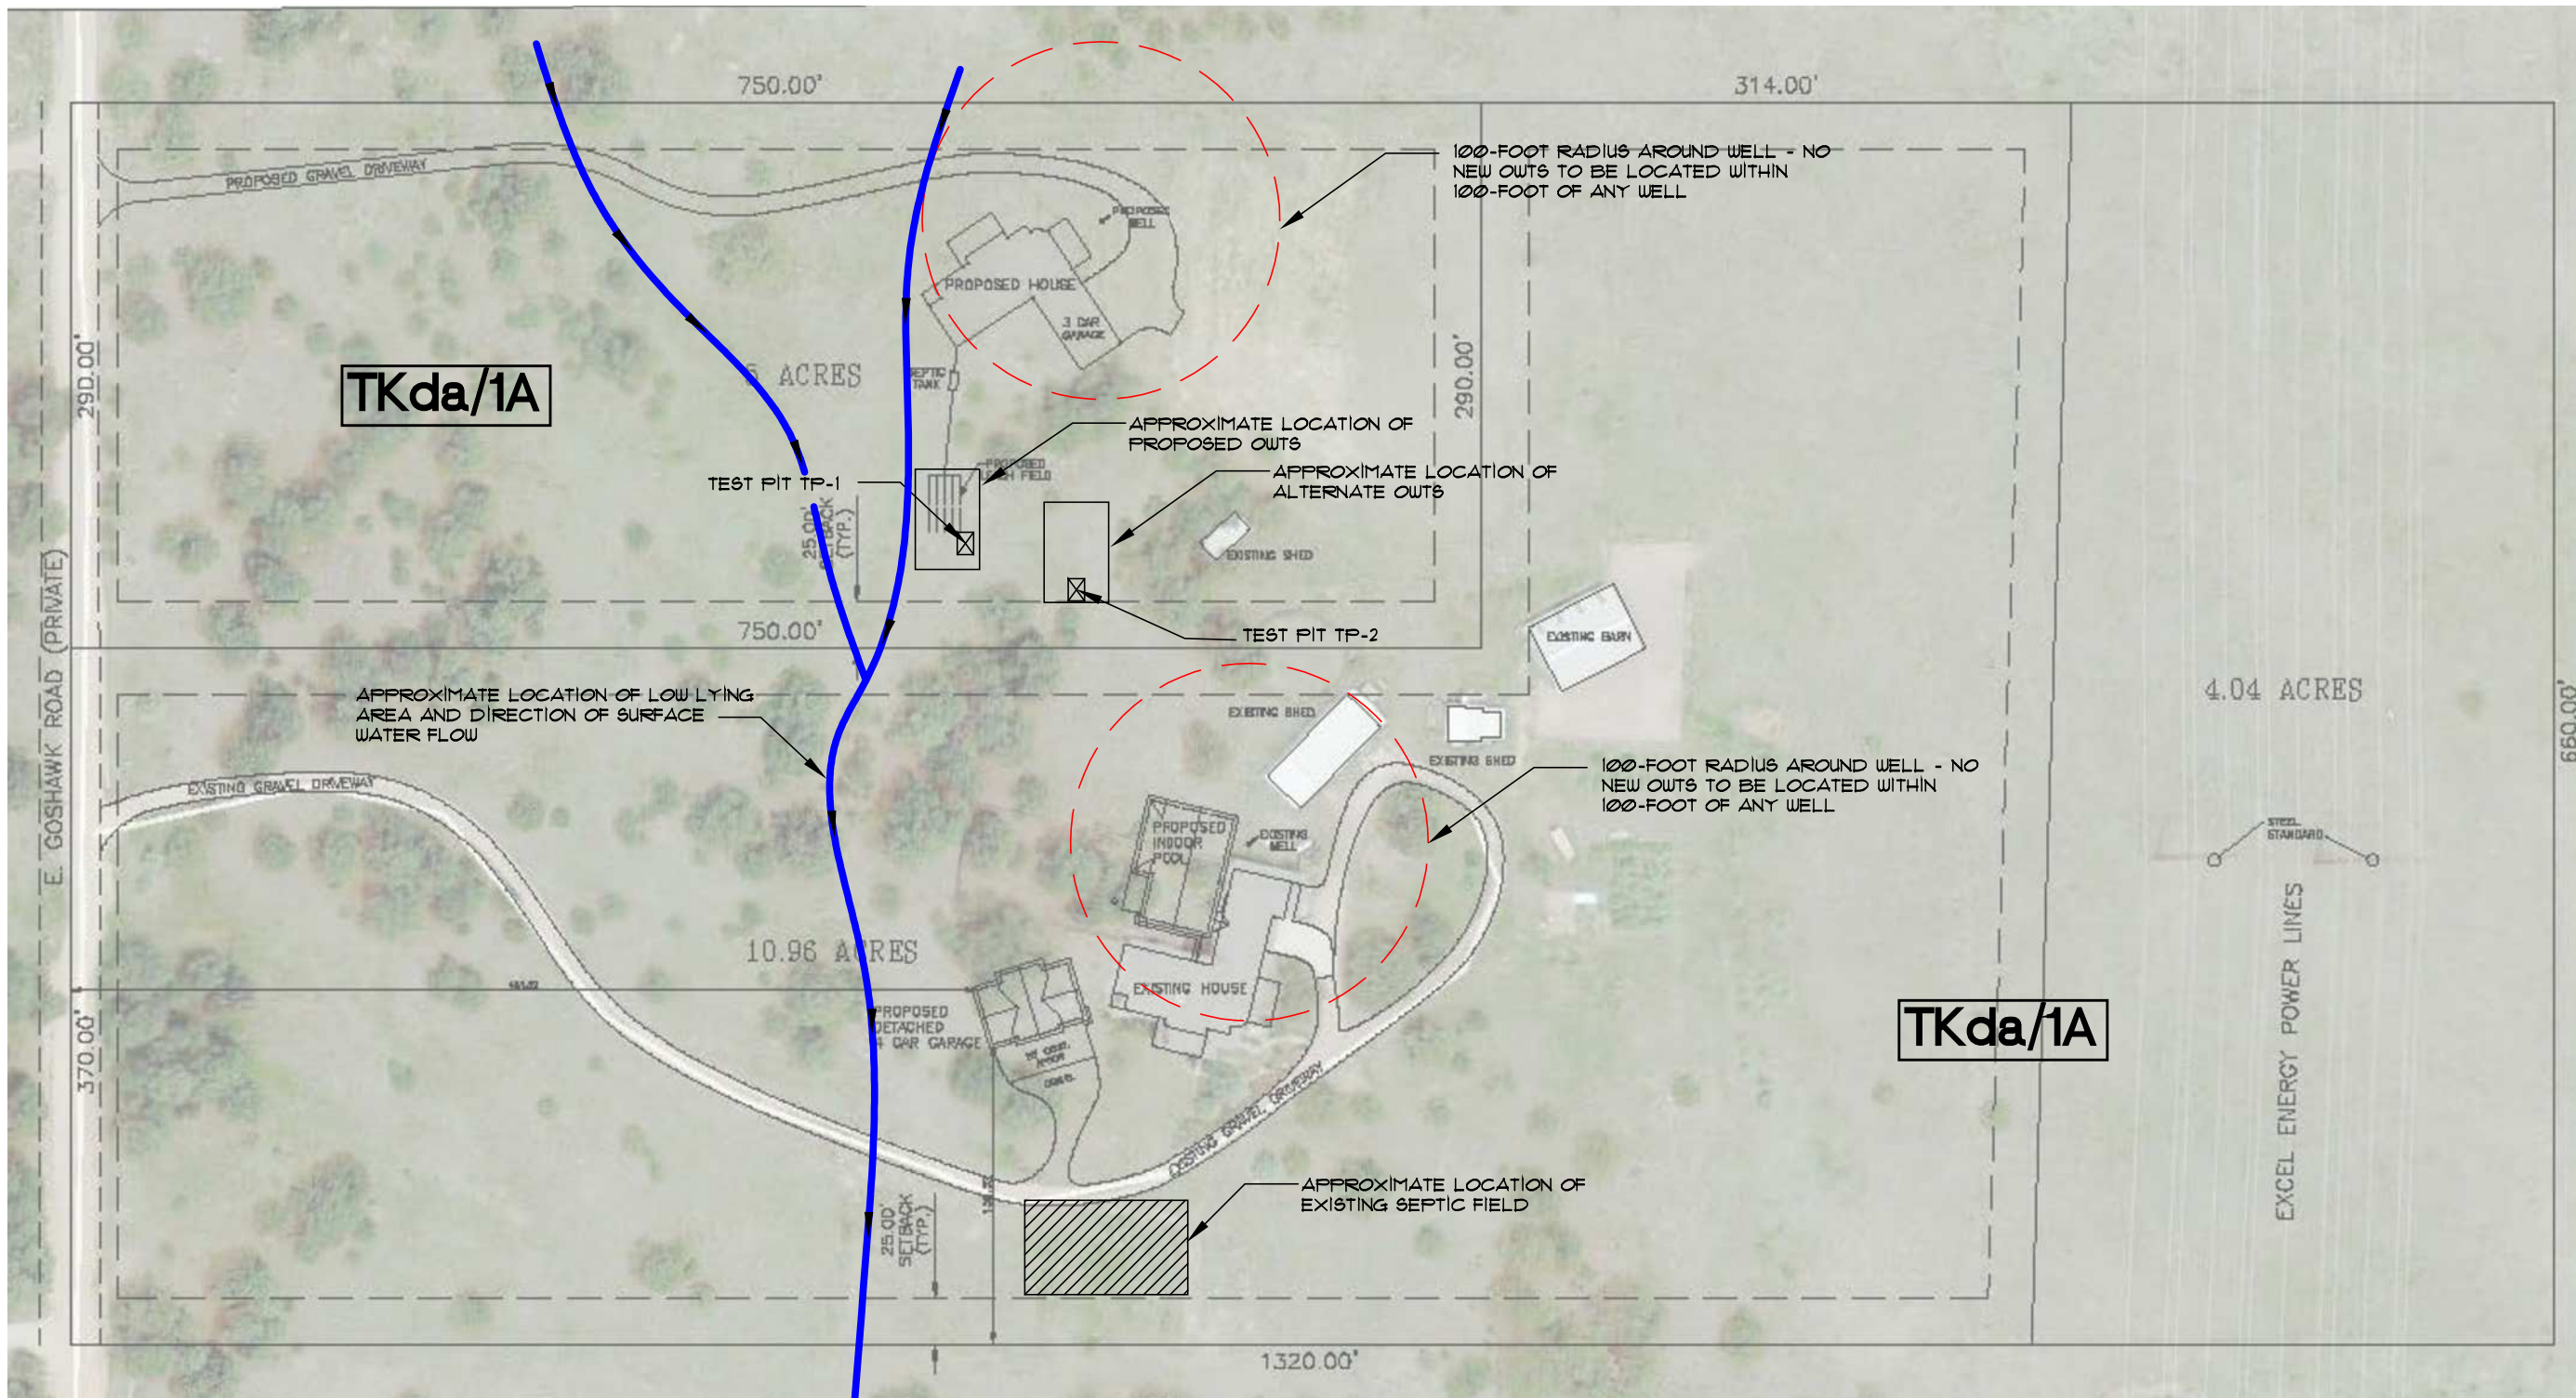
FIG-6

Disclaimer: The chosen Onsite Wastewater Treatment system (OWTS) locations are for illustration only. If the El Paso County Health Department physical setback requirements are met for the lot, there are no restrictions on the placement of the individual OWTS

TKda5 - Dawson Formation
1A - Stable alluvium, colluvium and bedrock

Test Pit TP-1 was performed in the location of the proposed OWTS and TP-2 was performed in the portion of the soil treatment area that was anticipated to have the most limiting condition. The Test Pit locations are presented in The General and Engineering Geology Map, Figure 6.

The General Geology and Engineering Geology Map is presented in Figure 6.

The Engineering Geology is presented in the General Geology and Engineering Geology Map, Figure 6.

- The new parcel shall be designed to insure that a minimum of 2 sites are appropriate for an OWTS and do not fall within any restricted areas, (e.g. utility easements, right of ways). Based on the test pit observation performed, the parcel does have a minimum of two locations for the OWTS as presented on the General and Engineering Geology Map, Figure 6.

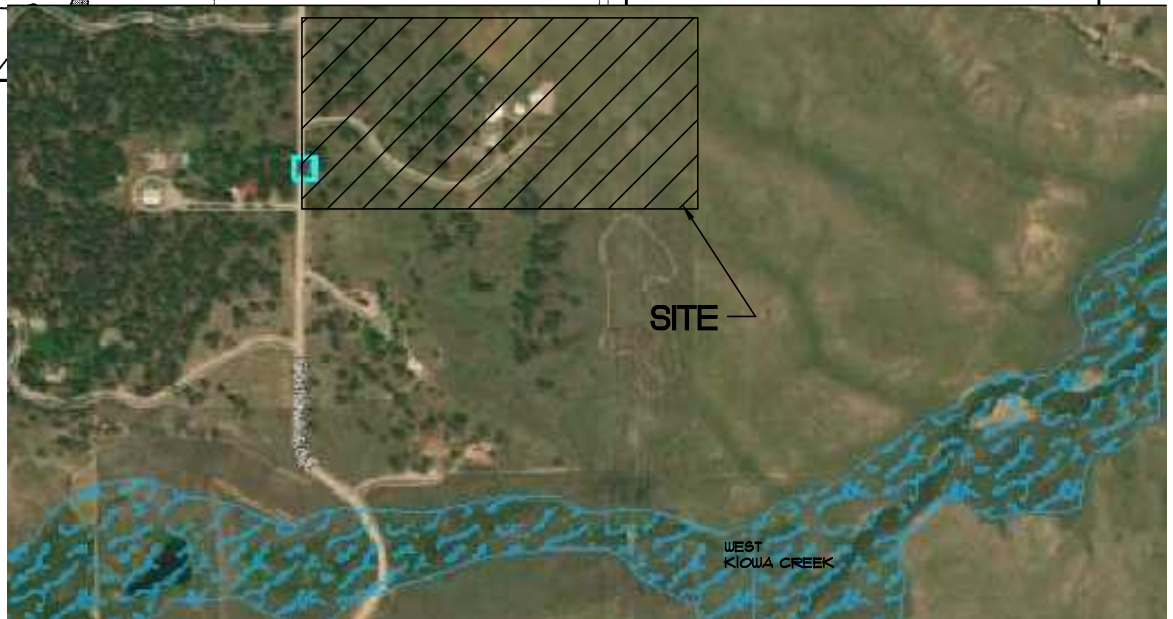
Pikes Peak Regional Floodplain Map

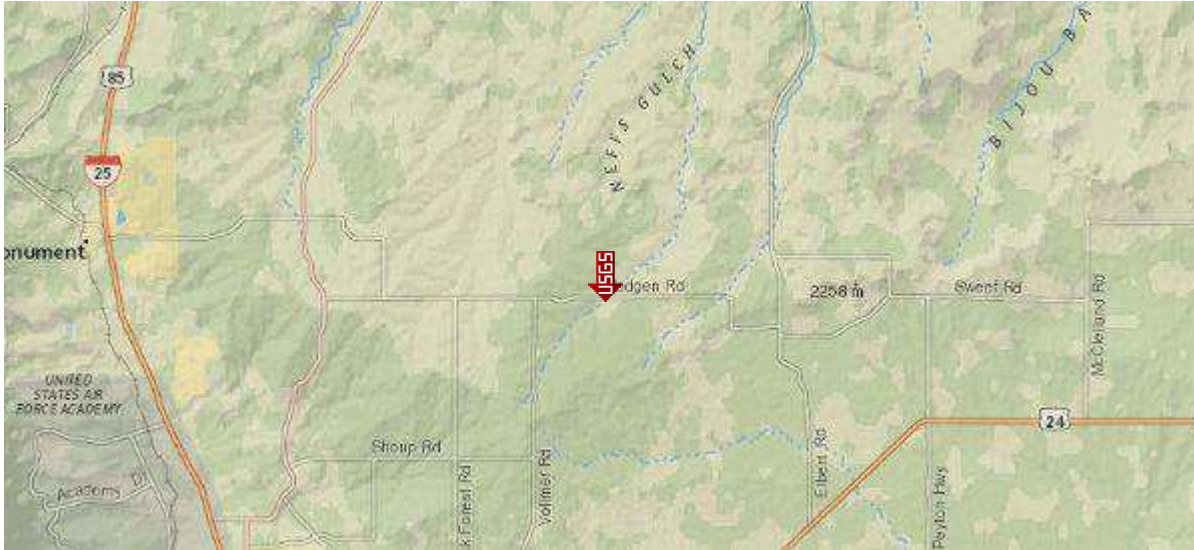
Site Soil Classification Site Class D – “Stiff Soil”

Risk Category IV (e.g. essential facilities)

USGS-Provided Output

$S_s = 0.172 \text{ g}$	$S_{MS} = 0.275 \text{ g}$	$S_{DS} = 0.183 \text{ g}$
$S_1 = 0.058 \text{ g}$	$S_{M1} = 0.139 \text{ g}$	$S_{D1} = 0.093 \text{ g}$
