June 15, 2021

ENTECH
ENGINEERING, INC.

Re: Soil, Geology, and Geologic Hazard Study
Skyfall Subdivision
Parcel No. 52212-00-027
7985 Burgess Road
El Paso County, Colorado

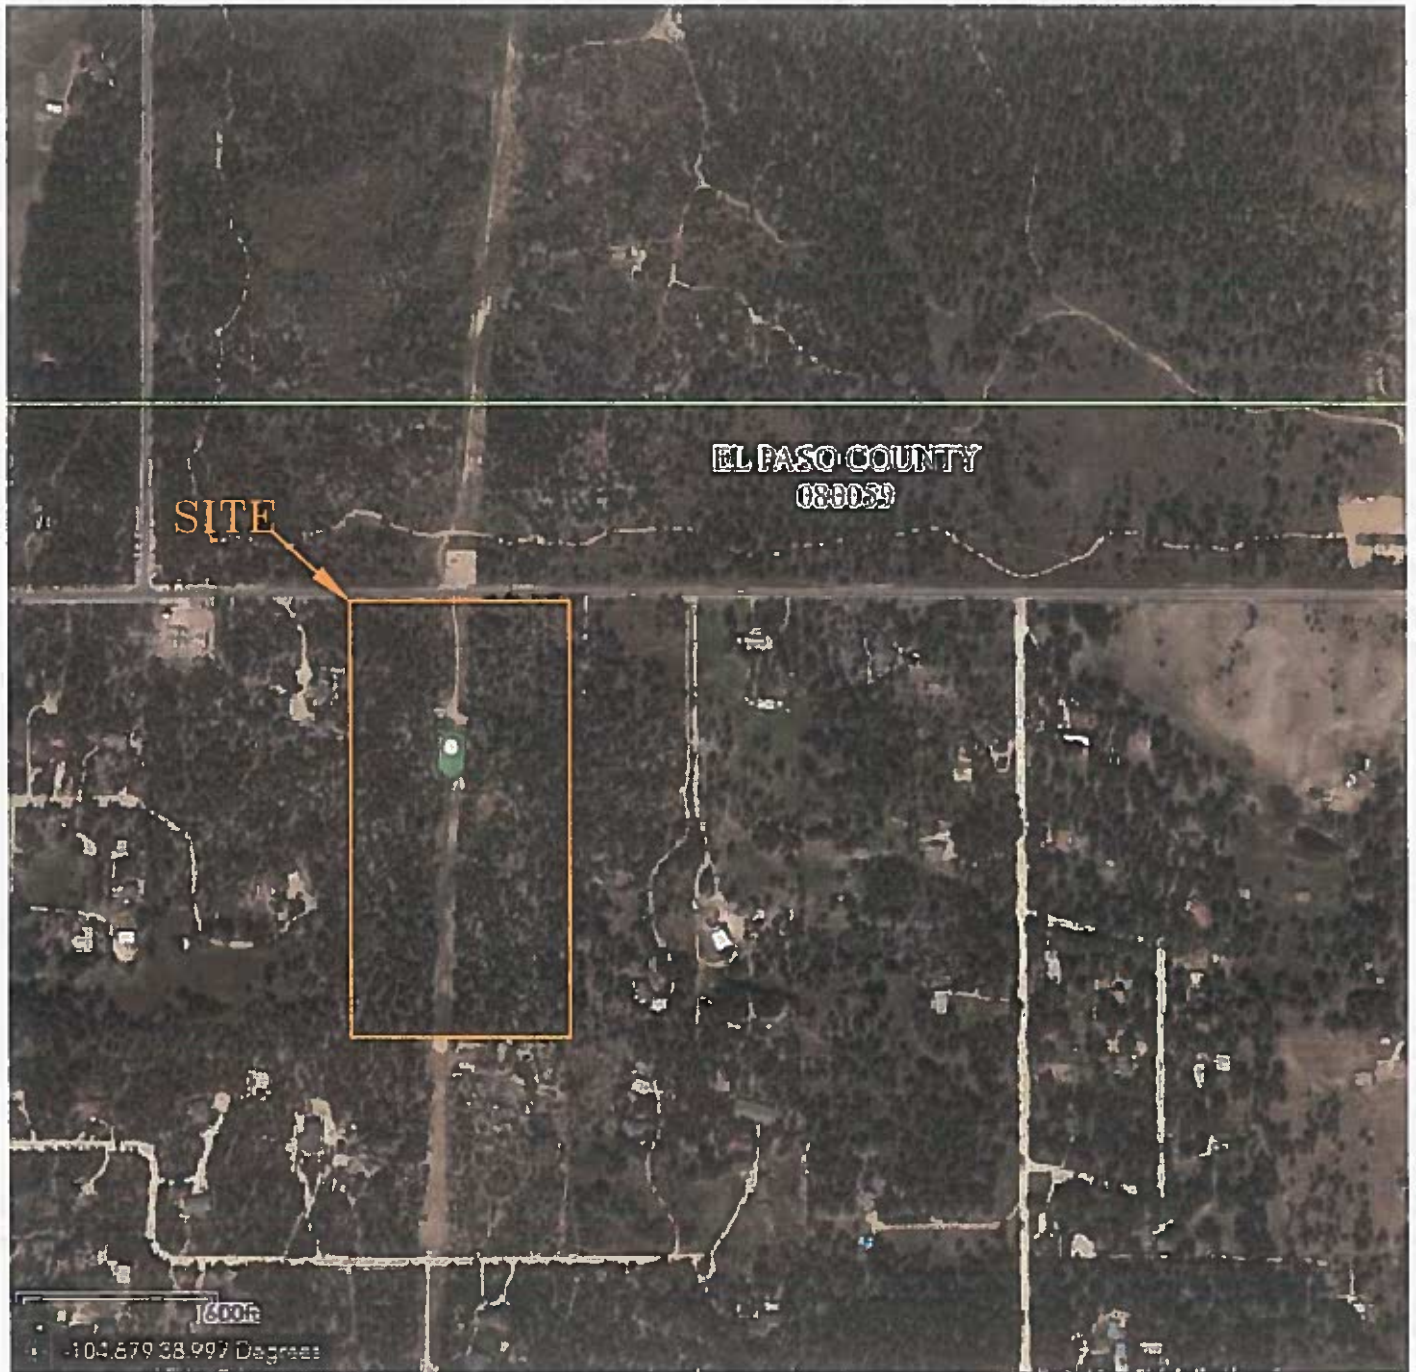
FIG NO.:
7

FEMA FLOODPLAIN MAP
SKYFALL SUBDIVISION
7985 BURGESS ROAD
EL PASO COUNTY, CO.
FOR: RAMSES II PROPERTIES, LLC

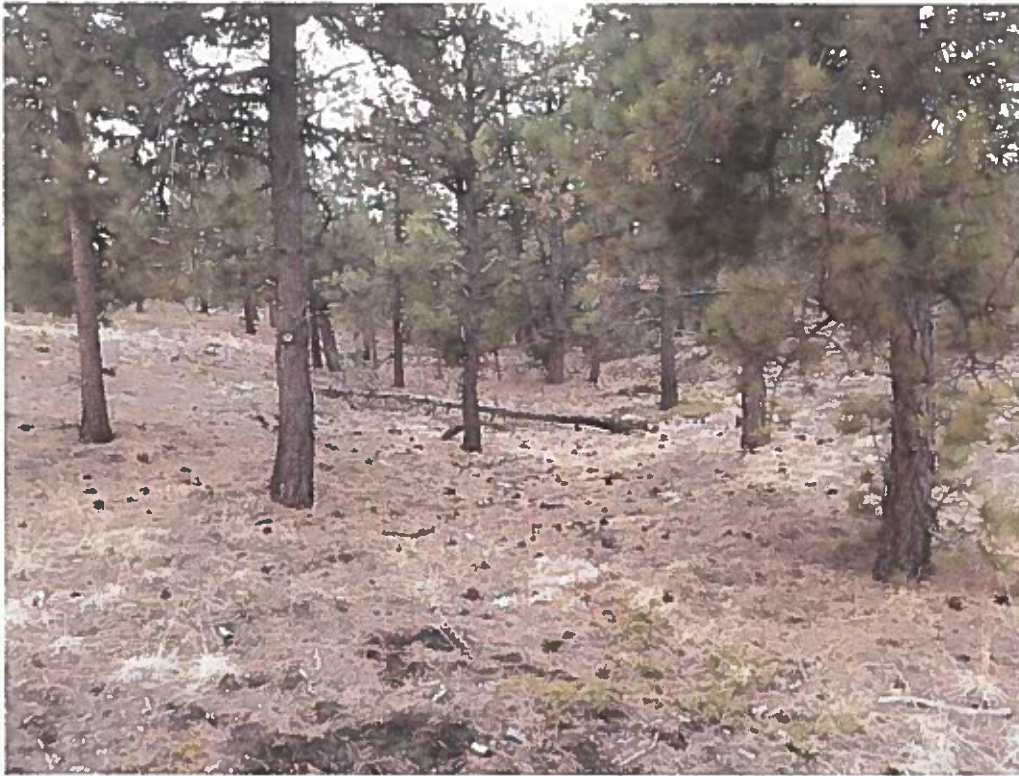
**Looking southwest
along drainage swale
in the southwestern
portion of Lot 2.**

Minor drainages exist in the southwestern portion of proposed Lot 1 and southern portion of Lot 3. No water was observed flowing in the drainage, however, the potential for seasonal shallow groundwater exists in these areas during periods of high runoff. According to the development plan and lot size, these areas can be avoided by the structures. Structures should not block drainages. Grading should direct surface waters around structures and roadways to prevent areas of ponded water.

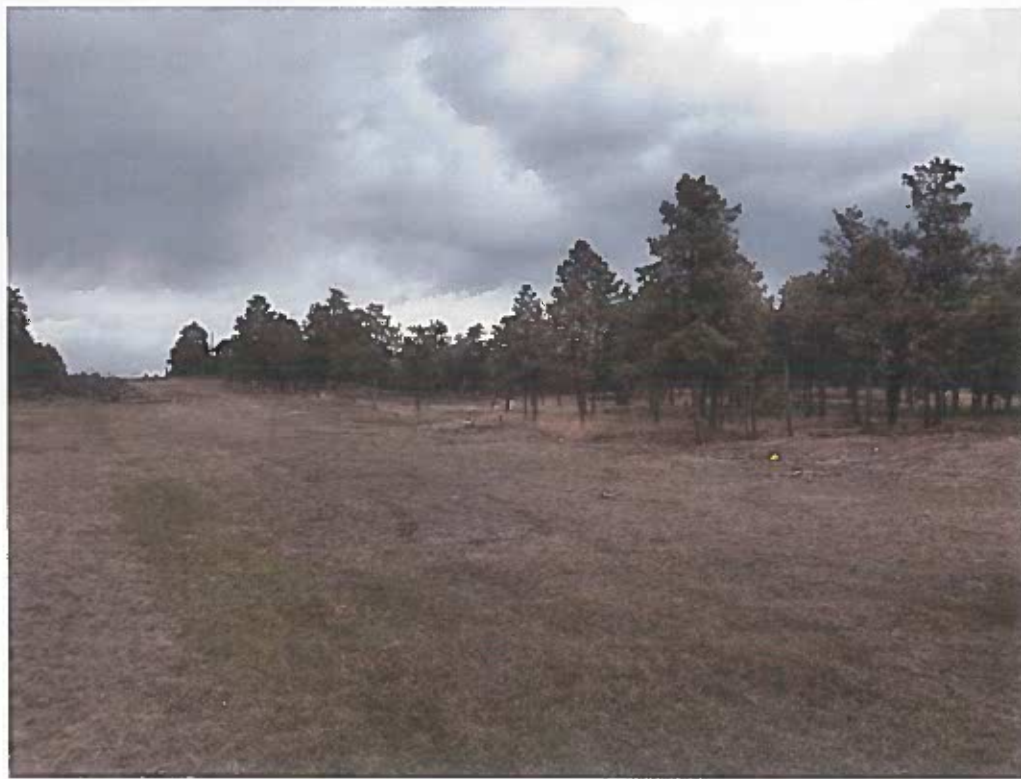
**Looking northwest
along the pipeline
easement in the
central portion of the
site.**

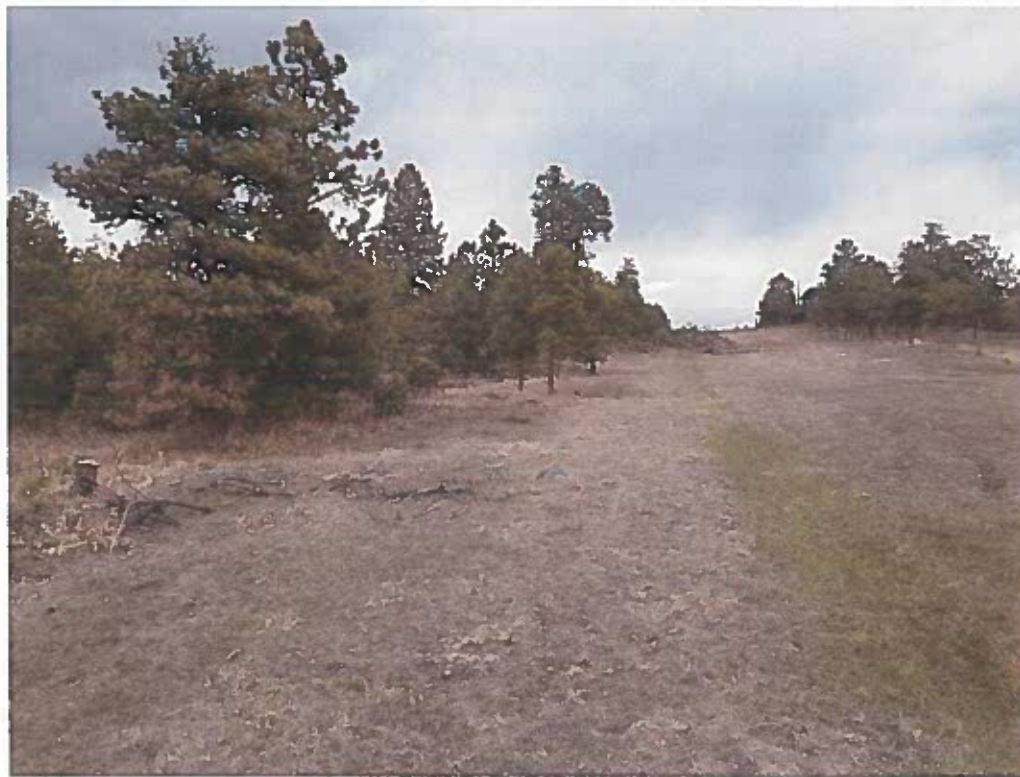
**Looking north along
pipeline easement in
the southern portion of
the site.**
