**ENTECH**  
ENGINEERING, INC.

Re: OWTS – Wastewater Study  
Skyfall Subdivision  
Parcel No. 52212-00-027  
7985 Burgess Road  
El Paso County, Colorado

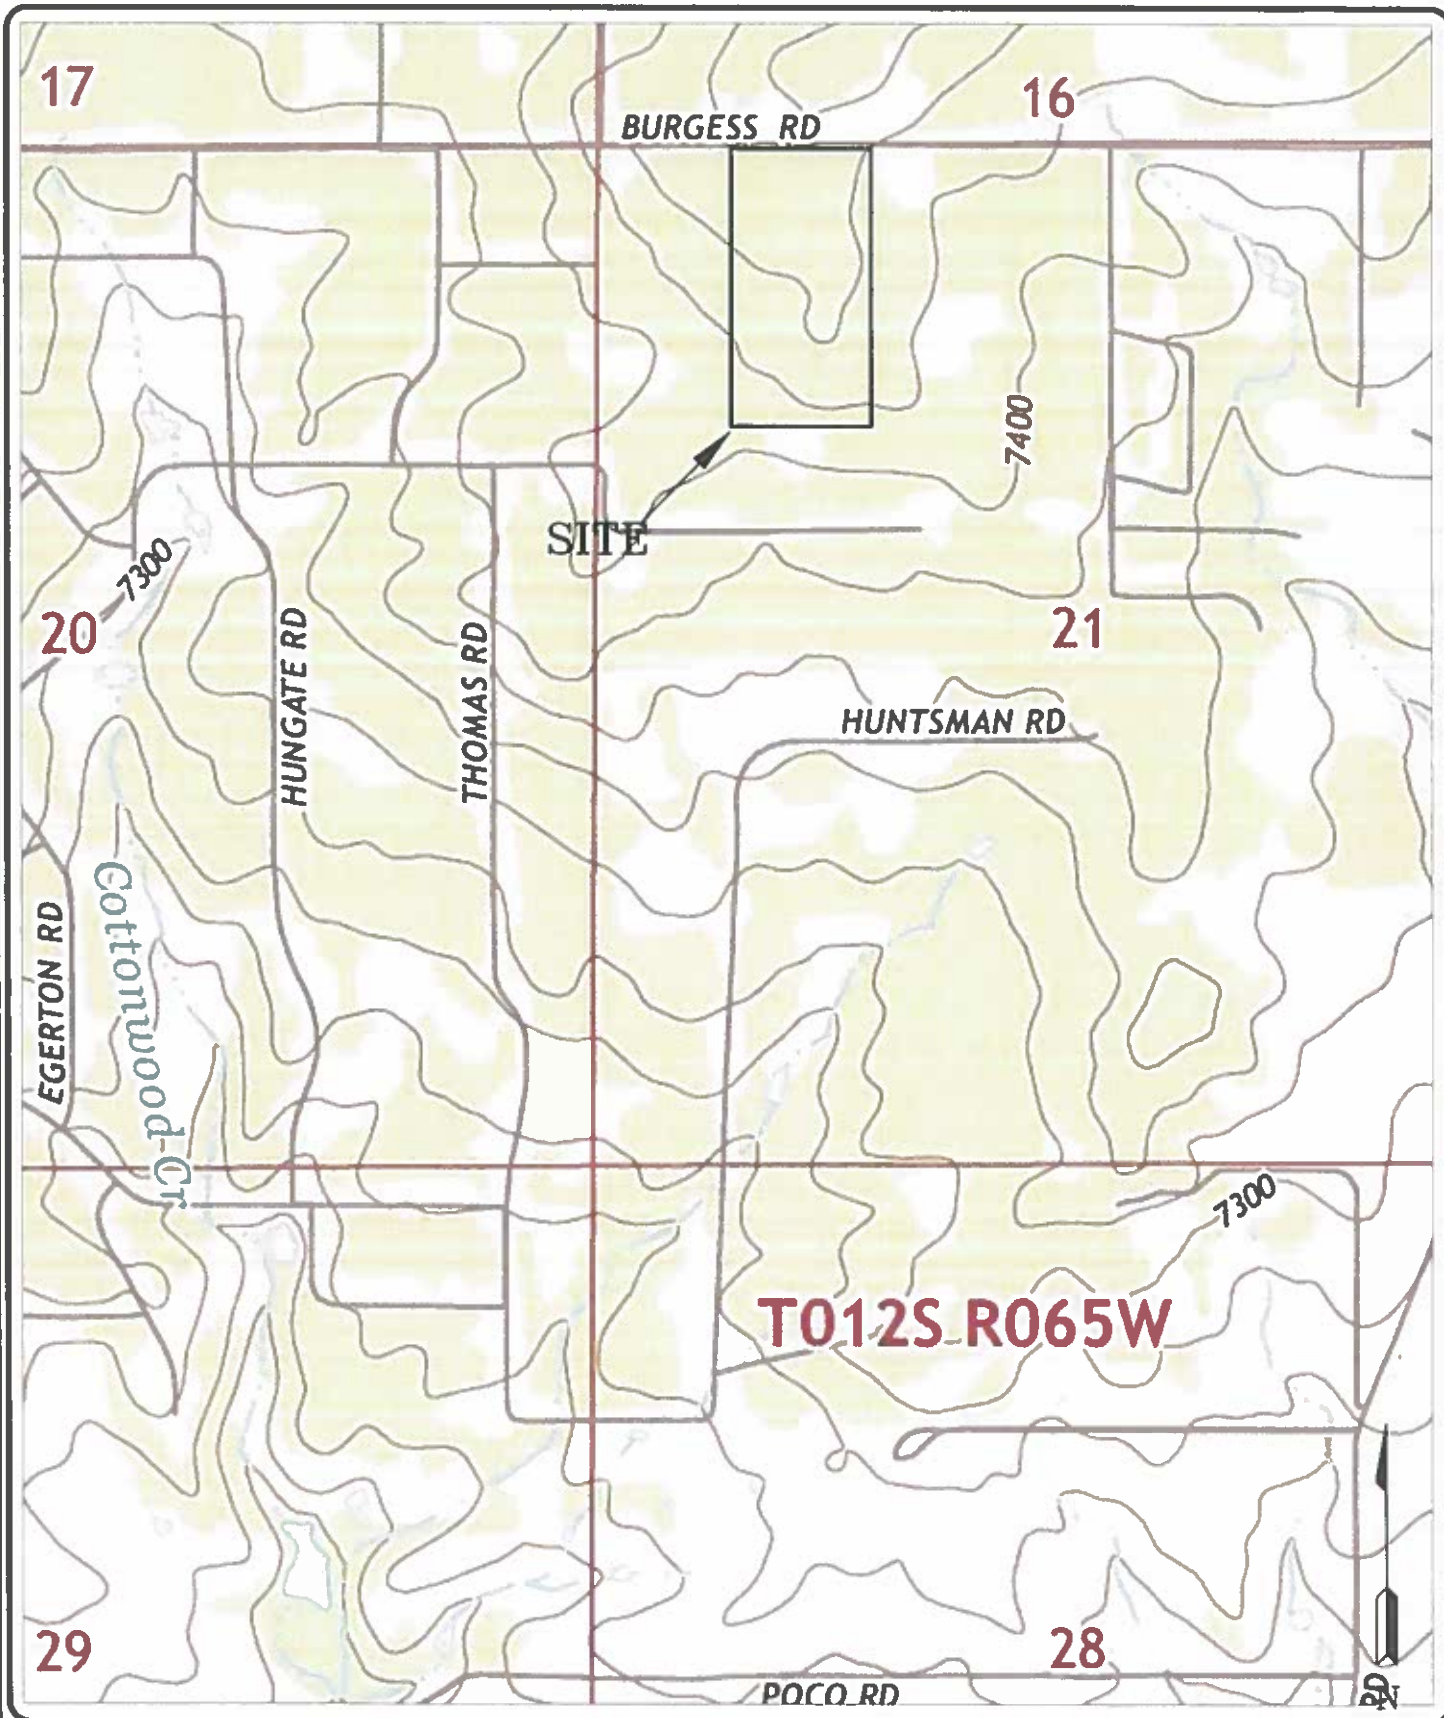
FIG NO.:  
2

USGS TOPOGRAPHY MAP  
SKYFALL SUBDIVISION  
7985 BURGESS ROAD  
EL PASO COUNTY, CO.  
FOR: RAMSES II PROPERTIES, LLC

The topography of the site is gradually to moderately sloping to the south-southeast. A minor drainage swale is located in the northern portion of the property. Water was not observed in the drainages at the time of this investigation. The site boundaries are indicated on the USGS Map, Figure 2. Previous land uses have included undeveloped and rural residential. The site contains field grasses, weeds, and ponderosa pines. The existing house with a water well and septic system located on Lot 2, will remain. Site photographs were taken and site mapping was completed on April 22, 2021. Site photographs are included in appendix A. Test Borings and Test Pits were performed on April, 29, 2021.

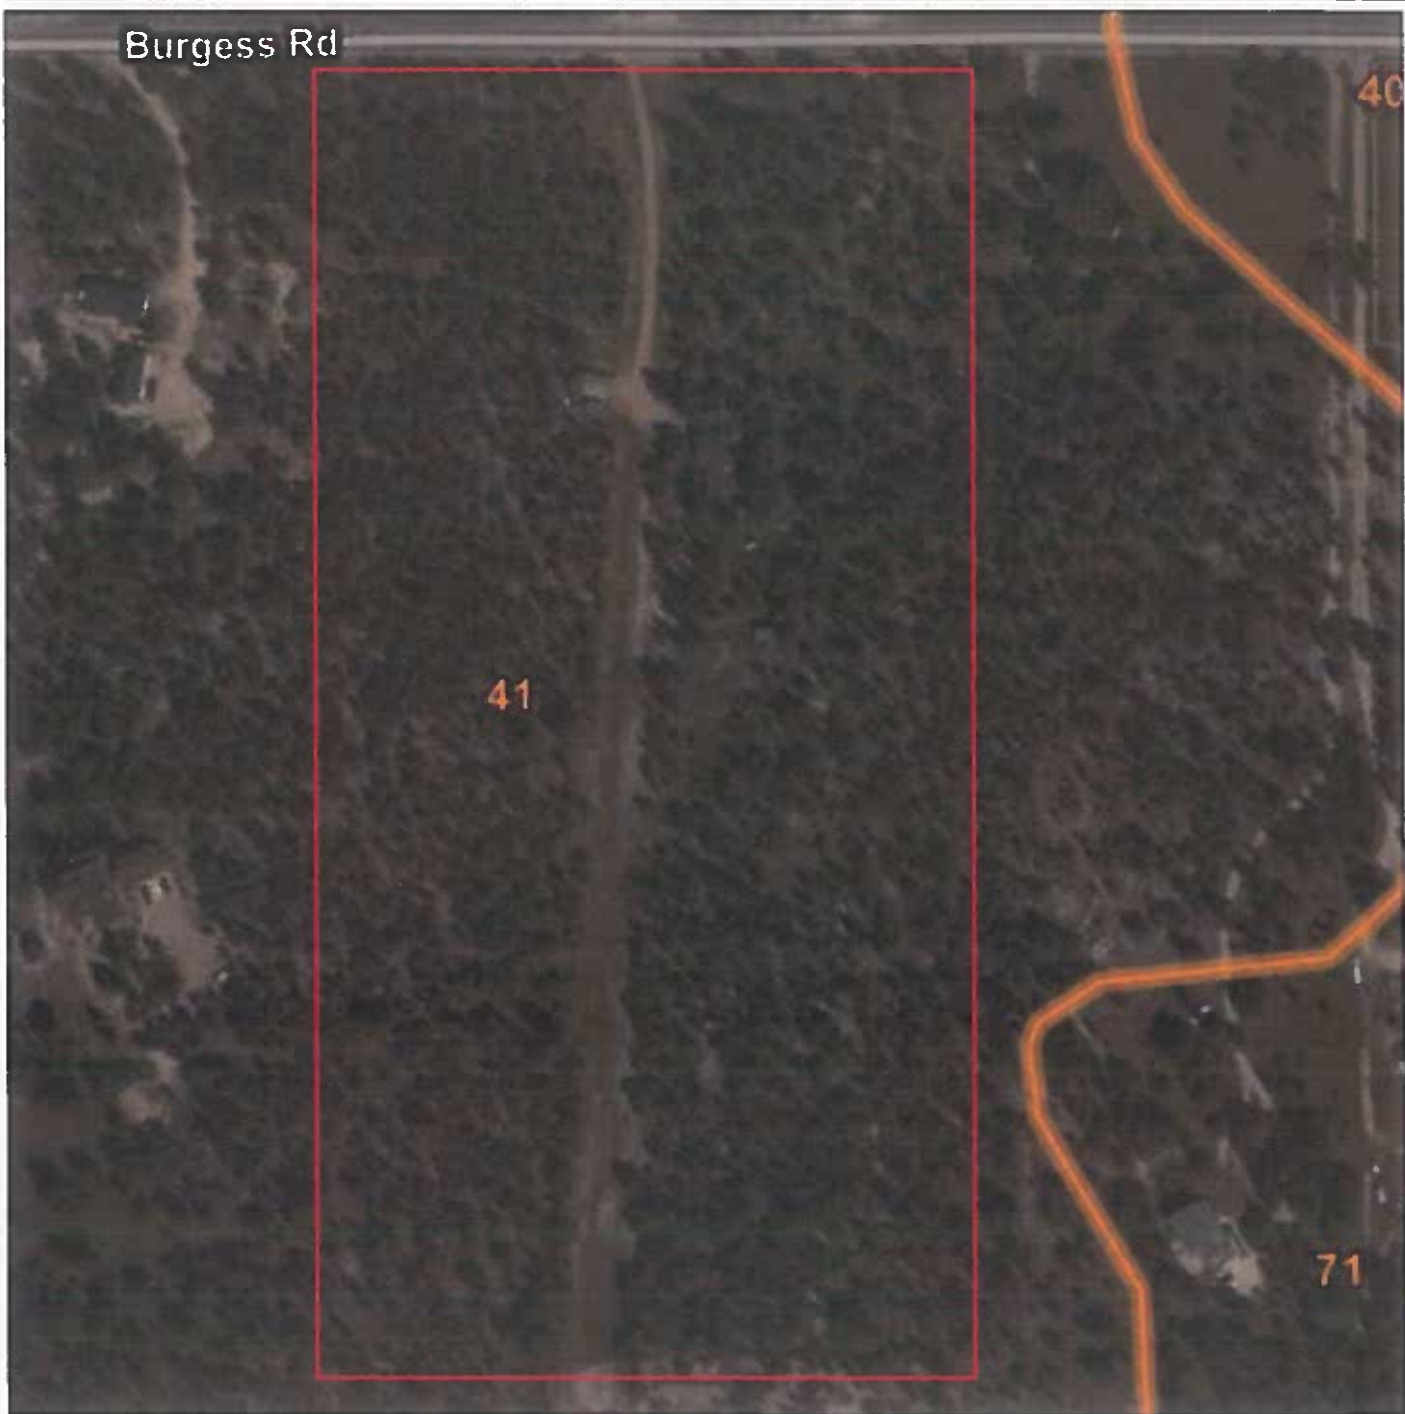
FIG NO.:  
4

SOIL SURVEY MAP  
SKYFALL SUBDIVISION  
7985 BURGESS ROAD  
EL PASO COUNTY, CO.  
FOR: RAMSES II PROPERTIES, LLC

The soils have been described to have rapid permeabilities. The soils are described as well suited for use as home sites. Possible hazards with soils erosion are present on the site. The erosion potential can be controlled with vegetation. The soils have been described to have moderate erosion hazards (Reference 2).

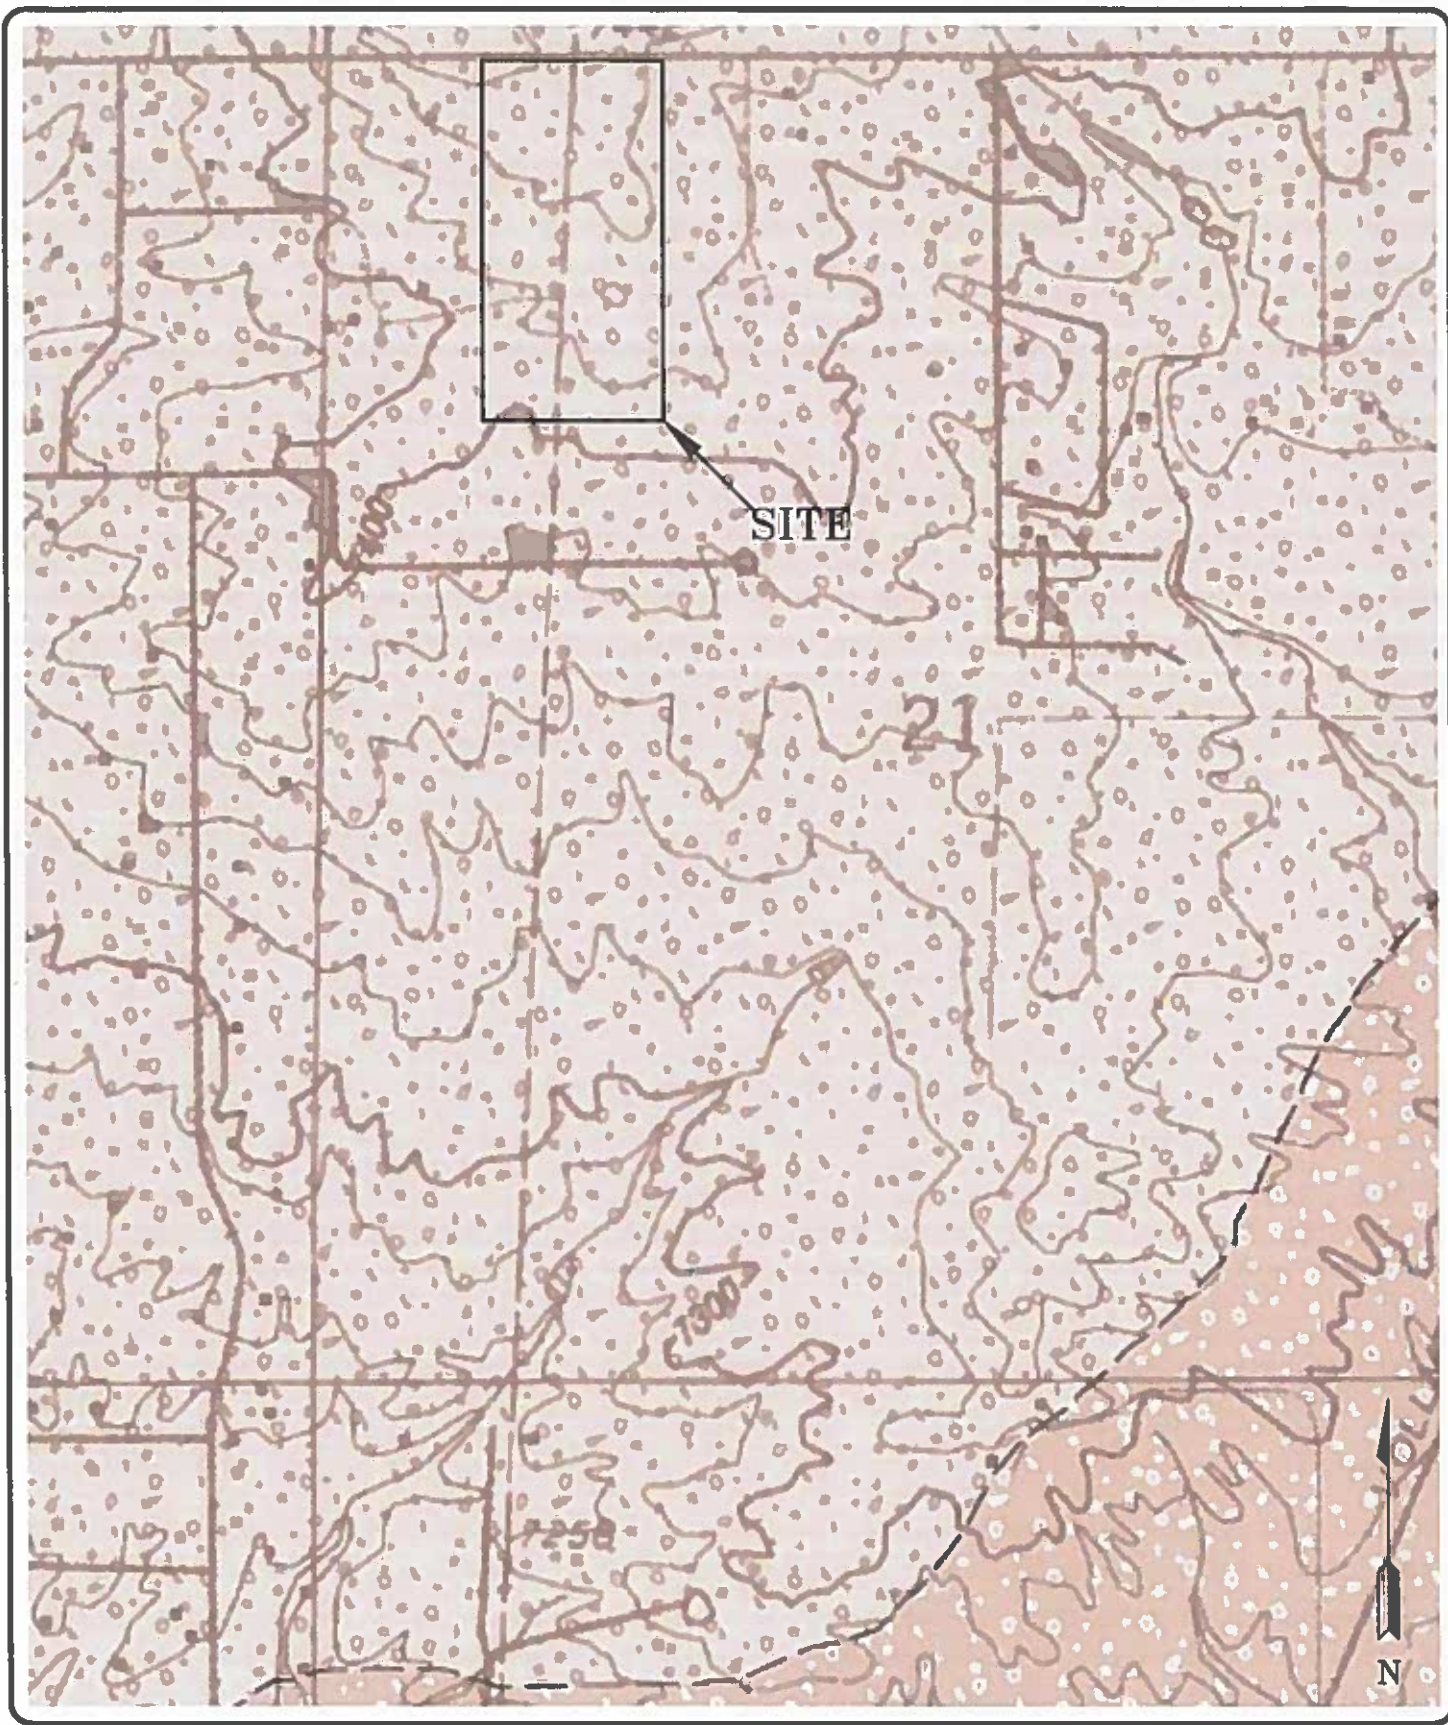
FIG NO.:  
5

FALCON NW QUADRANGLE GEOLOGIC MAP  
SKYFALL SUBDIVISION  
7985 BURGESS ROAD  
EL PASO COUNTY, CO.  
FOR: RAMSES II PROPERTIES, LLC

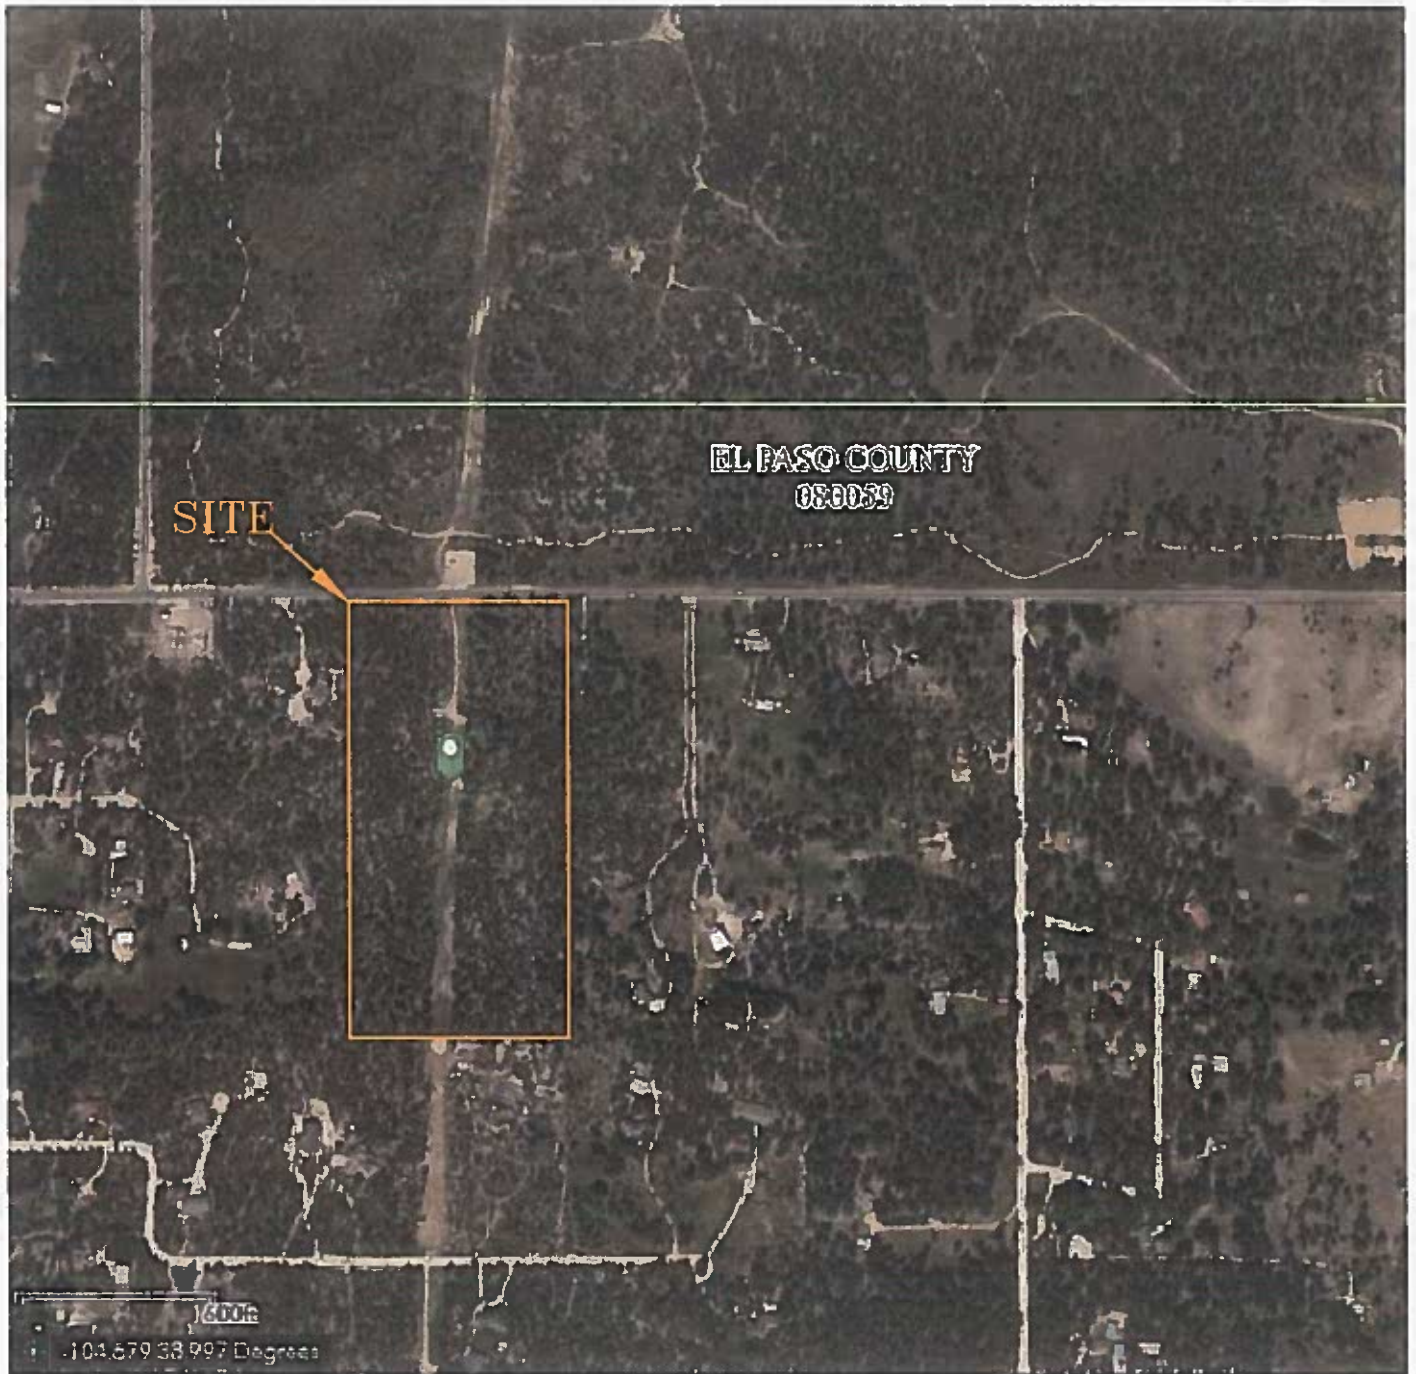
FIG NO.:  
7

FEMA FLOODPLAIN MAP  
SKYFALL SUBDIVISION  
7985 BURGESS ROAD  
EL PASO COUNTY, CO.  
FOR: RAMSES II PROPERTIES, LLC

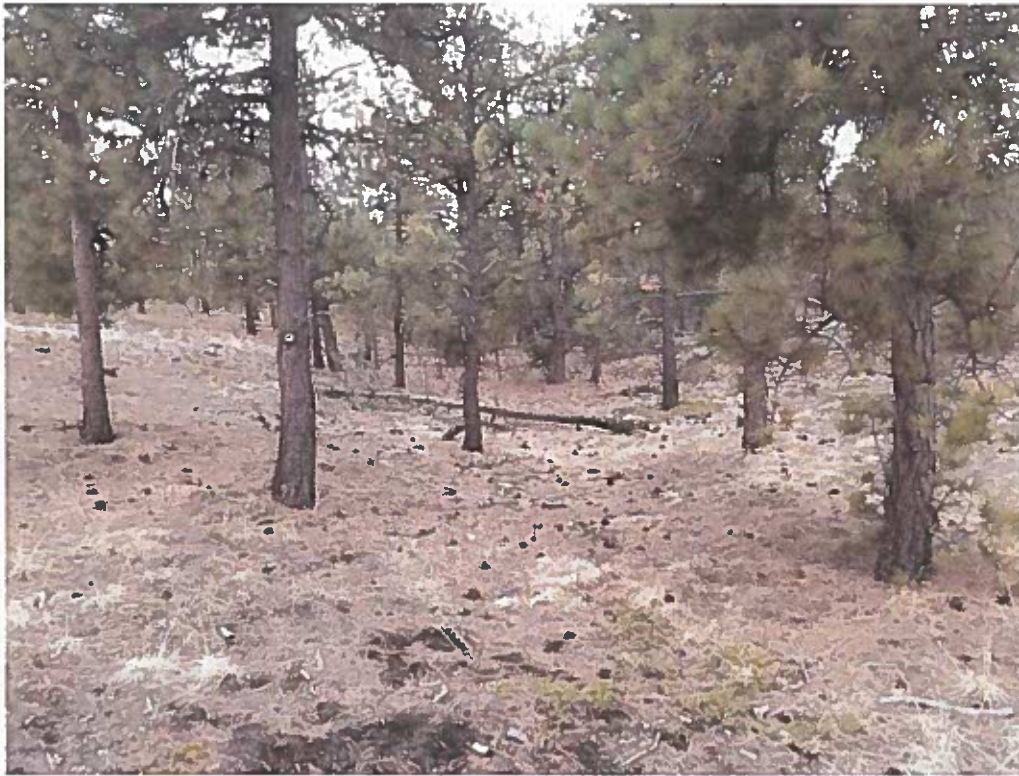
**Looking southwest  
along drainage swale  
in the southwestern  
portion of Lot 2.**

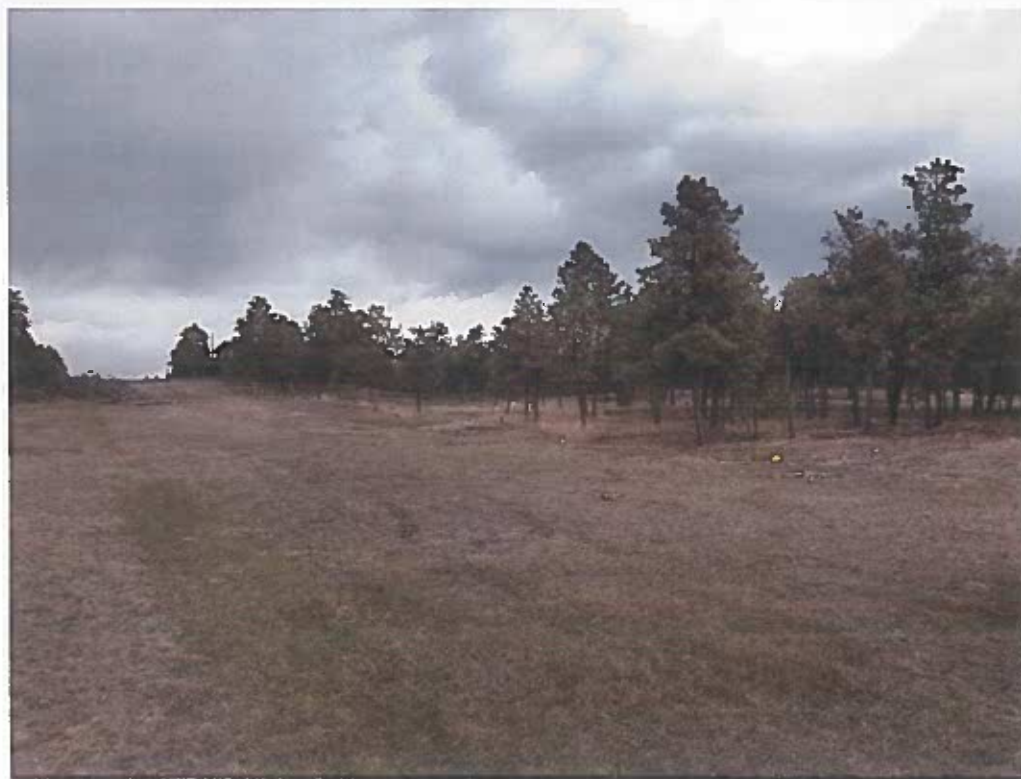
**Looking northwest  
along the pipeline  
easement in the  
central portion of the  
site.**

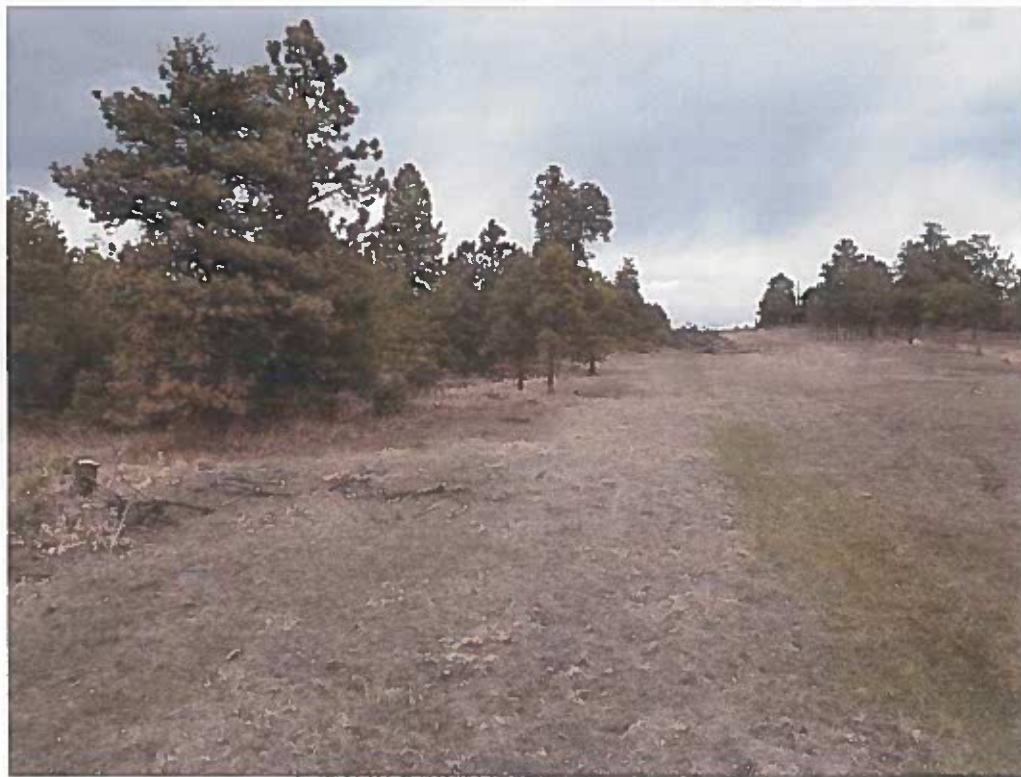
**Looking north along  
pipeline easement in  
the southern portion of  
the site.**

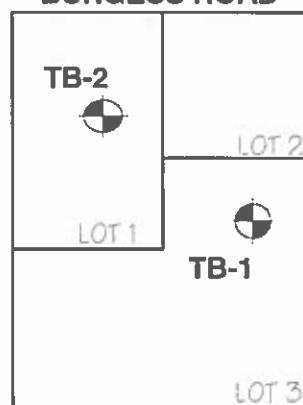
LOCATIONS OF TEST BORINGS ARE APPROXIMATE

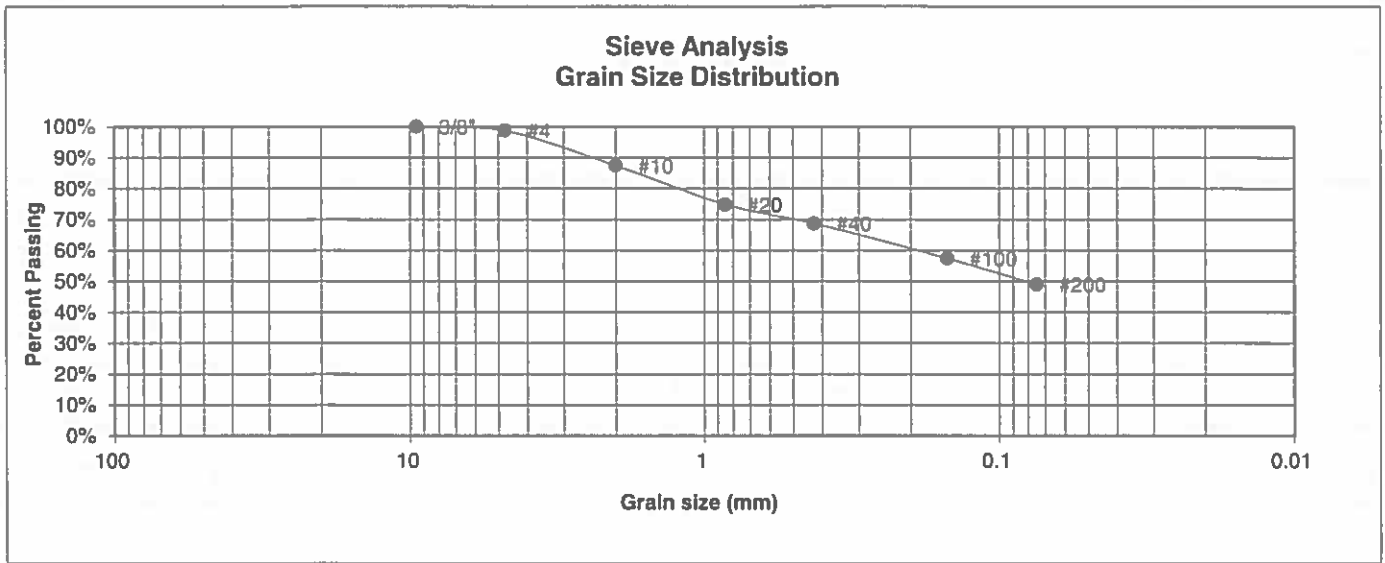
FIG NO.:  
C-1

BORING NO.	1	UNIFIED CLASSIFICATION	SC	TEST BY	BL
DEPTH(ft)	2-3	AASHTO CLASSIFICATION		JOB NO.	210901
CLIENT	RAMSES II PROPERTIES				
PROJECT	7985 BURGESS ROAD

U.S. Sieve #	Percent Finer
3"	
1 1/2"	
3/4"	
1/2"	
3/8"	100.0%
4	98.7%
10	87.4%
20	74.8%
40	68.7%
100	57.4%
200	49.0%

<b>Swell</b>	
Moisture at start	13.2%
Moisture at finish	20.2%
Moisture increase	7.1%
Initial dry density (pcf)	100
Swell (psf)	670

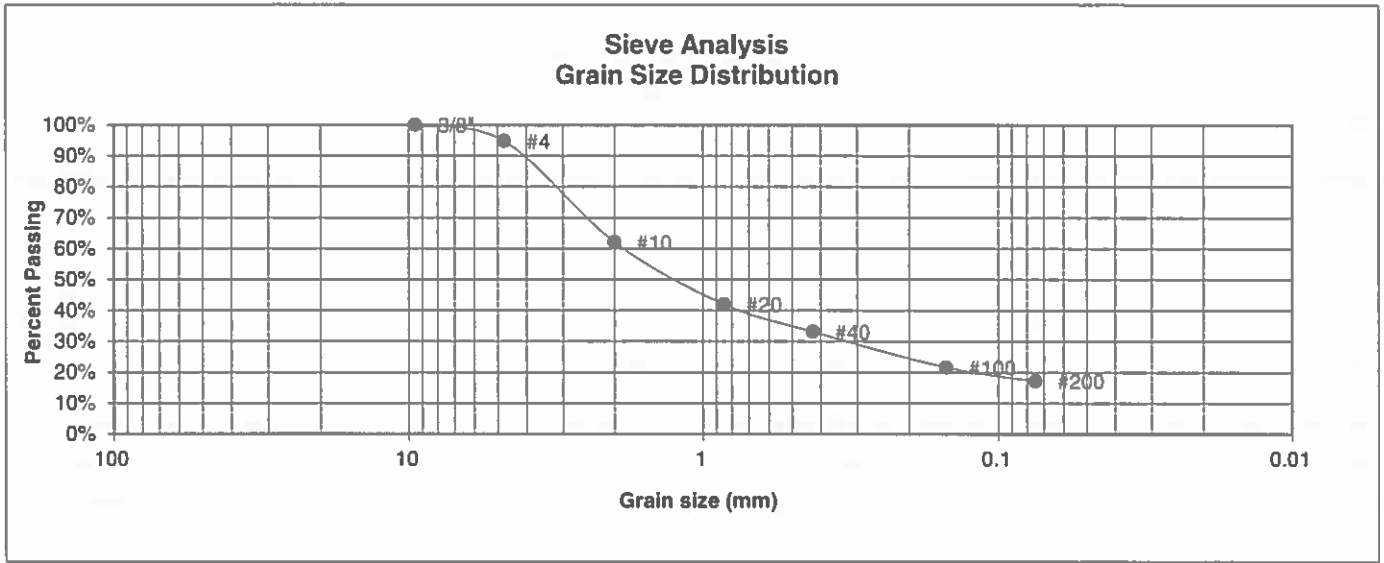
FIG NO.  
 L-2

BORING NO.	1	UNIFIED CLASSIFICATION	SM	TEST BY	BL
DEPTH(ft)	10	AASHTO CLASSIFICATION		JOB NO.	210901
CLIENT	RAMSES II PROPERTIES				
PROJECT	7985 BURGESS ROAD

U.S. Sieve #	Percent Finer
3"	
1 1/2"	
3/4"	
1/2"	
3/8"	100.0%
4	94.8%
10	62.1%
20	42.0%
40	33.1%
100	21.6%
200	17.2%

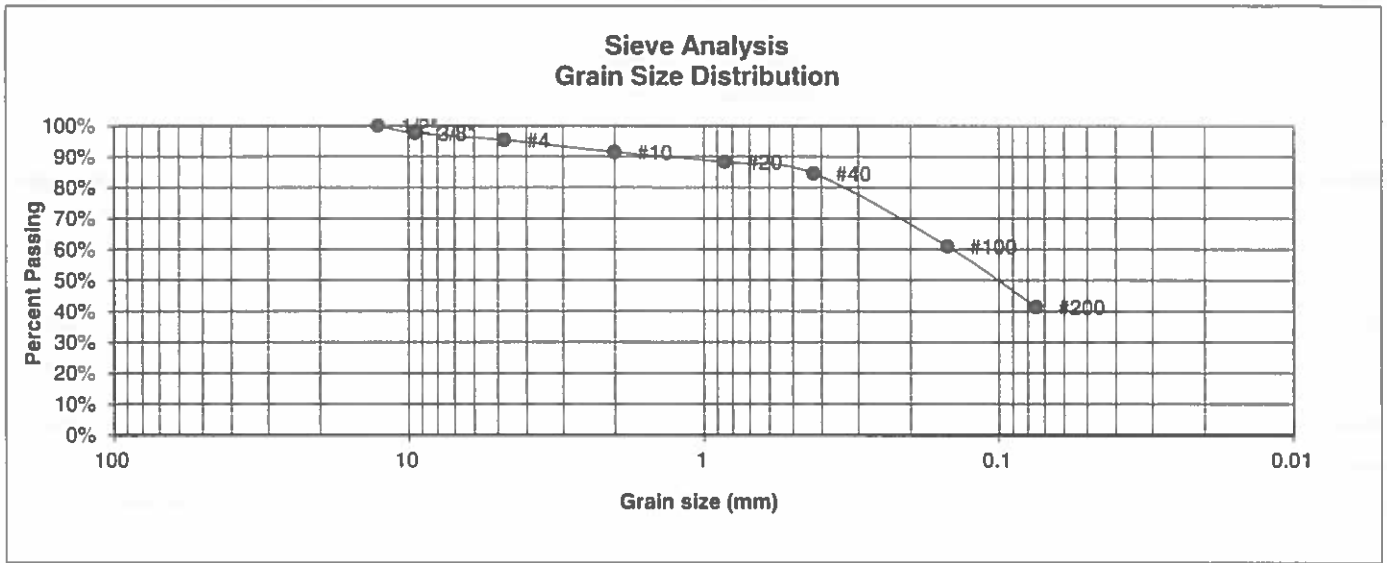
FIG NO.  
C-3

BORING NO.	2	UNIFIED CLASSIFICATION	SM	TEST BY	BL
DEPTH(ft)	5	AASHTO CLASSIFICATION		JOB NO.	210901
CLIENT	RAMSES II PROPERTIES				
PROJECT	7985 BURGESS ROAD

U.S. Sieve #	Percent Finer
3"	
1 1/2"	
3/4"	
1/2"	100.0%
3/8"	97.6%
4	95.3%
10	91.4%
20	88.3%
40	84.6%
100	61.0%
200	41.4%

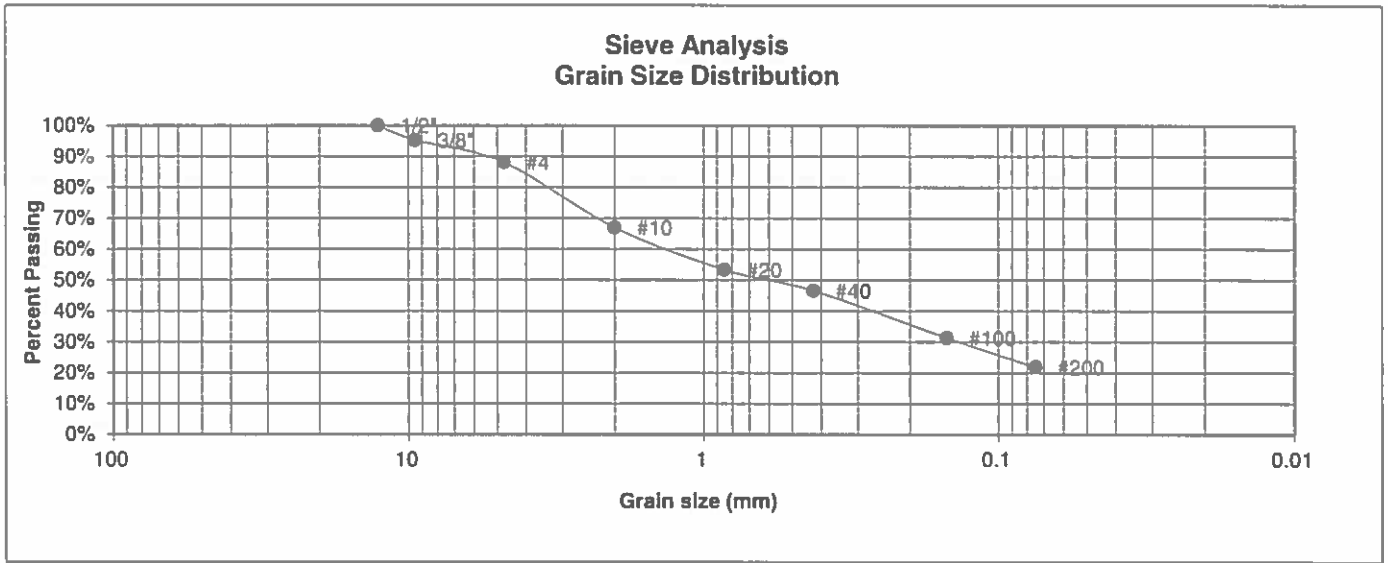
FIG NO:  
C-4

BORING NO.	TP-1	UNIFIED CLASSIFICATION	SC	TEST BY	BL
DEPTH(ft)	1	AASHTO CLASSIFICATION		JOB NO.	210901
CLIENT	RAMSES II PROPERTIES				
PROJECT	7985 BURGESS ROAD

U.S. Sieve #	Percent Finer
3"	
1 1/2"	
3/4"	
1/2"	100.0%
3/8"	95.3%
4	88.1%
10	67.0%
20	53.4%
40	46.6%
100	31.3%
200	21.9%

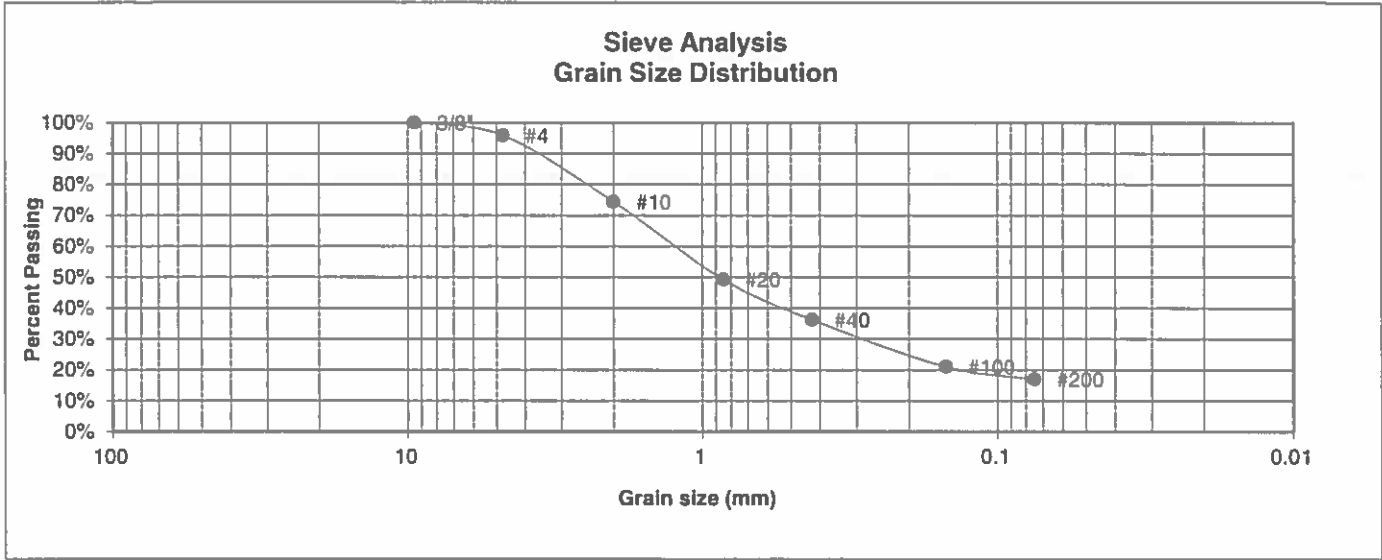
FIG NO:  
C-5

BORING NO.	TP-1	UNIFIED CLASSIFICATION	SM	TEST BY	BL
DEPTH(ft)	2-3	AASHTO CLASSIFICATION		JOB NO.	210901
CLIENT	RAMSES II PROPERTIES				
PROJECT	7985 BURGESS ROAD

U.S. Sieve #	Percent Finer	Atterberg Limits
3"		Plastic Limit
1 1/2"		Liquid Limit
3/4"		Plastic Index
1/2"		
3/8"	100.0%	
4	95.9%	
10	74.4%	
20	49.3%	
40	36.2%	
100	21.0%	
200	17.0%
