SOIL, GEOLOGY AND GEOTECHNICAL REPORT

**5080 Tamlin Road
EPC Schedule No. 5321002001
El Paso County, Colorado**

**JOB NO. 174679
PCD File No. PPR1945**

**March 2, 2020
Amended August 14, 2020**

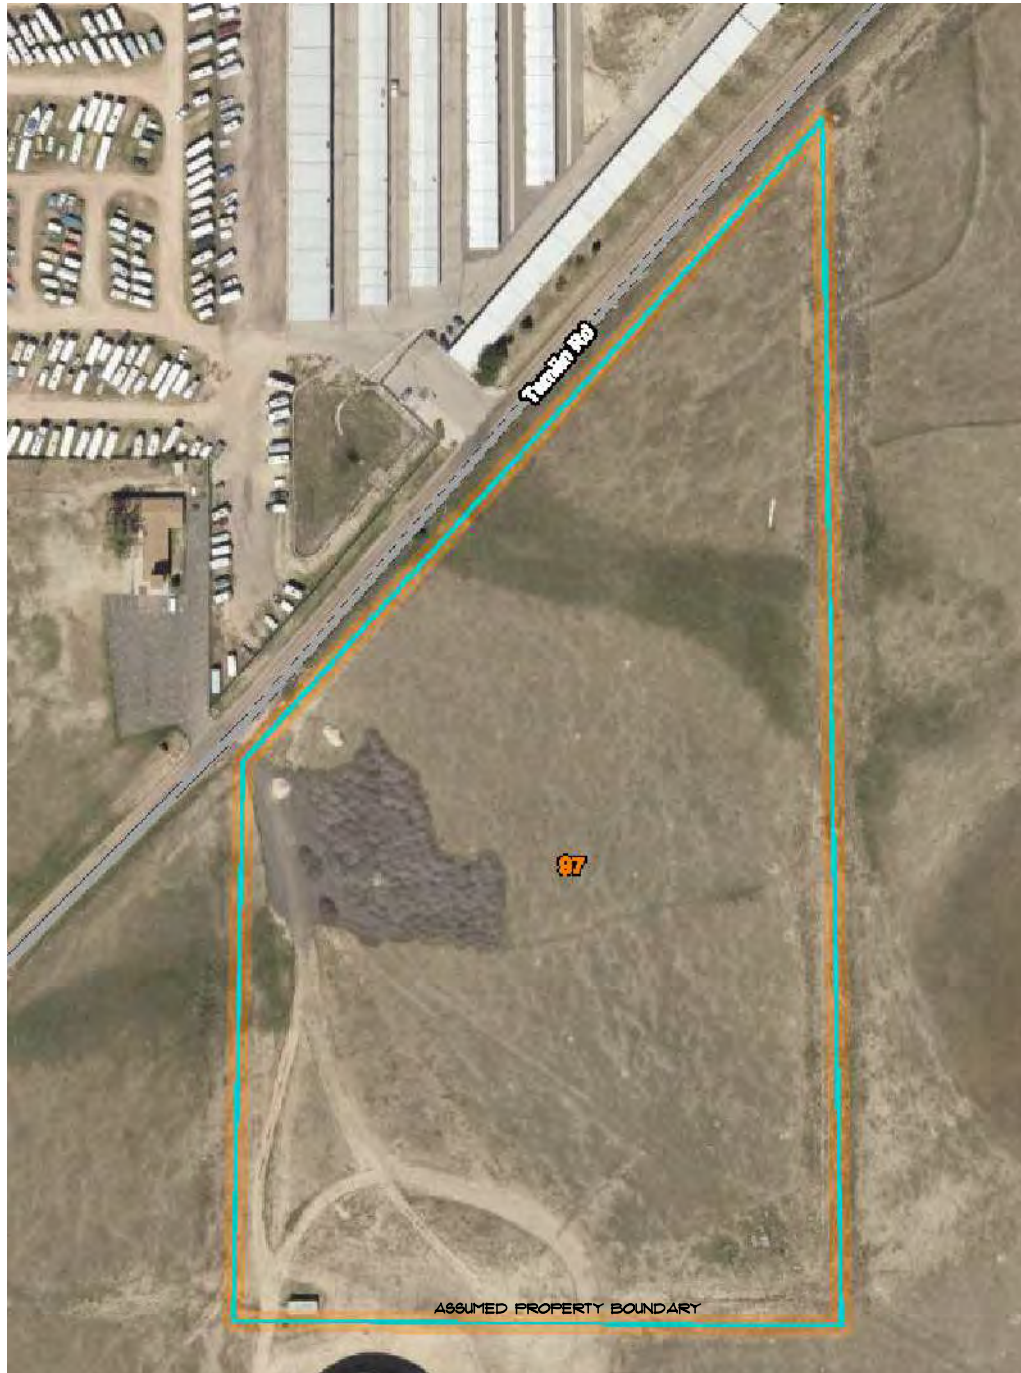
FIG No. 11

97 - Truckton sandy loam 3 to 9 percent slopes

The USDA Soil Survey Map is presented in Figure 11.

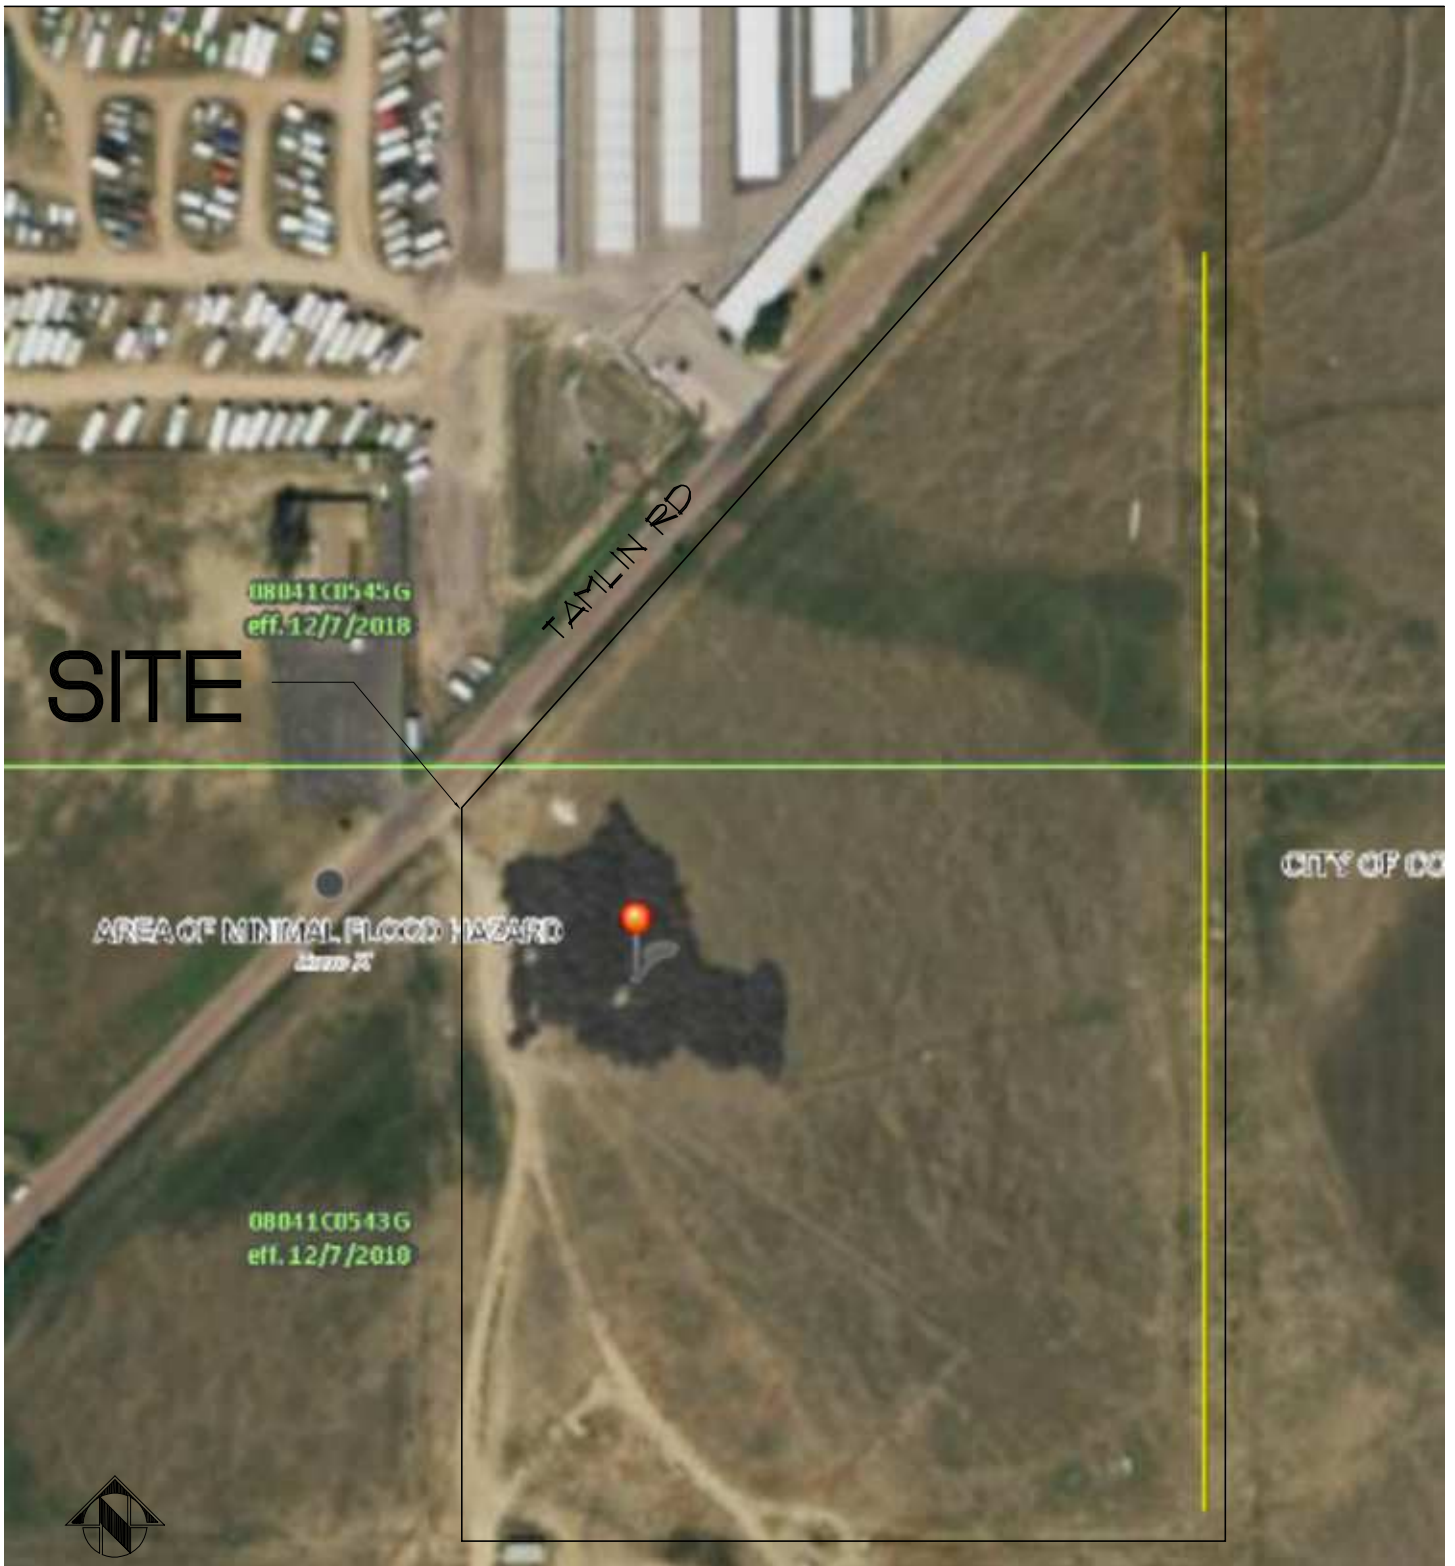
FIG No. 13

SITE

08041C0543G
eff. 12/7/2018

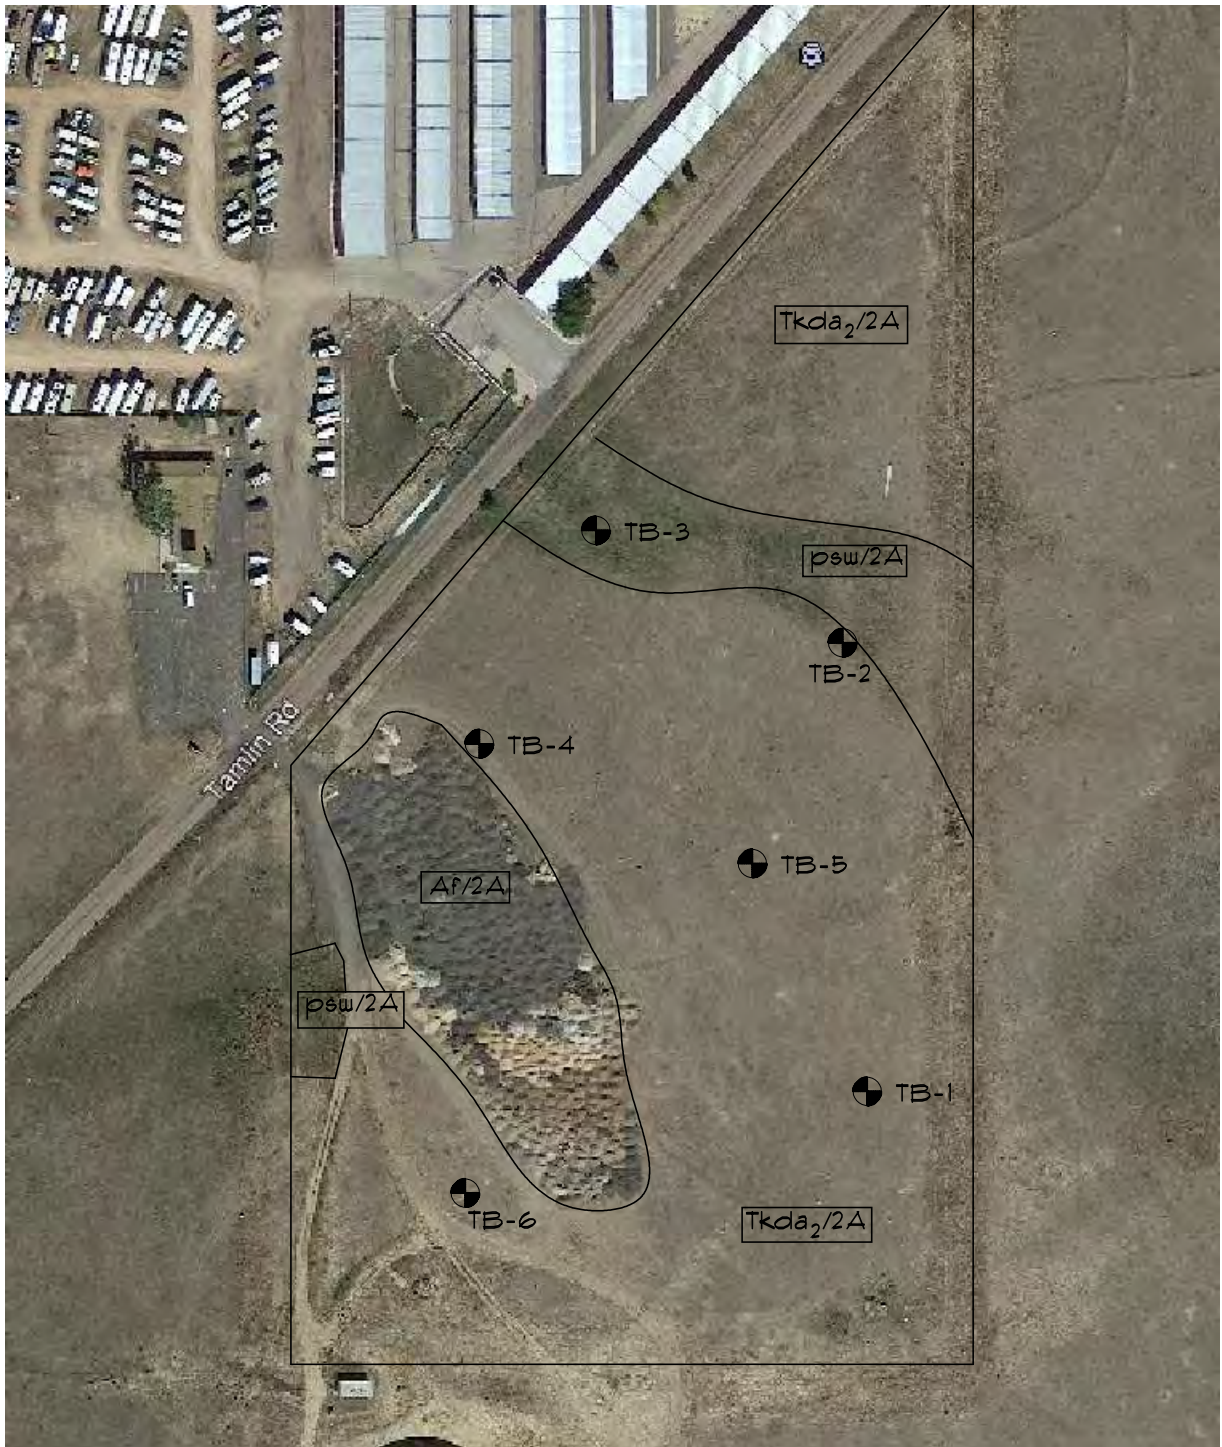
Geologic

- Af - Artificial Fill
- psw - potentially seasonally wet
- Tkda₂ - Dawson Formation
