ENTECH
ENGINEERING, INC.

**WASTEWATER STUDY
FLYING HORSE NORTH FILING NO. 3
EL PASO COUNTY, COLORADO**

August 23, 2023
Revised March 5, 2024

PCD No. SF2326

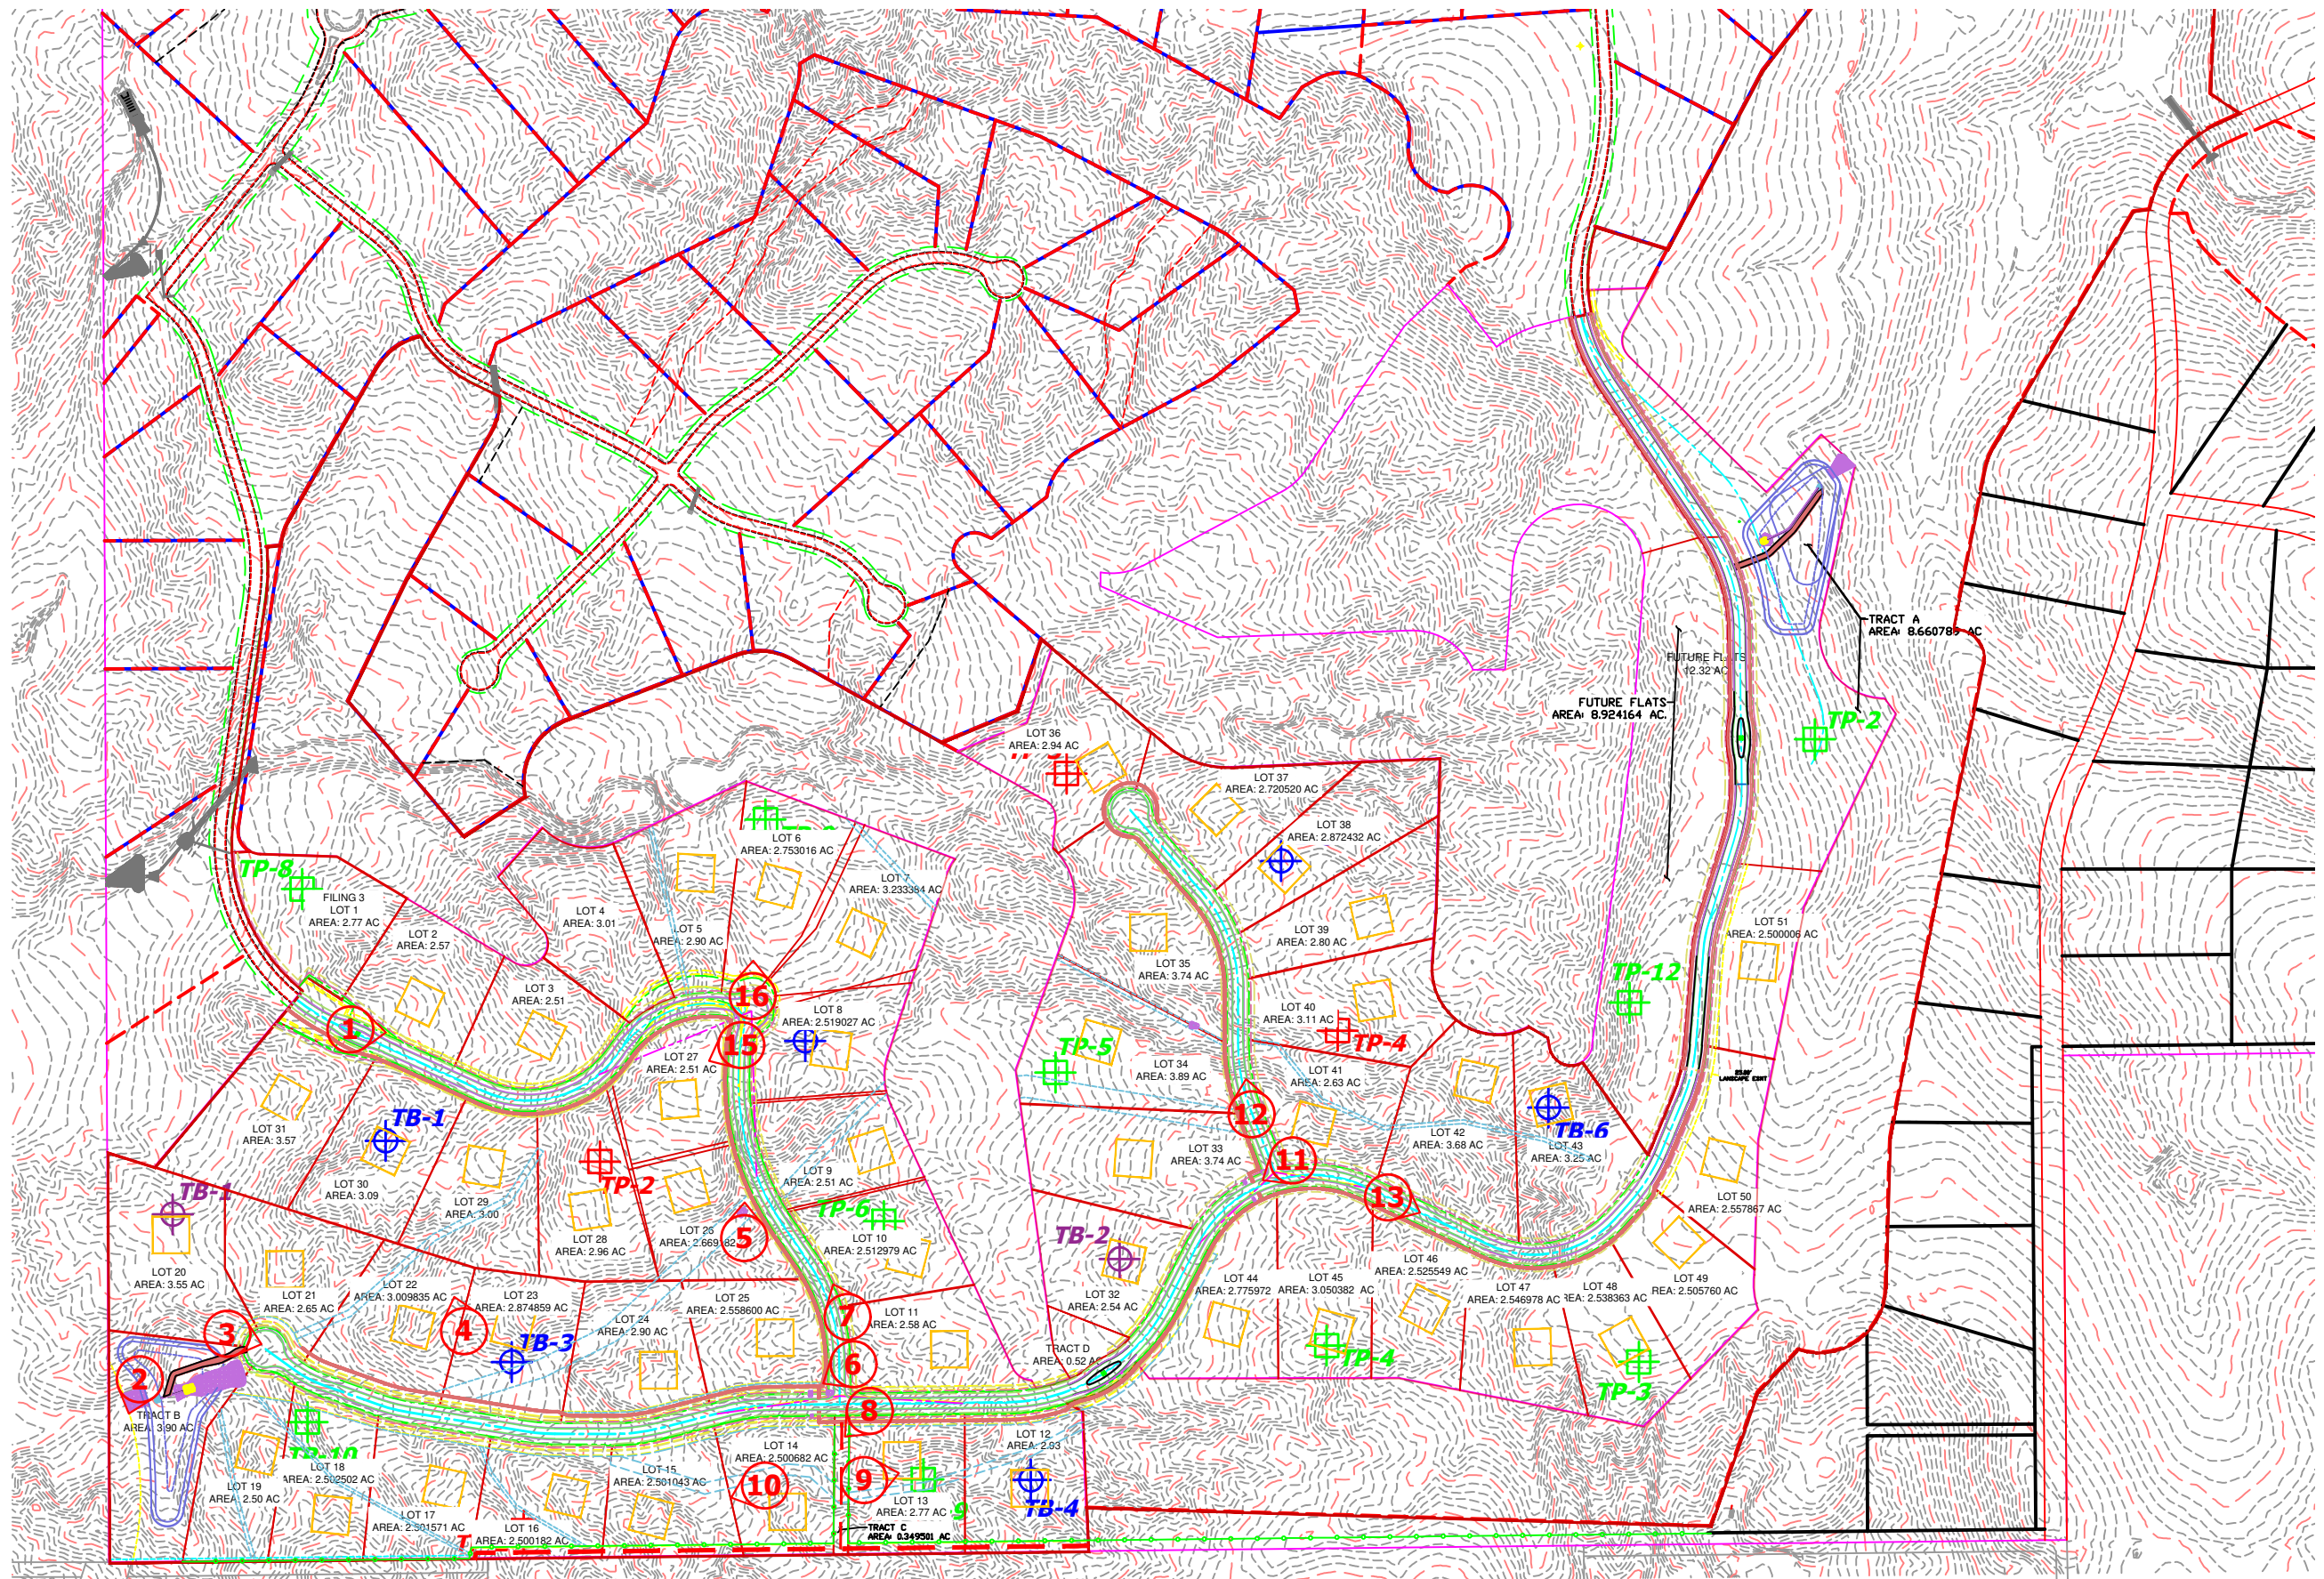
FIG. 3

SITE PLANT/TESTING LOCATION MAP
 FLYING HORSE NORTH FILING NO. 3
 EL PASO COUNTY, COLORADO
 FLYING HORSE NORTH, LLC

- APPROXIMATE TEST PIT LOCATION AND NUMBER (OLD, NEW)
- APPROXIMATE TEST BORING LOCATION AND NUMBER (OLD, NEW)
- APPROXIMATE PHOTOGRAPH LOCATION AND NUMBER

Flying Horse North Filing No. 3 Subdivision is 293.7 acres (173.5 acres of residential estate lot subdivision area and 120.2 acres of replatted existing golf course area. Fifty-one (51) lots are proposed for the filing. The proposed development is to consist of 2.5 to 3.9-acre single-family residential estate lots, two drainage tracts, and other associated site improvements. Grading is expected to be primarily associated with the construction of roads. The Development Plan/Test Boring Location Map is presented in Figure 3.

The previous field investigation consisted of six (6) test borings and eighteen (18) test pits to determine general suitability of the site for construction (Reference 3). The location of the previous Test Borings and Test Pits indicated on the Site Map/Testing Location Map, Figure 3. Additionally, fourteen (14) profile holes were performed on the entire Flying Horse North property in previous studies.

The site was evaluated for individual on-site wastewater treatment systems in accordance with El Paso Land Development Code. Fourteen (14) tactile test pits were excavated across the site. The test pits were located in potential locations of future systems. The approximate locations of the Test Pits are indicated on Figure 3, and on the Septic Suitability Map, Figure 8. A table showing the results of the Tactile Test Pits is presented in Table B-1. Test Pit Logs are included in Appendix B, and Laboratory Test Results in Appendix C. Previous Laboratory Testing Summary and Test Pit Logs are included in Appendix D.

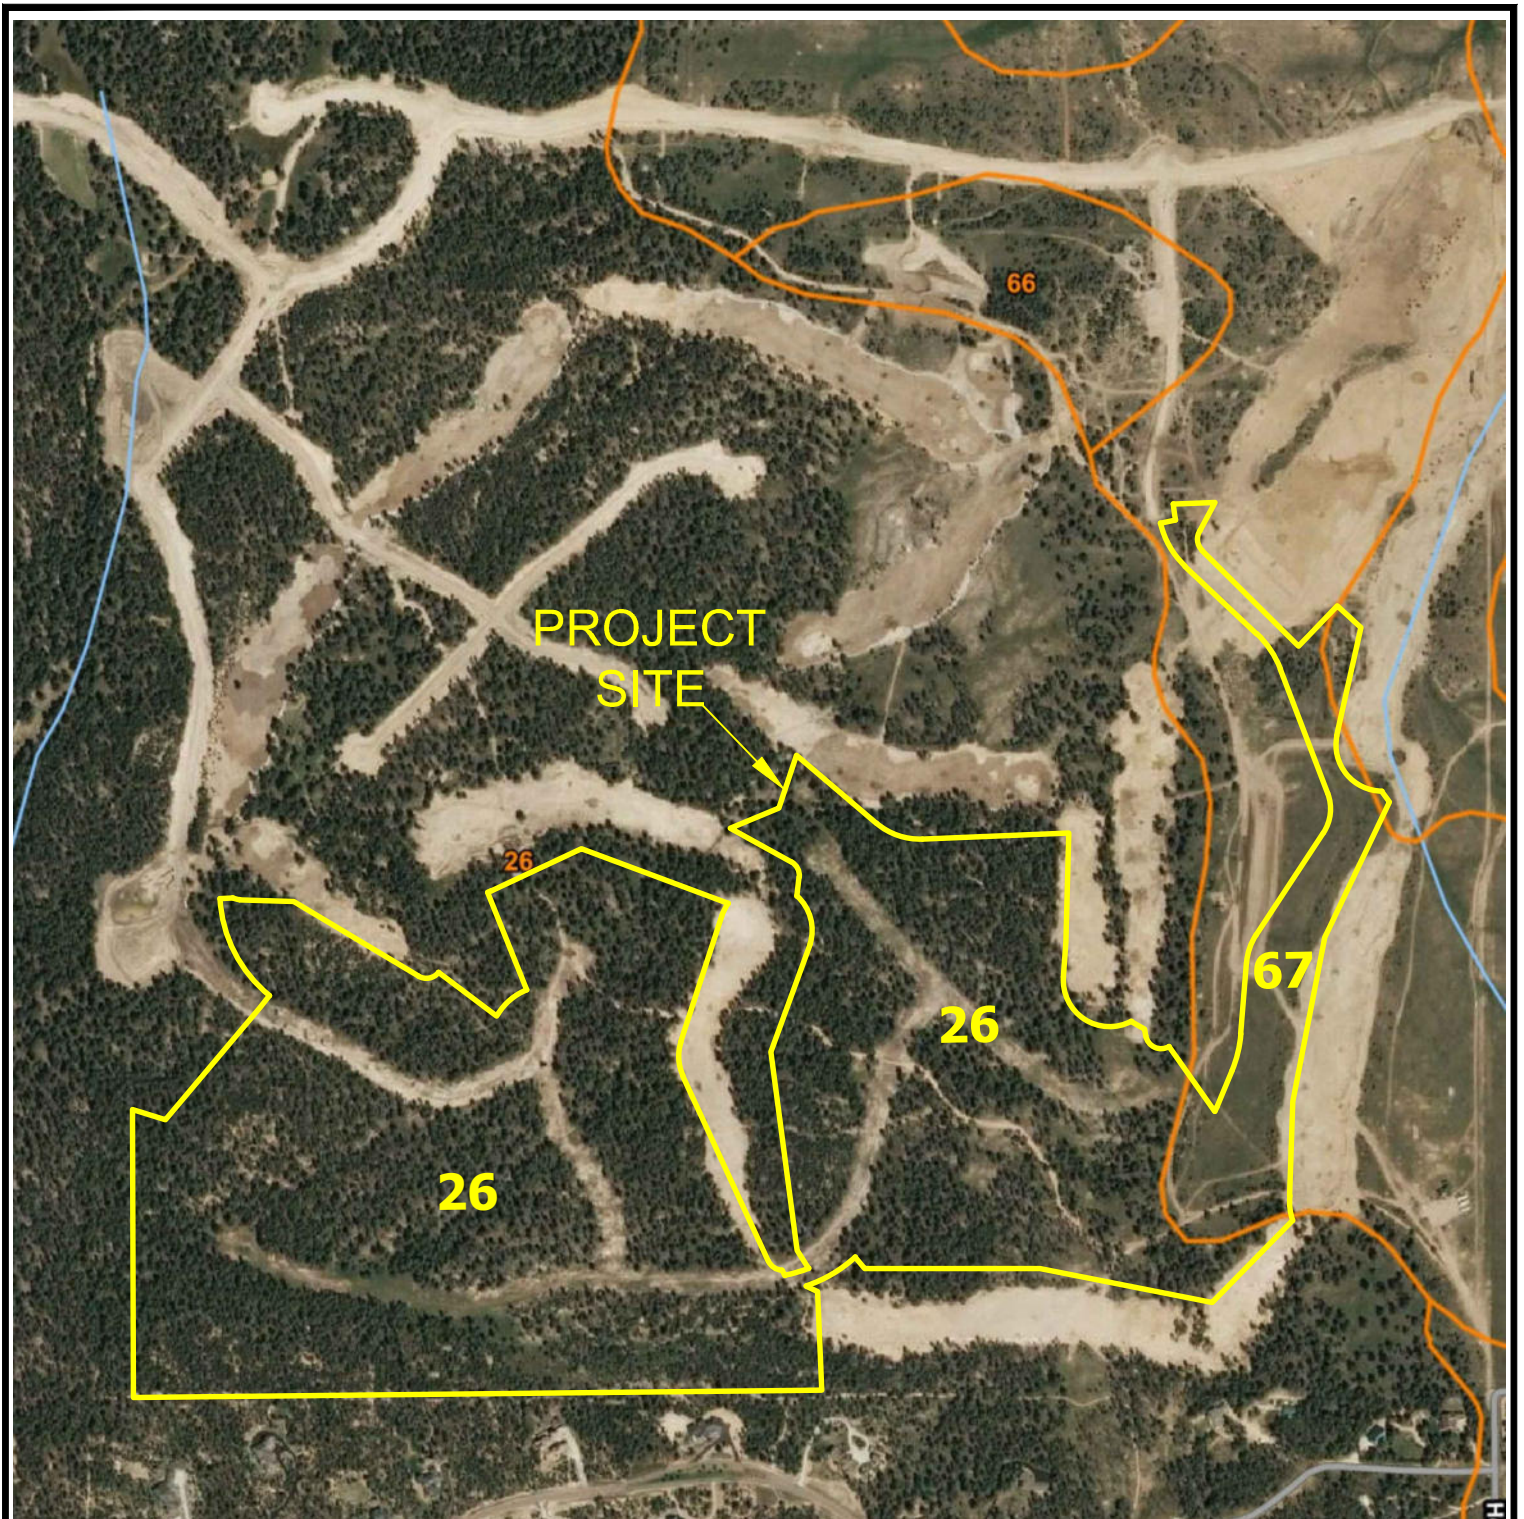
FIG. 4

SOIL SURVEY MAP
FLYING HORSE NORTH FILING NO. 3
EL PASO COUNTY, COLORADO
FLYING HORSE NORTH, LLC

The Natural Resource Conservation Service (Reference 5), previously the Soil Conservation Service (Reference 6) has mapped two soil types on the site (Figure 4). In general, the soils classify as coarse sandy loam, and sandy loam. The soils are described as follows:

The Natural Resource Conservation Service (Reference 5), previously the Soil Conservation Service (Reference 6) has been mapped with two soil descriptions. The Soil Survey Map (Reference 5) is presented in Figure 4, and the Soil Survey Descriptions are presented in Appendix D. The soils are described as having slow to rapid percolation rates. The majority of the soils have been described with moderate permeabilities.

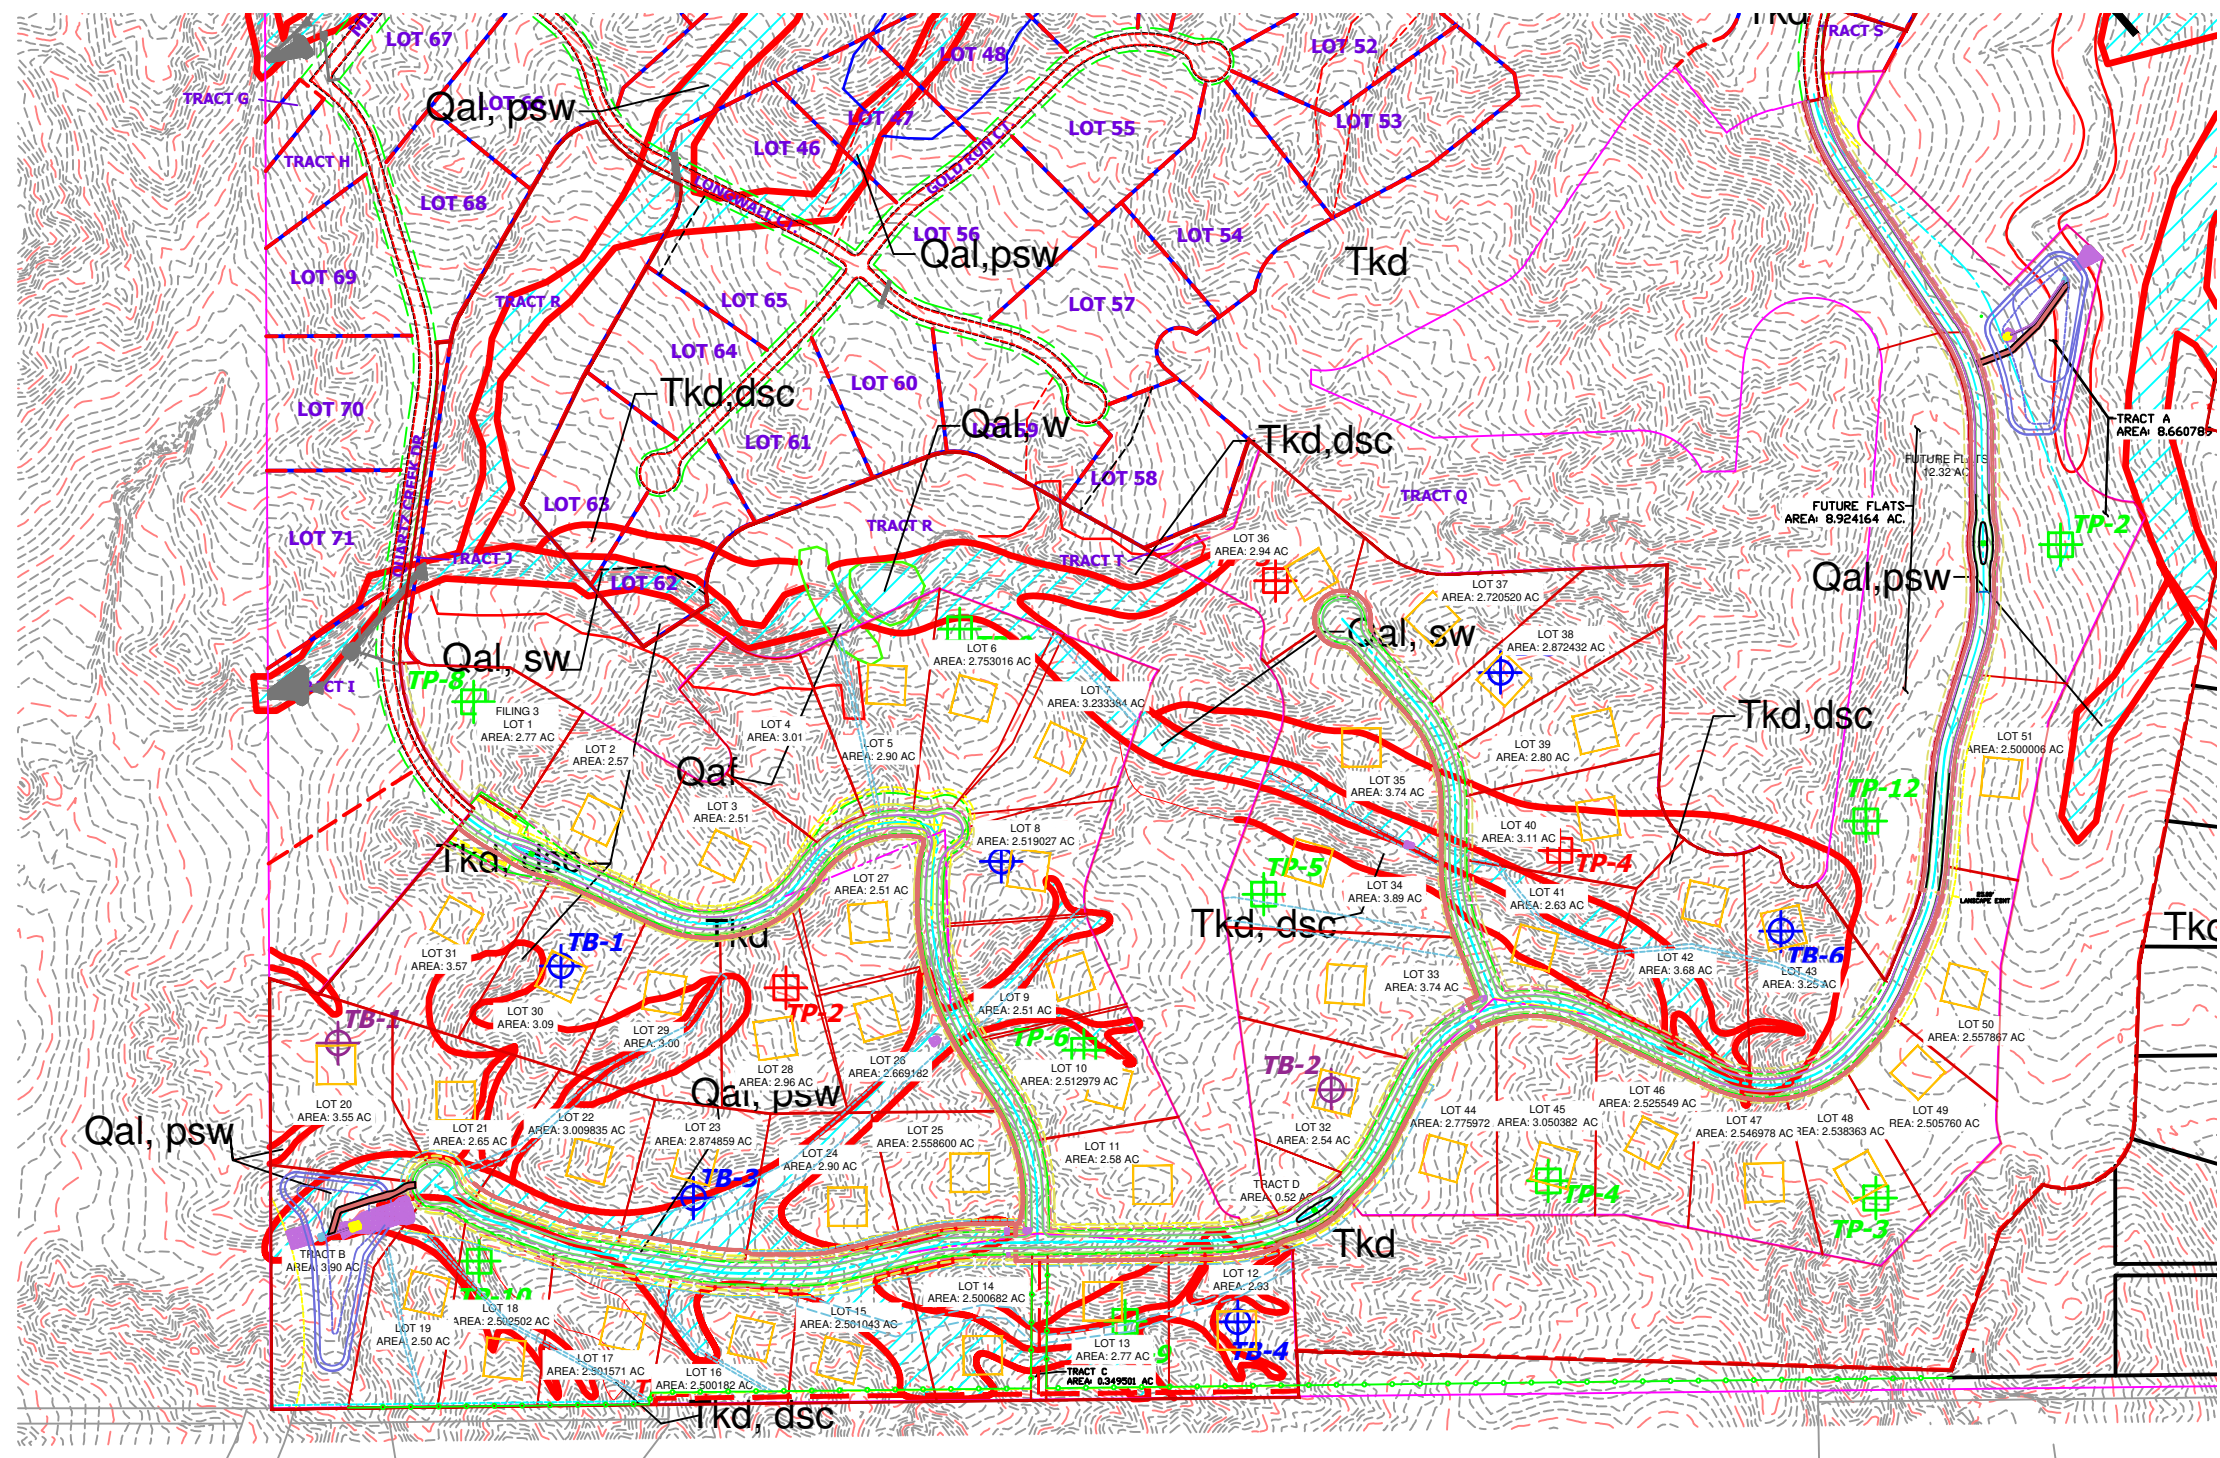
FIG. 6

- Legend:**
- Qaf -** Artificial Fill of Quaternary Age: man-made fill deposits associated with erosion berms, and earthen dams
 - Qal -** Alluvium of Quaternary Age: recent stream deposited materials
 - TKd -** Dawson Formation of Tertiary to Cretaceous Age: colluvial and residual soils overlying arkosic sandstone with interbedded fine-grained sandstone, siltstone, and claystone
 - dsc -** downslope creep
 - er -** erosion
 - fp -** floodplain
 - psw -** potentially seasonal shallow groundwater area
 - sw -** seasonally wet areas
 - w -** ponded water

GEOLOGY/ENGINEERING MAP
 FLYING HORSE NORTH FILING NO. 3
 EL PASO COUNTY, COLORADO
 FLYING HORSE NORTH, LLC

The soils listed above were mapped from site-specific mapping, the *Geologic Map of the Black Forest Quadrangle* distributed by the Colorado Geological Survey in 2003 (References 7), the *Geologic Map of the Colorado Springs-Castle Rock Area*, distributed by the US Geological Survey in 1979 (Reference 8), and the *Geologic Map of the Denver 1⁰ x 2⁰ Quadrangle*, distributed by the US Geological Survey in 1981 (Reference 9). The Test Pit Logs used in evaluating the site and are included in Appendix B. The Geology Map prepared for the site is presented in Figure 7.

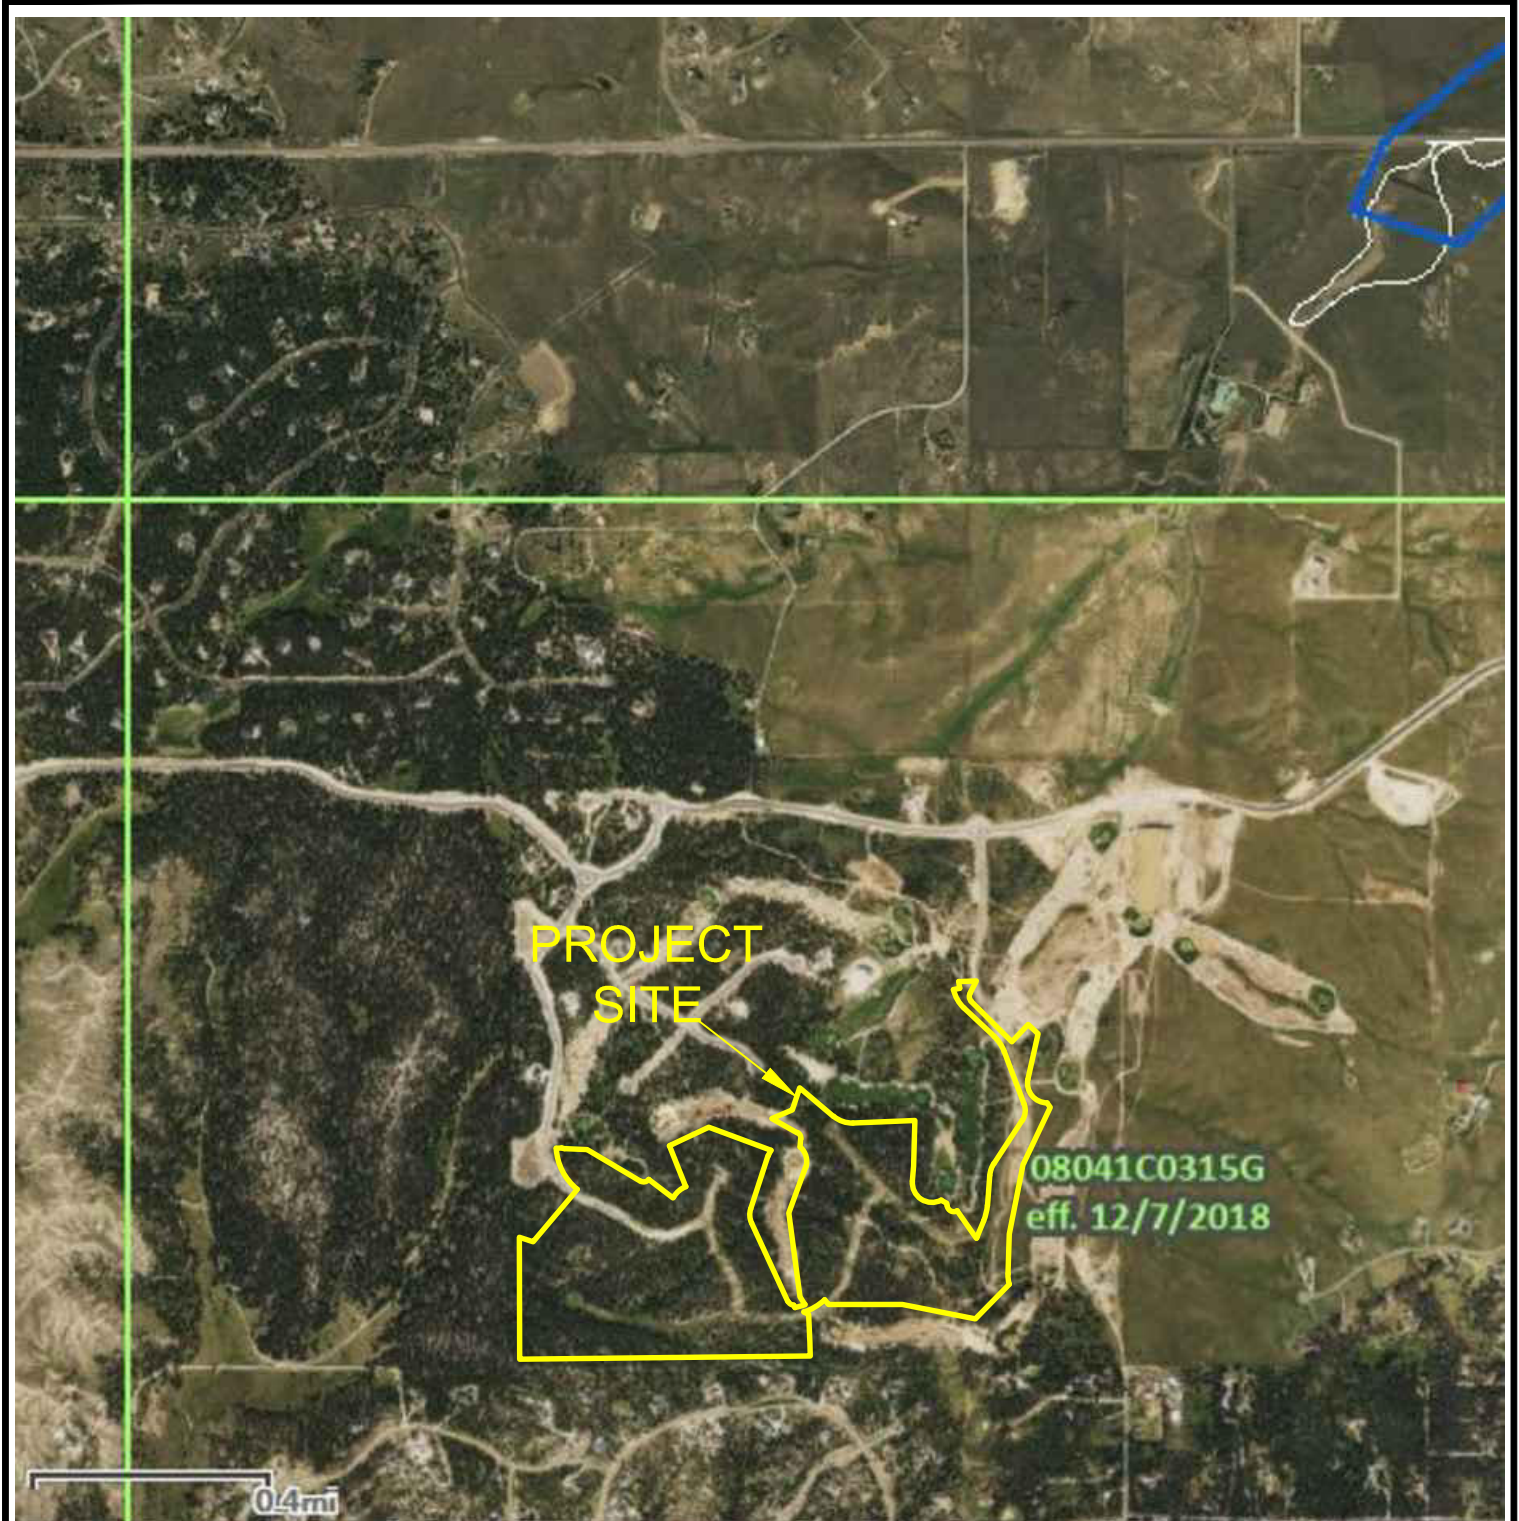
FIG. 7

FEMA FLOODPLAIN MAP
FLYING HORSE NORTH FILING NO. 3
EL PASO COUNTY, COLORADO
FLYING HORSE NORTH, LLC

Drainages are located in the northern and southern portions site, and several minor drainages are located across the site that generally flow in westerly directions. None of the drainages on the site have been mapped within floodplain zones according to the FEMA Map No. 08041CO315G, (Figure 7, Reference 11). Areas where potentially seasonal shallow, seasonal shallow, and ponded water have been indicated on the site geology/engineering geology map, Figure 6. OWTS soil treatment areas should not be located within areas mapped as seasonally shallow and potential seasonally shallow groundwater areas.

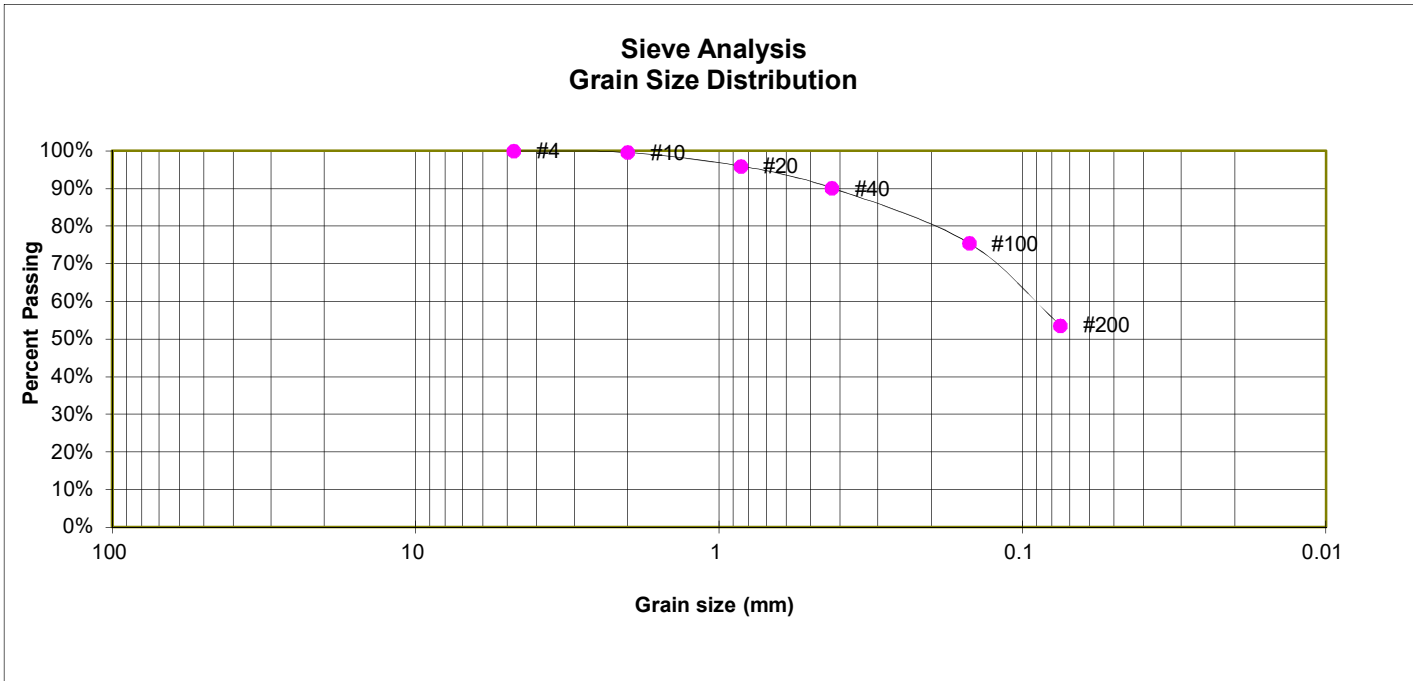
TEST PIT	TP-1	SOIL DESCRIPTION	CLAY, SANDY
DEPTH (FT)	3

GRAIN SIZE ANALYSIS

U.S. Sieve #	Percent Finer
3"	
1 1/2"	
3/4"	
1/2"	
3/8"	
4	100.0%
10	99.6%
20	96.0%
40	90.1%
100	75.5%
200	53.6%

Laboratory testing was performed on some of the soils to classify and determine the soils engineering characteristics. Laboratory tests included moisture content testing, ASTM D-2216, tests included grain-size analysis ASTM D-422. Results of the laboratory testing are included in Appendix C. Previous Laboratory Testing Summary and Test Pit Logs are included in Appendix D.

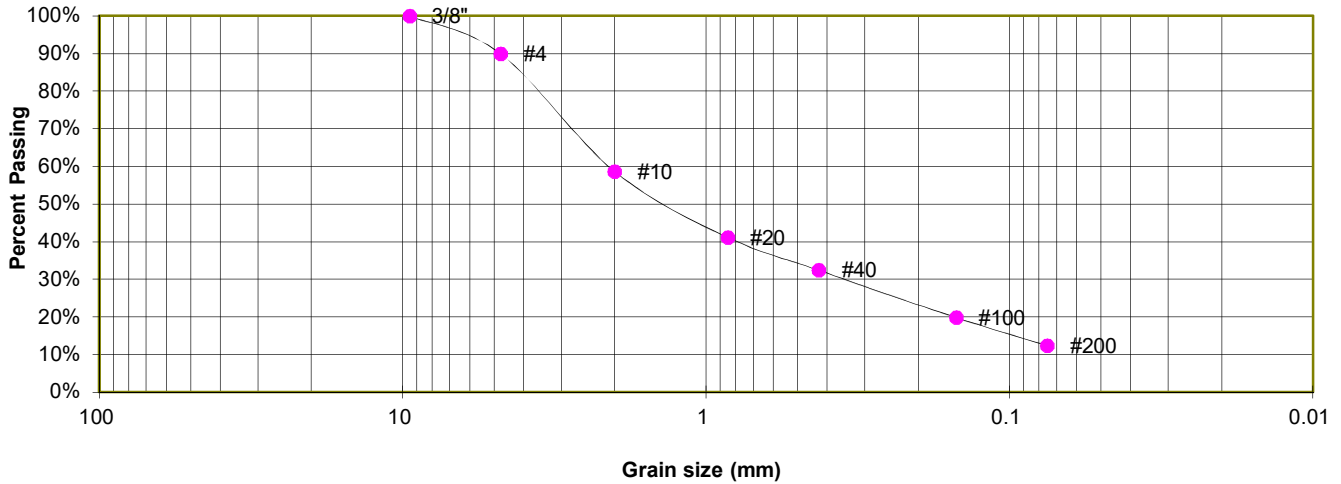
TEST PIT	TP-1	SOIL DESCRIPTION SANDSTONE, SILTY
DEPTH (FT)	5

**Sieve Analysis
Grain Size Distribution**

GRAIN SIZE ANALYSIS

U.S. Sieve #	Percent Finer
3"	
1 1/2"	
3/4"	
1/2"	
3/8"	100.0%
4	89.9%
10	58.6%
20	41.2%
40	32.4%
100	19.8%
200	12.4%

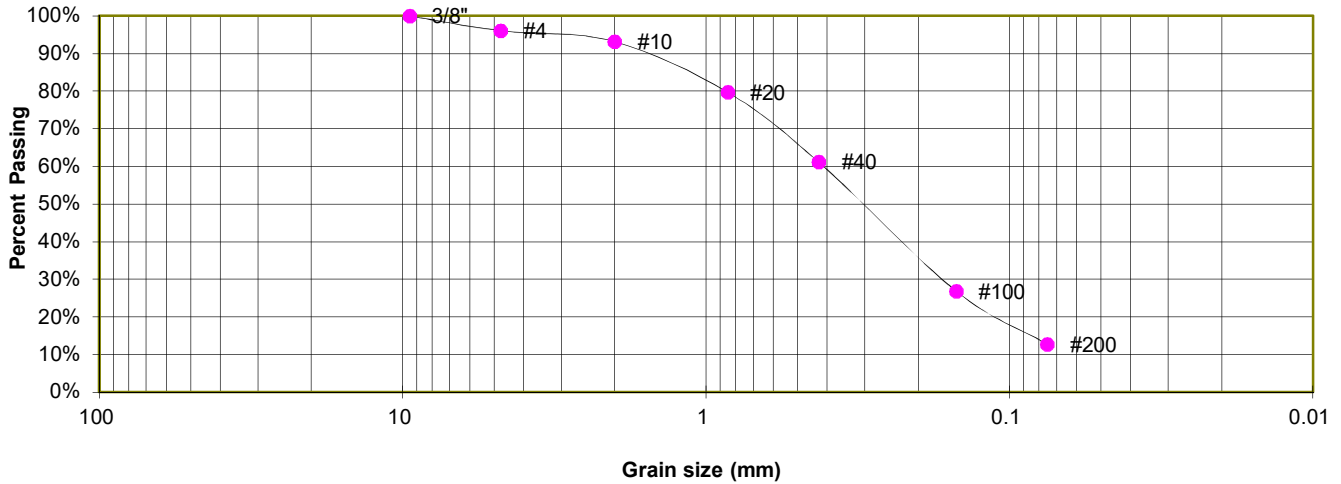
SOIL DESCRIPTION SAND, SILTY

**Sieve Analysis
 Grain Size Distribution**

GRAIN SIZE ANALYSIS

U.S. Sieve #	Percent Finer
3"	
1 1/2"	
3/4"	
1/2"	
3/8"	100.0%
4	96.1%
10	93.2%
20	79.7%
40	61.1%
100	26.9%
200	12.8%

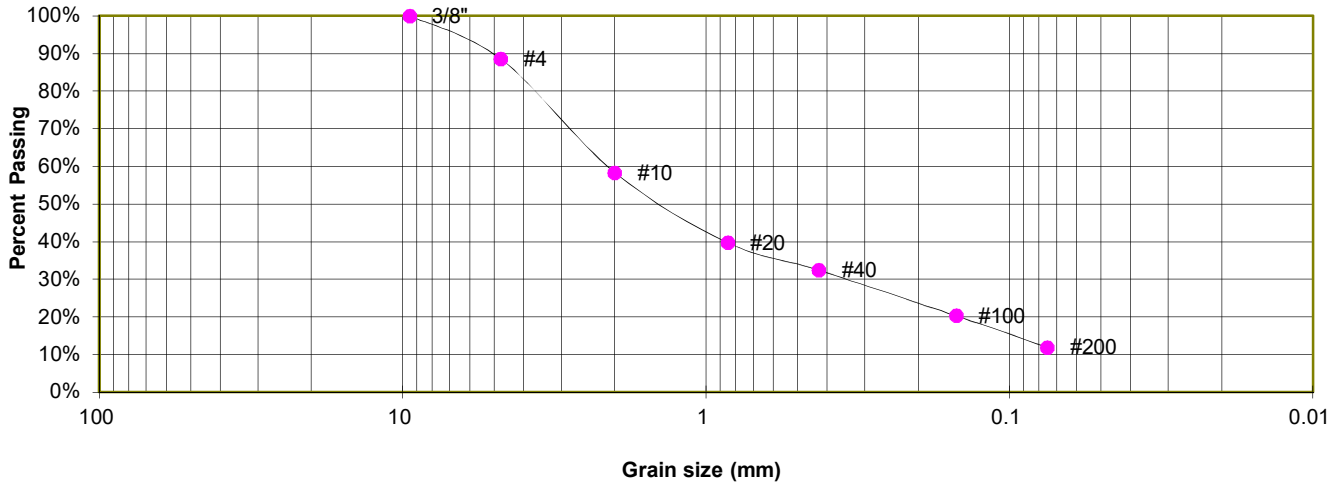
TEST PIT	TP-2	SOIL DESCRIPTION SAND, WITH SILT
DEPTH (FT)	7

**Sieve Analysis
Grain Size Distribution**

GRAIN SIZE ANALYSIS

U.S. Sieve #	Percent Finer
3"	
1 1/2"	
3/4"	
1/2"	
3/8"	100.0%
4	88.6%
10	58.4%
20	39.8%
40	32.4%
100	20.3%
200	11.9%

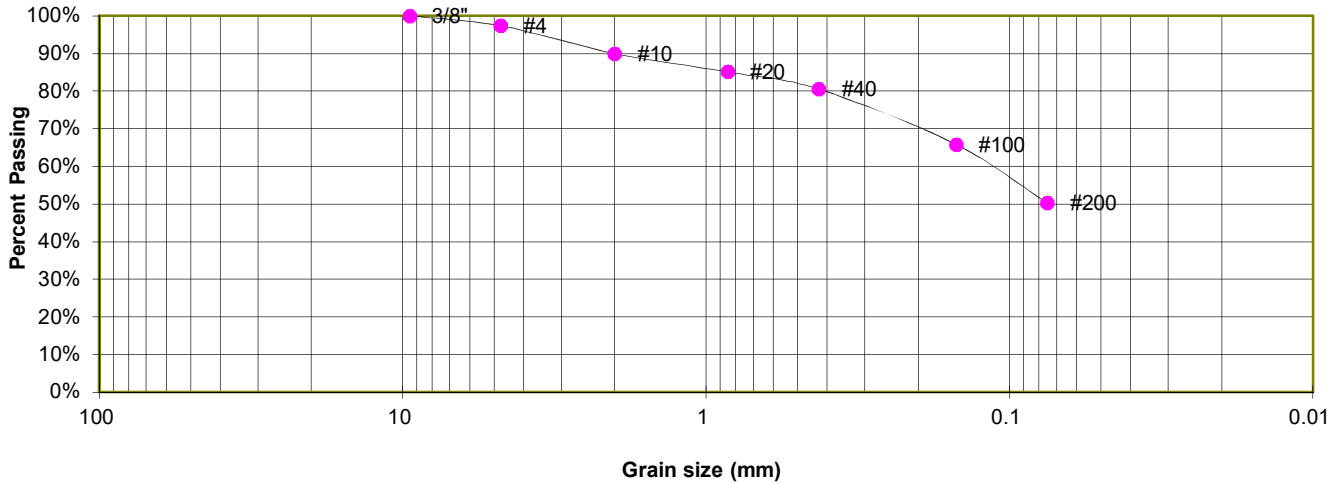
SOIL DESCRIPTION CLAY, SANDY

**Sieve Analysis
 Grain Size Distribution**

GRAIN SIZE ANALYSIS

U.S. Sieve #	Percent Finer
3"	
1 1/2"	
3/4"	
1/2"	
3/8"	100.0%
4	97.4%
10	90.0%
20	85.1%
40	80.5%
100	65.8%
200	50.3%

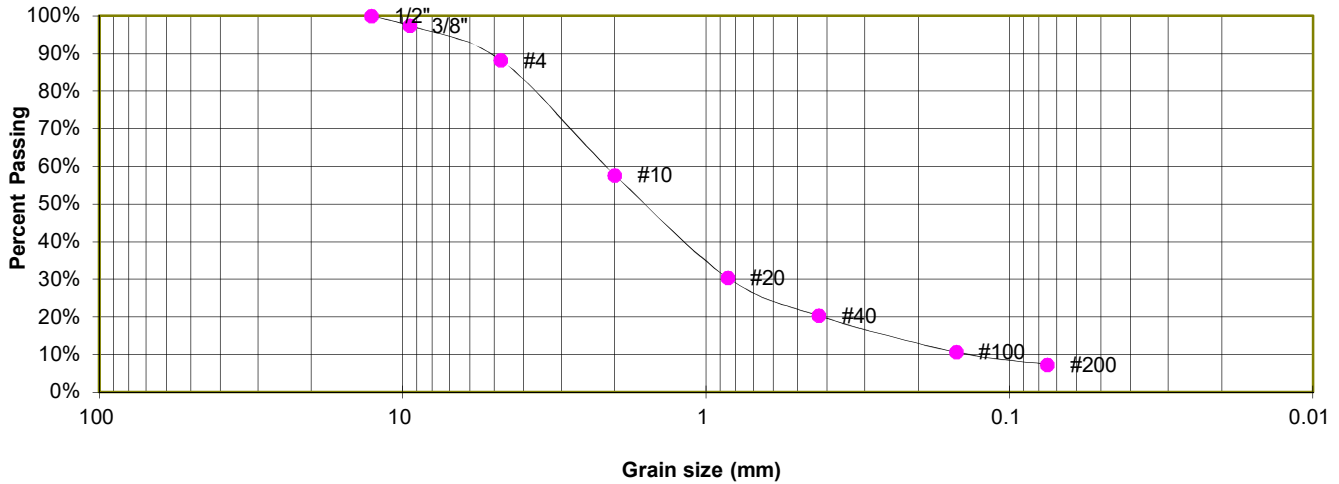
TEST PIT	TP-4	SOIL DESCRIPTION SAND, WITH SILT
DEPTH (FT)	3

**Sieve Analysis
Grain Size Distribution**

GRAIN SIZE ANALYSIS

U.S. Sieve #	Percent Finer
3"	
1 1/2"	
3/4"	
1/2"	100.0%
3/8"	97.4%
4	88.3%
10	57.7%
20	30.4%
40	20.3%
100	10.7%
200	7.4%

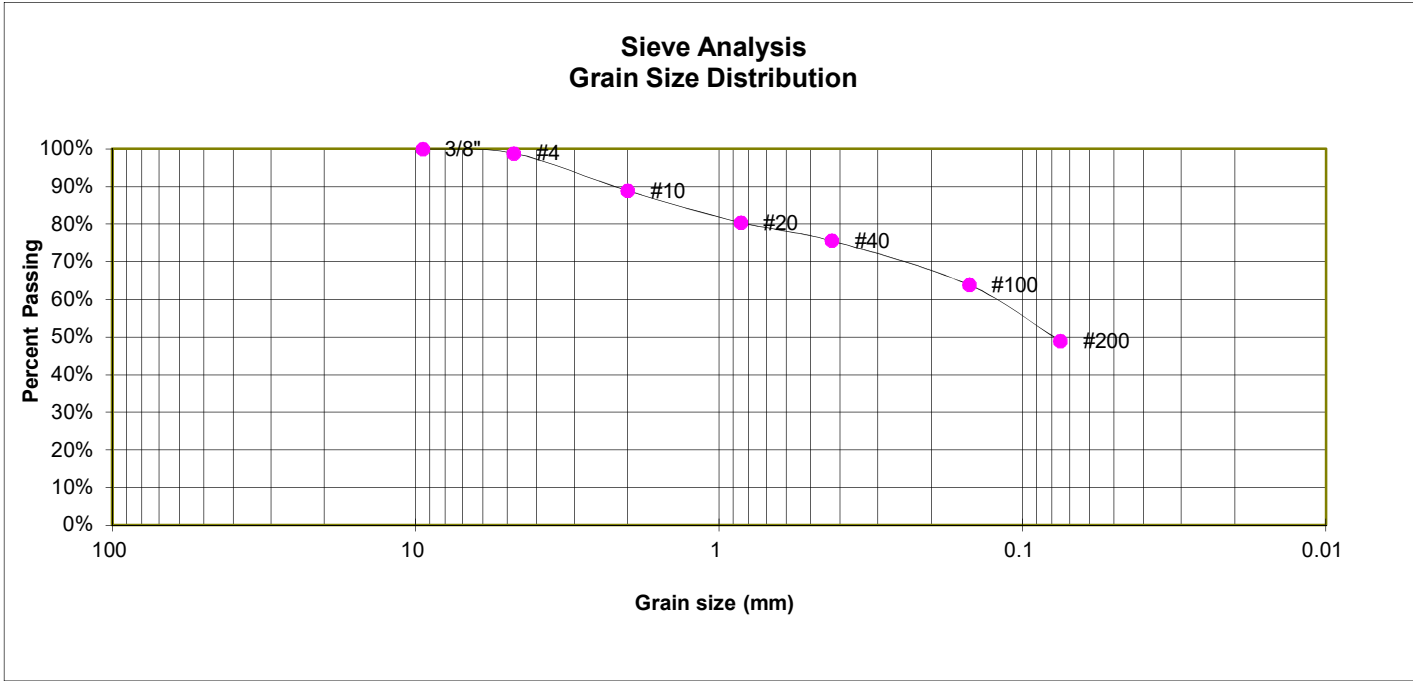
C-6

TEST PIT	TP-4	SOIL DESCRIPTION SAND, CLAYEY
DEPTH (FT)	5

GRAIN SIZE ANALYSIS

U.S. Sieve #	Percent Finer
3"	
1 1/2"	
3/4"	
1/2"	
3/8"	100.0%
4	98.9%
10	88.9%
20	80.5%
40	75.6%
100	63.9%
200	48.9%
