ENTECH
ENGINEERING, INC.

**WASTEWATER STUDY
FLYING HORSE NORTH FILING NO. 3
EL PASO COUNTY, COLORADO**

August 23, 2023

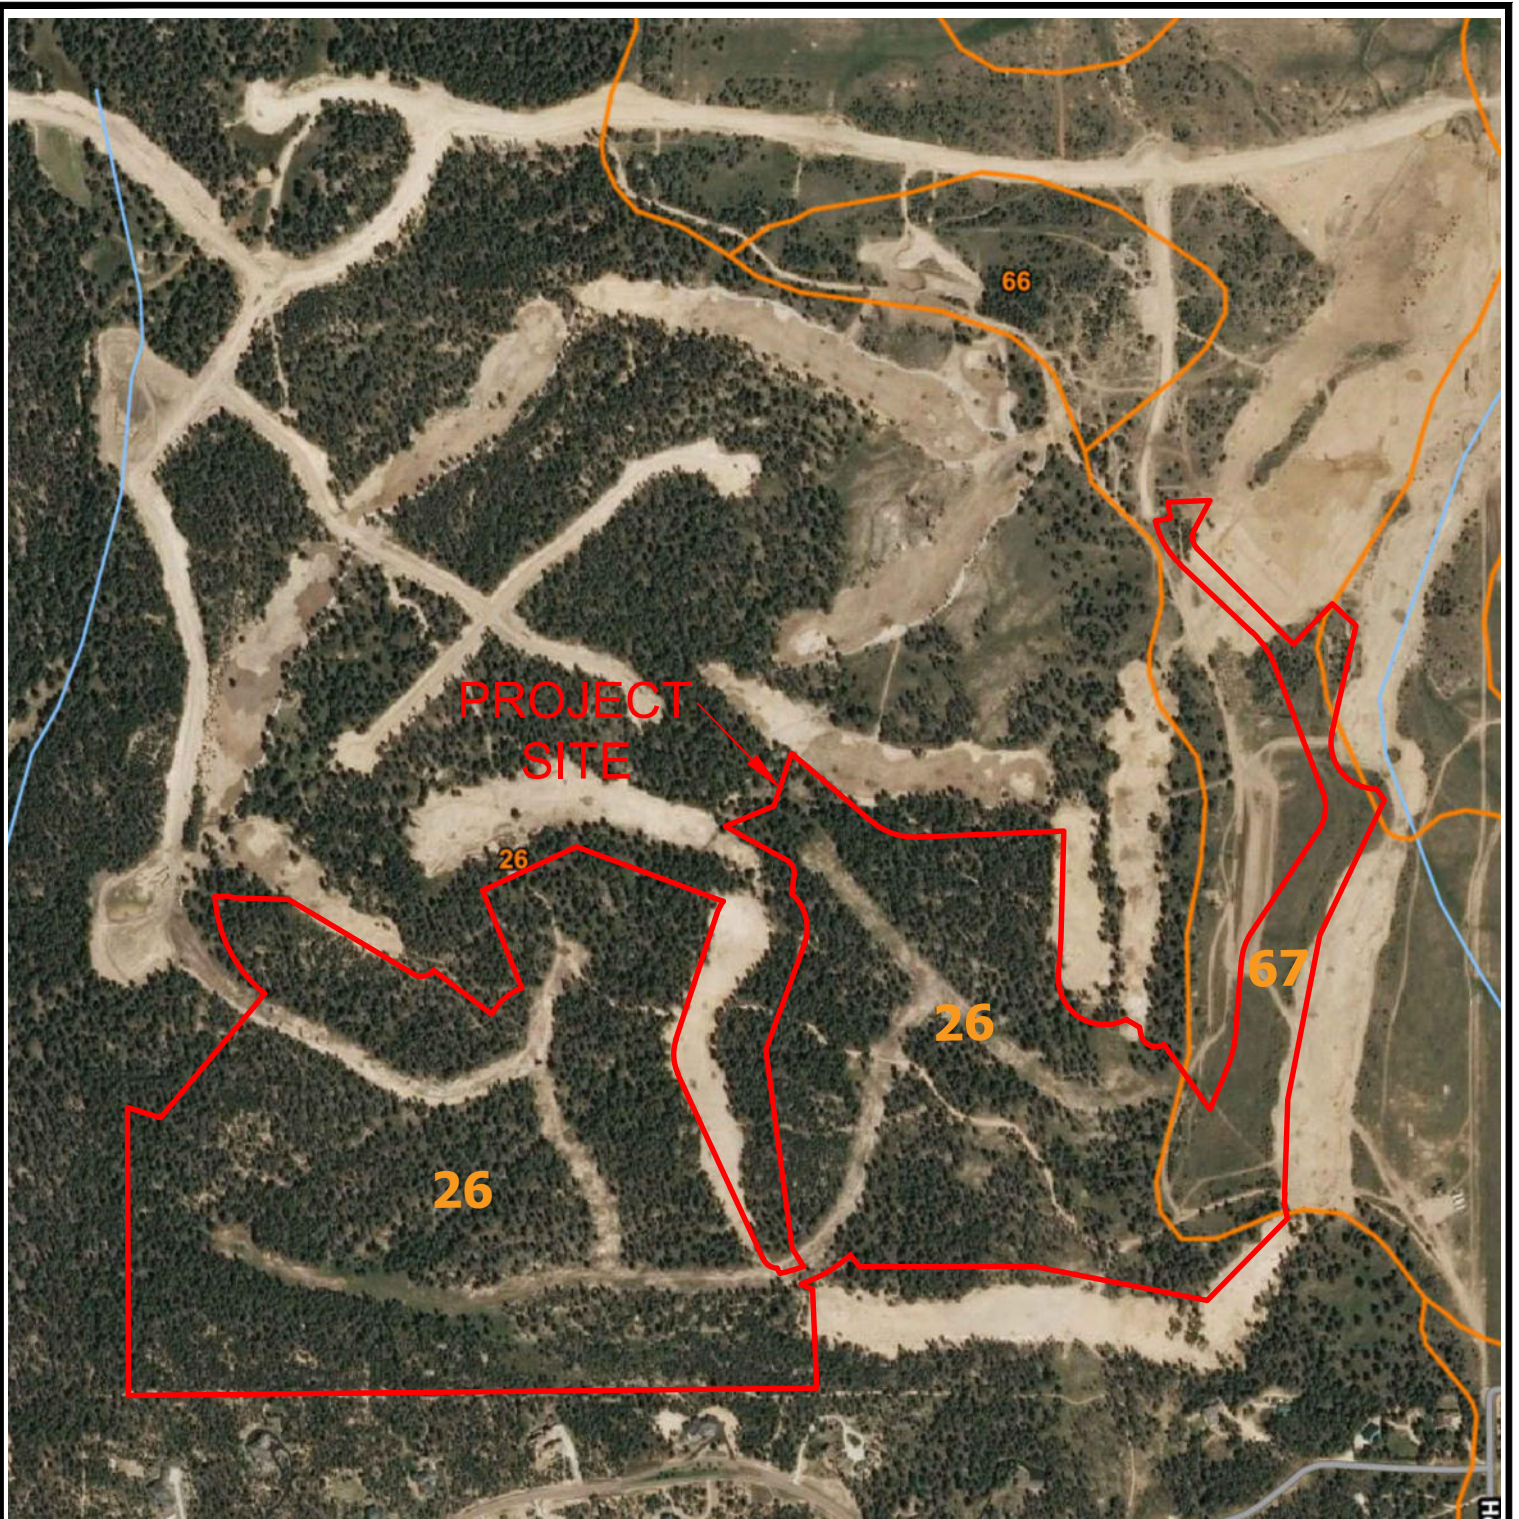
FIG. 4

SOIL SURVEY MAP
FLYING HORSE NORTH FILING NO. 3
EL PASO COUNTY, COLORADO
FLYING HORSE NORTH, LLC

The Natural Resource Conservation Service (Reference 5), previously the Soil Conservation Service (Reference 6) has mapped two soil types on the site (Figure 4). In general, the soils classify as coarse sandy loam, and sandy loam. The soils are described as follows:

The Natural Resource Conservation Service (Reference 5), previously the Soil Conservation Service (Reference 6) has been mapped with two soil descriptions. The Soil Survey Map (Reference 5) is presented in Figure 4, and the Soil Survey Descriptions are presented in Appendix D. The soils are described as having slow to rapid percolation rates. The majority of the soils have been described with moderate permeabilities.

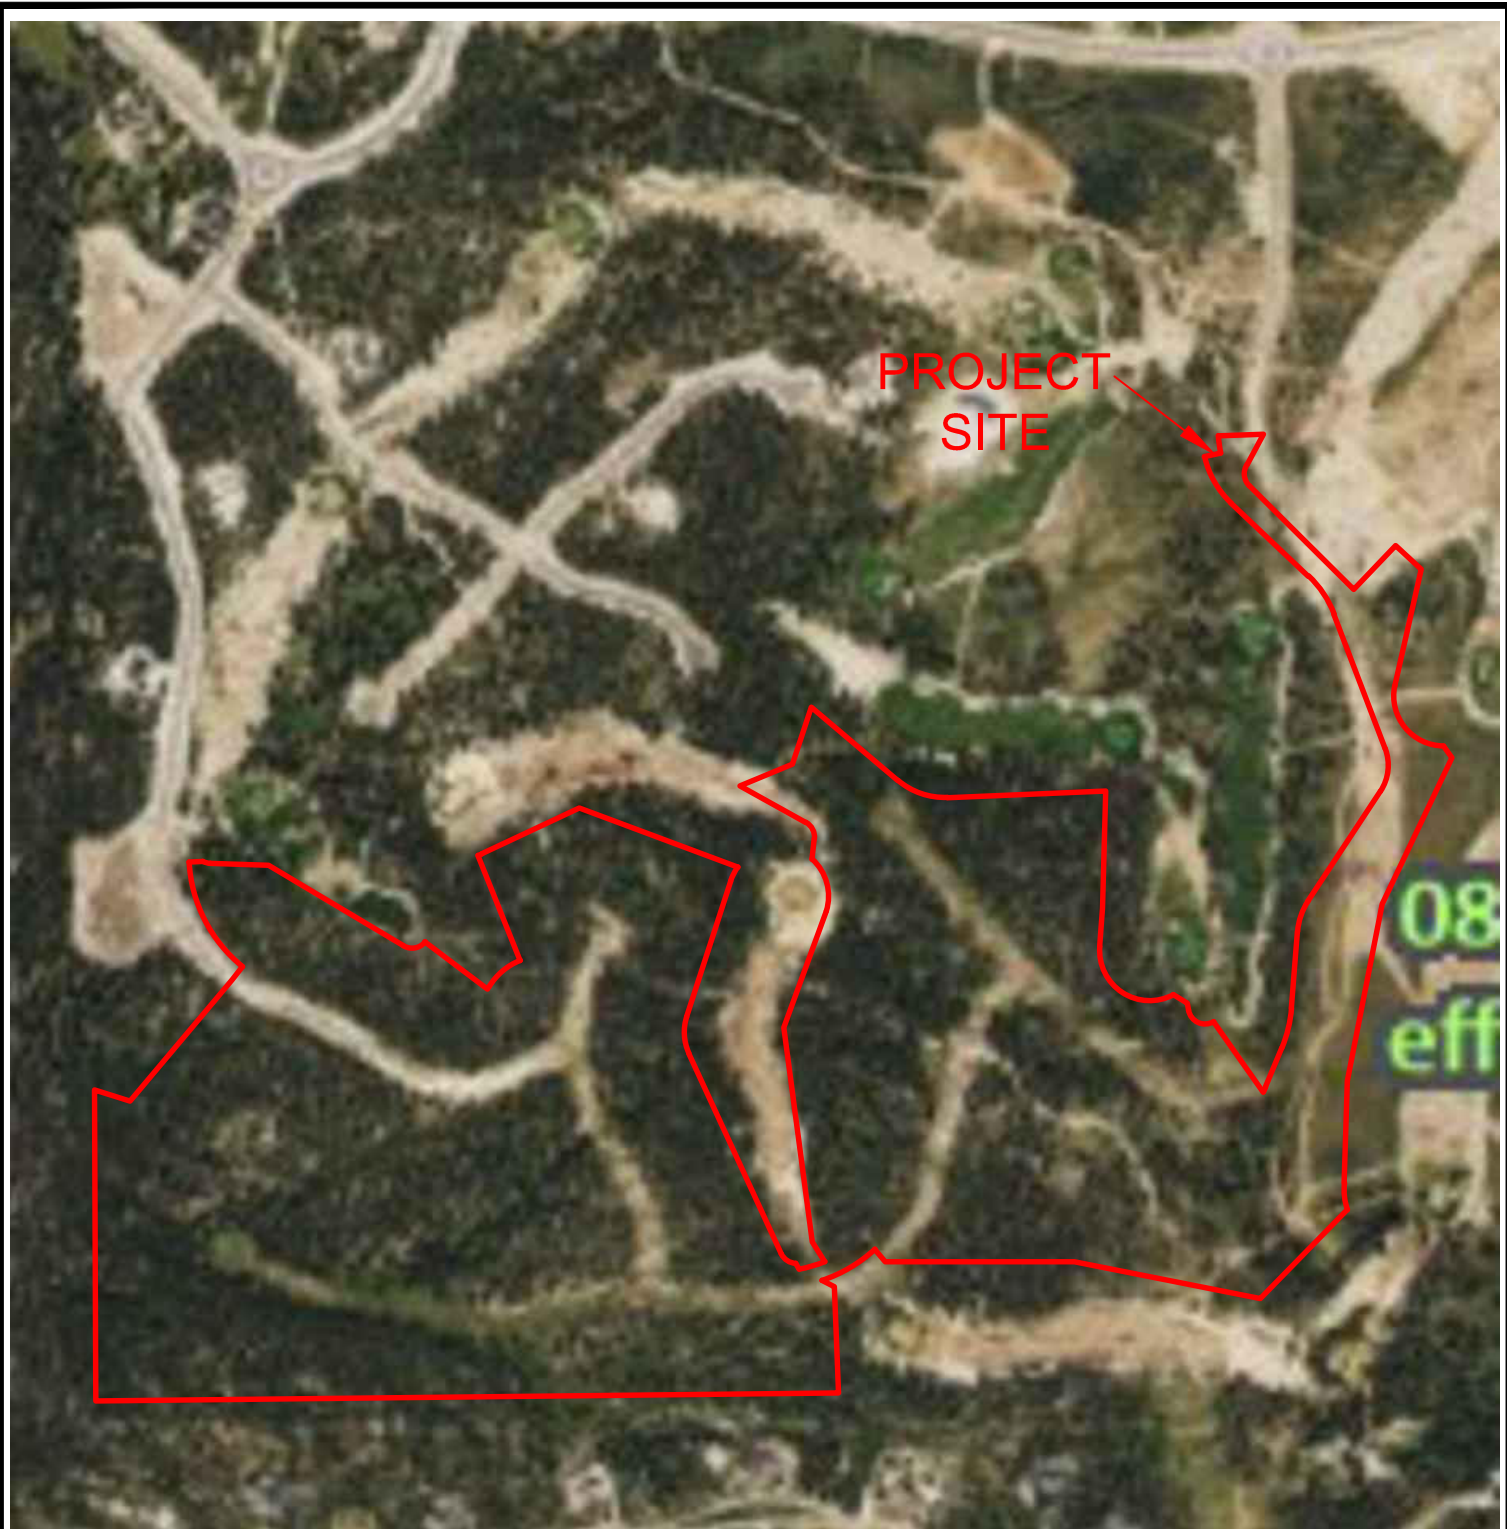
FIG. 7

FEMA FLOODPLAIN MAP
FLYING HORSE NORTH FILING NO. 3
EL PASO COUNTY, COLORADO
FLYING HORSE NORTH, LLC

Drainages are located in the northern and southern portions site, and several minor drainages are located across the site that generally flow in westerly directions. None of the drainages on the site have been mapped within floodplain zones according to the FEMA Map No. 08041CO315G, (Figure 7, Reference 11). Areas where potentially seasonal shallow, seasonal shallow, and ponded water have been indicated on the site geology/engineering geology map, Figure 6. OWTS soil treatment areas should not be located within areas mapped as seasonally shallow and potential seasonally shallow groundwater areas.
