**SOILS AND GEOLOGY STUDY
FLYING HORSE NORTH FILING NO. 3
EL PASO COUNTY, COLORADO**

August 23, 2023
Revised March 5, 2024

PCD No. SF2326

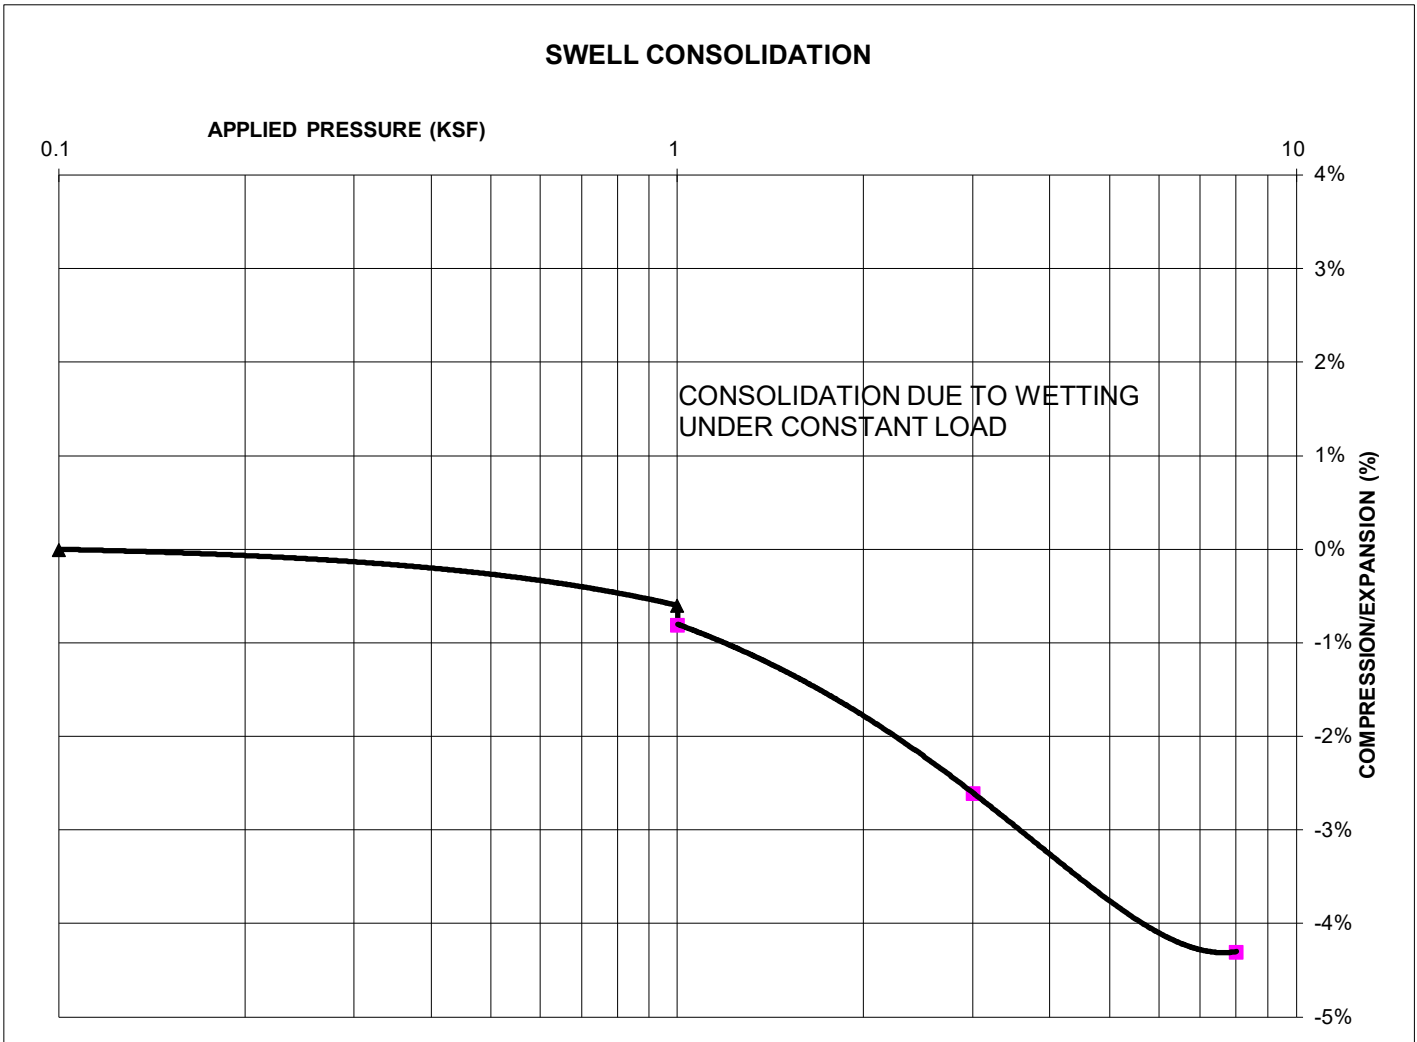
TEST BORING 2
DEPTH (FT) 5

SOIL DESCRIPTION CLAY, SANDY
SOIL TYPE 2

SWELL/CONSOLIDATION TEST RESULTS

NATURAL UNIT DRY WEIGHT (PCF): 115
NATURAL MOISTURE CONTENT: 7.8%
SWELL/CONSOLIDATION (%): -0.2%
