ENTECH
ENGINEERING, INC.

Re: Soils and Geology Study
Misfit Crew Estates
5775 Mountain Shadow View
Parcel No. 61240-00-013
El Paso County, Colorado
Entech Job No. 240944

The project consists of subdividing approximately 36 acres. Three rural residential lots are proposed. Existing houses and structures on Lot 1 will remain, with two new lots proposed. The site is located southeast of the intersection of northwest of Hodgen Road and Thompson Road, in northern El Paso County, Colorado.

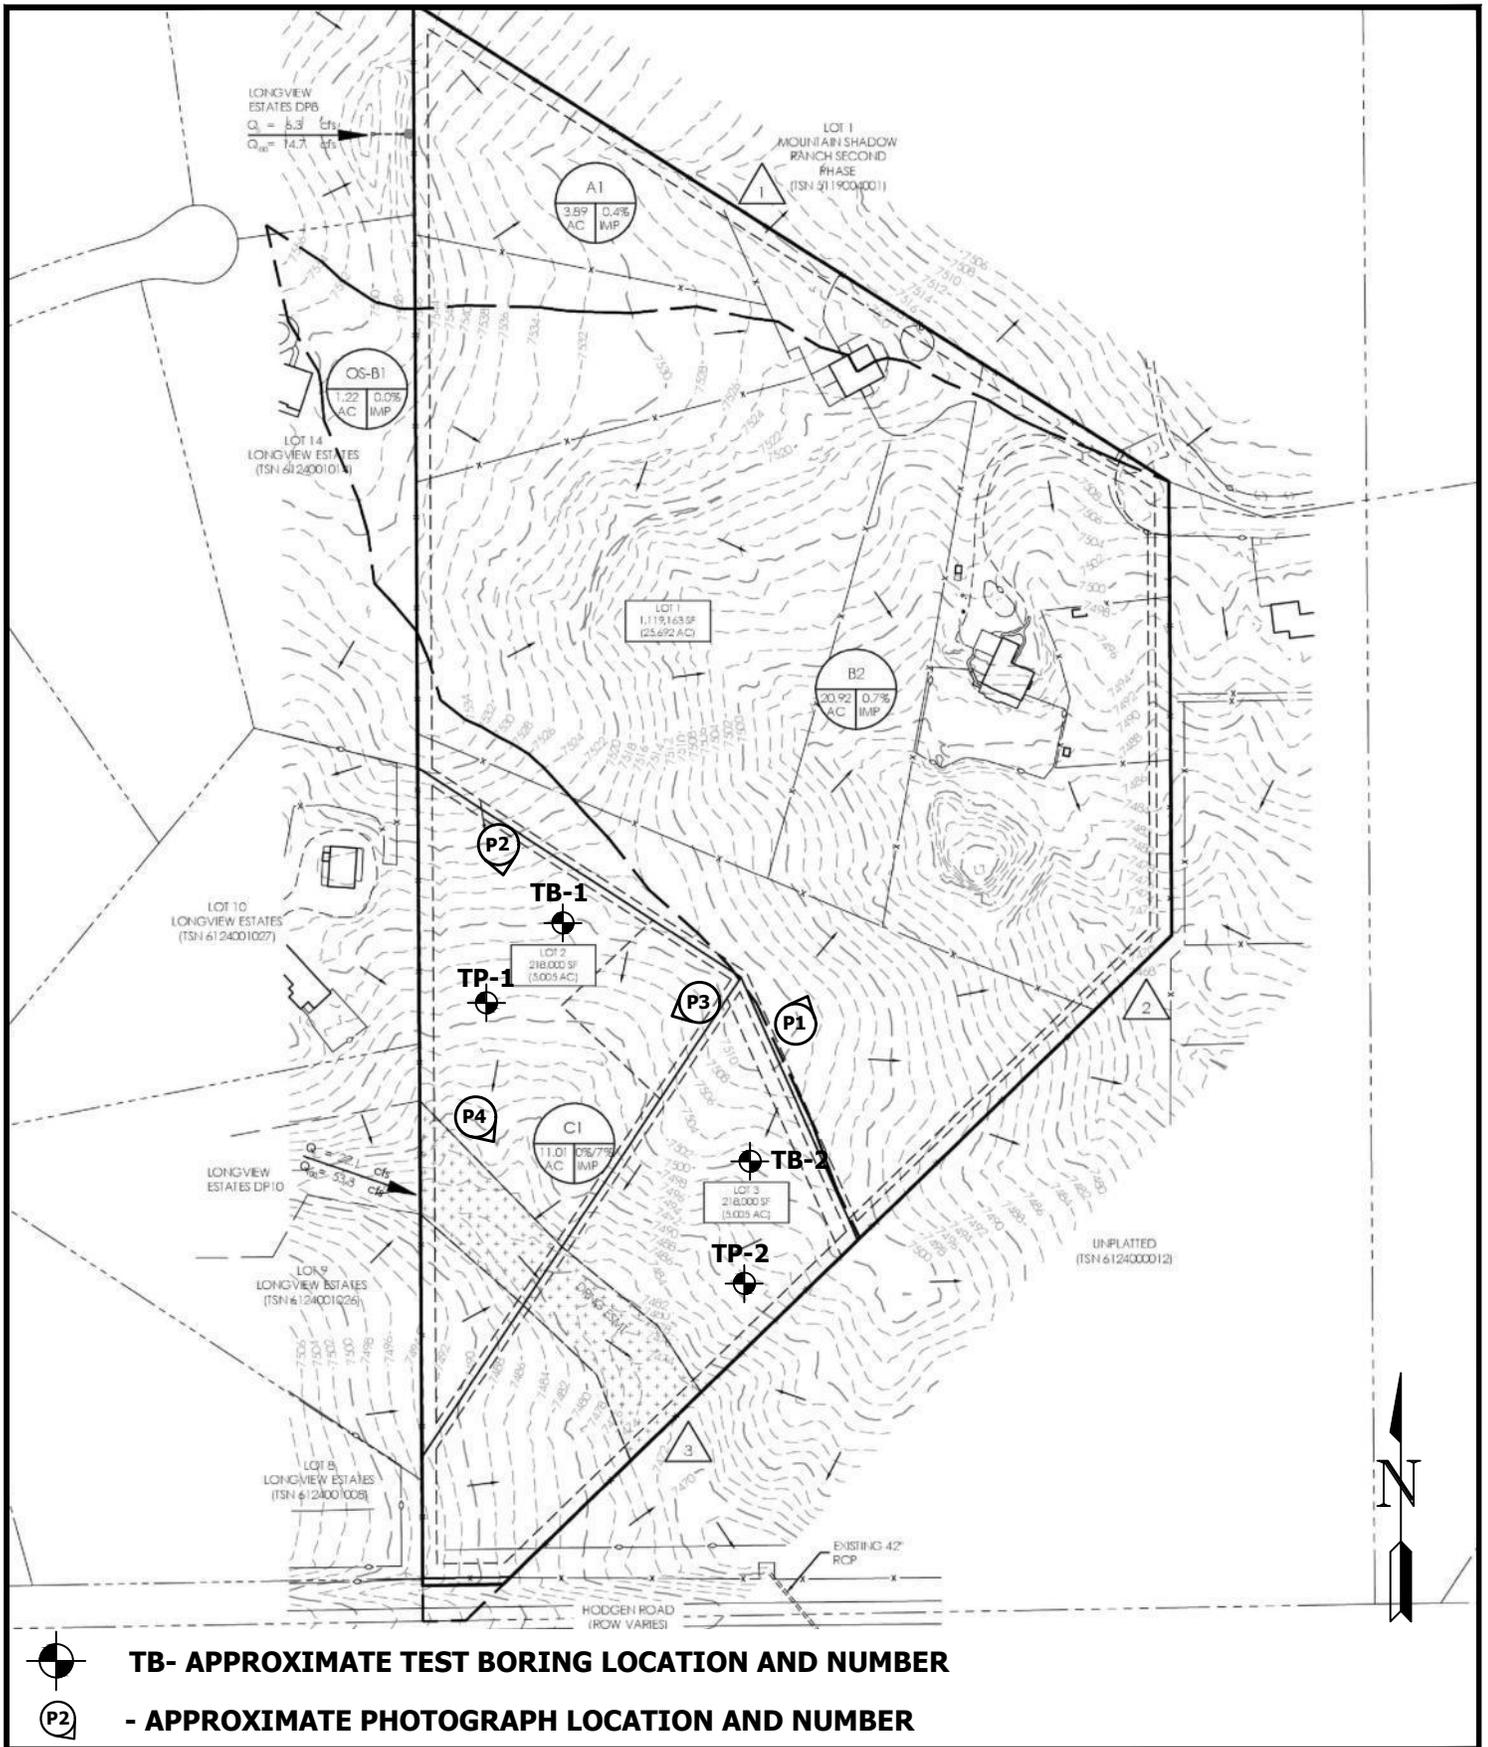
FIG. 3

TB- APPROXIMATE TEST BORING LOCATION AND NUMBER

Total acreage involved in the proposed subdivision is approximately 36 acres. Three rural residential lots are proposed as part of the replat. The proposed lot sizes range from approximately 5 to 25 acres. The existing residence and outbuildings will remain on Lot 1. The two new lots will be serviced by individual wells and on-site wastewater treatment systems. Existing septic records for the residence on Lot 1 are included with this report. The Site and Exploration Plan with the proposed replat is presented in Figure 3.

Two test borings were drilled to determine general soil conditions and two test pits were excavated to determine the general suitability for the use of on-site wastewater treatment systems. The location of the test borings and test pits are indicated on the Site Plan/Test Pit Location Map, Figure 3. The Test Boring and Test Pit Logs are presented in Appendix B. Results of this testing will be discussed later in this report.

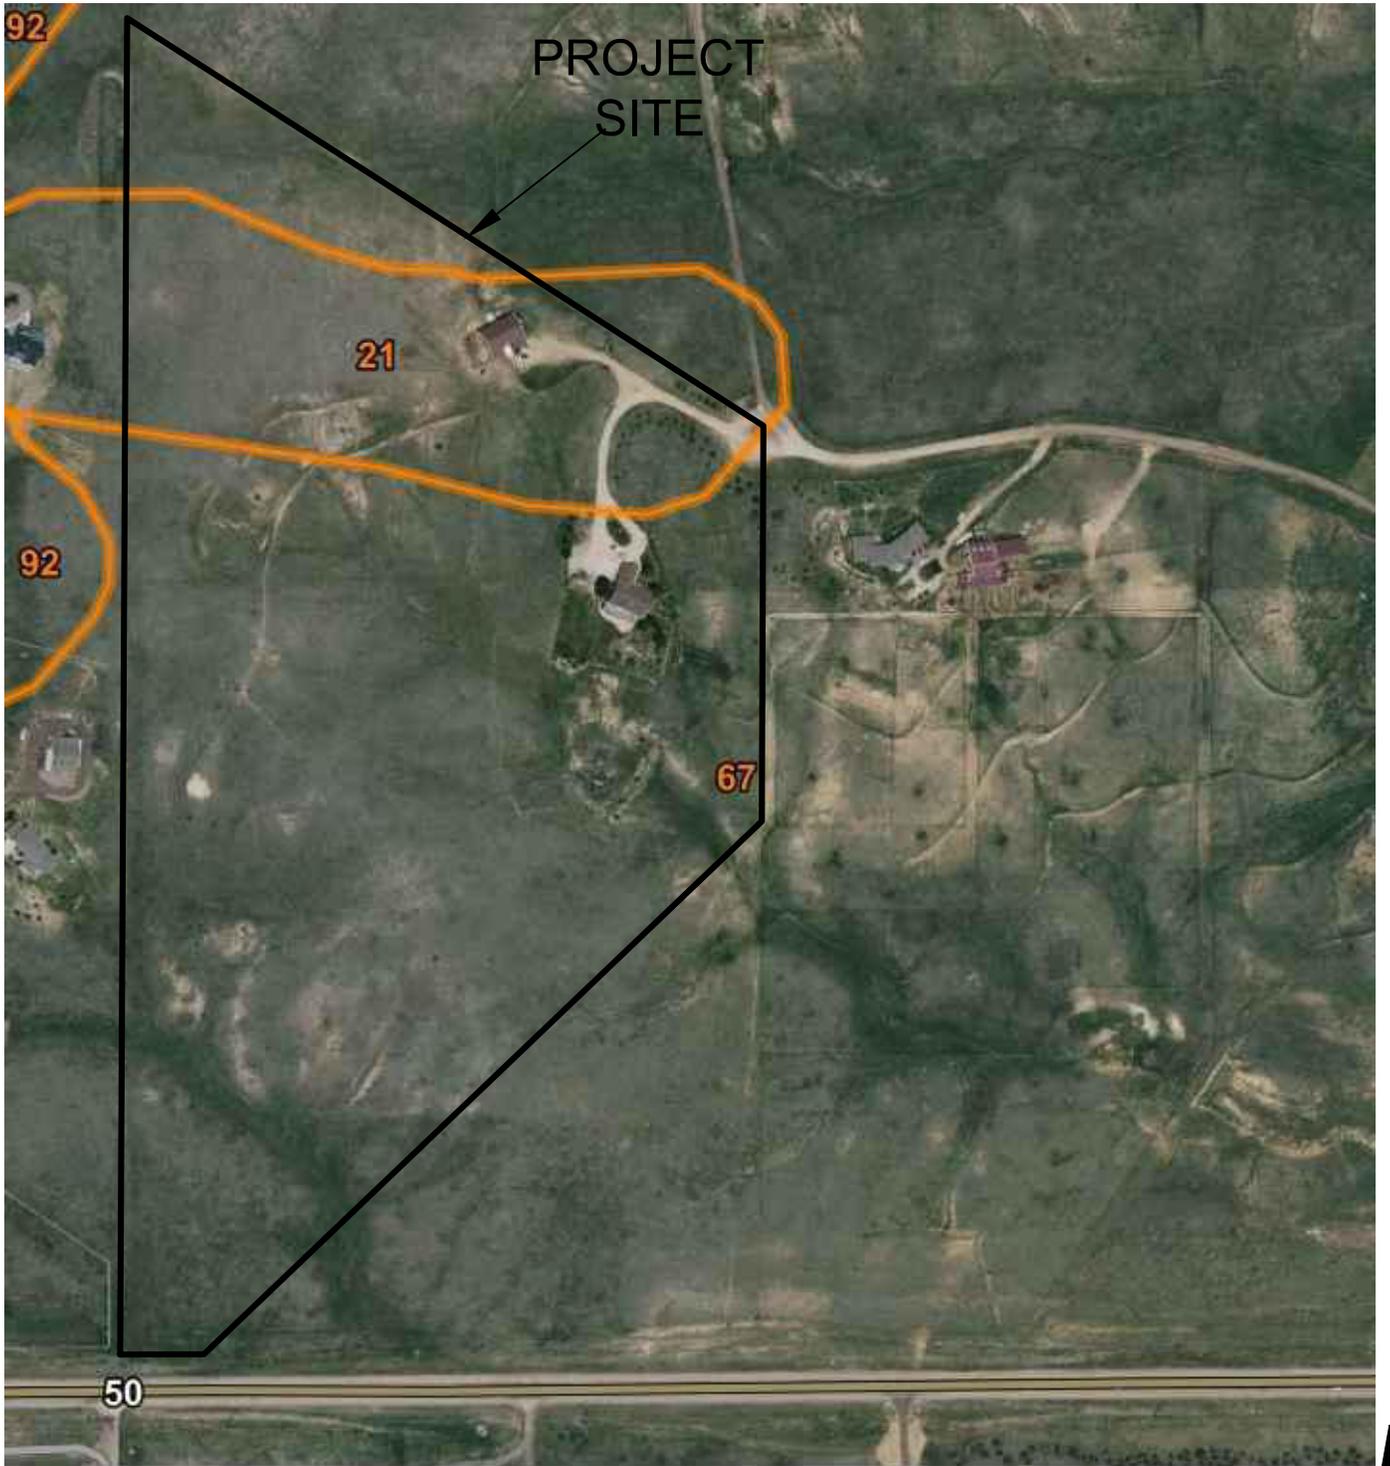
FIG. 4

SOIL SURVEY MAP

The Natural Resource Conservation Service (NRCS) (Reference 1, Figure 4), previously the Soil Conservation Service (Reference 2) has mapped two soil types on the site. Complete descriptions of the soil types are presented in Appendix D. In general, the soils consist of sandy loam to gravelly loamy sand. The soils are described as follows:

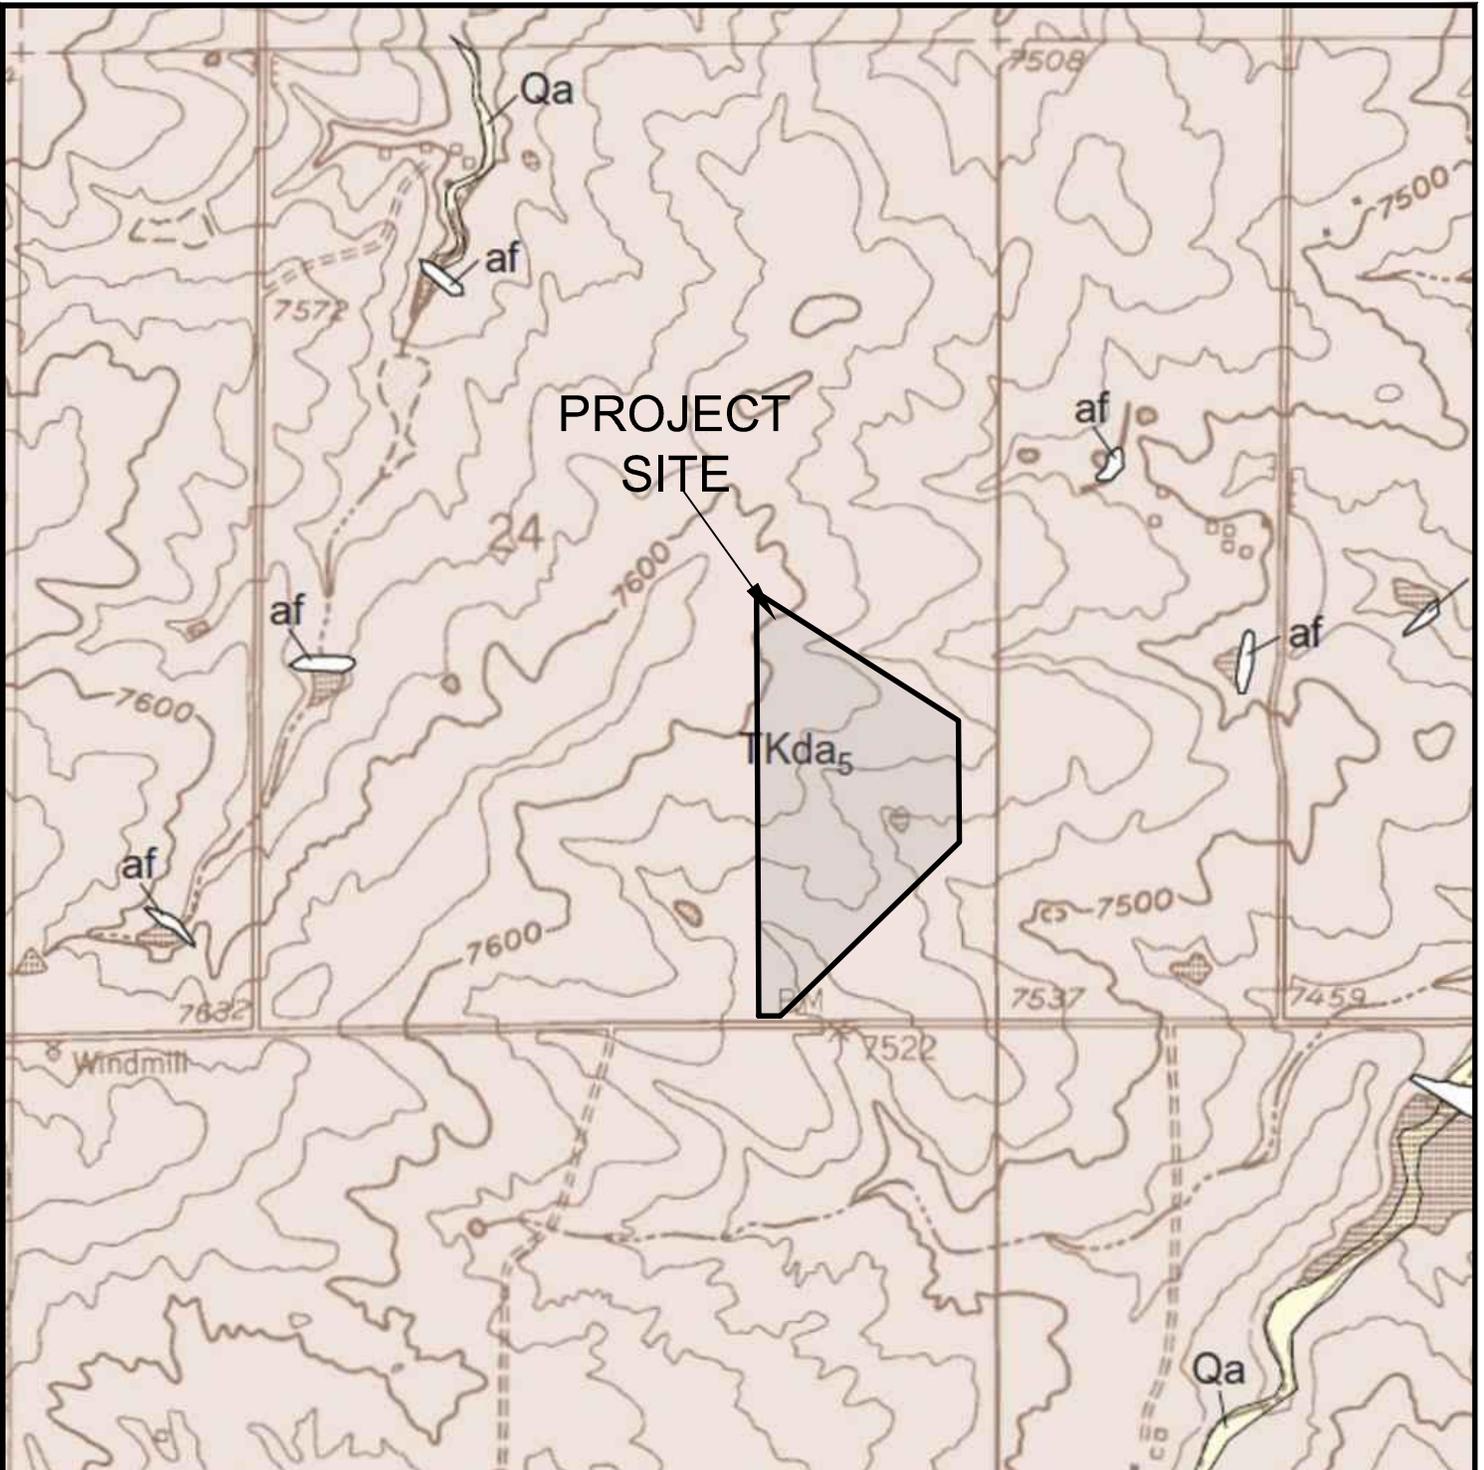
FIG. 5

**GEOLOGIC MAP OF THE
BLACK FOREST QUADRANGLE**
5775 MOUNTAIN SHADOW VIEW
MARK MCDONALD

The geology of the site was evaluated using the *Geologic Map of the Black Forest Quadrangle*, by Thorson in 2003, (Reference 4, Figure 5). The Geology Map for the site is presented in Figure 6. Two mappable units were identified on this site which is described as follows:

The soils listed above were mapped from site-specific mapping, the *Geologic Map of the Black Forest Quadrangle* distributed by the Colorado Geologic Survey in 2003 (Reference 4, Figure 5), The *Geologic Map of the Colorado Springs-Castle Rock Area*, distributed by the US Geological Survey in 1979 (Reference 5), and the *Geologic Map of the Pueblo 1° x 2° Quadrangle*, distributed by the US Geological Survey in 1978 (Reference 6). The test borings and test pits were also used in evaluating the site and are included in Appendix B. The Geology Map prepared for the site is presented in Figure 6.

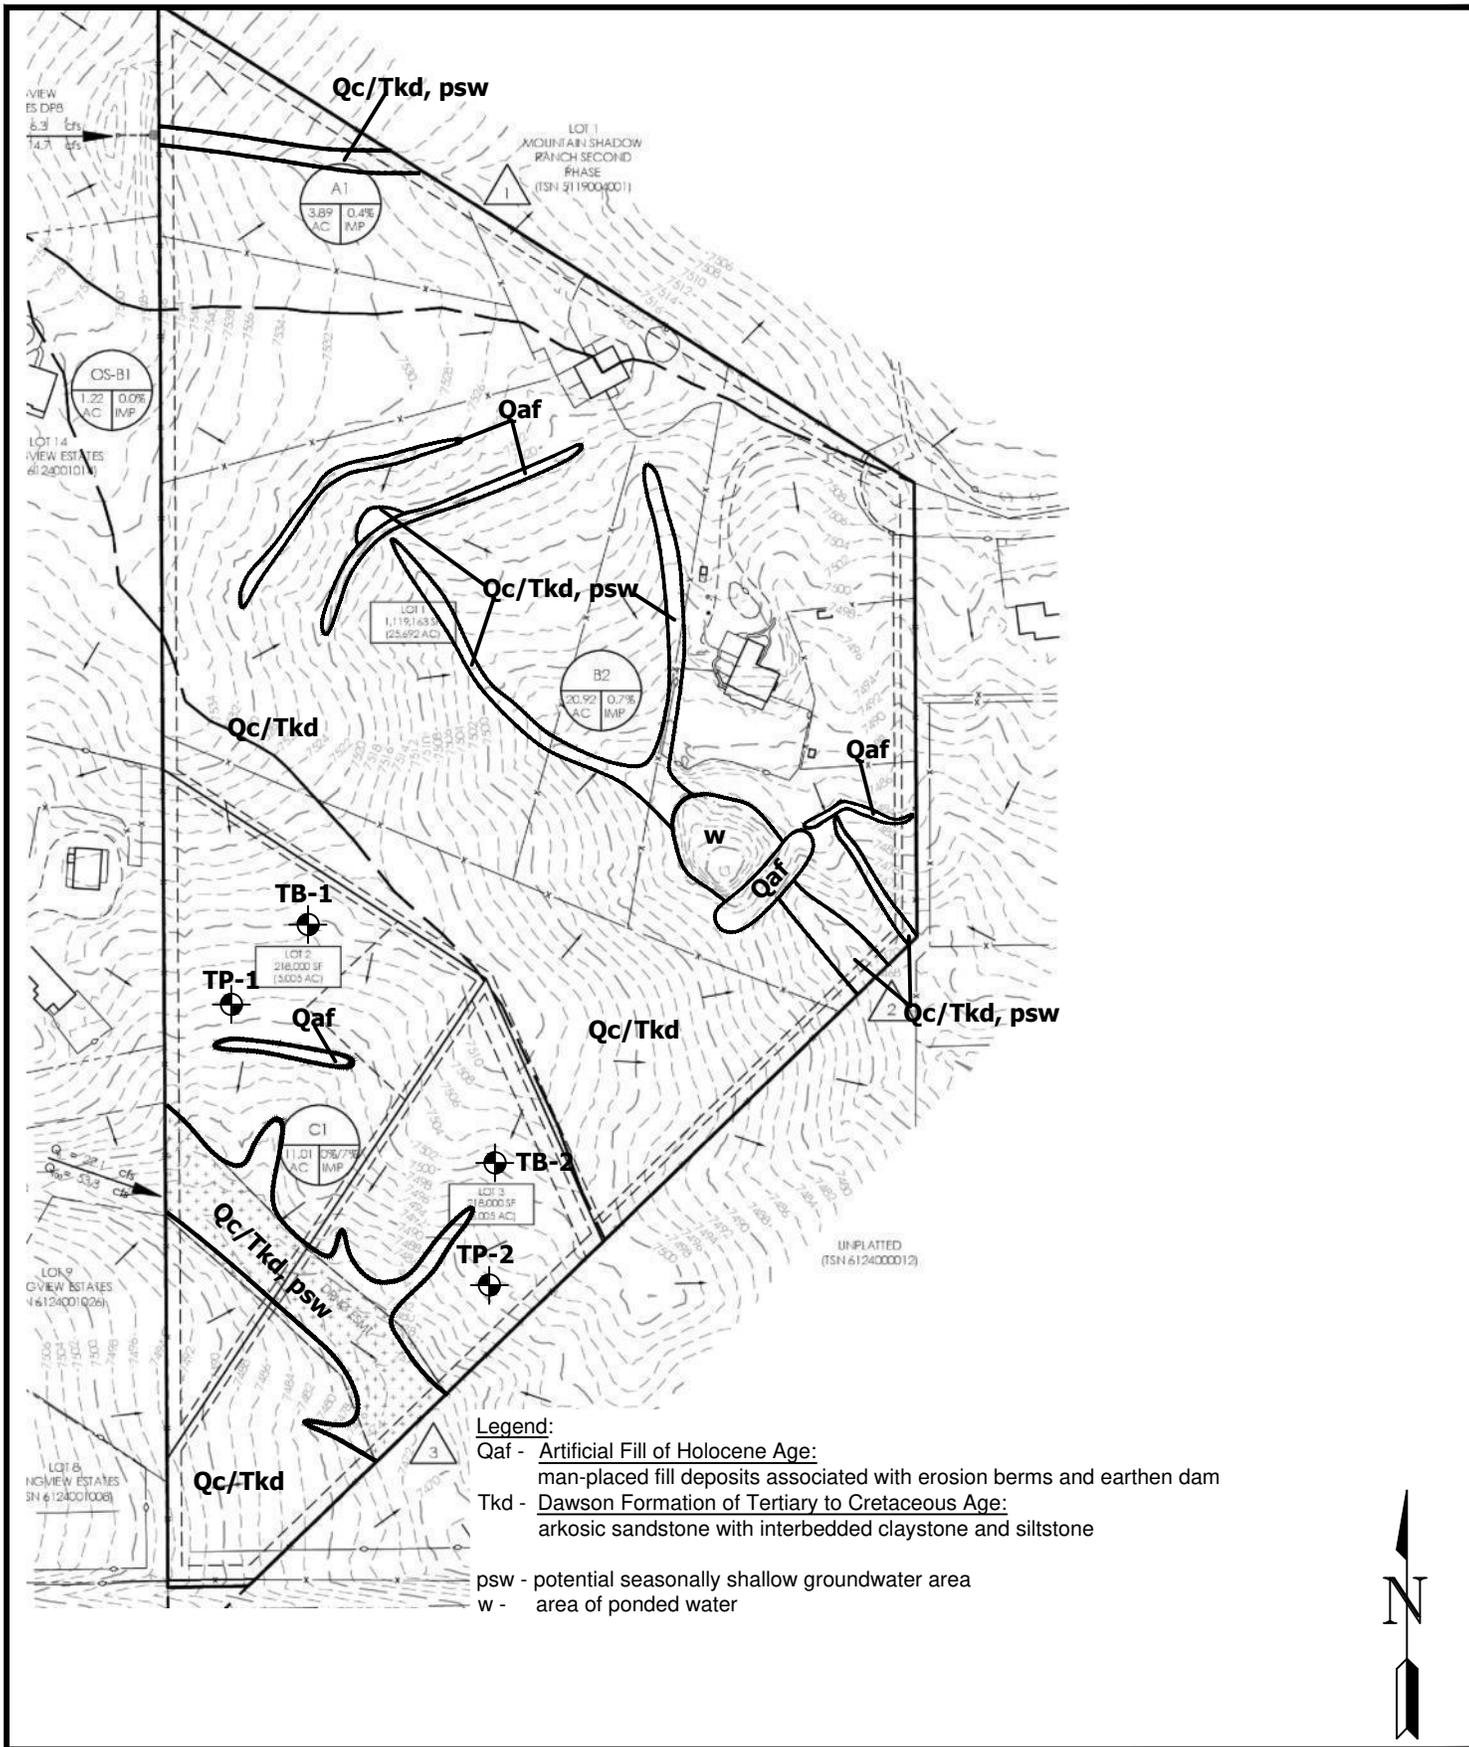
FIG. 6

GEOLOGY/ENGINEERING GEOLOGY MAP

A drainage is located in the southern portion of the site within proposed Lots 2 and 3, and several minor drainage swales and a pond are located on Lot 1. The pond seasonally contains water. Water was not observed flowing in any of the drainages the time of this investigation. This area is indicated in the Geology/Engineering Geology Map (Figure 6) and are discussed below. The drainage on Lots 2 and 3 is within a drainage easement no-build area. The site does not lie within any floodplain zones according to the FEMA Map No. 08041CO305G dated December 7, 2018 (Figure 7, Reference 7). Exact locations of floodplain and specific drainage studies are beyond the scope of this report.

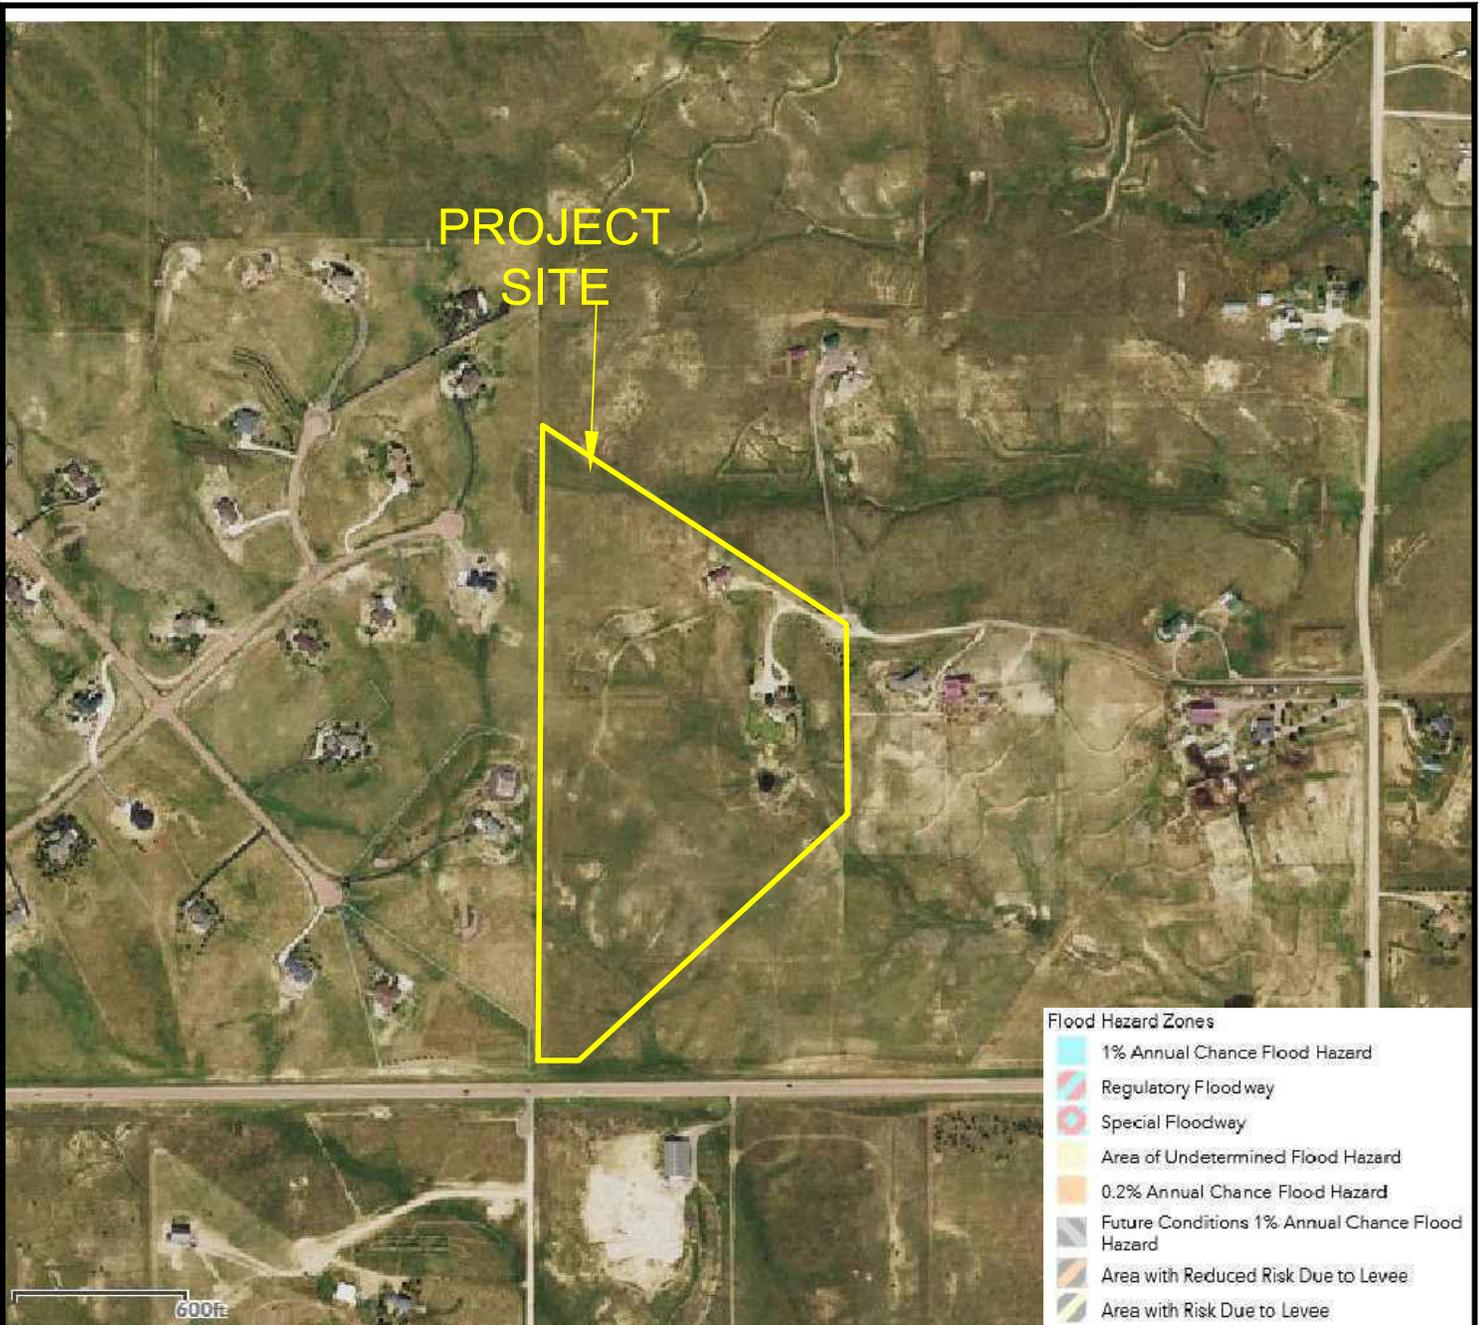
FIG. 7

FEMA FLOODPLAIN MAP

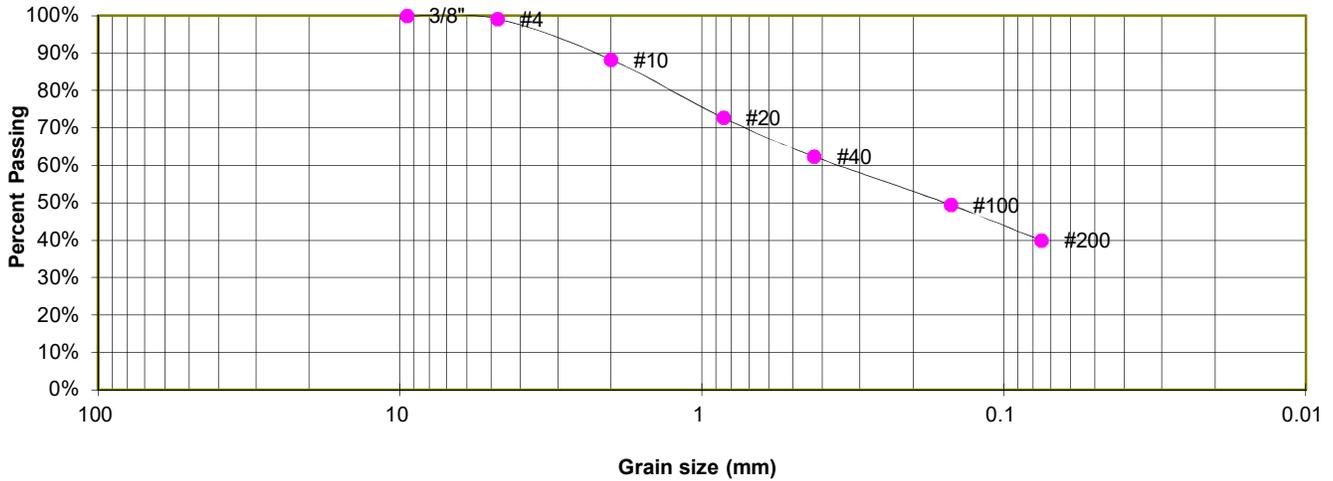
SOIL DESCRIPTION SAND, CLAYEY

**Sieve Analysis
 Grain Size Distribution**

GRAIN SIZE ANALYSIS

U.S. Sieve #	Percent Finer
3"	
1 1/2"	
3/4"	
1/2"	
3/8"	100.0%
4	99.2%
10	88.3%
20	72.7%
40	62.4%
100	49.5%
200	39.9%

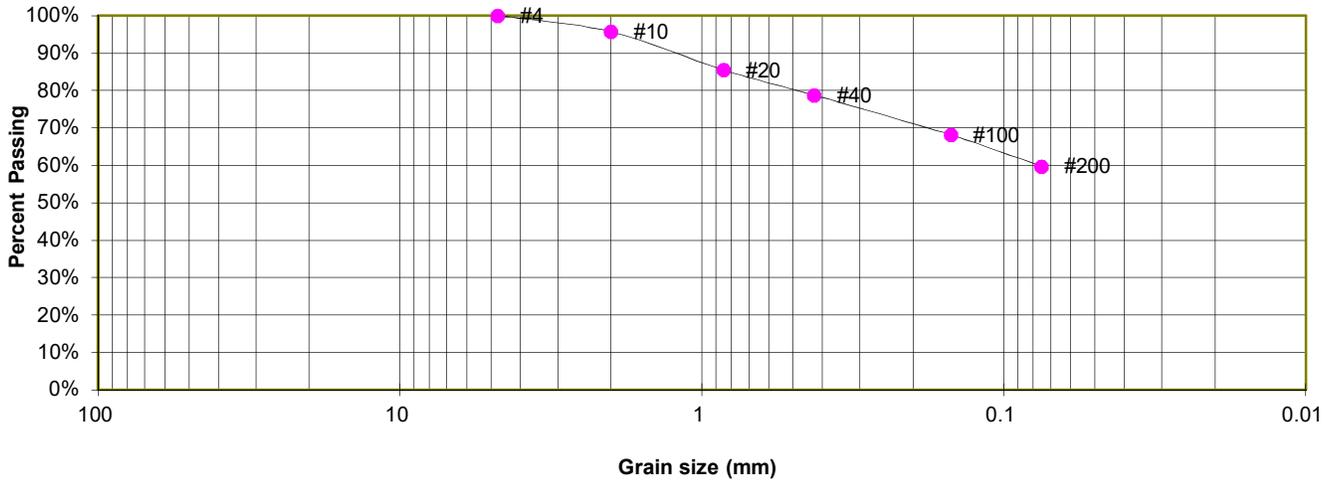
SOIL DESCRIPTION CLAYSTONE (CLAY, SANDY)

**Sieve Analysis
Grain Size Distribution**

GRAIN SIZE ANALYSIS

U.S. Sieve #	Percent Finer
3"	
1 1/2"	
3/4"	
1/2"	
3/8"	
4	100.0%
10	95.8%
20	85.5%
40	78.8%
100	68.2%
200	59.8%

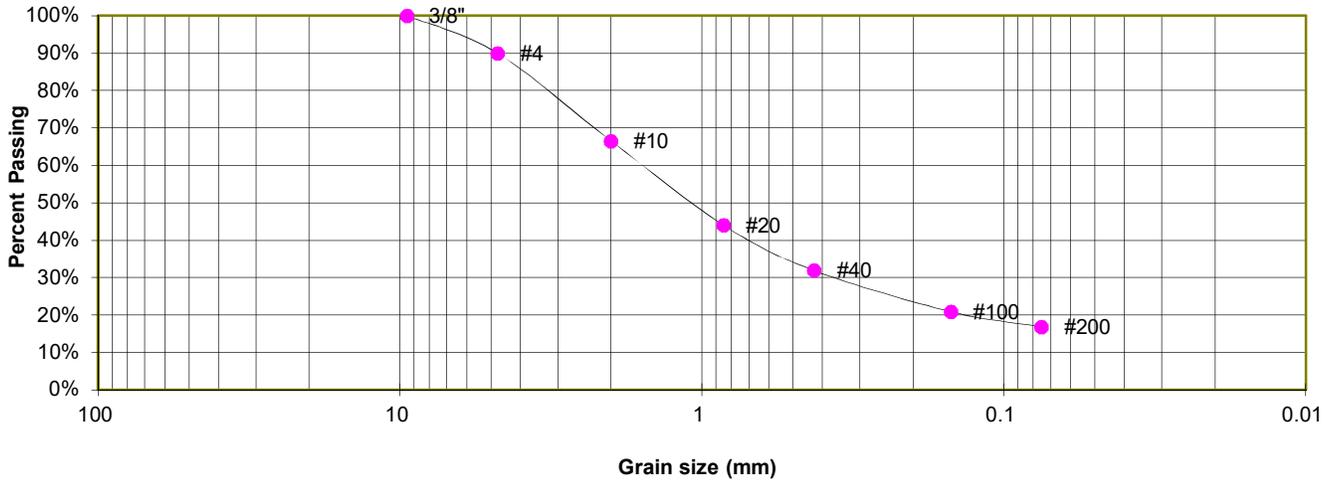
SOIL DESCRIPTION SAND, SILTY, GRAVELLY

Sieve Analysis Grain Size Distribution

GRAIN SIZE ANALYSIS

U.S. Sieve #	Percent Finer
3"	
1 1/2"	
3/4"	
1/2"	
3/8"	100.0%
4	89.9%
10	66.5%
20	44.1%
40	31.9%
100	21.0%
200	16.8%

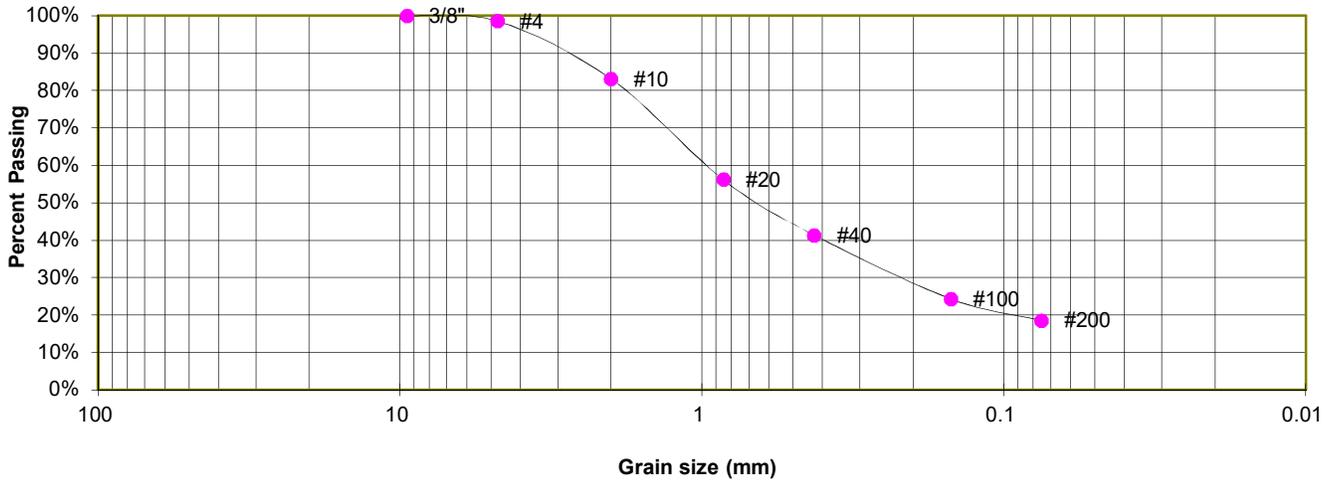
SOIL DESCRIPTION SANDSTONE (SAND, SILTY)

Sieve Analysis Grain Size Distribution

GRAIN SIZE ANALYSIS

U.S. Sieve #	Percent Finer
3"	
1 1/2"	
3/4"	
1/2"	
3/8"	100.0%
4	98.6%
10	83.1%
20	56.2%
40	41.4%
100	24.3%
200	18.6%

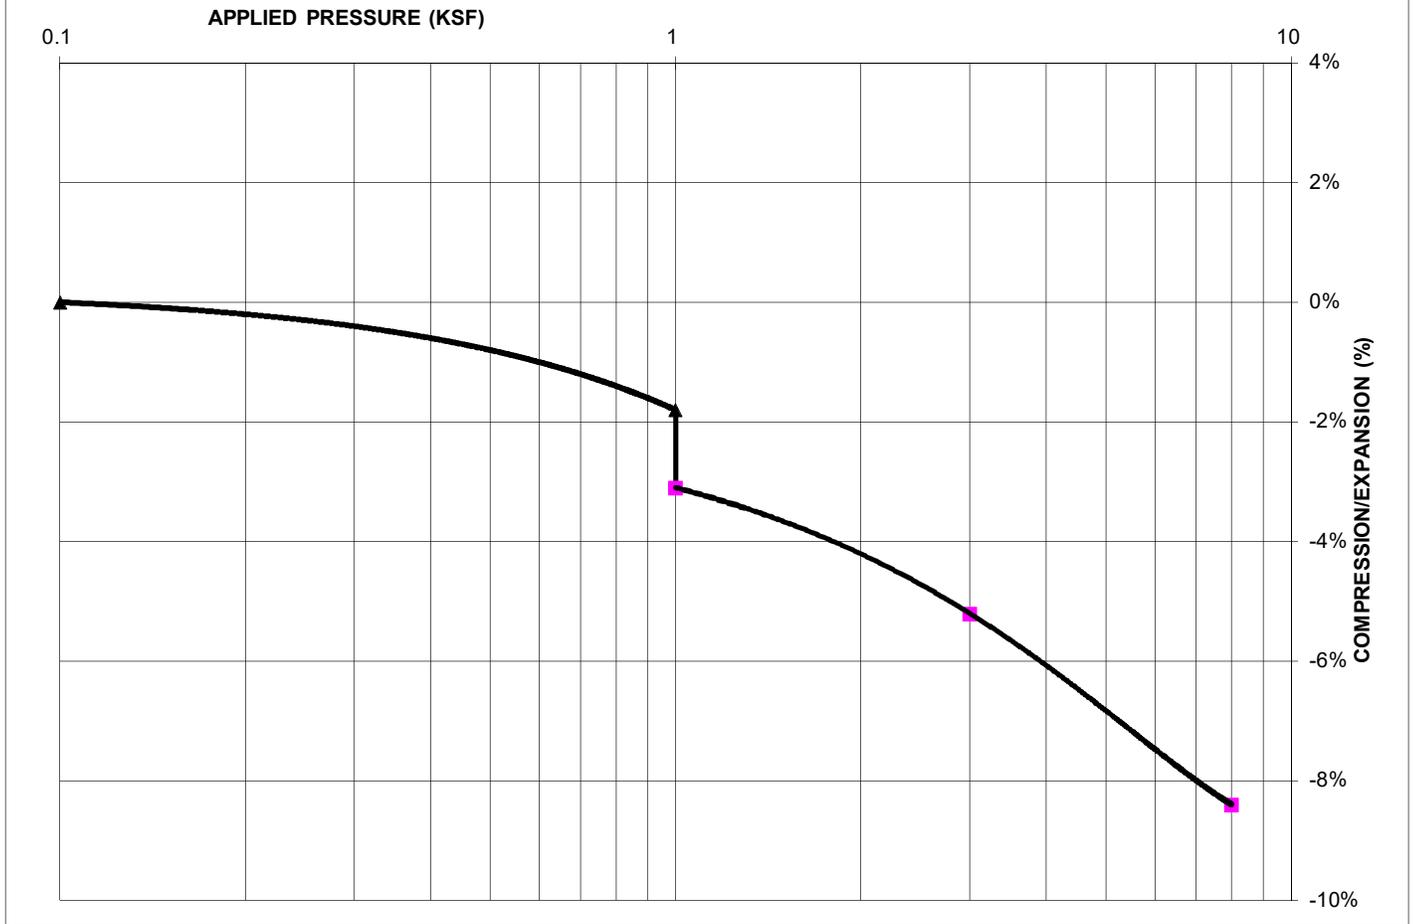
SOIL DESCRIPTION CLAYSTONE (CLAY, SANDY)

SWELL CONSOLIDATION

SWELL/COLLAPSE TEST RESULTS

NATURAL UNIT DRY WEIGHT (PCF): 119
NATURAL MOISTURE CONTENT: 10.5%
SWELL/COLLAPSE (%): -1.3%

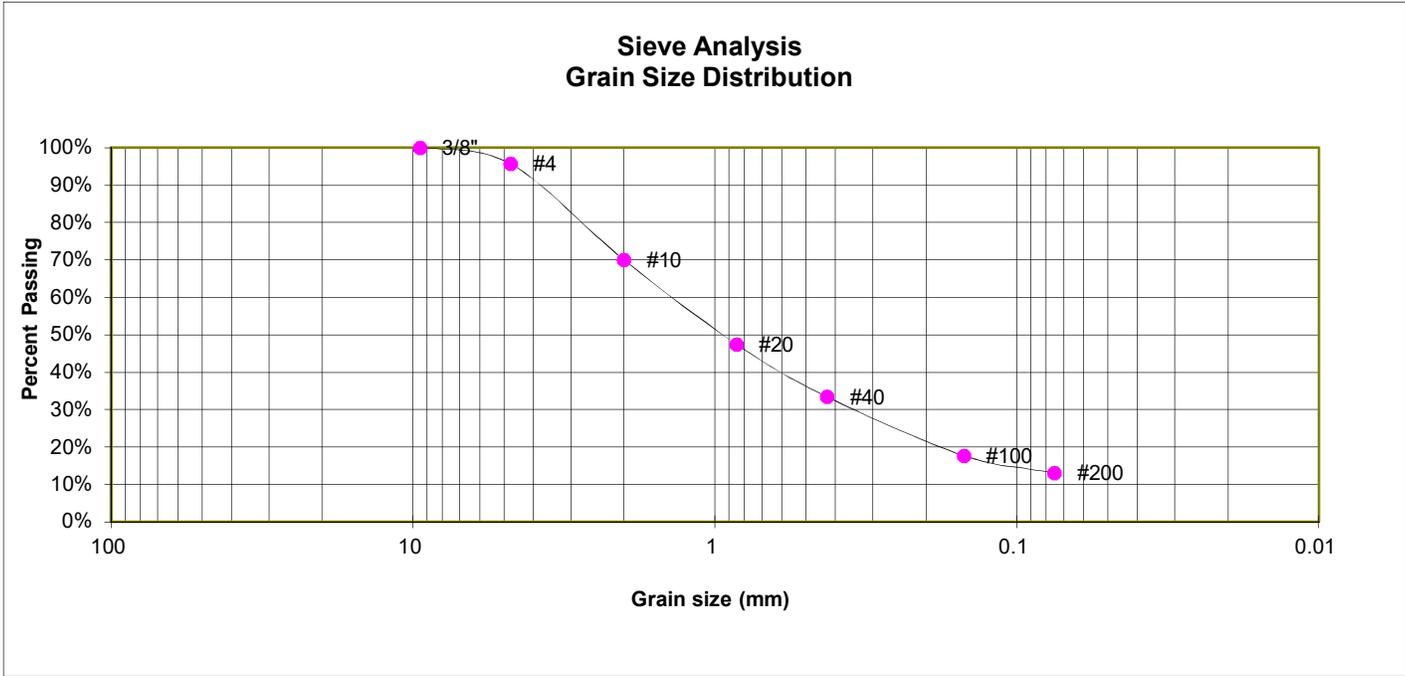
TEST PIT	TP-1	SOIL DESCRIPTION SCL
DEPTH (FT)	3

GRAIN SIZE ANALYSIS

U.S. Sieve #	Percent Finer
3"	
1 1/2"	
3/4"	
1/2"	
3/8"	100.0%
4	95.7%
10	70.0%
20	47.5%
40	33.4%
100	17.7%
200	13.1%

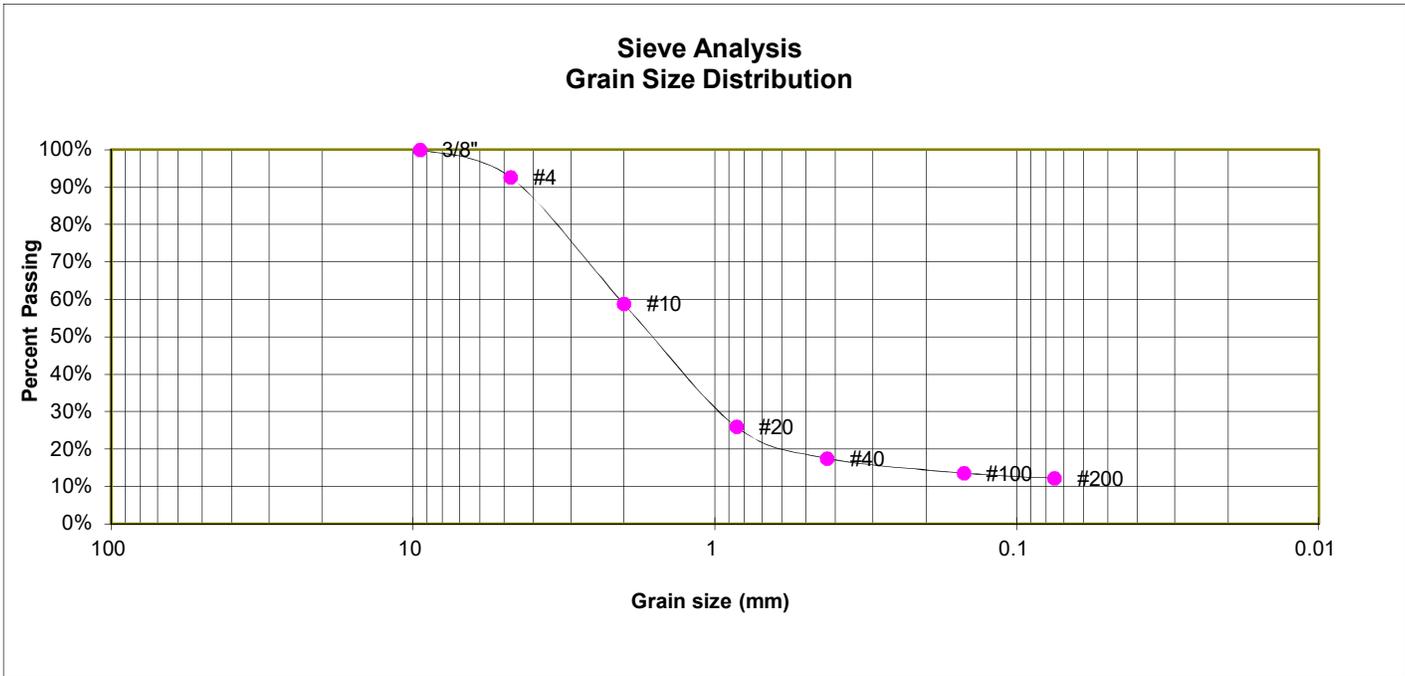
TEST PIT	TP-2	SOIL DESCRIPTION	SC
DEPTH (FT)	6

GRAIN SIZE ANALYSIS

U.S. Sieve #	Percent Finer
3"	
1 1/2"	
3/4"	
1/2"	
3/8"	100.0%
4	92.6%
10	58.8%
20	26.0%
40	17.5%
100	13.6%
200	12.1%
