**ENTECH**  
ENGINEERING, INC.

Re: Wastewater Study  
Misfit Crew Estates  
5775 Mountain Shadow View  
El Paso County, Colorado  
Entech Job No. 240944

The project consists of subdividing approximately 36 acres. Three rural residential lots are proposed. Existing houses and structures on Lot 1 will remain, with two new lots proposed. The site is located southeast of the intersection of northwest of Hodgen Road and Thompson Road, in northern El Paso County, Colorado.

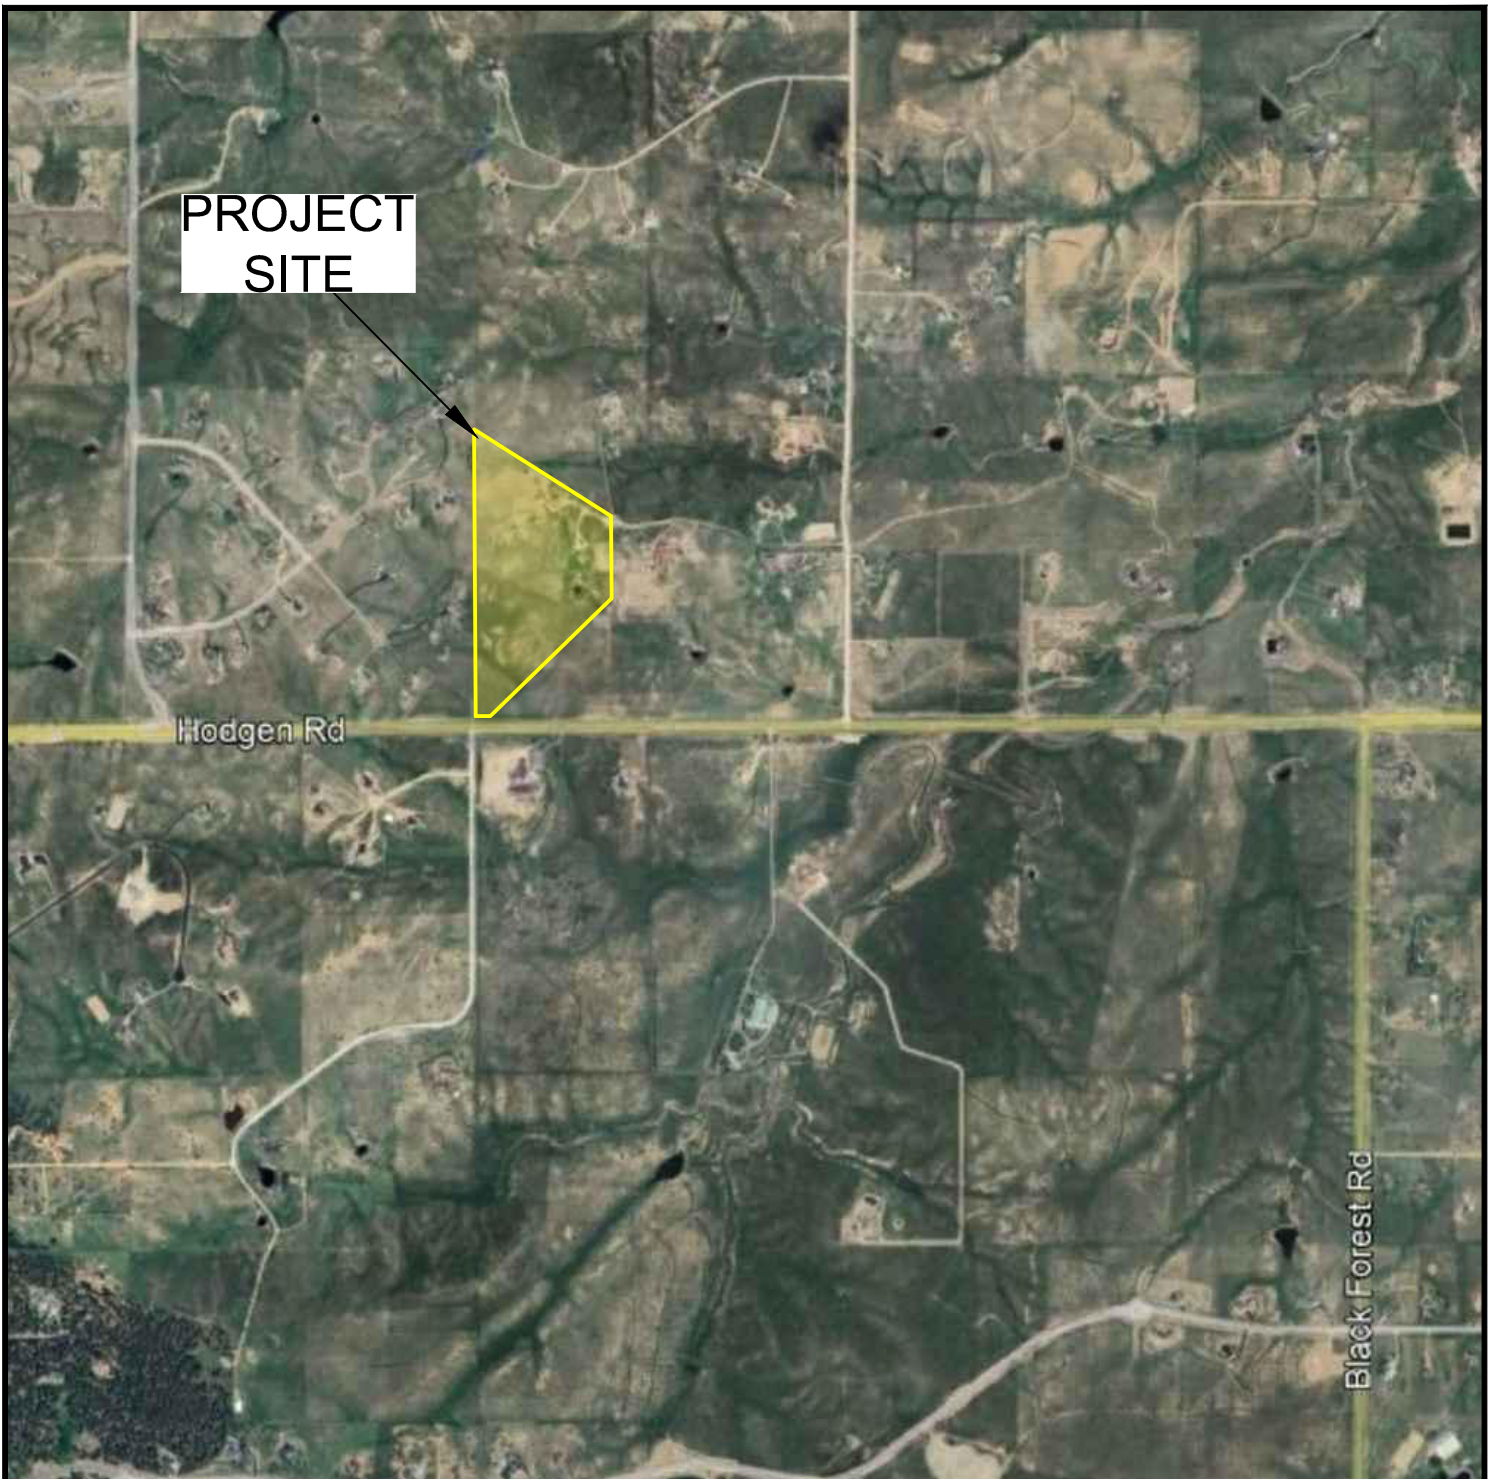
**FIG. 1**

## VICINITY MAP

The site is located in a portion of the SE¼ of Section 24, Township 11 South, Range 66 West of the 6<sup>th</sup> Principal Meridian in El Paso County, Colorado. The location of the site is as shown on the Vicinity Map, Figure 1.

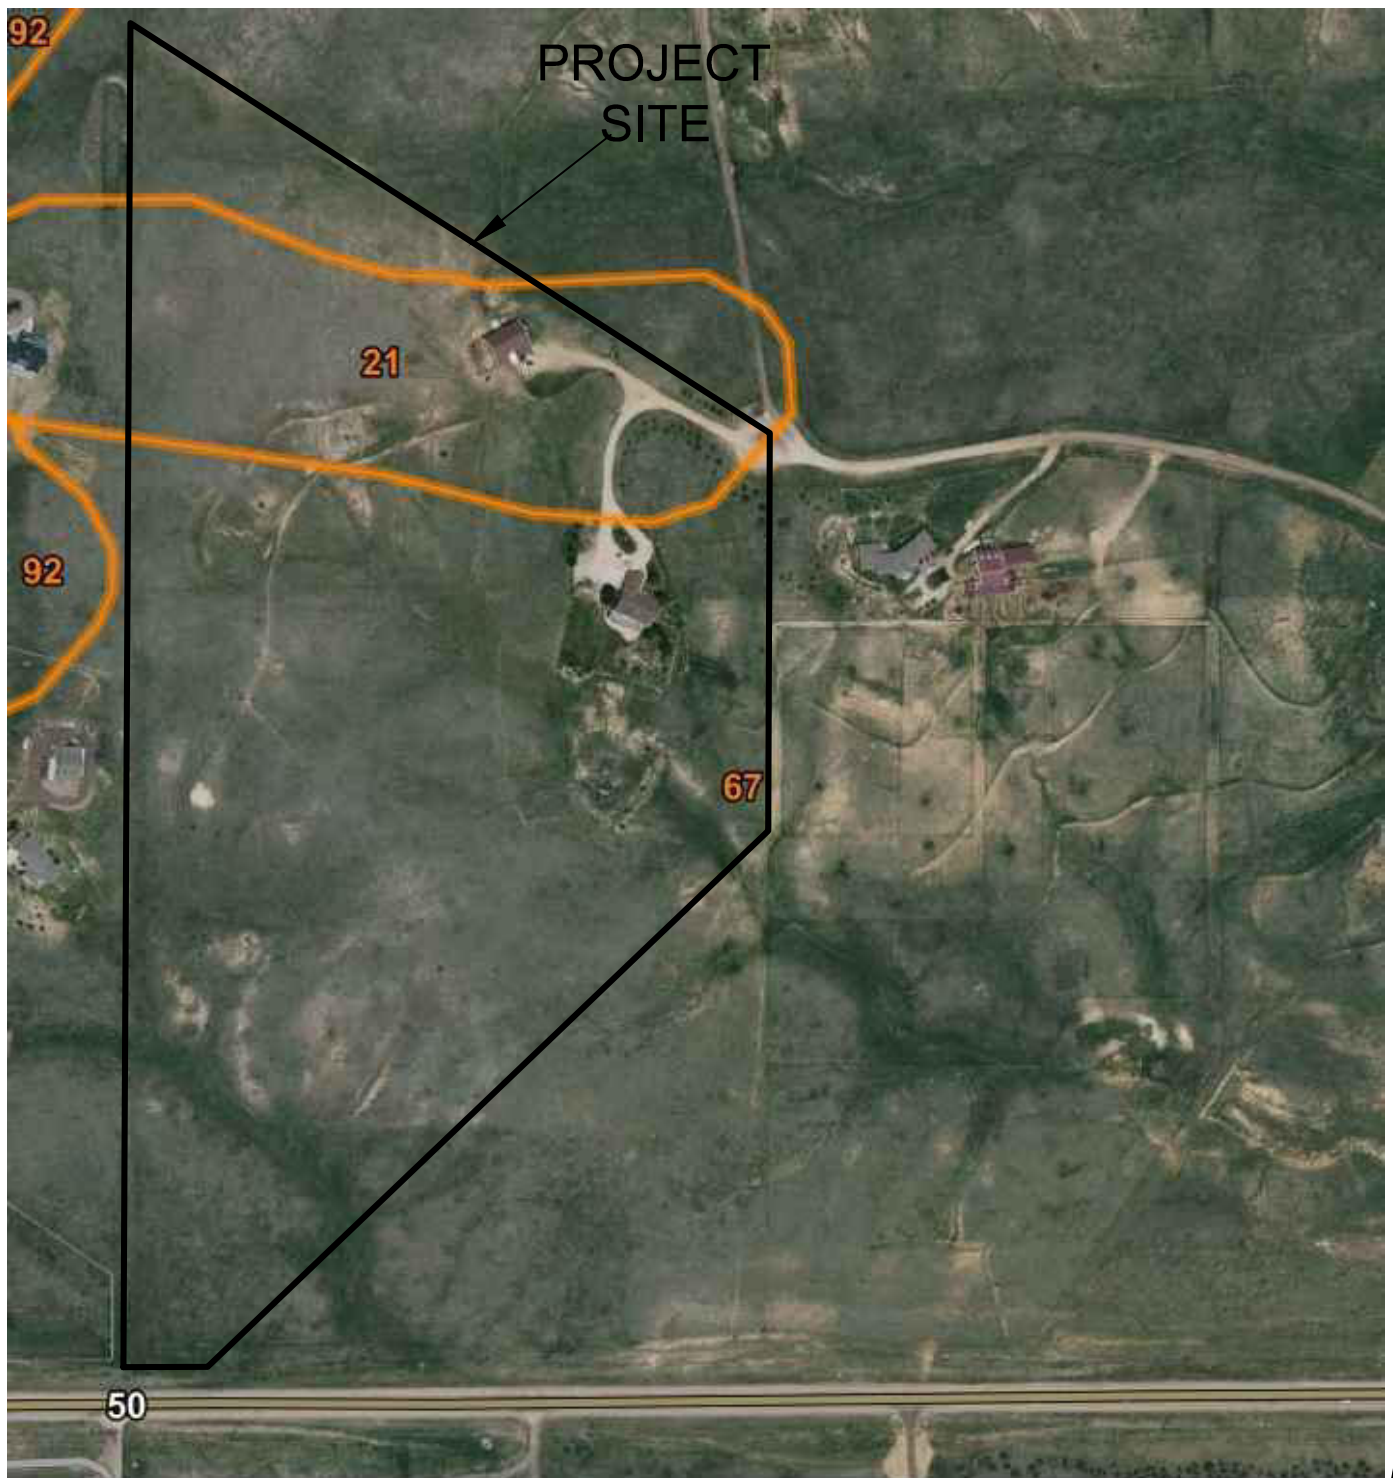
**FIG. 4**

## SOIL SURVEY MAP

The Natural Resource Conservation Service (NRCS) (Reference 1, Figure 4), previously the Soil Conservation Service (Reference 2) has mapped two soil types on the site. Complete descriptions of the soil types are presented in Appendix D. In general, the soils consist of sandy loam to gravelly loamy sand. The soils are described as follows:

The Natural Resource Conservation Service (Reference 1), previously the Soil Conservation Service (Reference 2) has been mapped with two soil descriptions. The Soil Survey Map (Reference 1) is presented in Figure 4, and the Soil Survey Descriptions (Reference 2) are presented in Appendix D. The soils are described as having moderate to rapid percolation rates. Records for the existing septic system located on Lot 1 are included in Appendix E.

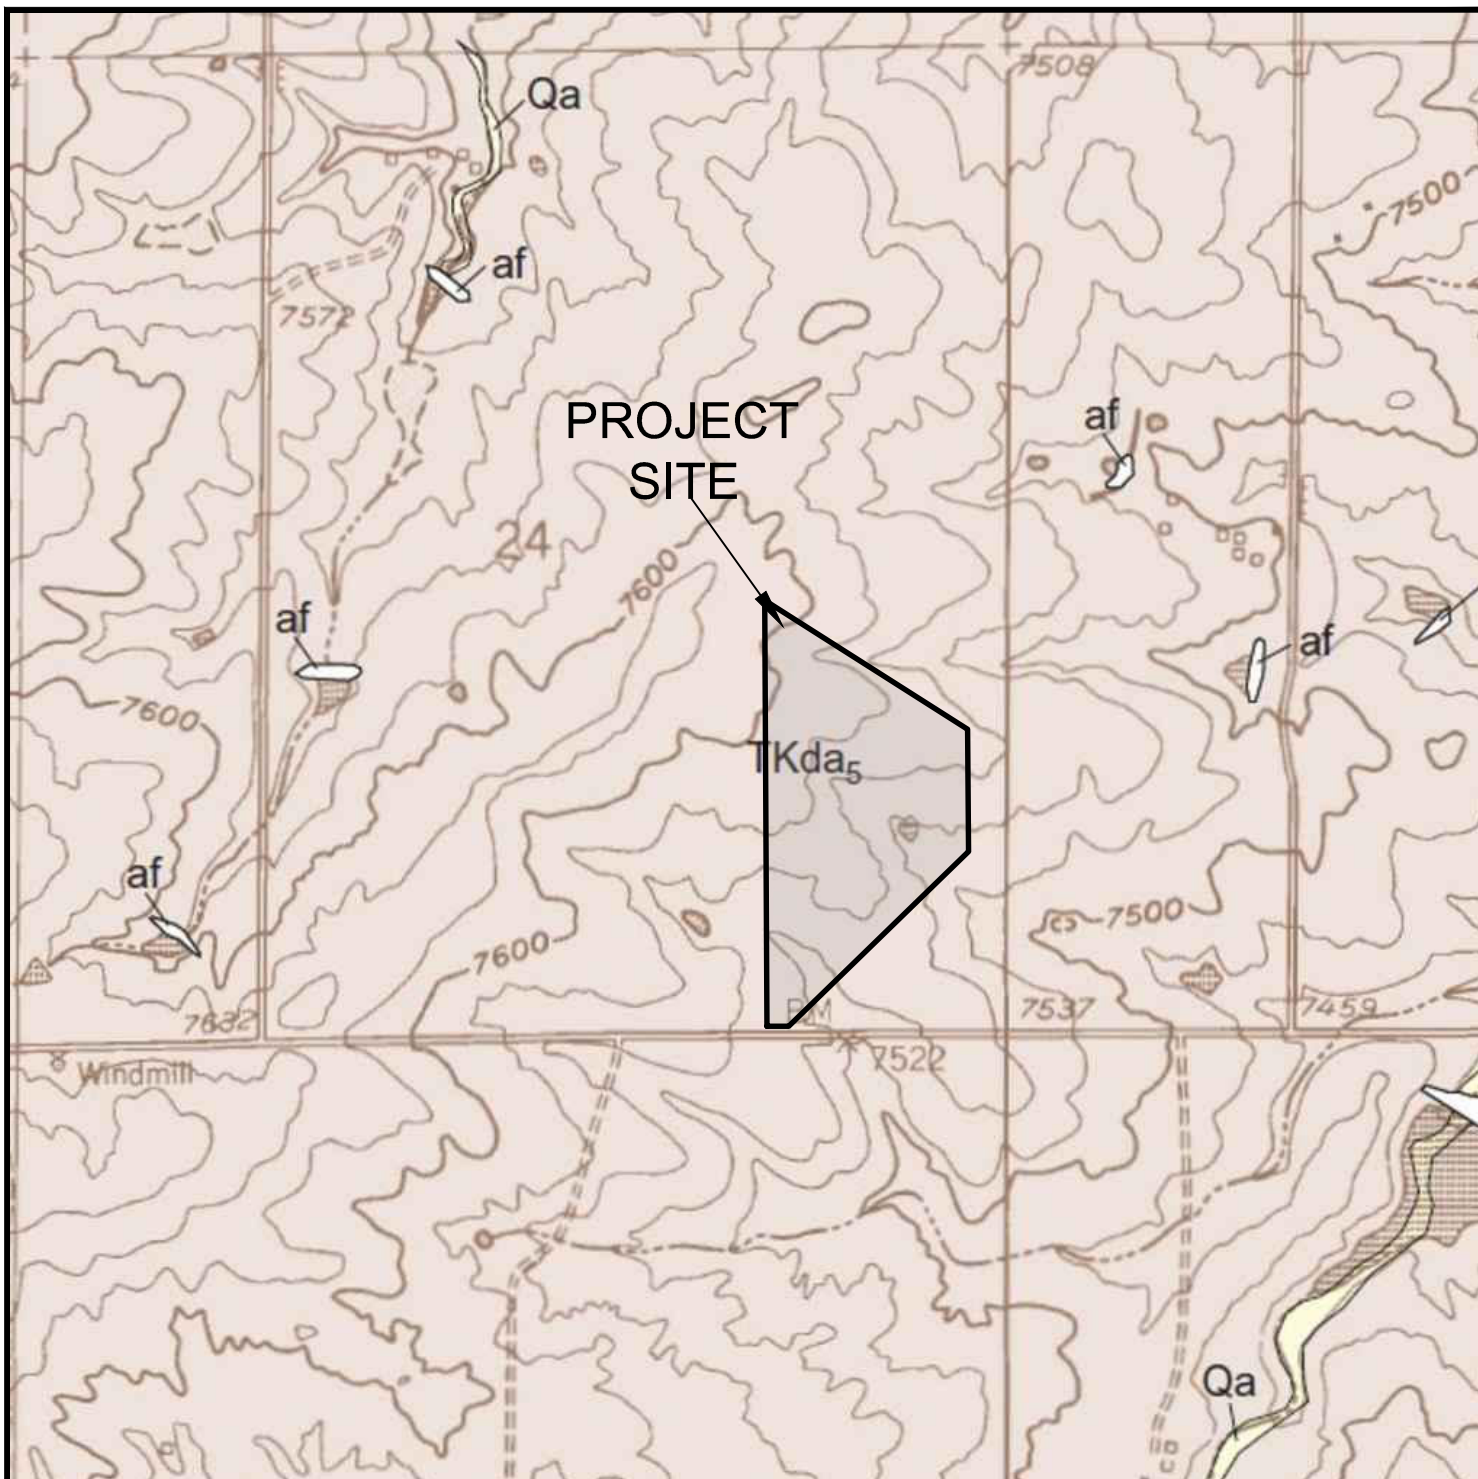
**FIG. 5**

**GEOLOGIC MAP OF THE  
BLACK FOREST QUADRANGLE**  
5775 MOUNTAIN SHADOW VIEW  
MARK McDONALD

The geology of the site was evaluated using the *Geologic Map of the Black Forest Quadrangle*, by Thorson in 2003, (Reference 4, Figure 5). The Geology Map for the site is presented in Figure 6. Two mappable units were identified on this site which is described as follows:

The soils listed above were mapped from site-specific mapping, the *Geologic Map of the Black Forest Quadrangle* distributed by the Colorado Geologic Survey in 2003 (Reference 4, Figure 5), The *Geologic Map of the Colorado Springs-Castle Rock Area*, distributed by the US Geological Survey in 1979 (Reference 5), and the *Geologic Map of the Pueblo 1° x 2° Quadrangle*, distributed by the US Geological Survey in 1978 (Reference 6). The test borings and test pits were used in evaluating the site and is included in Appendix B. The Geology Map prepared for the site is presented in Figure 6.

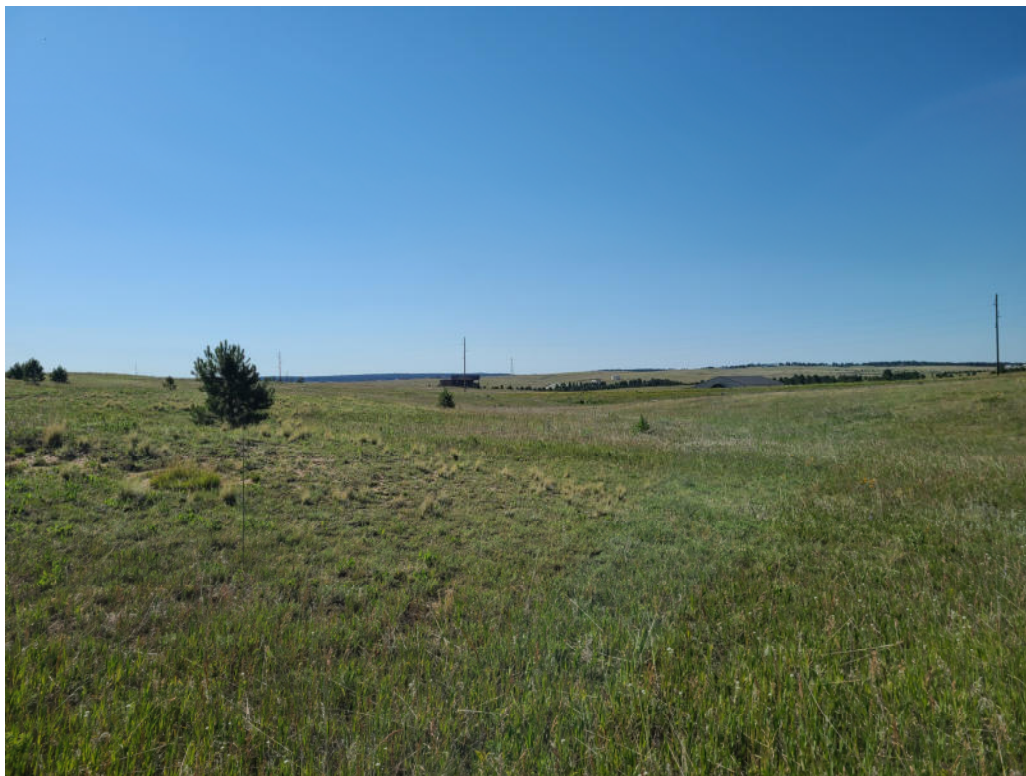
**Looking southeast  
along drainage  
easement.**

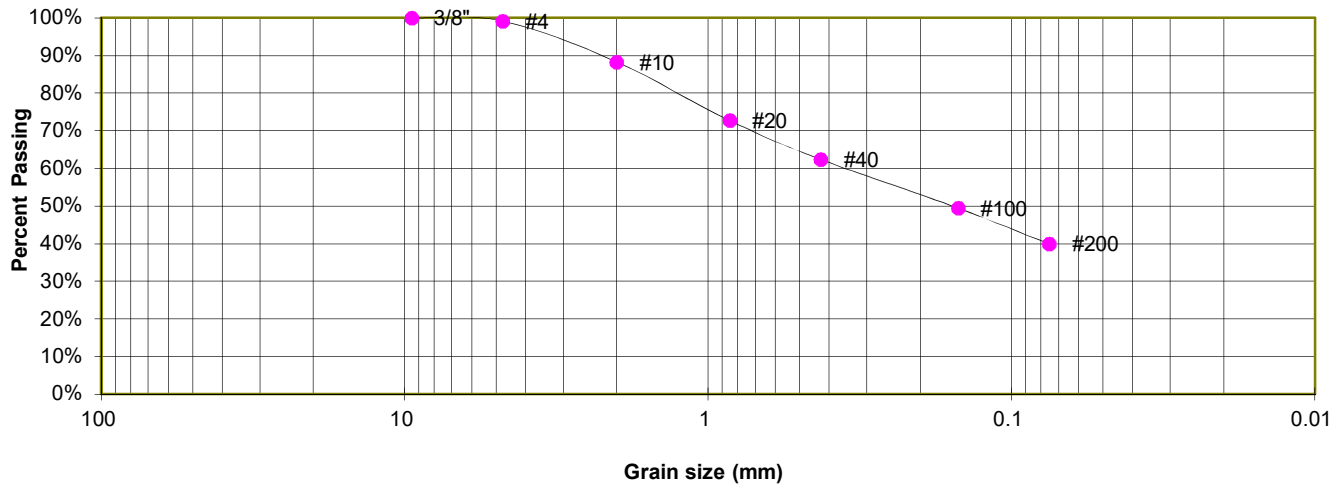
SOIL DESCRIPTION SAND, CLAYEY

### Sieve Analysis Grain Size Distribution

#### GRAIN SIZE ANALYSIS

U.S. Sieve #	Percent Finer
3"	
1 1/2"	
3/4"	
1/2"	
3/8"	100.0%
4	99.2%
10	88.3%
20	72.7%
40	62.4%
100	49.5%
200	39.9%

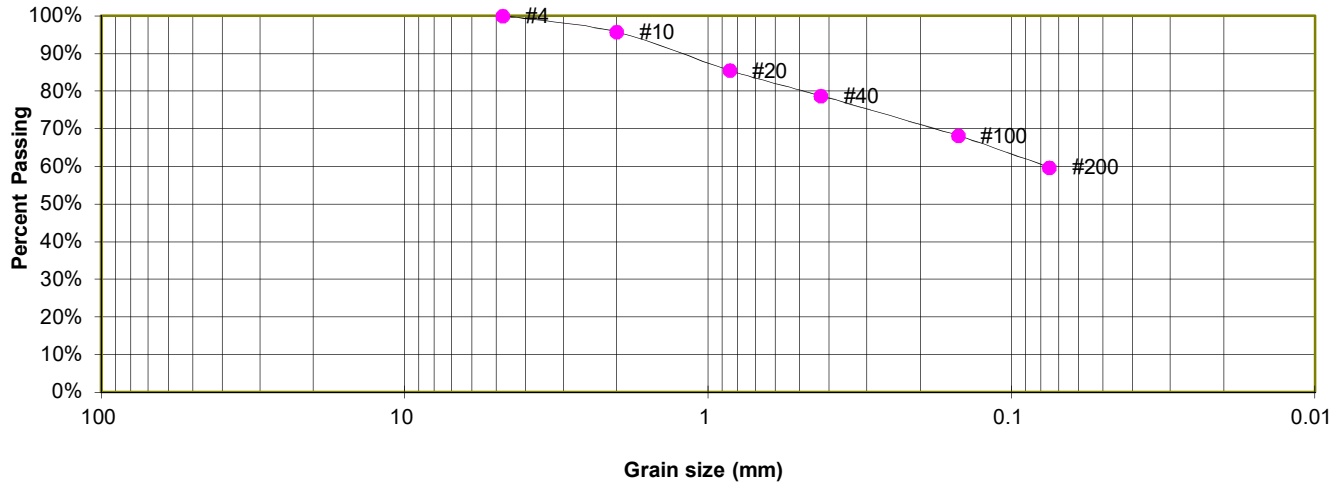
SOIL DESCRIPTION	CLAYSTONE (CLAY, SANDY)
------------------	-------------------------

**Sieve Analysis  
Grain Size Distribution**

**GRAIN SIZE ANALYSIS**

U.S. Sieve #	Percent Finer
3"	
1 1/2"	
3/4"	
1/2"	
3/8"	
4	100.0%
10	95.8%
20	85.5%
40	78.8%
100	68.2%
200	59.8%

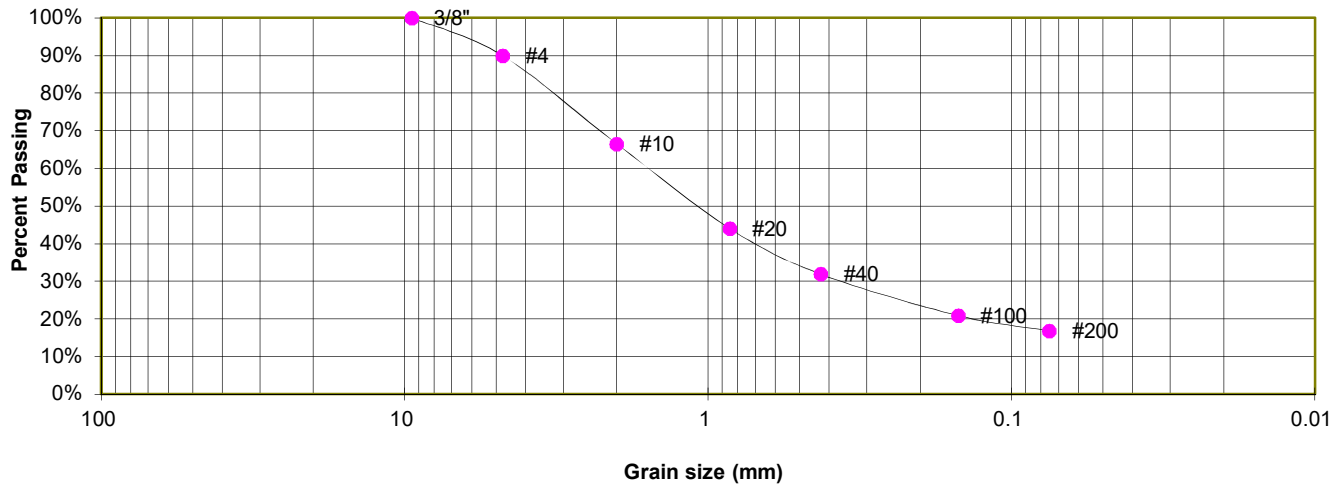
SOIL DESCRIPTION	SAND, SILTY, GRAVELLY
------------------	-----------------------

### Sieve Analysis Grain Size Distribution

#### GRAIN SIZE ANALYSIS

U.S. Sieve #	Percent Finer
3"	
1 1/2"	
3/4"	
1/2"	
3/8"	100.0%
4	89.9%
10	66.5%
20	44.1%
40	31.9%
100	21.0%
200	16.8%

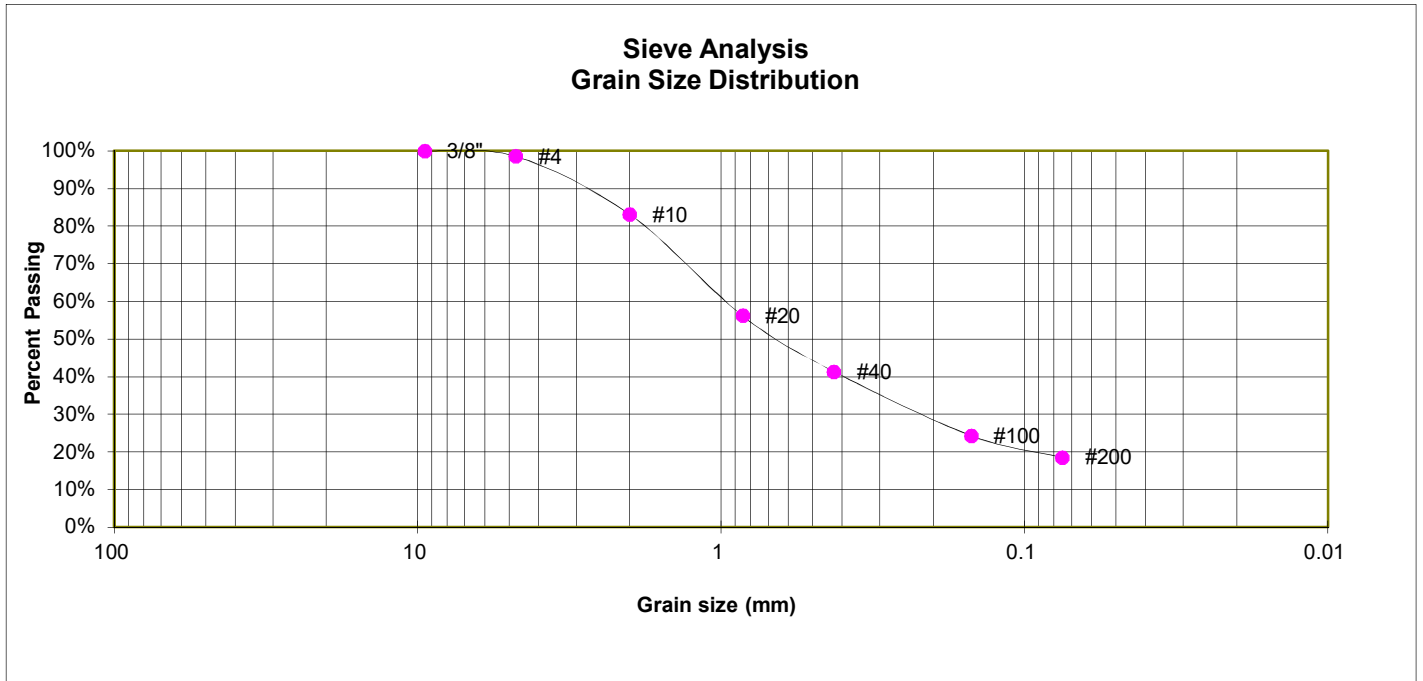
TEST BORING	2
DEPTH (FT)	20

SOIL DESCRIPTION	SANDSTONE (SAND, SILTY)
------------------	-------------------------

#### **GRAIN SIZE ANALYSIS**

U.S. Sieve #	Percent Finer
3"	
1 1/2"	
3/4"	
1/2"	
3/8"	100.0%
4	98.6%
10	83.1%
20	56.2%
40	41.4%
100	24.3%
200	18.6%

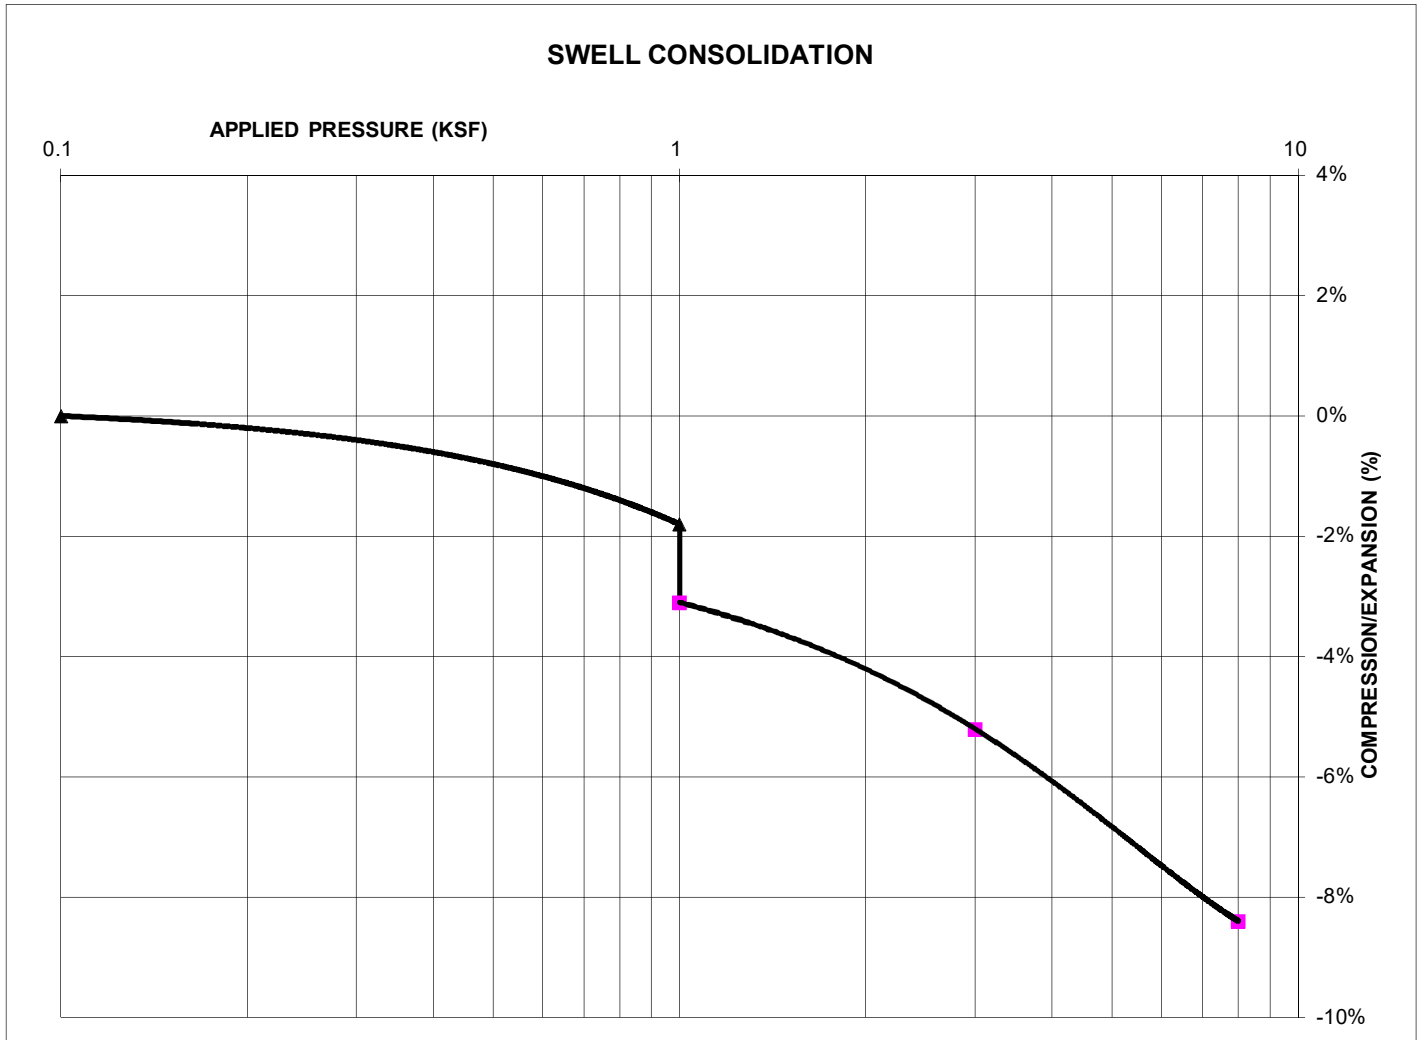
**FIG. C-5**

TEST BORING 1  
DEPTH (FT) 15

SOIL DESCRIPTION CLAYSTONE (CLAY, SANDY)

**SWELL/COLLAPSE TEST RESULTS**

NATURAL UNIT DRY WEIGHT (PCF): 119  
NATURAL MOISTURE CONTENT: 10.5%  
SWELL/COLLAPSE (%): -1.3%

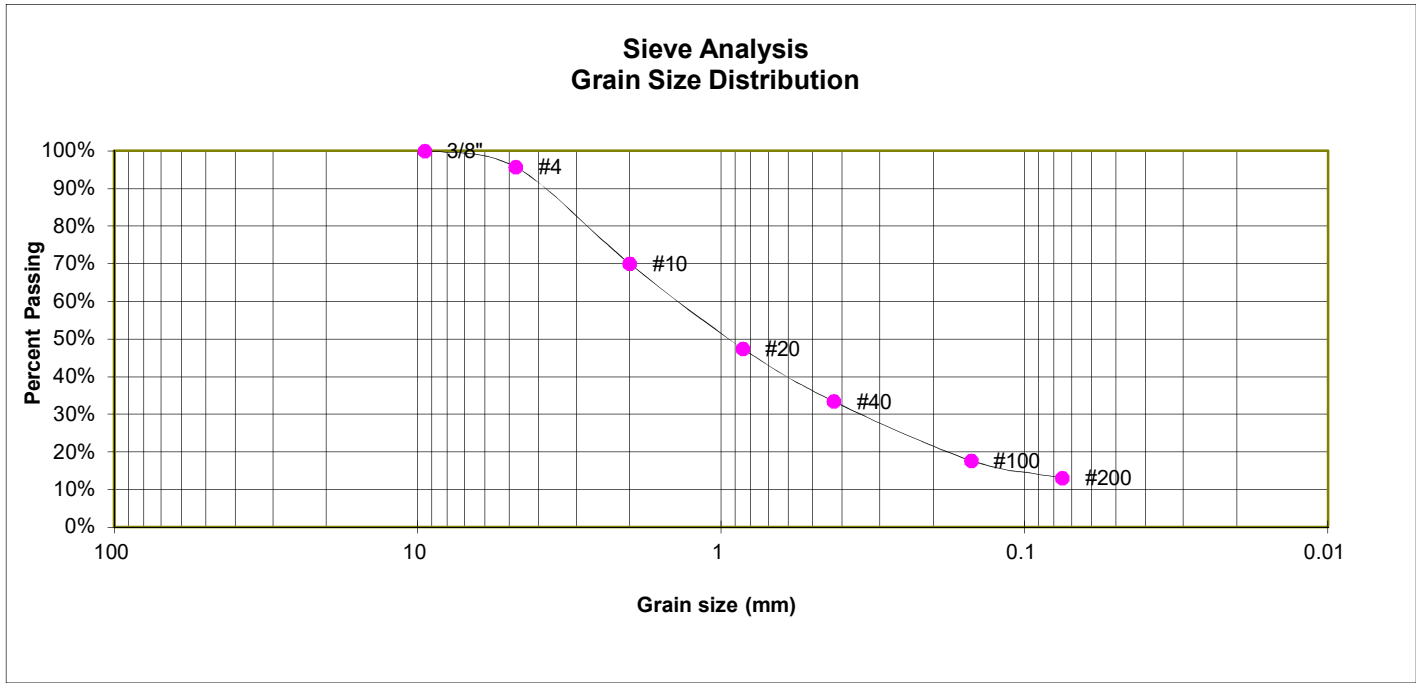
TEST PIT	TP-1	SOIL DESCRIPTION	SCL
DEPTH (FT)	3

#### **GRAIN SIZE ANALYSIS**

U.S. Sieve #	Percent Finer
3"	
1 1/2"	
3/4"	
1/2"	
3/8"	100.0%
4	95.7%
10	70.0%
20	47.5%
40	33.4%
100	17.7%
200	13.1%

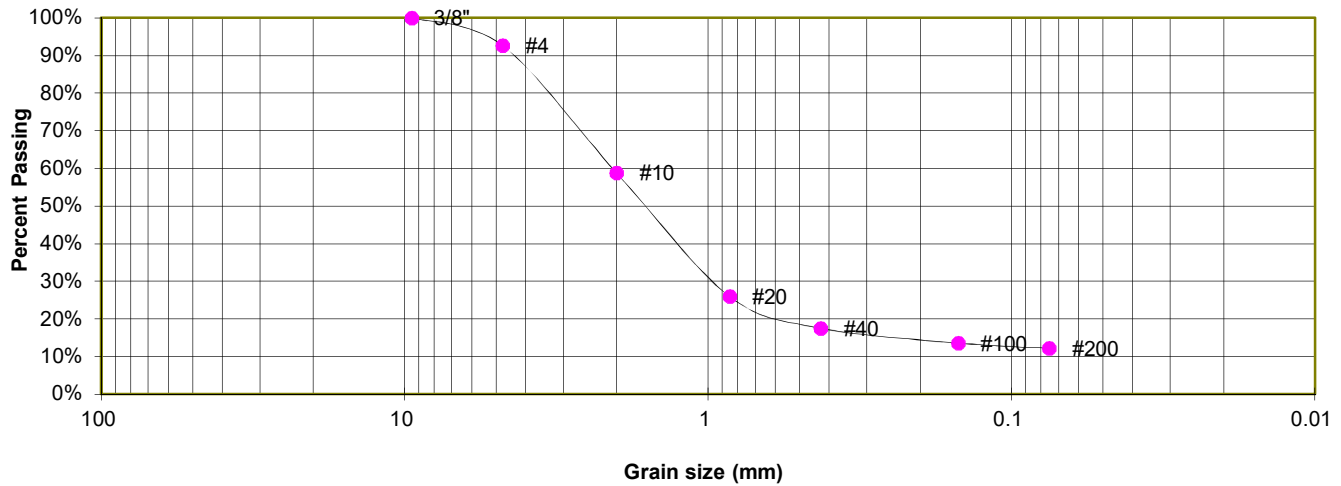
SOIL DESCRIPTION SC

**Sieve Analysis  
Grain Size Distribution**

**GRAIN SIZE ANALYSIS**

U.S. Sieve #	Percent Finer
3"	
1 1/2"	
3/4"	
1/2"	
3/8"	100.0%
4	92.6%
10	58.8%
20	26.0%
40	17.5%
100	13.6%
200	12.1%
