**ENTECH**  
ENGINEERING, INC.

Re: Wastewater Study  
Vollmer Road and Arroya Lane  
Parcel No. 52214-00-002  
El Paso County, Colorado

The project consists of platting a 7.65-acre parcel for a proposed single-family residence. The site is located northeast of the intersection of Vollmer Road and Arroya Lane, in El Paso County, Colorado.

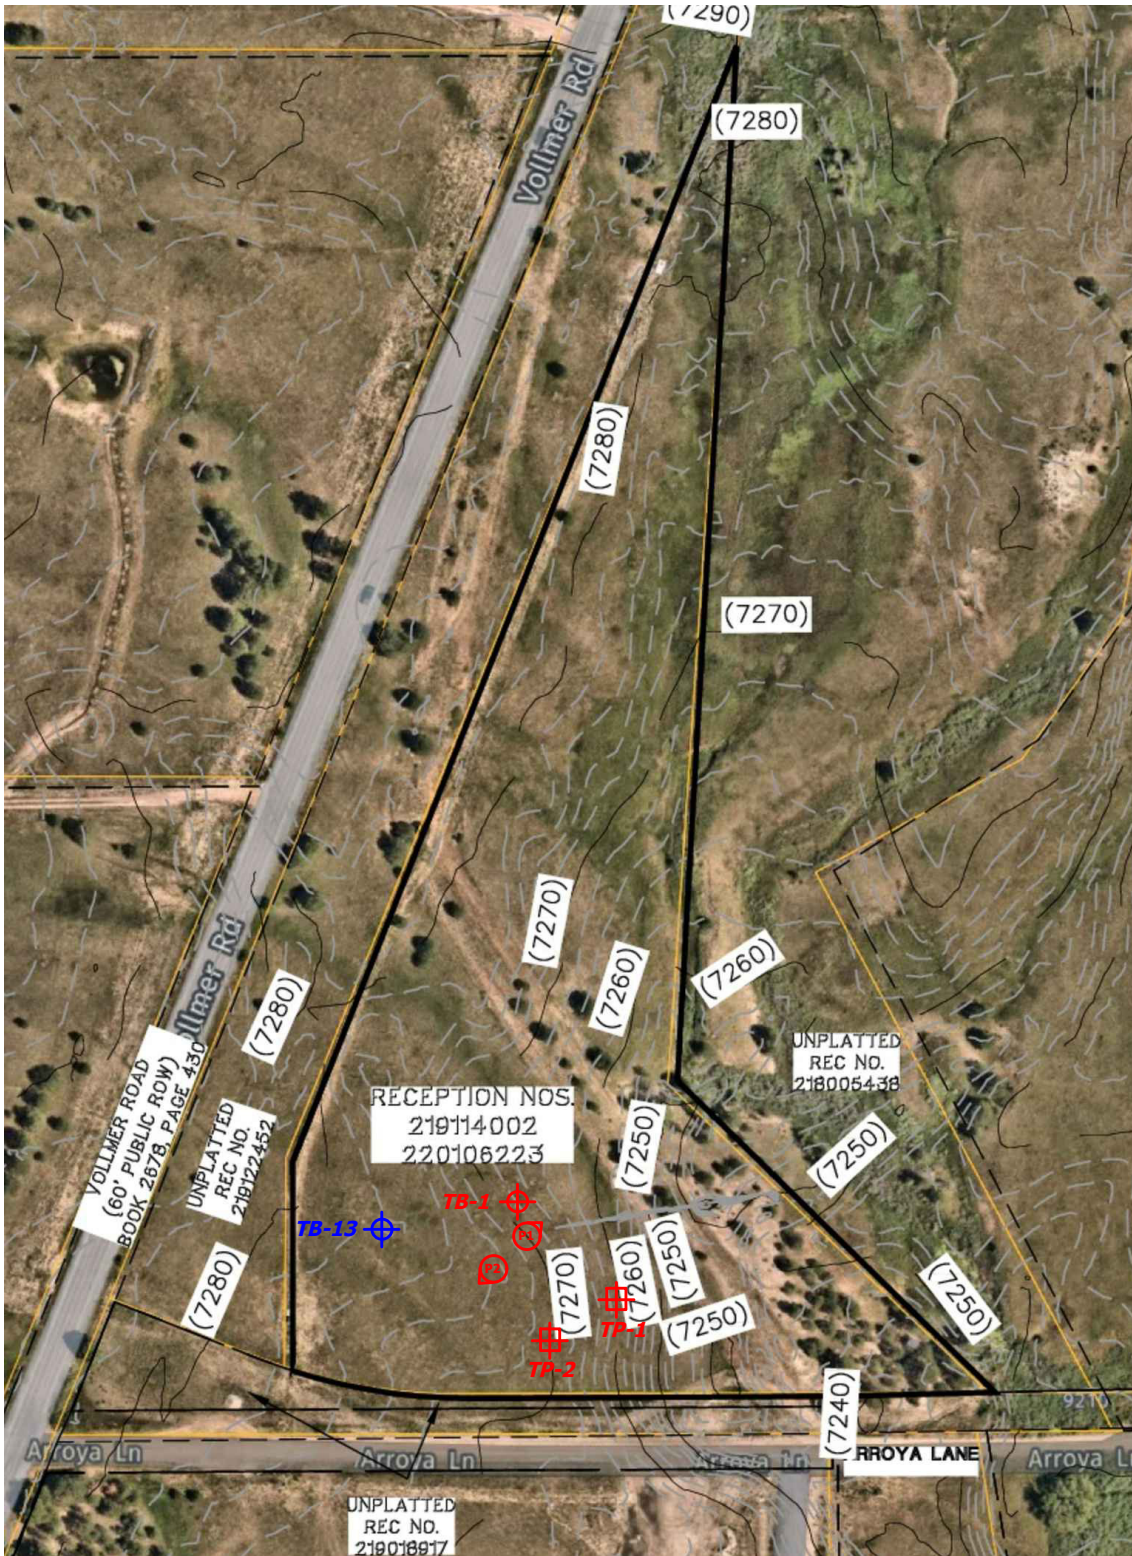
JOB NO.  
 231494  
 FIG. 3

- APPROXIMATE TEST BORING LOCATION AND NUMBER
-

- APPROXIMATE TEST PIT LOCATION AND NUMBER
-

**SITE AND EXPLORATION PLAN**  
 VOLLMER ROAD AND ARROYA LANE  
 PARCEL NO. 52214-00-002  
 STIMPLE FAMILY LLLP

The lot is 7.65-acres. The new lot will be serviced by an individual well and on-site wastewater treatment system. One test boring and two test pits were completed as part of this investigation. The test boring and test pit locations are indicated on the Site and Exploration Plan, Figure 3. Test Boring and Test Pit Logs are included in Appendix B, and the laboratory testing results are included in Appendix C.

One test boring and two test pits were completed on the site to determine general suitability for the use of an on-site wastewater treatment system and general soil characteristics. The location of the test borings and test pits are indicated on the Site and Exploration Plan, Figure 3. The Test Boring and Test Pit Logs are presented in Appendix B. Results of this testing will be discussed later in this report.

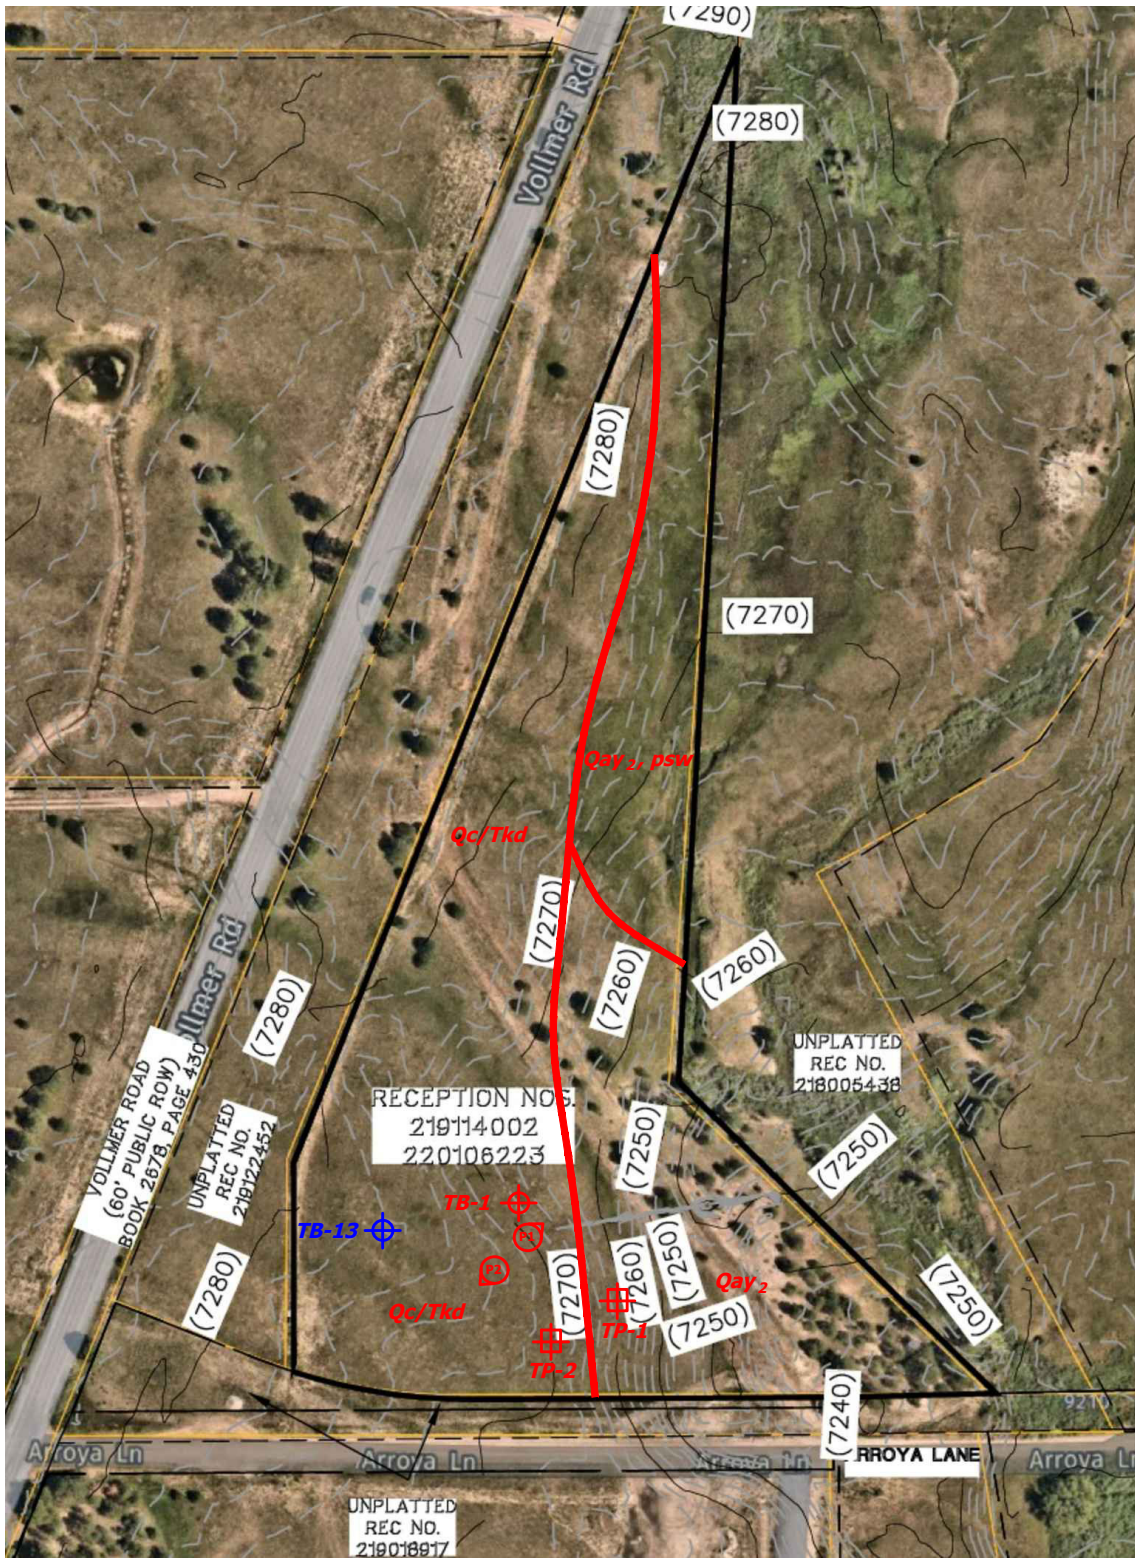
FIG. 6

- Qay<sub>2</sub> - Young Alluvium Two of Holocene Age:  
water deposited sands and clays
- Qc/Tkd - Colluvium of Quaternary Age overlying The Dawson Formation of Tertiary to Cretaceous Age:  
sheetwash and residual soil deposits overlying arkosic sandstone with interbedded claystone and siltstone
- psw - potentially shallow groundwater area

Approximately 12 miles west of the site is a major structural feature known as the Rampart Range Fault. This fault marks the boundary between the Great Plains Physiographic Province and the Southern Rocky Mountain Province. The site exists within a large structural feature known as the Denver Basin. Bedrock in the area is typically gently dipping in a northerly direction (Reference 4). The bedrock underlying the site consists of the Dawson Formation of Cretaceous Age. The Dawson Formation typically consists of coarse-grained arkosic sandstone with interbedded layers claystone or siltstone. The Geology Map for the site is presented in Figure 6. Two mappable units were identified on this site which are described as follows:

by the US Geological Survey in 1978 (Reference 7). The test borings and test pits were used in evaluating the site and is included in Appendices B and C. The Geology Map prepared for the site is presented in Figure 6.

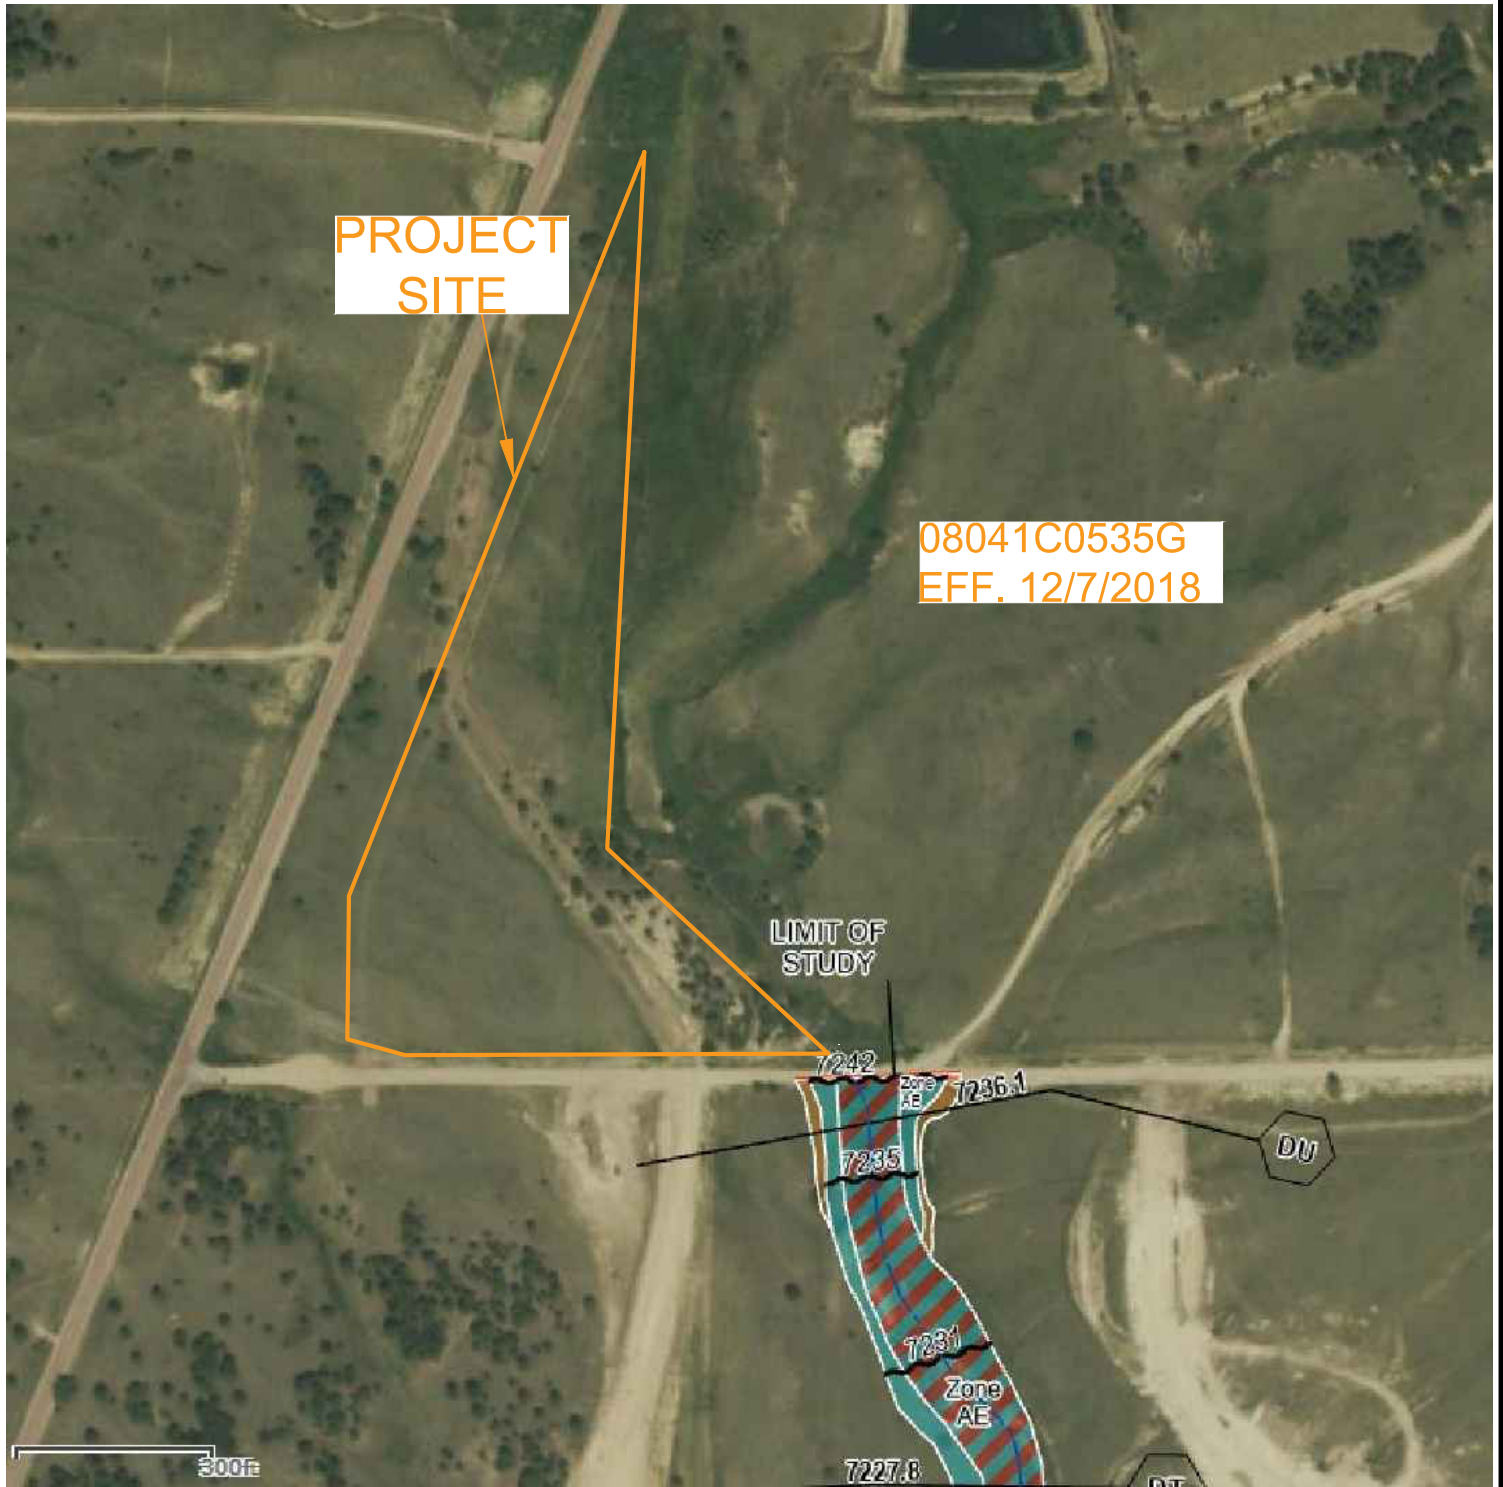
FIG. 7

**FEMA FLOODPLAIN MAP**  
VOLLMER ROAD AND ARROYA LANE  
PARCEL NO. 52214-00-002  
STIMPLE FAMILY LLLP

The site is not mapped within any floodplains according to the FEMA Map No. 08041C0535G, dated December 7, 2018 (Reference 8, Figure 7). It should be noted that the mapping stops at Arroya Lane and Sand Creek is located along the eastern side of the property. Areas of potential seasonally shallow groundwater were observed in the northern portion of the site (Figure 6). In these areas, we would anticipate the potential for periodically high subsurface moisture conditions and frost heave potential. These areas lie along the headwaters of Sand Creek and are north of the proposed building area. Water was in Sand Creek at the time of our site investigation. These areas will likely be avoided by development. Exact locations of floodplain and specific drainage studies are beyond the scope of this report. Individual wastewater treatment systems must be located a minimum of 25 feet from dry gulches and 50 feet from water courses or floodplains.

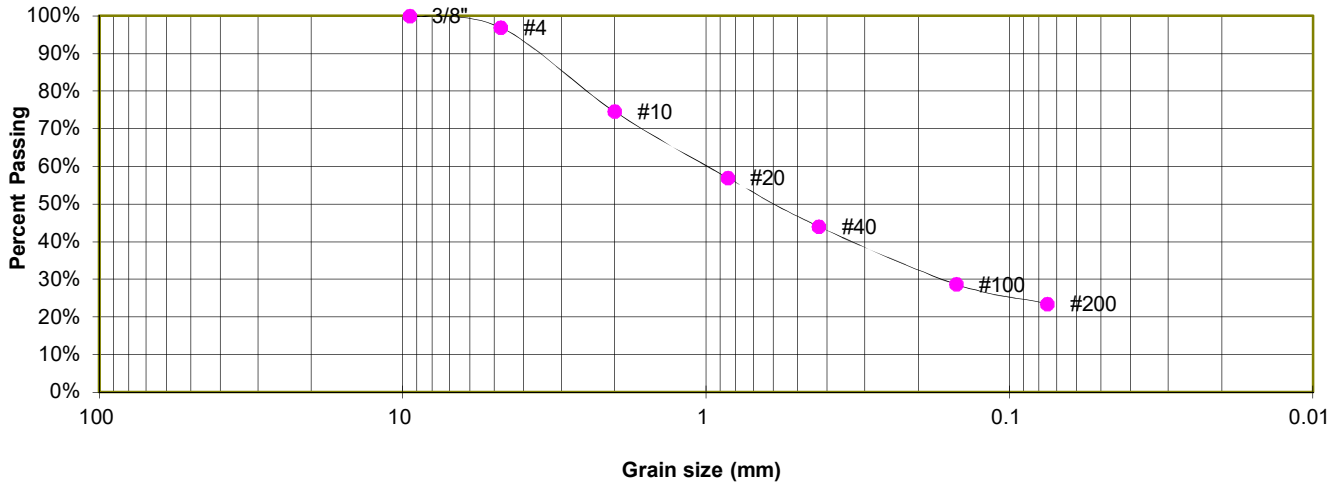
SOIL DESCRIPTION SAND, SILTY  
 SOIL TYPE 1

**GRAIN SIZE ANALYSIS**

U.S. Sieve #	Percent Finer
3"	
1 1/2"	
3/4"	
1/2"	
3/8"	100.0%
4	96.9%
10	74.6%
20	57.0%
40	44.0%
100	28.7%
200	23.5%

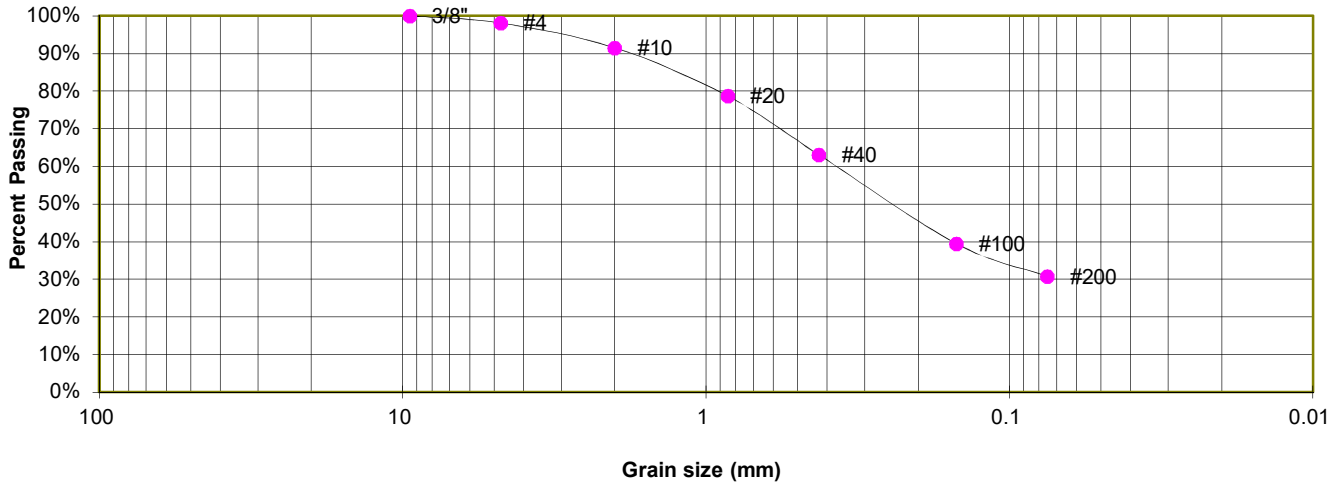
SOIL DESCRIPTION SAND, SILTY  
 SOIL TYPE 1

**GRAIN SIZE ANALYSIS**

U.S. Sieve #	Percent Finer
3"	
1 1/2"	
3/4"	
1/2"	
3/8"	100.0%
4	98.1%
10	91.5%
20	78.7%
40	63.1%
100	39.5%
200	30.8%

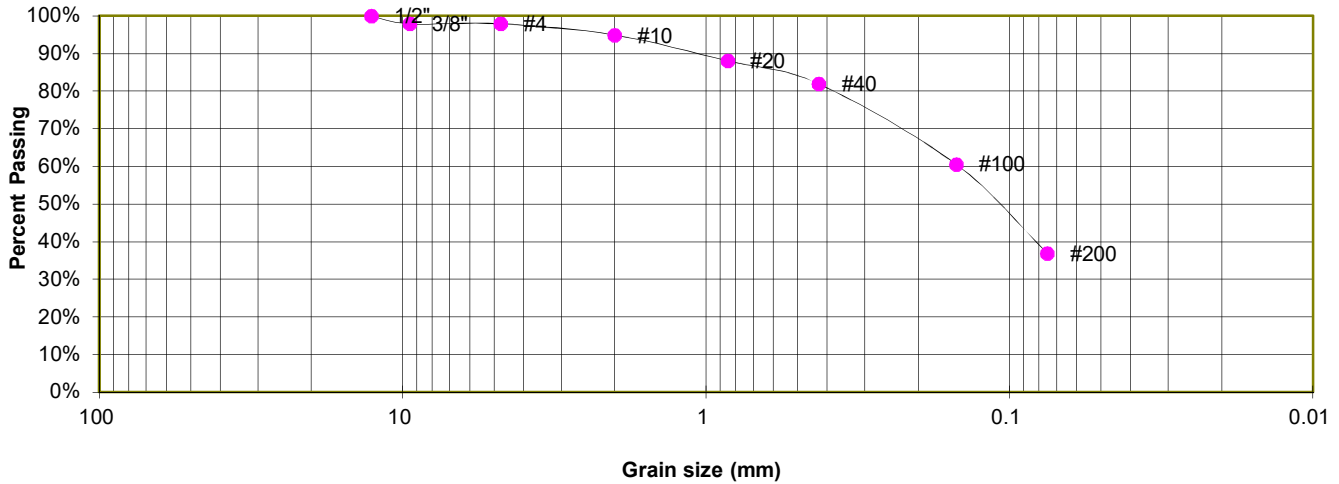
SOIL DESCRIPTION SANDSTONE, (SAND, CLAYEY)  
 SOIL TYPE 2

**GRAIN SIZE ANALYSIS**

U.S. Sieve #	Percent Finer
3"	
1 1/2"	
3/4"	
1/2"	100.0%
3/8"	97.9%
4	97.9%
10	94.9%
20	88.1%
40	81.9%
100	60.6%
200	36.9%

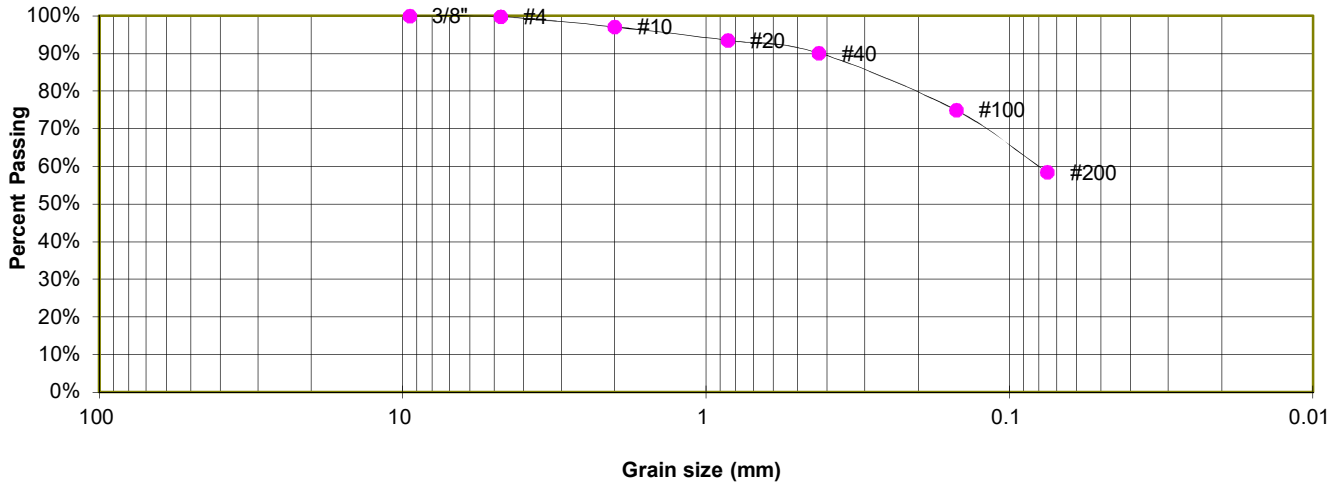
SOIL DESCRIPTION CLAYSTONE, (CLAY, SANDY)  
 SOIL TYPE 3

**GRAIN SIZE ANALYSIS**

U.S. Sieve #	Percent Finer
3"	
1 1/2"	
3/4"	
1/2"	
3/8"	100.0%
4	99.8%
10	97.1%
20	93.5%
40	90.2%
100	74.9%
200	58.4%

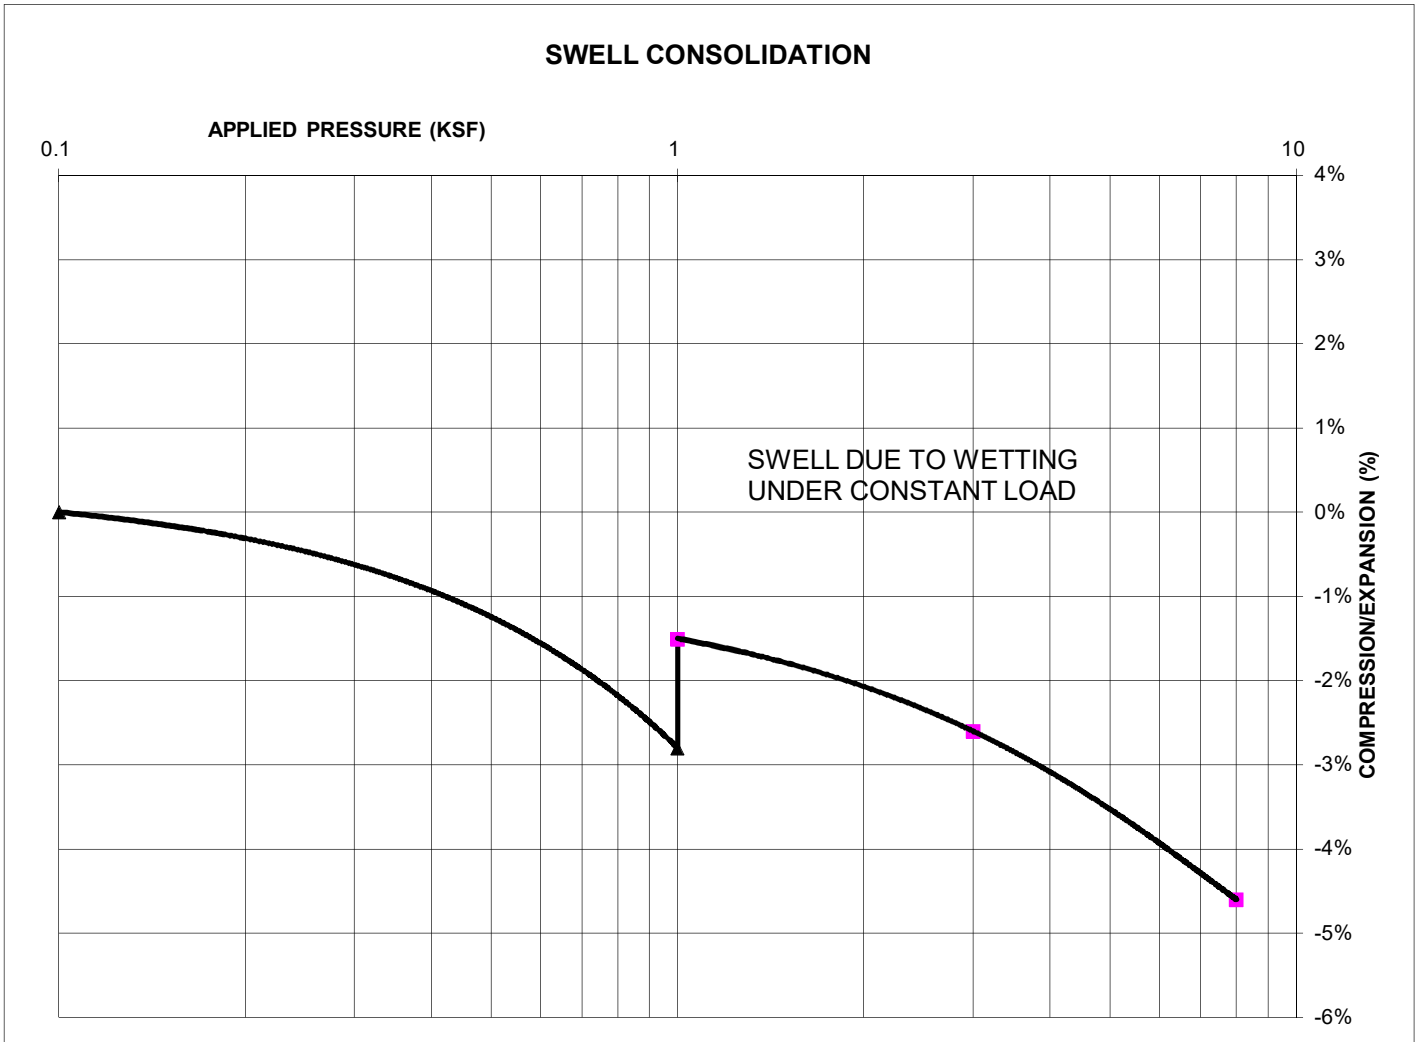
TEST BORING 1  
DEPTH (FT) 10

SOIL DESCRIPTION CLAYSTONE, (CLAY, SANDY)  
SOIL TYPE 3

**SWELL/CONSOLIDATION TEST RESULTS**

NATURAL UNIT DRY WEIGHT (PCF): 115  
NATURAL MOISTURE CONTENT: 12.8%  
SWELL/CONSOLIDATION (%): 1.3%
