Job No. 180213

Re: Response to CGS Comments  
16975 Falcon Highway  
El Paso County, Colorado

RMG – Rocky Mountain Group (RMG) prepared the *Soils and Geology Study* (RMG Job No. 180213, last dated June 28, 2023) for the proposed development comprising 7 single-family residential lots located approximately 2 miles east of the intersection of Curtis Road and Falcon Highway. The report was reportedly reviewed by personnel of the Colorado Geological Survey (CGS). The CGS comments (dated January 19, 2020) were reviewed on EDARP.

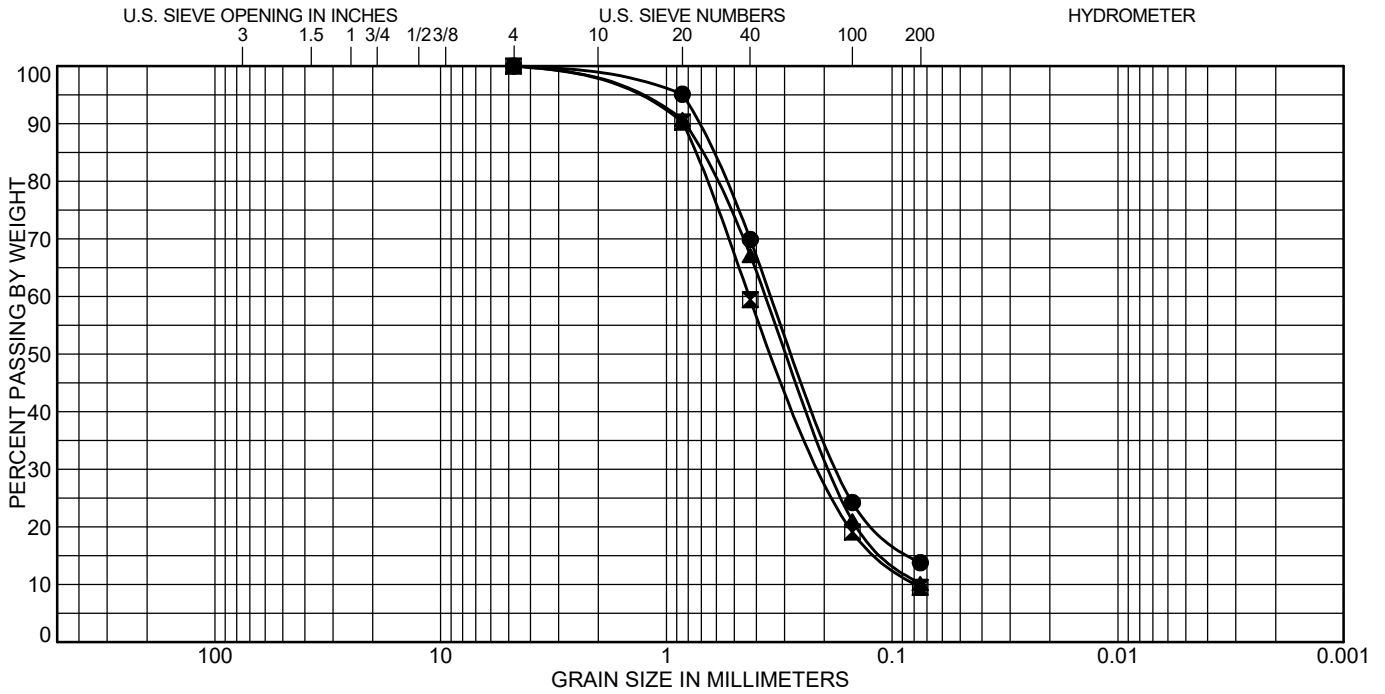
FIGURE No. 9

COBBLES	GRAVEL		SAND			SILT OR CLAY
	coarse	fine	coarse	medium	fine

Test Boring	Depth (ft)	Classification	LL	PL	PI
● 1	4.0	SILTY SAND(SM)	NP	NP	NP
☒ 2	9.0	POORLY GRADED SAND with SILT(SP-SM)	NP	NP	NP
▲ 3	14.0	POORLY GRADED SAND with SILT(SP-SM)	NP	NP	NP

Soil laboratory testing was performed as part of this investigation. The laboratory tests included moisture content, dry density, grain-size analyses and Atterberg Limits. Swell/Consolidation tests were not performed on the onsite non-expansive silty sand. A Summary of Laboratory Test Results is presented in Figure 8. Soils Classification Data is presented in Figure 9.

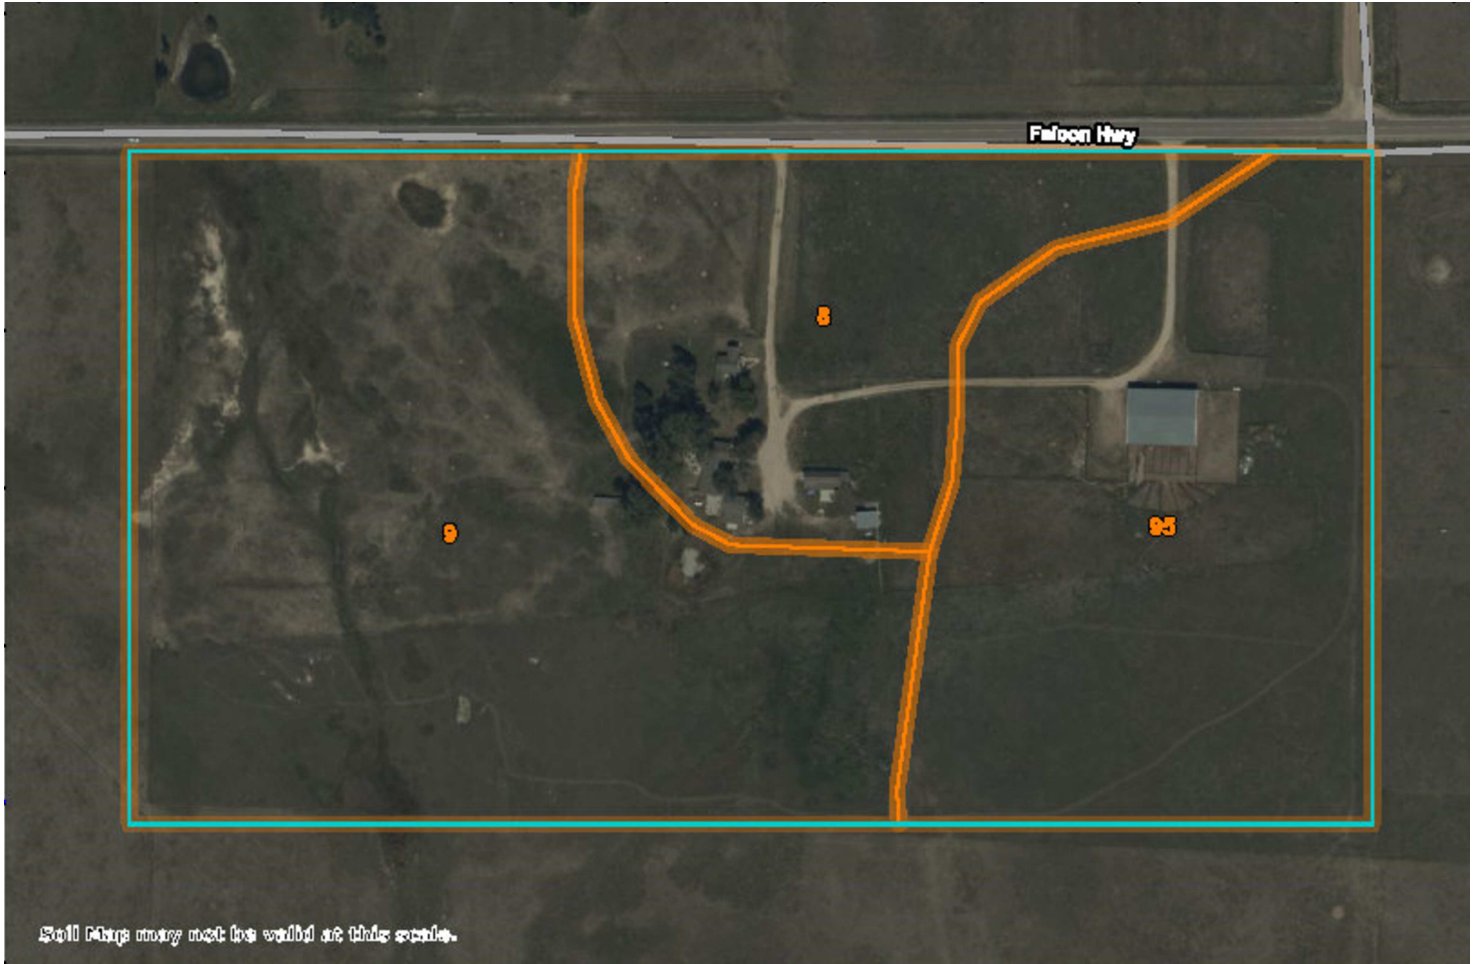
- 8 - Blakeland loamy sand, (1 to 9 percent slopes)
- 9 - Blakeland Fluvaquentic Haplaquolis
- 95 - Truckton loamy sand, 1 to 9 percent slopes

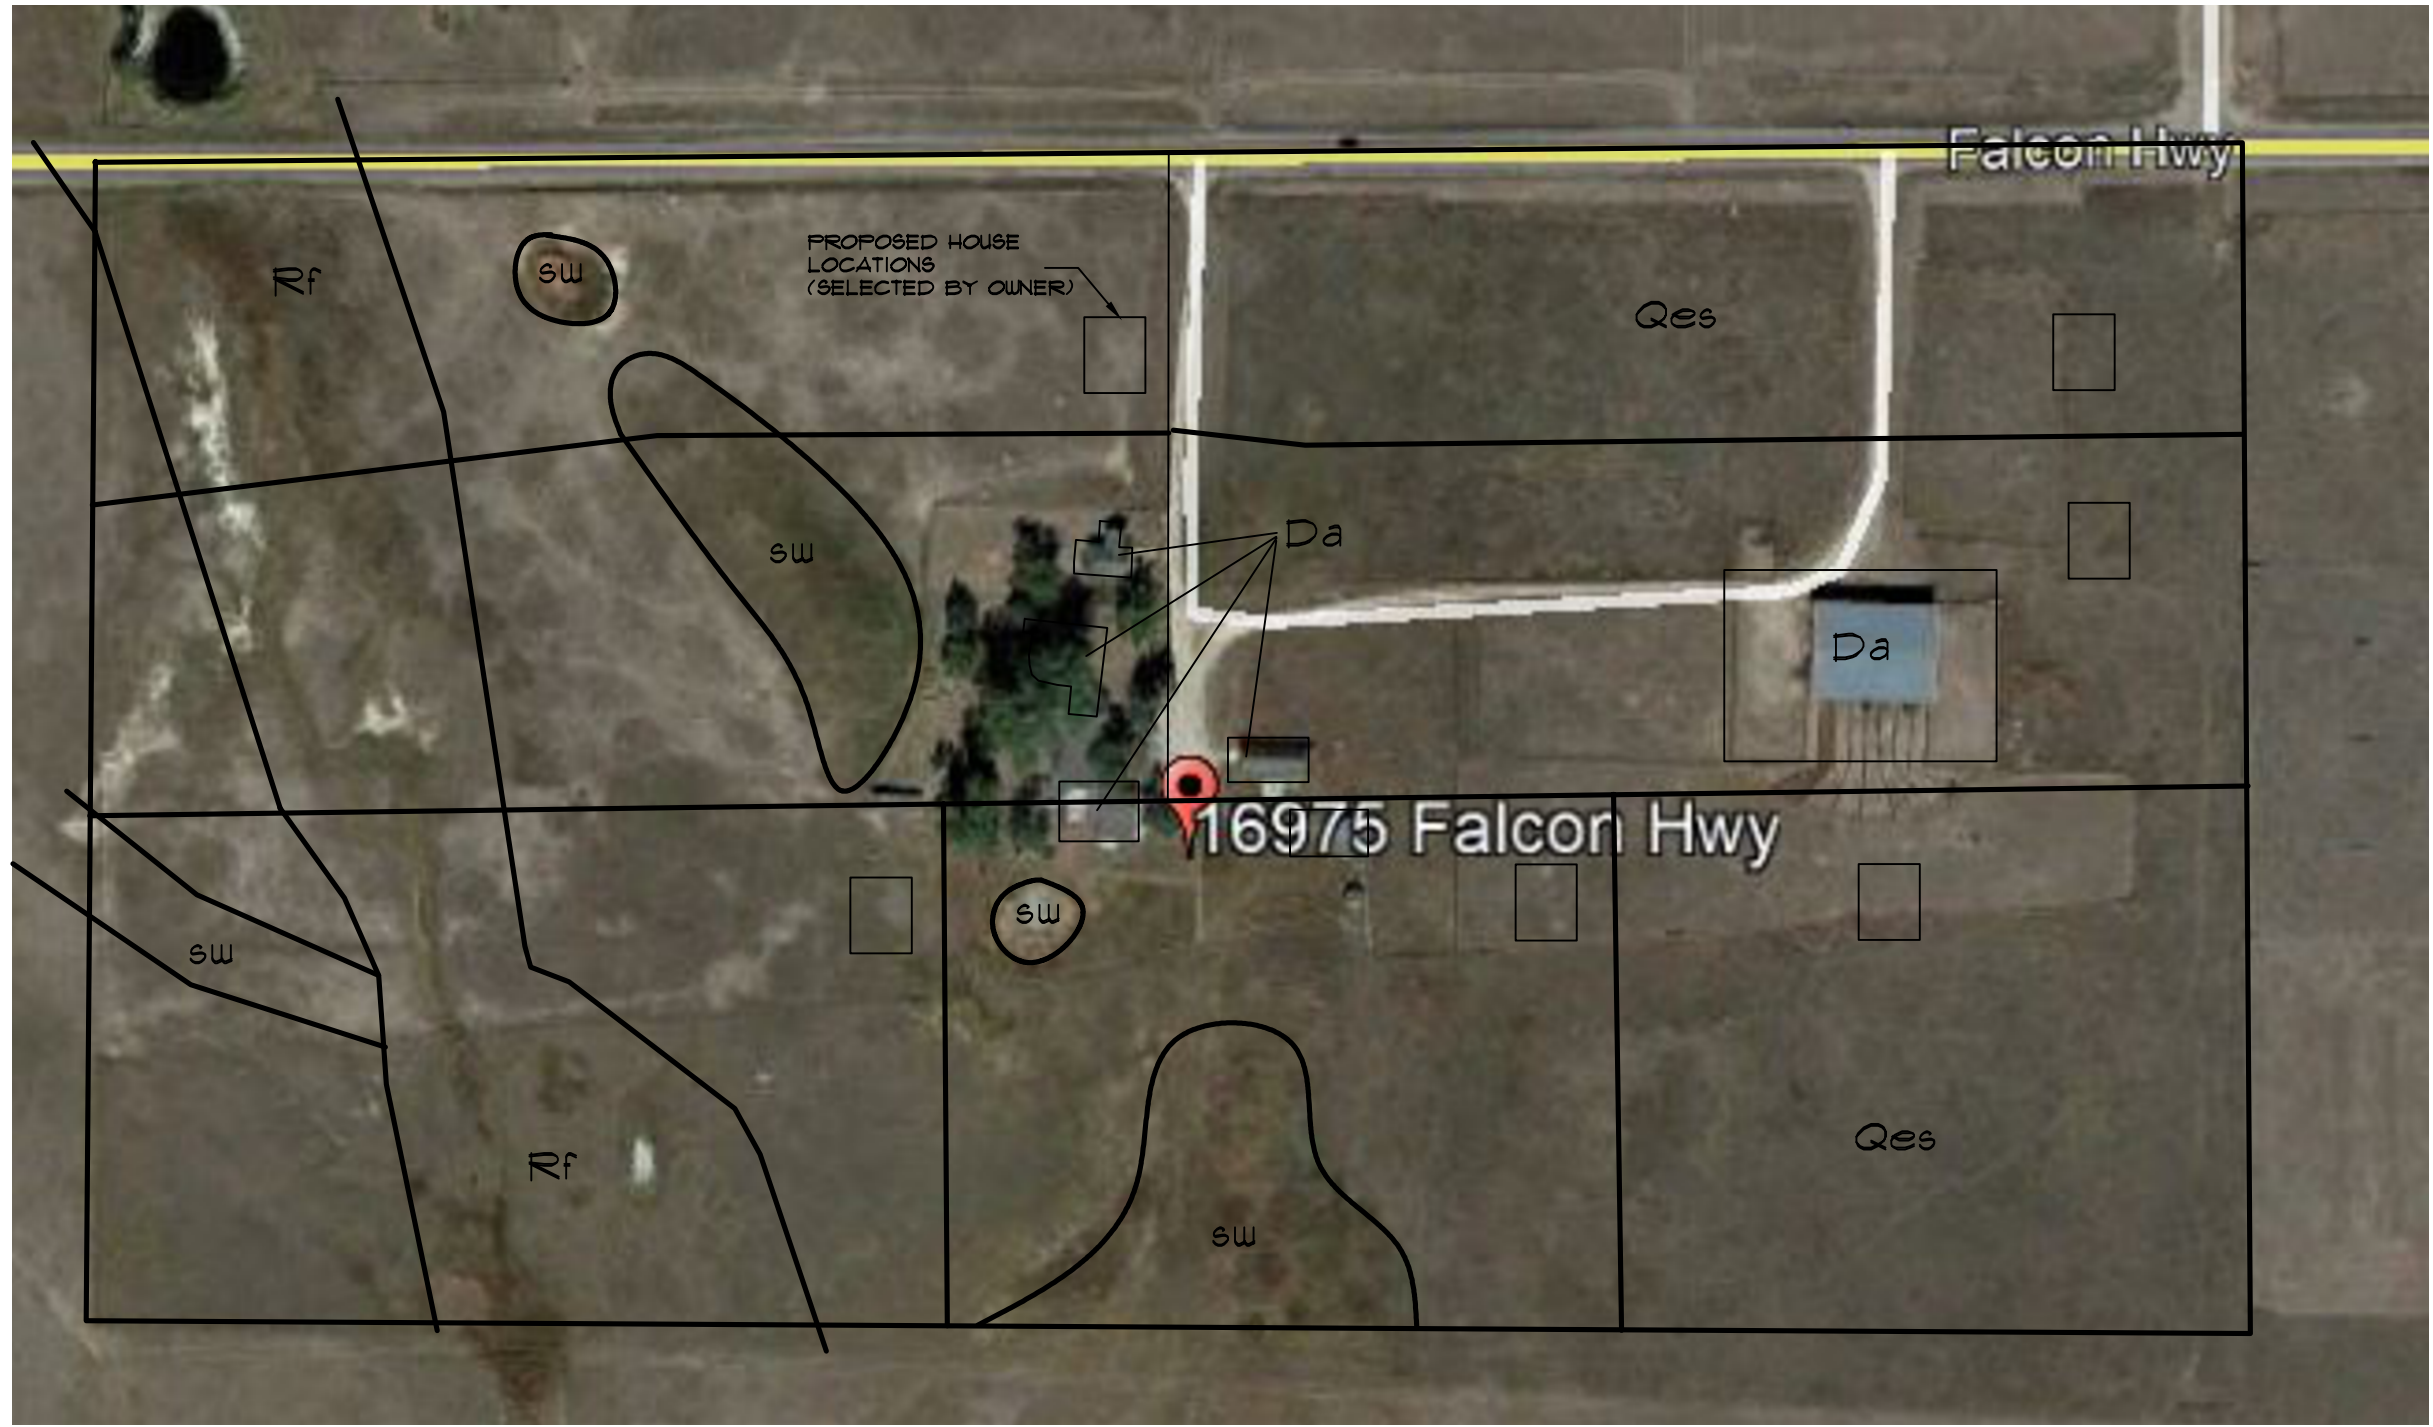
SHEET No. FIG-11

GEOLOGIC UNITS

- *Qes* - eolian sand (Holocene to upper Pleistocene) - Eolian sand is moderately compacted, easily excavated, and drains well. Eolian sand was encountered in all three test borings to depths of approximately 20 feet.
- *Da* - disturbed areas - areas that are no longer in their native state, soils have been removed and/or replaced for the existing driveway, existing residence, existing OWTS, and utility easements.

ENGINEERING AND GEOLOGY MAP

Based on our field observations and review of relevant geologic maps, a geologic map was prepared which identifies the geologic conditions affecting the development. The geologic units present on the site are presented in the Engineering and Geology Map, Figure 11.

The engineering geology is presented in the Engineering and Geology Map, Figure 11.

All construction should remain outside the floodway. It is recommended the unnamed drainageway be identified as a "No Build Area" unless additional studies are performed, in conjunction with the drainage engineer, prior to any new construction. The drainageway is fairly shallow and does not contain banks that would scour and eroded away. This area is shown on the Engineering and Geology Map, Figure 11.

All construction should remain outside the unnamed creek drainageway. It is recommended the unnamed creek drainageway be identified as a “No Build Area” unless additional studies are performed, in conjunction with the drainage engineer, prior to any new construction. This area is shown on the Engineering and Geology Map, Figure 11.

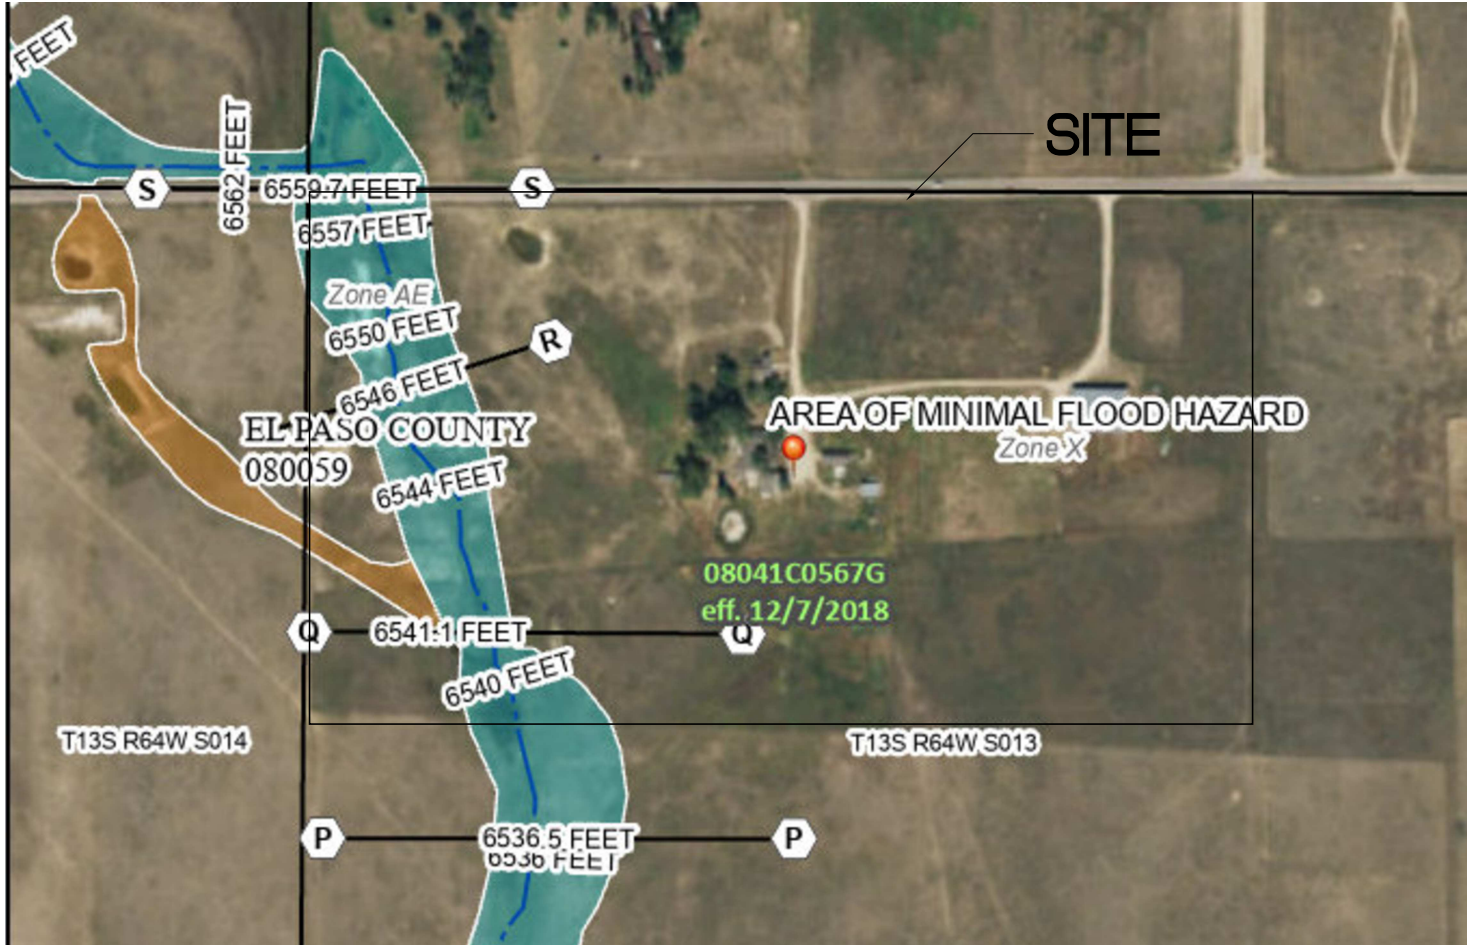
FIG No. 12

NOT TO SCALE  
 BASE MAP PROVIDED BY FEMA

PROPERTY BOUNDARIES ARE NOT ACCURATE, LINES  
 DRAWN FOR VISUAL LOT PLACEMENT ONLY

Based on our review of the Federal Emergency Management Agency (FEMA) Community Panel No. 08041C0567G the online ArcGIS Pikes Peak Regional Floodplain Map, the western portion of the site lies within an areas mapped as AE. Per FEMA, AE indicates areas that have at least a 1% annual-chance of being flooded, but where wave heights are less than 3 feet. The Floodway is mapped with designated Base Flood Elevations (BFE). The BFE for the western portion of the subdivision ranges between 6559.7 to 6530.0 feet. The proposed residences on Lot 1 and 5 and any future structures proposed for lot 3 will need to consider the BFE at the time of construction. The FEMA Map is presented in Figure 12.

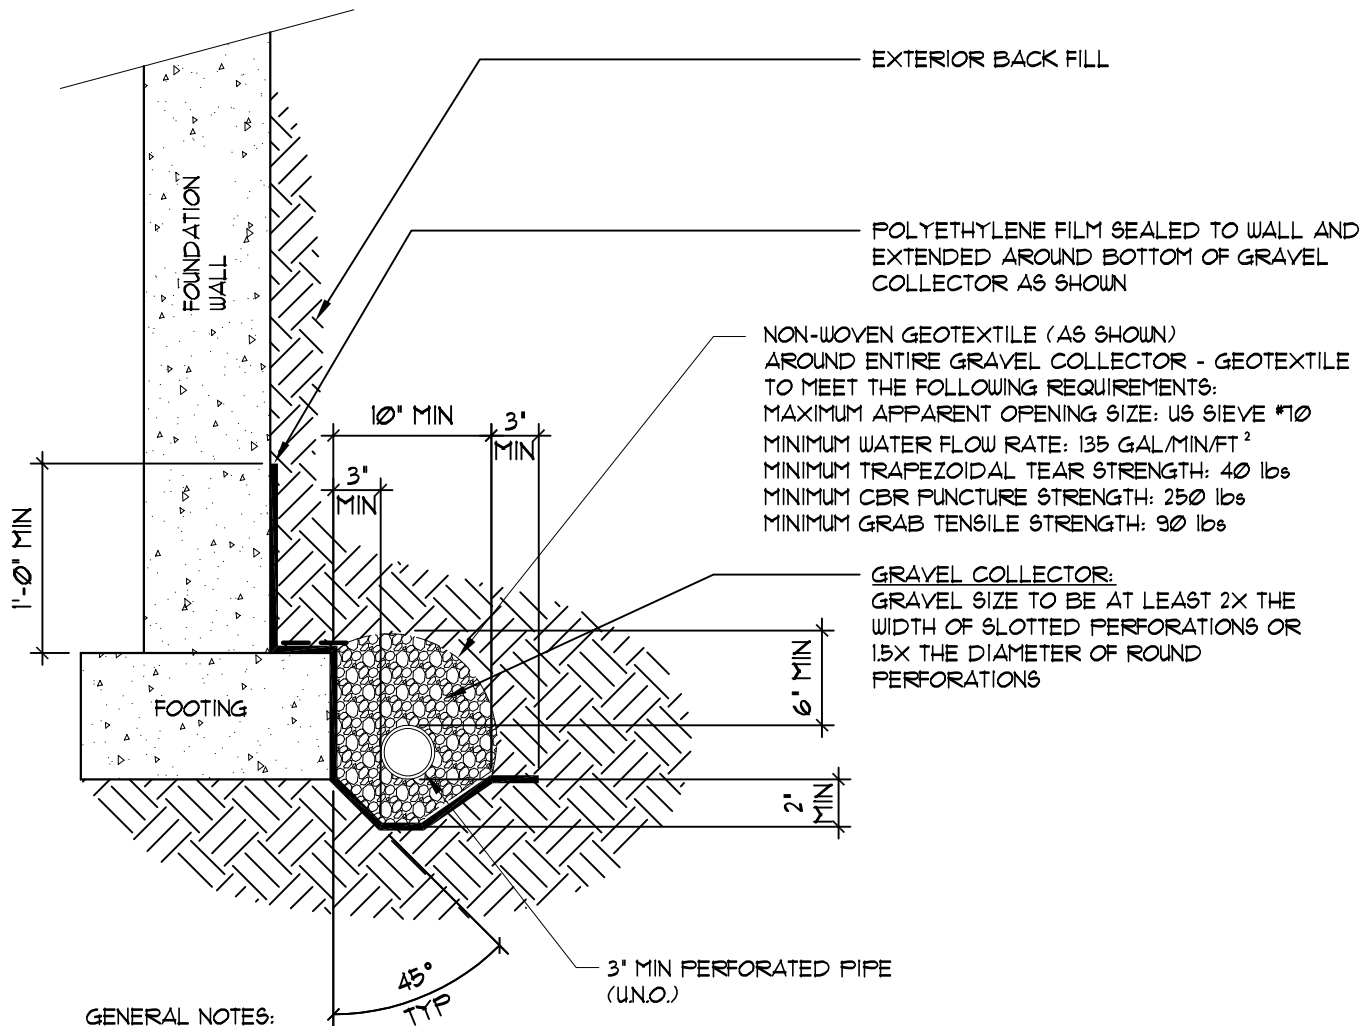
**FIG No. 13**

1. BOTTOM OF DRAIN PIPE SHALL BE AT OR BELOW BOTTOM OF FOOTING AT ALL LOCATIONS
2. ALL DRAIN PIPE SHALL BE PERFORATED PLASTIC, WITH THE EXCEPTION OF THE DISCHARGE PORTION WHICH SHALL BE SOLID, NON-PERFORATED PIPE.

**PERIMETER DRAIN**

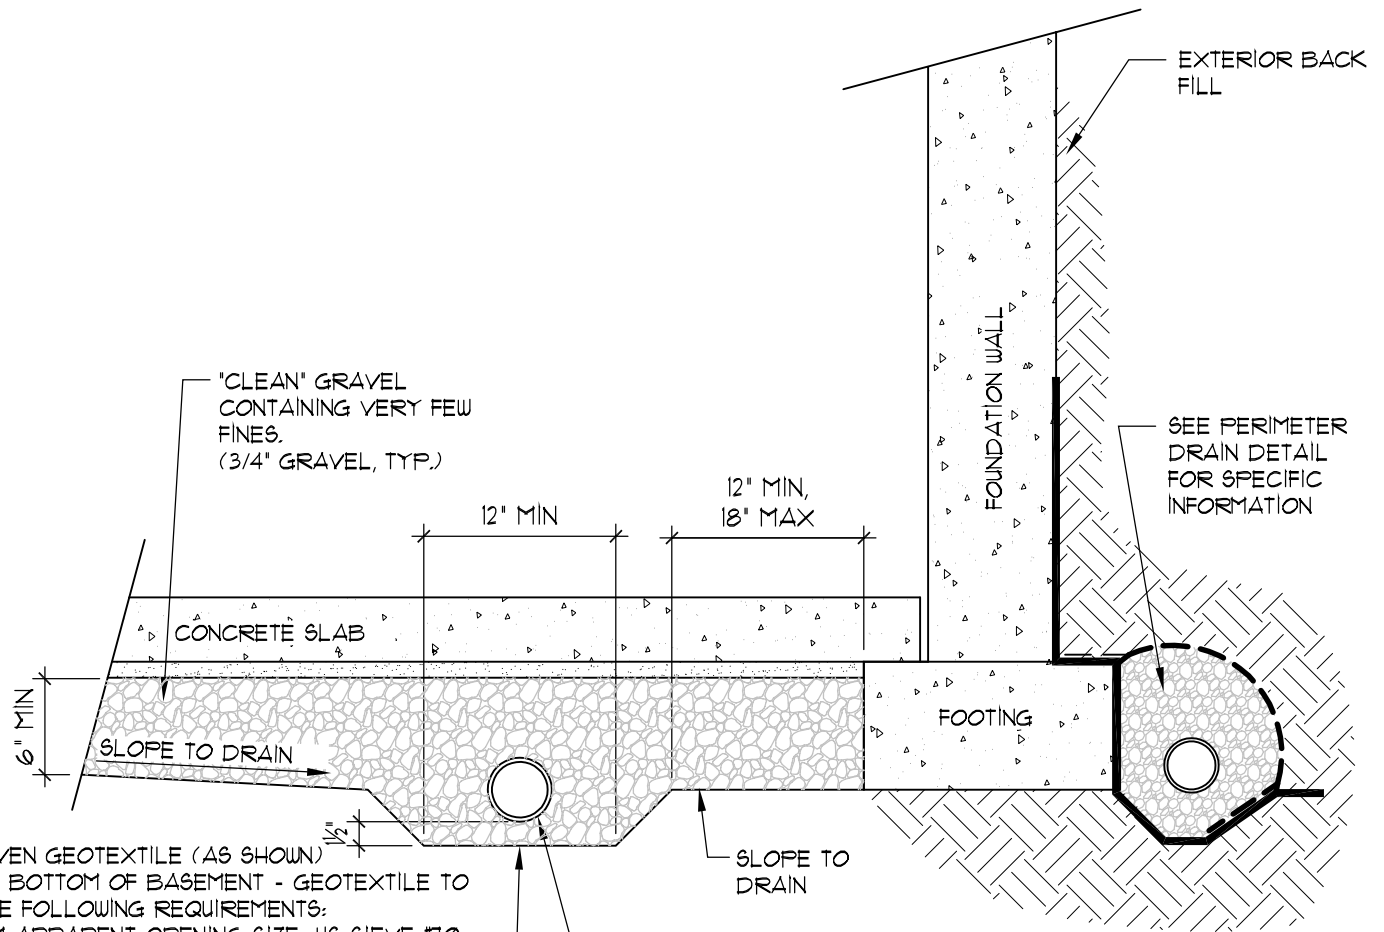
NON-WOVEN GEOTEXTILE (AS SHOWN) ACROSS BOTTOM OF BASEMENT - GEOTEXTILE TO MEET THE FOLLOWING REQUIREMENTS:  
 MAXIMUM APPARENT OPENING SIZE: US SIEVE #10  
 MINIMUM WATER FLOW RATE: 135 GAL/MIN/FT<sup>2</sup>  
 MINIMUM TRAPEZOIDAL TEAR STRENGTH: 40 lbs  
 MINIMUM CBR PUNCTURE STRENGTH: 250 lbs  
 MINIMUM GRAB TENSILE STRENGTH: 90 lbs

3' DIAMETER RIGID PERFORATED PIPE CONNECTED TO A SUITABLE GRAVITY OUTFALL SUCH AS AN UNDERDRAIN LOCATED IN THE UTILITY TRENCH IN THE STREET WITH A MIN. GRADE OF PIPE = 15%. IF A FREE GRAVITY OUTFALL CANNOT BE ACHIEVED, A SUMP PIT AND PUMP SHOULD BE PROVIDED.

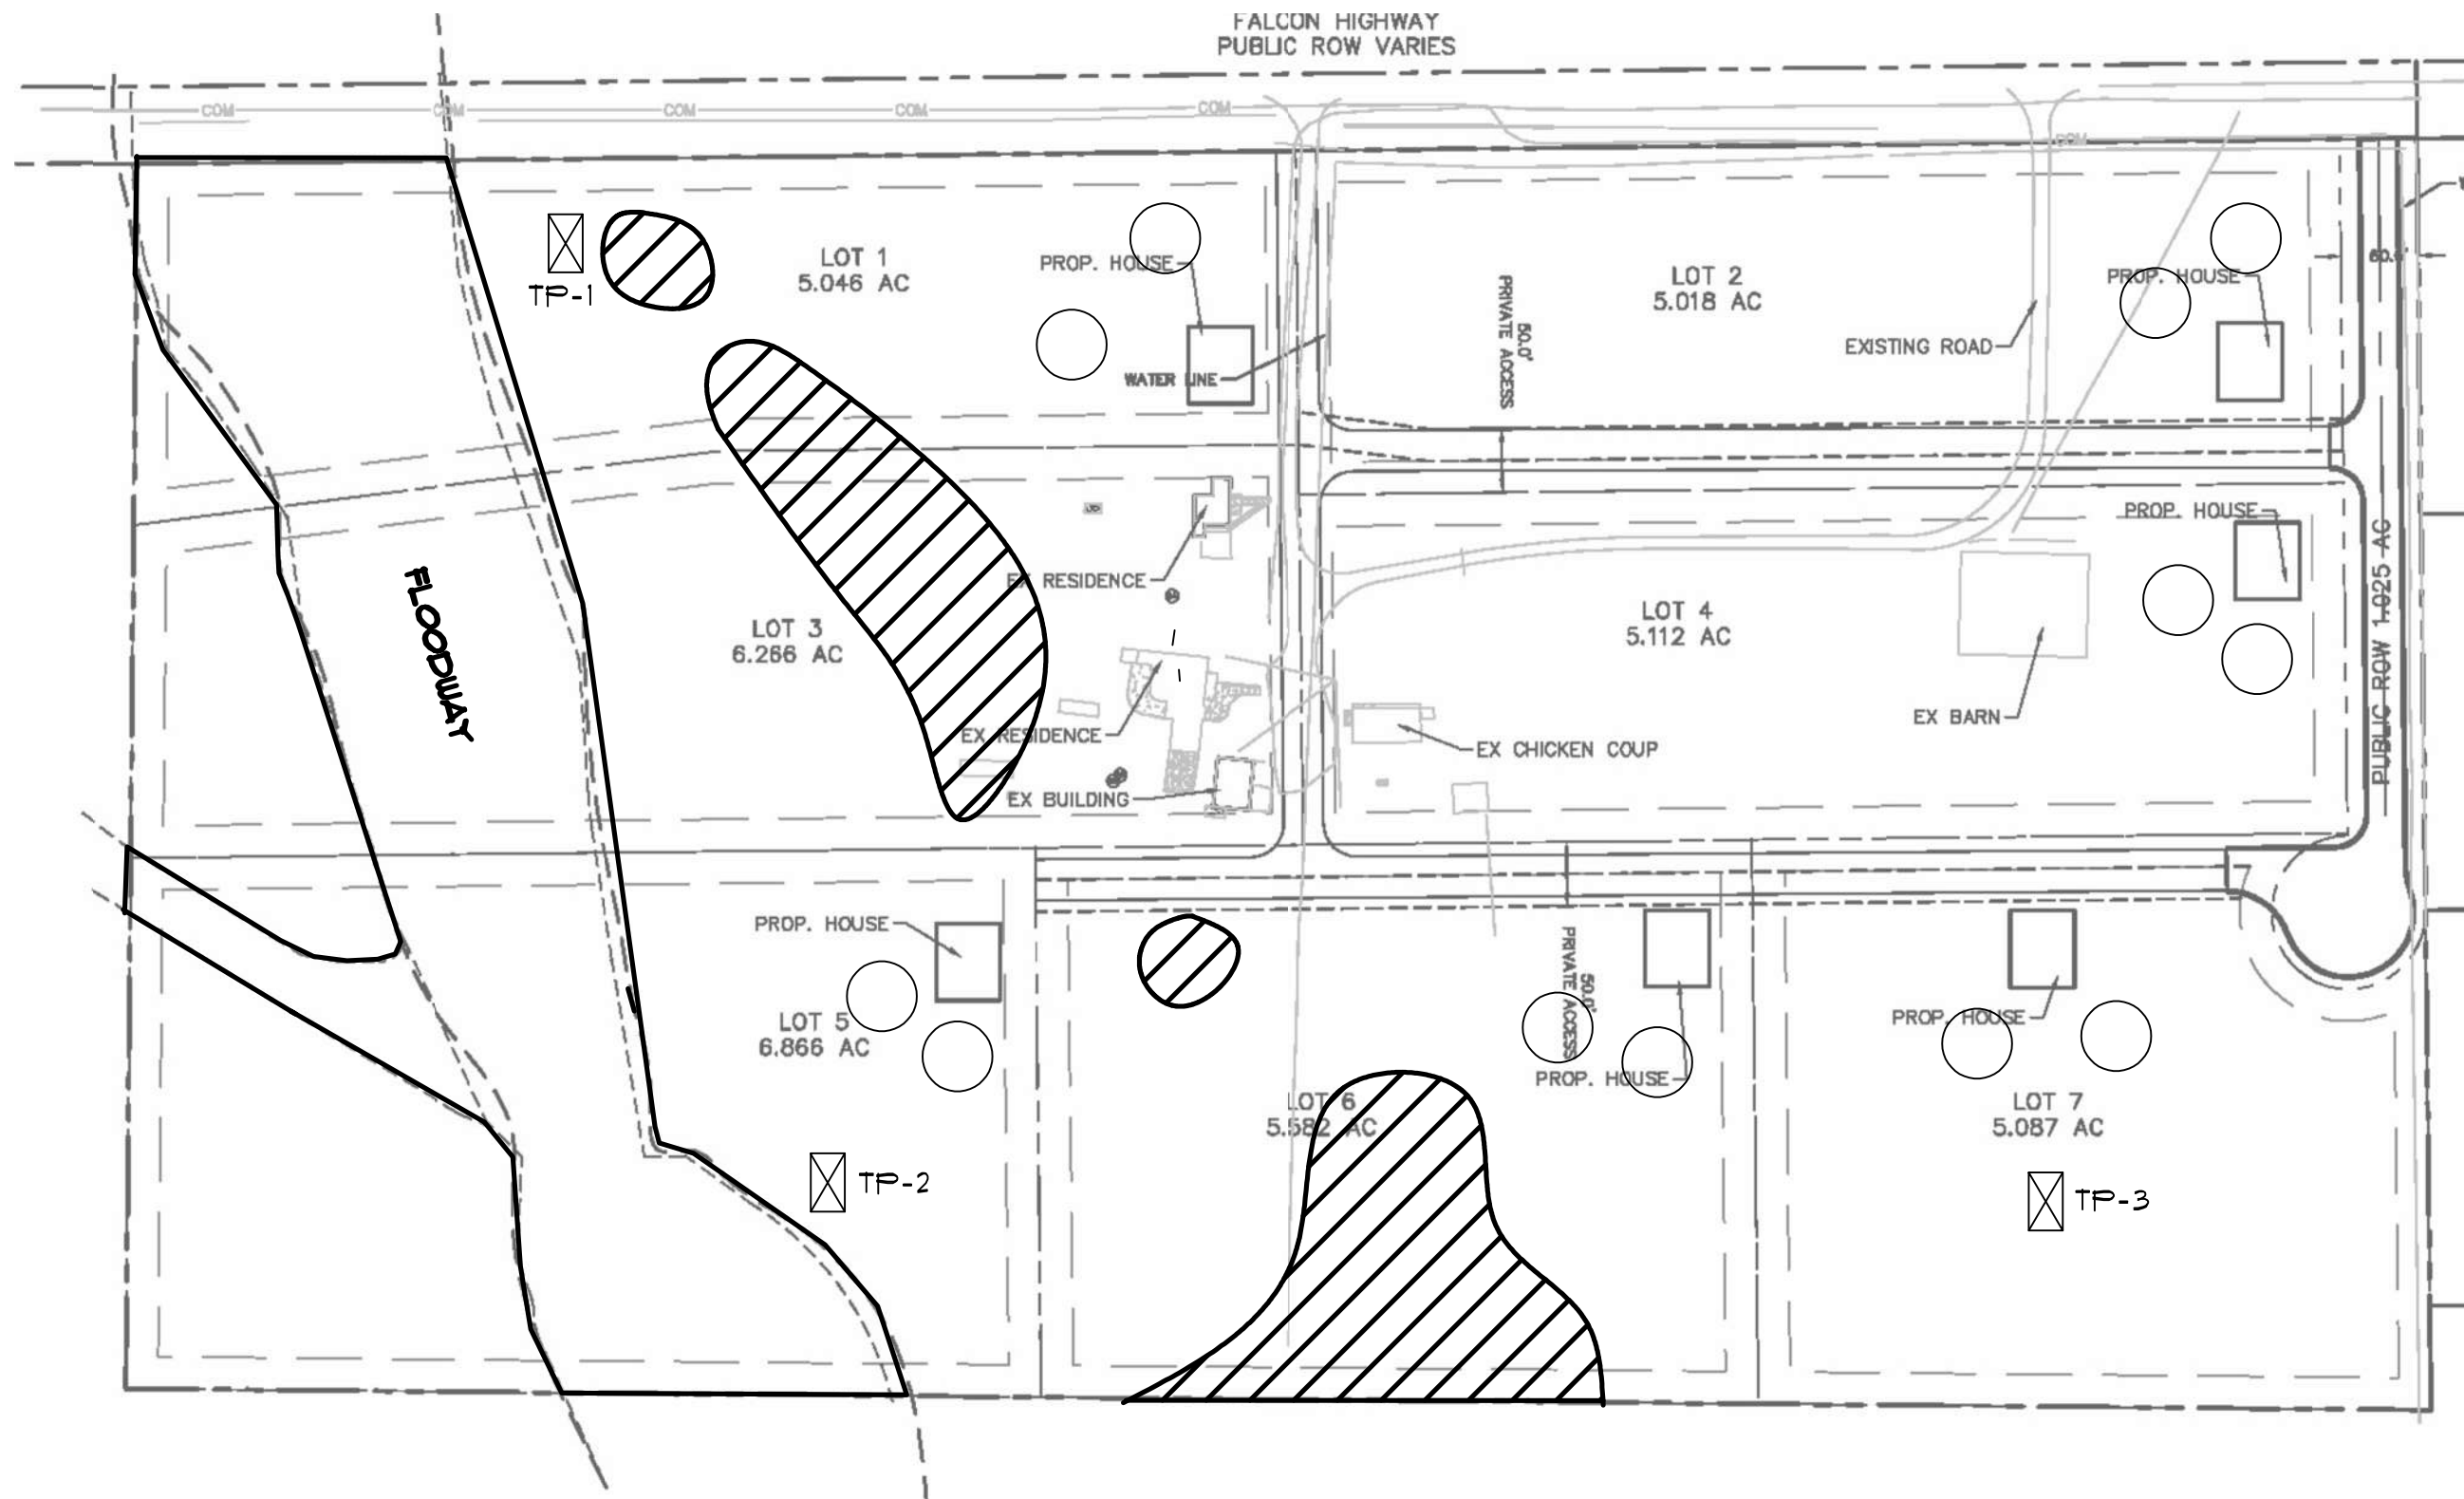
FIG-5

○ SELECTED AREAS THAT ARE SUITABLE FOR THE LOCATION OF A NEW ON-SITE WASTEWATER TREATMENT SYSTEM (OWTS)

▨ AREAS TO AVOID WITH THE PLACEMENT OF A NEW OWTS

Personnel of RMG performed a soil evaluation to include three 8-foot deep test pits, on February 26, 2021 (TP-1, TP-2, and TP-3), utilizing the visual and tactile method for the evaluation of the site soils. The test pits were excavated in areas that appeared most likely to be used for residential OWTS placement. Test Pit Logs are presented in Figures 3 and 4. A Septic Suitability map is presented in Figure 5.

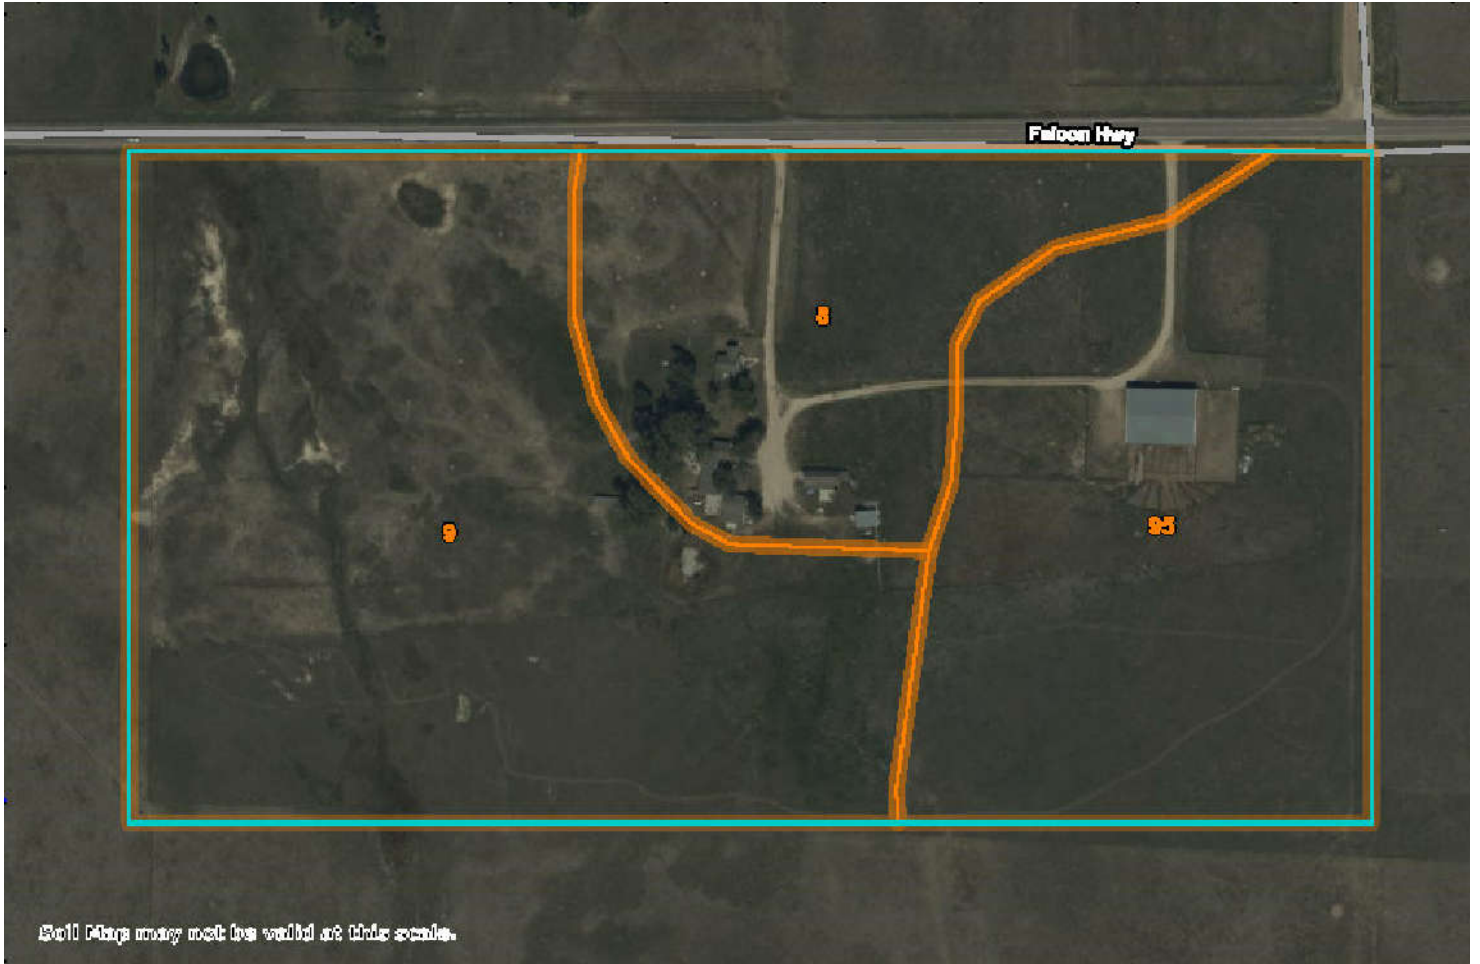
- 8 - Blakeland loamy sand, (1 to 9 percent slopes)
- 9 - Blakeland Fluvaquentic Haplaquolis
- 95 - Truckton loamy sand, 1 to 9 percent slopes
