ENTECH
ENGINEERING, INC.

Re: Subsurface Soil Investigation – Detention Pond
3966 Clear View Loop South
Lot 4A, Clear View Industrial Park
Colorado Springs, Colorado

Entech Engineering, Inc. performed a subsurface soil investigation for the proposed detention pond. The location is indicated on the Vicinity Map, Figure 1. The project is to consist of construction of a detention pond at the above referenced site. Two test borings were drilled in the area of the proposed detention pond. The location of the test borings is shown on Site Plan/Test Boring Location Map, Figure 2. This letter provides recommendations for the embankment improvements based on the site conditions encountered in this investigation and the above referenced report.

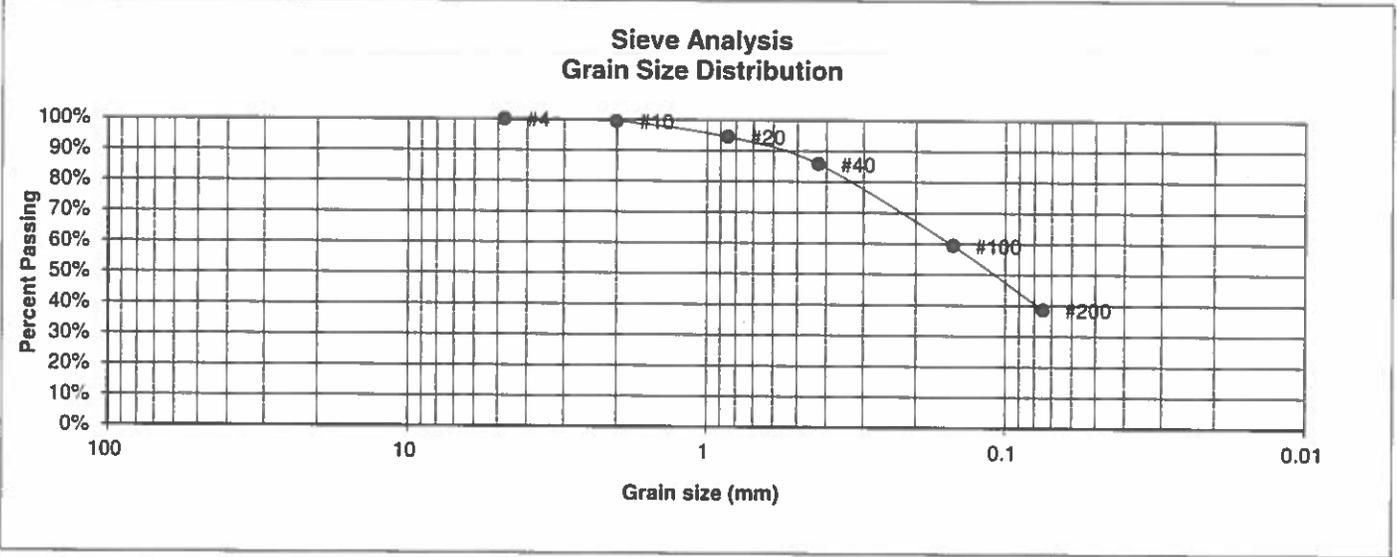
UNIFIED CLASSIFICATION	SM	CLIENT	CLEARVIEW PROPERTIES
SOIL TYPE #	1	PROJECT	3966 CLEARVIEW LOOP
TEST BORING #	1	JOB NO.	201777
DEPTH (FT)	5	TEST BY	BL

U.S. Sieve #	Percent Finer
3"	
1 1/2"	
3/4"	
1/2"	
3/8"	
4	100.0%
10	99.4%
20	94.5%
40	85.7%
100	59.4%
200	38.6%

SOIL TYPE	TEST BORING NO.	DEPTH (FT)	WATER (%)	DRY DENSITY (PCF)	PASSING NO. 200 SIEVE (%)	LIQUID LIMIT (%)	PLASTIC INDEX (%)	SULFATE (WT %)	FHA SWELL (PSF)	SWELL/ CONSOL (%)	UNIFIED CLASSIFICATION	SOIL DESCRIPTION
1	1	5			38.6	NV	NP	<0.01			SM	SAND, VERY SILTY
1	2	10			22.6						SM	SAND, SILTY

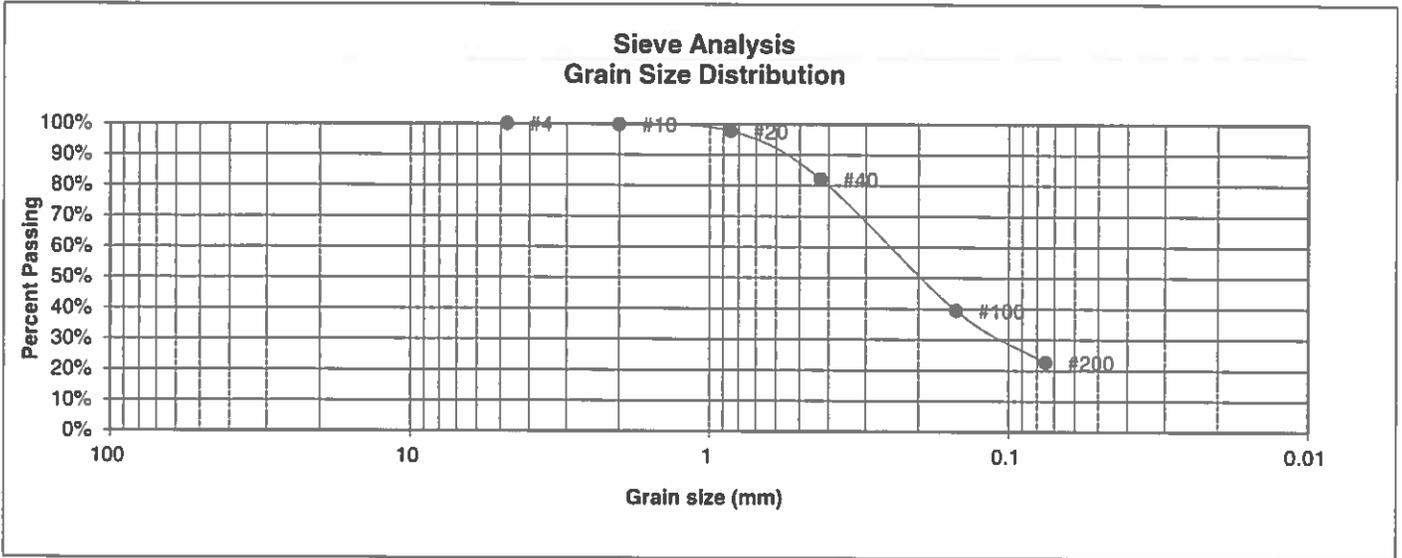
UNIFIED CLASSIFICATION SM
SOIL TYPE # 1
TEST BORING # 2
DEPTH (FT) 10

U.S. Sieve #	Percent Finer
3"	
1 1/2"	
3/4"	
1/2"	
3/8"	
4	100.0%
10	99.8%
20	97.7%
40	82.1%
100	39.4%
200	22.6%

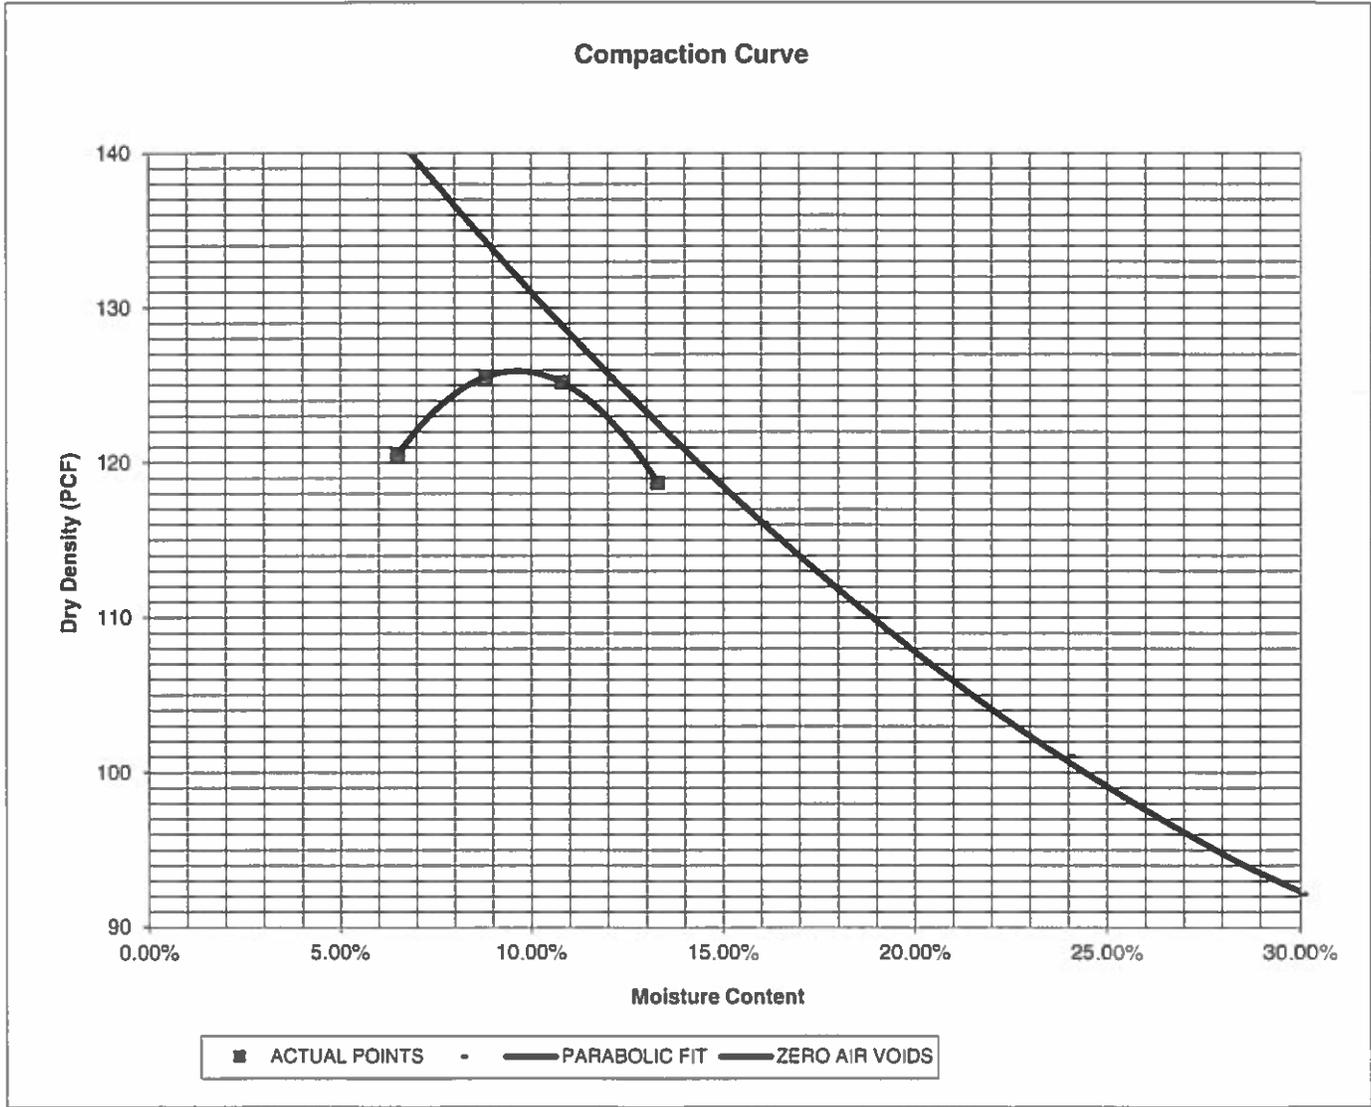
MOISTURE DENSITY RELATION

PROJECT	CLEARVIEW LOOP	CLIENT	CLEARVIEW PROPERTIES
SAMPLE LOCATION	TB'S 1 & 2	JOB NO.	201777
SOIL DESCRIPTION	SAND, SILTY, BROWN	DATE	09/14/20

IDENTIFICATION	SM	PROCTOR TEST #	1
TEST DESIGNATION / METHOD	ASTM D-1557-A	TEST BY	AL
MAXIMUM DRY DENSITY (PCF)	125.9	OPTIMUM MOISTURE	9.7%

New fill should be placed in lifts not to exceed 6 inches after compaction while maintaining at least 95% of its maximum Modified Proctor Dry Density, ASTM D-1557. These materials should be placed at a moisture content conducive to compaction, usually $\pm 2\%$ of Proctor optimum moisture content. The placement and compaction of fill should be observed and tested by Entech during construction/grading. Entech should approve any import materials prior to hauling them to the site.
