Re: Subsurface Soil Investigation – Detention Pond  
3966 Clear View Loop South  
Lot 4A, Clear View Industrial Park  
Colorado Springs, Colorado

Entech Engineering, Inc. performed a subsurface soil investigation for the proposed detention pond. The location is indicated on the Vicinity Map, Figure 1. The project is to consist of construction of a detention pond at the above referenced site. Two test borings were drilled in the area of the proposed detention pond. The location of the test borings is shown on Site Plan/Test Boring Location Map, Figure 2. This letter provides recommendations for the embankment improvements based on the site conditions encountered in this investigation and the above referenced report.

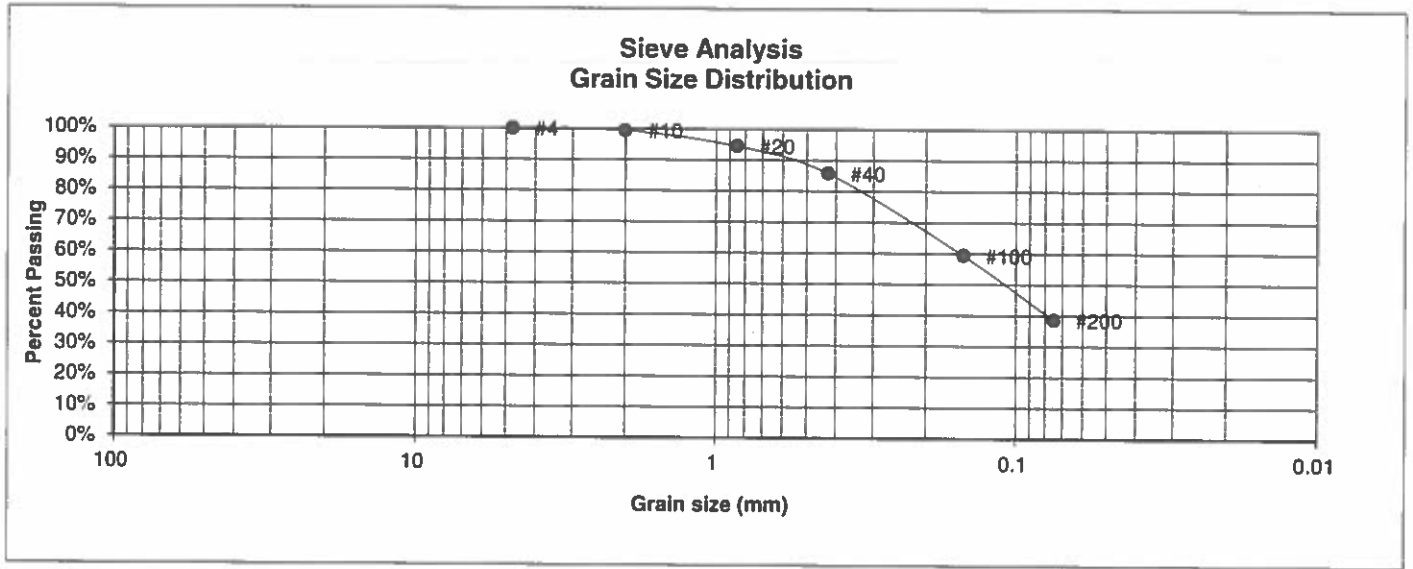
UNIFIED CLASSIFICATION SM  
 SOIL TYPE # 1  
 TEST BORING # 1  
 DEPTH (FT) 5

U.S. Sieve #	Percent Finer
3"	
1 1/2"	
3/4"	
1/2"	
3/8"	
4	100.0%
10	99.4%
20	94.5%
40	85.7%
100	59.4%
200	38.6%

**Atterberg Limits**  
 Plastic Limit NP  
 Liquid Limit NV  
 Plastic Index NP

Soil Type 1 classified as silty to very silty sand (SM). The sand was encountered in Test Boring Nos. 1 and 2 at the existing ground surface and extending to the termination of the test borings (20 feet). Standard Penetration Testing conducted on the sand resulted in N-values ranging between 10 to 30 bpf, which indicated medium dense to dense states. Moisture content and grain size testing resulted in moisture contents of 7 to 18 percent with 22 to 39 percent of the soil size particles passing the No. 200 sieve. Atterberg Limits Testing resulted in non-plastic values. Sulfate testing resulted in less than 0.01 percent soluble sulfate by weight, indicating negligible to severe potential for below grade concrete degradation due to sulfate attack.

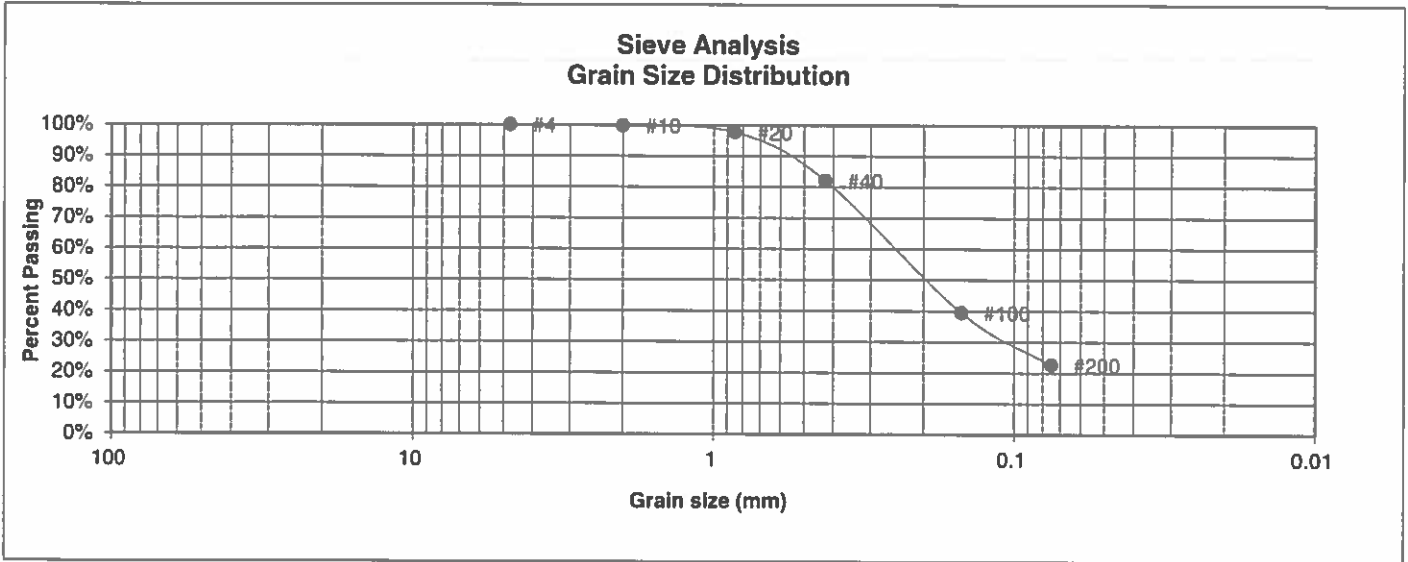
**UNIFIED CLASSIFICATION** SM  
**SOIL TYPE #** 1  
**TEST BORING #** 2  
**DEPTH (FT)** 10

U.S. Sieve #	Percent Finer
3"	
1 1/2"	
3/4"	
1/2"	
3/8"	
4	100.0%
10	99.8%
20	97.7%
40	82.1%
100	39.4%
200	22.6%

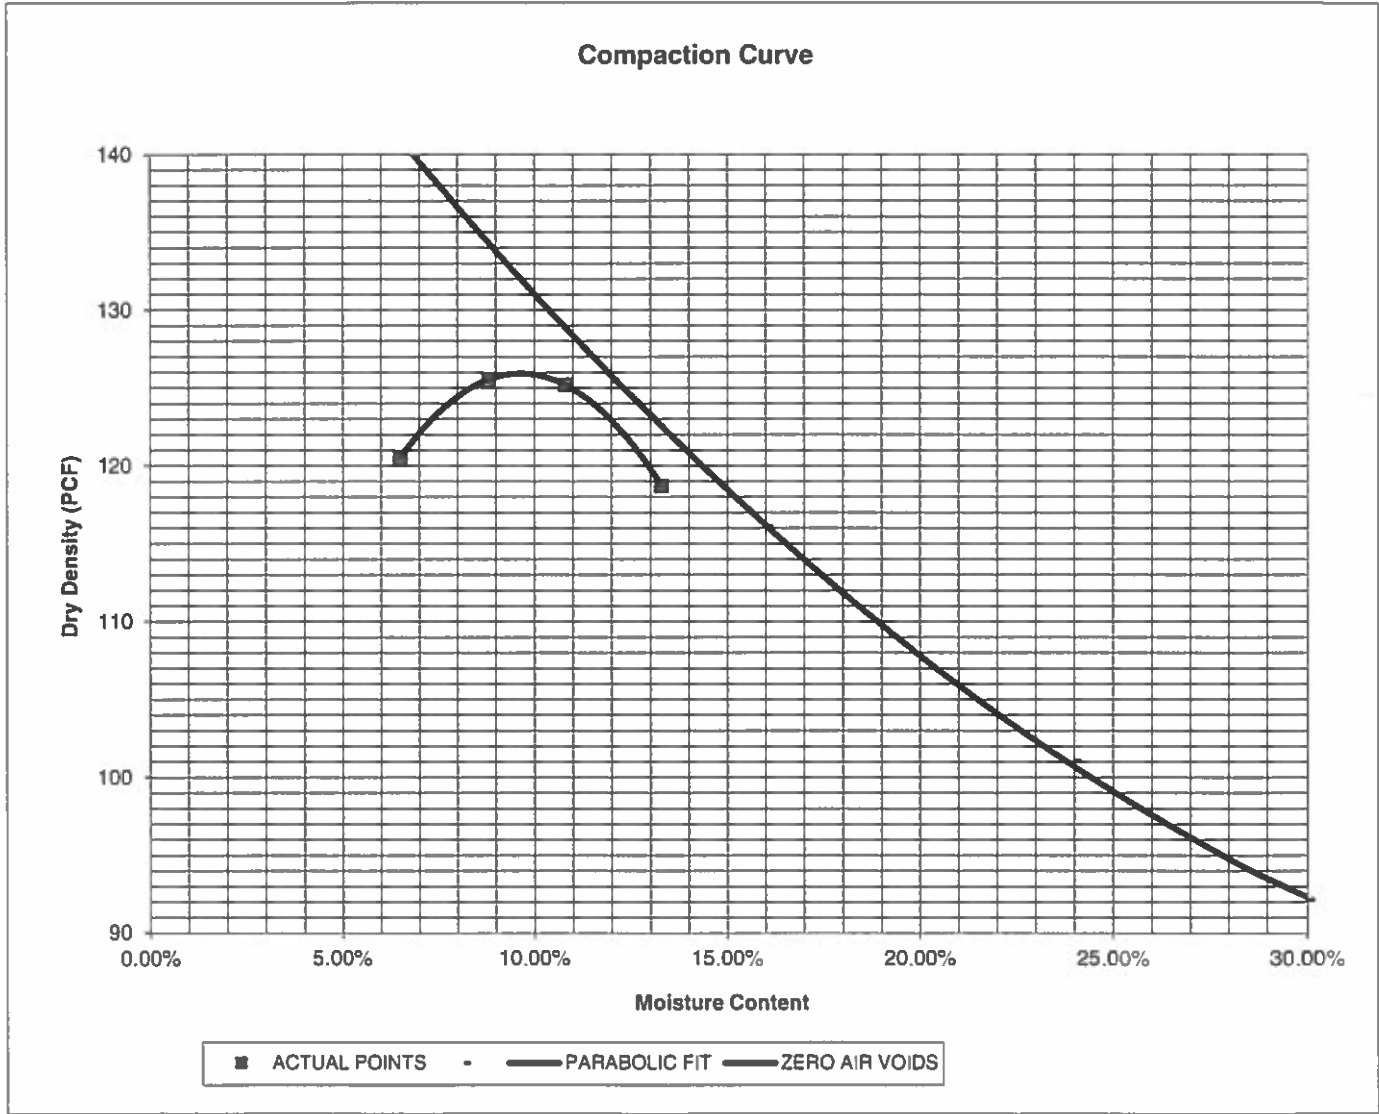
**MOISTURE DENSITY RELATION**

<b>PROJECT</b>	CLEARVIEW LOOP	<b>CLIENT</b>	CLEARVIEW PROPERTIES
<b>SAMPLE LOCATION</b>	TB'S 1 & 2	<b>JOB NO.</b>	201777
<b>SOIL DESCRIPTION</b>	SAND, SILTY, BROWN	<b>DATE</b>	09/14/20

<b>IDENTIFICATION</b>	SM	<b>PROCTOR TEST #</b>	1
<b>TEST DESIGNATION / METHOD</b>	ASTM D-1557-A	<b>TEST BY</b>	AL
<b>MAXIMUM DRY DENSITY (PCF)</b>	125.9	<b>OPTIMUM MOISTURE</b>	9.7%

New fill should be placed in lifts not to exceed 6 inches after compaction while maintaining at least 95% of its maximum Modified Proctor Dry Density, ASTM D-1557. These materials should be placed at a moisture content conducive to compaction, usually  $\pm 2\%$  of Proctor optimum moisture content. The placement and compaction of fill should be observed and tested by Entech during construction/grading. Entech should approve any import materials prior to hauling them to the site.
