ENTECH ENGINEERING, INC.

WASTEWATER (OWTS) STUDY RETREAT AT TIMBERRIDGE, FILING 3 VOLLMER ROAD AND ARROYA LANE EL PASO COUNTY, COLORADO

June 10, 2022

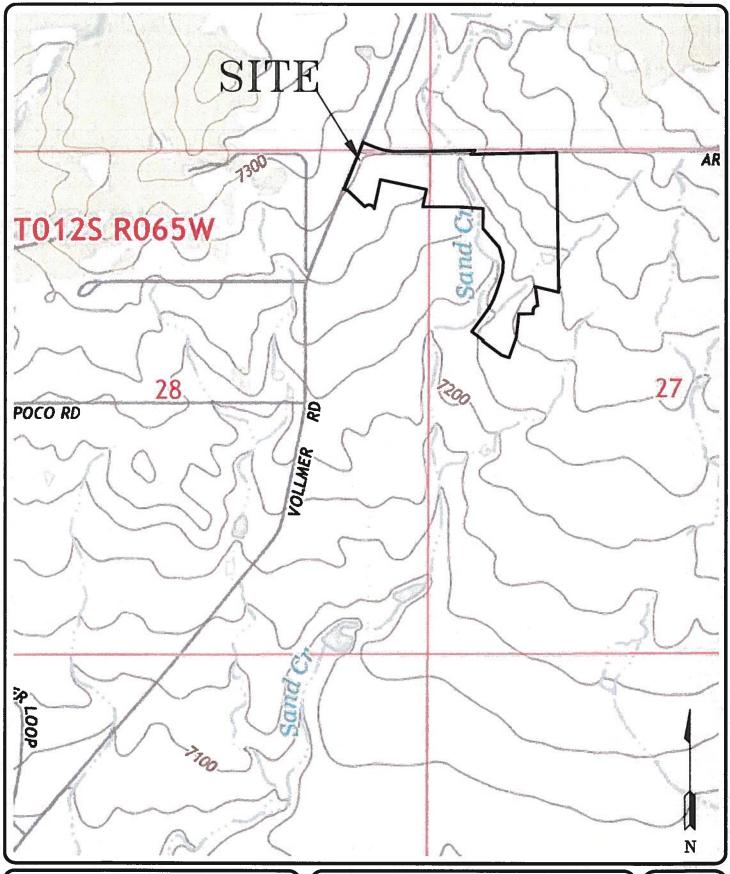
JOB NO.: 221106 FIG NO.: 2

USGS MAP
RETREAT AT TIMBERRIDGE, FILING 3
VOLLMER ROAD AND ARROYA LANE
EL PASO COUNTY, CO.
FOR: TIMBERRIDGE DEVELOPMENT GROUP, LLC

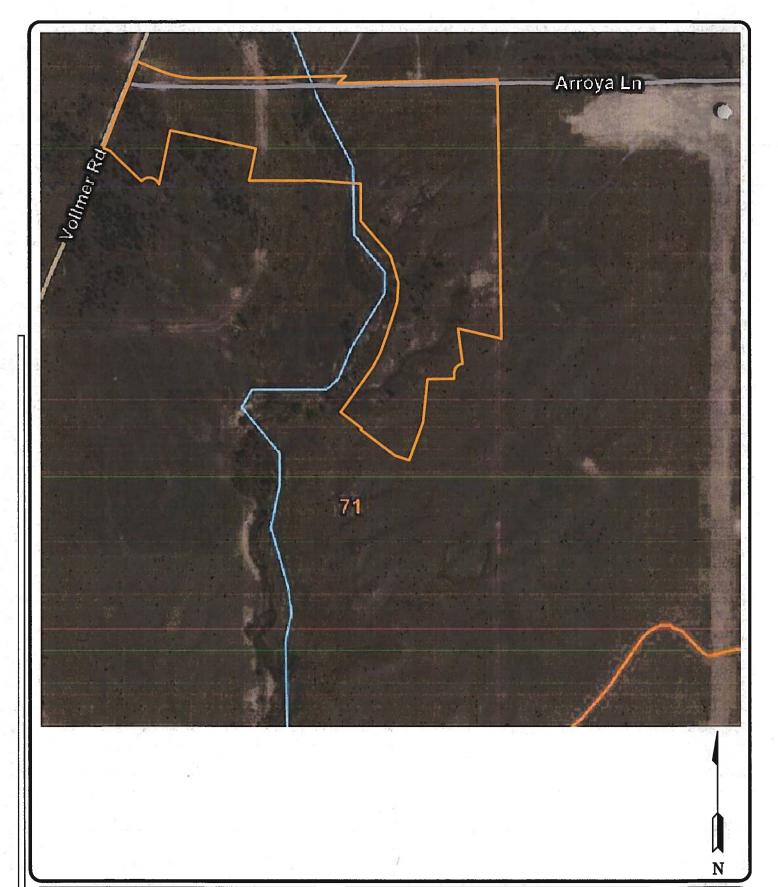
4

SOIL SURVEY MAP
RETREAT AT TIMBERRIDGE, FILING 3
VOLLMER ROAD AND ARROYA LANE
EL PASO COUNTY, CO.
FOR: TIMBERRIDGE DEVELOPMENT GROUP, LLC

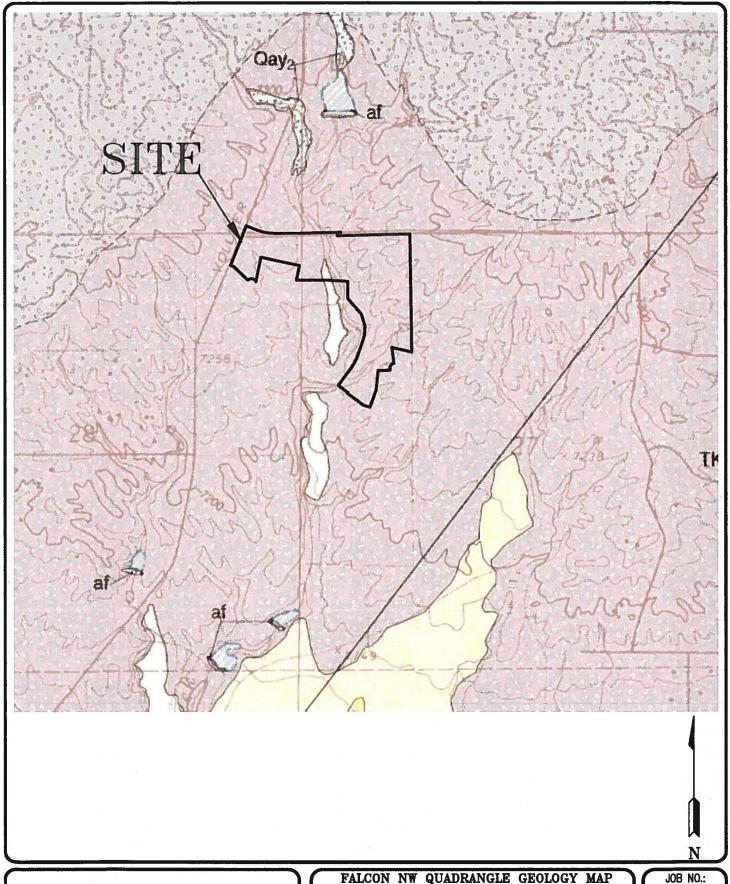
221106 FIG NO.: 5

FALCON NW QUADRANGLE GEOLOGY MAP RETREAT AT TIMBERRIDGE, FILING 3 VOLLMER ROAD AND ARROYA LANE EL PASO COUNTY, CO. FOR: TIMBERRIDGE DEVELOPMENT GROUP, LLC DATE: 6/7/22 DRAWN: LLL CHECKED: DATE:

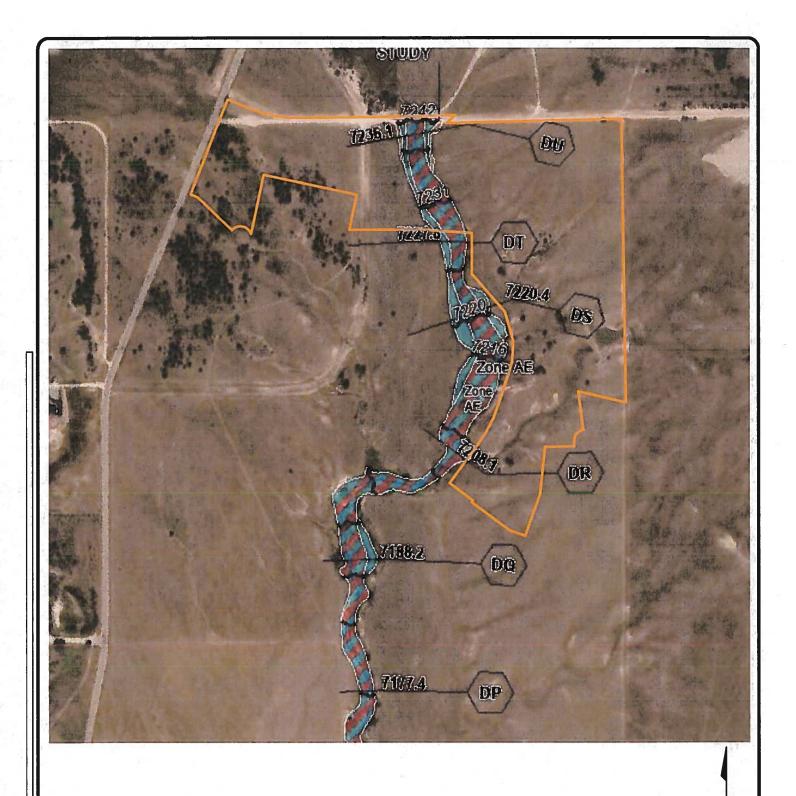
FLOODPLAIN MAP
RETREAT AT TIMBERRIDGE, FILING 3
VOLLMER ROAD AND ARROYA LANE
EL PASO COUNTY, CO.
FOR: TIMBERRIDGE DEVELOPMENT GROUP, LLC

Areas within the drainages on-site have been identified as areas of seasonally wet and/or seasonally high groundwater areas. Water was observed in the three ponds on-site, and flowing in Sand Creek. The majority of the drainages across the site were dry. The site is mapped within floodplain zones according to the FEMA Map No. 08041CO535G, Figure 7 (Reference 8). The floodplain area is to consist of open space/ park for the development. These areas are discussed as follows:

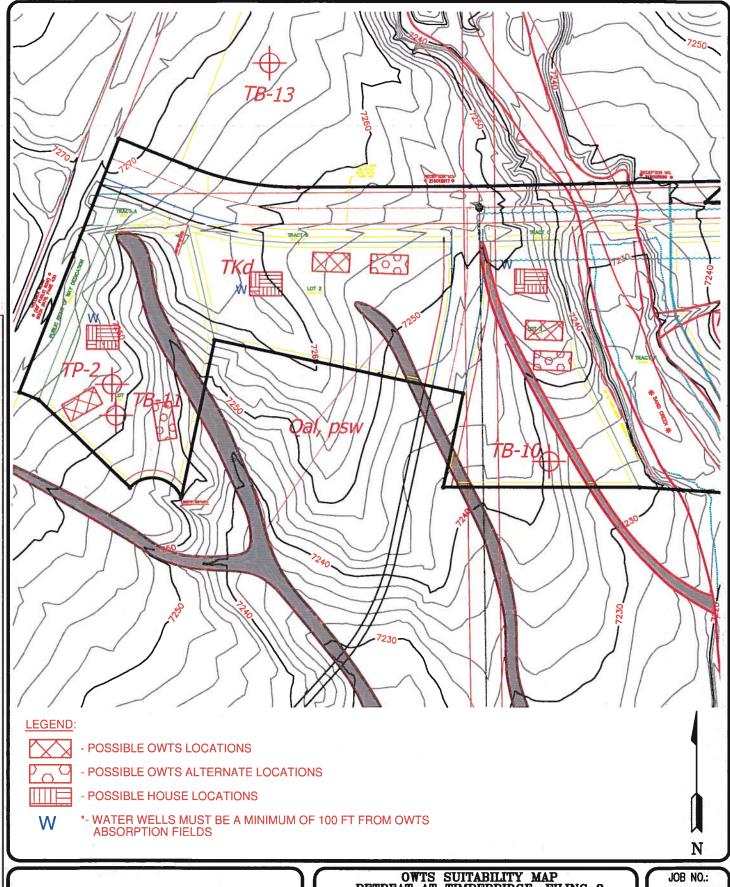
221106 FIG NO.: 8 APPENDIX A: Site Photographs

OWTS SUITABILITY MAP
RETREAT AT TIMBERRIDGE, FILING 3
VOLLMER ROAD AND ARROYA LANE
EL PASO COUNTY, CO.
FOR: TIMBERRIDGE DEVELOPMENT GROUP, LLC

The site was evaluated for on-site wastewater treatment systems for the proposed lots in accordance with El Paso Land Development Code. Six (6) tactile test pits were performed across the larger lots, Test Pit Nos. 1 and 2 are located within Filing No. 3. Test pits were located in anticipated locations of proposed on-site wastewater treatment system (OWTS) for the rural lots. The locations were chosen to determine a general understanding of the soil and bedrock conditions across the site. The results of the test pits are presented in Table 2, and Test Pit Logs are included in Appendix D. The approximate locations of the test pits are indicated on Figure 3 and 6, and on the Septic Suitability Map, Figure 8.

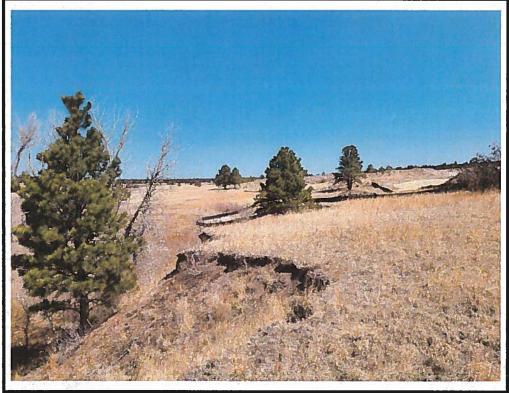
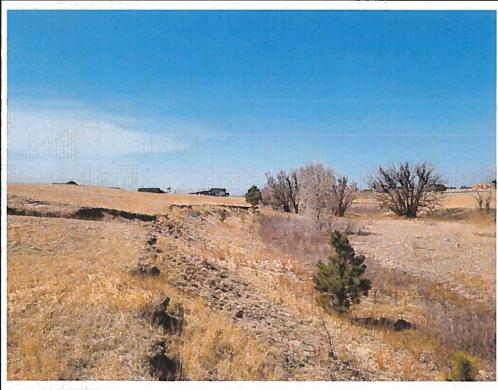
Looking north along the eastern side of Sand Creek.

Looking south along the eastern side of Sand Creek.

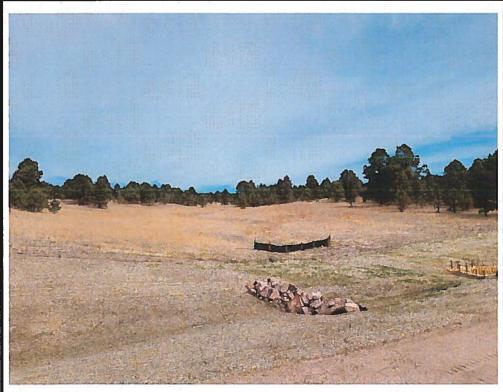
Looking northwest along minor drainage in the northwestern portion of the site.

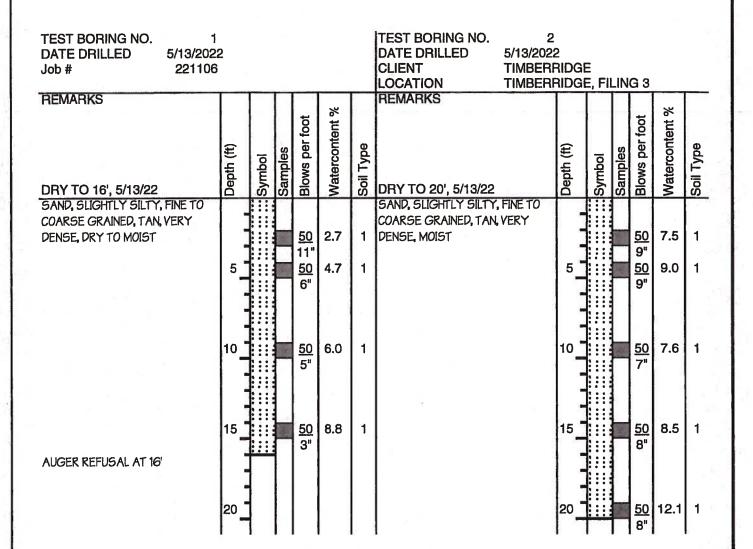
JOB NO. 221106 FIG NO. B-Z **APPENDIX C: Laboratory Test Results**

TEST BORING LOG						
DRAWN:	DATE:	CHECKED:	DATE: 6/6/22

TEST BORING NO. TEST BORING NO. 3 DATE DRILLED DATE DRILLED 5/13/2022 CLIENT **TIMBERRIDGE** Job# 221106 LOCATION TIMBERRIDGE, FILING 3 REMARKS REMARKS Watercontent % Watercontent % Blows per foot Blows per foot Samples Depth (ft) Depth (ft) Symbol Symbol DRY TO 17', 5/13/22 SAND, SILTY TO SLIGHTLY SILTY, FINE TO COARSE GRAINED, <u>50</u> 11" 6.3 1 TAN, VERY DENSE, MOIST 50 7.2 1 5 6" 10 <u>50</u> 7.2 1 10 5" 9.4 1 15 15 <u>50</u> 3" AUGER REFUSAL AT 17'

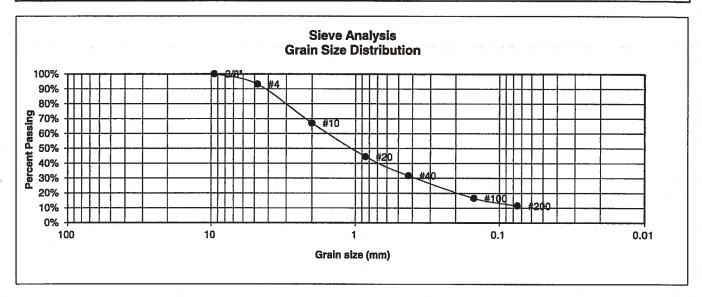
UNIFIED CLASSIFICATION	SM-SW	CLIENT	TIMBERRIDGE
SOIL TYPE #	1	PROJECT	TIMBERRIDGE, FILING 3
TEST BORING #	1	JOB NO.	221106
DEPTH (FT)	2-3	TEST BY	BL

U.S. <u>Sieve #</u> 3" 1 1/2"	Percent <u>Finer</u>	Atterberg <u>Limits</u> Plastic Limit NP Liquid Limit NV
3/4"		Plastic Index NP
1/2"		
3/8"	100.0%	
4	93.1%	<u>Swell</u>
10	67.0%	Moisture at start
20	44.4%	Moisture at finish
40	31.7%	Moisture increase
100	16.6%	Initial dry density (pcf)
200	11.4%	Swell (psf)

for below grade concrete degradation due to sulfate attack. Results of the laboratory testing are included in Appendix C. A Summary of Laboratory Test Results is presented in Table 1.

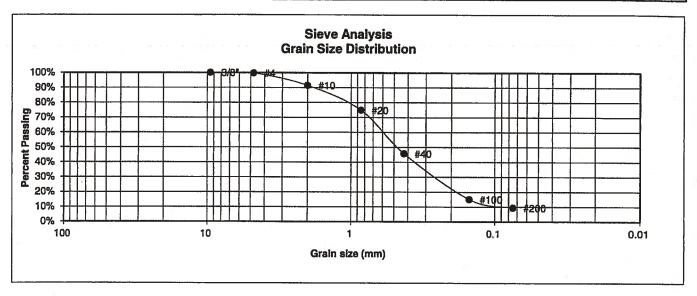
UNIFIED CLASSIFICATION	SM-SW	CLIENT	TIMBERRIDGE
SOIL TYPE #	1	PROJECT	TIMBERRIDGE, FILING 3
TEST BORING #	2	JOB NO.	221106
DEPTH (FT)	10	TEST BY	BL

U.S. Sieve # 3"	Percent <u>Finer</u>	Atterberg <u>Limits</u> Plastic Limit
1 1/2" 3/4" 1/2"		Liquid Limit Plastic Index
3/8"	100.0%	O
4	99.7%	<u>Swell</u>
10	91.4%	Moisture at start
20	74.8%	Moisture at finish
40	45.7%	Moisture increase
100	15.1%	Initial dry density (pcf)
200	9.3%	Swell (psf)

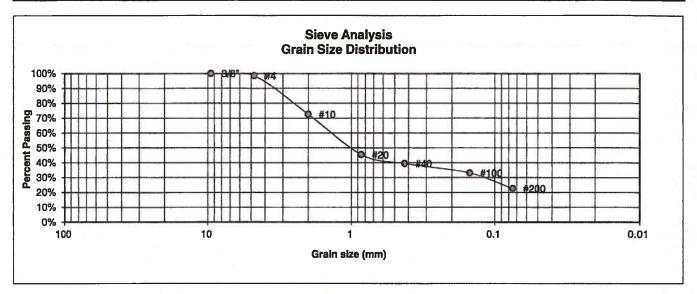
UNIFIED CLASSIFICATION	SM	CLIENT	TIMBERRIDGE
SOIL TYPE #	1	PROJECT	TIMBERRIDGE, FILING 3
TEST BORING #	3	JOB NO.	221106
DEPTH (FT)	5	TEST BY	BL

U.S. <u>Sieve #</u> 3" 1 1/2" 3/4" 1/2"	Percent <u>Finer</u>	Atterberg <u>Limits</u> Plastic Limit Liquid Limit Plastic Index
3/8"	100.0%	
4	98.4%	<u>Swell</u>
10	72.5%	Moisture at start
20	45.4%	Moisture at finish
40	39.4%	Moisture increase
100	33.1%	Initial dry density (pcf)
200	22.6%	Swell (psf)
