**Honor Charter School - No. EP-27-0008**

Good morning Amy, I'm following up on my voice mail from yesterday about the Honor Charter school located in El Paso County, town of Peyton.

Attached is an updated site plan with the Bore info and grading plan added, I'm hoping this will address item 1 and support 3 & 4.

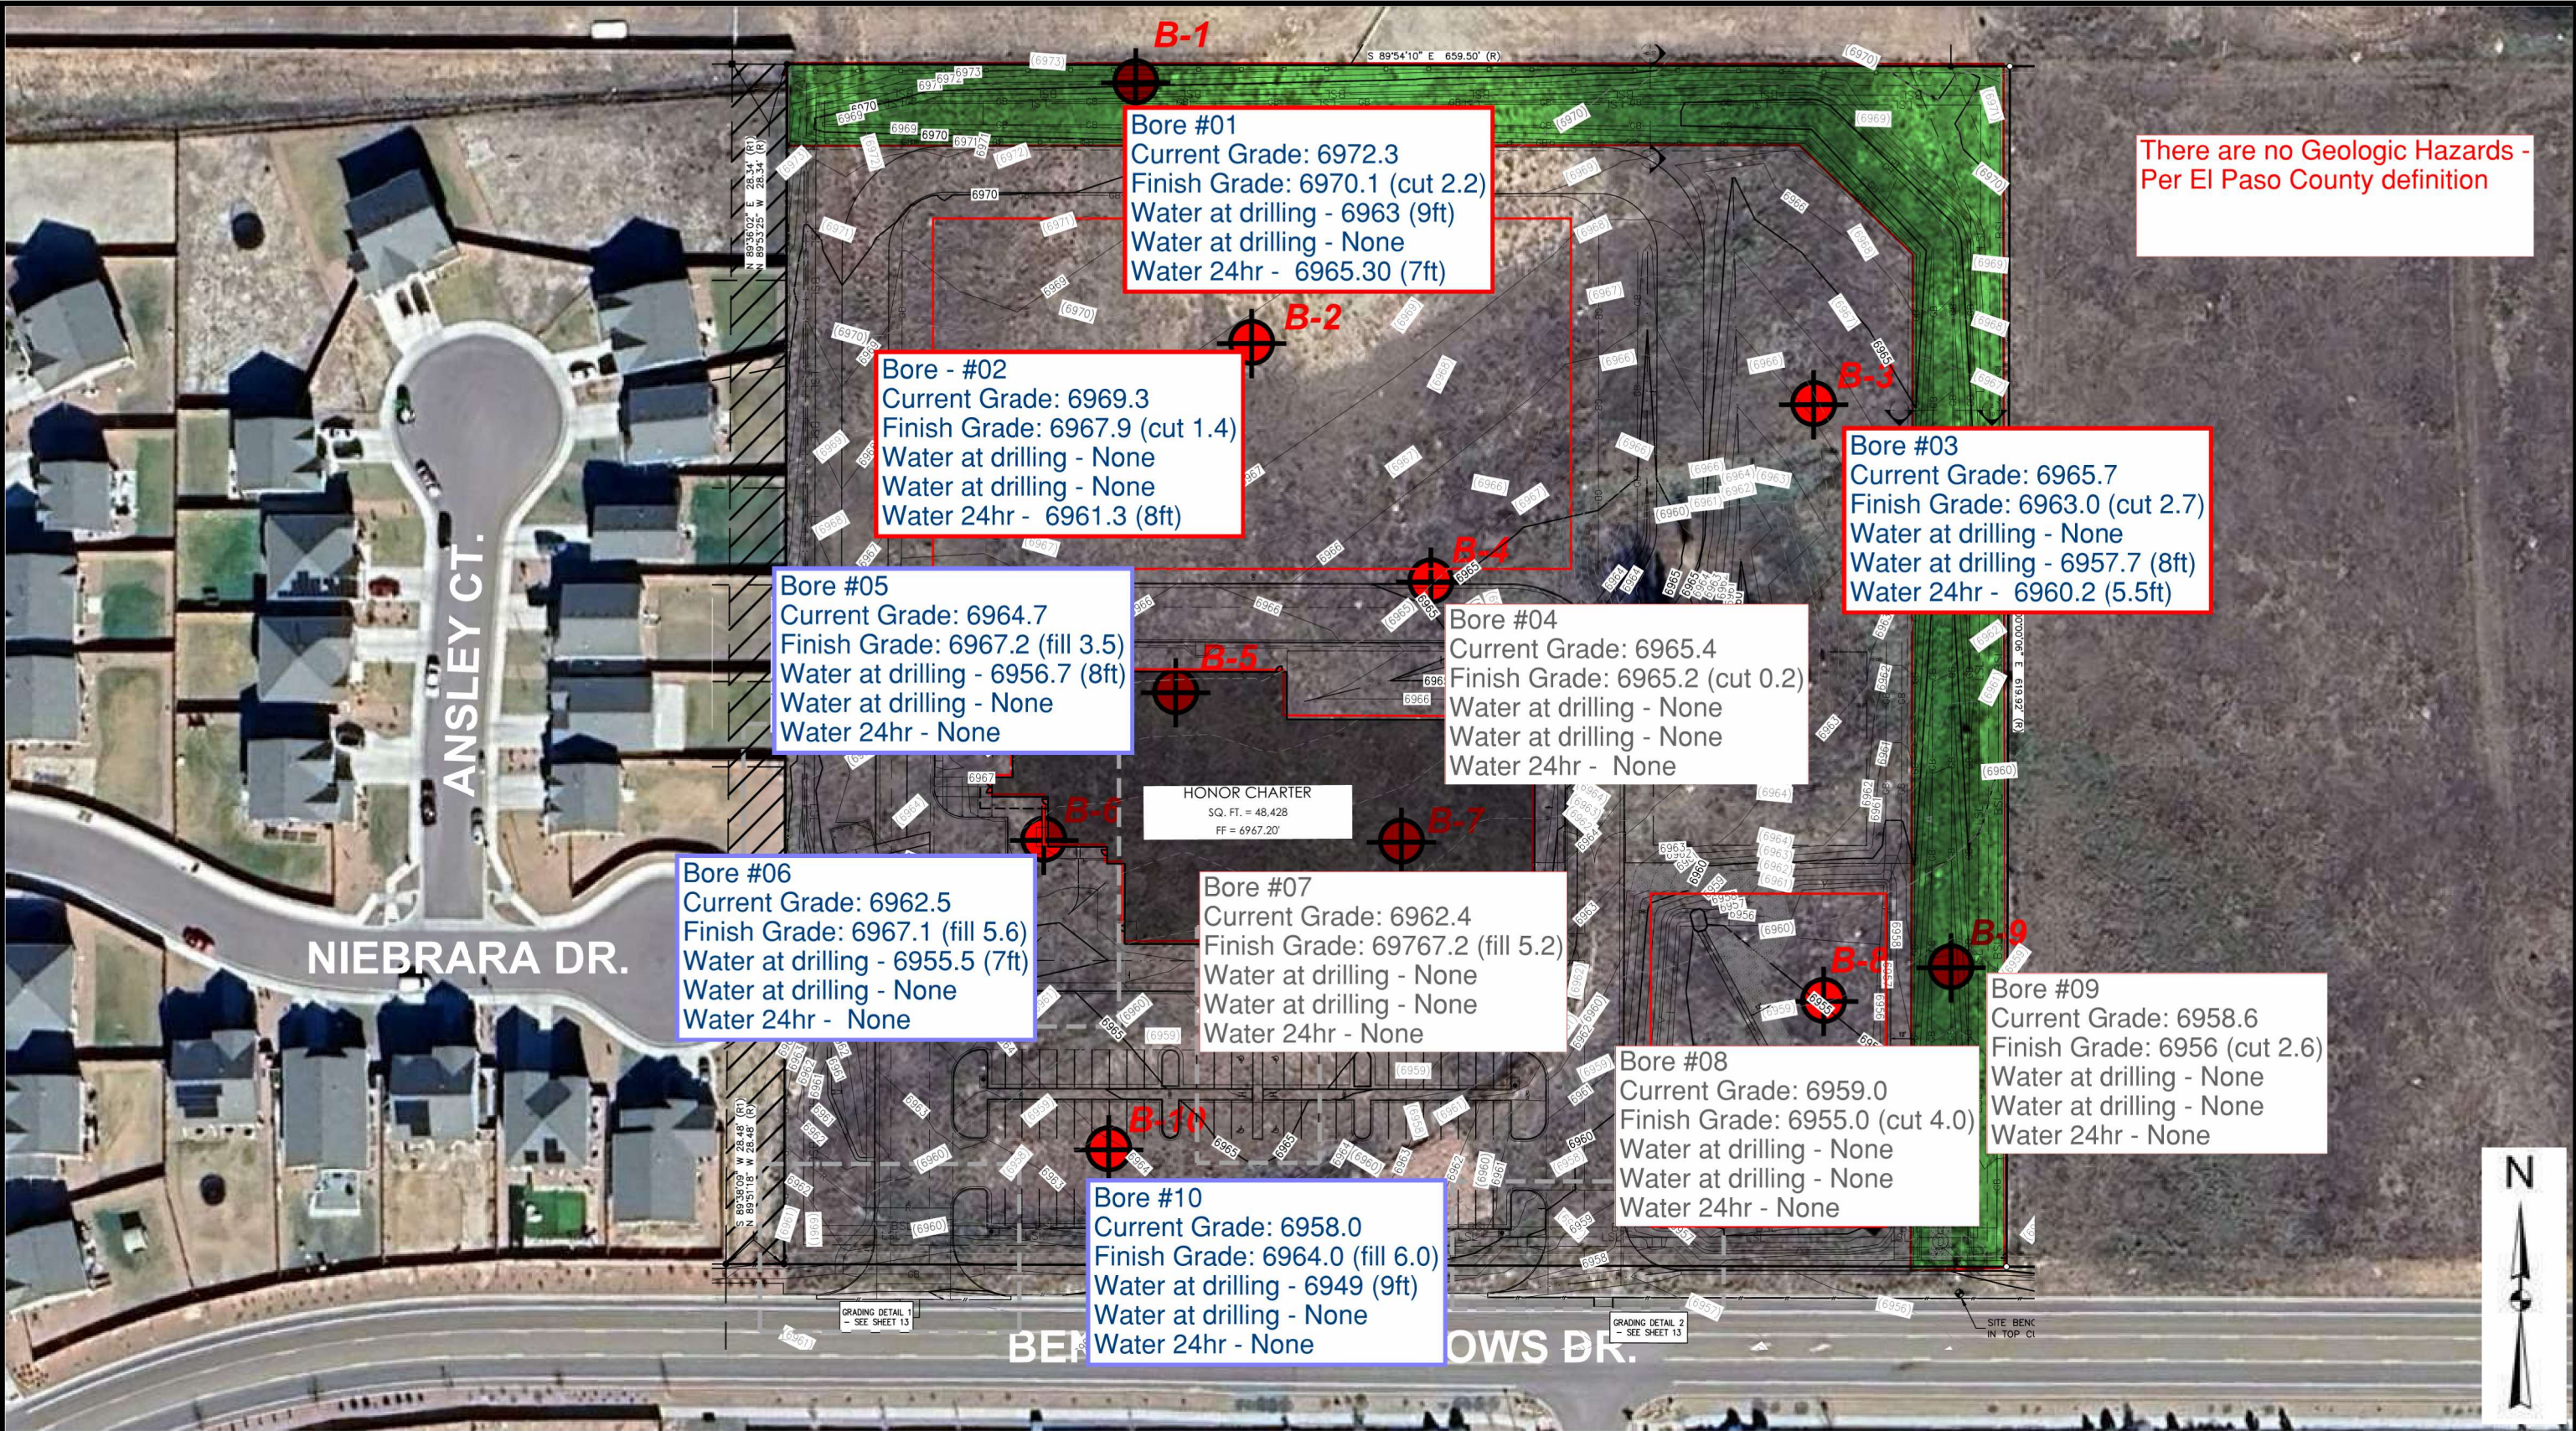
I'm a visual person (because I think it helps see solutions) so I used the text colour to indicate ground water - Blue for water and gray for no water (even after 24hrs)

I think used the box frame to indicate cut/fill at the bore that had water - red being cut (caution) and fill purple (consider)

As you mentioned in the report, we included the foundation drain even with the 3-5ft of will at the building site as a precaution. At the pond we internally shallowed the pond as much as possible, balancing the cut condition along the north side (of the pond) with the required volume. As a result, we were able to keep the cut to 4ft at the northside (see Bore #08) and almost at grade along the south (street). Additionally, the 3 closest bores (Bore #04, #07, #09) all shoed no ground water. As a result, we felt this would address any season conditions at the pond as it mimics a lot of the existing condition and is similar to improvements in the area.
