GEOLOGY AND SOILS REPORT

**Carriage Meadows South
El Paso County, Colorado**

JOB NO. 152427

**June 15, 2016
Amended June 29, 2016
Amended October 7, 2016**

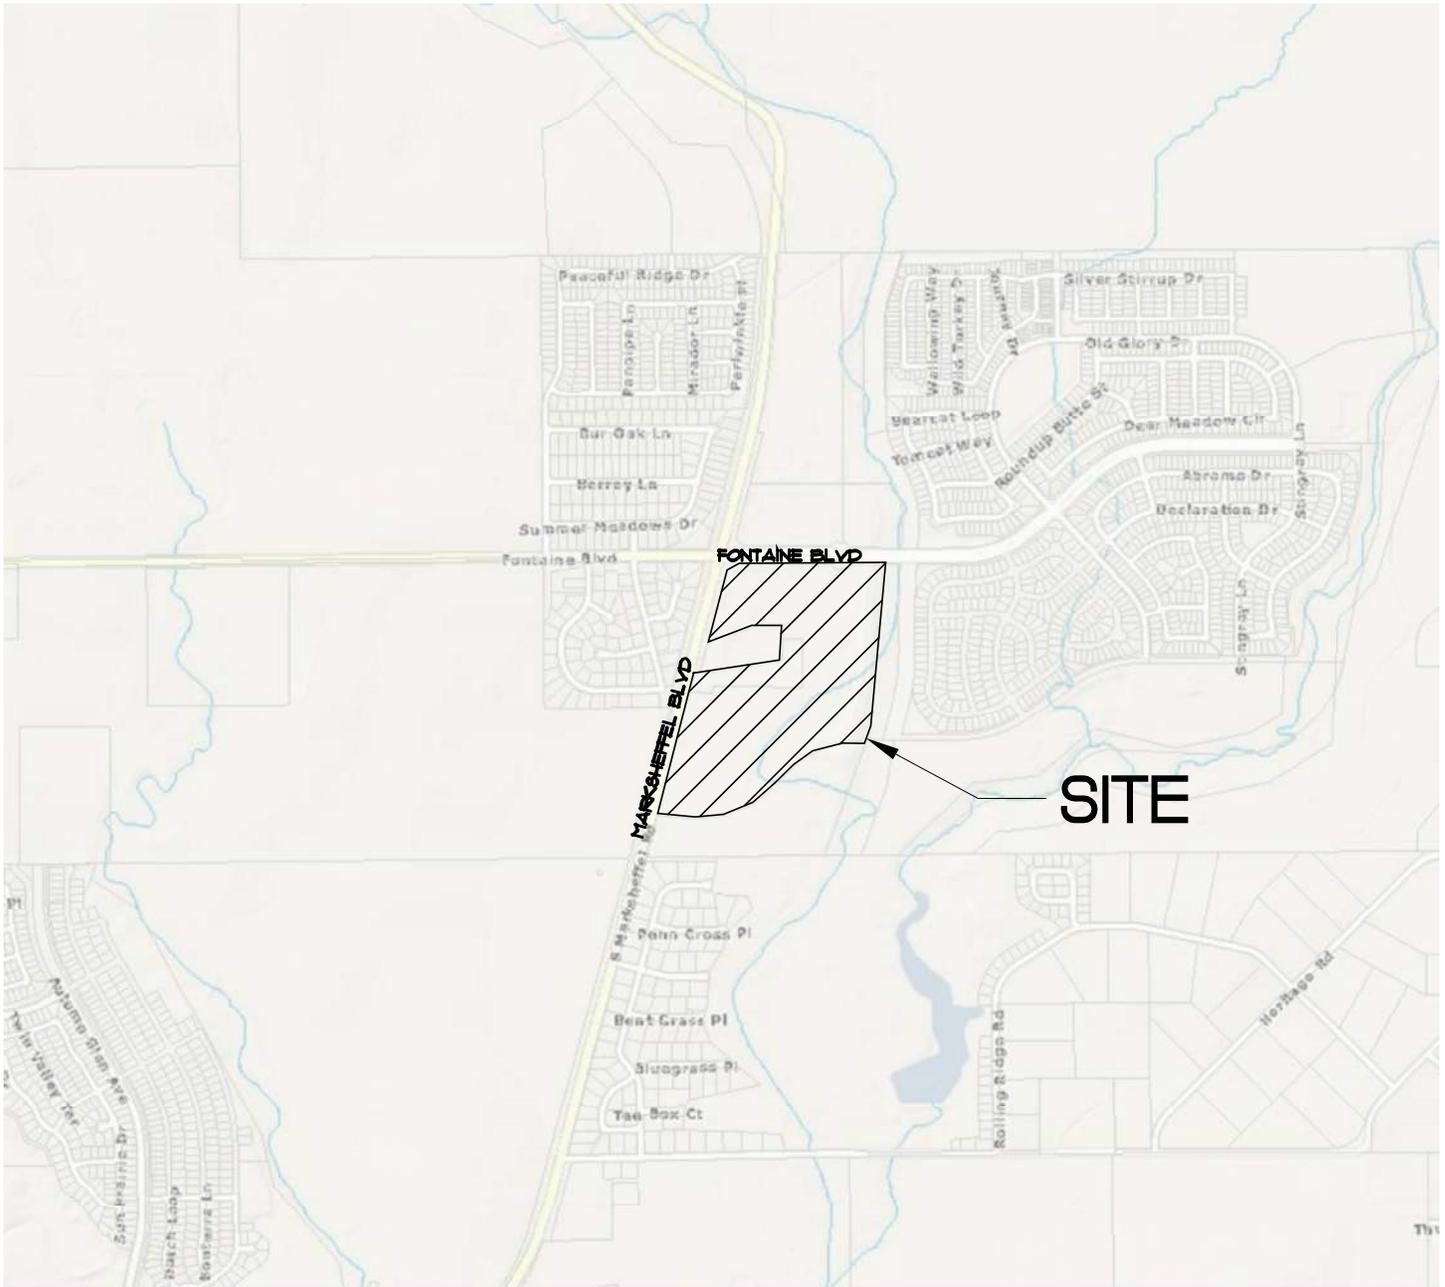
FIG No. 1

NOT TO SCALE

The project is generally located southeast of the intersection of Marksheffel Road and Fontaine Boulevard in El Paso County, Colorado. The proposed subdivision name is Carriage Meadows South. The approximate location of the site is shown on the Site Vicinity Map, Figure 1.

Figure 1 presents the general boundaries of our investigation.

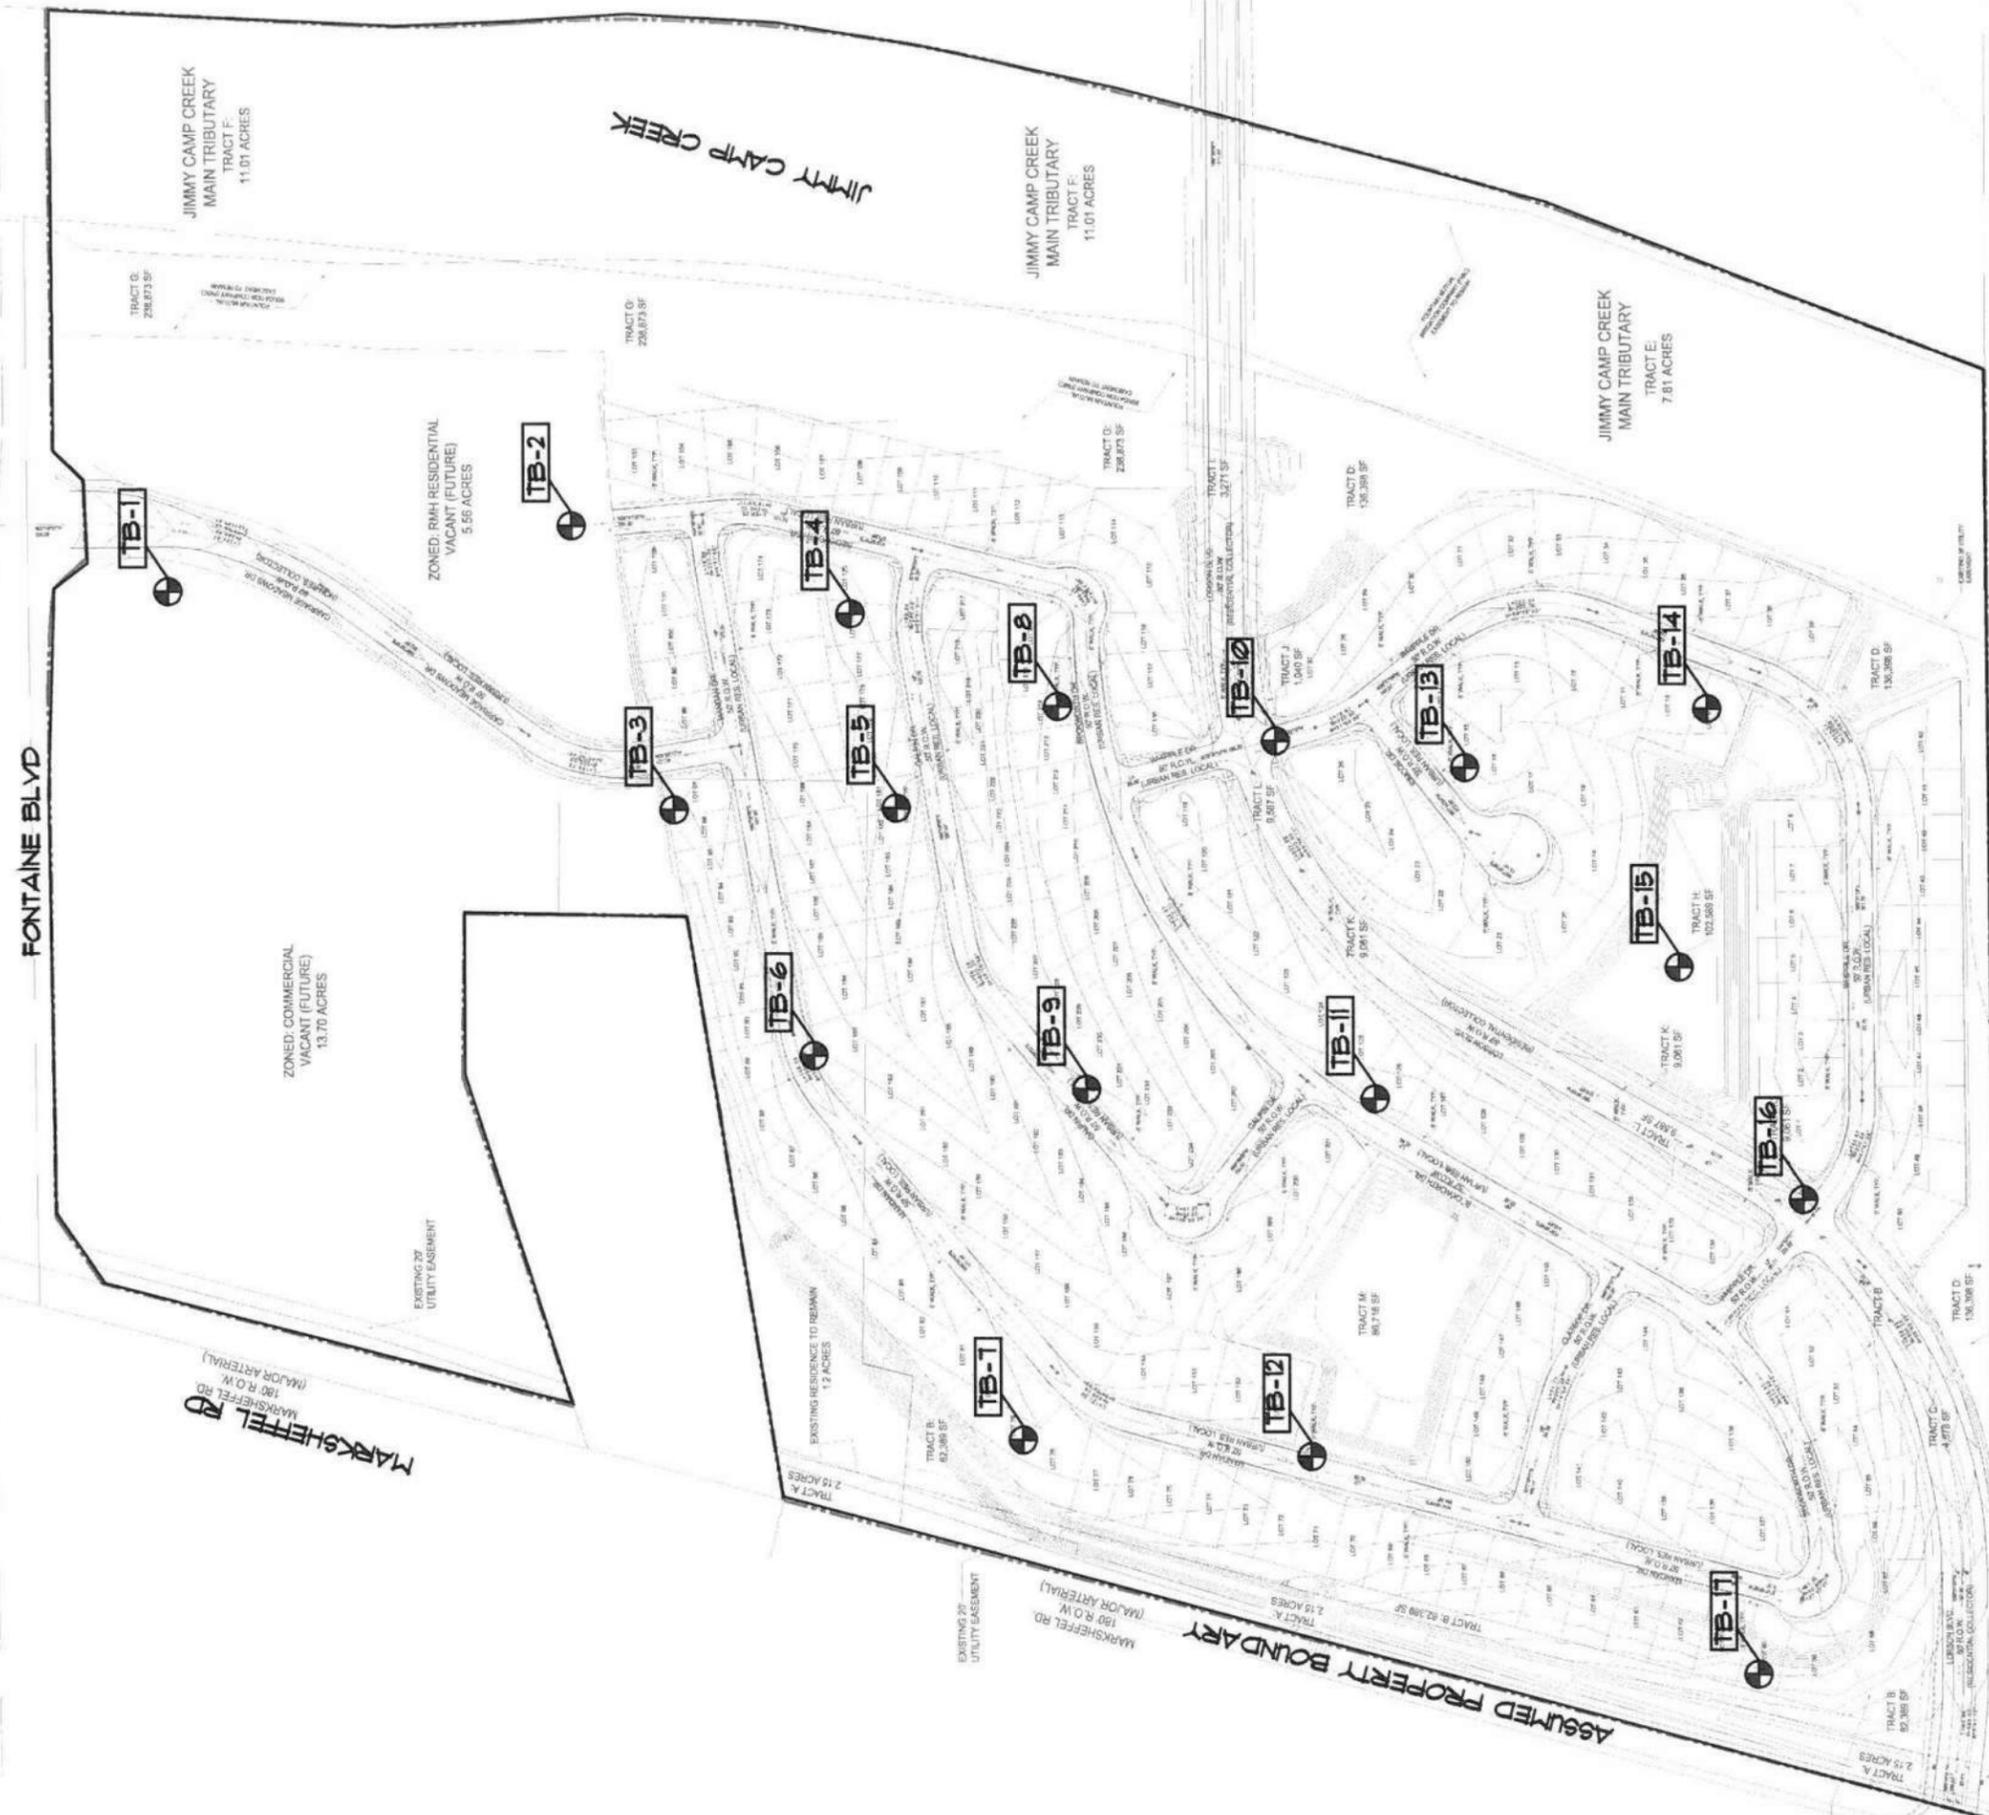
⊕ DENOTES APPROXIMATE
LOCATION OF TEST BORINGS

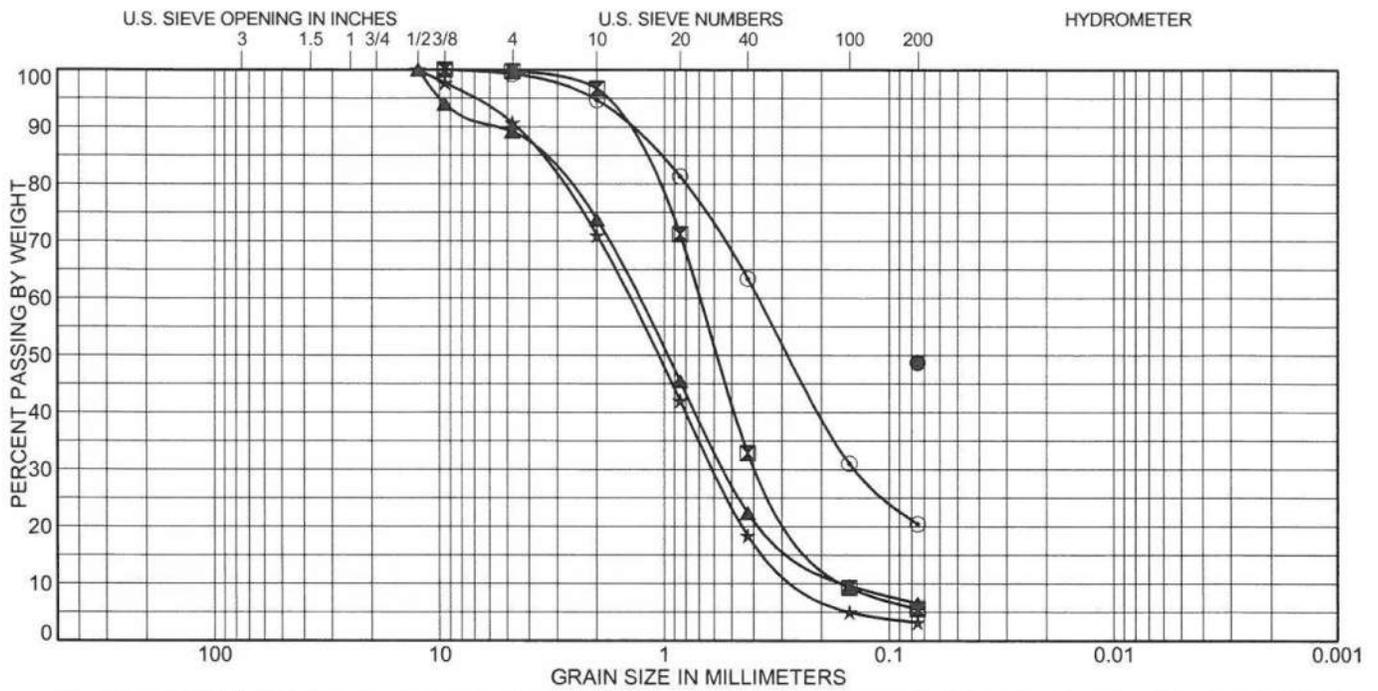
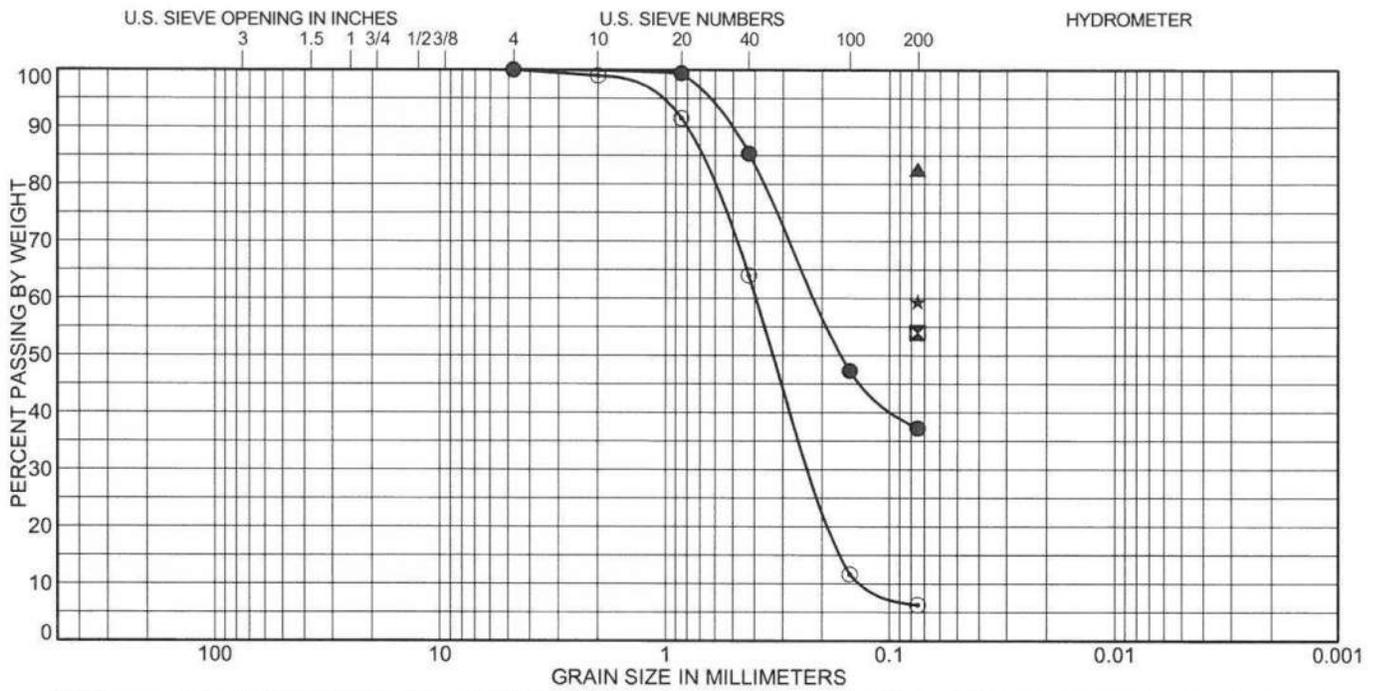
FIGURE No. 16

Test Boring	Depth (ft)	Classification	LL	PL	PI
● 6	4.0	SILTY SAND(SM)	NP	NP	NP
⊠ 6	19.0	SANDY SILT(ML)	NP	NP	NP
▲ 7	14.0	LEAN CLAY with SAND(CL)	31	17	14
★ 8	9.0	SANDY SILT(ML)	NP	NP	NP
⊙ 9	4.0	POORLY GRADED SAND with SILT(SP-SM)	NP	NP	NP

Test Boring	Depth (ft)	%Gravel	%Sand	%Silt	%Clay
● 6	4.0	0.0	62.7	37.3	
⊠ 6	19.0			54.0	
▲ 7	14.0			82.6	
★ 8	9.0			59.4	
⊙ 9	4.0	0.0	93.7	6.3

SOIL CLASSIFICATION DATA

Soil laboratory testing was performed as part of this investigation. The laboratory tests included moisture content, dry density, grain-size analyses, Atterberg Limits, Swell/Consolidation tests and one FHA swell test. A Summary of Laboratory Test Results is presented in Figure 14. Soils Classification Data is presented in Figures 15 through 18. Swell/Consolidation Test Results are presented in Figures 19 through 21.

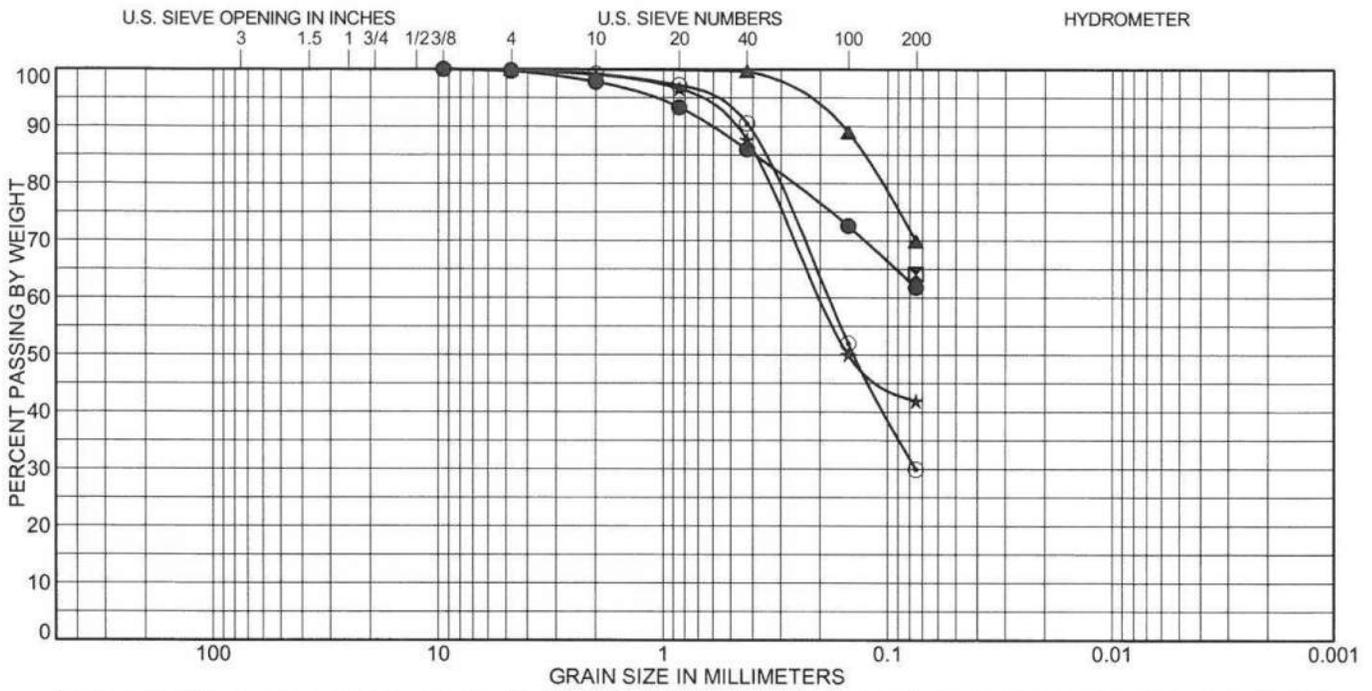
FIGURE No. 18

Test Boring	Depth (ft)	Classification	LL	PL	PI
● 14	29.0	SANDY LEAN CLAY(CL)	29	16	13
☒ 15	9.0	SANDY SILT(ML)	NP	NP	NP
▲ 16	14.0	SANDY SILT(ML)	NP	NP	NP
★ 16	24.0	CLAYEY SAND(SC)	40	22	18
⊙ 17	4.0	SILTY SAND(SM)	NP	NP	NP

Test Boring	Depth (ft)	%Gravel	%Sand	%Silt	%Clay
● 14	29.0	0.3	37.9	61.8	
☒ 15	9.0			64.1	
▲ 16	14.0	0.0	30.1	69.9	
★ 16	24.0	0.3	57.8	41.9	
⊙ 17	4.0	0.2	69.9	29.9

SOIL CLASSIFICATION DATA

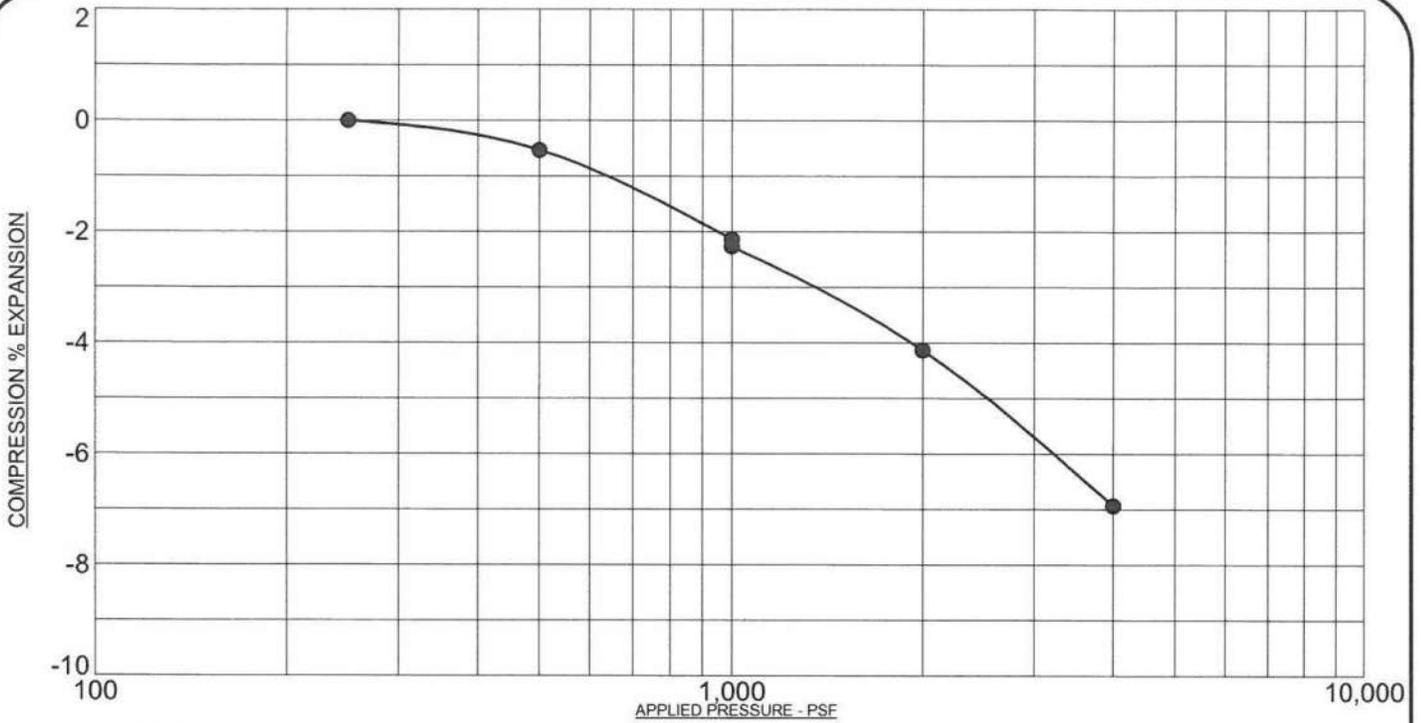
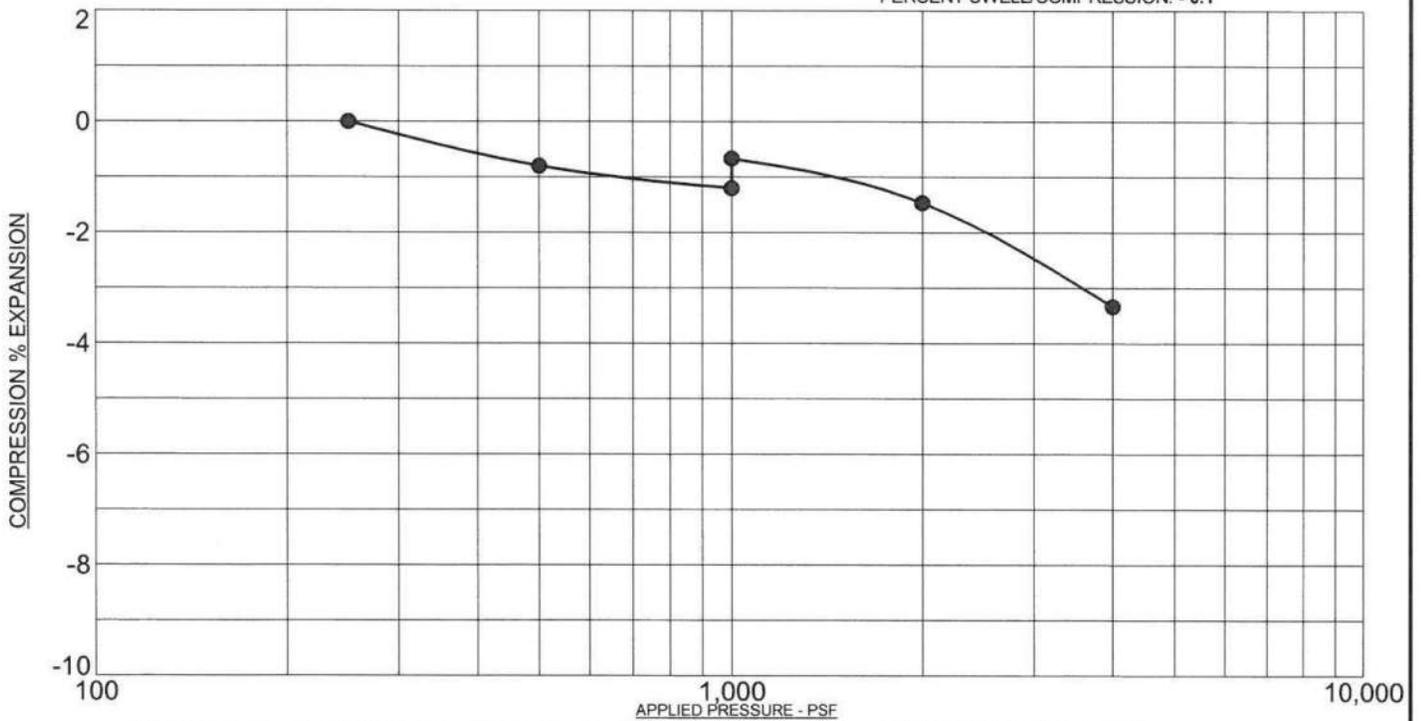
FIGURE No. 19

PROJECT: Carriage South Subdivision, El Paso County, Colorado
 SAMPLE DESCRIPTION: CLAY, SANDY
 NOTE: SAMPLE WAS INUNDATED WITH WATER AT 1,000 PSF

SAMPLE LOCATION: 6 @ 19 FT
 NATURAL DRY UNIT WEIGHT: 97.1 PCF
 NATURAL MOISTURE CONTENT: 19.0%
 PERCENT SWELL/COMPRESSION: - 0.1

SAMPLE LOCATION: 7 @ 14 FT
 NATURAL DRY UNIT WEIGHT: 98.0 PCF
 NATURAL MOISTURE CONTENT: 13.4%
 PERCENT SWELL/COMPRESSION: 0.5

**SWELL/CONSOLIDATION
 TEST RESULTS**

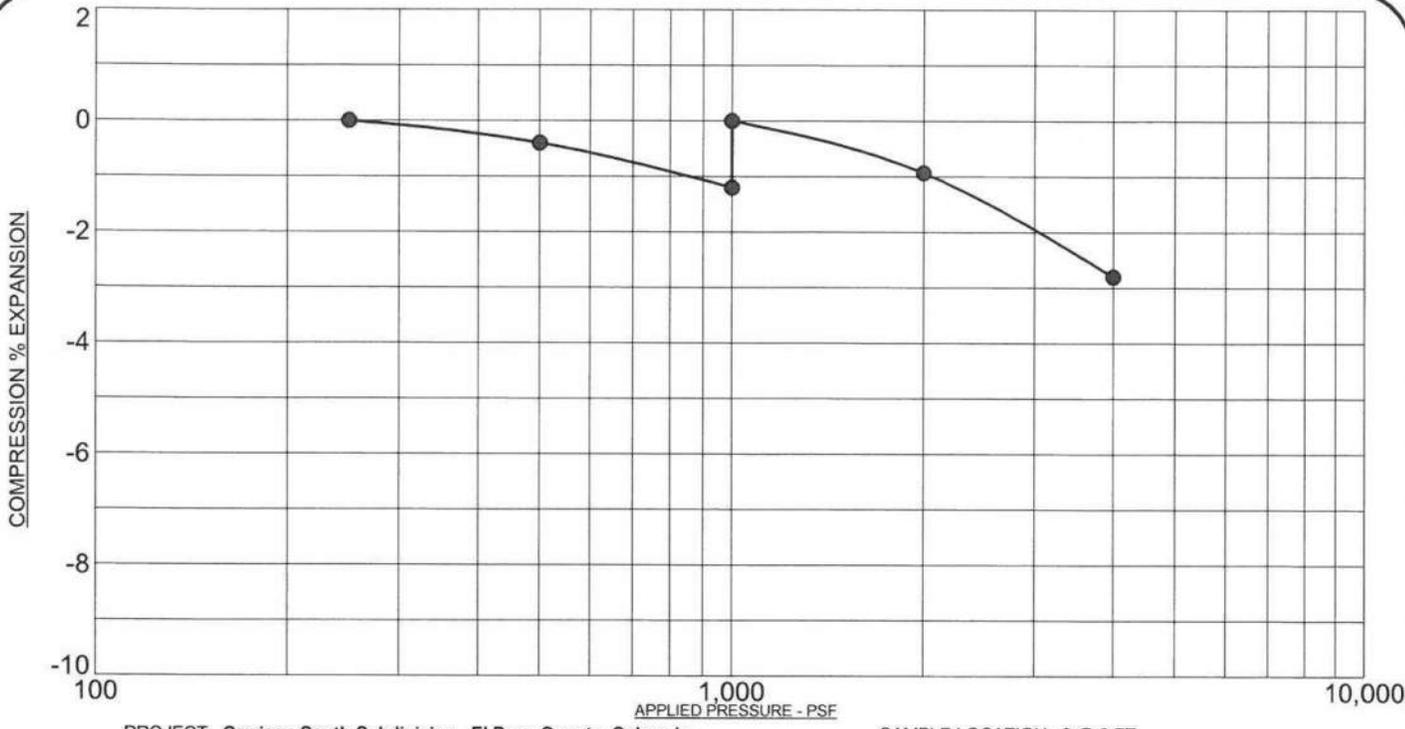
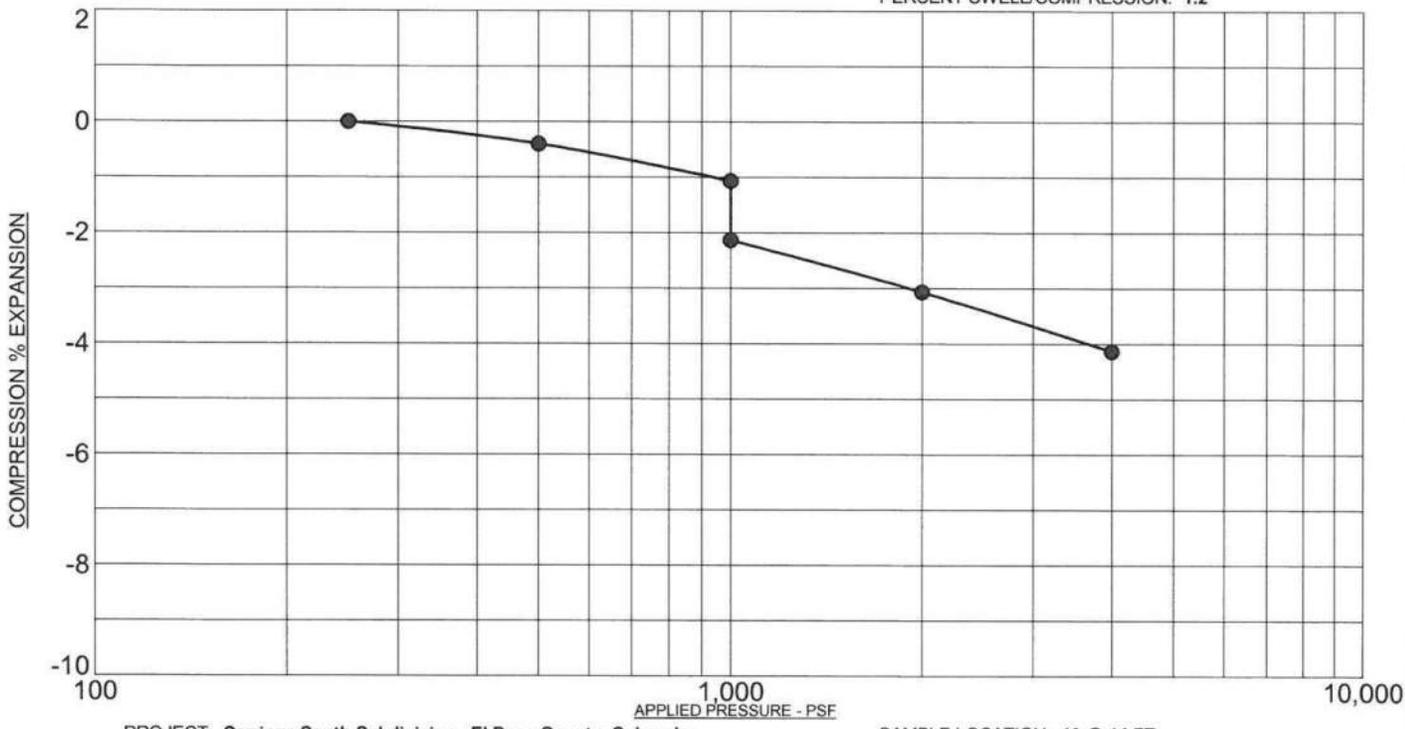
JOB No. 152427
 FIGURE No. 20
 DATE 6/29/16

PROJECT: Carriage South Subdivision, El Paso County, Colorado
 SAMPLE DESCRIPTION: SAND, SILTY
 NOTE: SAMPLE WAS INUNDATED WITH WATER AT 1,000 PSF

SAMPLE LOCATION: 8 @ 9 FT
 NATURAL DRY UNIT WEIGHT: 101.0 PCF
 NATURAL MOISTURE CONTENT: 8.8%
 PERCENT SWELL/COMPRESSION: 1.2

SAMPLE LOCATION: 10 @ 14 FT
 NATURAL DRY UNIT WEIGHT: 95.4 PCF
 NATURAL MOISTURE CONTENT: 6.4%
 PERCENT SWELL/COMPRESSION: - 1.1

SWELL/CONSOLIDATION TEST RESULTS

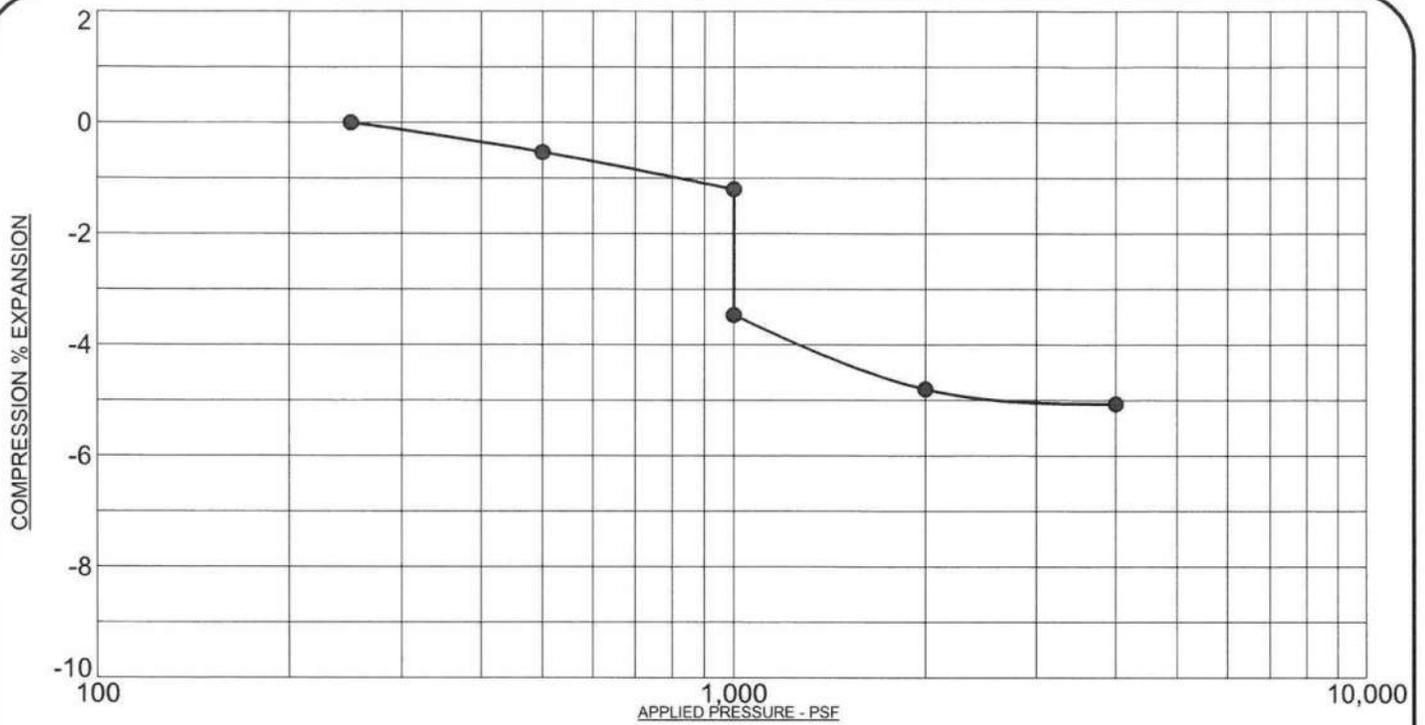
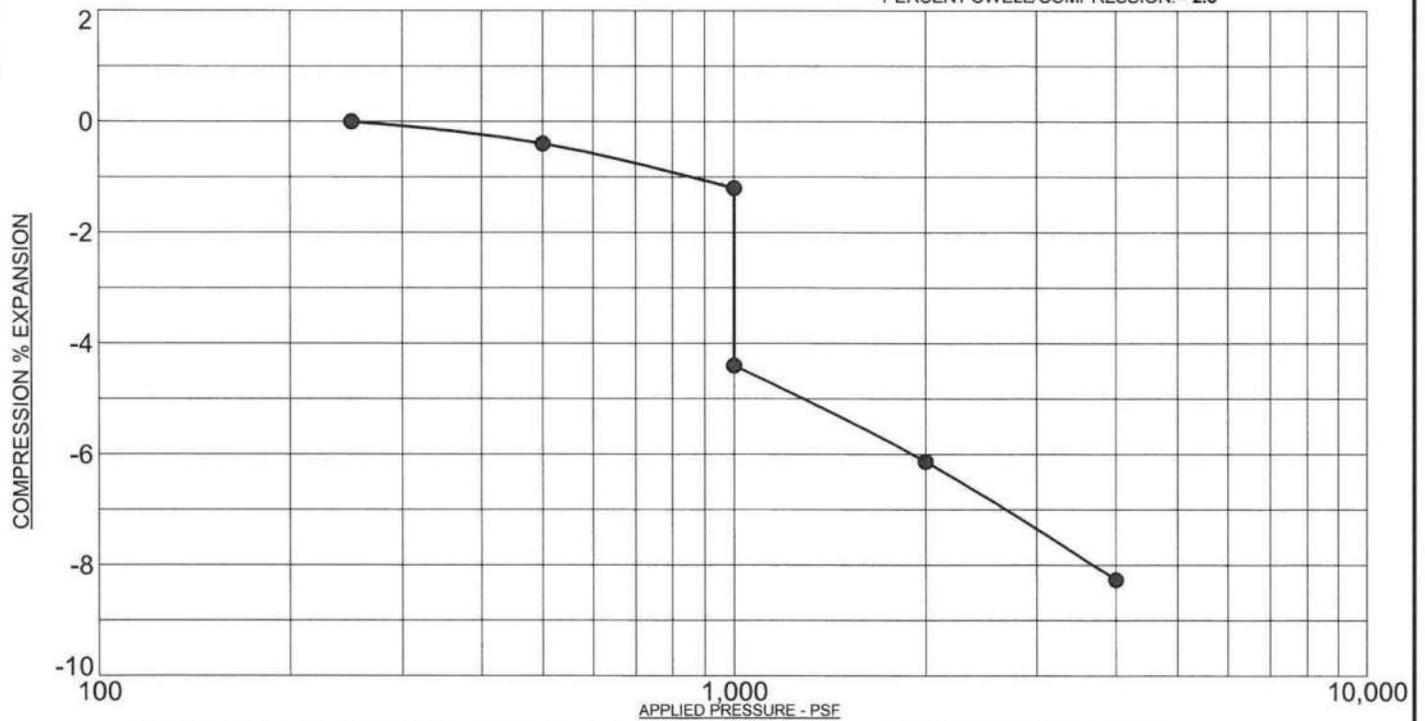
PROJECT: Carriage South Subdivision, El Paso County, Colorado
 SAMPLE DESCRIPTION: SAND, SILTY
 NOTE: SAMPLE WAS INUNDATED WITH WATER AT 1,000 PSF

SAMPLE LOCATION: 15 @ 9 FT
 NATURAL DRY UNIT WEIGHT: 88.4 PCF
 NATURAL MOISTURE CONTENT: 13.5%
 PERCENT SWELL/COMPRESSION: - 2.3

SAMPLE LOCATION: 16 @ 14 FT
 NATURAL DRY UNIT WEIGHT: 88.4 PCF
 NATURAL MOISTURE CONTENT: 11.1%
 PERCENT SWELL/COMPRESSION: - 3.2

SWELL/CONSOLIDATION TEST RESULTS

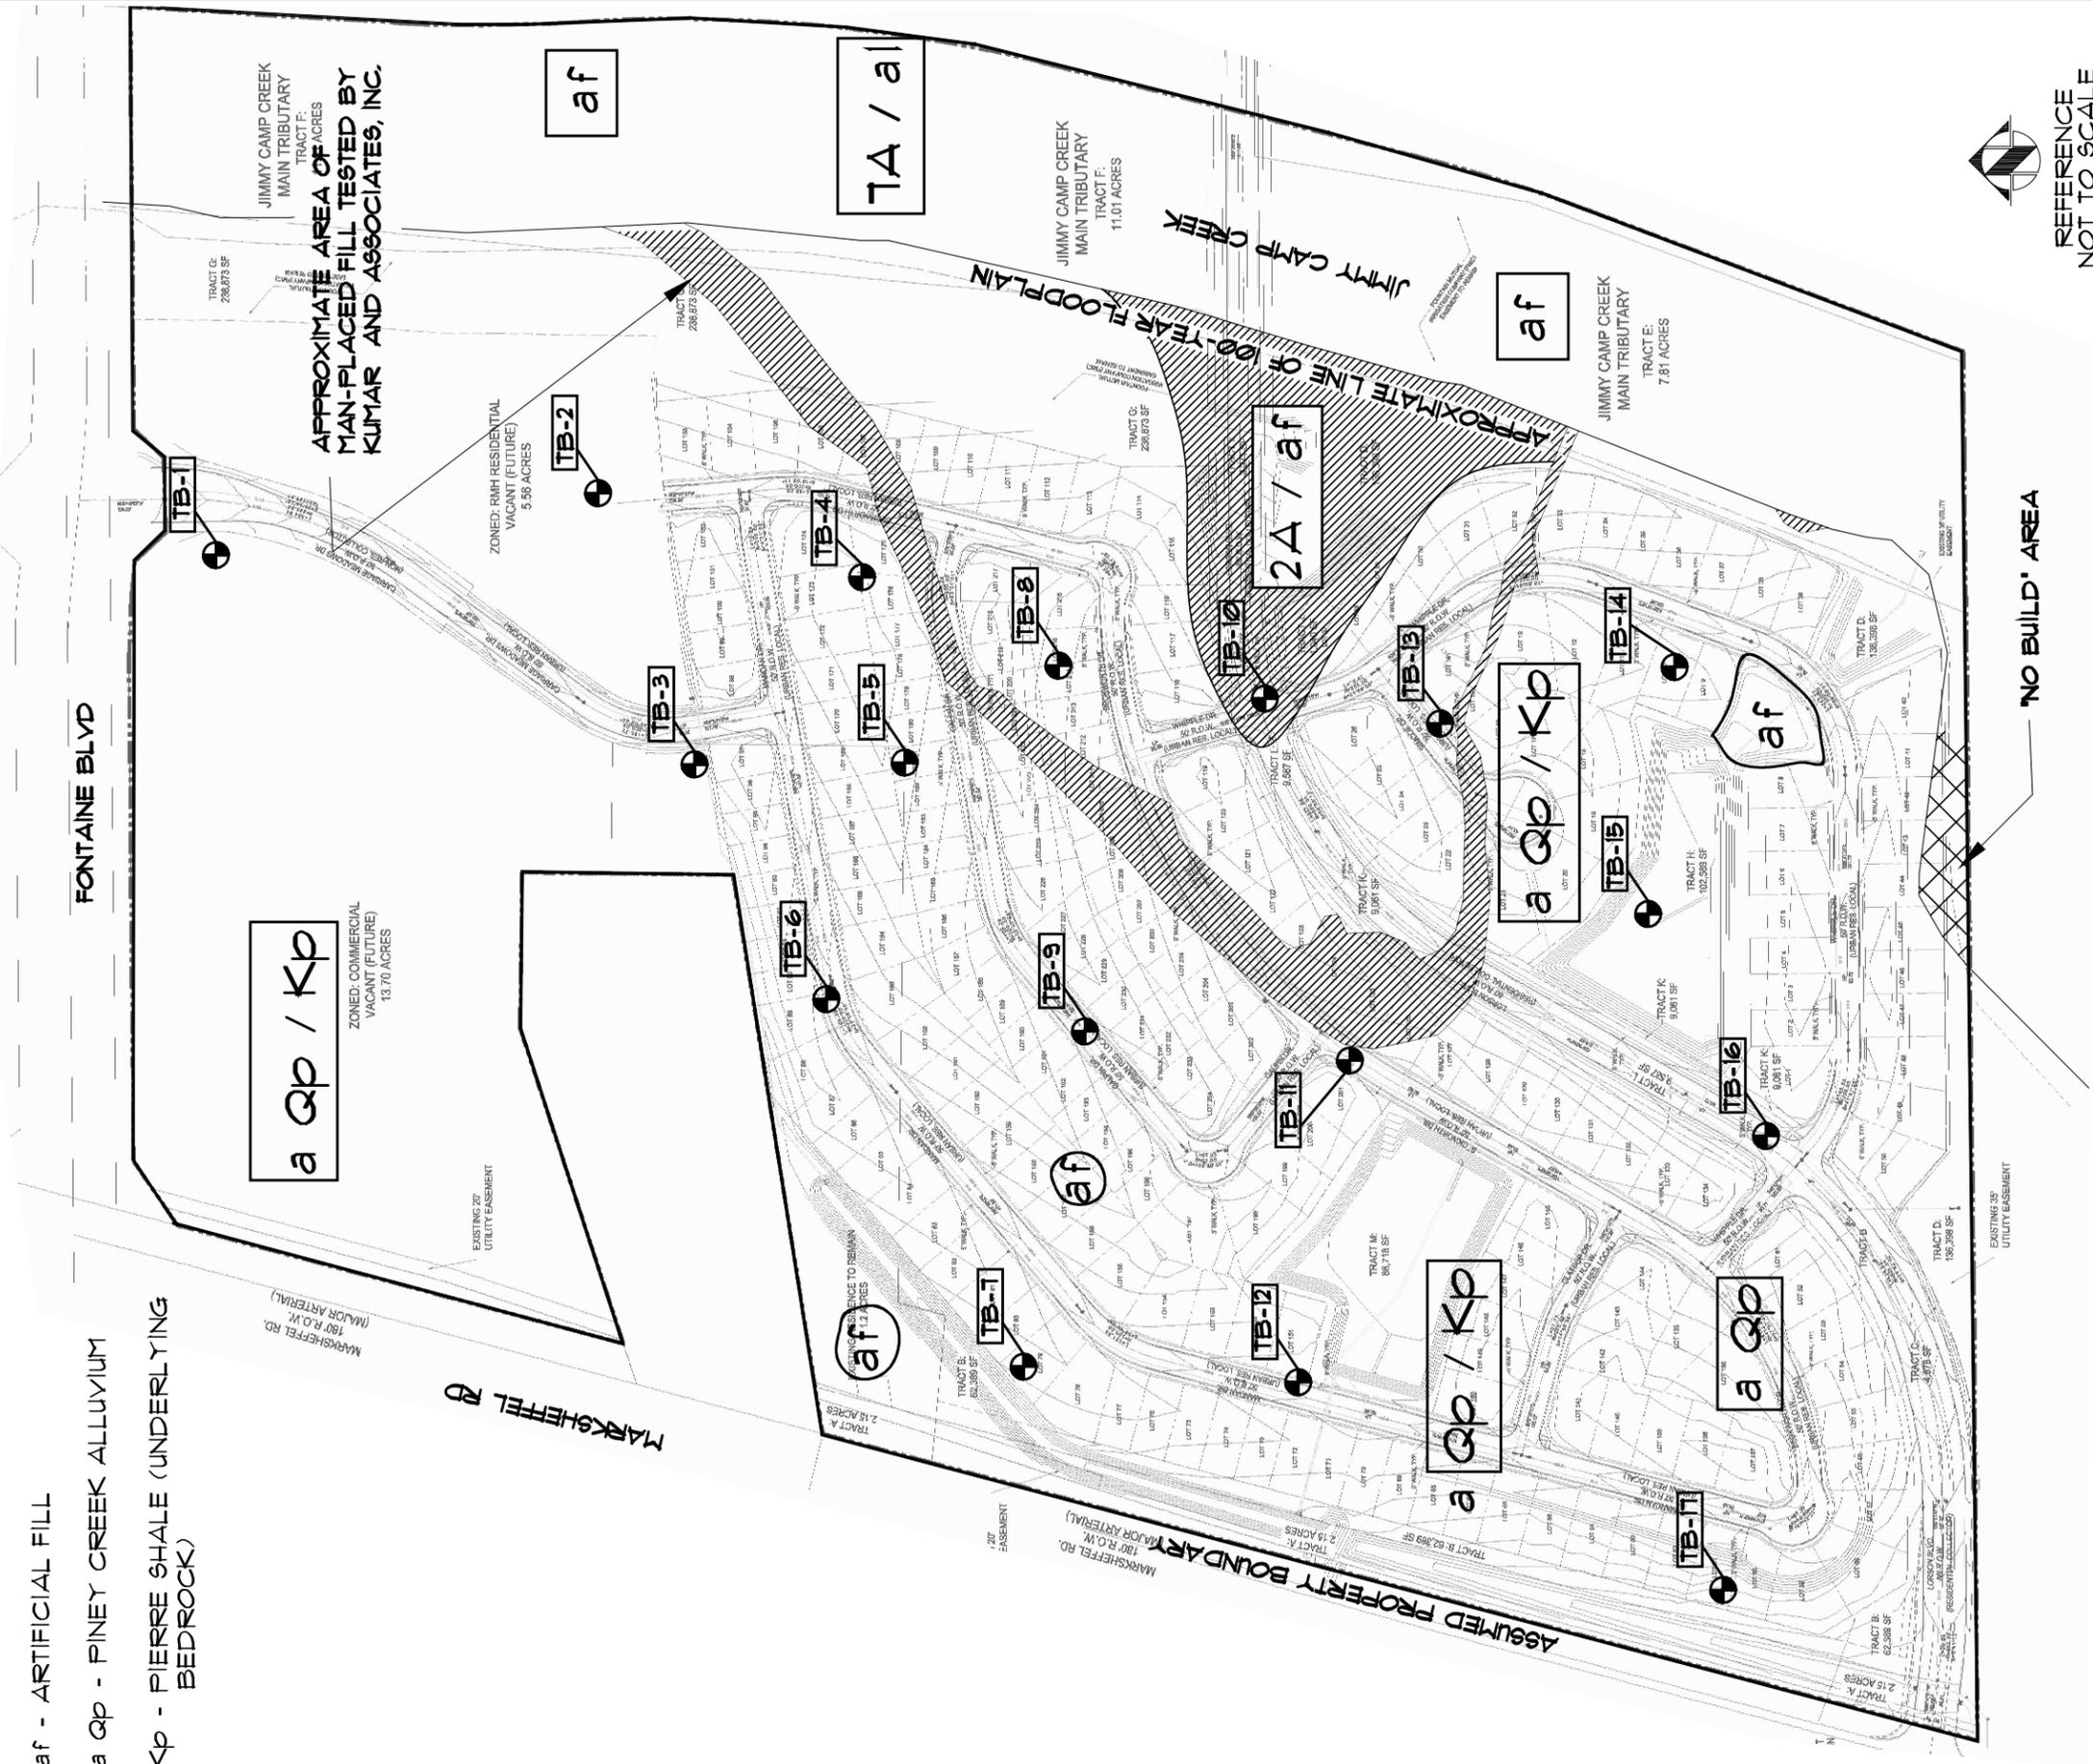
SHEET No.
FIG-22

a Qp - PINEY CREEK ALLUVIUM

Kp - PIERRE SHALE (UNDERLYING BEDROCK)

● DENOTES APPROXIMATE LOCATION OF TEST BORINGS

GEOLOGIC
CONDITIONS MAP

The areas of fill identified by Kumar and Associates have been added to Figure 22 of the amended report dated October 7, 2016. The approximate boundary of the 100-year floodplain has also been added to Figure 22 of the amended report dated October 7, 2016. This boundary does not intersect any of the proposed roads, but it does cross the southernmost portion of lots 40 through 45. It is not anticipated that there will be adequate separation between the floodplain and the proposed residences on lots 40 through 42 and 45. Additional care may be required on lots 43 and 44 to ensure that the residence does not encroach within the 100-year floodplain. These areas should be marked as "No Build" zones on the approved plat and/or development plans.

The General Geology is presented in the Geologic Conditions Map, Figure 22.

The Engineering Geology is presented on the Geologic Conditions Map presented in Figure 22.

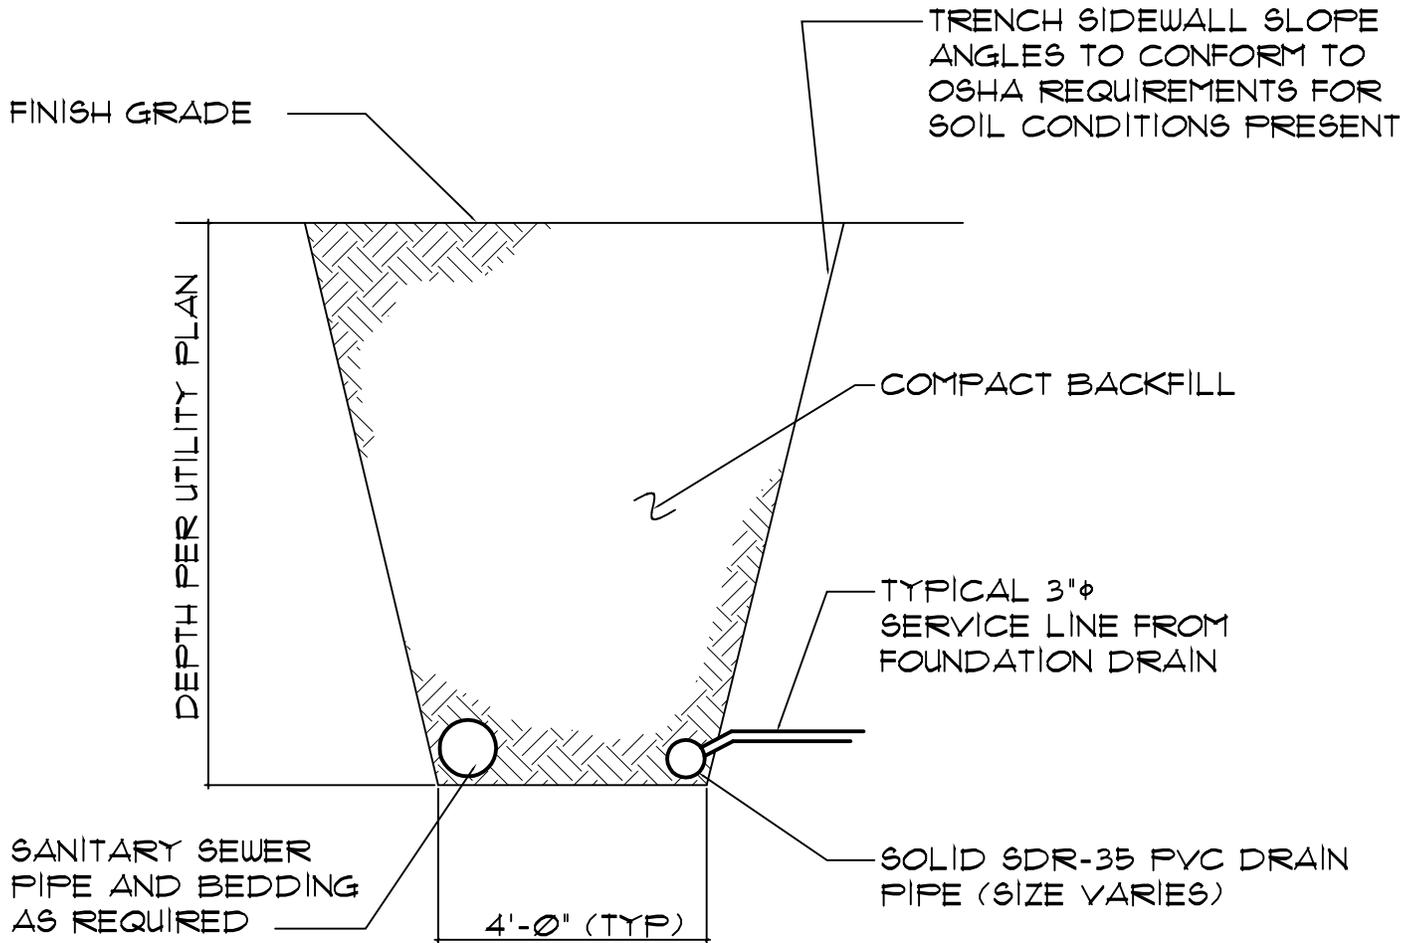
FIG No. 24

NOTE: TO BE USED WHERE NO SHALLOW GROUNDWATER IS KNOWN TO EXIST

It is a common local practice for underdrains to be placed at the bottom of sanitary sewer trenches within drive lanes. Underdrains placed in the sanitary sewer trenches in areas where groundwater is anticipated will likely be the "active" type, which uses a perforated drain pipe. In areas where groundwater is not anticipated, "passive" type underdrains may be used. Typical underdrain details are presented in Figures 22 and 23. The outfall for the sanitary sewer trench underdrain was not known at the time of this investigation because the development plan and grading plan were not available for our review. However, based on information received from personnel of Core Engineering Group, there is no suitable gravity outfall for an underdrain system for this development. If an underdrain system is used, it will likely necessitate construction and maintenance of a pumping station to collect and redirect the discharge from the underdrain system. One potential alternative to this approach would be to provide individual sump pits and pumps for each residence to collect and redirect discharge water from all recommended subsurface foundation drains. If this option is selected, care should be taken to ensure that the sump pumps have outfall to a location that is graded to direct the discharge water away from the surrounding structures and to a suitable collection or drainage area.

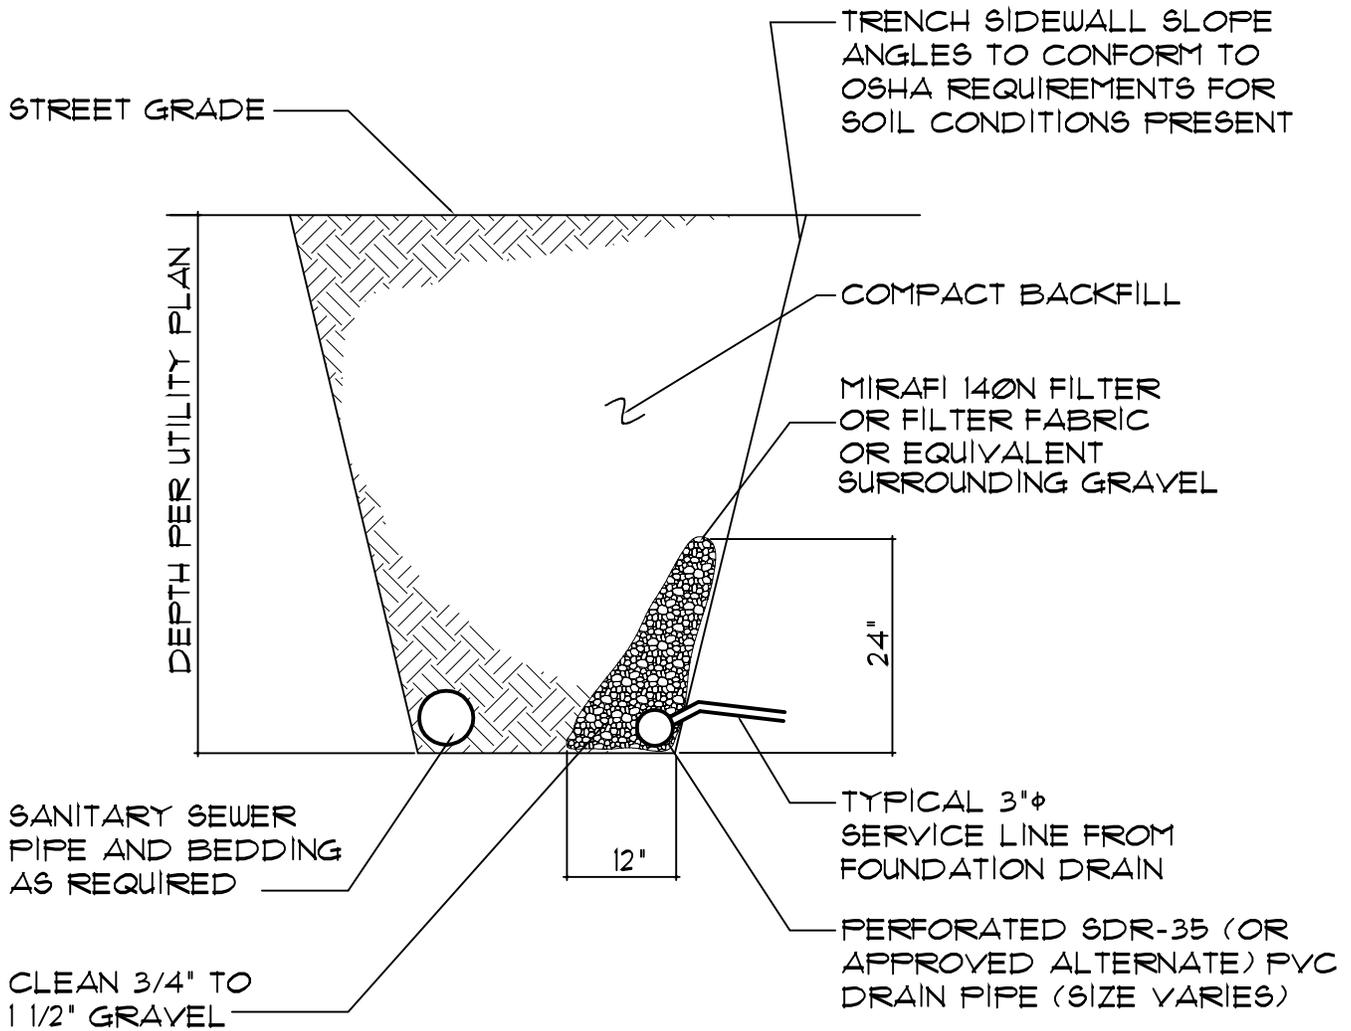
NOTE: TO BE USED IN CASES WHERE
 GROUNDWATER IS FOUND DURING
 TRENCHING OR WHERE SHALLOW
 GROUNDWATER IS KNOWN TO EXIST
