Job No. 172445

Re: Response to CGS Comments
Lots 1-50, Carriage Meadows South at Lorson Ranch, Filing No. 2
El Paso County, Colorado

RMG – Rocky Mountain Group (RMG) prepared the *Geology and Soils Study* (RMG Job No. 172445, last dated October 7, 2019) for the proposed development to consist of 50 multi-family residential lots on 85.32 acres located south and east of the intersection of Marksheffel Road and Fontaine Boulevard in El Paso County, Colorado. The report was reviewed by personnel of the Colorado Geological Survey (CGS). A copy of the review comment from CGS was provided to us by personnel of Thomas + Thomas. This comment appears to have been downloaded from the El Paso County EDARP system, and is included at the end of this document.

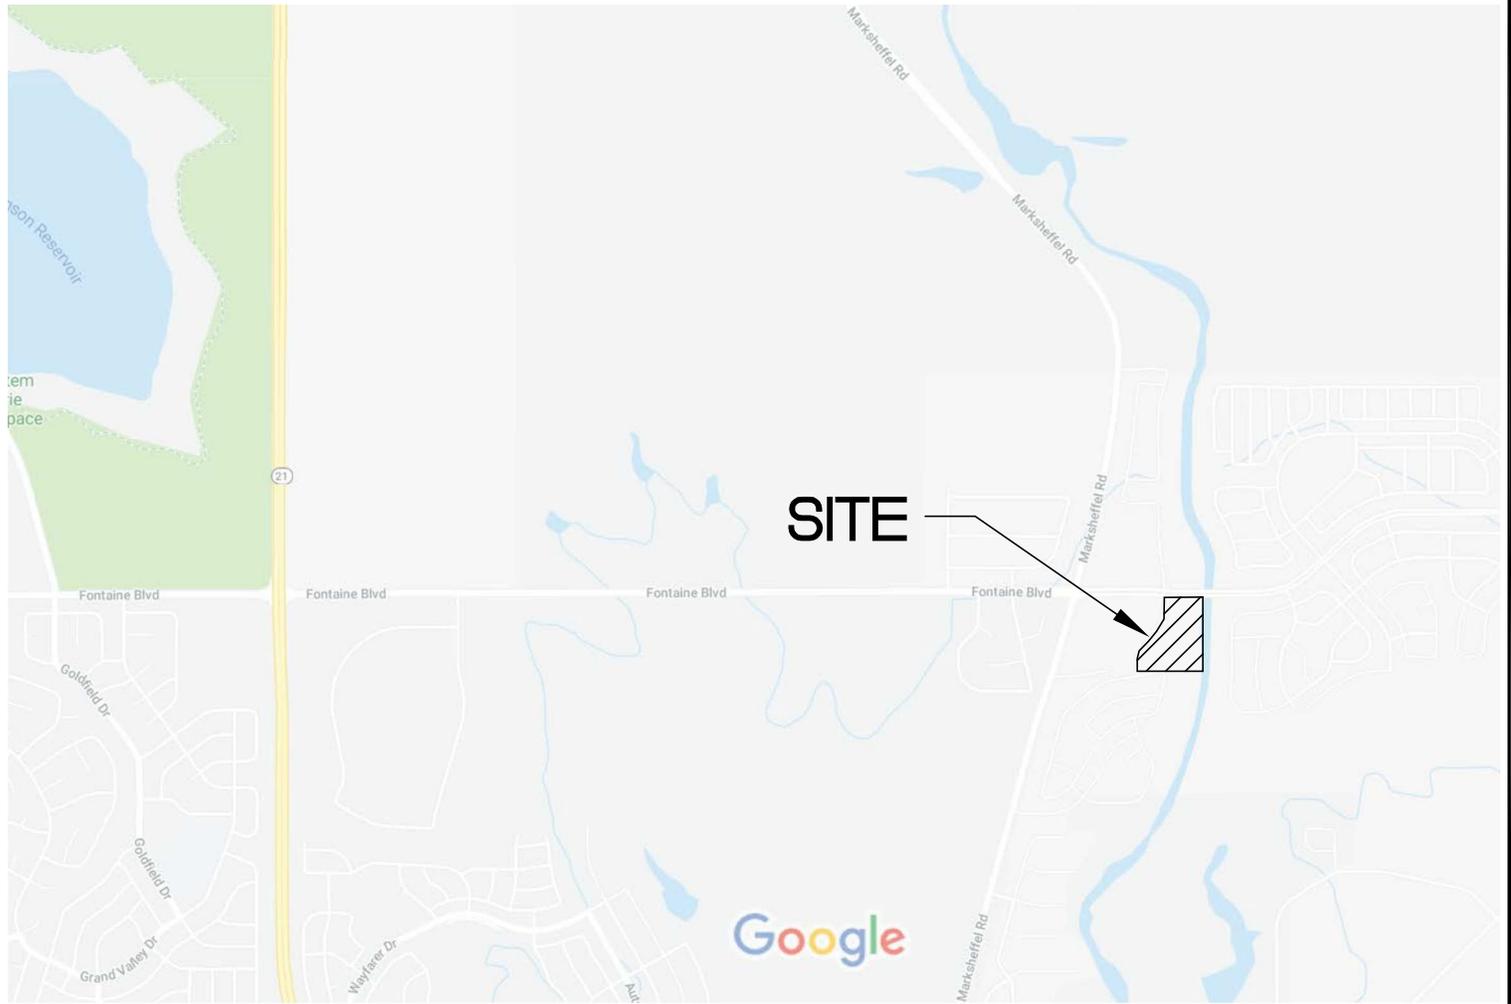
FIG No. 1

The project lies in a portion of the northeast one-quarter of Section 22 and a portion of the northwest one-quarter of Section 23, Township 15 South, Range 65 West of the 6th Principal Meridian in El Paso County, Colorado. The site is located approximately 1/2 mile to the south and east of the intersection of Marksheffel Road and Fontaine Boulevard. The approximate location of the site is shown on the Site Vicinity Map, Figure 1.

The site consists of one parcel with a total acreage of approximately 5.32 acres. The included parcel has a Schedule No. of 5522105006 and is currently zoned *PUD – Planned Unit Development*. The zoning is to remain PUD. It is our understanding the proposed site development is to consist of multi-family construction on 50 lots. The development is to utilize sewer services provided by Widefield Water and Sanitation District. Individual wells and on-site wastewater treatment systems are not proposed. Figure 1 presents the general boundaries of our investigation.

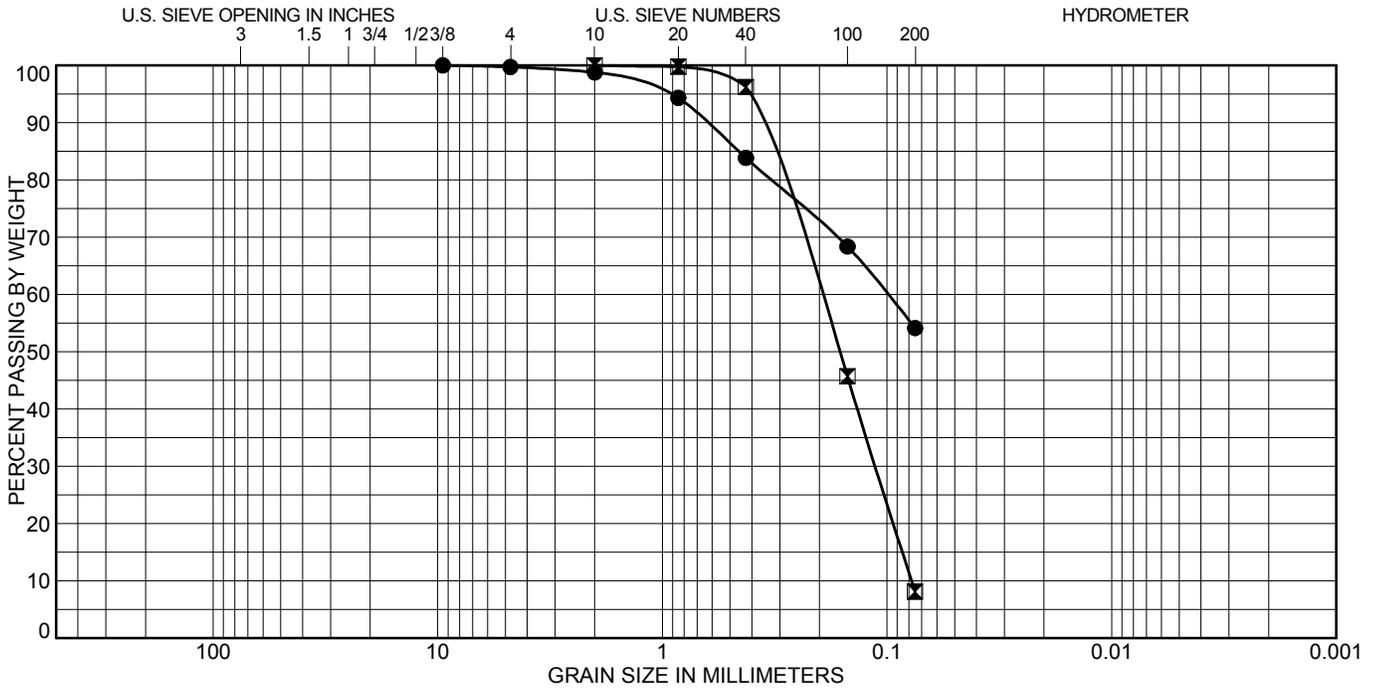
JOB No. 172445
FIGURE No. 5
PAGE 1 OF 1
DATE 10/7/19

COBBLES	GRAVEL		SAND			SILT OR CLAY
	coarse	fine	coarse	medium	fine

Test Boring	Depth (ft)	Classification	LL	PL	PI
● 1	4.0	SANDY LEAN CLAY (CL)	28	17	11
⊠ 1	9.0	POORLY GRADED SAND with SILT (SP-SM)	NP	NP	NP

Soil laboratory testing was performed as part of this investigation. The laboratory tests included moisture content, dry density, grain-size analyses and Atterberg Limits testing. A Summary of Laboratory Test Results is presented in Figure 7. Soils Classification Data is presented in Figure 8. Swell/Consolidation Test Results are presented in Figure 9. The Test Boring Log and Summary of Laboratory Test Results for Test Boring No. 2 drilled previously is presented in Appendix B.

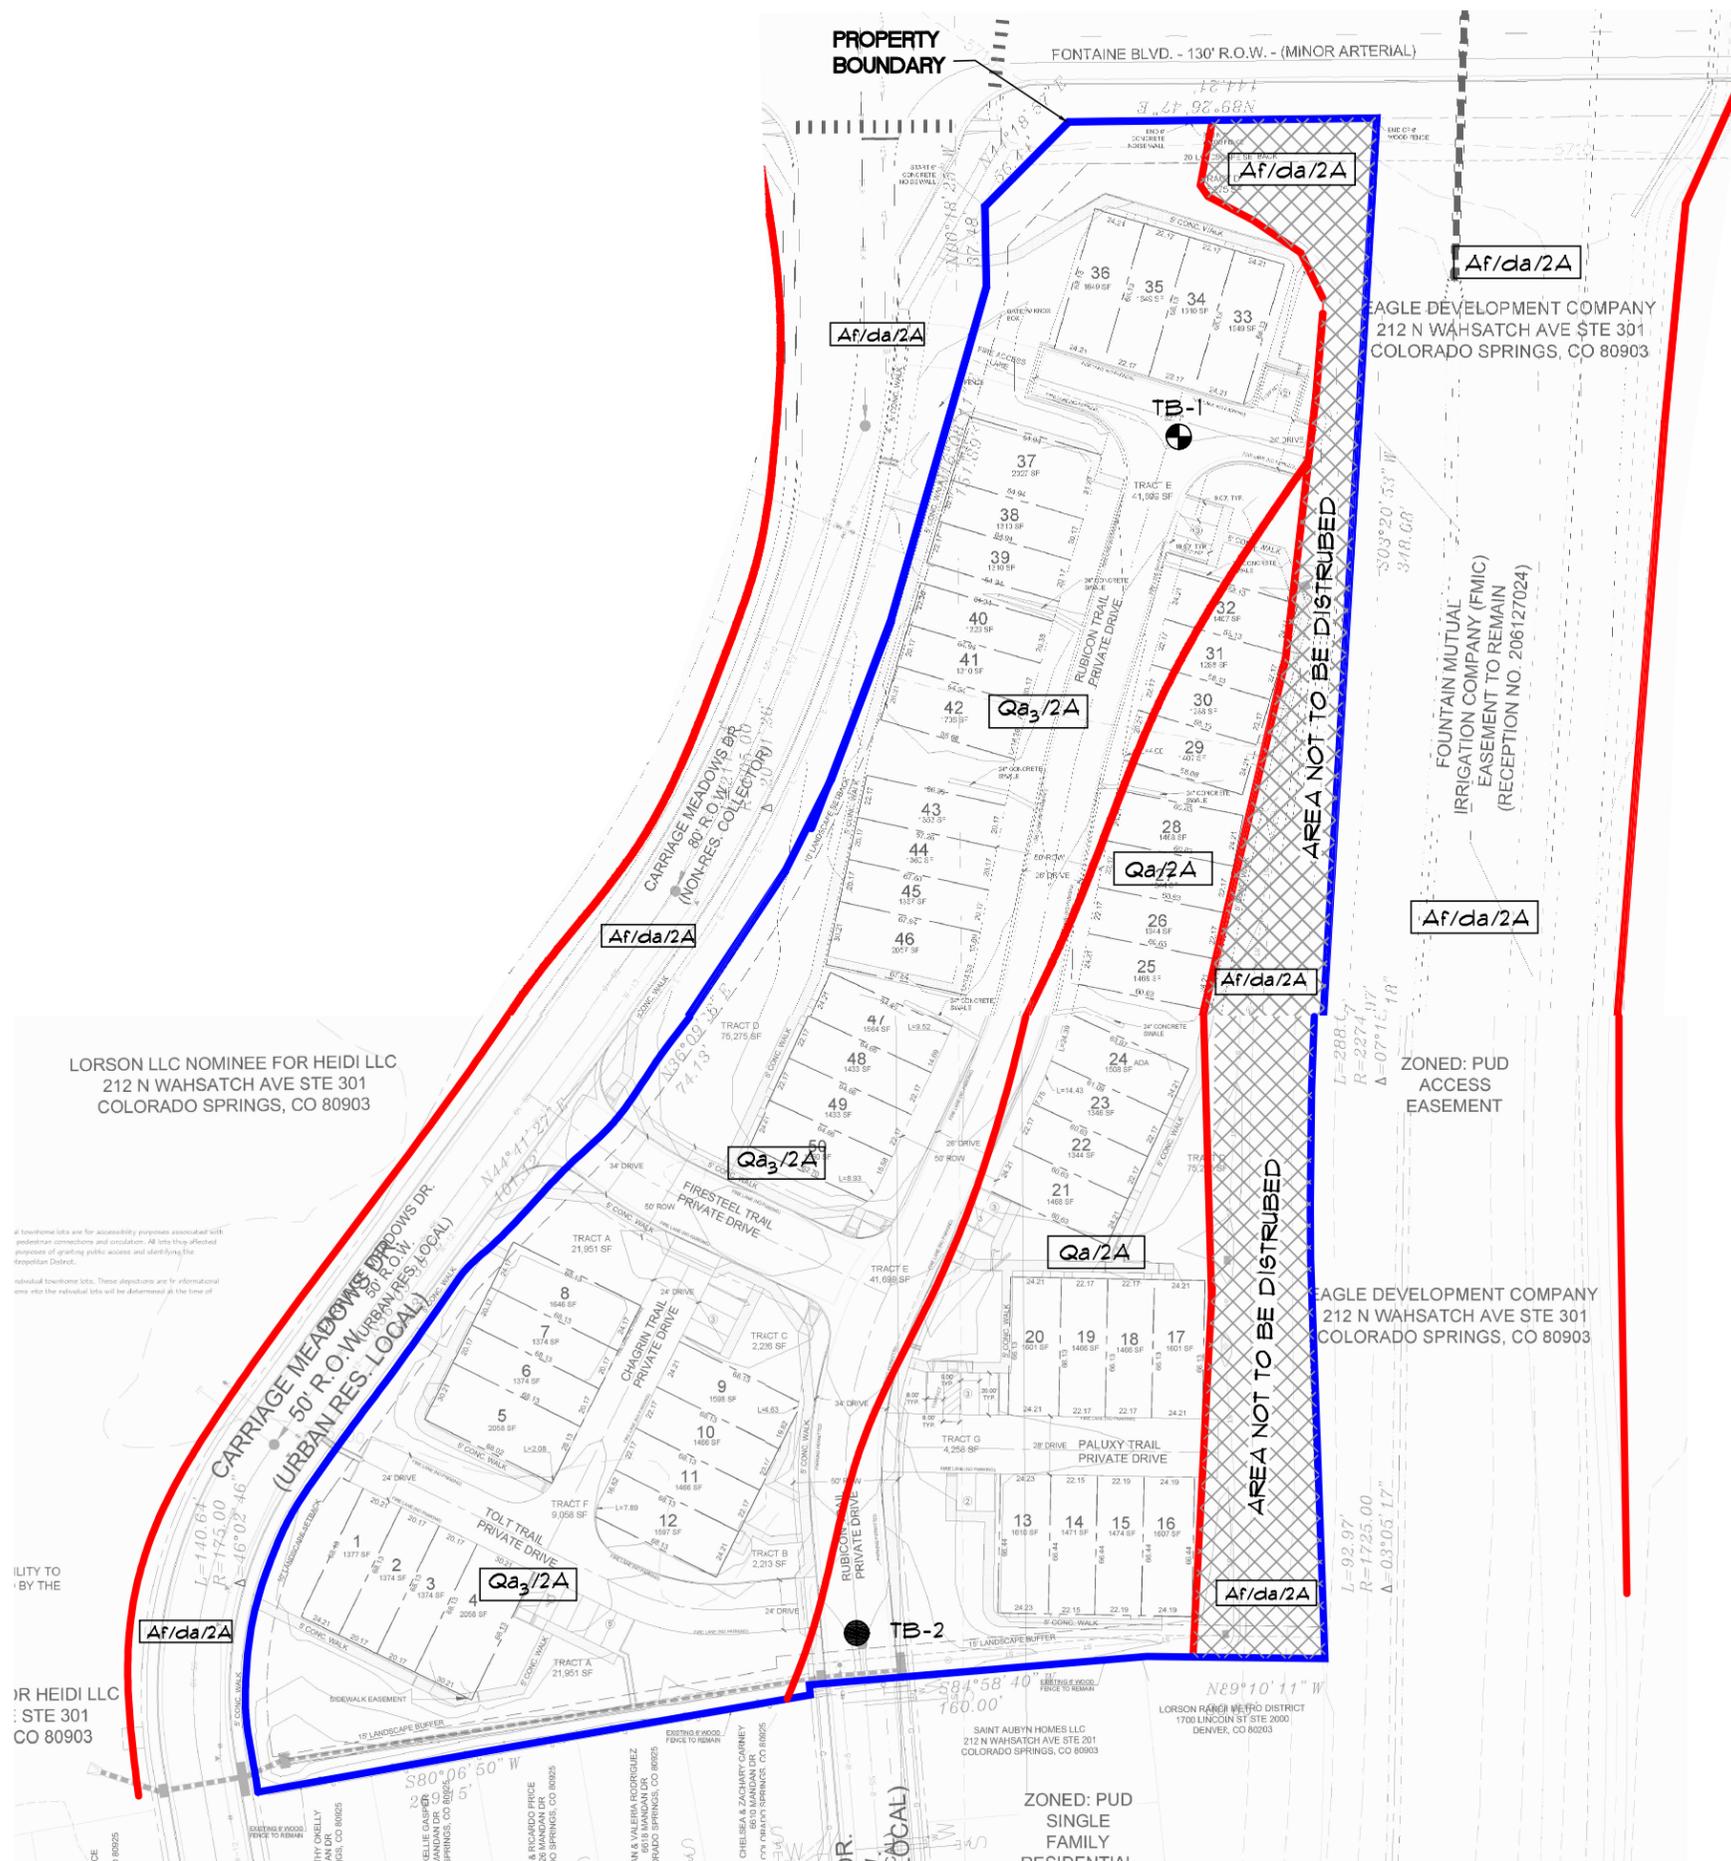
FIG-7

Geologic

Qa₃ - Alluvium three: well sorted sand and clayey to silty sand with gravel lenses. Forms broad terraces along Jimmy Camp Creek. The estimated depth of this unit is 50 feet.

Based on our field observations, the USDA map, and the Geologic Map of the Fountain Quadrangle, an interpreted geologic map of significant surficial deposits and features was mapped for the site. The identified geologic conditions affecting the development are presented in the Engineering and Geology Map, Figure 7.

The Engineering Geology is presented in the Engineering and Geology Map, Figure 7.

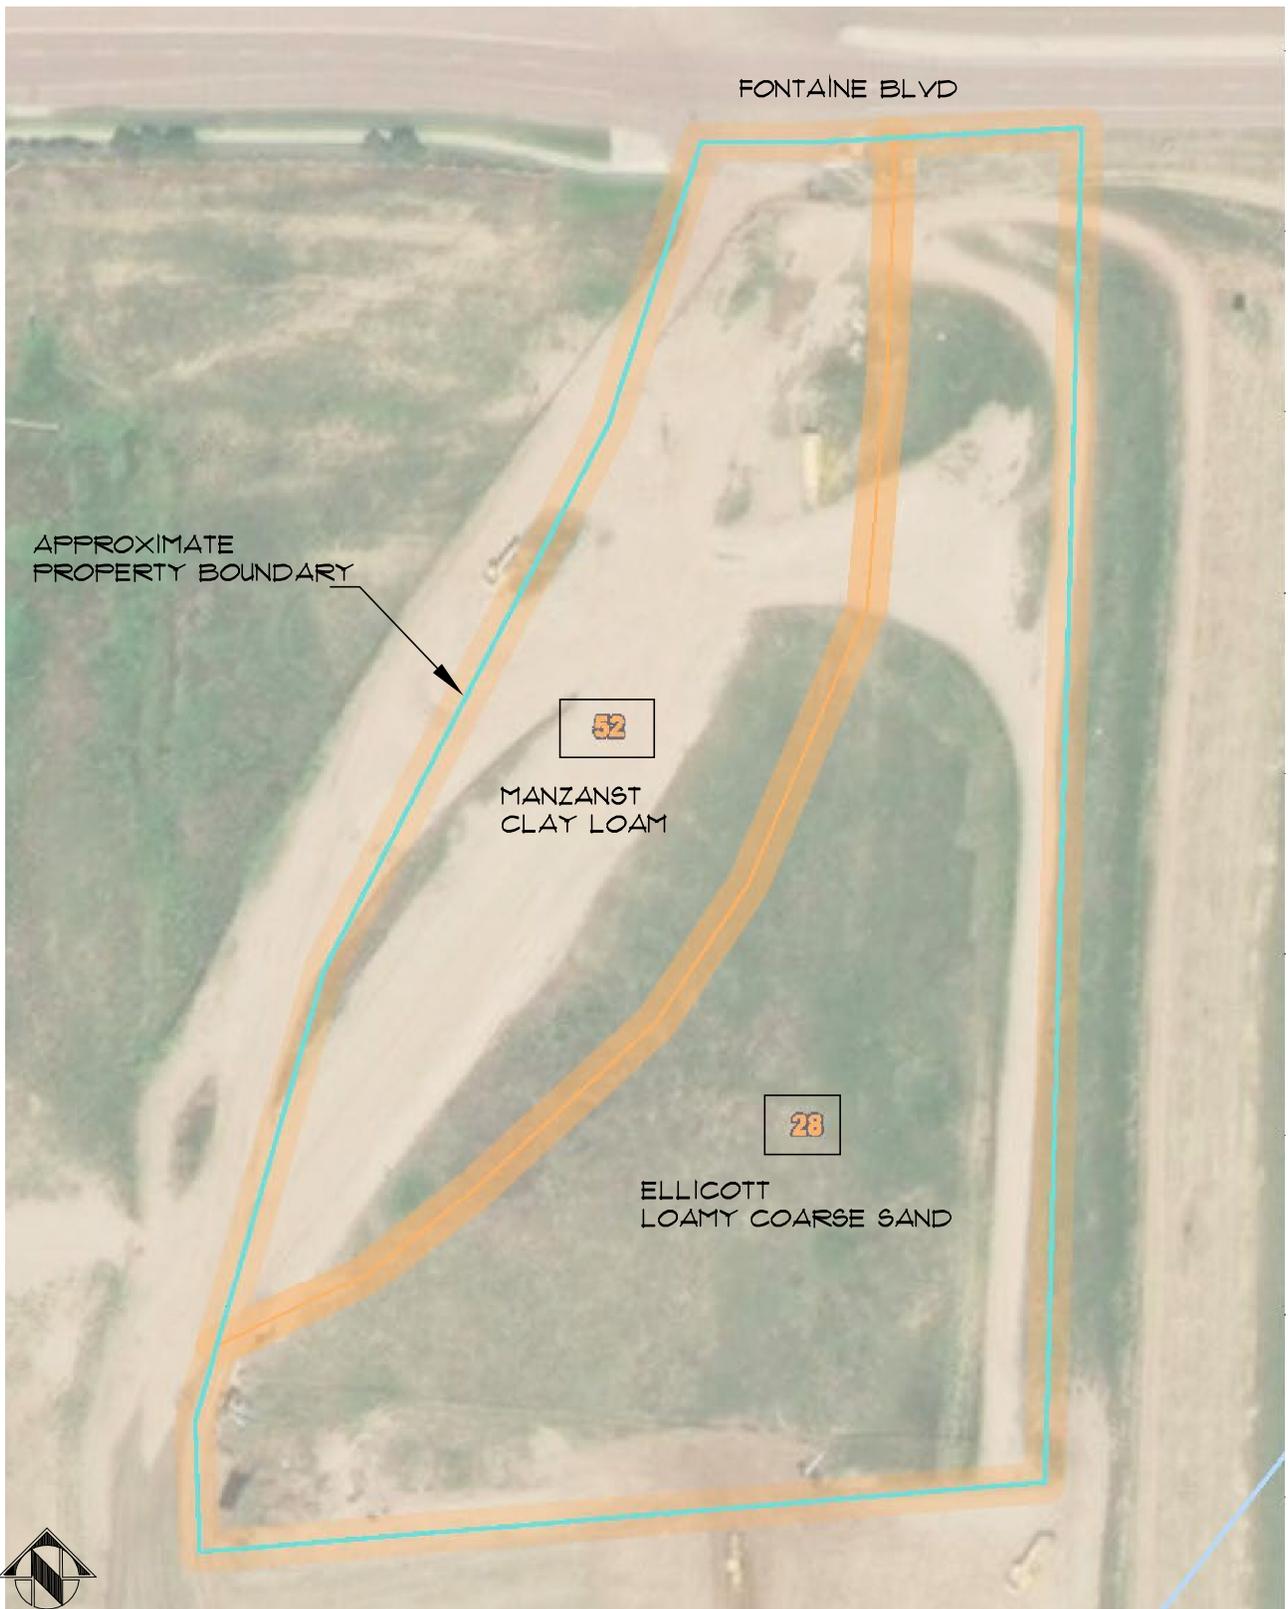
FIG No. 8

APPROXIMATE
PROPERTY BOUNDARY

The USDA Soil Survey Map is presented in Figure 8.

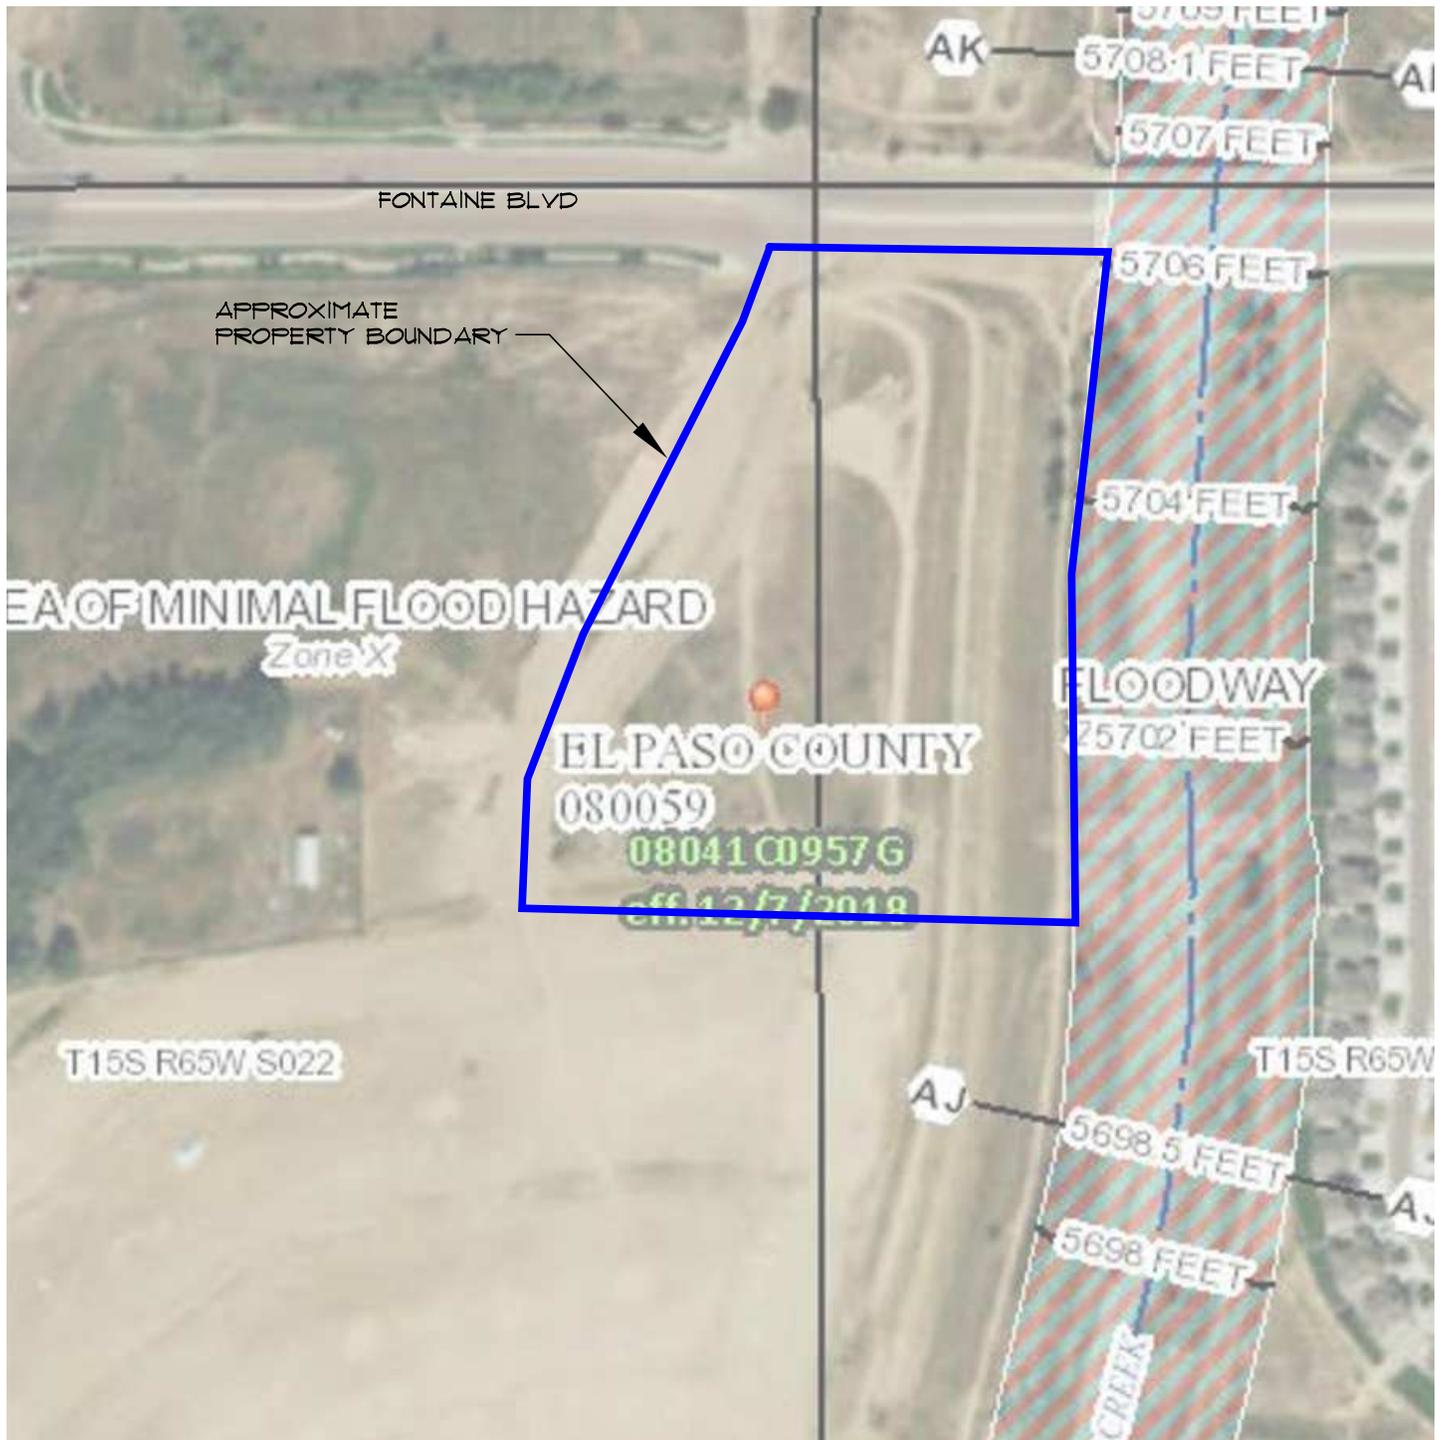
NOT TO SCALE
 BASE MAP PROVIDED BY: FEMA
