GEOLOGY AND SOILS REPORT

**Carriage Meadows South
El Paso County, Colorado**

JOB NO. 152427

Re: Response to
Colorado Geological Survey Review Comments
Carriage Meadows South at Lorson Ranch
El Paso County, Colorado

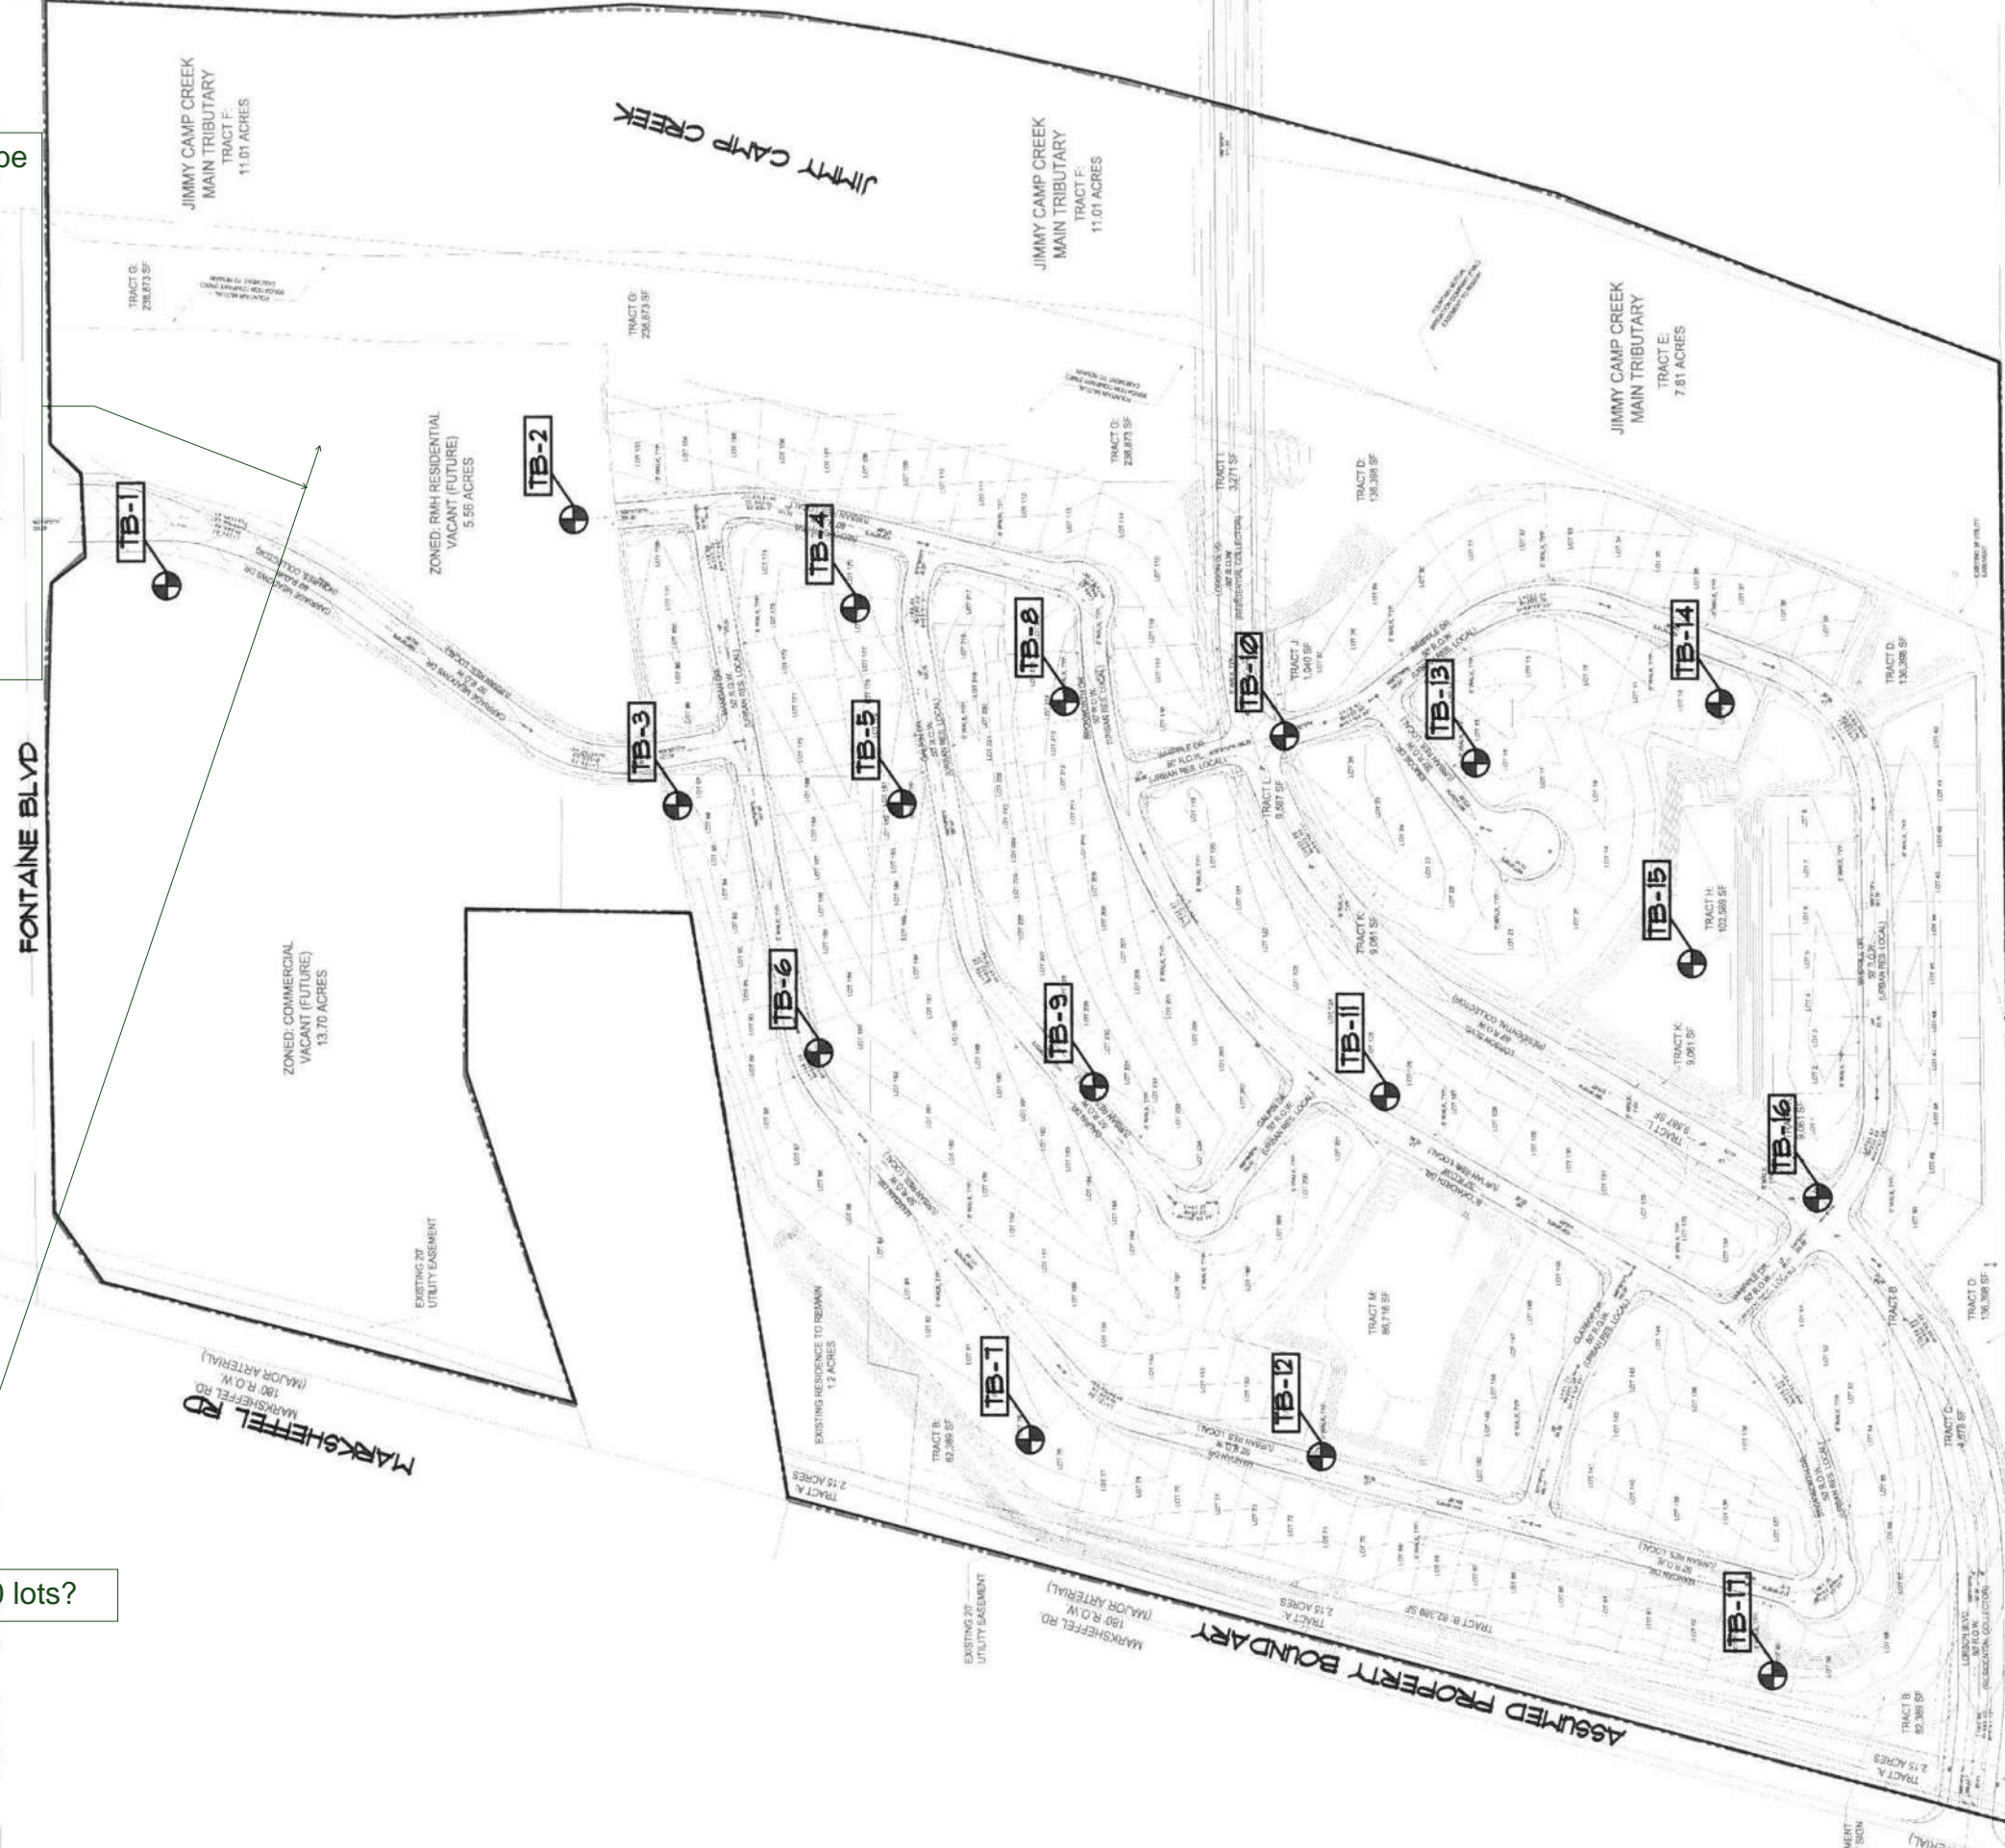
⊕ DENOTES APPROXIMATE LOCATION OF TEST BORINGS

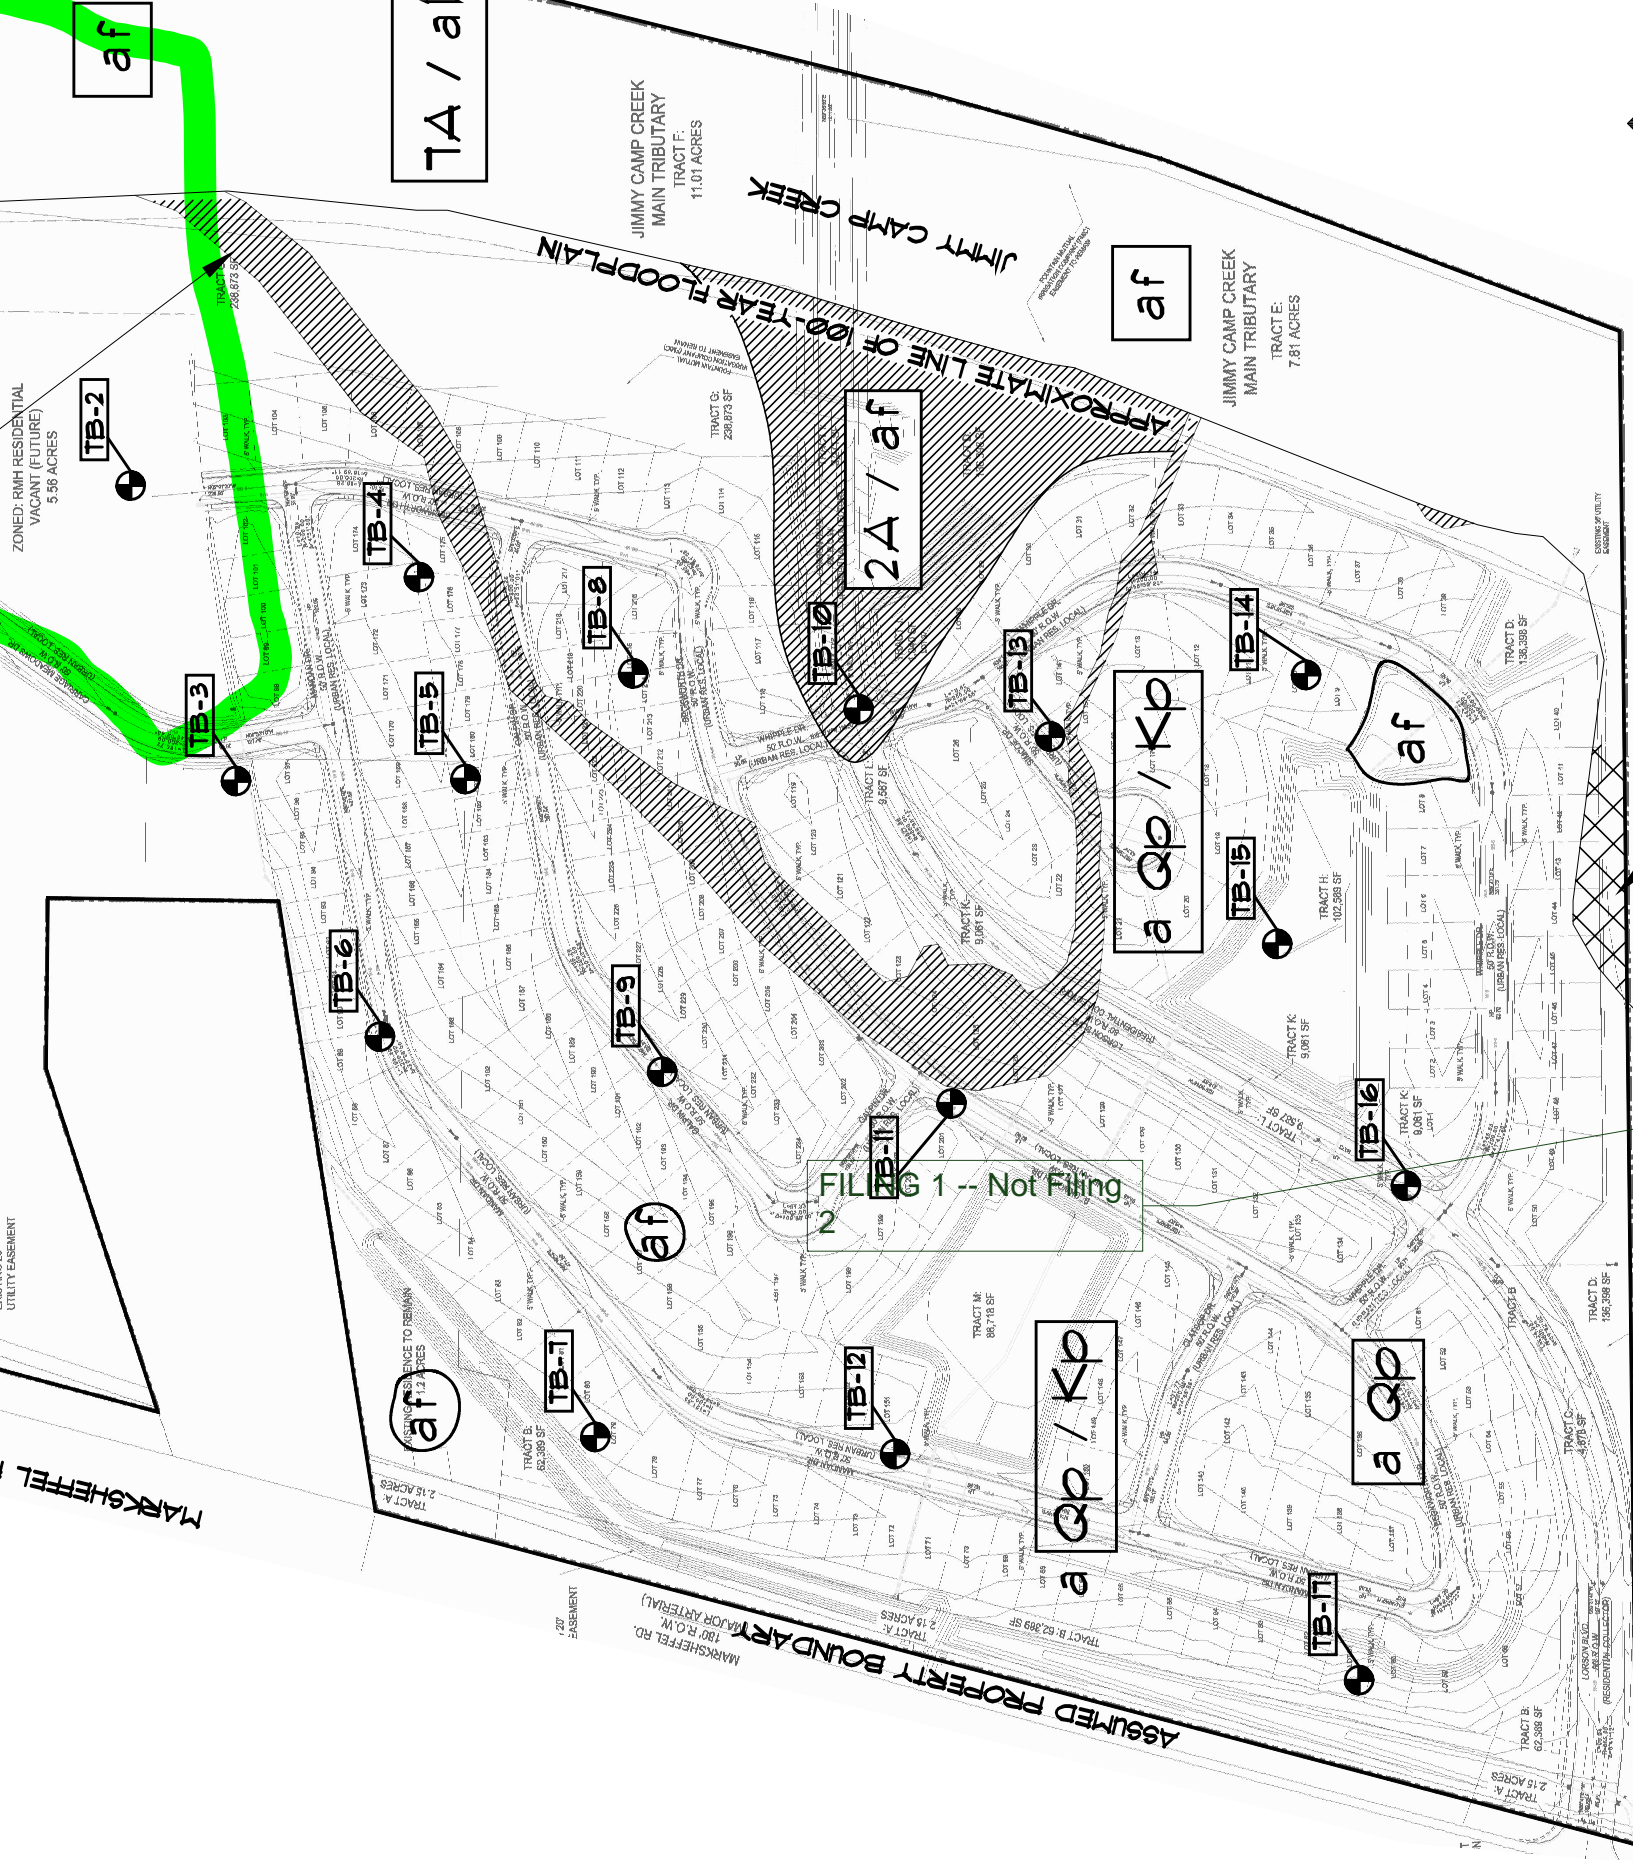
JIMMY CAMP CREEK
MAIN TRIBUTARY
TRACT F:
APPROXIMATE AREA OF
MAN-PLACED FILL TESTED BY
KUMAR AND ASSOCIATES, INC.

● DENOTES APPROXIMATE
LOCATION OF TEST BORINGS
