## GEOLOGY AND SOILS STUDY

**Lots 1-50  
Carriage Meadows South at Lorson Ranch  
Filing No. 2  
El Paso County, Colorado**

**JOB NO. 172445**

**October 7, 2019**

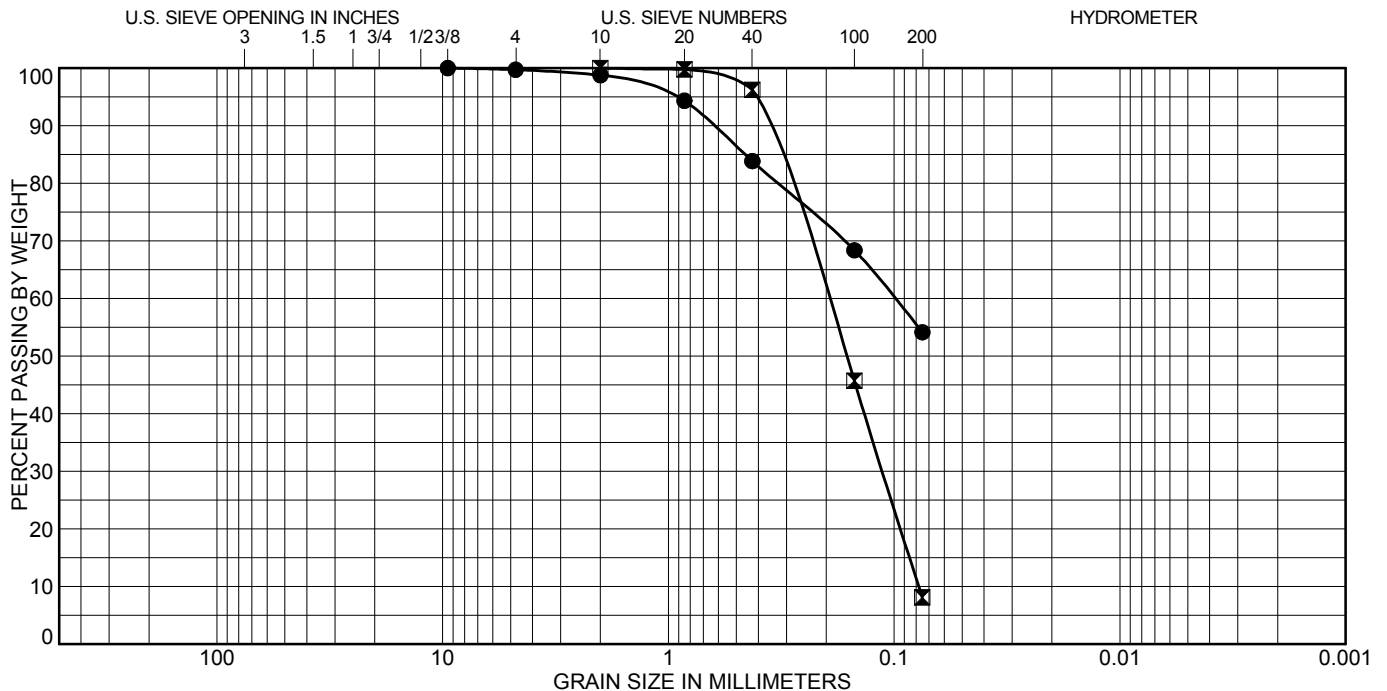
FIGURE No. 6

COBBLES	GRAVEL		SAND			SILT OR CLAY
	coarse	fine	coarse	medium	fine

Test Boring	Depth (ft)	Classification	LL	PL	PI
● 1	4.0	<b>SANDY LEAN CLAY (CL)</b>	<b>28</b>	<b>17</b>	<b>11</b>
✕ 1	9.0	<b>POORLY GRADED SAND with SILT (SP-SM)</b>	<b>NP</b>	<b>NP</b>	<b>NP</b>

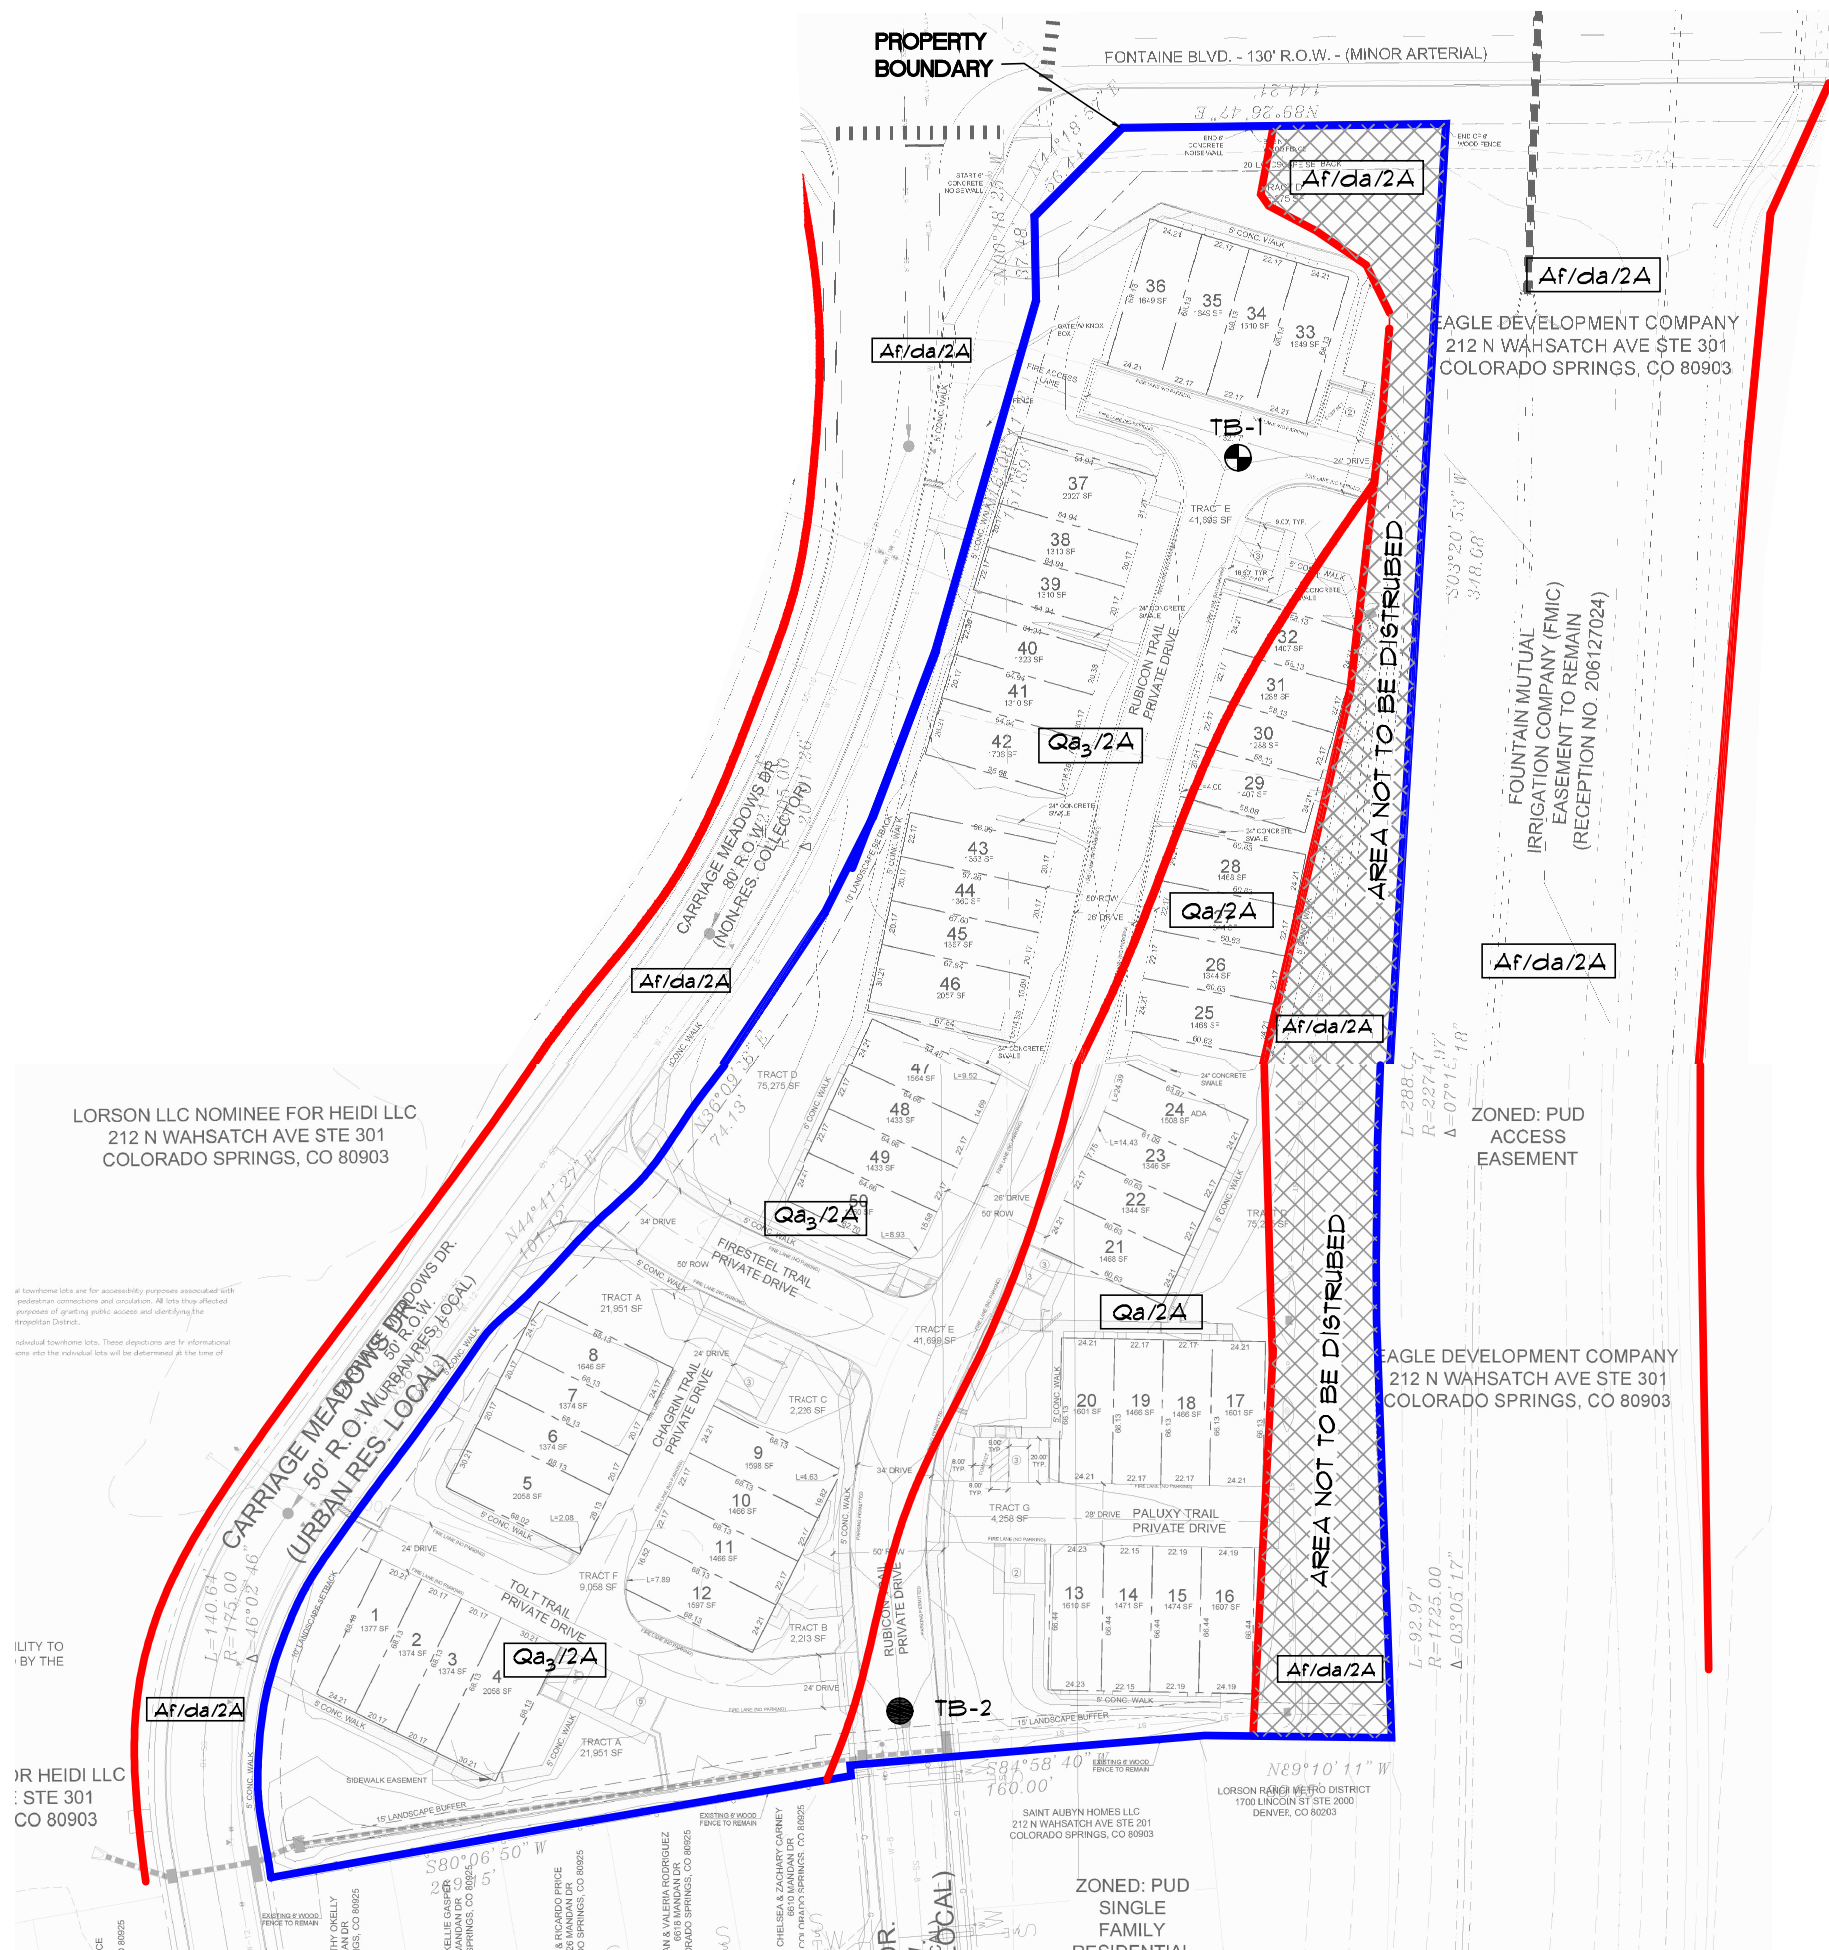
FIG-7

### Geologic

**Qa<sub>3</sub>** - Alluvium three: well sorted sand and clayey to silty sand with gravel lenses. Forms broad terraces along Jimmy Camp Creek. The estimated depth of this unit is 50 feet.

Based on our field observations, the USDA map, and the Geologic Map of the Fountain Quadrangle, an interpreted geologic map of significant surficial deposits and features was mapped for the site. The identified geologic conditions affecting the development are presented in the Engineering and Geology Map, Figure 7.

The Engineering Geology is presented in the Engineering and Geology Map, Figure 7.

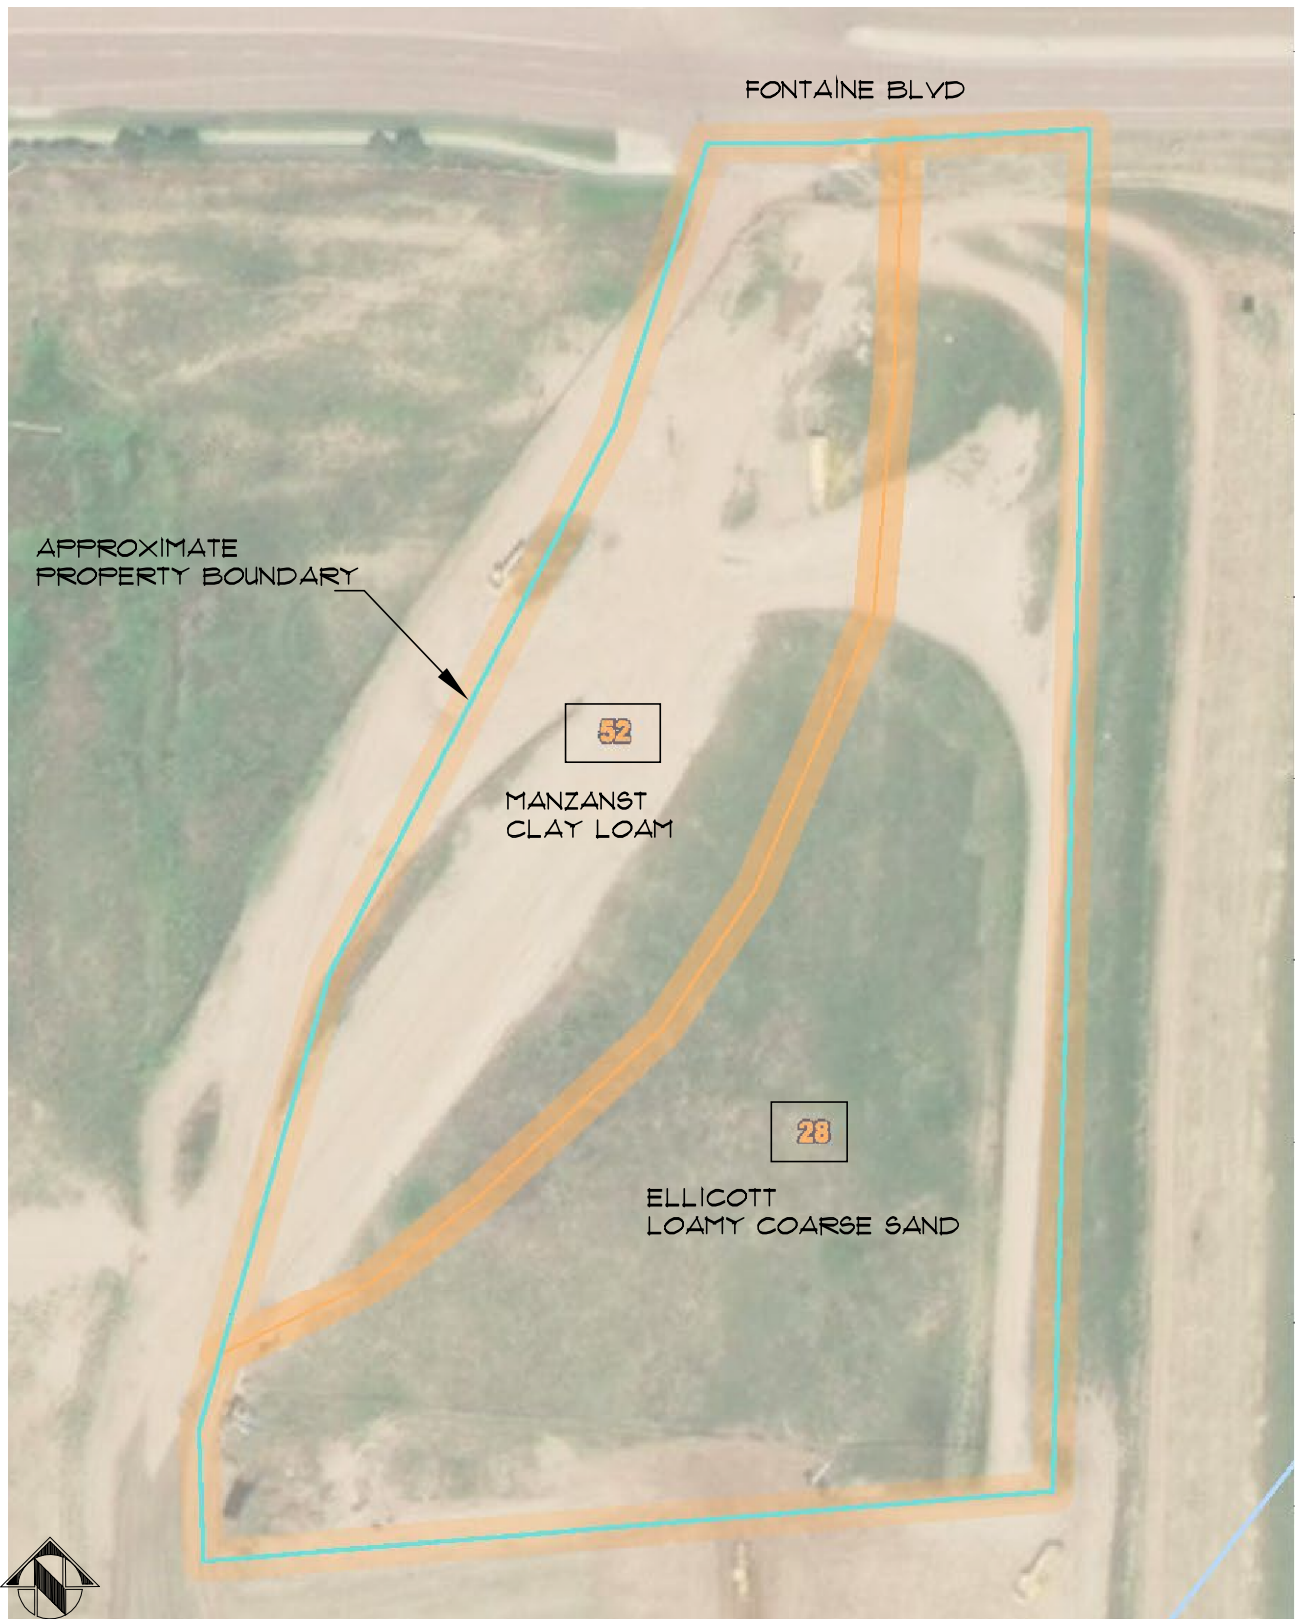
FIG No. 8

NOT TO SCALE  
BASE MAP PROVIDED BY: USDA

The USDA Soil Survey Map is presented in Figure 8.
