Ocotber 28, 2022
Revised Novemeber 3, 2023

ENTECH
ENGINEERING, INC.

Re: OWTS – Wastewater Study
Hill Subdivision
Parcel Nos. 51290-04-018 and 51290-09-002
Alpaca Heights and Black Forest Road
El Paso County, Colorado
Entech Job No. 221947

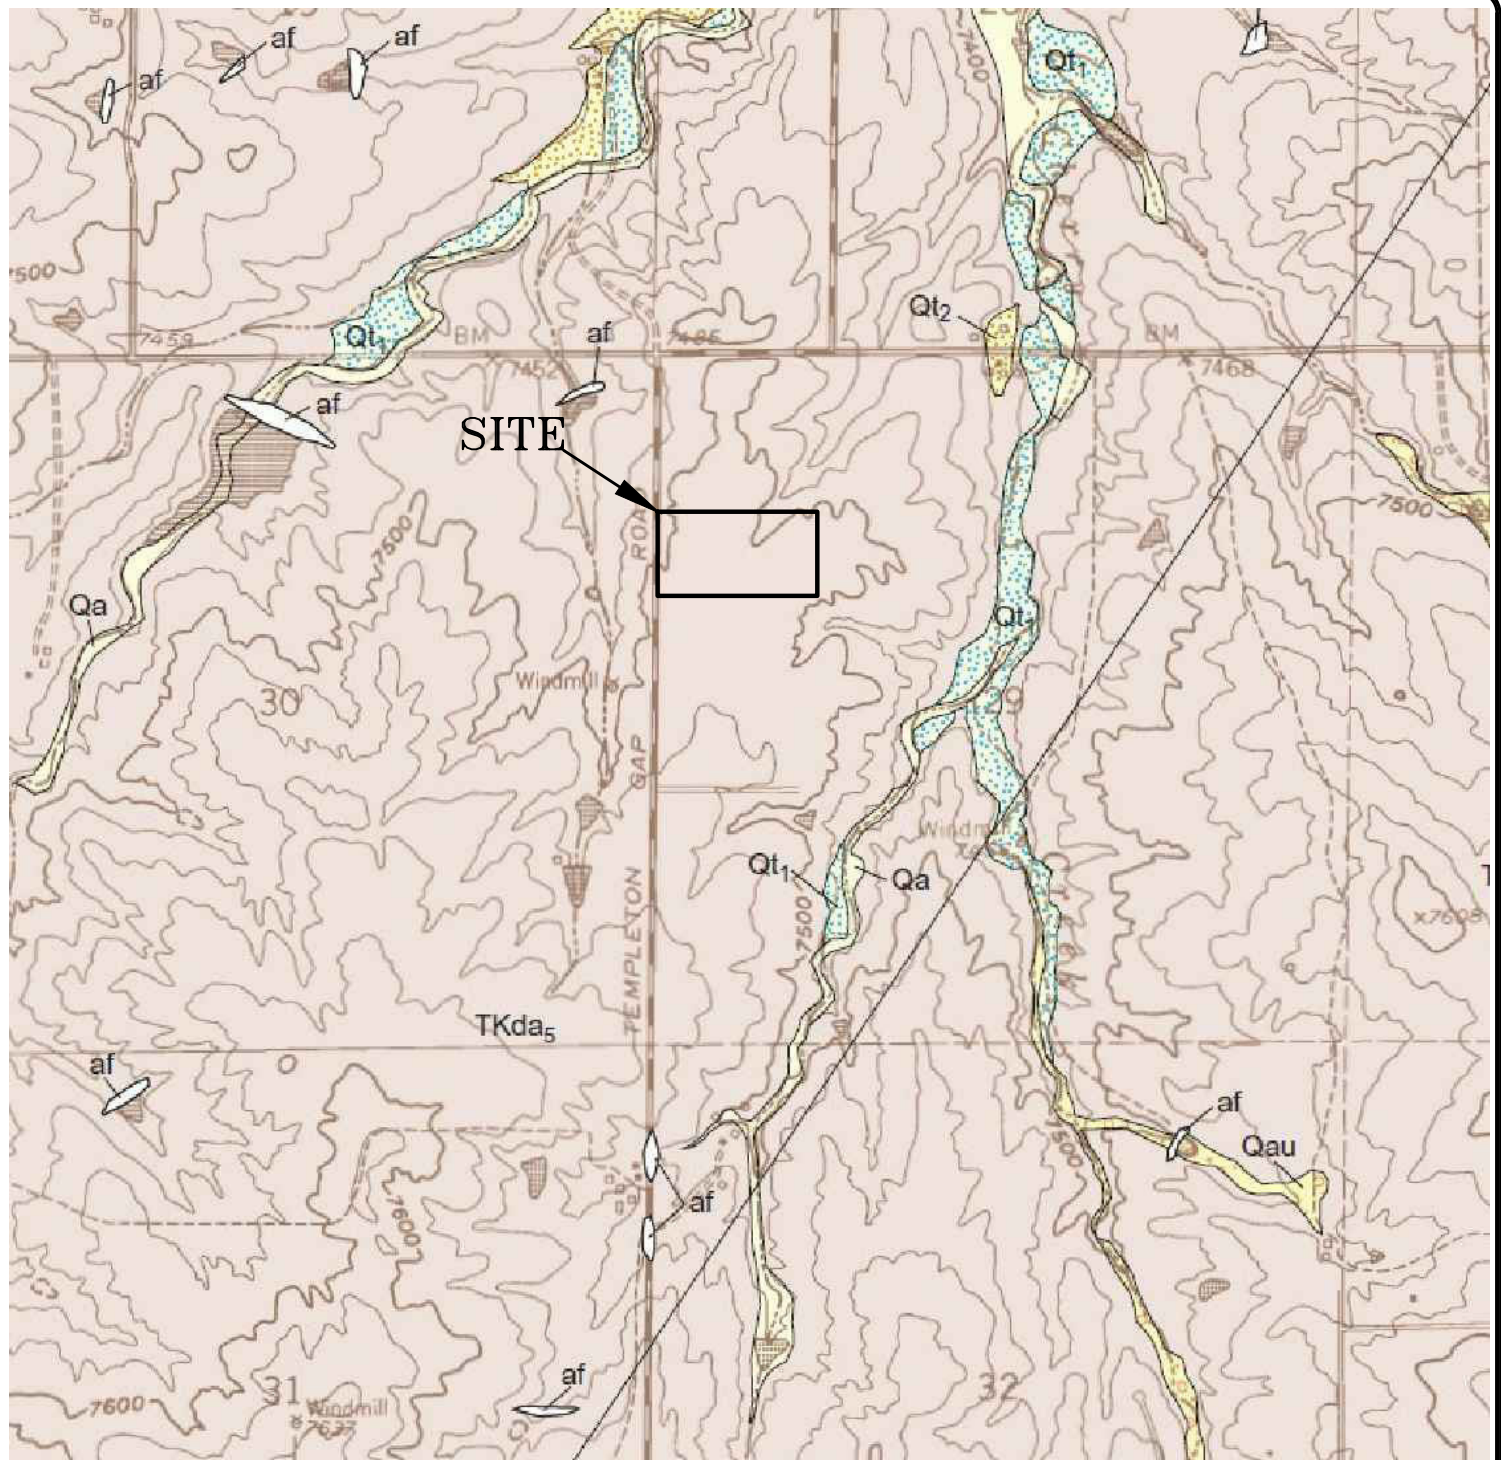
DRAWN L.L.
CHECKED
DATE 11/3/23
SCALE AS SHOWN
JOB NO. 221947
FIGURE No. 6

GEOLGY/ENGINEERING GEOLOGY MAP
HILL SUBDIVISION
ALPACA HEIGHTS & BLACK FOREST ROAD
EL PASO COUNTY, CO.
FOR: DOUG HILL

The geology of the site was evaluated using the *Geologic Map of the Black Forest Quadrangle*, by Thorson in 2003, (Reference 4, Figure 5). The Geology Map for the site is presented in Figure 6. Two mappable units were identified on this site which are described as follows:

The soils listed above were mapped from site-specific mapping, the *Geologic Map of the Black Forest Quadrangle* distributed by the Colorado Geologic Survey in 2003 (Reference 4, Figure 5), the *Geologic Map of the Colorado Springs-Castle Rock Area*, distributed by the US Geological Survey in 1979 (Reference 5), and the *Geologic Map of the Pueblo 1° x 2° Quadrangle*, distributed by the US Geological Survey in 1978 (Reference 6). The test borings and test pits logs used in evaluating the site and are included in Appendix B. The Geology Map prepared for the site is presented in Figure 6.

A minor drainage areas exist in the northeastern portion of the site on proposed Lot 2. No water was observed flowing in the drainage, however, this area has the potential for seasonal shallow groundwater. This area is indicated in the Geology/Engineering Geology Map (Figure 6) and are discussed below. Due to the size of the proposed lot this area can be avoided or redirected around proposed structures or proposed soil treatment areas. The site does not lie within any floodplain zones according to the FEMA Map No. 08041CO305G dated December 7, 2018 (Figure 7, Reference 7). Exact locations of floodplain and specific drainage studies are beyond the scope of this report.

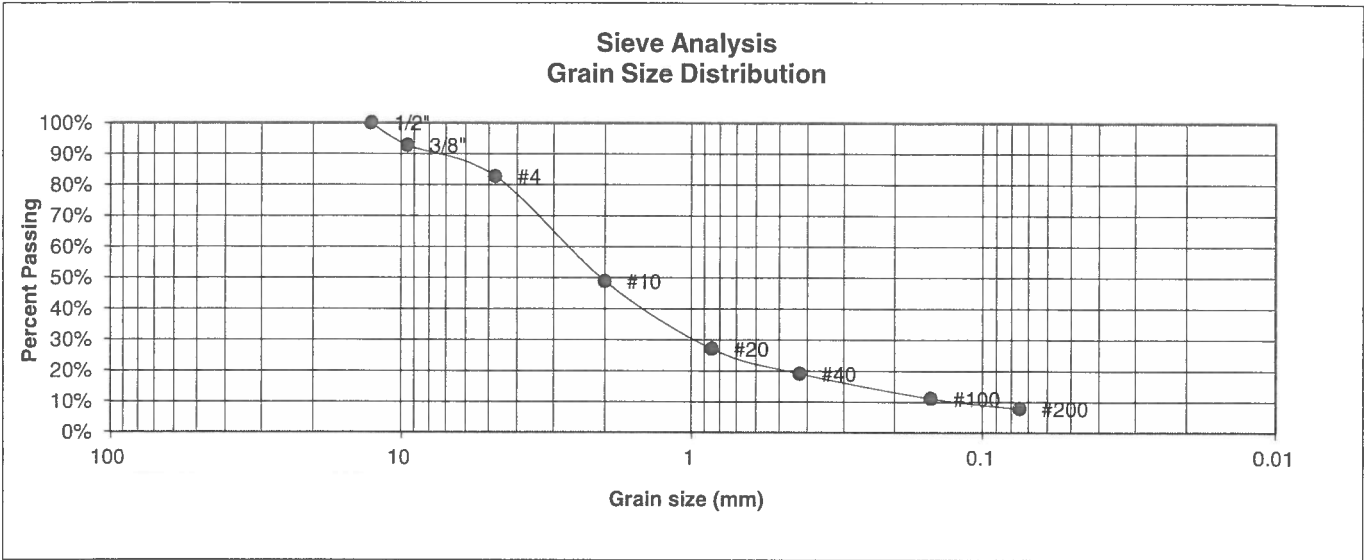
C-1

BORING NO.	2	UNIFIED CLASSIFICATION	SM-SW	TEST BY	BL
DEPTH(ft)	5	AASHTO CLASSIFICATION		JOB NO.	221947
CLIENT	DOUG HILL				
PROJECT	ALPACA HTS. & BLACK FOREST

U.S. Sieve #	Percent Finer
3"	
1 1/2"	
3/4"	
1/2"	100.0%
3/8"	92.7%
4	82.7%
10	48.9%
20	27.1%
40	19.1%
100	11.1%
200	7.8%

Atterberg Limits
 Plastic Limit NP
 Liquid Limit NV
 Plastic Index NP

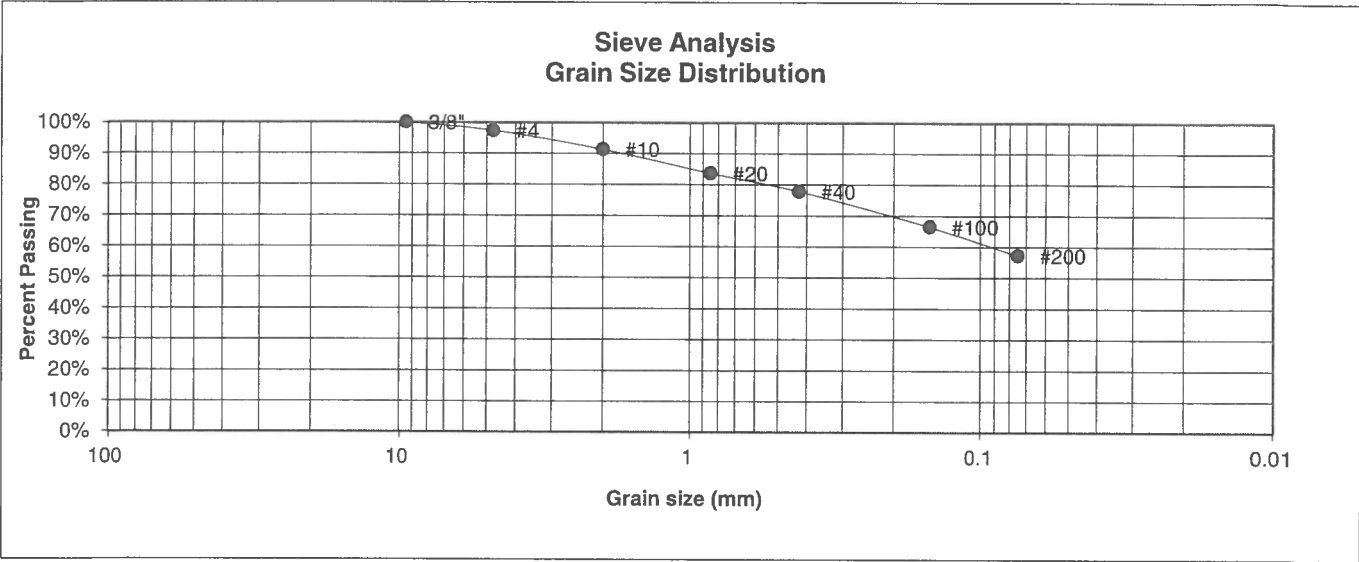
FIG NO.:
C-2

BORING NO. 3	UNIFIED CLASSIFICATION	CL	TEST BY	BL
DEPTH(ft) 2-3	AASHTO CLASSIFICATION		JOB NO.	221947
CLIENT DOUG HILL				
PROJECT ALPACA HTS. & BLACK FOREST

U.S. Sieve #	Percent Finer
3"	
1 1/2"	
3/4"	
1/2"	
3/8"	100.0%
4	97.3%
10	91.3%
20	83.7%
40	77.8%
100	66.5%
200	57.2%

Swell
Moisture at start 7.9%
Moisture at finish 20.9%
Moisture increase 13.0%
Initial dry density (pcf) 103
Swell (psf) 580

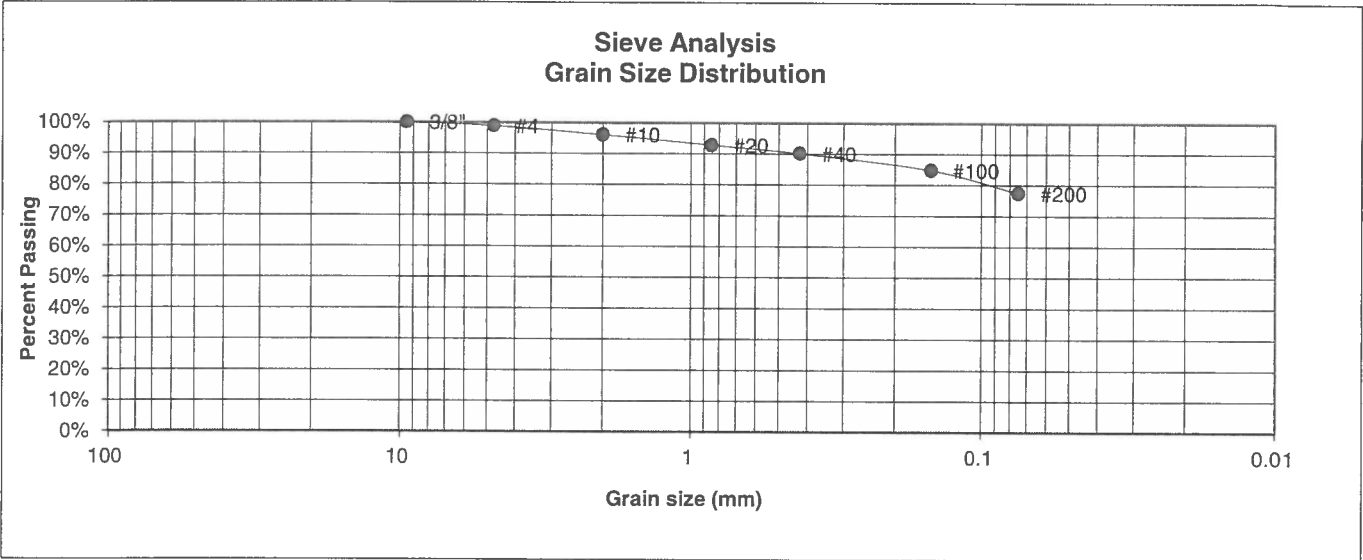
C-3

BORING NO.	TP-1	<u>UNIFIED CLASSIFICATION</u>	CL	<u>TEST BY</u>	BL
DEPTH(ft)	2	<u>AASHTO CLASSIFICATION</u>		<u>JOB NO.</u>	221947
CLIENT	DOUG HILL				
PROJECT	ALPACA HEIGHTS AND BLACK FOREST

U.S. Sieve #	Percent Finer
3"	
1 1/2"	
3/4"	
1/2"	
3/8"	100.0%
4	98.9%
10	96.0%
20	92.8%
40	90.1%
100	84.8%
200	77.4%

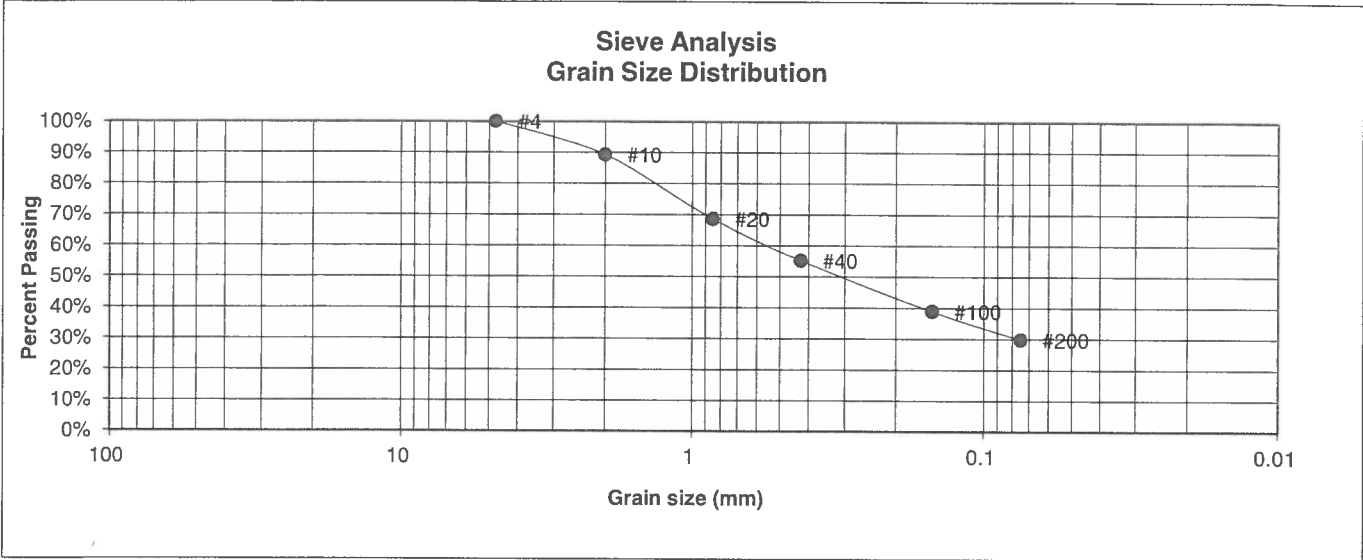
BORING NO.	1	UNIFIED CLASSIFICATION	SM	TEST BY	BL
DEPTH(ft)	15	AASHTO CLASSIFICATION		JOB NO.	221947
CLIENT	DOUG HILL				
PROJECT	ALPACA HTS. & BLACK FOREST

U.S. Sieve #	Percent Finer
3"	
1 1/2"	
3/4"	
1/2"	
3/8"	
4	100.0%
10	89.2%
20	68.6%
40	55.2%
100	38.9%
200	29.8%
