**ENTECH**  
ENGINEERING, INC.

Re: OWTS – Wastewater Study  
Hill Subdivision  
Parcel Nos. 51290-04-018 and 51290-09-002  
Alpaca Heights and Black Forest Road  
El Paso County, Colorado

Doug Hill  
OWTS – Wastewater Study  
Hill Subdivision  
Parcel Nos. 51290-04-018 and 51290-09-002  
Alpaca Heights and Black Forest Road  
El Paso County, Colorado  
Entech Job No. 221947

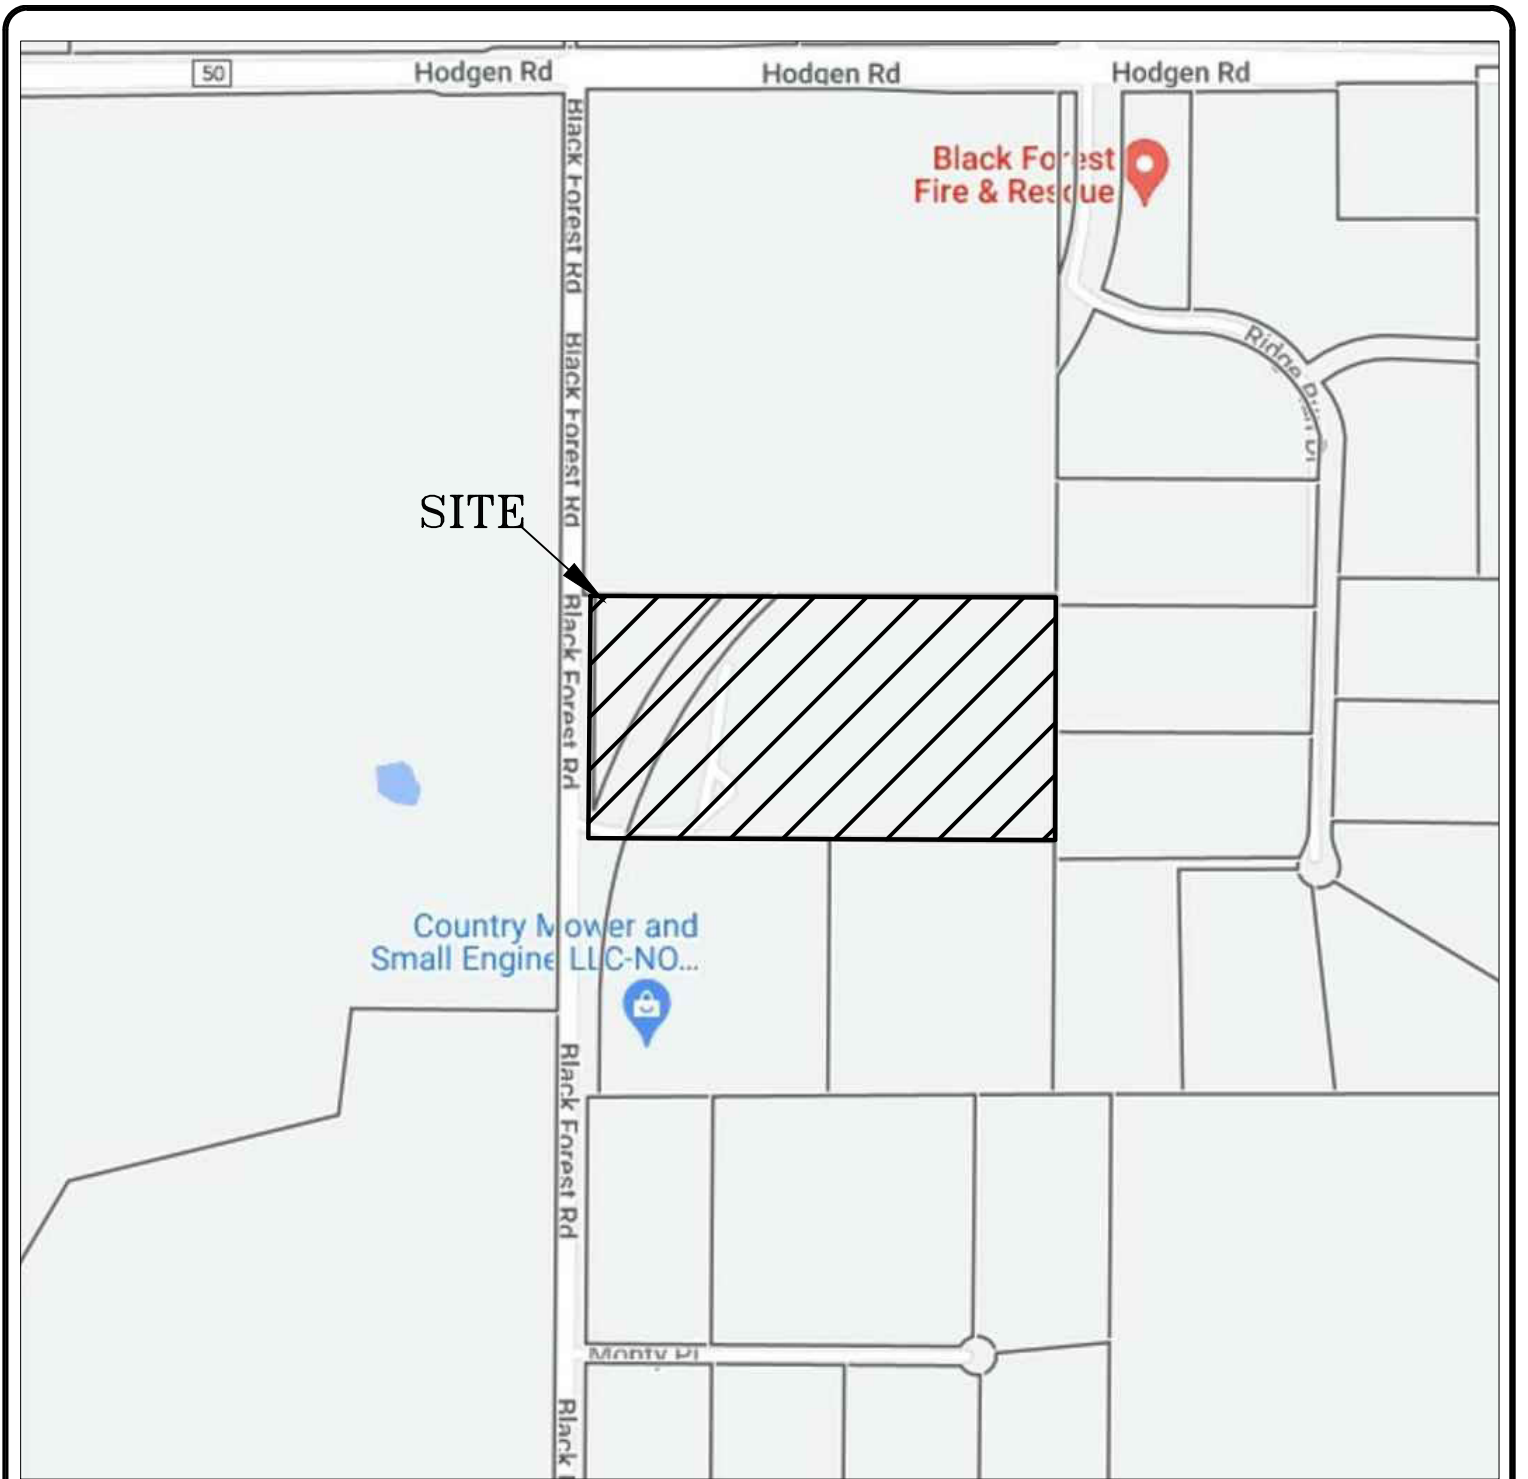
FIG NO.:  
**1**

VICINITY MAP  
HILL SUBDIVISION  
ALPACA HEIGHTS & BLACK FOREST ROAD  
EL PASO COUNTY, CO.  
FOR: DOUG HILL

The site is located in a portion of the NW¼ of Section 29 Township 11 South, Range 65 West of the 6<sup>th</sup> Principal Meridian in El Paso County, Colorado. The site is located approximately 7 miles east of the town of Monument, southeast of the intersection of Hodgen Road and Black Forest Road, in El Paso County, Colorado. The location of the site is as shown on the Vicinity Map, Figure 1.
