SOIL AND GEOLOGY STUDY

**Team Chris Subdivision
Black Squirrel Creek
El Paso County, Colorado**

JOB NO. 196369

September 13, 2024

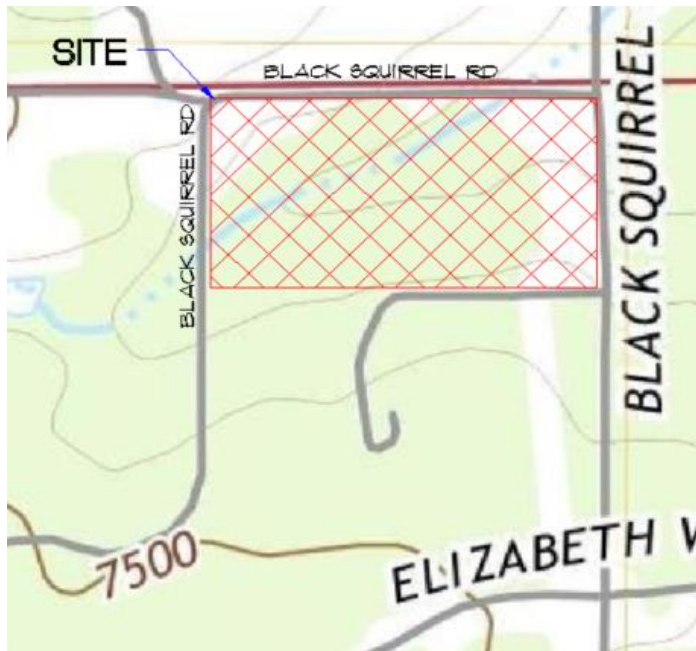
Insert from USGS 2022 Topo

The site surface characteristics were observed to consist of flat to mildly rolling terrain with low lying grasses, weeds, and dense forest. An intermittent drainage is traverses the lots from the northeast corner to the southwest corner. Below is an image from the Black Forest 2022 (US Topo) indicating the intermittent drainage.

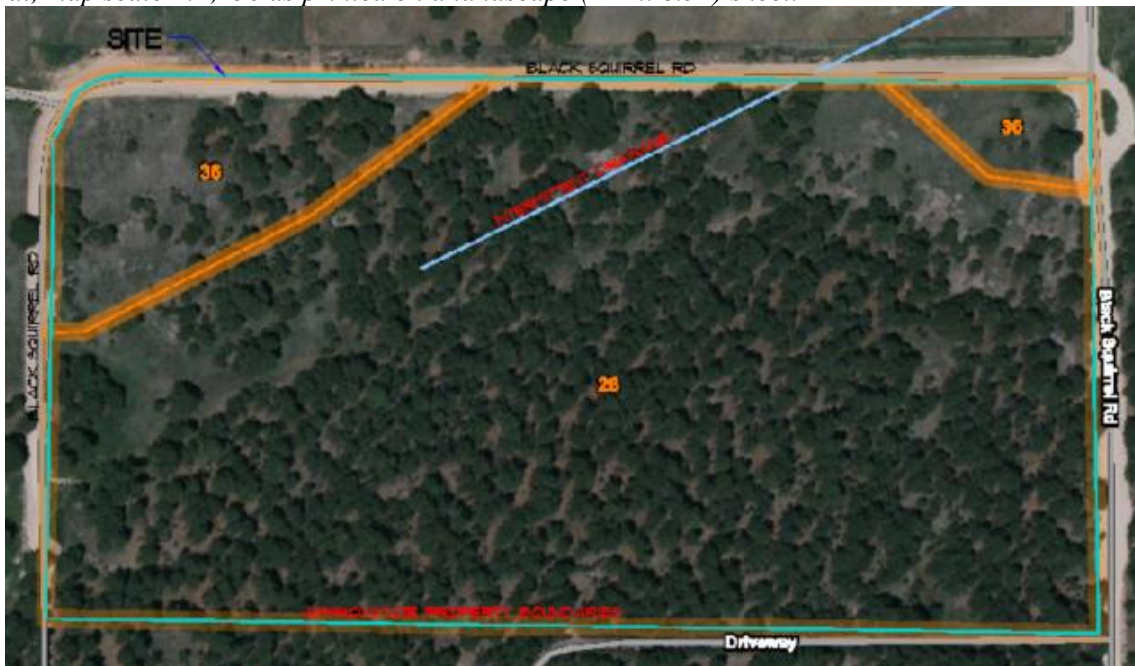
Insert from USDA, National Resources Conservation Service

- 26 – Elbeth sandy loam, 8 to 15 percent slopes. The Elbeth sandy loam was mapped by the USDA to encompass the majority of the site. Properties of the Elbeth sandy loam include well drained soils, depth of the water table is anticipated to be greater than 80 inches, runoff is anticipated to be medium, frequency of flooding and/or ponding is none, and landforms include hills.
- 36 – Holderness loam, 8 to 15 percent slopes. The Holderness loam was mapped by the USDA to encompass the northeast and northwest corners of the site. Properties of the Holderness loam include well drained soils, depth of the water table is anticipated to be greater than 80 inches, runoff is anticipated to be medium, frequency of flooding and/or ponding is none, and landforms include hills. The USDA Soil Survey Map is presented below.

Note, as stated on the original download from the USDA, the soil map may not be valid at the scale it was printed at, map scale 1:2,150 as printed on a landscape (11" x 8.5") sheet.

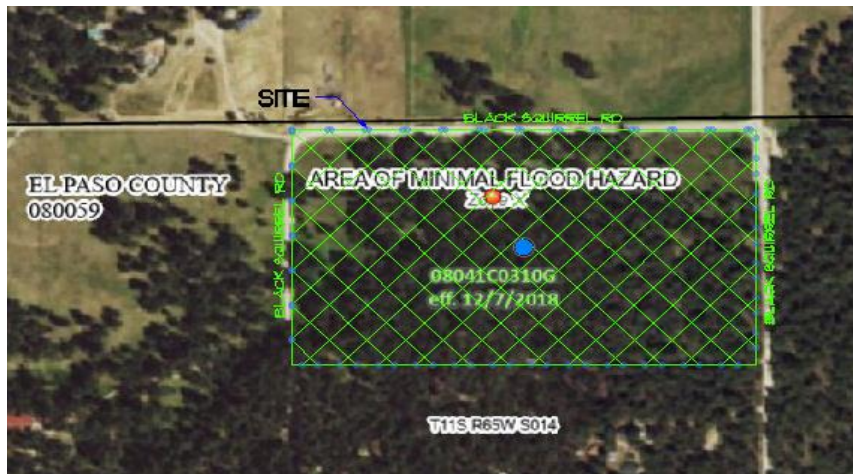
Insert from National Flood Hazard Layer FIRMette, USGS National Map 2023

Zone X is defined by FEMA as an area of minimal flood hazard that is determined to be outside the Special Flood Hazard Area and higher than the elevation of the 0.2-percent-annual-chance (or 500-year) flood. The entire site lies within Zone X, as indicated in the photo below.

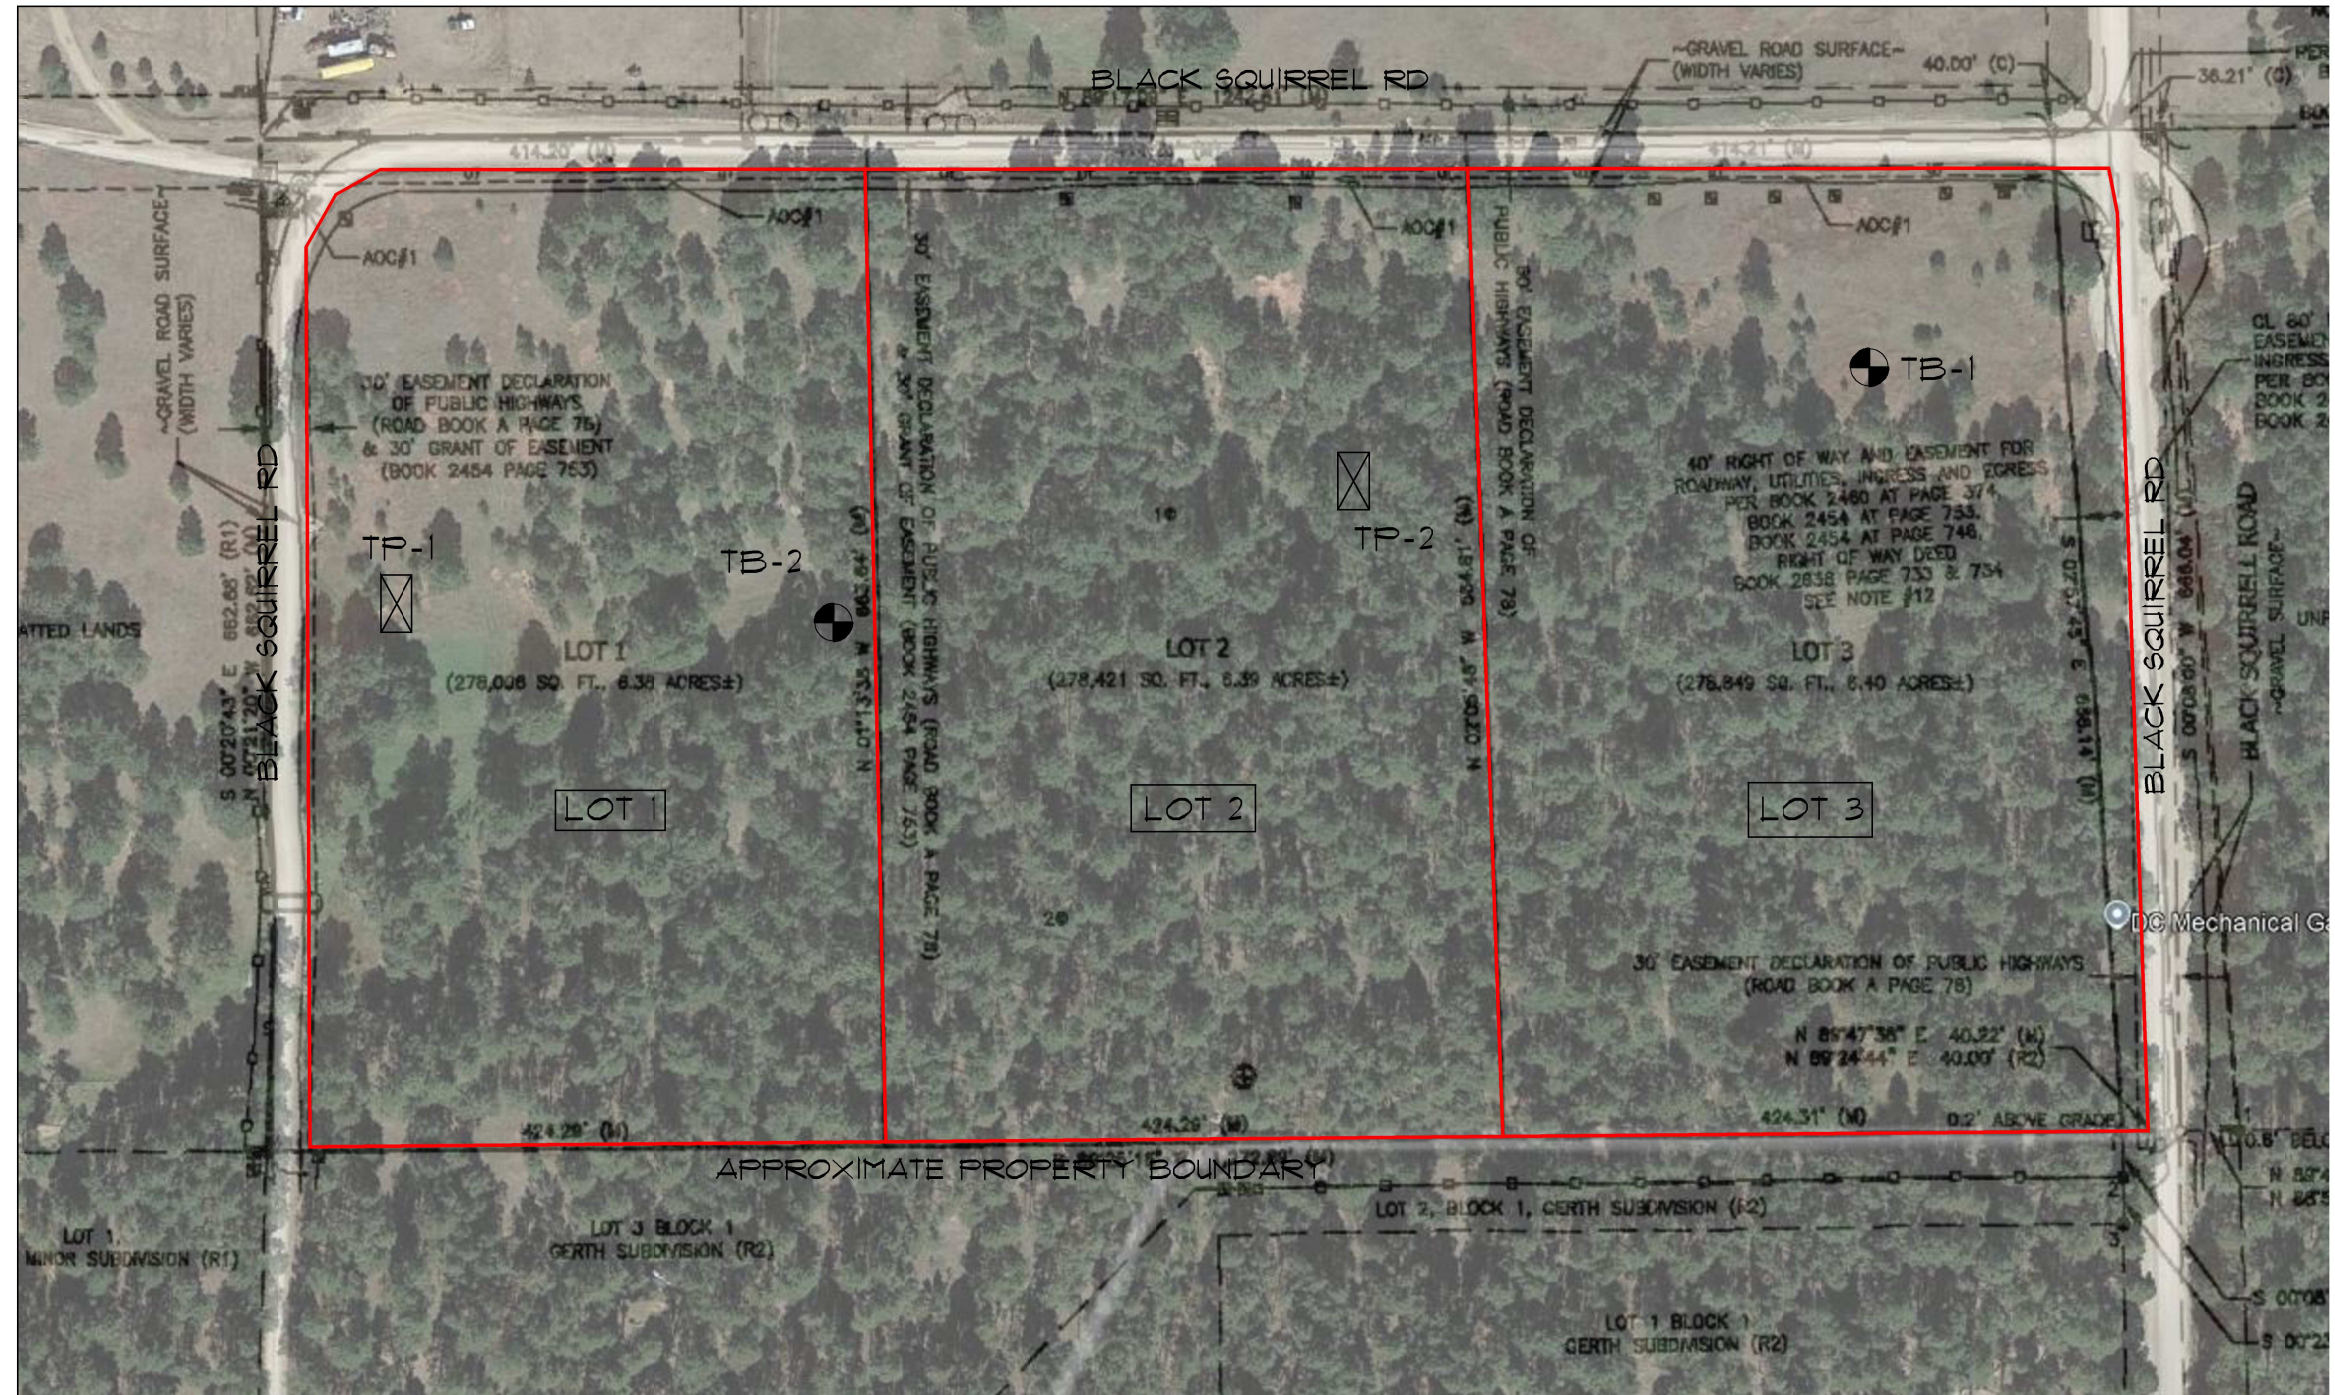
⊙ DENOTES APPROXIMATE LOCATION OF TEST BORINGS

⊠ DENOTES APPROXIMATE LOCATION OF TEST PITS

The current subsurface conditions within the property were explored by drilling two (2) exploratory test borings to depths of 20-feet below the existing ground surface on May 10, 2024 and observing two 8-foot deep test pits on May 17, 2024. The test pits were excavated for preliminary OWTS purposes. The total number of borings generally meets the minimum criteria as stipulated in the ECM, Section C.3.3.
