SOIL AND GEOLOGY STUDY

**Team Chris Subdivision
Black Squirrel Creek
El Paso County, Colorado**

JOB NO. 196369

**September 13, 2024
Amended November 26, 2024**

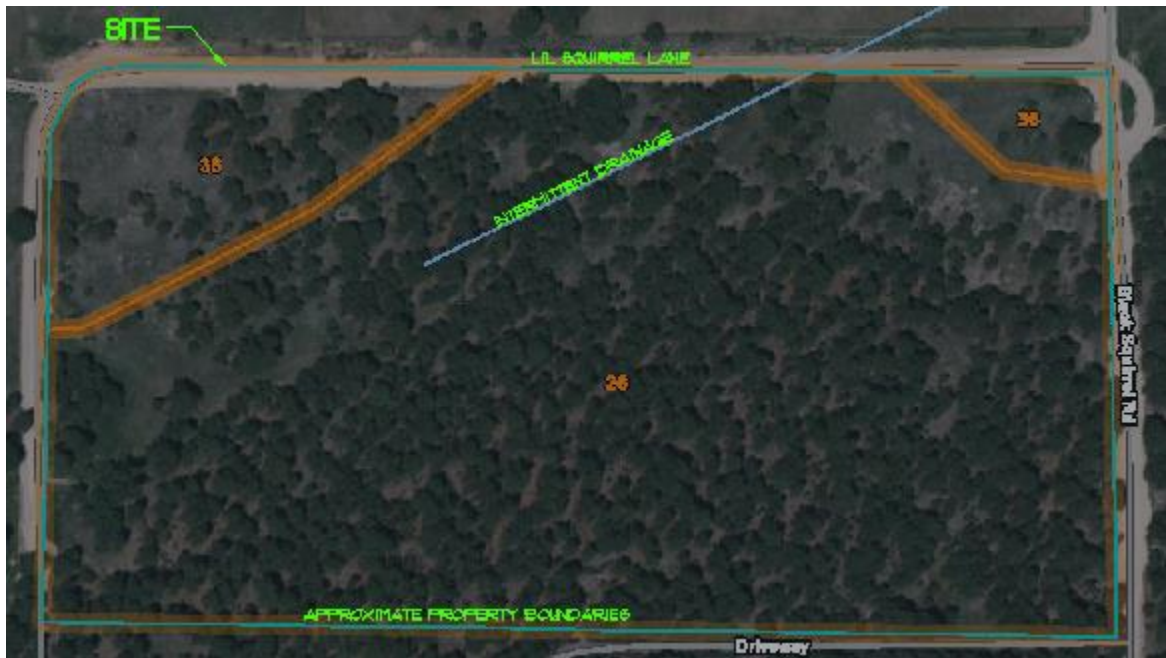
Insert from USDA, National Resources Conservation Service

- 26 – Elbeth sandy loam, 8 to 15 percent slopes. The Elbeth sandy loam was mapped by the USDA to encompass the majority of the site. Properties of the Elbeth sandy loam include well drained soils, depth of the water table is anticipated to be greater than 80 inches, runoff is anticipated to be medium, frequency of flooding and/or ponding is none, and landforms include hills.
- 36 – Holderness loam, 8 to 15 percent slopes. The Holderness loam was mapped by the USDA to encompass the northeast and northwest corners of the site. Properties of the Holderness loam include well drained soils, depth of the water table is anticipated to be greater than 80 inches, runoff is anticipated to be medium, frequency of flooding and/or ponding is none, and landforms include hills. The USDA Soil Survey Map is presented below.

Note, as stated on the original download from the USDA, the soil map may not be valid at the scale it was printed at, map scale 1:2,150 as printed on a landscape (11" x 8.5") sheet.

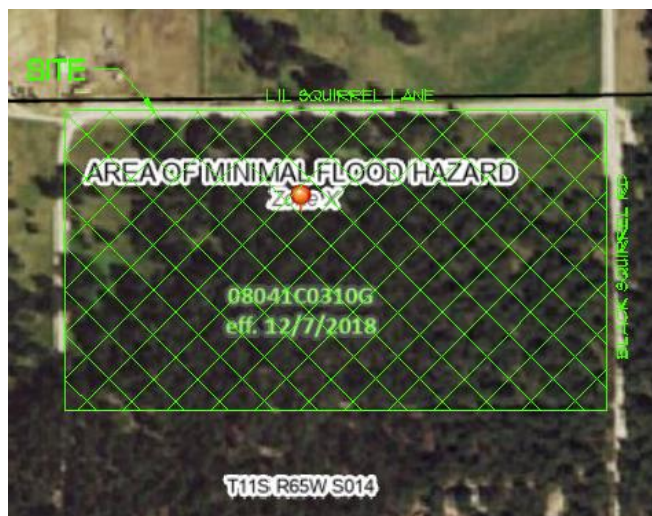
Insert from National Flood Hazard Layer FIRMette, USGS National Map 2023

Based on our review of the Federal Emergency Management Agency (FEMA) Community Panel No. 08041C00310G and the online ArcGIS El Paso County Risk Map, the entire site lies outside of a 100-year floodplain.

Zone X is defined by FEMA as an area of minimal flood hazard that is determined to be outside the Special Flood Hazard Area and higher than the elevation of the 0.2-percent-annual-chance (or 500-year) flood. The entire site lies within Zone X, as indicated in the photo below.
