SOIL AND GEOLOGY STUDY

**Team Chris Subdivision
Black Squirrel Creek
El Paso County, Colorado**

JOB NO. 196369

September 13, 2024

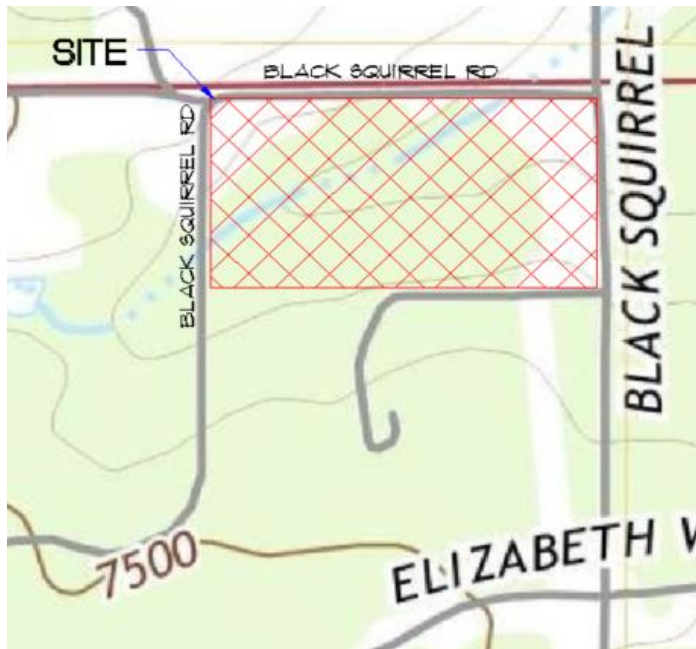
Insert from USGS 2022 Topo

The site surface characteristics were observed to consist of flat to mildly rolling terrain with low lying grasses, weeds, and dense forest. An intermittent drainage is traverses the lots from the northeast corner to the southwest corner. Below is an image from the Black Forest 2022 (US Topo) indicating the intermittent drainage.
