ENTECH
ENGINEERING, INC.

**SOILS AND GEOLOGY STUDY
PRELIMINARY PLAN STERLING RANCH EAST – FILING NO. 6
EL PASO COUNTY, COLORADO**

September 24, 2024

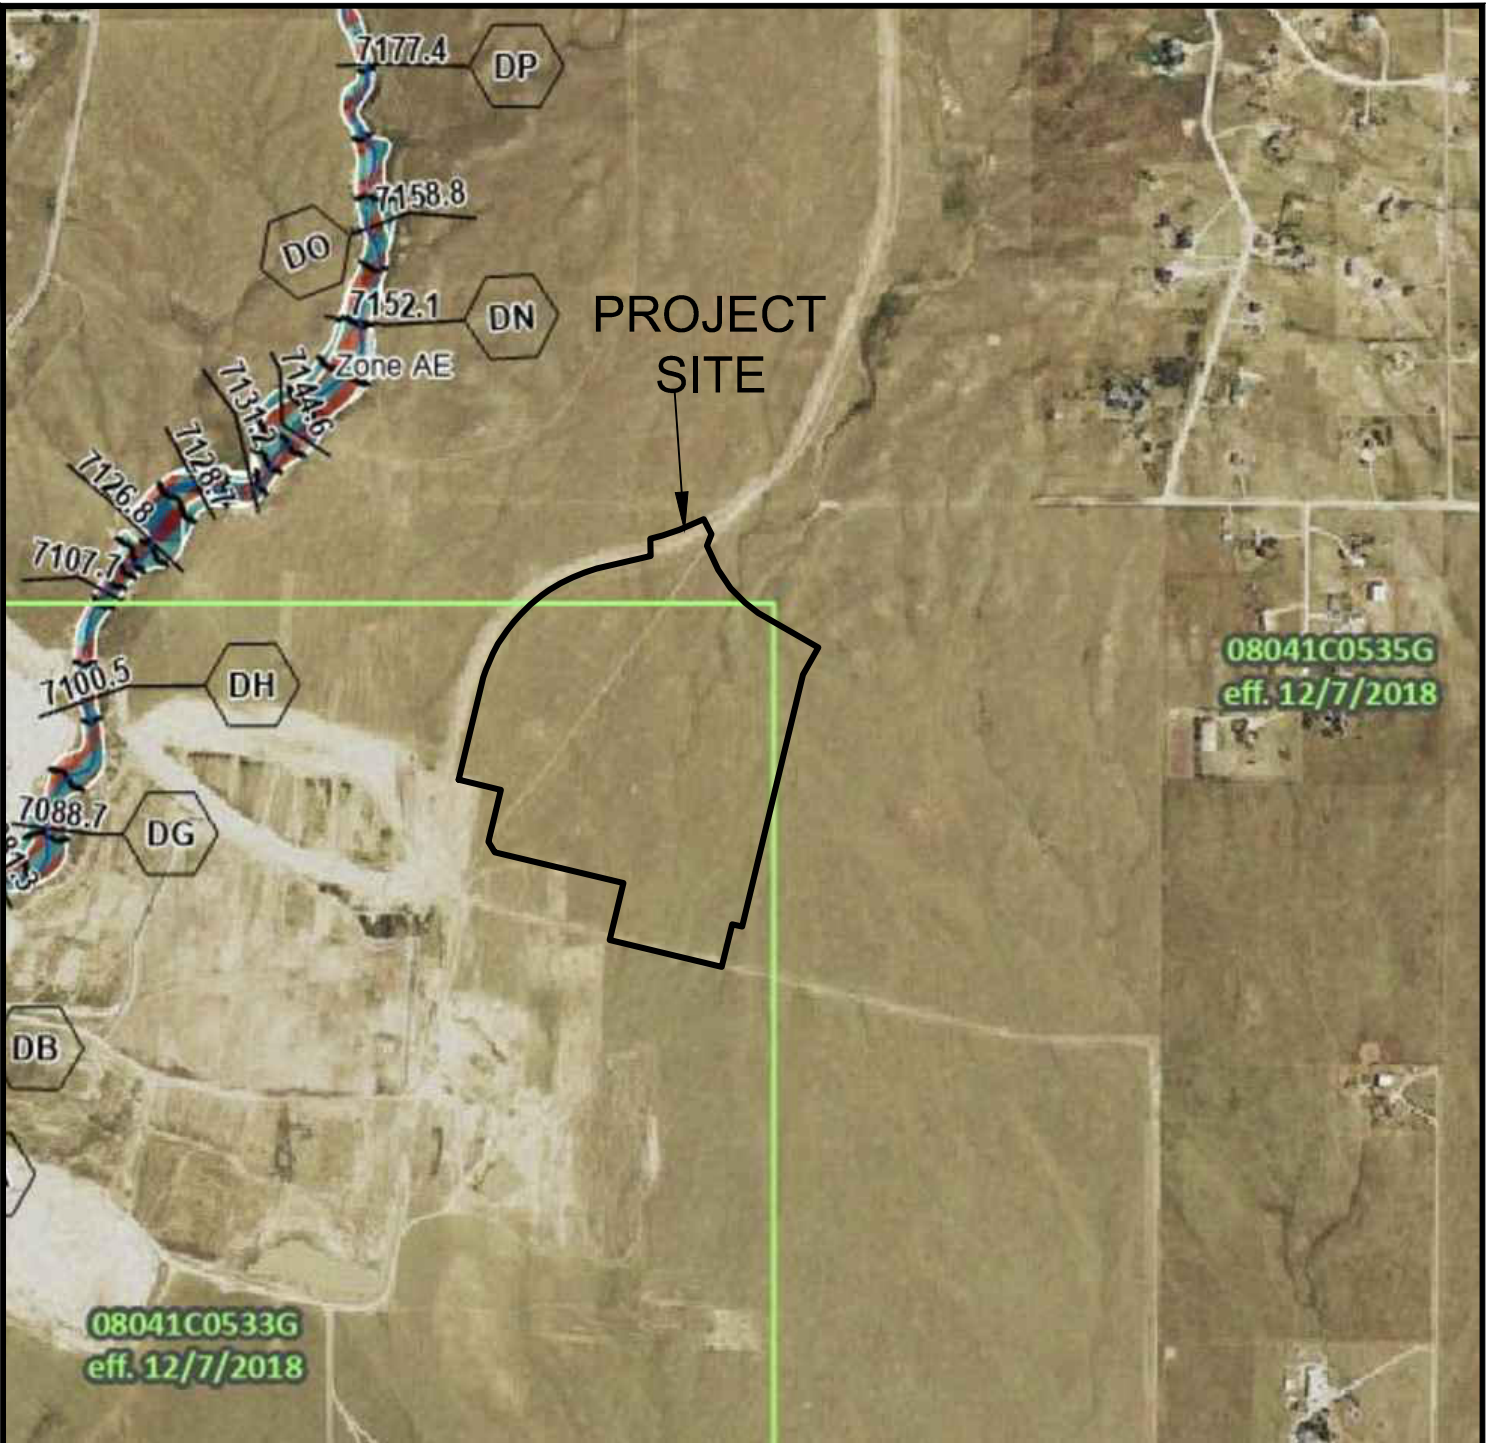
FIG. 7

FEMA FLOODPLAIN MAP
STERLING RANCH EAST FILING NO. 6
CLASSIC SRJ

The site is not mapped within floodplain zones according to the FEMA Map Nos. 08041CO533G and 08041CO535G, Figure 7 (Reference 11). The topography of the site is gradually sloping to the south-southwest with a minor drainage located in the northeastern portion of the site. The drainage was dry at the time of our site observation, and no areas of ponded water were observed within Filing No. 6. The minor drainage in the northeastern portion of the filing has been identified as a potentially seasonal shallow groundwater area and is shown on the Geology/Engineering Geology Map, Figure 6. This area mapped as potentially seasonal shallow groundwater has been identified in the National Wetland Inventory as Freshwater Emergent Wetland habitats classified as PEM1C (Palustrine – P, Emergent – EM, Persistent – 1, Seasonally Flooded – C) (Figure 9, Reference 11). This area is discussed as follows:
