ENTECH
ENGINEERING, INC.

**WASTEWATER STUDY
WINSOME SUBDIVISION – FILING NO. 1
A PORTION OF PARCEL NO. 51000-00-493
17480 MERIDIAN ROAD NORTH
EL PASO COUNTY, COLORADO**

January 22, 2020
Revised April 14, 2020

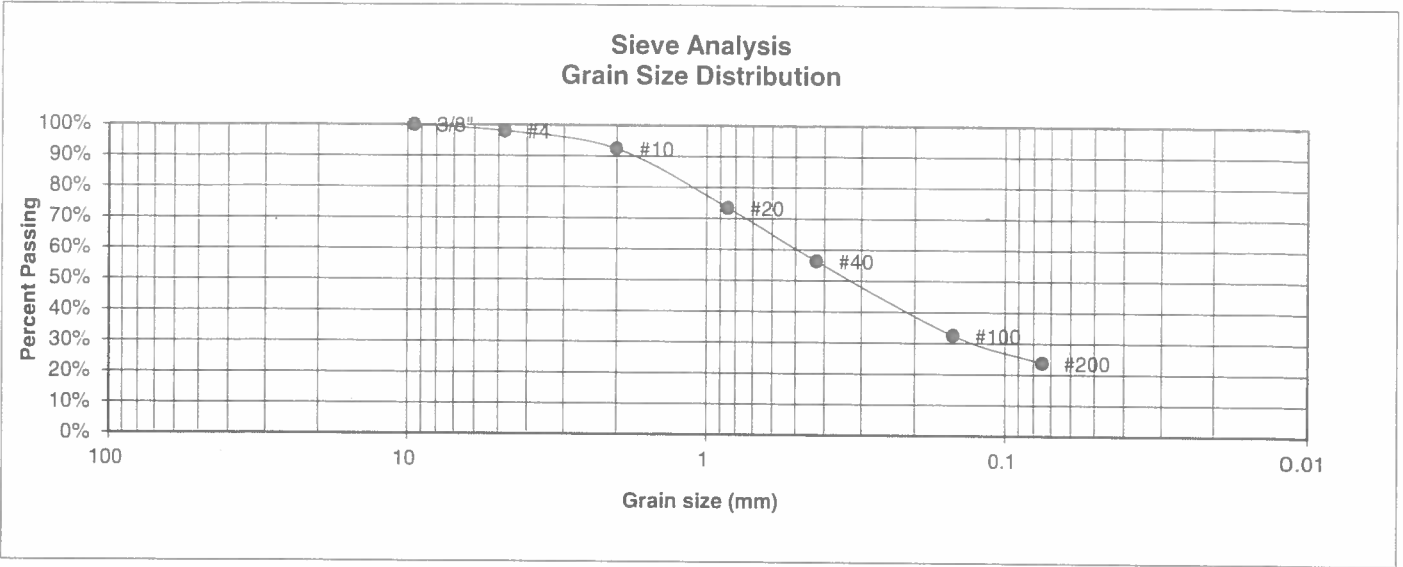
FIG NO
B-1

<u>UNIFIED CLASSIFICATION</u>	SM	<u>CLIENT</u>	WINSOME, LLC
<u>SOIL TYPE #</u>	1	<u>PROJECT</u>	HODGEN ROAD
<u>TEST BORING #</u>	TP-1	<u>JOB NO.</u>	200032
<u>DEPTH (FT)</u>	2-3	<u>TEST BY</u>	BL

<u>U.S. Sieve #</u>	<u>Percent Finer</u>
3"	
1 1/2"	
3/4"	
1/2"	
3/8"	100.0%
4	98.0%
10	92.4%
20	73.4%
40	56.3%
100	32.5%
200	23.8%

Soil Type 1 is a slightly silty to silty sand (SM-SW, SM). This material was encountered in the test borings and in the ten test pits. The sand was encountered at depths ranging from the existing surface to 12 to 15 feet bgs and extended to the termination of the Test Boring Nos. 2 and 3 of this investigation, and Test Boring No. 3 from the previous investigation (20 feet). These soils were encountered at loose to medium dense states and at dry to moist conditions. Samples tested had 7 to 26 percent of the soil sized particles passing the No. 200 Sieve. Atterberg Limits Testing resulted in the sand being non-plastic. FHA Swell Testing on a sample of the sand resulted in an expansion of 30 psf, indicating a low expansion potential. Swell/Consolidation Testing resulted in a consolidation of 0.2 percent, indicating a low consolidation potential.

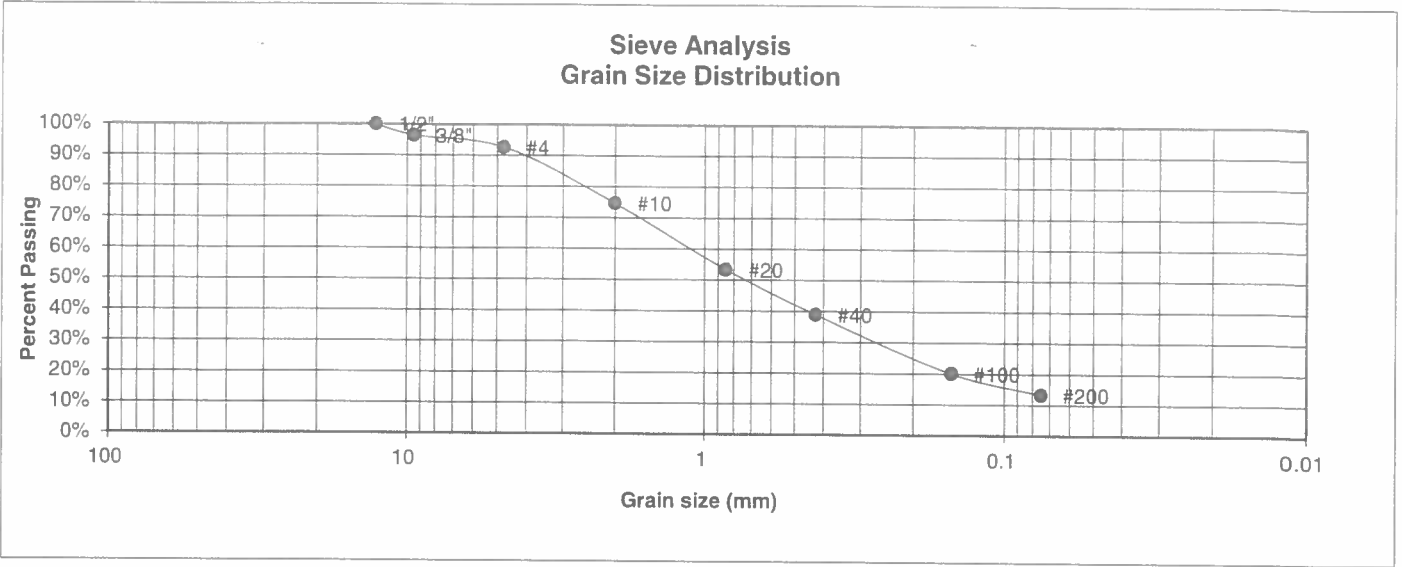
FIG NO.:
B-2

<u>UNIFIED CLASSIFICATION</u>	SM	<u>CLIENT</u>	WINSOME, LLC
<u>SOIL TYPE #</u>	1	<u>PROJECT</u>	HODGEN ROAD
<u>TEST BORING #</u>	TP-2	<u>JOB NO.</u>	200032
<u>DEPTH (FT)</u>	5-6	<u>TEST BY</u>	BL

<u>U.S. Sieve #</u>	<u>Percent Finer</u>
3"	
1 1/2"	
3/4"	
1/2"	100.0%
3/8"	96.4%
4	92.6%
10	74.7%
20	53.4%
40	38.9%
100	20.1%
200	13.3%

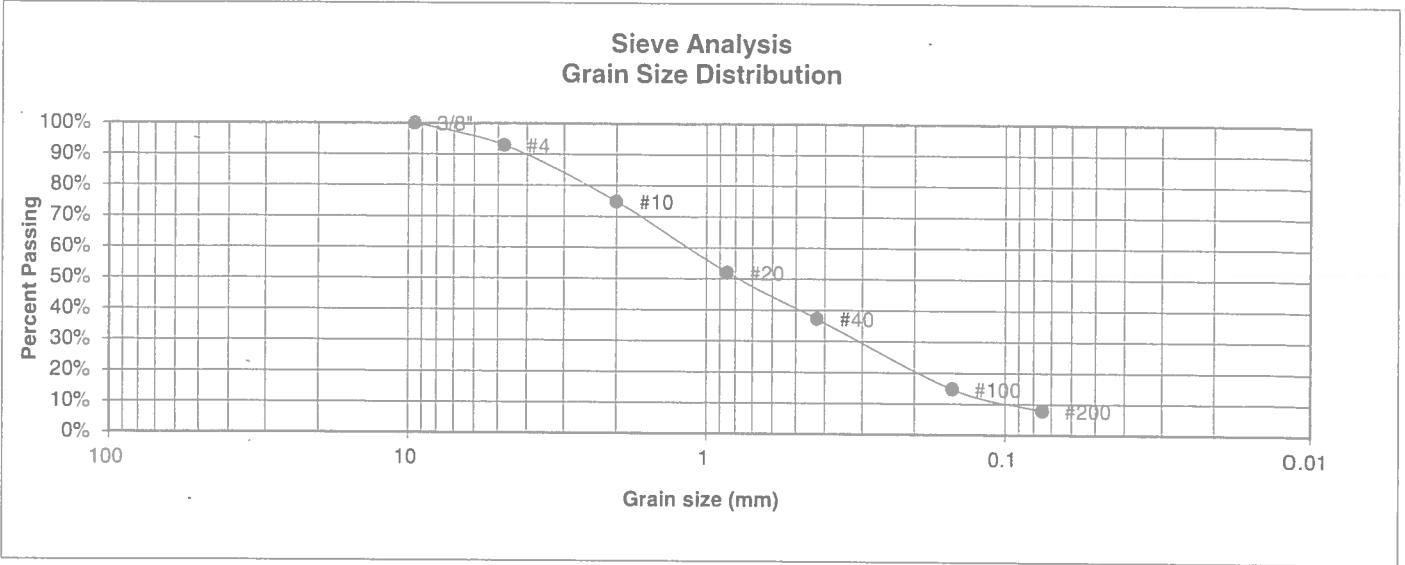
<u>UNIFIED CLASSIFICATION</u>	SM-SW	<u>CLIENT</u>	WINSOME, LLC
<u>SOIL TYPE #</u>	1	<u>PROJECT</u>	HODGEN ROAD
<u>TEST BORING #</u>	TP-4	<u>JOB NO.</u>	200032
<u>DEPTH (FT)</u>	2-3	<u>TEST BY</u>	BL

<u>U.S. Sieve #</u>	<u>Percent Finer</u>
3"	
1 1/2"	
3/4"	
1/2"	
3/8"	100.0%
4	92.9%
10	74.8%
20	52.0%
40	37.2%
100	14.8%
200	7.9%

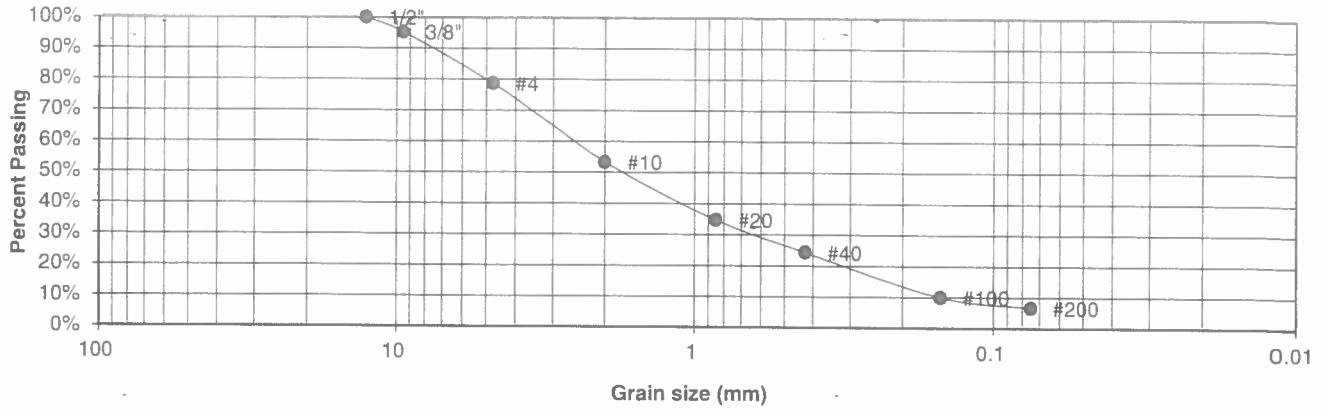
FIG NO.
B-4

CLIENT WINSOME, LLC
 PROJECT HODGEN ROAD
 JOB NO. 200032
 TEST BY BL

Sieve Analysis
 Grain Size Distribution

U.S. Sieve #	Percent Finer
3"	
1 1/2"	
3/4"	
1/2"	100.0%
3/8"	95.2%
4	78.7%
10	53.3%
20	34.7%
40	24.3%
100	10.0%
200	6.7%

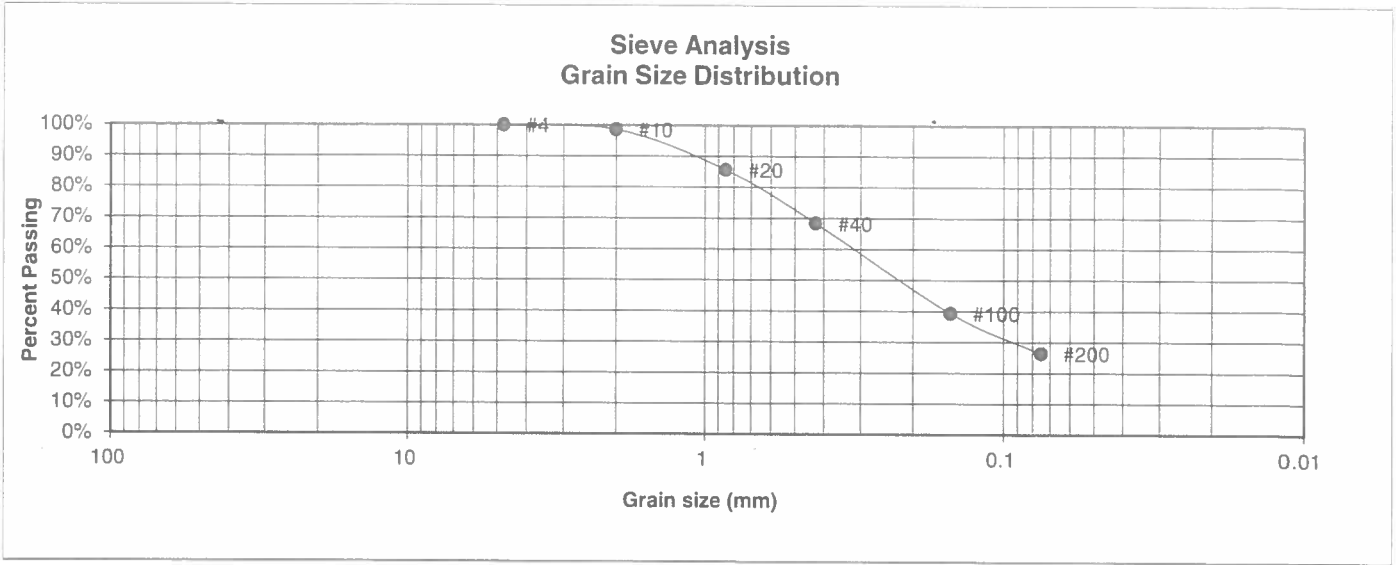
FIG NO.:
B-5

<u>UNIFIED CLASSIFICATION</u>	SM	<u>CLIENT</u>	WINSOME, LLC
<u>SOIL TYPE #</u>	1	<u>PROJECT</u>	HODGEN ROAD
<u>TEST BORING #</u>	TP-7	<u>JOB NO.</u>	200032
<u>DEPTH (FT)</u>	2-3	<u>TEST BY</u>	BL

<u>U.S. Sieve #</u>	<u>Percent Finer</u>
3"	
1 1/2"	
3/4"	
1/2"	
3/8"	
4	100.0%
10	98.6%
20	85.6%
40	68.3%
100	39.3%
200	26.3%
