ENTECH
ENGINEERING, INC.

**SOIL, GEOLOGY, AND GEOLOGIC HAZARD STUDY
WINSOME SUBDIVISION – PHASE I
A PORTION OF PARCEL NO. 51000-00-493
17480 MERIDIAN ROAD NORTH
EL PASO COUNTY, COLORADO**

January 22, 2020

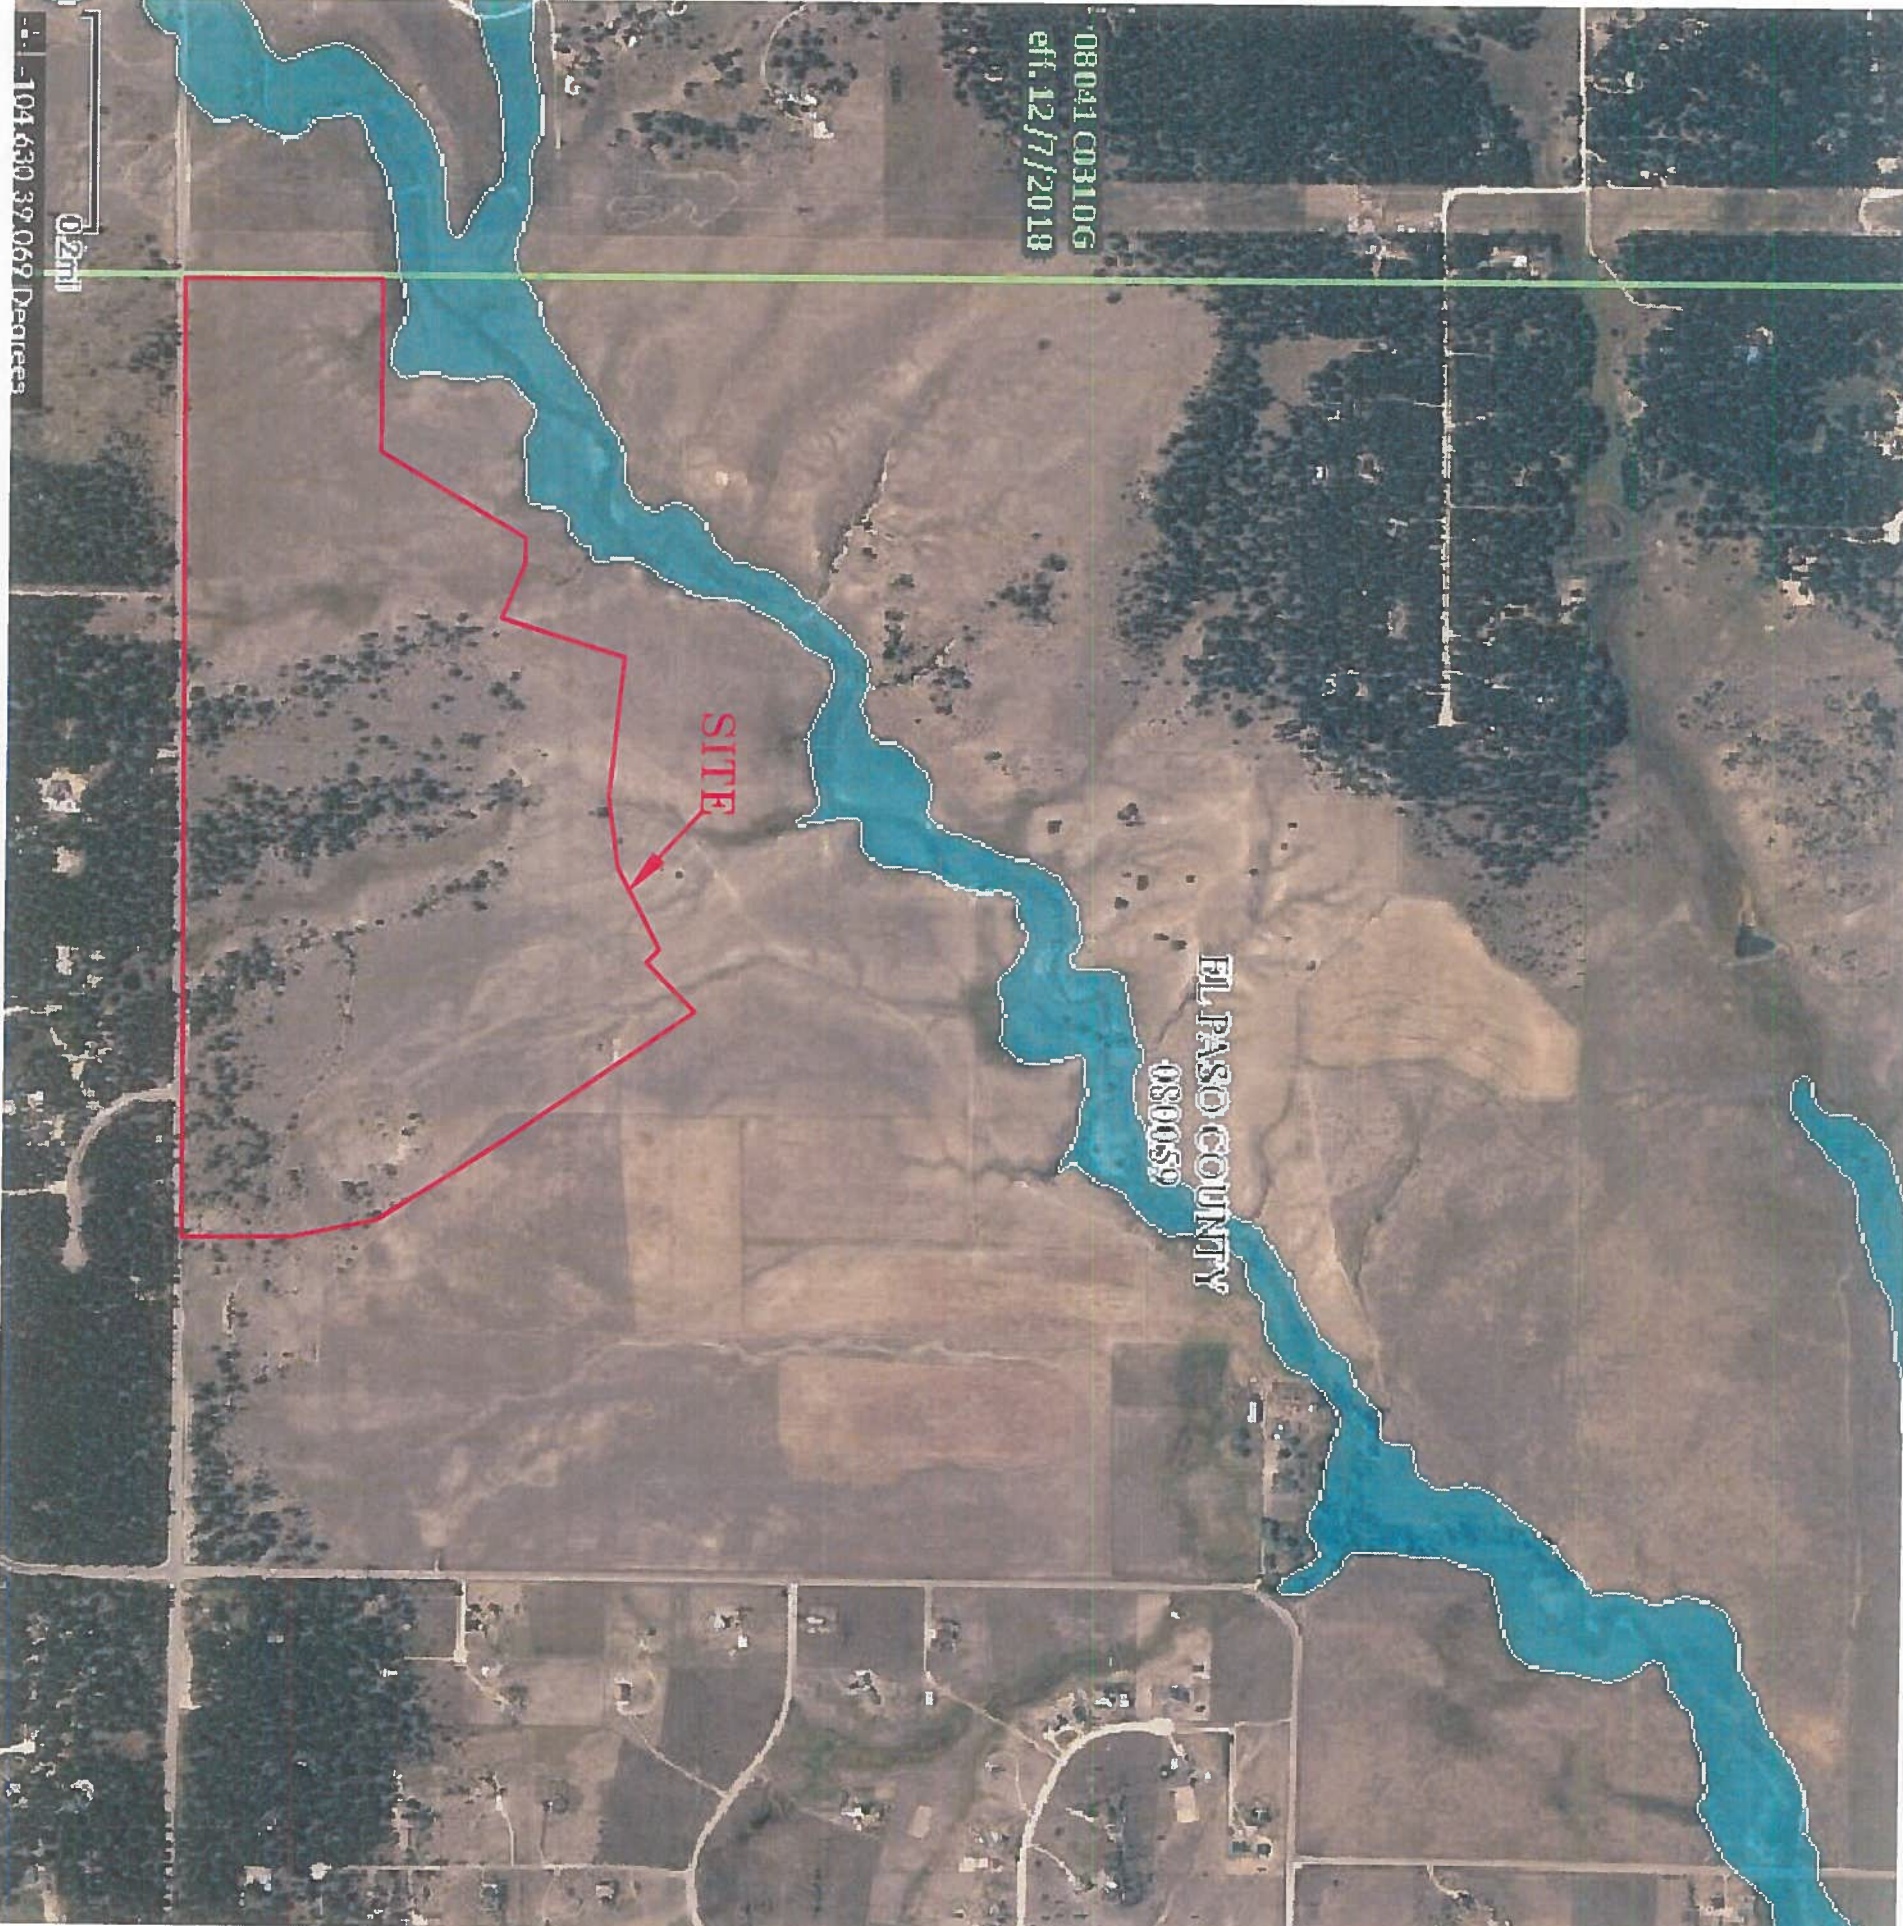
DATE	BY
1/17/20	AS SHOWN
200092	TRIPLE M.
7

FLOODPLAIN MAP
WINSOME SUBDIVISION - PHASE I
HODGEN ROAD & MERIDIAN ROAD
EL PASO COUNTY, CO.
FOR: WINSOME, LLC

Portions of the site associated with the West Kiowa Creek drainage are mapped within a floodplain zone according to the FEMA Map No. 08041CO350G, dated December 7, 2018 (Figure 7, Reference 6). Water was observed flowing in West Kiowa Creek. The floodplain areas have been designated as open space and/or can be avoided by construction and is located outside of Phase I of the development. Additionally, areas of seasonal and potentially seasonal shallow groundwater were observed across the site. In these areas, we would anticipate the potential for periodically high subsurface moisture conditions and frost heave potential. These areas lie within low-lying areas along the drainage in the southeastern portion of the site and in the low-lying areas and minor drainages across the site. Water was not observed in any of the minor drainages at the time of our site investigation. These areas can likely be avoided or properly mitigated by development. The floodplain should be avoided by construction unless site-specific floodplain determination and drainage studies are performed. The potential exists for high groundwater levels during high moisture periods and should structures encroach on these areas the following precautions should be followed.
