**WASTEWATER STUDY
WINSOME SUBDIVISION – PHASE I
A PORTION OF PARCEL NO. 51000-00-493
17480 MERIDIAN ROAD NORTH
EL PASO COUNTY, COLORADO**

1.0 SUMMARY

Total acreage involved in phase one of the project is 163.34 acres. The proposed site development consists of forty-seven single-family rural residential lots. The development will utilize individual wells and on-site wastewater treatment systems.

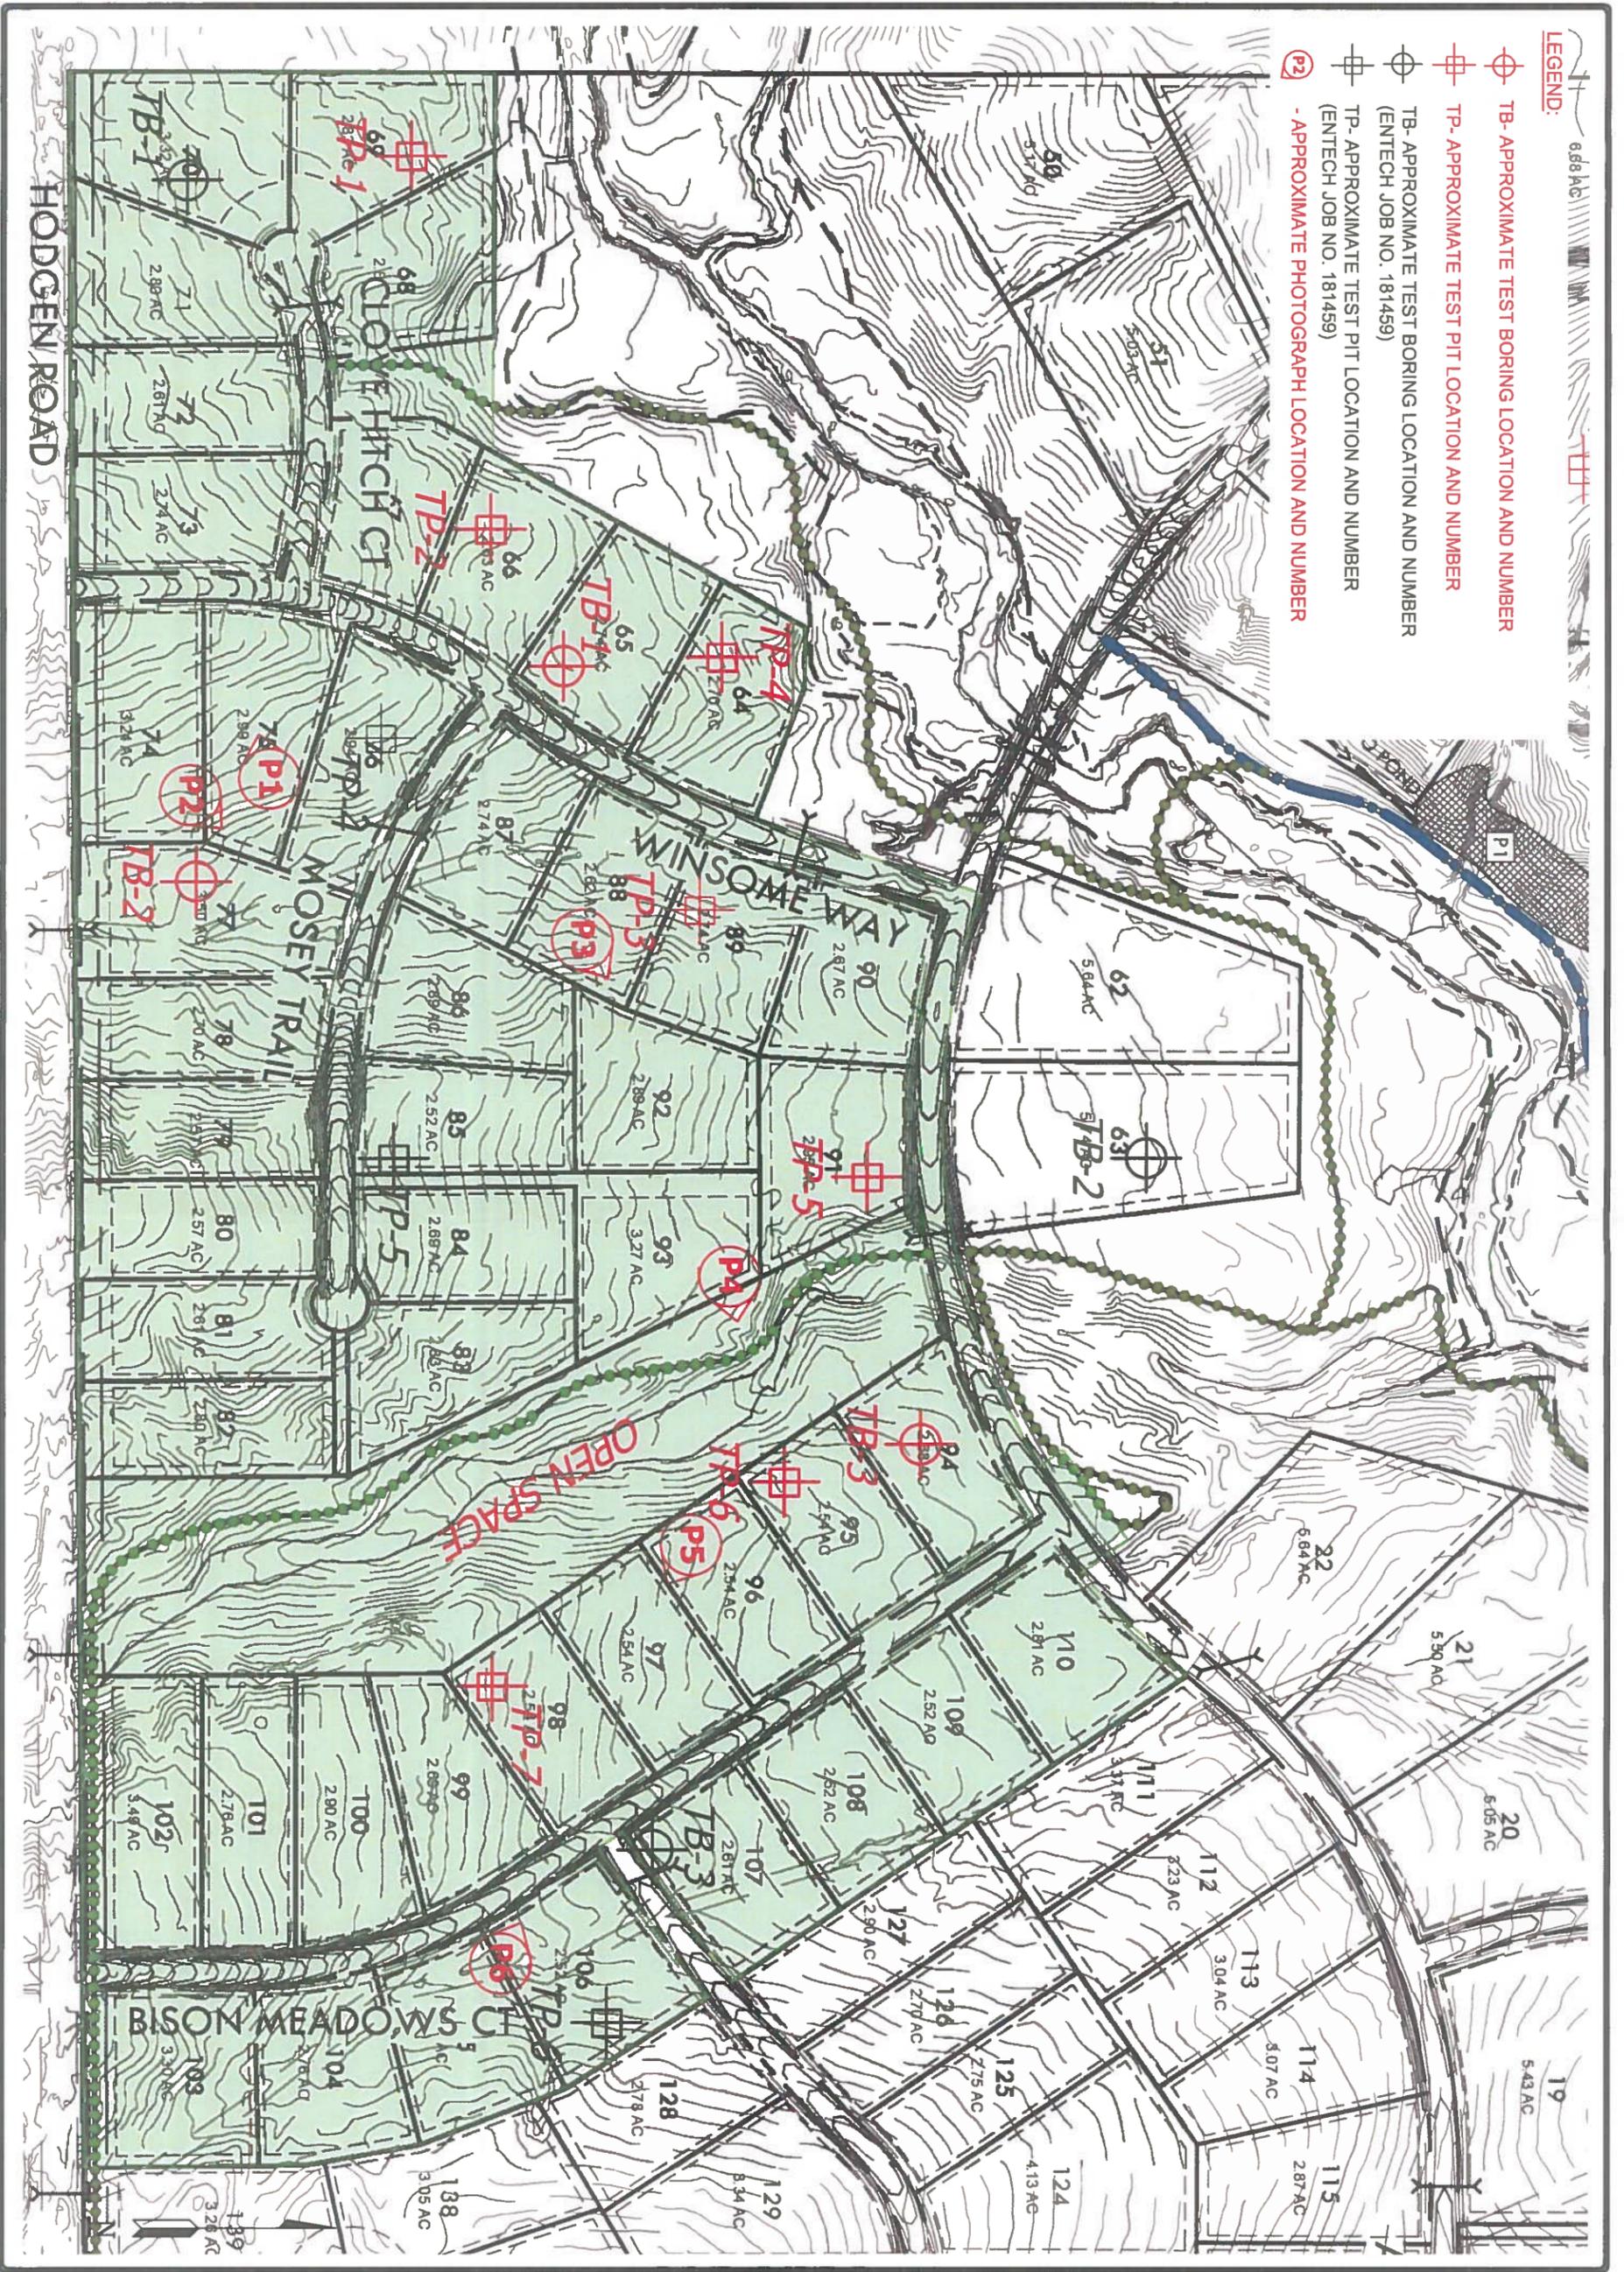
- ⊕ TB- APPROXIMATE TEST BORING LOCATION AND NUMBER
- ⊕ TP- APPROXIMATE TEST PIT LOCATION AND NUMBER
- ⊕ TB- APPROXIMATE TEST BORING LOCATION AND NUMBER (ENTECH JOB NO. 181459)
- ⊕ TP- APPROXIMATE TEST PIT LOCATION AND NUMBER (ENTECH JOB NO. 181459)
- ⊕ - APPROXIMATE PHOTOGRAPH LOCATION AND NUMBER

The site was previously investigated as part of a Preliminary Soils, Geology, Geologic Hazard and Wastewater Study, Entech Job No. 181459 (Reference 1). Five (5) test borings, and ten (10) tactile test pits were performed on the site to determine general suitability of the site for the use of on-site wastewater treatment systems. The previous report/investigation was used as part of this investigation. More specifically previous Test Boring Nos. (TB-1 and TB-3) and Test Pit Nos. (TP-4, TP-5 and TP-6) were used as part of the Winsome Subdivision Phase I investigation.

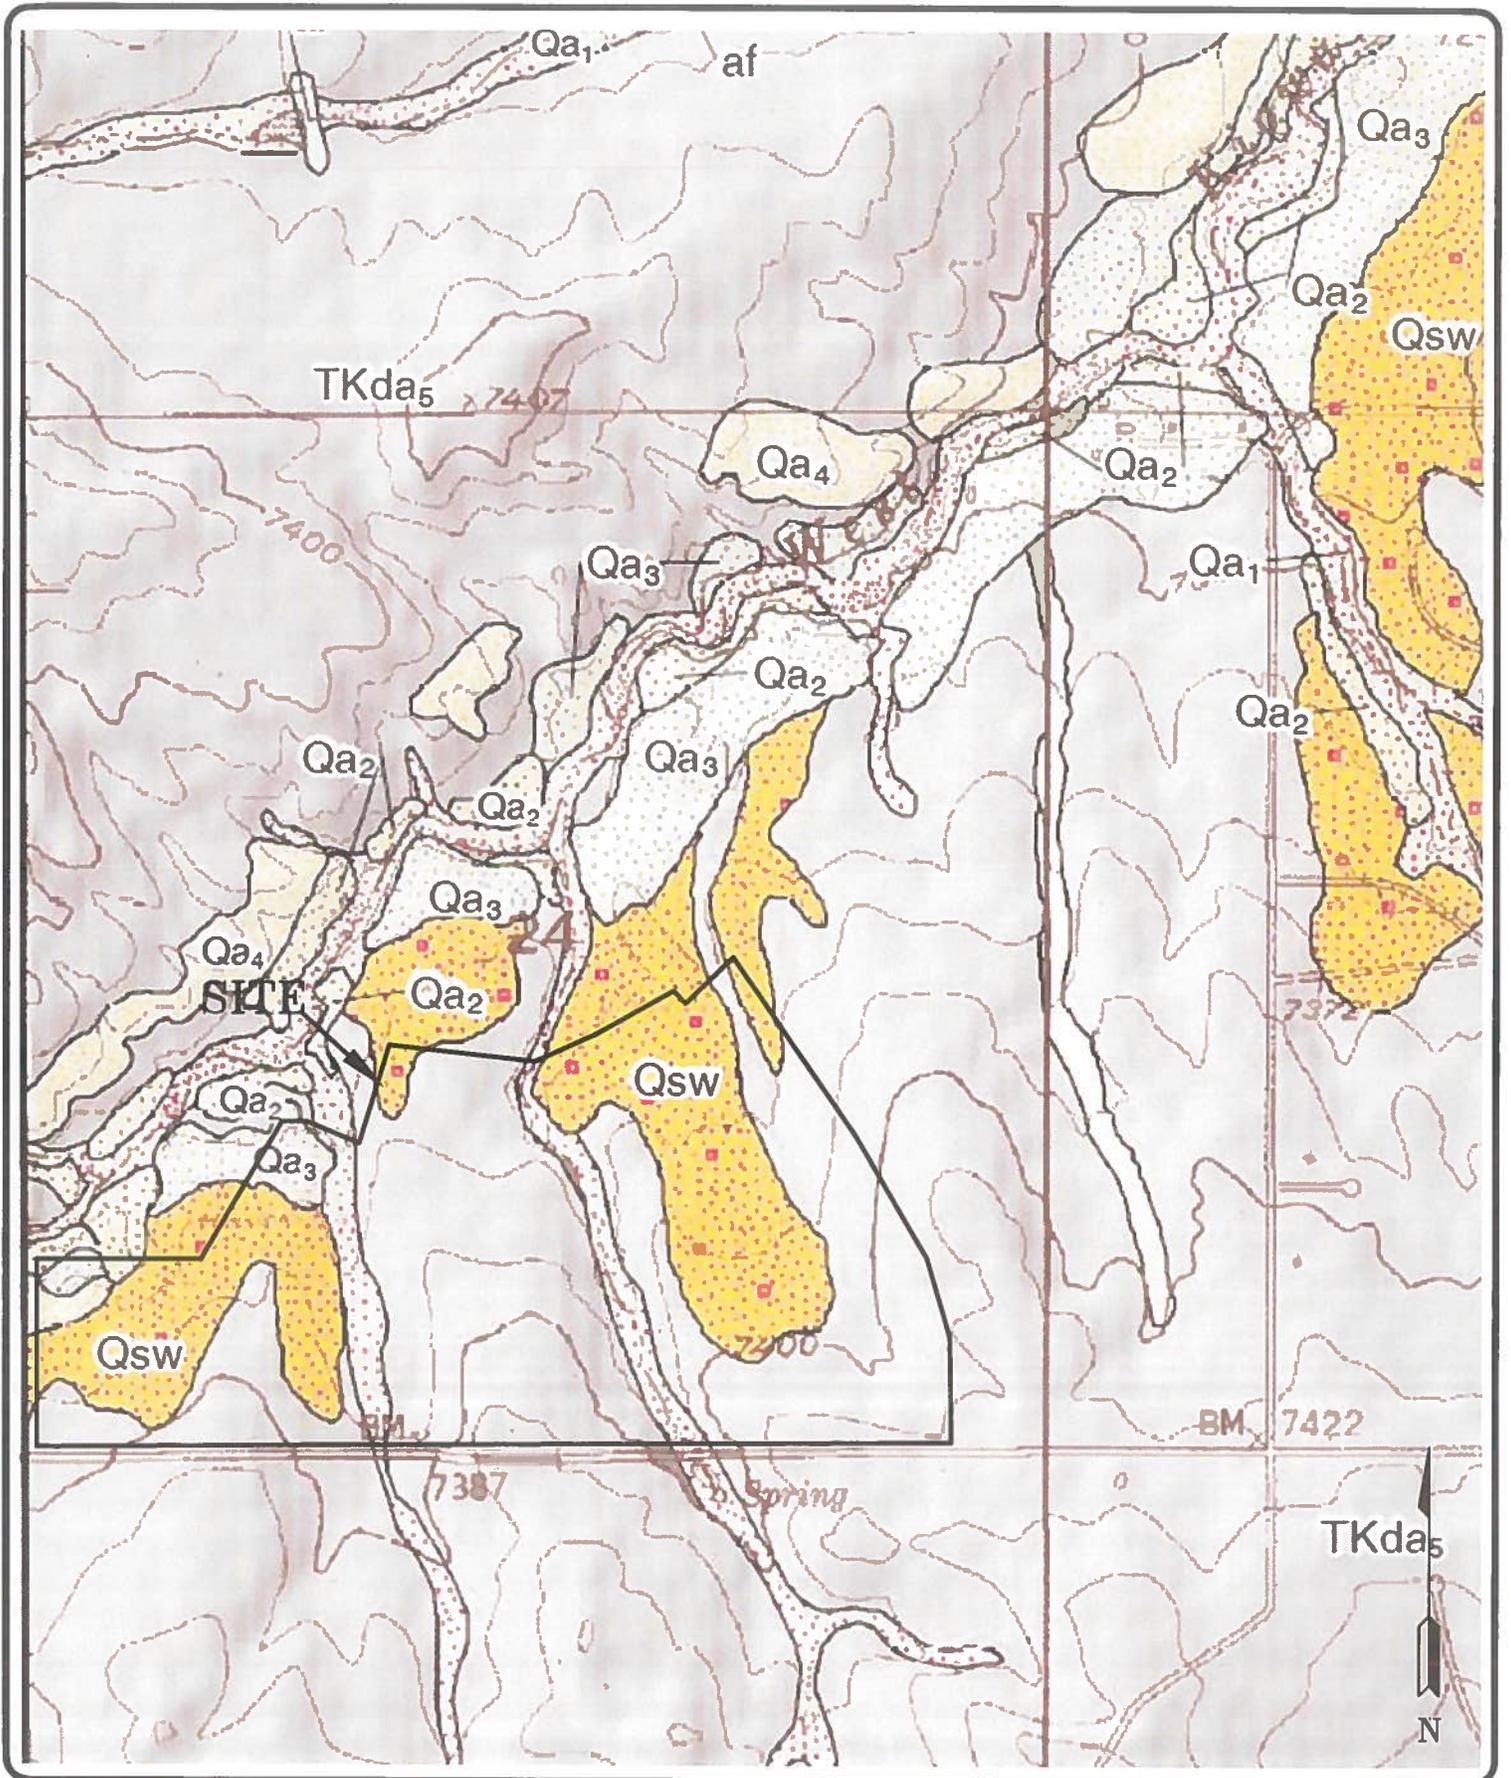
EASTONVILLE QUADRANGLE GEOLOGIC MAP
WINSOME SUBDIVISION - PHASE I
HODGEN ROAD & MERIDIAN ROAD
EL PASO COUNTY, CO.
FOR: WINSOME, LLC

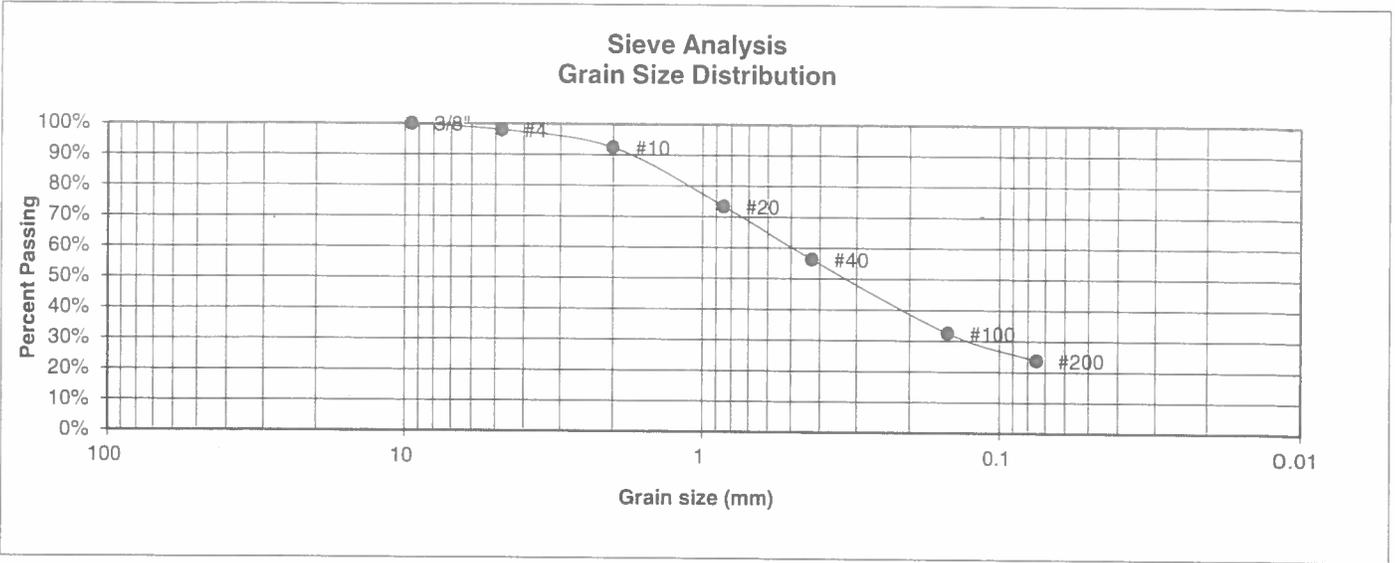
FIG NO
B-1

<u>UNIFIED CLASSIFICATION</u>	SM	<u>CLIENT</u>	WINSOME, LLC
<u>SOIL TYPE #</u>	1	<u>PROJECT</u>	HODGEN ROAD
<u>TEST BORING #</u>	TP-1	<u>JOB NO.</u>	200032
<u>DEPTH (FT)</u>	2-3	<u>TEST BY</u>	BL

<u>U.S. Sieve #</u>	<u>Percent Finer</u>
3"	
1 1/2"	
3/4"	
1/2"	
3/8"	100.0%
4	98.0%
10	92.4%
20	73.4%
40	56.3%
100	32.5%
200	23.8%

Soil Type 1 is a slightly silty to silty sand (SM-SW, SM). This material was encountered in the test borings and in the ten test pits. The sand was encountered at depths ranging from the existing surface to 12 to 15 feet bgs and extended to the termination of the Test Boring Nos. 2 and 3 of this investigation, and Test Boring No. 3 from the previous investigation (20 feet). These soils were encountered at loose to medium dense states and at dry to moist conditions. Samples tested had 7 to 26 percent of the soil sized particles passing the No. 200 Sieve. Atterberg Limits Testing resulted in the sand being non-plastic. FHA Swell Testing on a sample of the sand resulted in an expansion of 30 psf, indicating a low expansion potential. Swell/Consolidation Testing resulted in a consolidation of 0.2 percent, indicating a low consolidation potential.

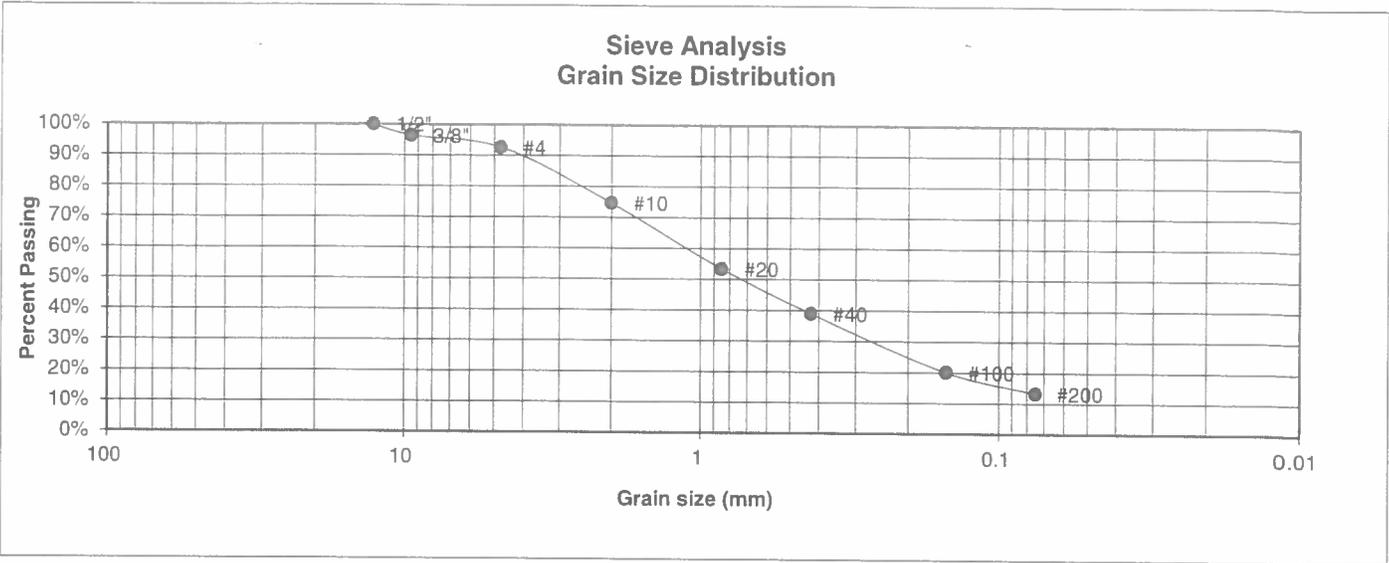
FIG NO.:
B-2

UNIFIED CLASSIFICATION	SM	CLIENT	WINSOME, LLC
SOIL TYPE #	1	PROJECT	HODGEN ROAD
TEST BORING #	TP-2	JOB NO.	200032
DEPTH (FT)	5-6	TEST BY	BL

U.S. Sieve #	Percent Finer
3"	
1 1/2"	
3/4"	
1/2"	100.0%
3/8"	96.4%
4	92.6%
10	74.7%
20	53.4%
40	38.9%
100	20.1%
200	13.3%

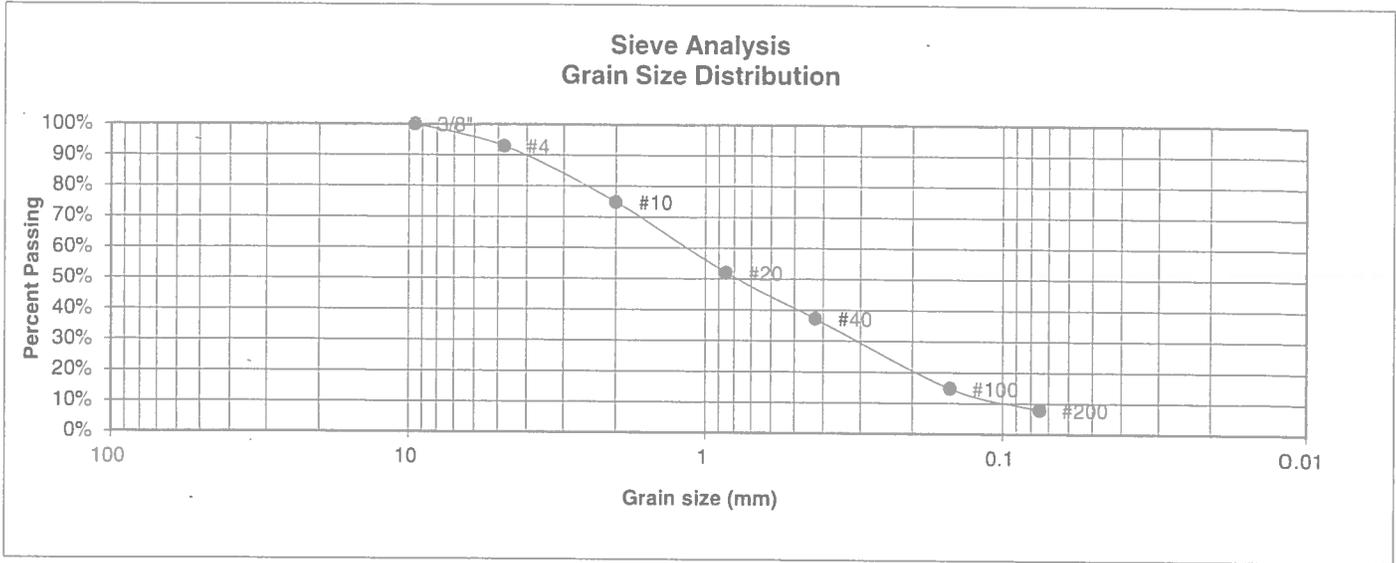
<u>UNIFIED CLASSIFICATION</u>	SM-SW	<u>CLIENT</u>	WINSOME, LLC
<u>SOIL TYPE #</u>	1	<u>PROJECT</u>	HODGEN ROAD
<u>TEST BORING #</u>	TP-4	<u>JOB NO.</u>	200032
<u>DEPTH (FT)</u>	2-3	<u>TEST BY</u>	BL

<u>U.S. Sieve #</u>	<u>Percent Finer</u>
3"	
1 1/2"	
3/4"	
1/2"	
3/8"	100.0%
4	92.9%
10	74.8%
20	52.0%
40	37.2%
100	14.8%
200	7.9%

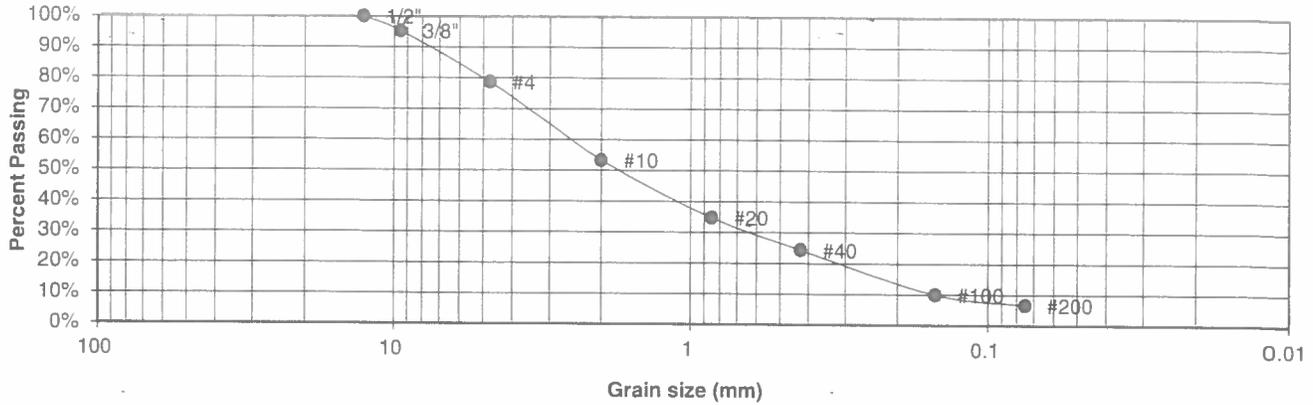
B-4

CLIENT WINSOME, LLC
 PROJECT HODGEN ROAD
 JOB NO. 200032
 TEST BY BL

Sieve Analysis
Grain Size Distribution

U.S. Sieve #	Percent Finer
3"	
1 1/2"	
3/4"	
1/2"	100.0%
3/8"	95.2%
4	78.7%
10	53.3%
20	34.7%
40	24.3%
100	10.0%
200	6.7%

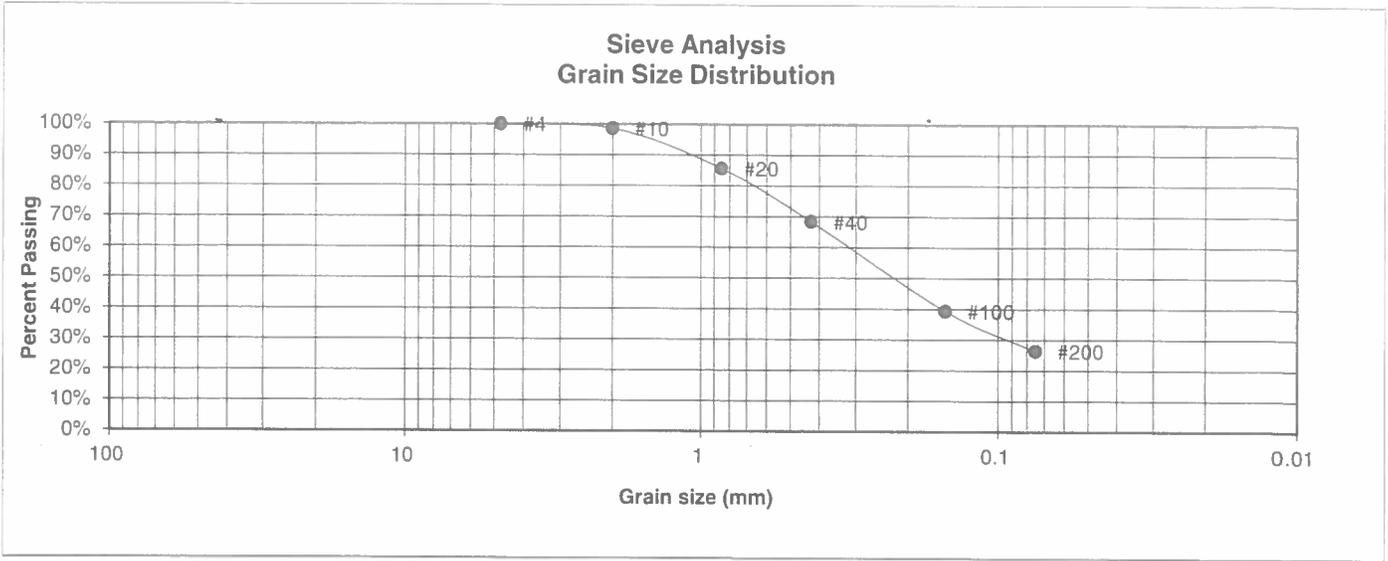
FIG NO.:
B-5

<u>UNIFIED CLASSIFICATION</u>	SM	<u>CLIENT</u>	WINSOME, LLC
<u>SOIL TYPE #</u>	1	<u>PROJECT</u>	HODGEN ROAD
<u>TEST BORING #</u>	TP-7	<u>JOB NO.</u>	200032
<u>DEPTH (FT)</u>	2-3	<u>TEST BY</u>	BL

<u>U.S. Sieve #</u>	<u>Percent Finer</u>
3"	
1 1/2"	
3/4"	
1/2"	
3/8"	
4	100.0%
10	98.6%
20	85.6%
40	68.3%
100	39.3%
200	26.3%

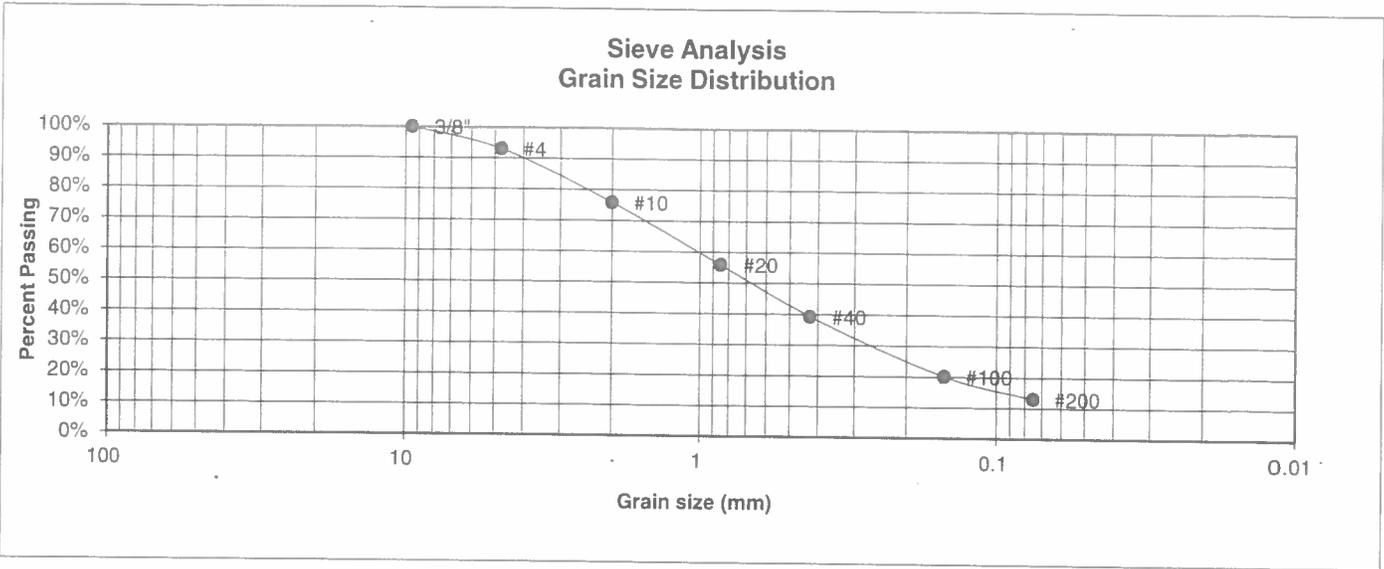
FIG NO
B-6

UNIFIED CLASSIFICATION	SM	CLIENT	WINSOME, LLC
SOIL TYPE #	3	PROJECT	HODGEN ROAD
TEST BORING #	TP-3	JOB NO.	200032
DEPTH (FT)	3-4	TEST BY	BL

U.S. Sieve #	Percent Finer
3"	
1 1/2"	
3/4"	
1/2"	
3/8"	100.0%
4	93.0%
10	75.9%
20	55.9%
40	39.2%
100	20.2%
200	13.0%

Soil Type 3 is a silty to clayey sandstone (SM, SM-SW, SC). This material was encountered Test Pit Nos. 2, 3, 6, 7 and 8. The sandstone was encountered at depths ranging from 2.5 to 4 feet bgs and extended to the termination of the and pits (5.5 to 7.5 feet). The sandstone was encountered at dense to very dense states and moist conditions. Samples tested had 10 to 13 percent of the soil sized particles passing the No. 200 sieve. Highly expansive clayey sandstone and claystone are commonly interbedded in the sandstone in the area.

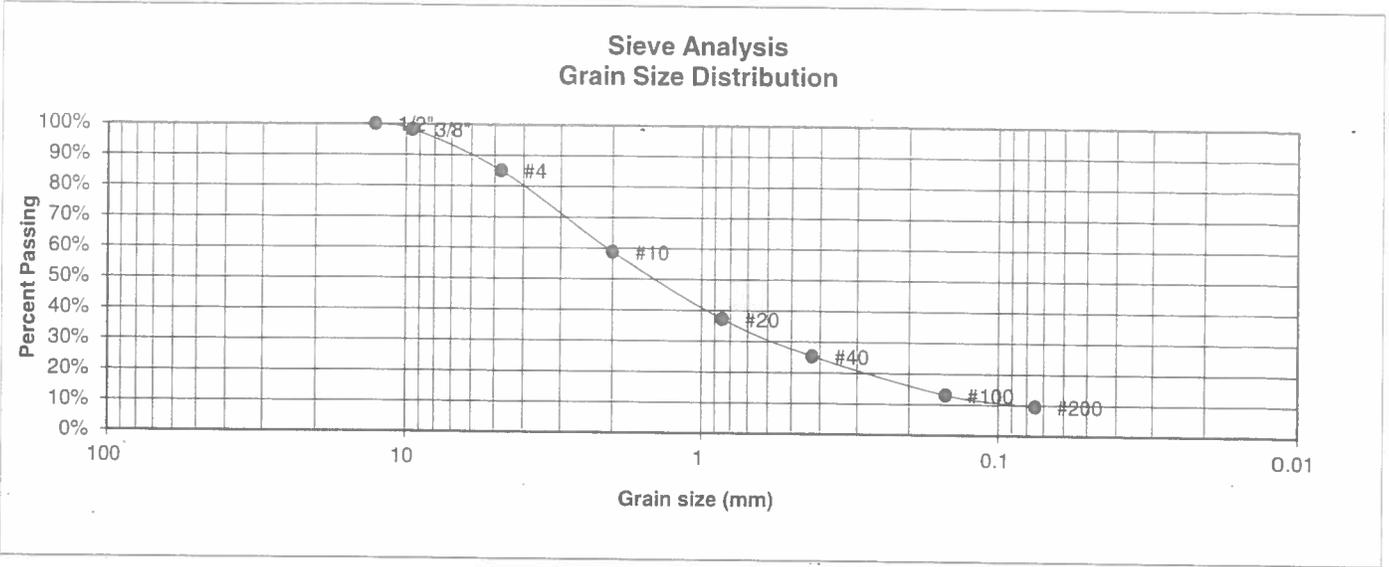
UNIFIED CLASSIFICATION	SM-SW	CLIENT	WINSOME, LLC
SOIL TYPE #	3	PROJECT	HODGEN ROAD
TEST BORING #	TP-6	JOB NO.	200032
DEPTH (FT)	5-6	TEST BY	BL

U.S. Sieve #	Percent Finer
3"	
1 1/2"	
3/4"	
1/2"	100.0%
3/8"	98.3%
4	85.1%
10	58.8%
20	37.2%
40	25.3%
100	13.1%
200	9.5%
