**ENTECH**  
ENGINEERING, INC.

**SOILS AND GEOLOGY STUDY  
TOWNHOMES AT WESTERN  
721 WESTERN DRIVE  
LOT 1, CIMARRON SOUTHEAST FILING NO. 2C  
EL PASO COUNTY, COLORADO**

April 24, 2024

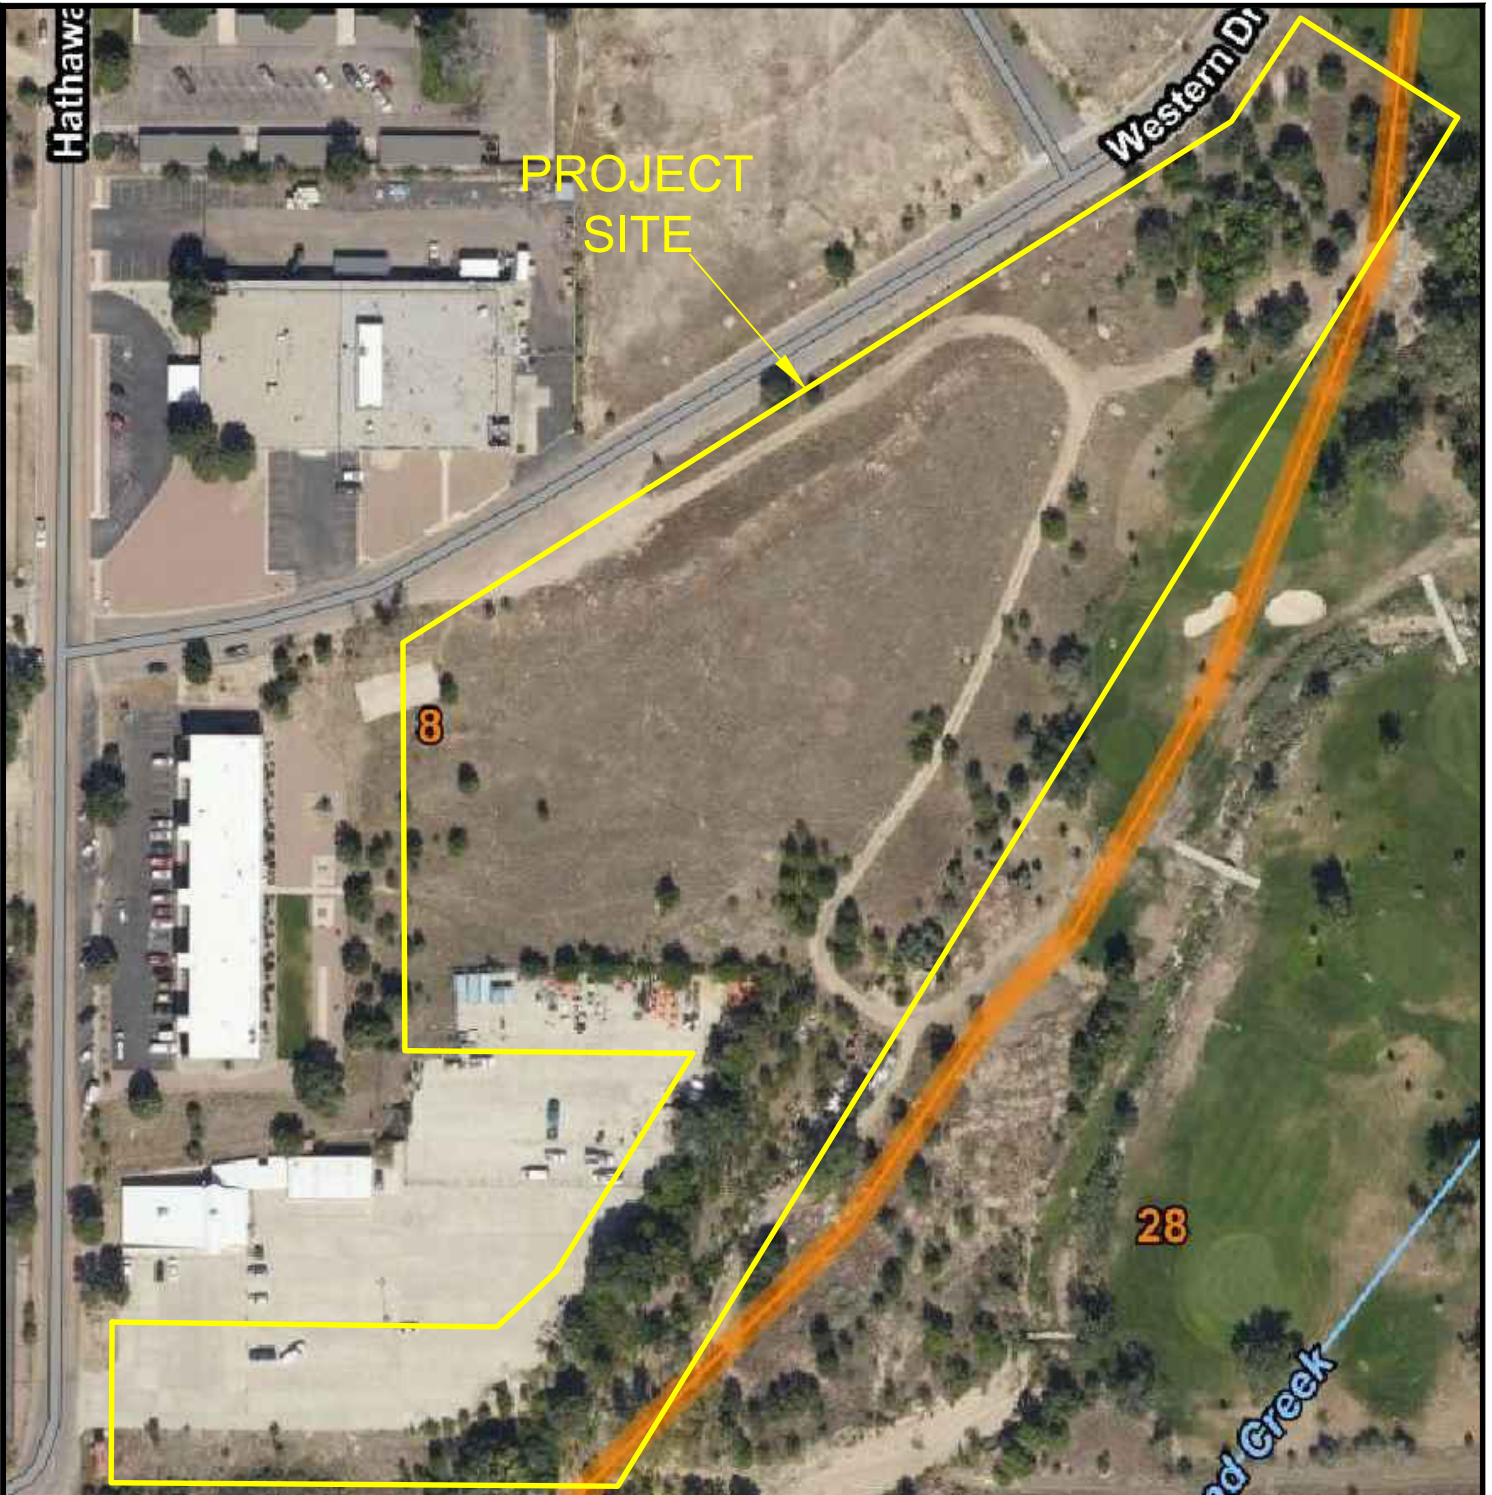
**FIG. 4**

## SOIL SURVEY MAP

The Natural Resource Conservation Service (Reference 3), previously the Soil Conservation Service (Reference 4), has mapped two soil types on the site (Figure 4). In general, the soil classifies as stratified loamy sand soils. The soils are described as follows:

Complete descriptions of each soil type are presented in Appendix E. The soils have generally been described to have moderate permeabilities. Possible hazards with soil erosion are present on the site. The erosion potential can be controlled with vegetation. The soils have been described as having moderate erosion hazards.

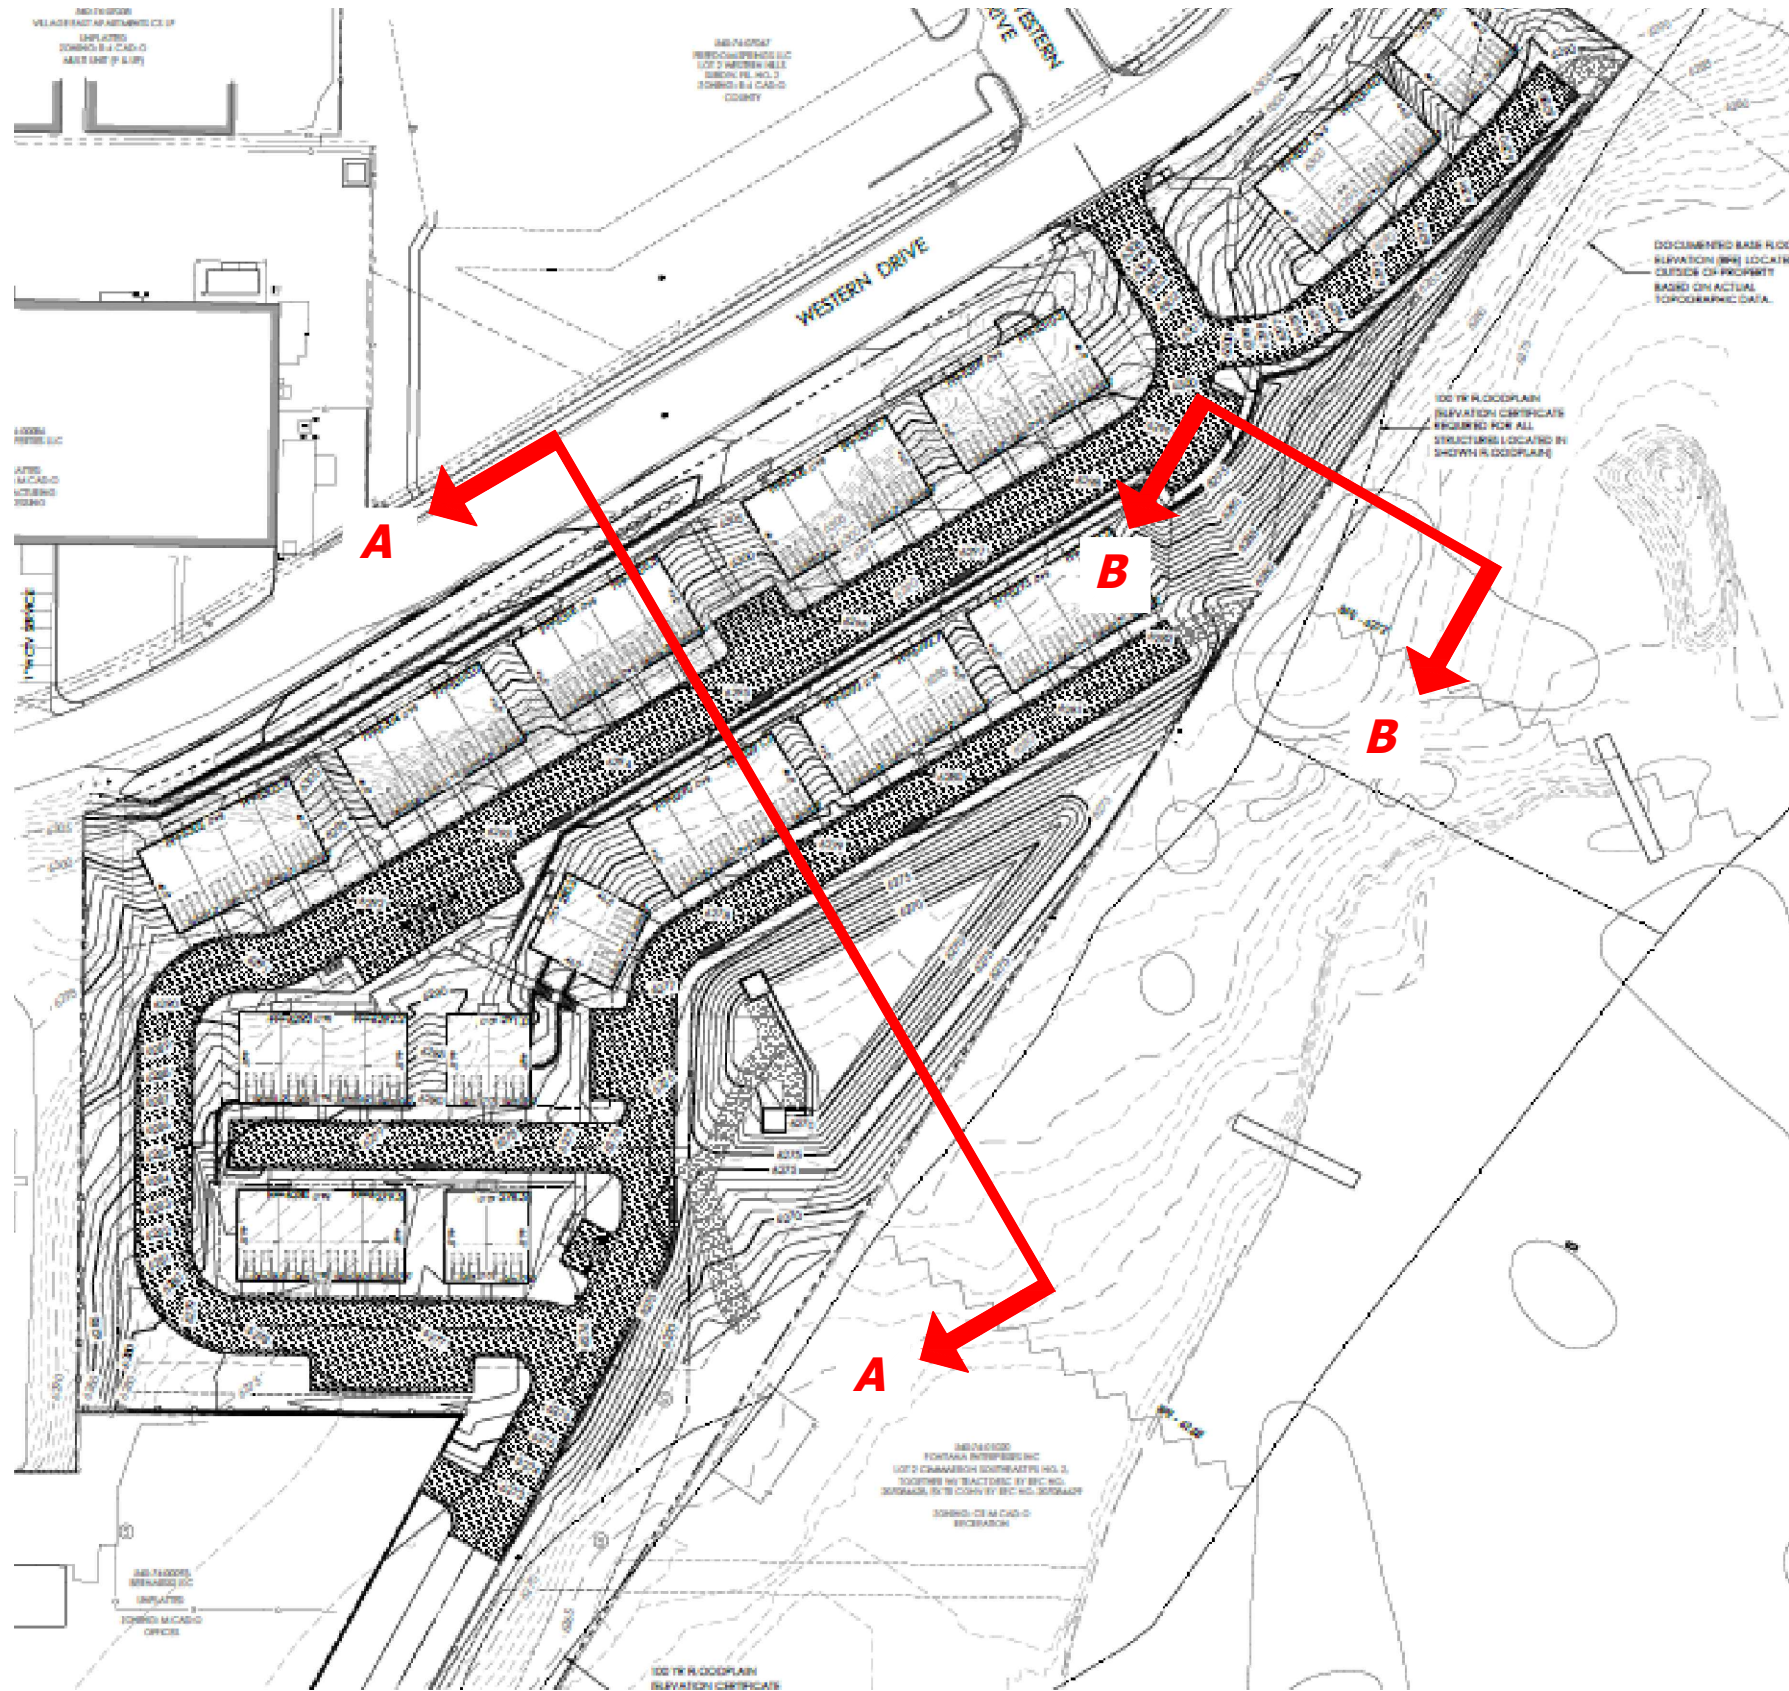
**SLOPE SECTION MAP**  
N.T.S.

SLOPE SECTION MAP  
721 WESTERN DRIVE  
COLORADO SPRINGS, CO  
J. ELLIOTT CONSTRUCTION CO.

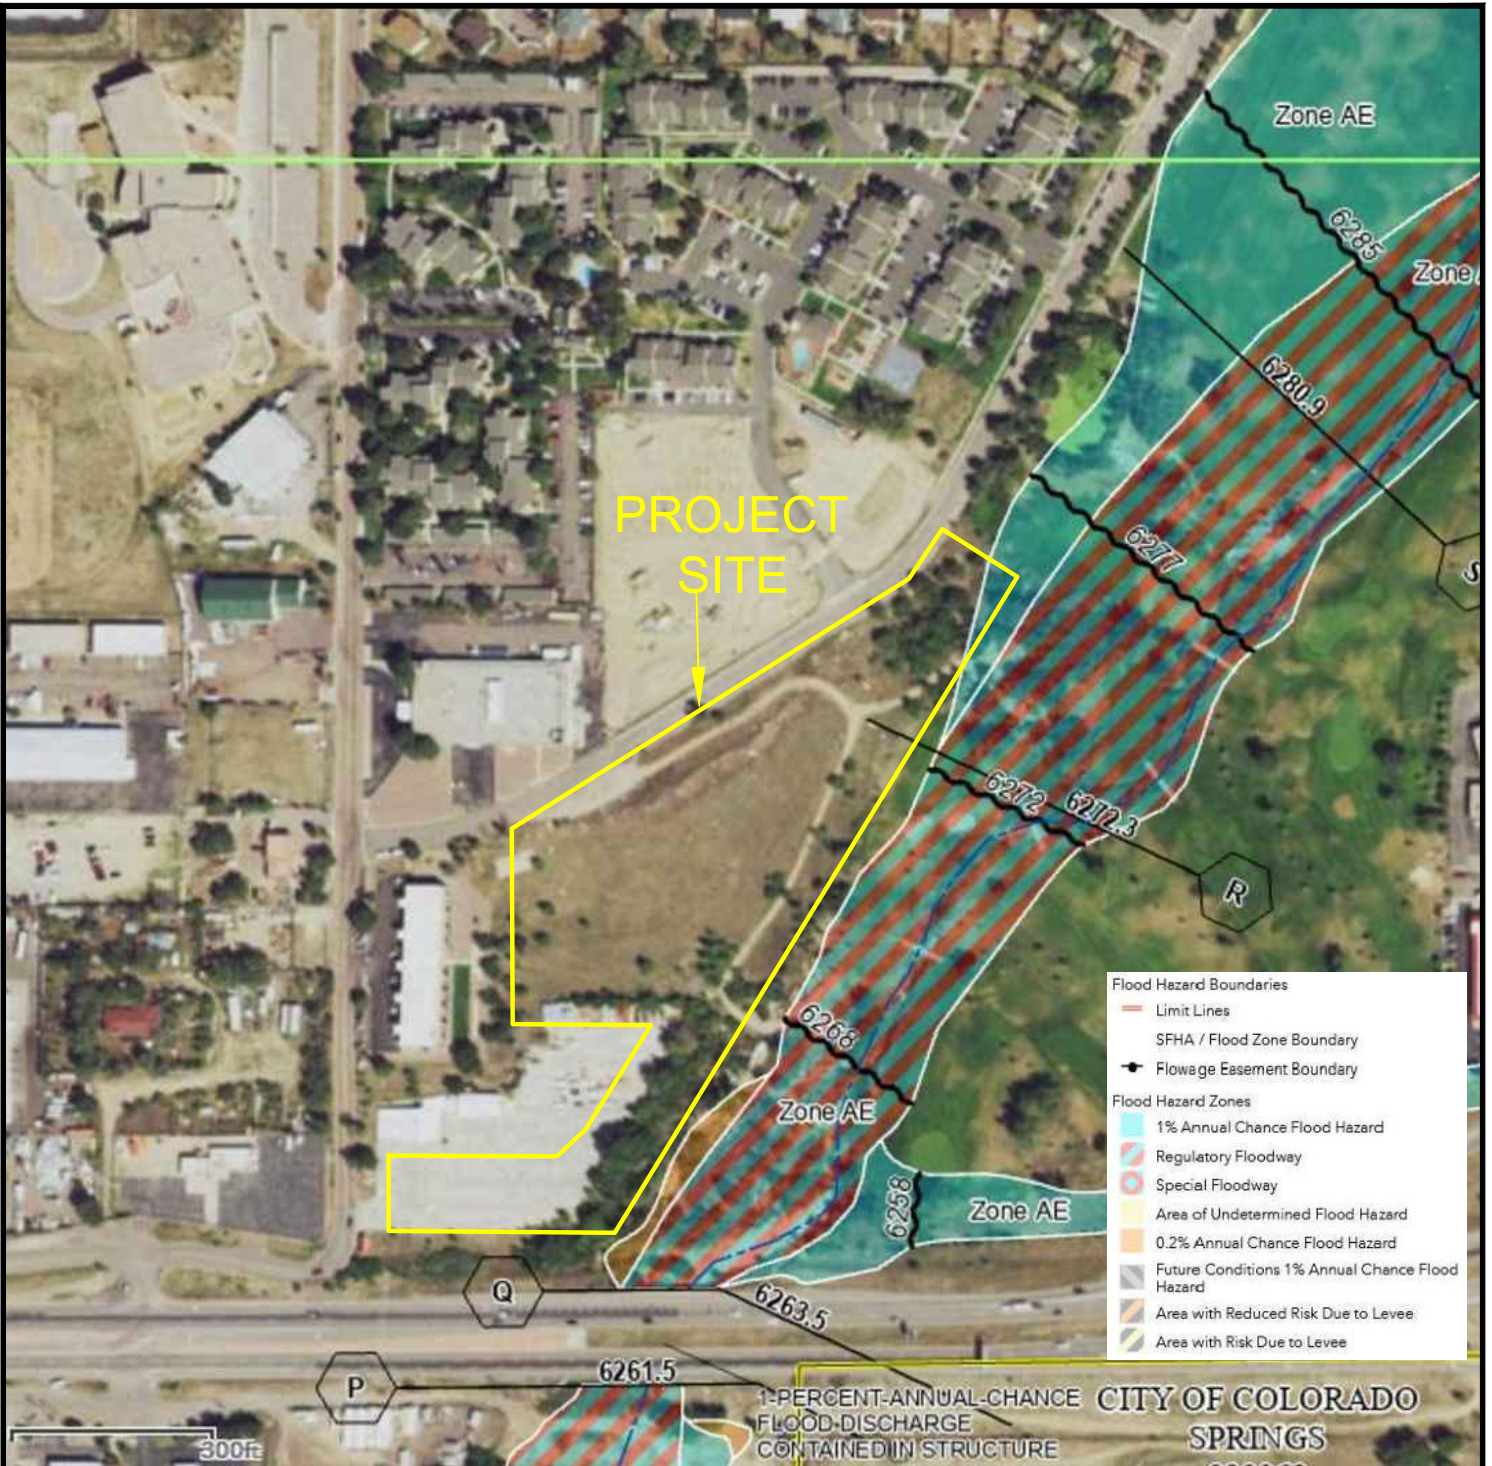
**FIG. 8**

- Flood Hazard Boundaries**
- Limit Lines
  - SFHA / Flood Zone Boundary
  - Flowage Easement Boundary
- Flood Hazard Zones**
- 1% Annual Chance Flood Hazard
  - Regulatory Floodway
  - Special Floodway
  - Area of Undetermined Flood Hazard
  - 0.2% Annual Chance Flood Hazard
  - Future Conditions 1% Annual Chance Flood Hazard
  - Area with Reduced Risk Due to Levee
  - Area with Risk Due to Levee

No drainages or areas of water were observed on the site. East Fork of Sand Creek is located just south of the site. A small portion of the northeastern portion of the site is mapped within a 100-year floodplain zone according to the FEMA Map No. 08041CO754G, (Figure 8, Reference 10).

No drainages or areas of water were observed on the site. East Fork of Sand Creek is located just south of the site. A small portion of the northeastern portion of the site is mapped within a 100-year floodplain zone according to the FEMA Map No. 08041CO754G, (Figure 8, Reference 10). It is our understanding that the site is well above the floodplain elevation. Groundwater was encountered in two of the test borings at 12.5 to 30 feet. The remaining borings were dry. Groundwater is not expected to affect the construction of the shallow foundations or excavation of the detention pond.

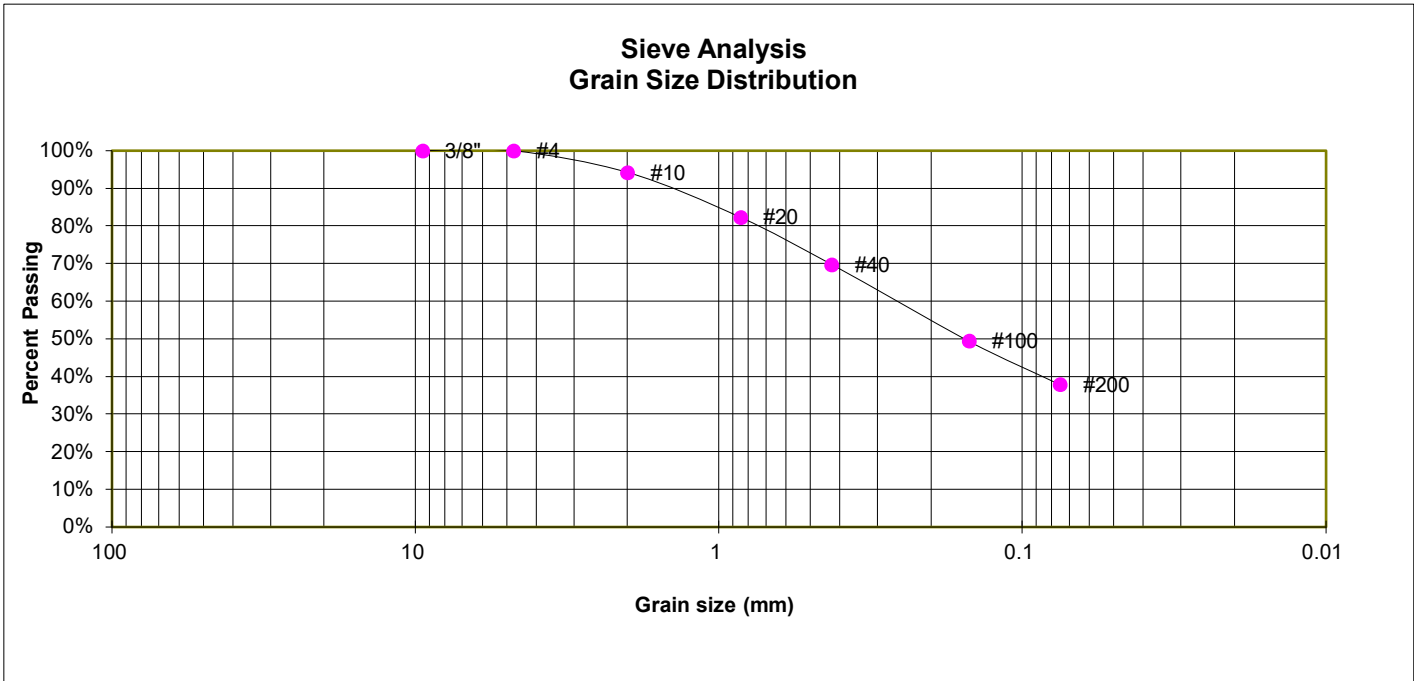
TEST BORING 1  
 DEPTH (FT) 10

SOIL DESCRIPTION FILL, SAND, CLAYEY  
 SOIL TYPE 1

**GRAIN SIZE ANALYSIS**

U.S. Sieve #	Percent Finer
3"	
1 1/2"	
3/4"	
1/2"	
3/8"	100.0%
4	100.0%
10	94.3%
20	82.4%
40	69.8%
100	49.4%
200	37.9%

Soil Type 1 classified as silty sand fill (SM). The loose to medium dense sand was encountered in TB-1 and TB-3 at the ground surface and extended to depths of 3 to 12 feet below ground surface (bgs), respectively. The sand fill is anticipated to exhibit a low expansion potential.

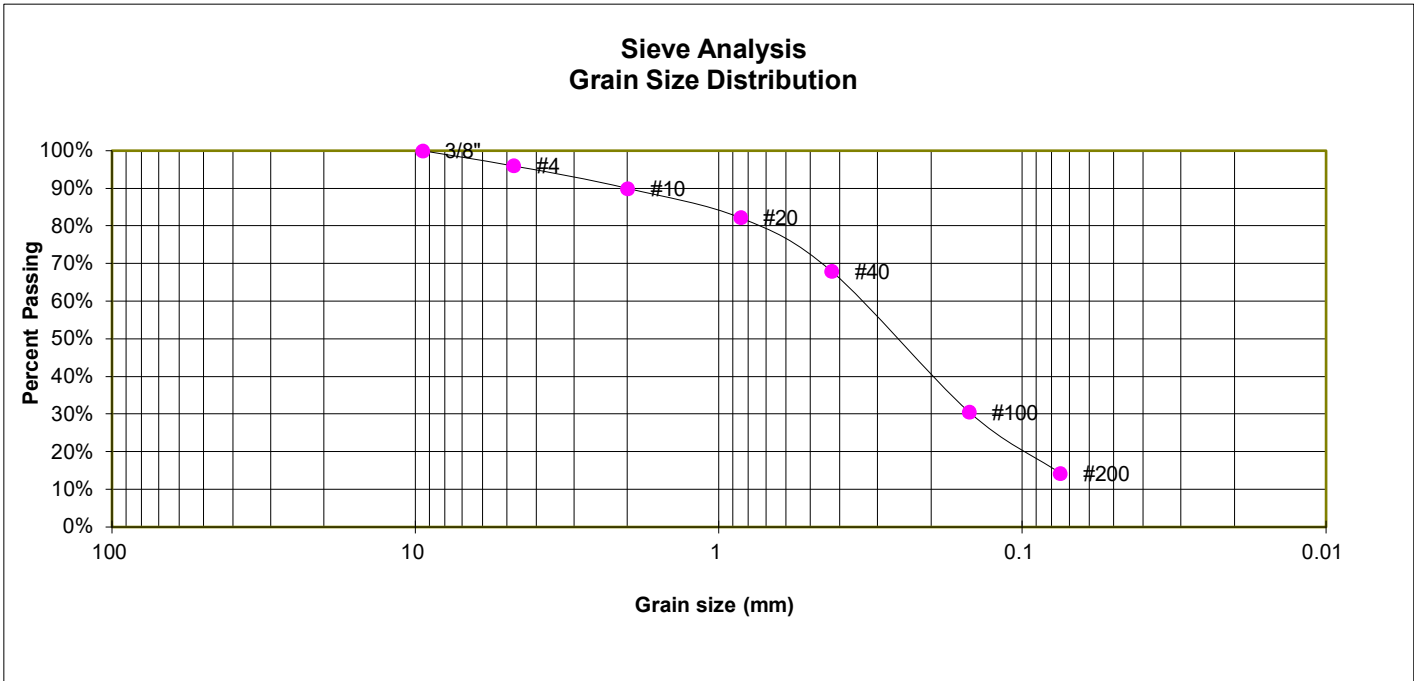
TEST BORING 2  
 DEPTH (FT) 5

SOIL DESCRIPTION SAND, SILTY  
 SOIL TYPE 2

**GRAIN SIZE ANALYSIS**

U.S. Sieve #	Percent Finer
3"	
1 1/2"	
3/4"	
1/2"	
3/8"	100.0%
4	96.0%
10	90.0%
20	82.2%
40	68.0%
100	30.6%
200	14.3%

Soil Type 2 classified as native sand with silt, silty sand, and silty sand with gravel (SW-SM, SM). The loose to medium sand was encountered in all of the test borings at depths ranging from the ground surface to 3 to 12 feet bgs and extended to the depths explored (20 to 35 feet) bgs. The native sand is also anticipated to exhibit a low expansion potential.

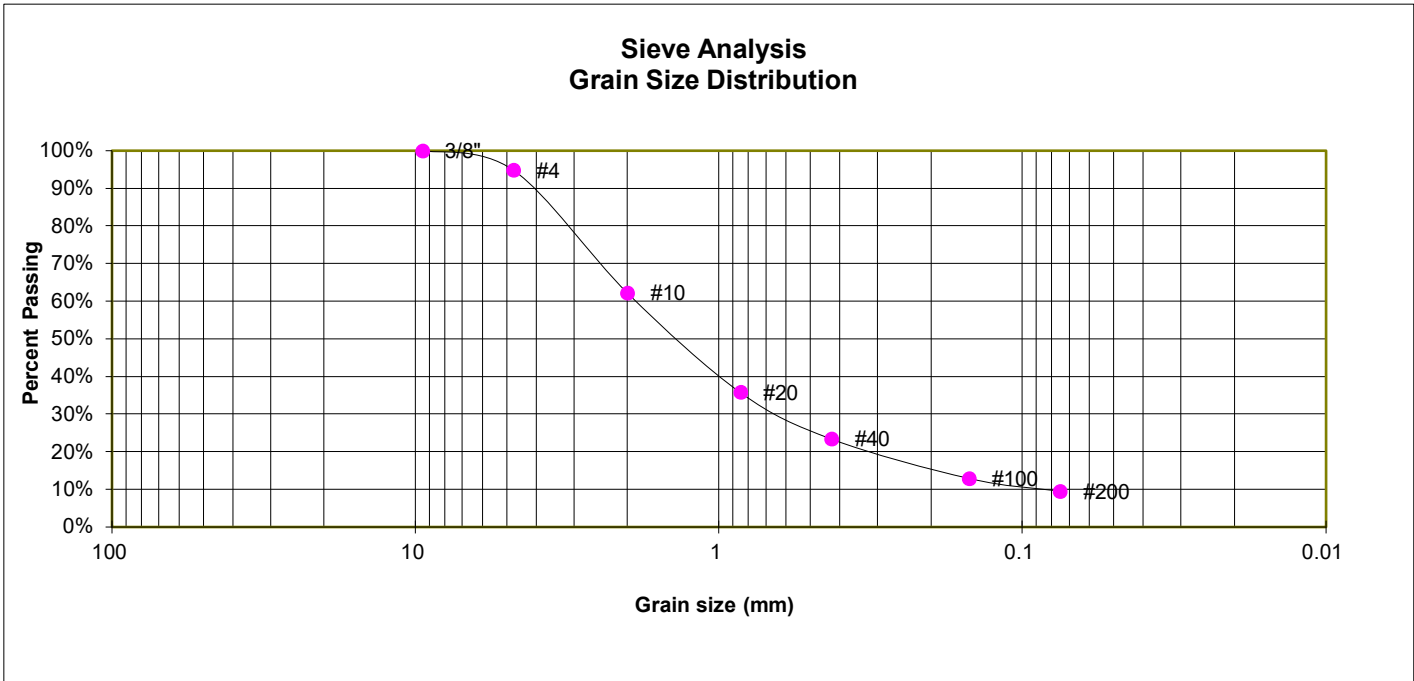
TEST BORING 3  
 DEPTH (FT) 15

SOIL DESCRIPTION SAND, WITH SILT  
 SOIL TYPE 2

**GRAIN SIZE ANALYSIS**

U.S. Sieve #	Percent Finer
3"	
1 1/2"	
3/4"	
1/2"	
3/8"	100.0%
4	94.9%
10	62.2%
20	35.8%
40	23.4%
100	12.9%
200	9.5%

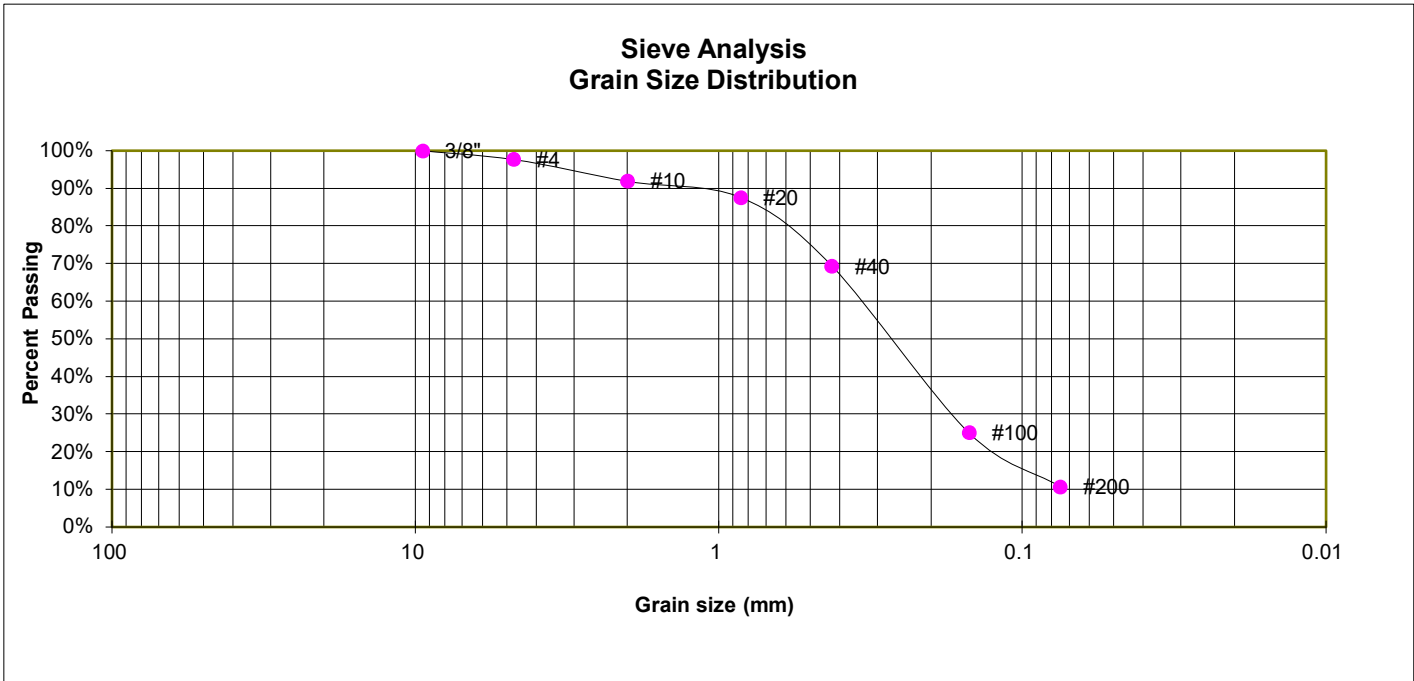
TEST BORING 4  
DEPTH (FT) 2-3

SOIL DESCRIPTION SAND, WITH SILT  
SOIL TYPE 2

**GRAIN SIZE ANALYSIS**

U.S. Sieve #	Percent Finer
3"	
1 1/2"	
3/4"	
1/2"	
3/8"	100.0%
4	97.7%
10	92.0%
20	87.6%
40	69.4%
100	25.1%
200	10.8%

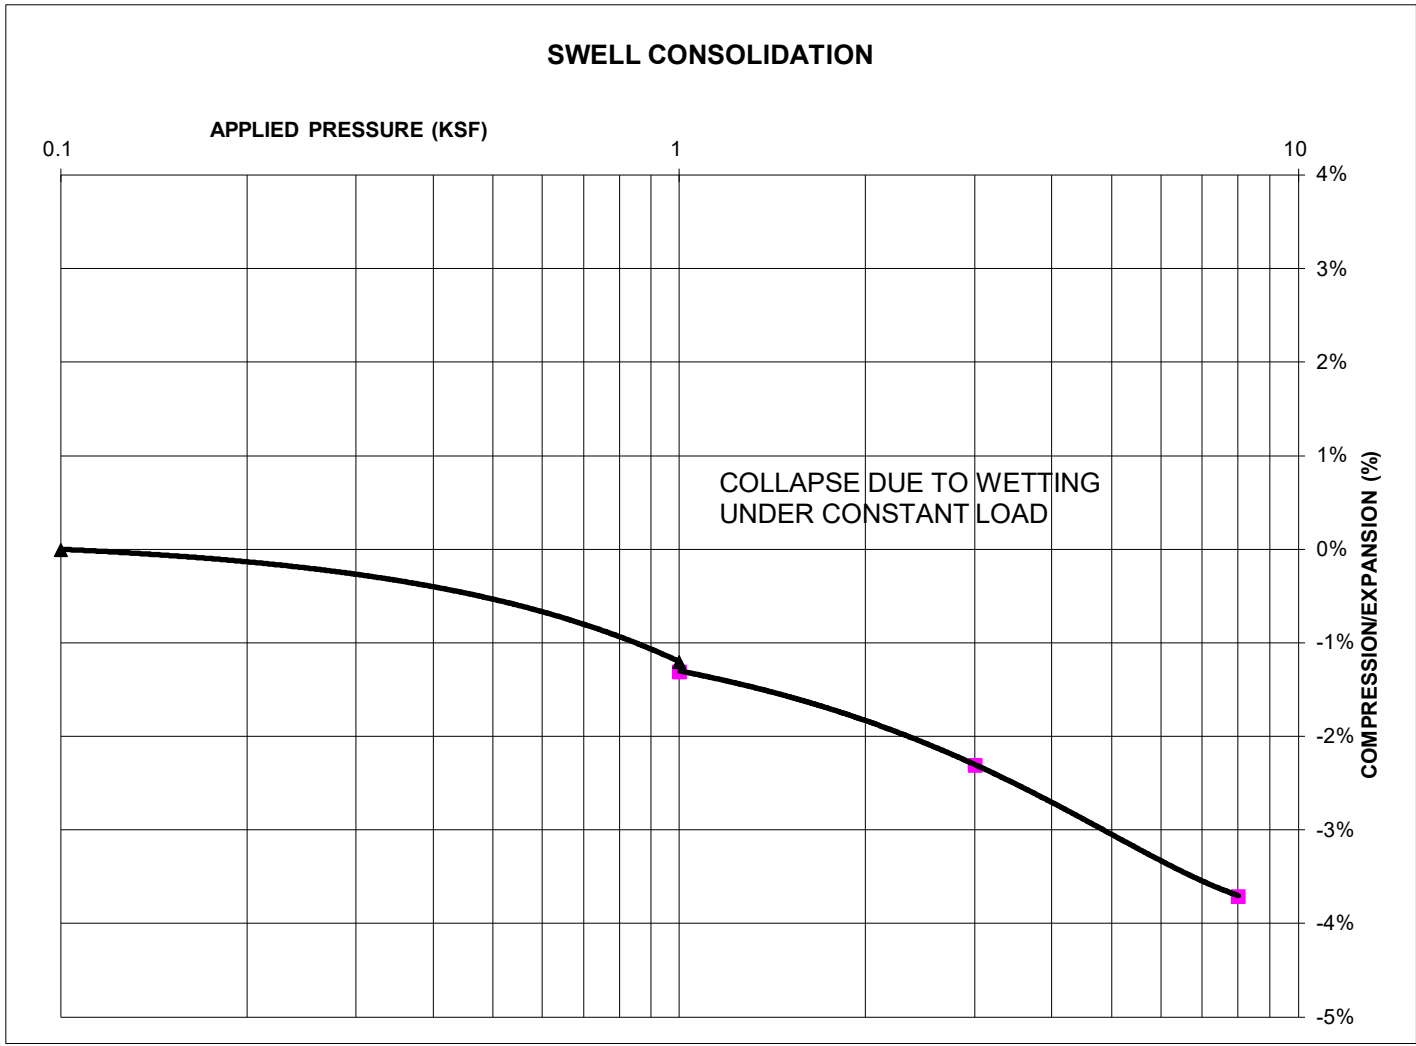
TEST BORING 1  
DEPTH (FT) 10

SOIL DESCRIPTION FILL, SAND, CLAYEY  
SOIL TYPE 1

**SWELL/COLLAPSE TEST RESULTS**

NATURAL UNIT DRY WEIGHT (PCF): 114  
NATURAL MOISTURE CONTENT: 12.4%  
SWELL/COLLAPSE (%): -0.1%

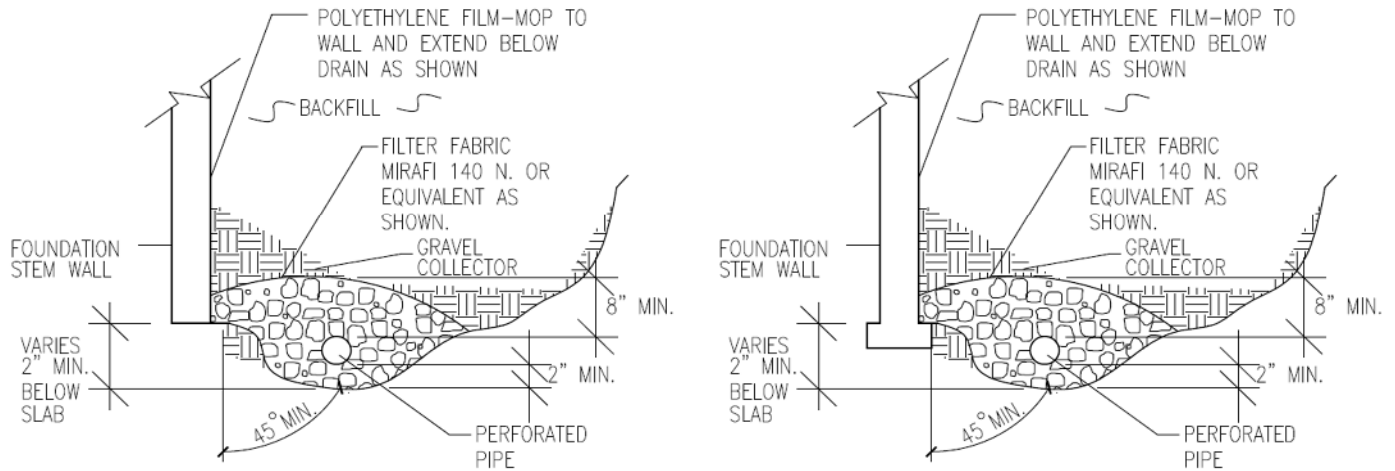
**FIG. 3**

-GRAVEL SIZE IS RELATED TO DIAMETER OF PIPE PERFORATIONS-85% GRAVEL GREATER THAN 2x PERFORATION DIAMETER.

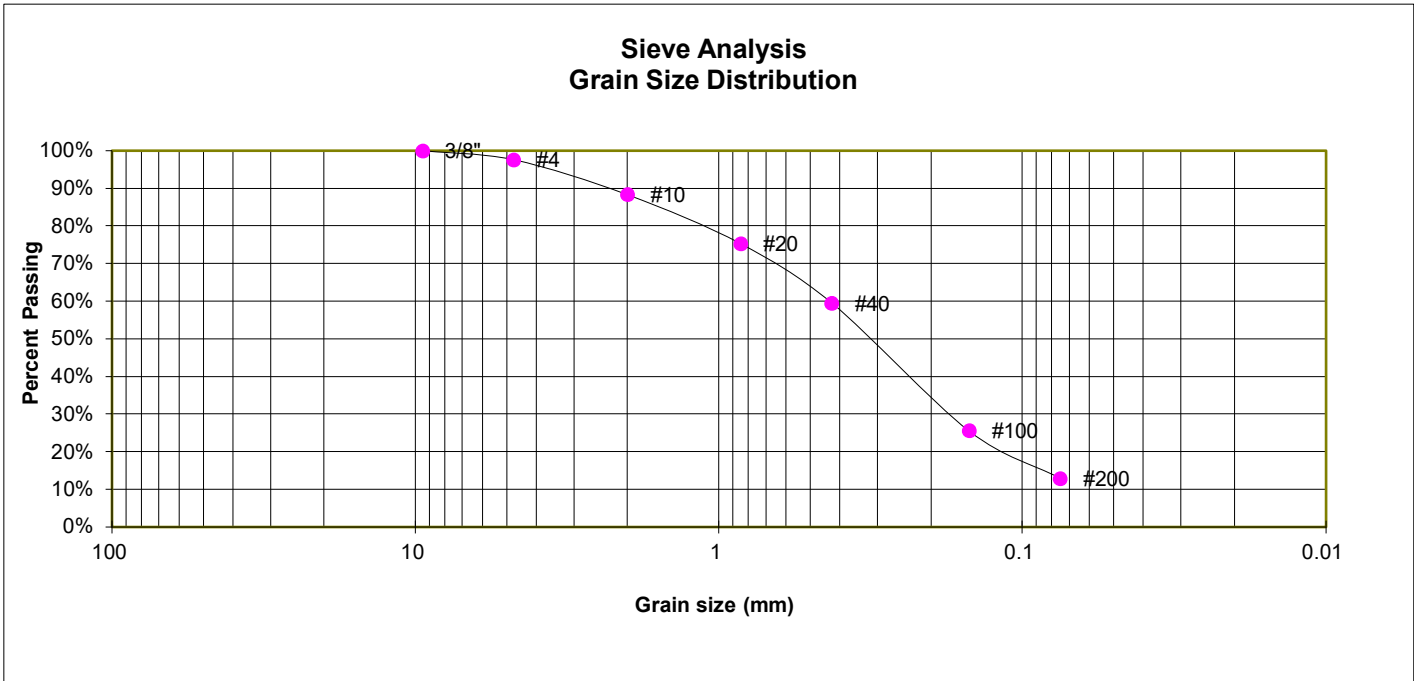
TEST BORING 1  
 DEPTH (FT) 5

SOIL DESCRIPTION SAND, SILTY  
 SOIL TYPE 1

**GRAIN SIZE ANALYSIS**

U.S. Sieve #	Percent Finer
3"	
1 1/2"	
3/4"	
1/2"	
3/8"	100.0%
4	97.6%
10	88.4%
20	75.3%
40	59.5%
100	25.6%
200	12.9%

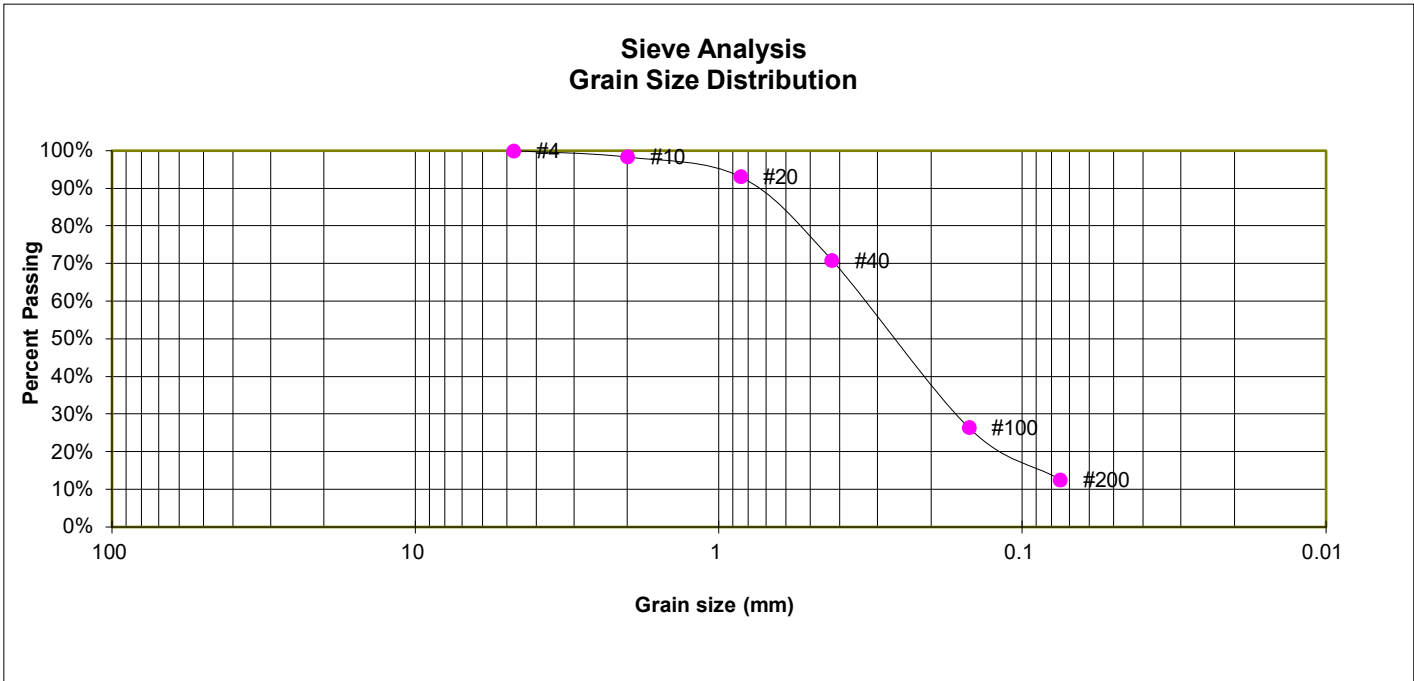
TEST BORING 2  
DEPTH (FT) 10

SOIL DESCRIPTION SAND, SILTY  
SOIL TYPE 1

**GRAIN SIZE ANALYSIS**

U.S. Sieve #	Percent Finer
3"	
1 1/2"	
3/4"	
1/2"	
3/8"	
4	100.0%
10	98.4%
20	93.2%
40	70.9%
100	26.5%
200	12.6%

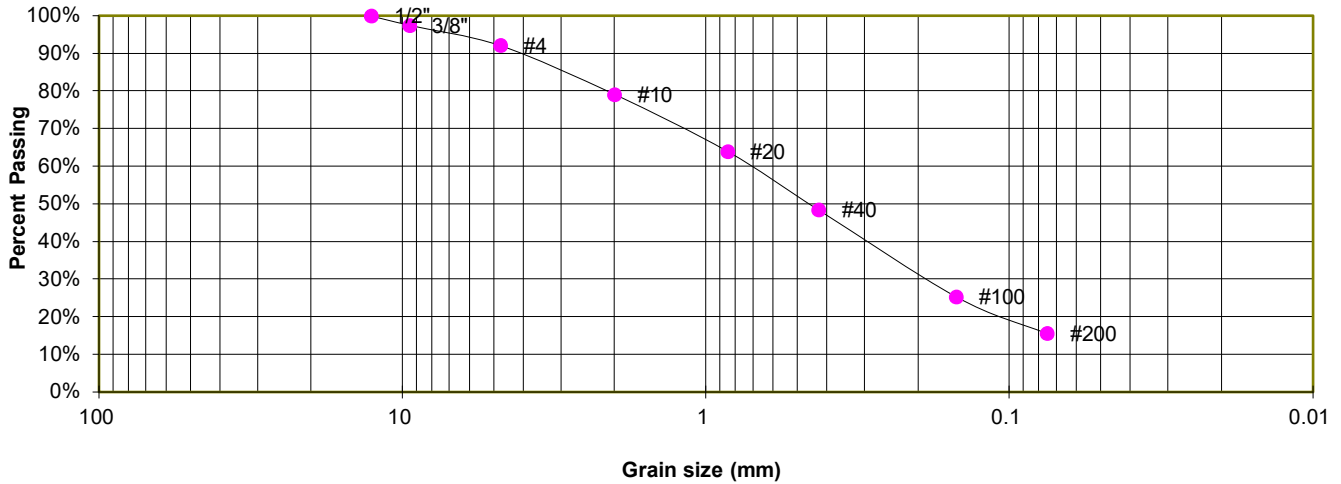
SOIL DESCRIPTION SAND, SILTY  
SOIL TYPE 1

#### GRAIN SIZE ANALYSIS

U.S. Sieve #	Percent Finer
3"	
1 1/2"	
3/4"	
1/2"	100.0%
3/8"	97.5%
4	92.1%
10	79.1%
20	63.9%
40	48.4%
100	25.3%
200	15.6%

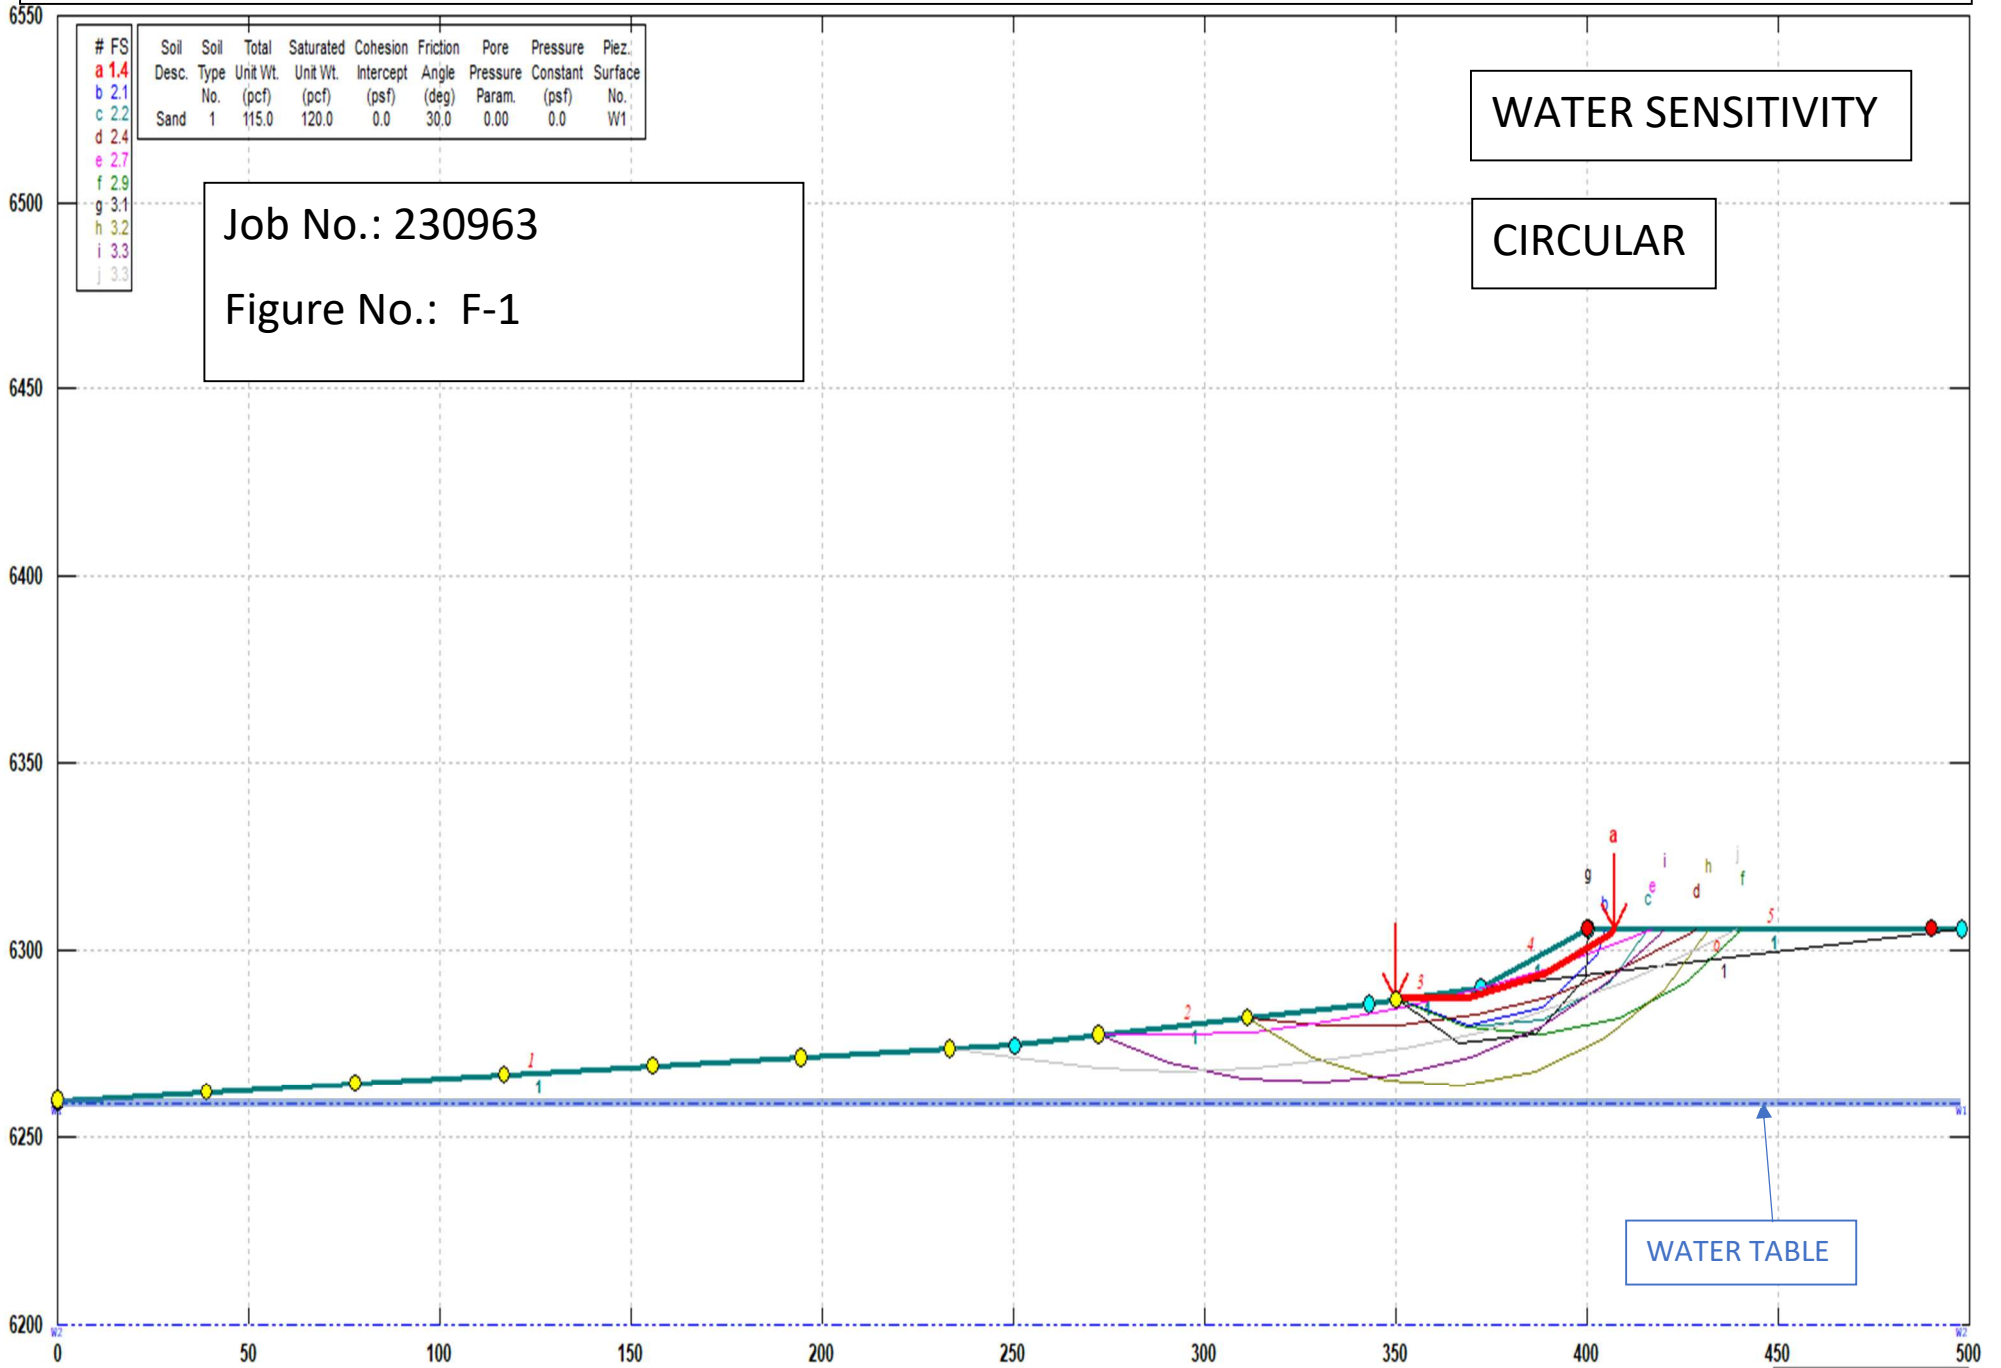
# J. ELLIOTT CONSTRUCTION– 721 WESTERN DRIVE – AA - EXISTING

GSTABL7 v.2 FSmin=1.4

Safety Factors Are Calculated By The Modified Bishop Method

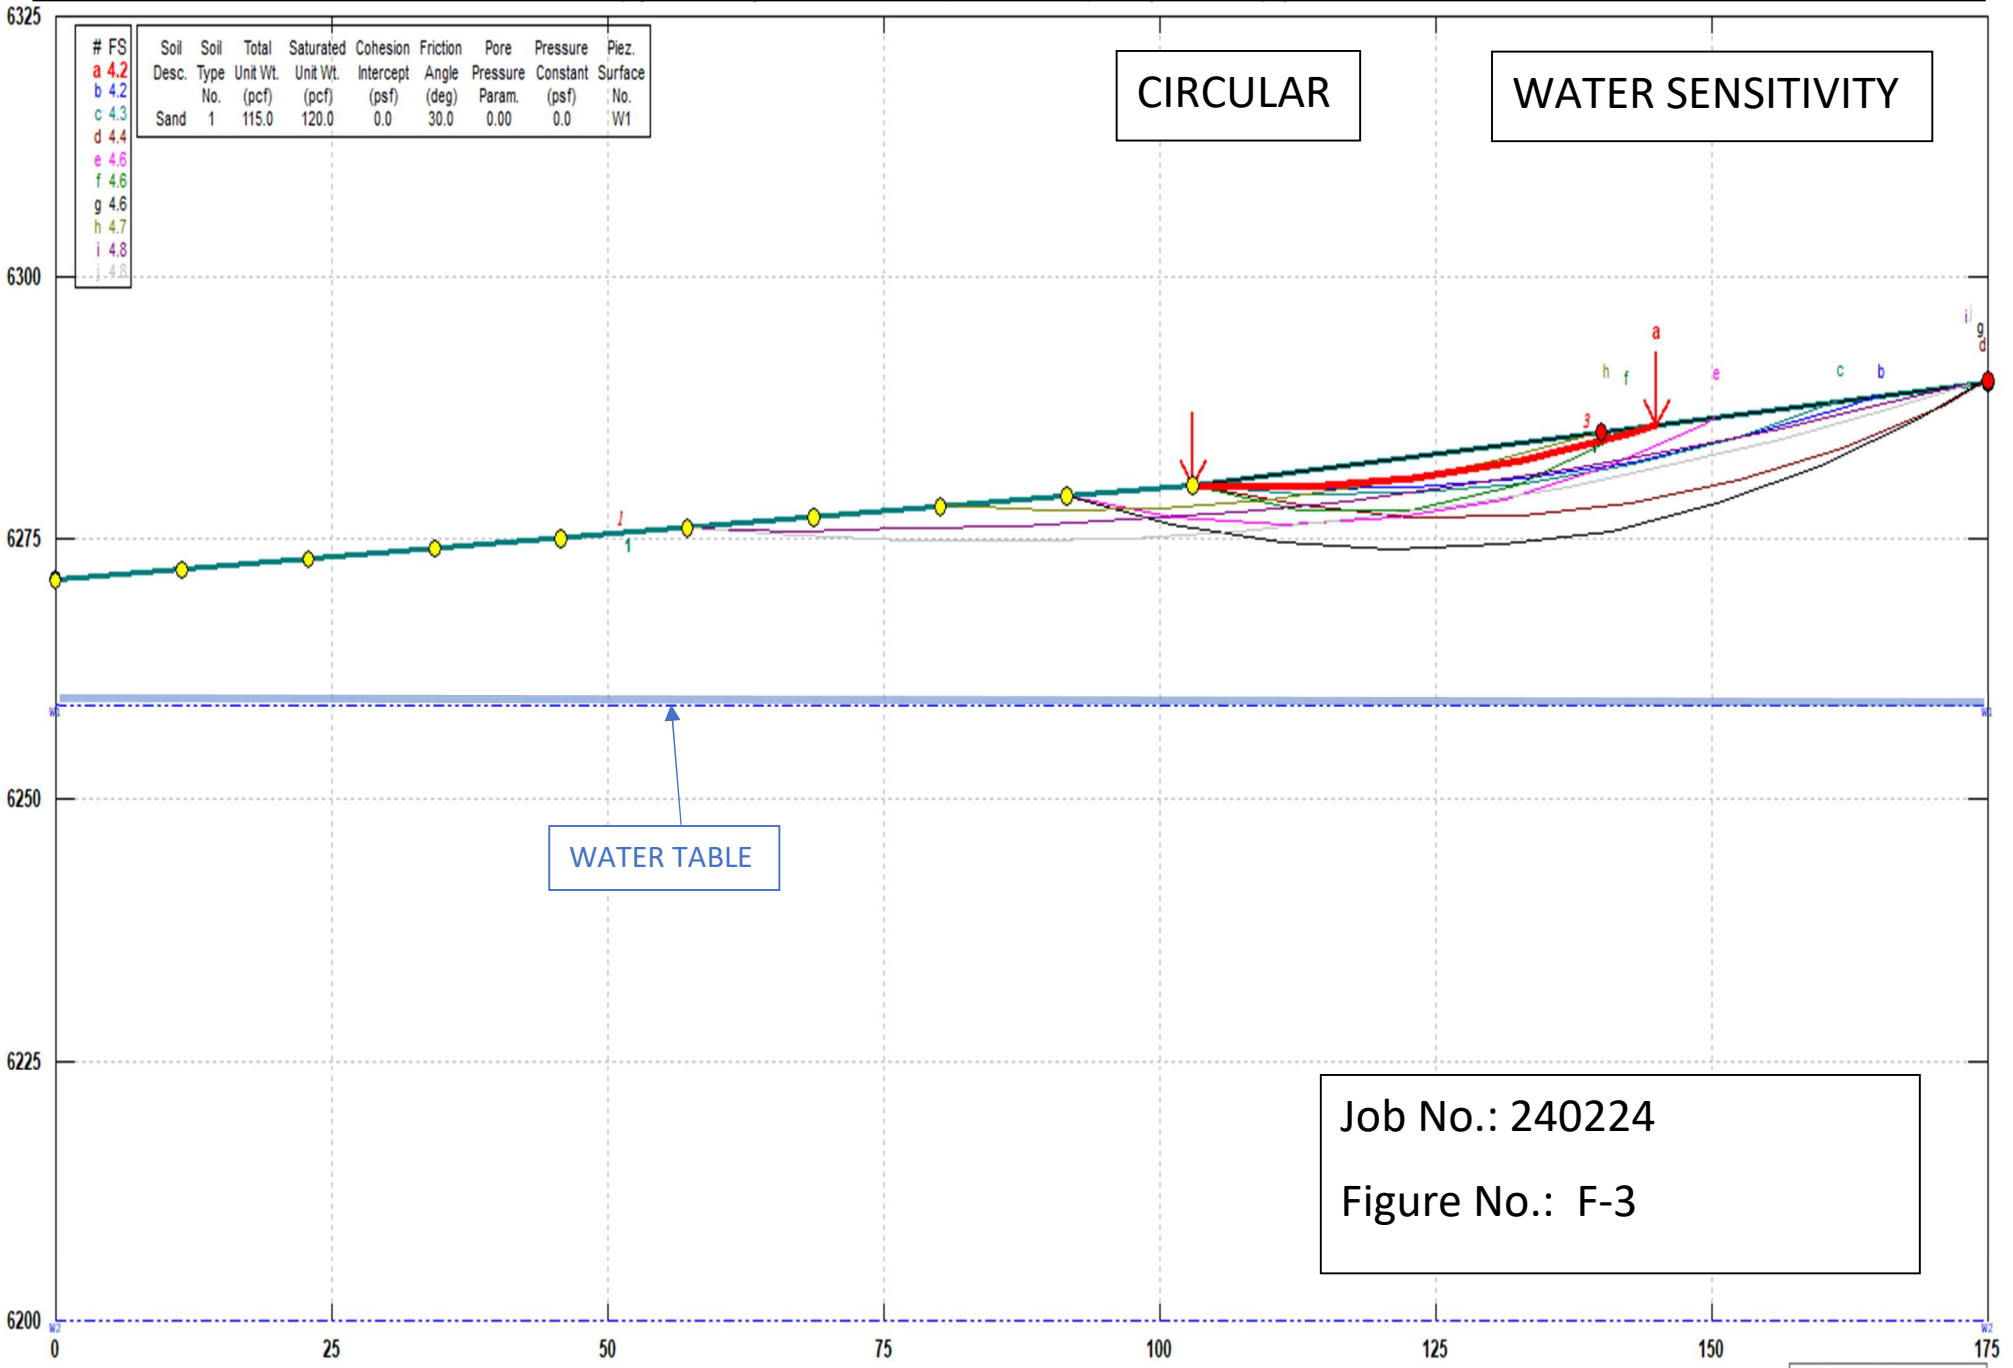
Job No.: 240224  
Figure No.: F-3

# J. ELLIOTT CONSTRUCTION— 721 WESTERN DRIVE – BB - EXISTING

CIRCULAR

WATER SENSITIVITY
