**ENTECH**  
ENGINEERING, INC.

**SOILS AND GEOLOGY STUDY  
TOWNHOMES AT WESTERN  
721 WESTERN DRIVE  
LOT 1, CIMARRON SOUTHEAST FILING NO. 2C  
EL PASO COUNTY, COLORADO**

April 24, 2024

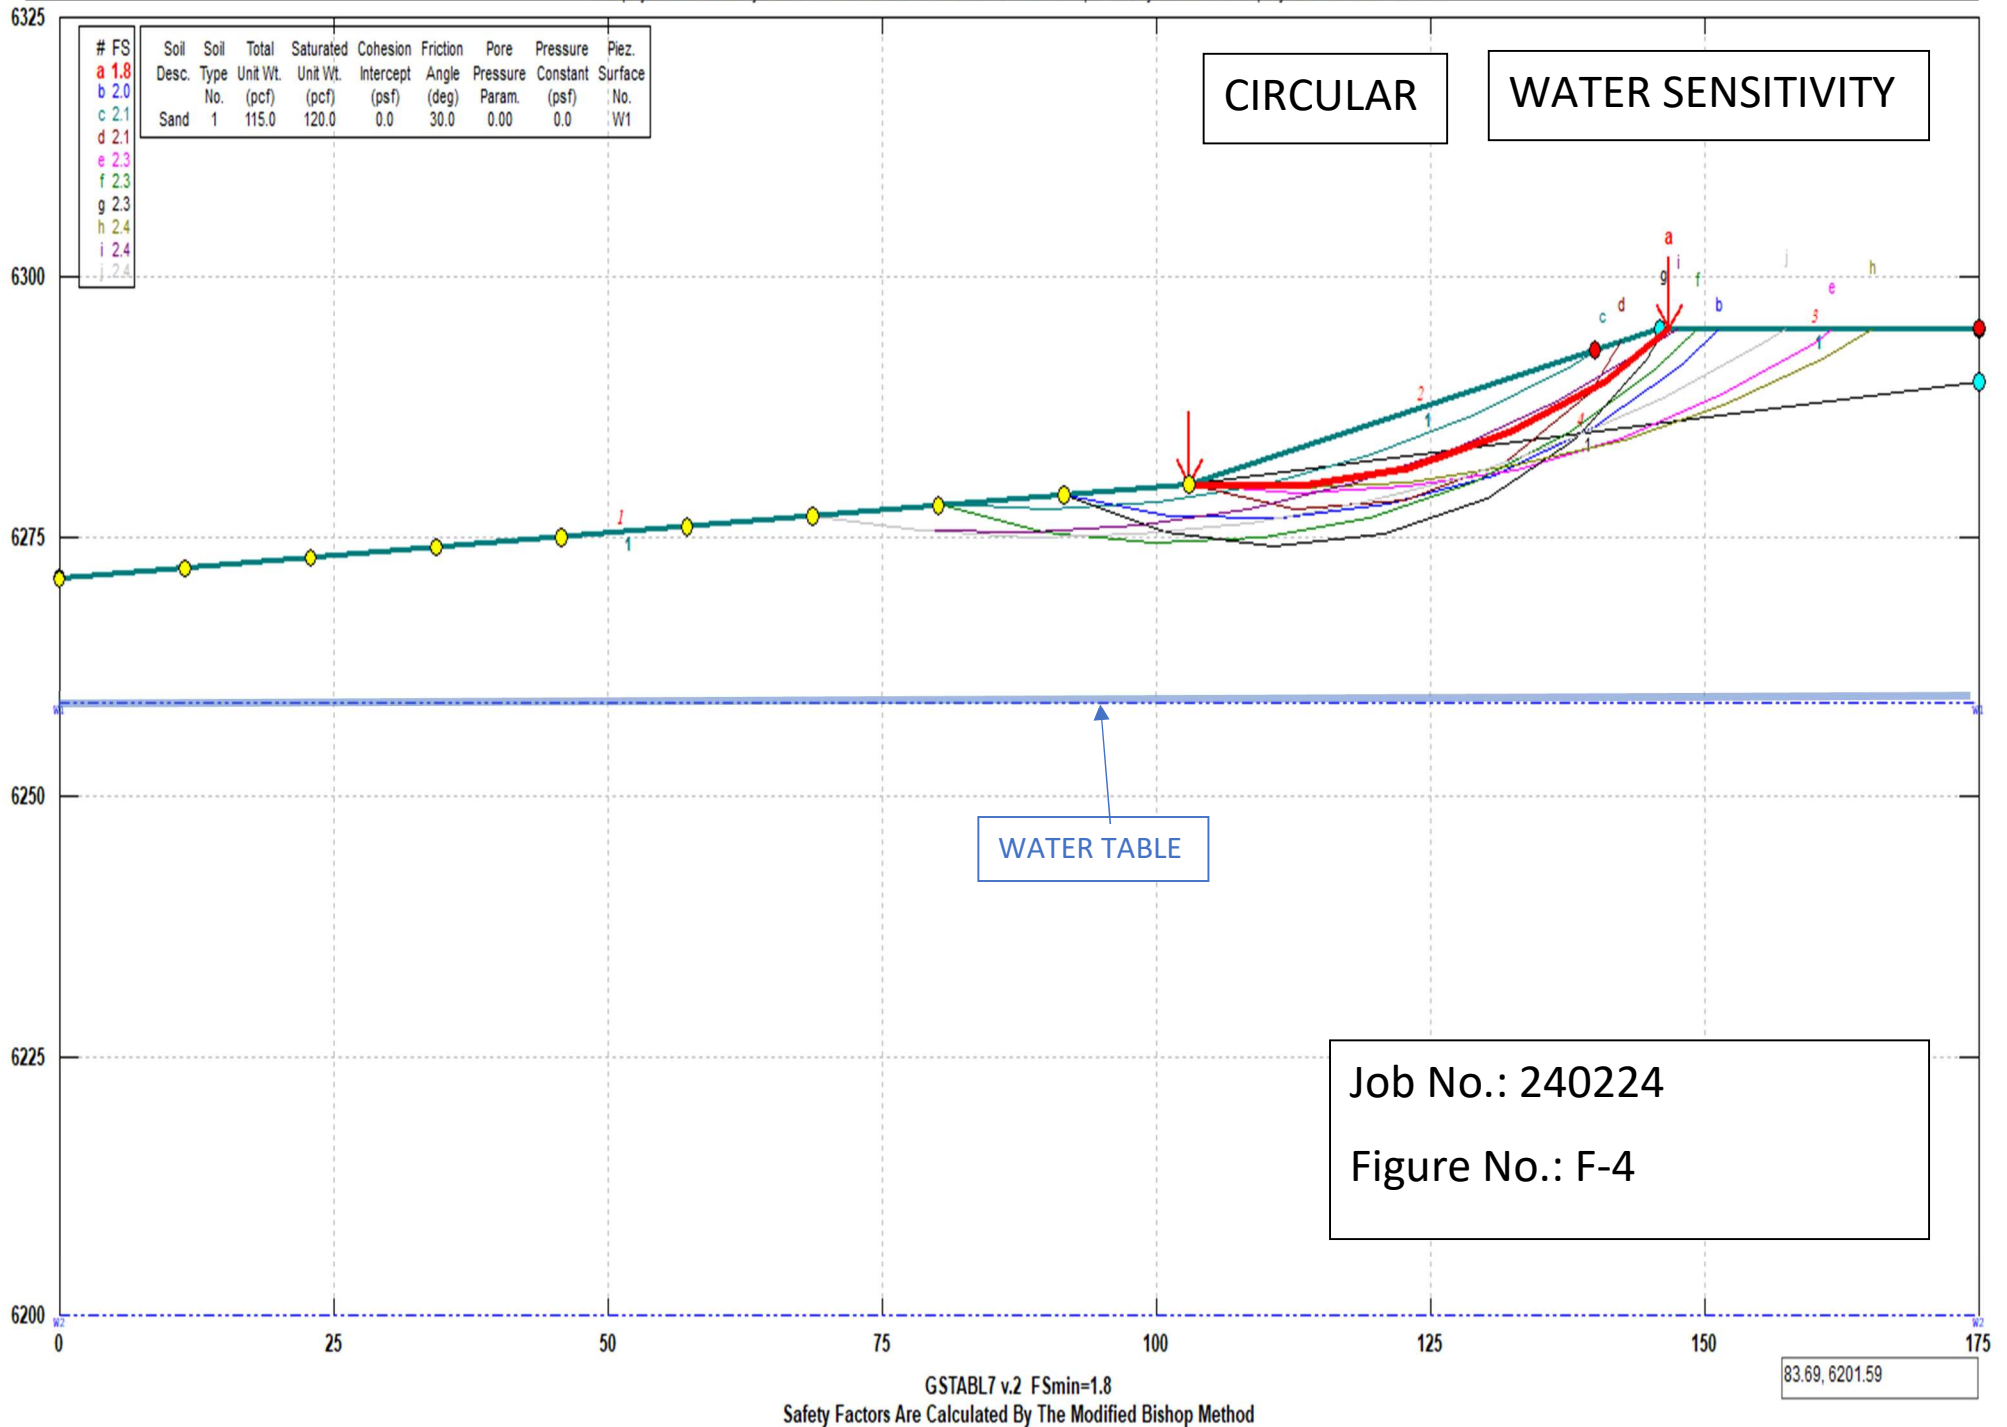
# J. ELLIOTT CONSTRUCTION– 721 WESTERN DRIVE – BB - PROPOSED
