# Soils and Geology Evaluation

Wyoming Estates

3050 N. Curtis Road

May 20, 2019

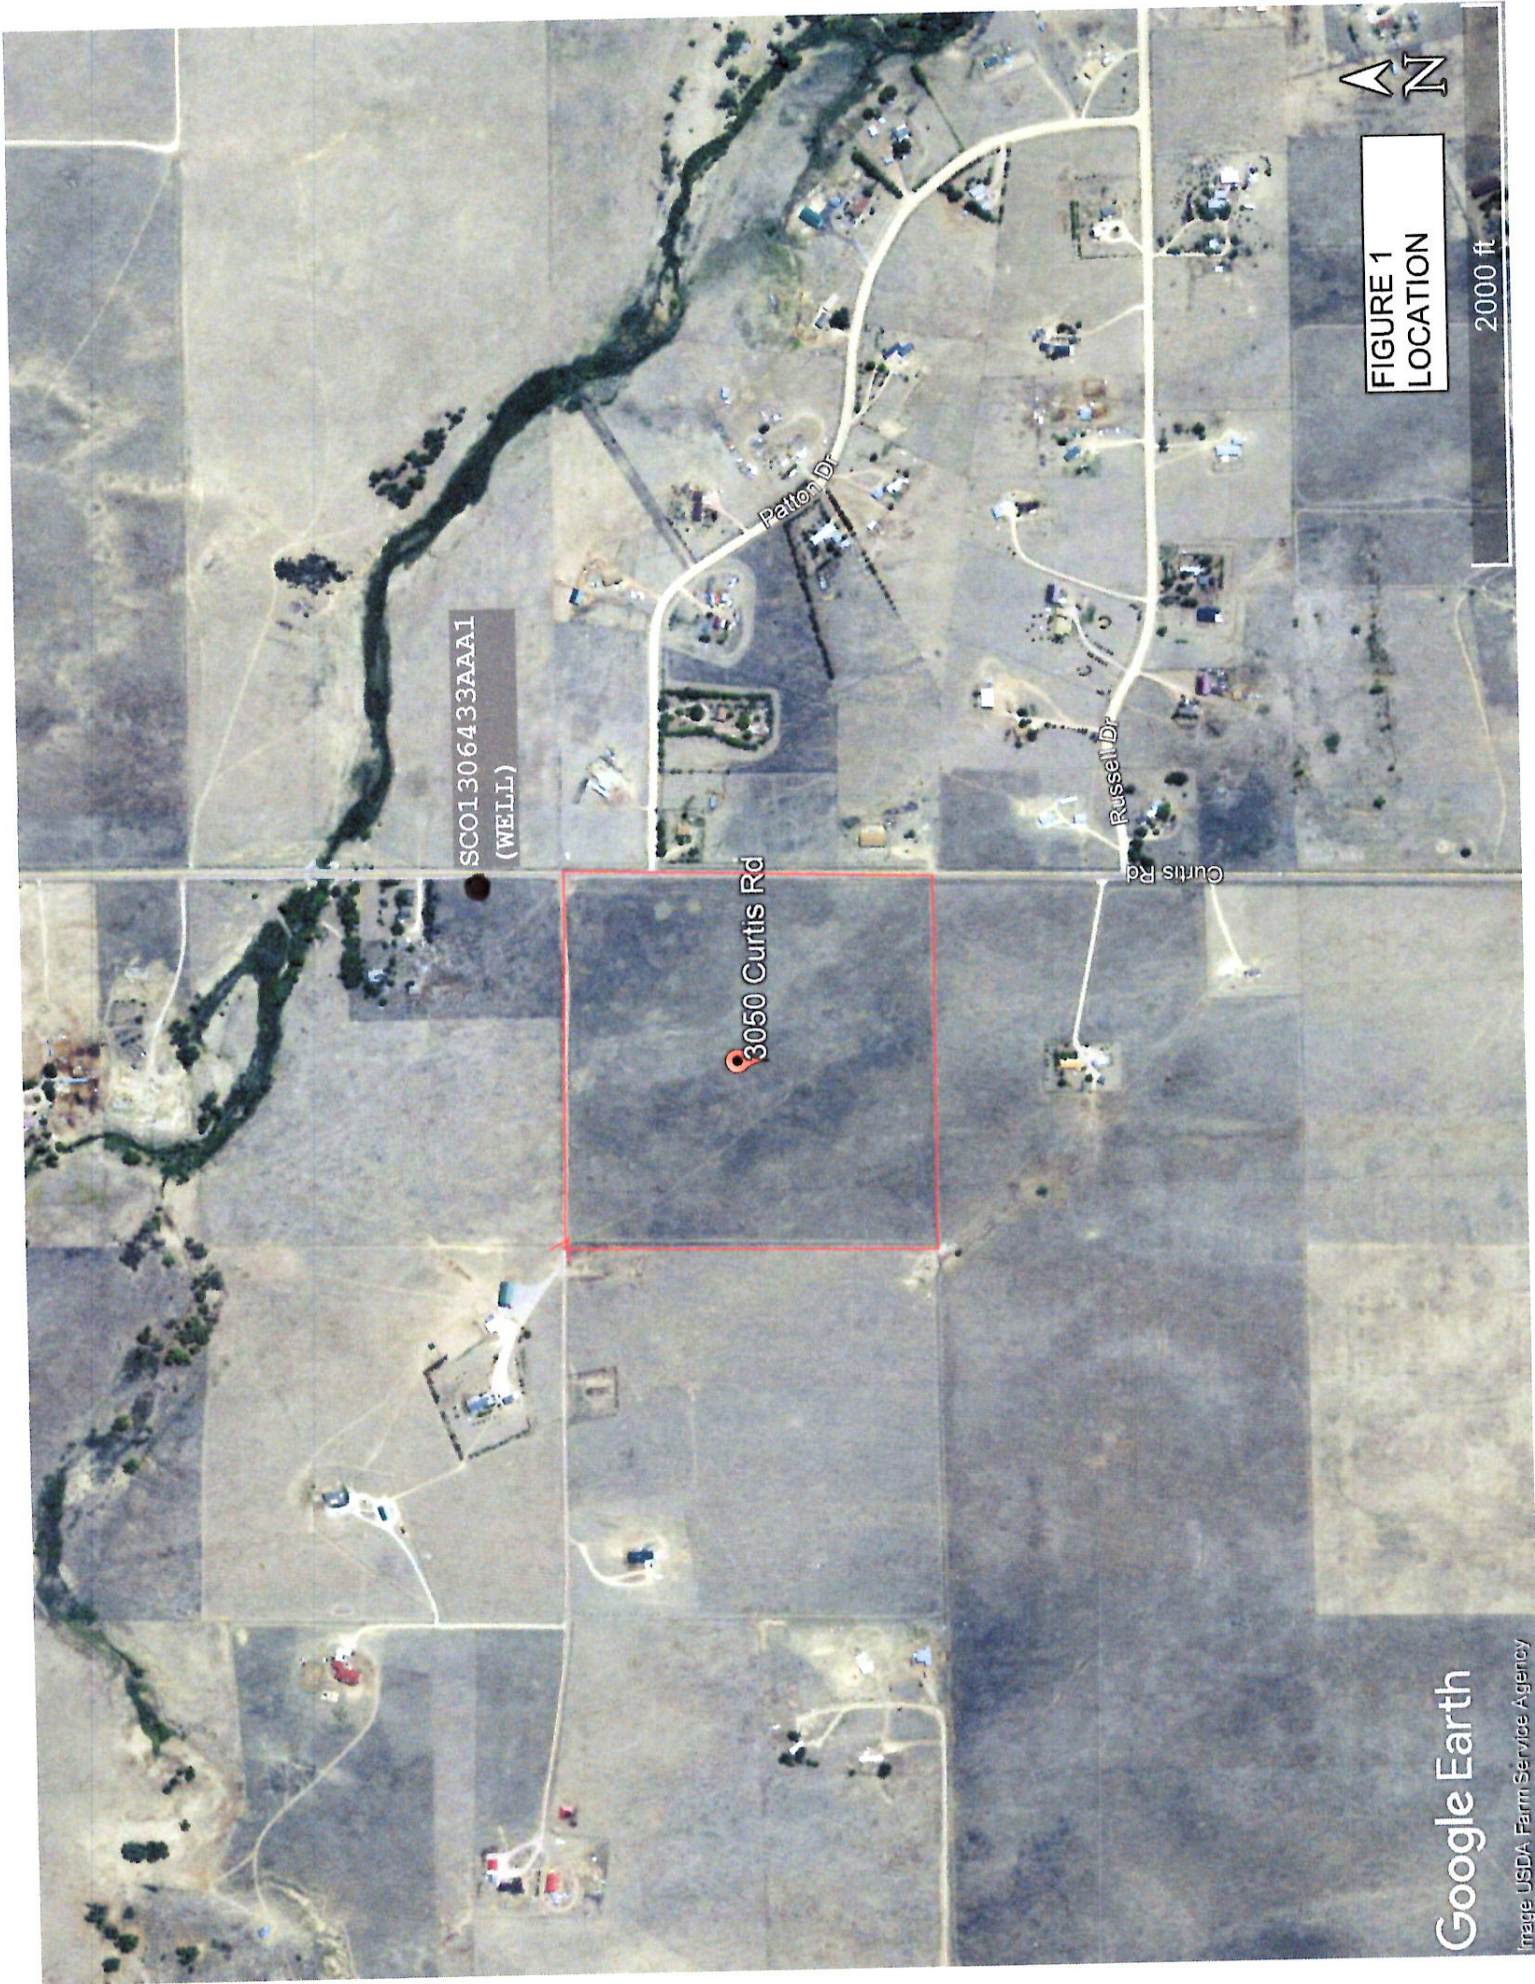
FIGURE 1  
LOCATION

The following presents Soils and Geology for the proposed Wyoming Estates Minor Subdivision (Project Site) located in the SE ¼ of the NE ¼ of Section 33, Township 13 South, Range 64 West of the 6<sup>th</sup> P.M. in the County of El Paso (Figure 1).
