Soils and Geology
And Wastewater Treatment System
Evaluation
For
Wyoming Estates
3050 N. Curtis Road
Final
October 5, 2020

PROJECT DESCRIPTION

The following presents Soils and Geology for the proposed Wyoming Estates Minor Subdivision (Project Site) located in the SE ¼ of the NE ¼ of Section 33, Township 13 South, Range 64 West of the 6th P.M. in the County of El Paso (Figure 1).

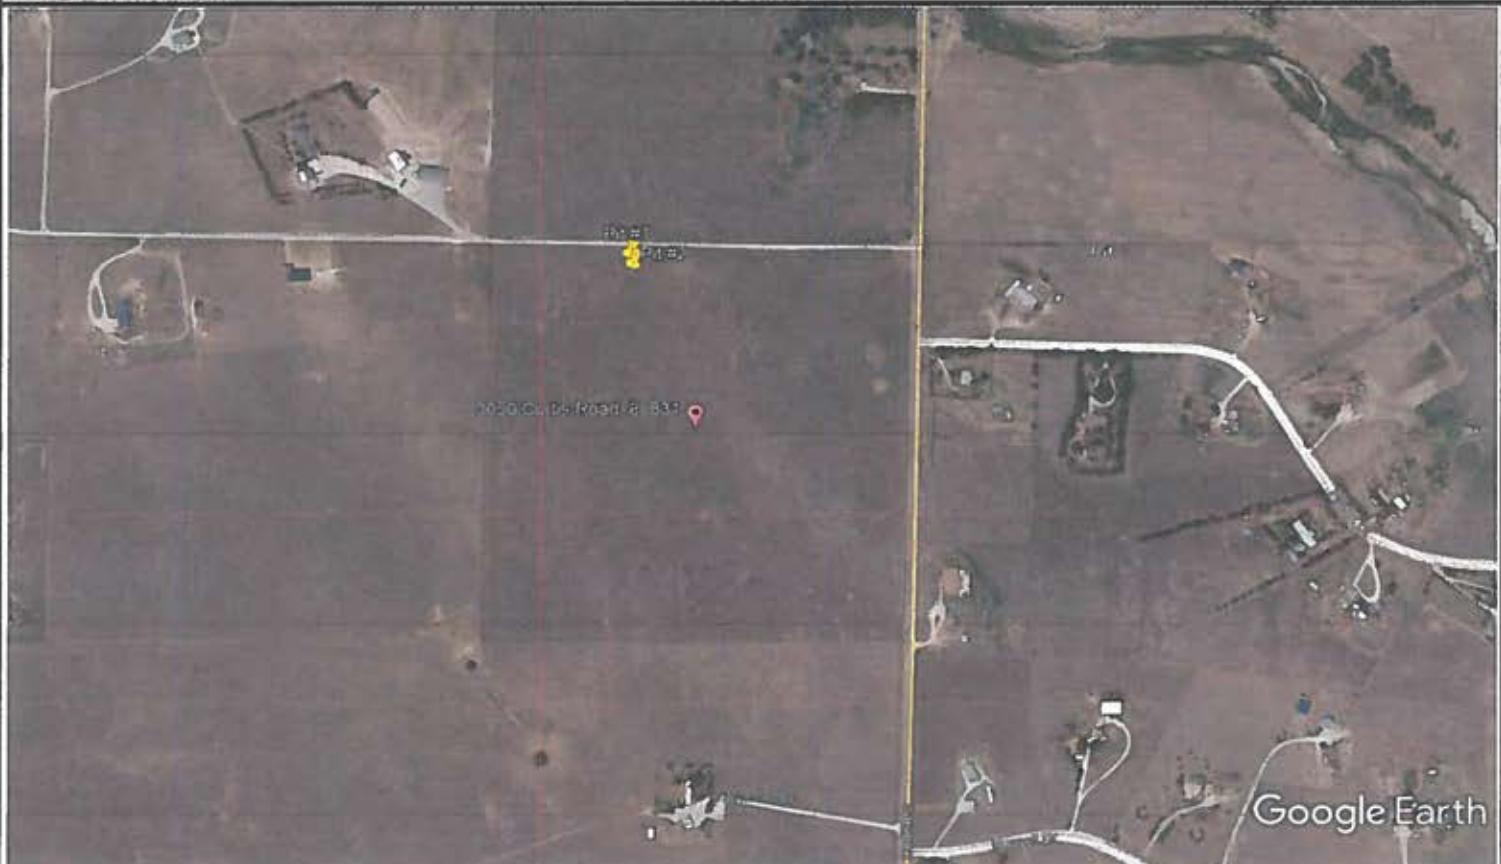
Google Site Map

Profile Pit 1	
Latitude:	38°52'41.42"N
Longitude:	104°33'25.06"W
Layer	Soil Type & LTAR
0 - 1'-0"	Topsoil
1'-0" - 6'-0"	Type 2 (LTAR=0.60)
6'-0" - 8'-6"	Type 4 (LTAR=0.20)
-	-

Profile Pit 2	
Latitude:	38°52'41.10"N
Longitude:	104°33'24.94"W
Layer	Soil Type & LTAR
0 - 1'-0"	Topsoil
1'-0" - 3'-0"	Type 2 (LTAR=0.60)
3'-0" - 8'-6"	Type 4 (LTAR=0.20)
-	-

<u>Recommendations:</u>	(1) An Engineered On-Site Wastewater Treatment system (OWTS) is required for this location due to: Soil Type 4 identified in the treatment zone of Profile Pit #1 & Profile Pit #2.	
-------------------------	--	--

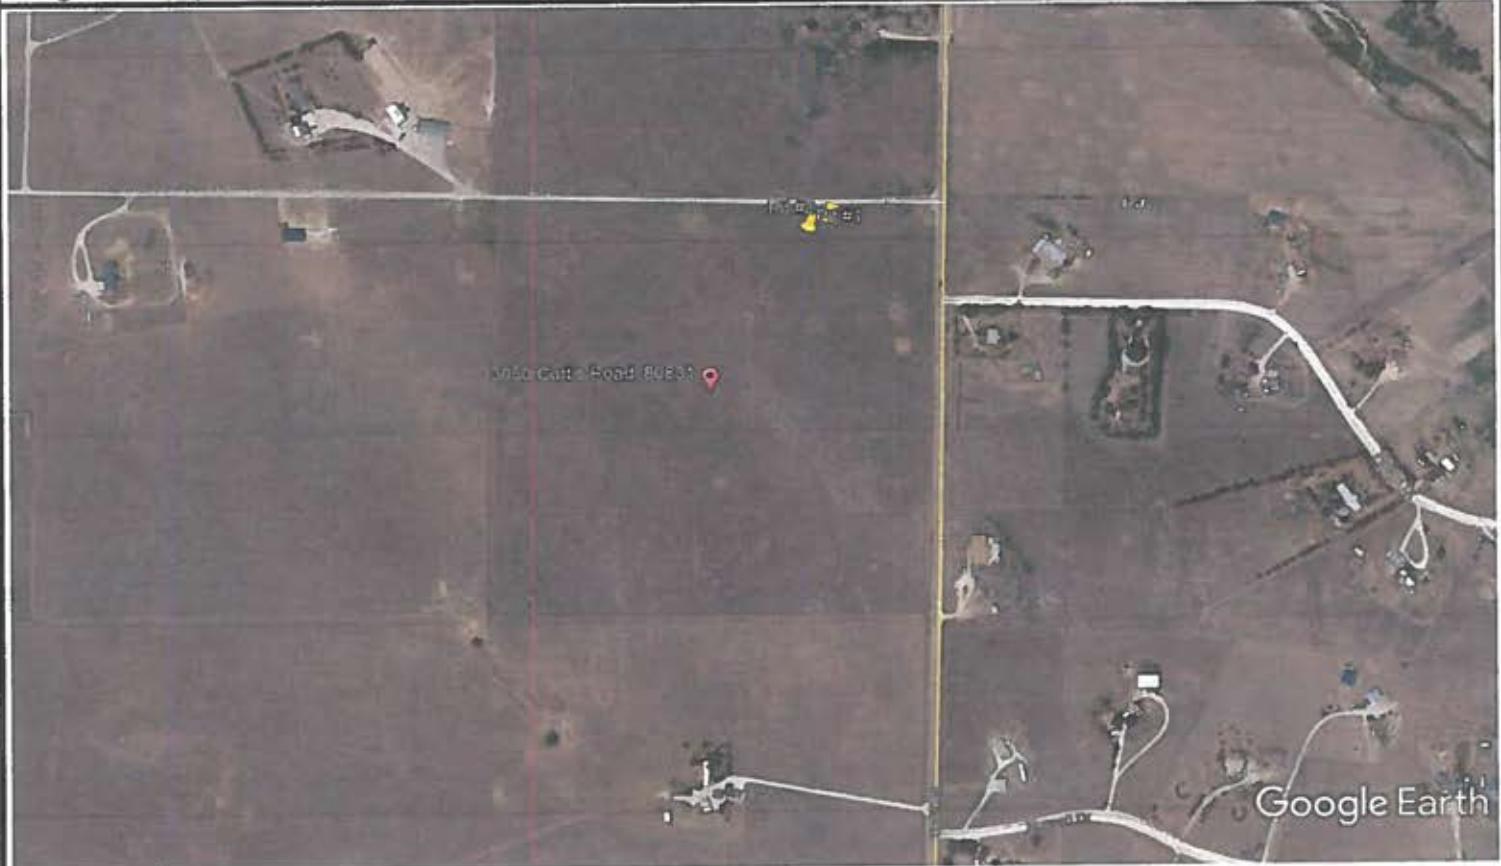
Google Site Map

Profile Pit 1	
Latitude:	38°52'40.93"N
Longitude:	104°33'18.76"W
Layer	Soil Type & LTAR
0 - 1'-0"	Topsoil
1'-0" - 8'-6"	Type 3 (LTAR=0.35)
-	-
-	-

Profile Pit 2	
Latitude:	38°52'41.21"N
Longitude:	104°33'18.03"W
Layer	Soil Type & LTAR
0 - 1'-0"	Topsoil
1'-0" - 8'-6"	Type 3 (LTAR=0.35)
-	-
-	-

Recommendations:	(1) A conventional, non-engineered On-Site Wastewater Treatment system (OWTS) is acceptable for this site.

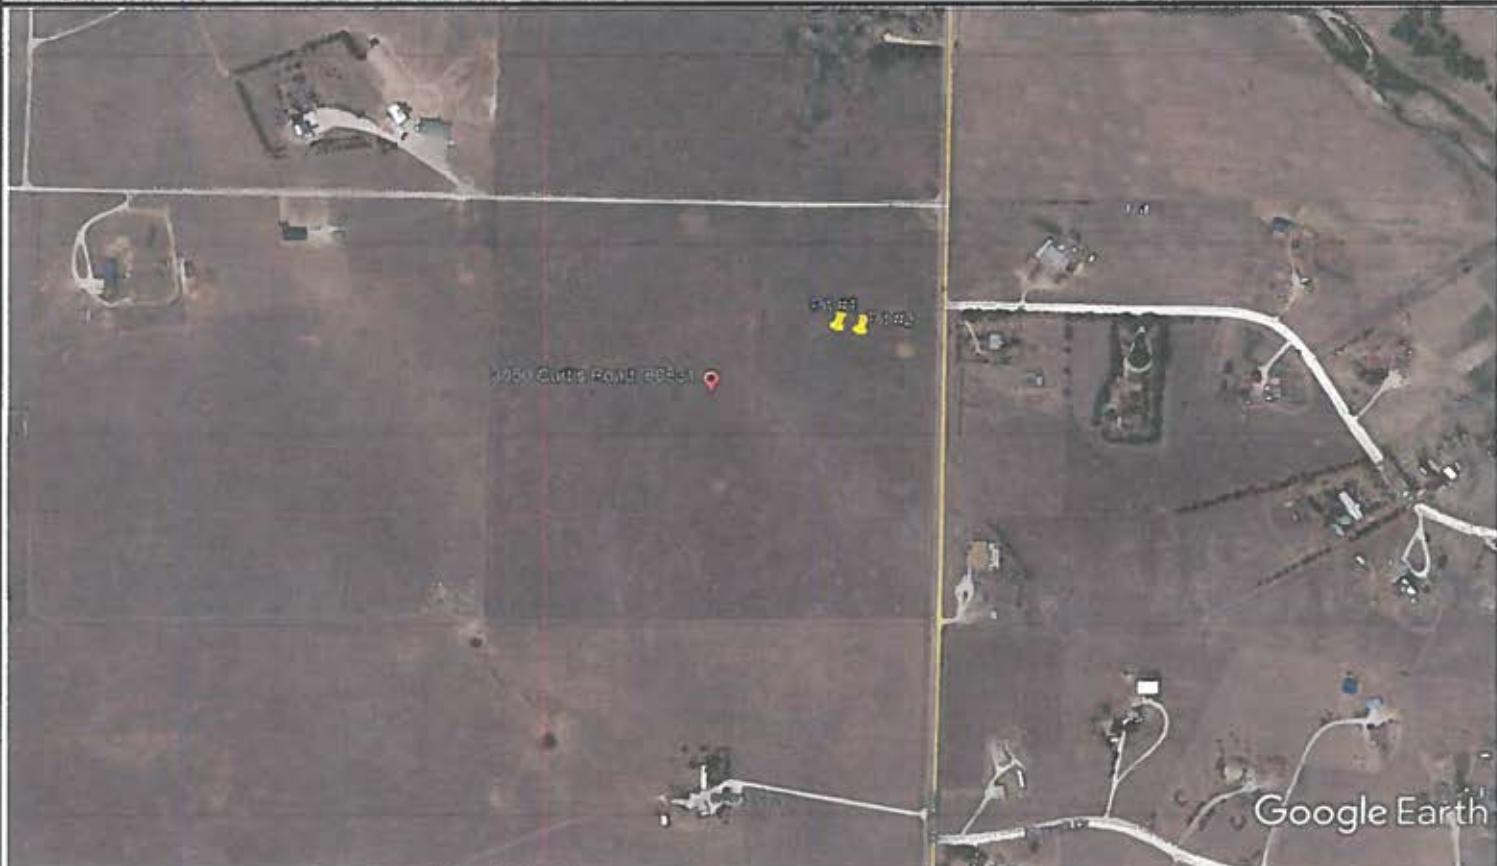
Google Site Map

Profile Pit 1	
Latitude:	38°52'37.92"N
Longitude:	104°33'17.81"W
Layer	Soil Type & LTAR
0 - 1'-0"	Topsoil
1'-0" - 2'-6"	Type 3 (LTAR=0.35)
2'-6" - 4'-0"	Type 3 (LTAR=0.35)
4'-0" - 8'-6"	Type 3 (LTAR=0.35)

Profile Pit 2	
Latitude:	38°52'37.81"N
Longitude:	104°33'16.94"W
Layer	Soil Type & LTAR
0 - 1'-0"	Topsoil
1'-0" - 8'-6"	Type 3 (LTAR=0.35)
-	-
-	-

Recommendations: (1) A conventional, non-engineered On-Site Wastewater Treatment system (OWTS) is acceptable for this site.

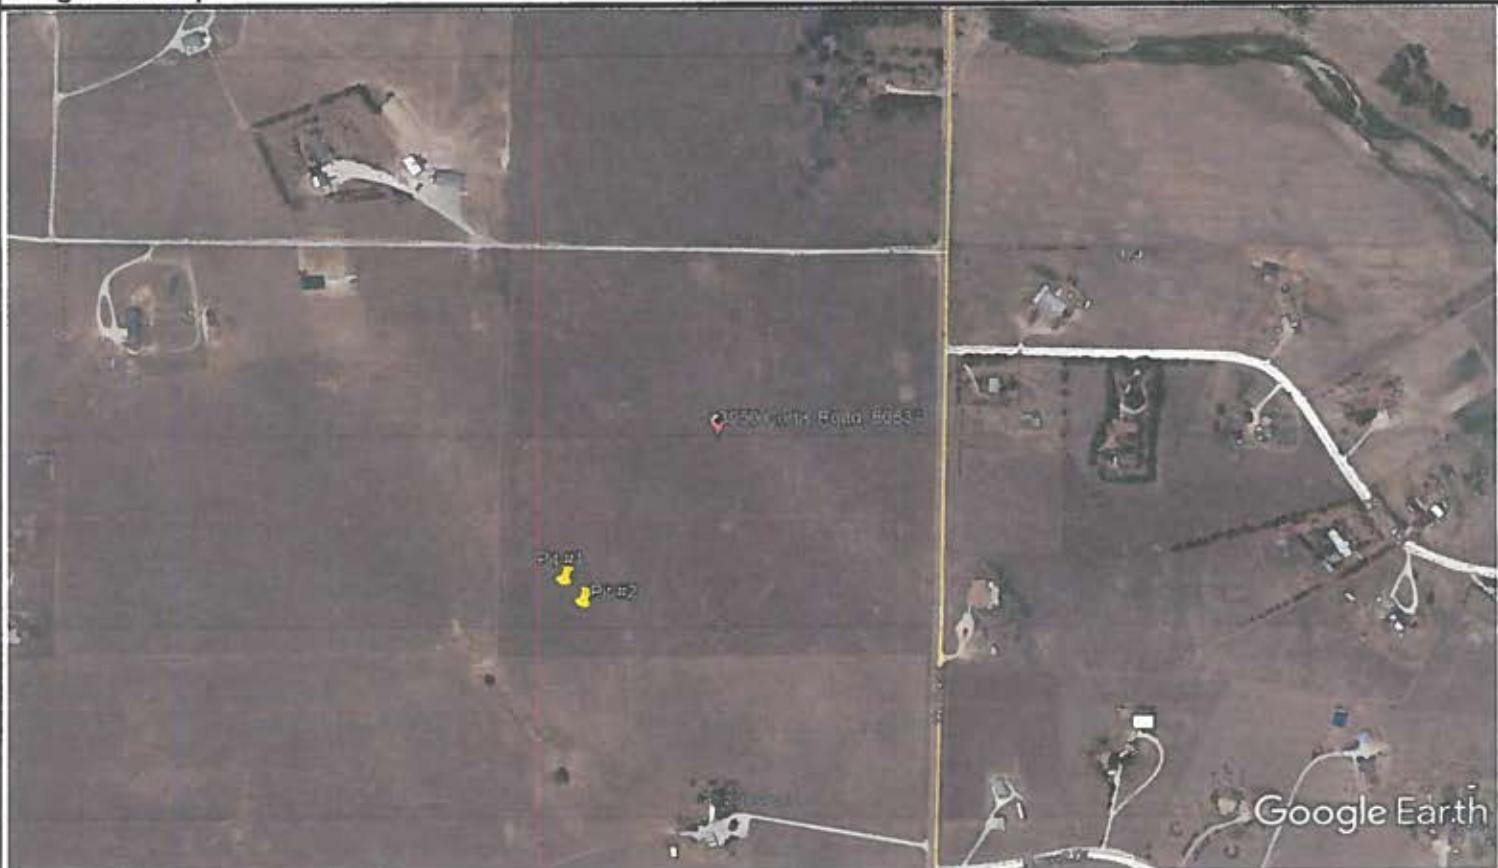
Google Site Map

Profile Pit 1	
Latitude:	38°52'31.31"N
Longitude:	104°33'28.35"W
Layer	Soil Type & LTAR
0 - 1'-0"	Topsoil
1'-0" - 5'-0"	Type 3 (LTAR=0.35)
5'-0" - 8'-0"	Type 2 (LTAR=0.60)
-	-

Profile Pit 2	
Latitude:	38°52'30.60"N
Longitude:	104°33'27.64"W
Layer	Soil Type & LTAR
0 - 1'-0"	Topsoil
1'-0" - 8'-6"	Type 3 (LTAR=0.35)
-	-
-	-

<u>Recommendations:</u>	(1) A conventional, non-engineered On-Site Wastewater Treatment system (OWTS) is acceptable for this site.	
-------------------------	--	--
