Soils and Geology
&
Wastewater Treatment
System
Evaluations
For
Wyoming Estates
3050 N. Curtis Road
June 6, 2019

The following presents Soils and Geology for the proposed Wyoming Estates Minor Subdivision (Project Site) located in the SE ¼ of the NE ¼ of Section 33, Township 13 South, Range 64 West of the 6th P.M. in the County of El Paso (Figure 1).

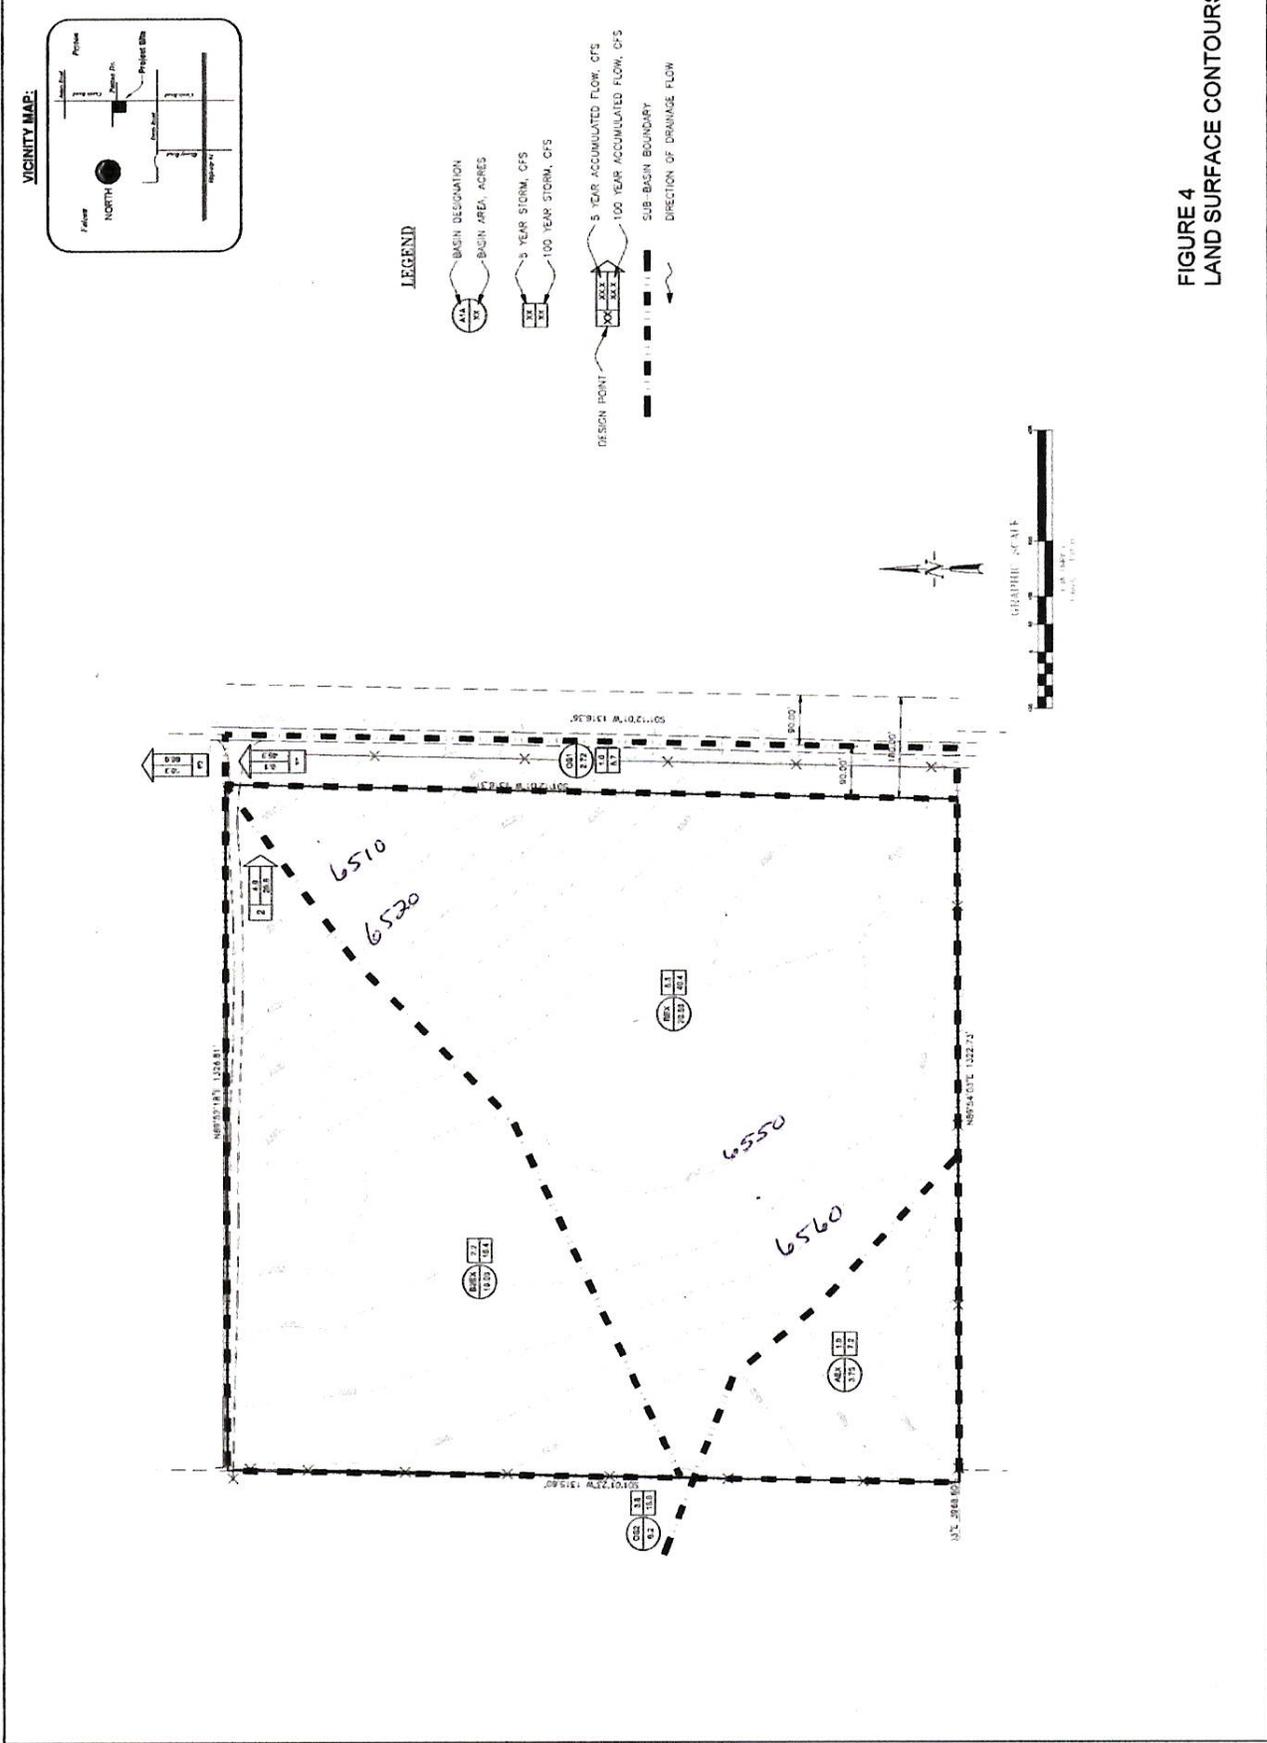
**FIGURE 4
LAND SURFACE CONTOURS**

The Project Site generally slopes to the northeast ranging from 1% to 9%. In the southwest corner, drainage is to the southeast. Figure 4 provides the Project Site Surface Contours.

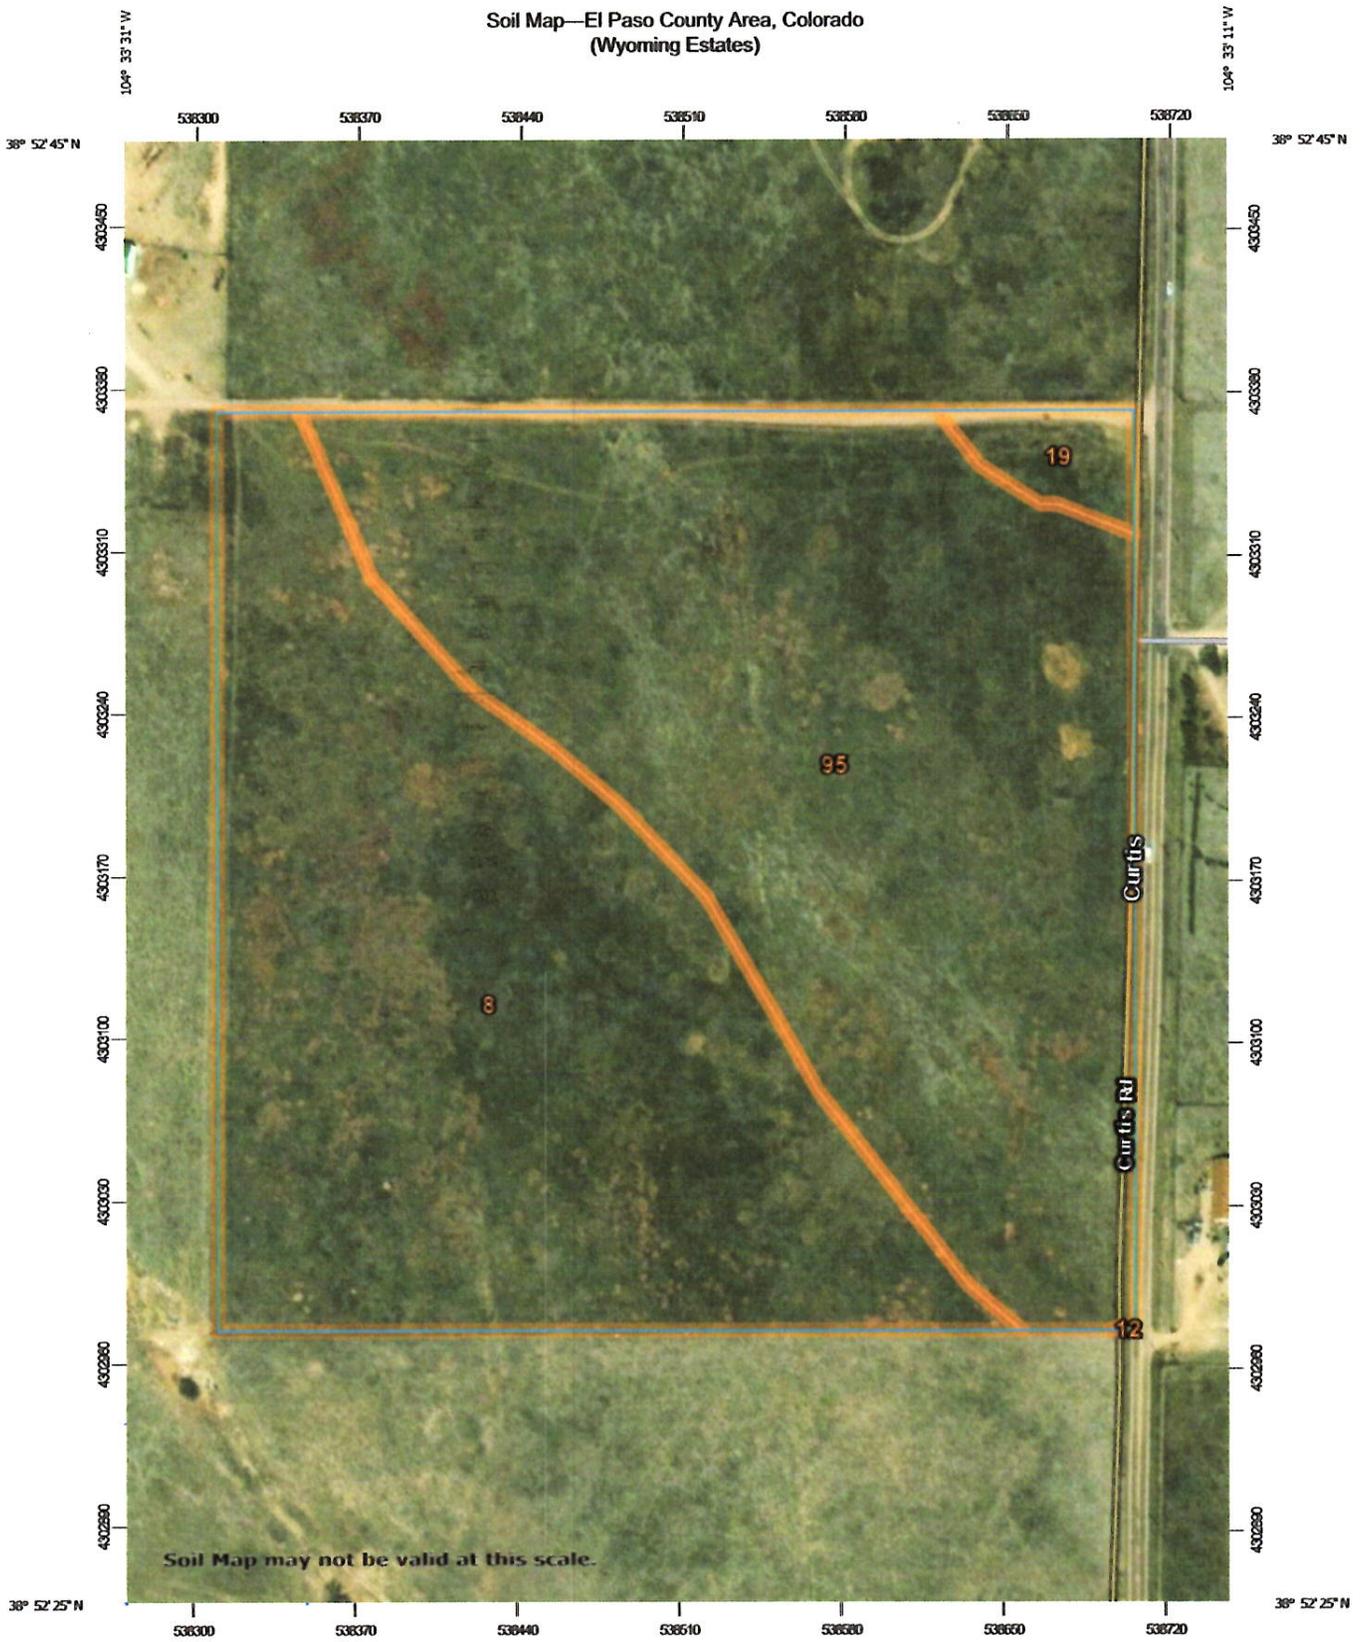
FIGURE 5
 Soil Map—El Paso County Area, Colorado
 (Wyoming Estates)

The National Resource Conservation Service (NRCS) has identified three soil types with a northeast trend on the Property (Figure 5).

Groundwater was not encountered in any of the OWTS test pit and was not evident in the profile test pits a week following excavation. There are no existing wells on the Project Site. Shallow alluvial wells in the area occur in the older gravels and alluviums to the northeast (Soil Type 19 on Figure 5, Qgo Figure 3) which are also on the eastern portion of Lot 3. USGS reported groundwater levels in a Well labeled as SCO1306433AAA1 and located just north of Lot 3. Groundwater levels were measured consistently over the last 40 years and consistently occurs at an elevation of about 6480 ft amsl (Attachment 2) approximately 20 feet below the northeast corner of Lot 3. Based on review of the geology, well reports, and surface drainage, this is likely the location /elevation of the highest water table underlying at the Project Site.

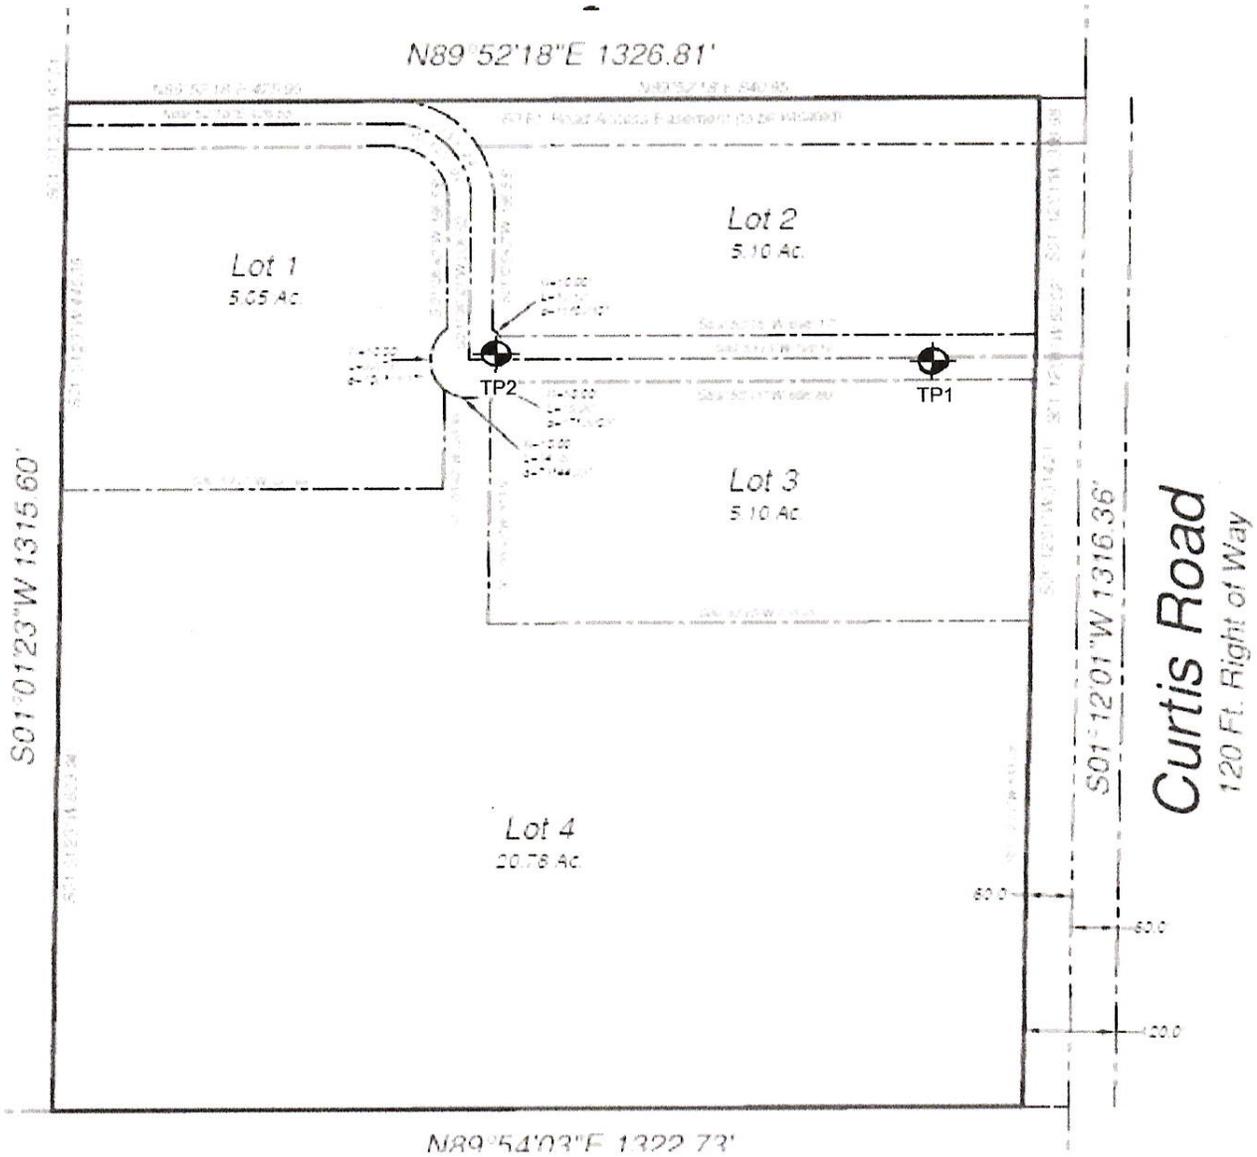
FIGURE 7
Pavement Design Test Pit Locations

Two test holes were evaluated for a proposed gravel roadway for pavement design (Raiper, 2019, Figure 7). Soil samples were collected with testing included sieve analysis and Atterberg limits in addition to determining resistance values (R-Values). The results are summarized in Table 2.

Location	Depth (ft)	Plasticity Index	%Passing #200	Moisture Content (%)	USCS Soil Classification	Tested R-Value
TP1	1-3	NP	26	4.2	SM	76
TP1	8-10	6	30	5.1	SC:SM	-
TP2	1-3	NP	17	3.6	SM	-
TP2	3-5	NP	20	3.5	SM	-

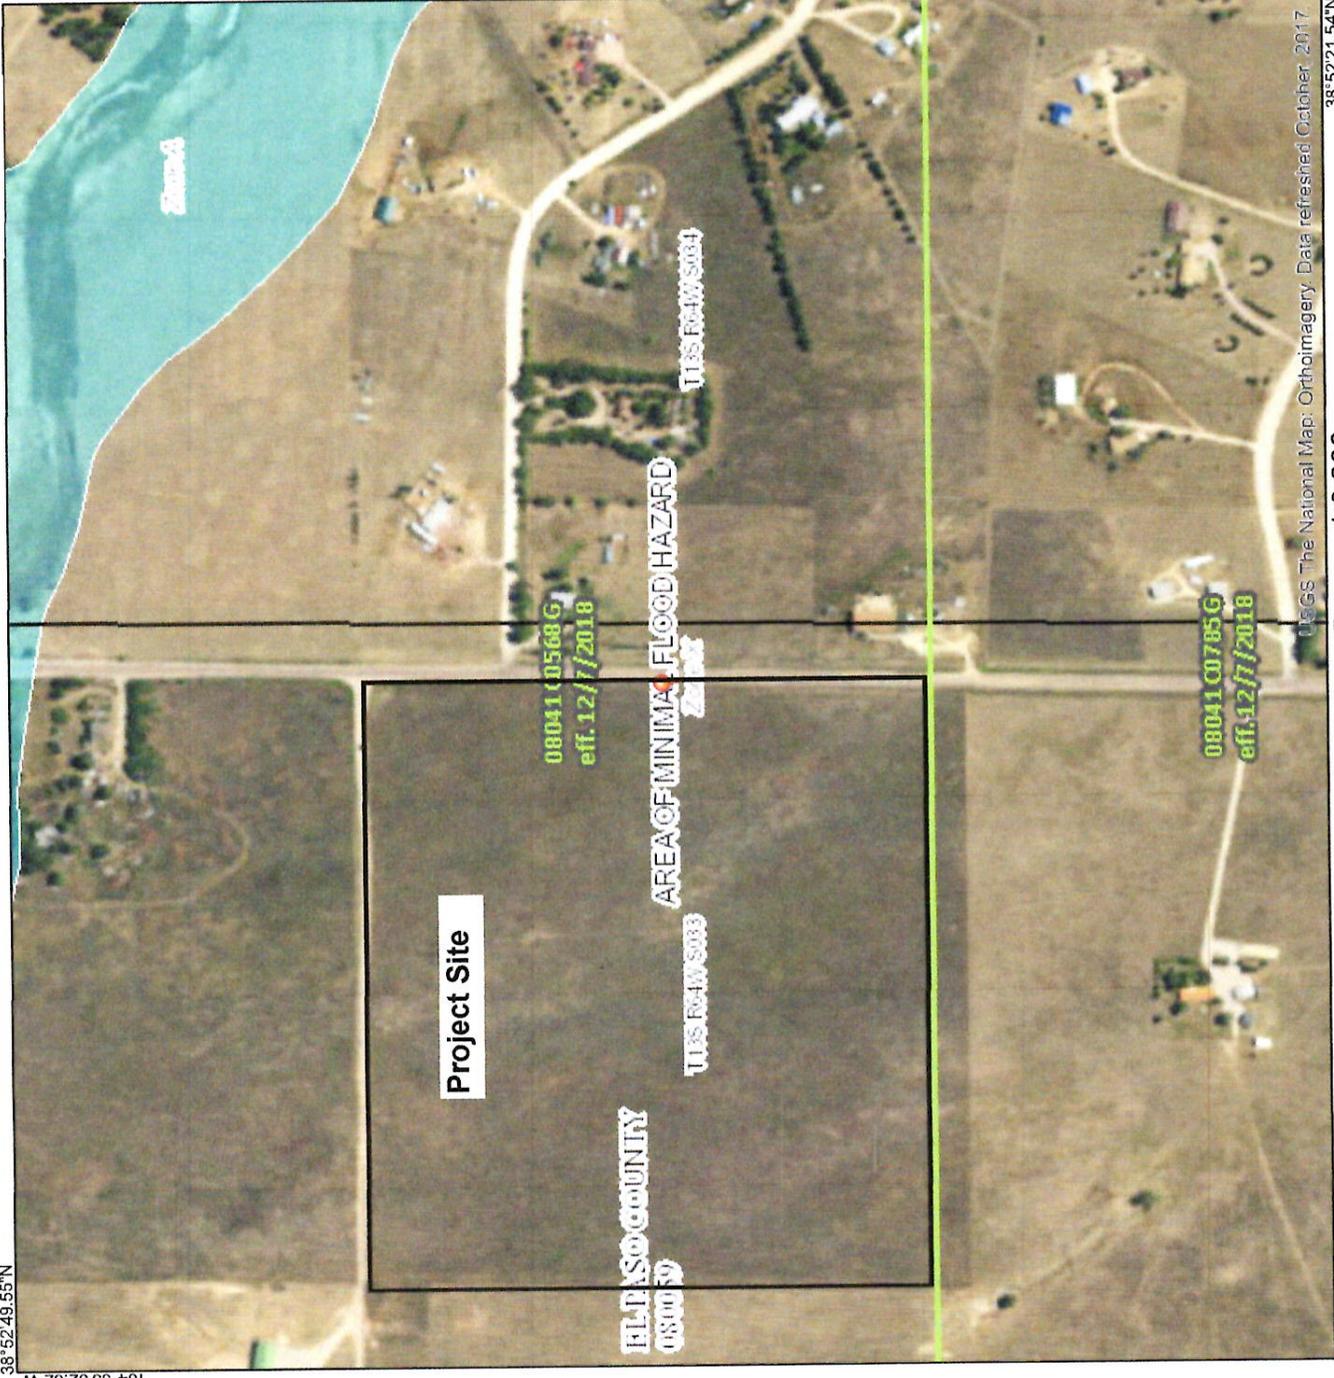
National Flood Hazard Layer FIRMette

The Project Site was evaluated for geologic hazards that may impact development. Hazards identified in the El Paso County Land Development Code including: Mining, wildfire, highwater table or polluted water, landfills, fill areas, contamination; airports and major utility facilities, and landslides were not identified on the Project Site. The National Flood Hazard map delineated the Property and surrounding area an “area of Minimal Flood Hazard” (FEMA 2018). The Project Site is not located in a flood plain (Figure 8).

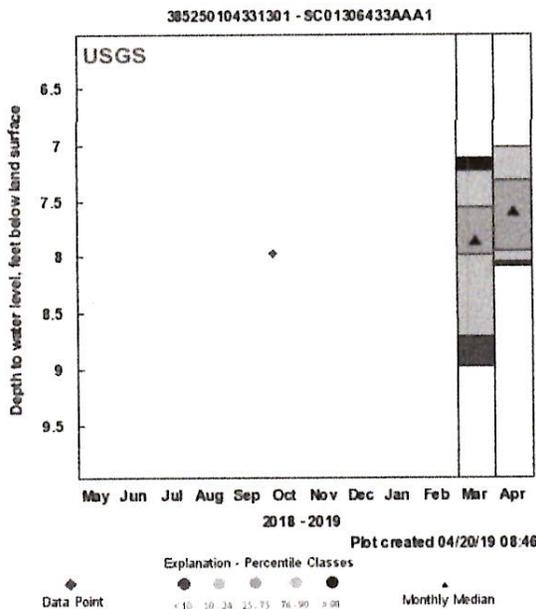
Site Statistics

Most recent data value: 7.97 on 10/2/2018
Period of Record Monthly Statistics for 385250104331301
Depth to water level, feet below land surface
All Approved Continuous & Periodic Data Used In Analysis
 Note: Highlighted values in the table indicate closest statistic to the most recent data value.

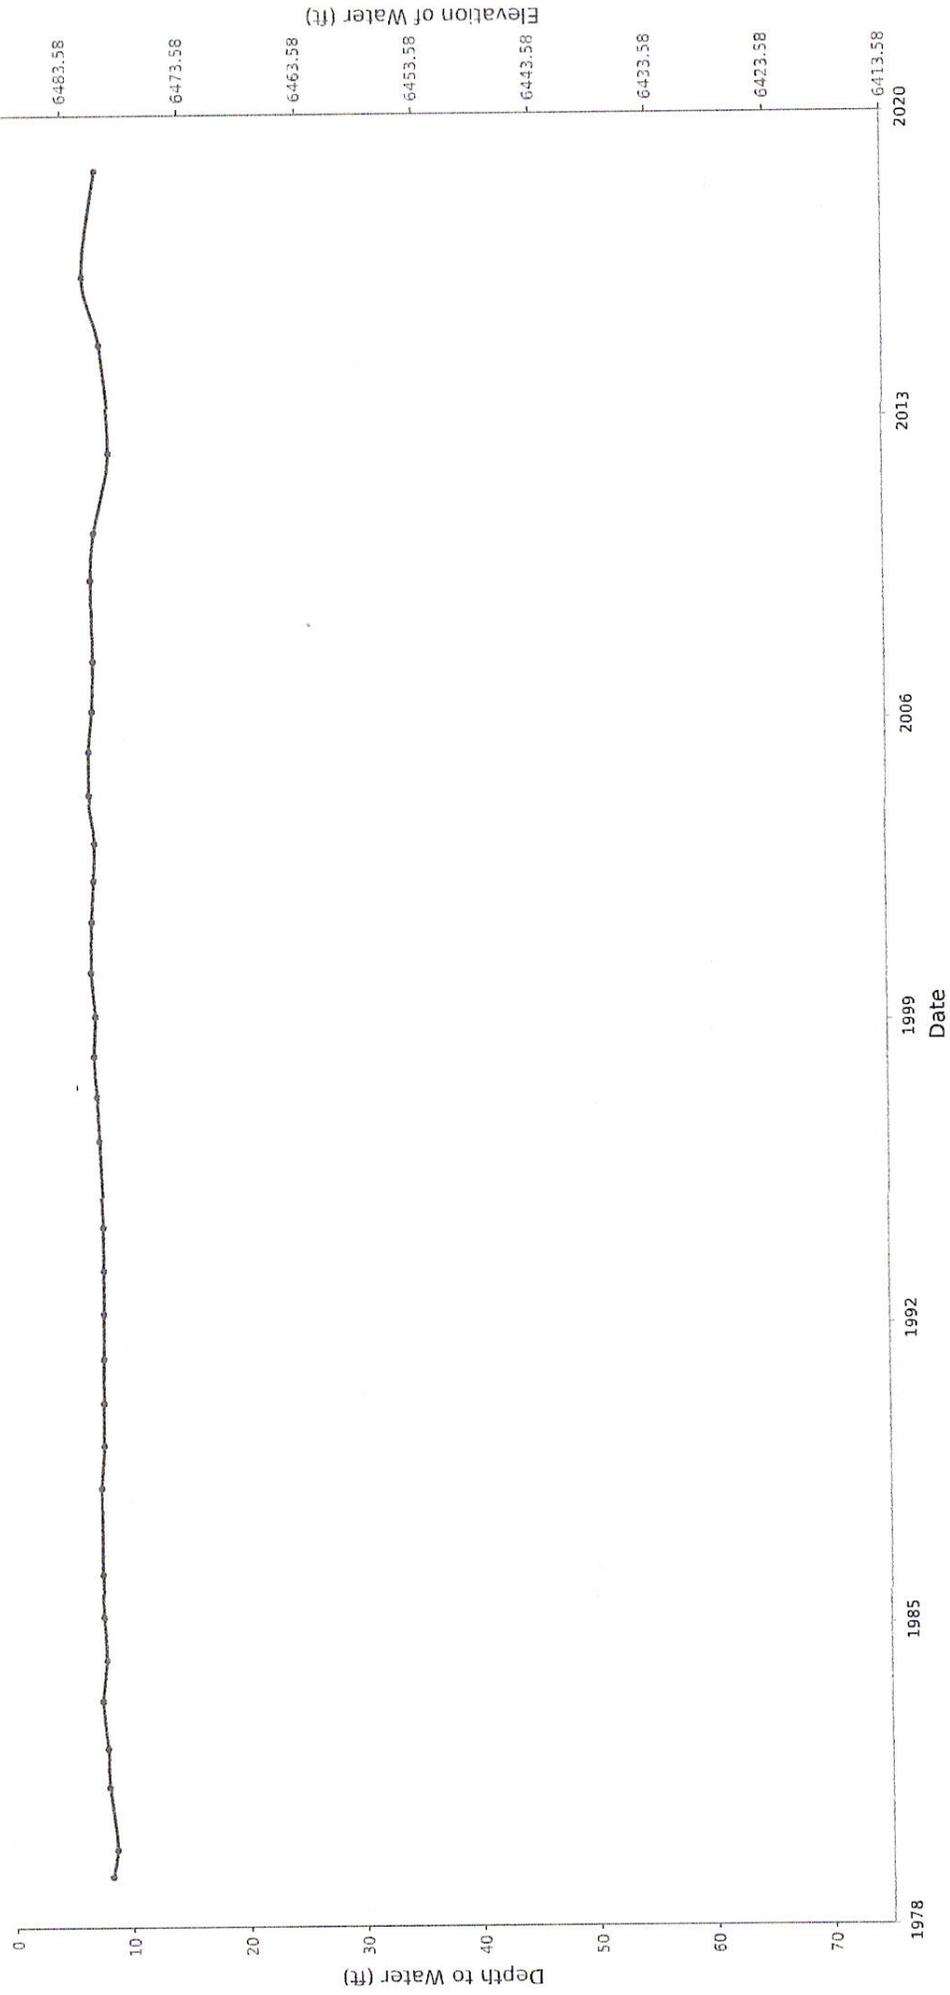
SC01306433AAA1

Highest WL	Date of Highest WL	Lowest WL	Date of Lowest WL
6.78	04/21/16	8.97	03/27/12
