# Soils and Geology And Wastewater Treatment System Evaluation

For  
Wyoming Estates  
3050 N. Curtis Road

Final  
February 27, 2020

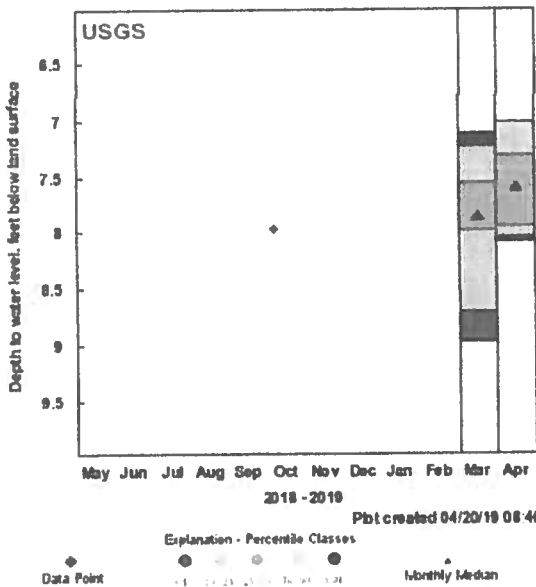
385250104331301 - SC01306433AAA1

Most recent data value: 7.97 on 10/2/2018  
 Period of Record Monthly Statistics for 385250104331301  
 Depth to water level, feet below land surface  
 All **Approved** Continuous & Periodic Data Used In Analysis  
 Note: Highlighted values in the table indicate closest statistic to the most recent data value.
