Soils and Geology
&
Wastewater Treatment
System
Evaluations
For
Wyoming Estates
3050 N. Curtis Road
June 6, 2019

PROJECT DESCRIPTION

The following presents Soils and Geology for the proposed Wyoming Estates Minor Subdivision (Project Site) located in the SE ¼ of the NE ¼ of Section 33, Township 13 South, Range 64 West of the 6th P.M. in the County of El Paso (Figure 1).

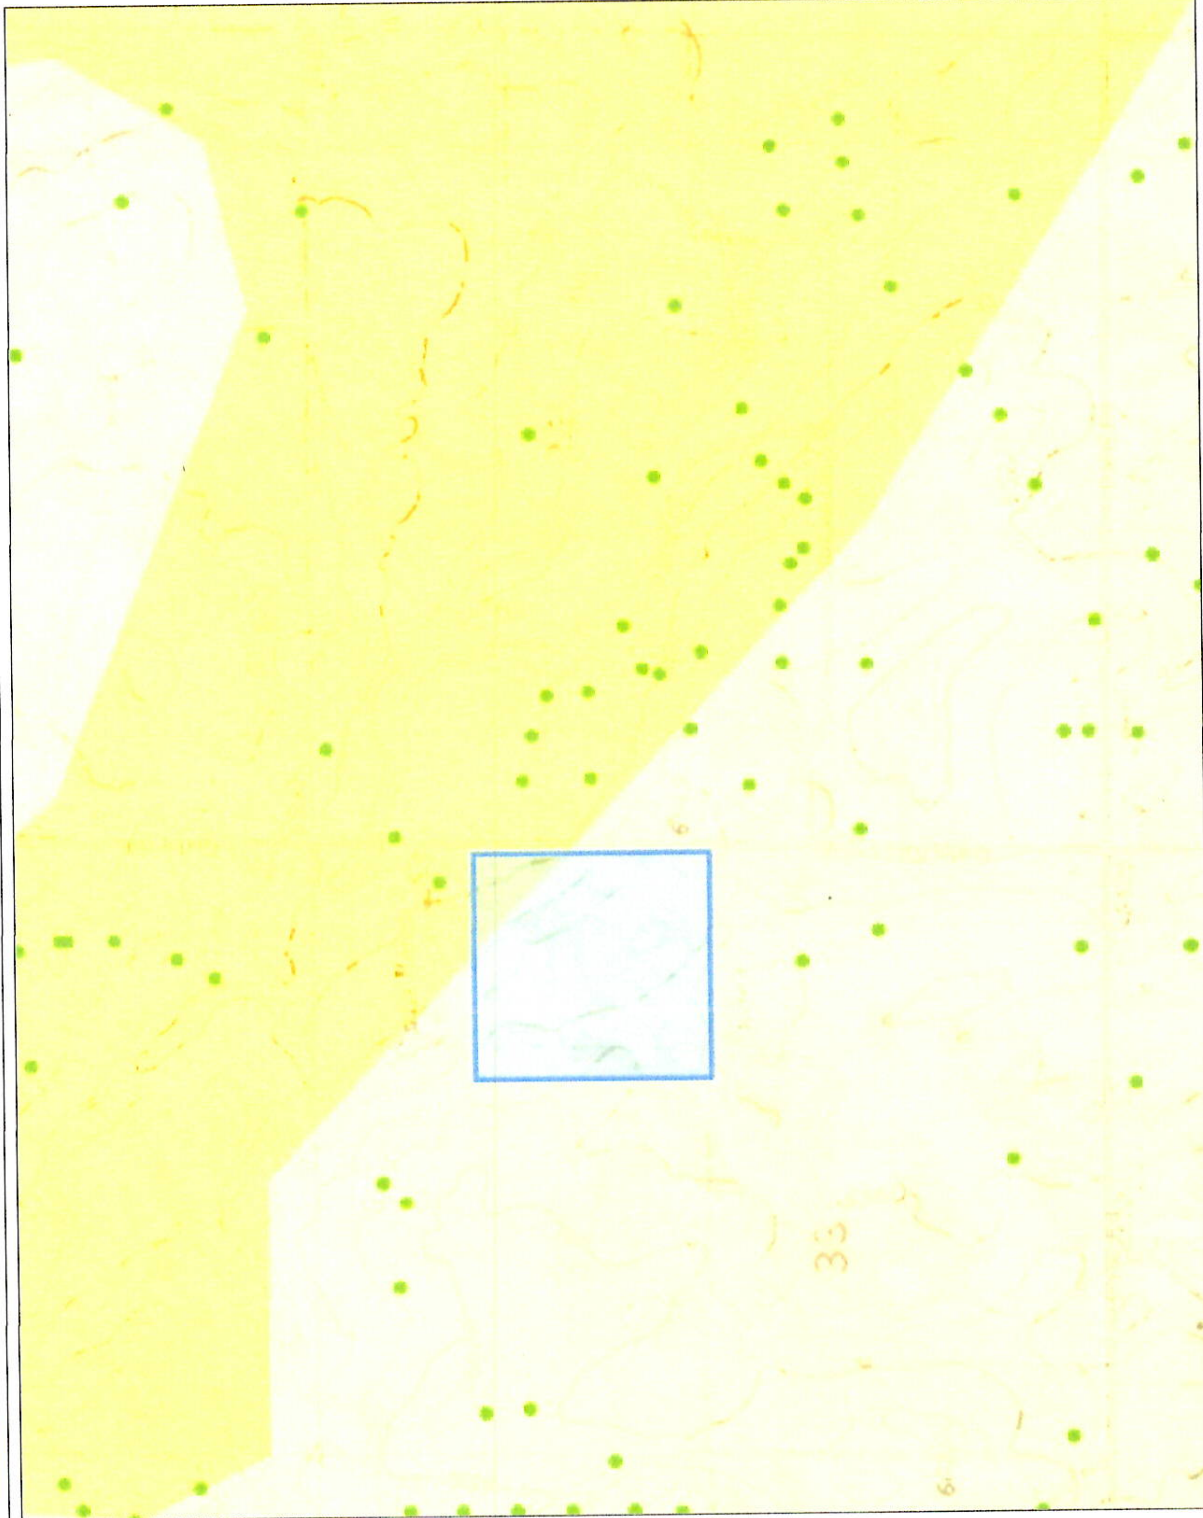
FIGURE 3

Depositional Boundary
Eolian Deposits and Older Gravels and
Alluvium (NE)

Groundwater was not encountered in any of the OWTS test pit and was not evident in the profile test pits a week following excavation. There are no existing wells on the Project Site. Shallow alluvial wells in the area occur in the older gravels and alluviums to the northeast (Soil Type 19 on Figure 5, Qgo Figure 3) which are also on the eastern portion of Lot 3. USGS reported groundwater levels in a Well labeled as SCO1306433AAA1 and located just north of Lot 3. Groundwater levels were measured consistently over the last 40 years and consistently occurs at an elevation of about 6480 ft amsl (Attachment 2) approximately 20 feet below the northeast corner of Lot 3. Based on review of the geology, well reports, and surface drainage, this is likely the location /elevation of the highest water table underlying at the Project Site.

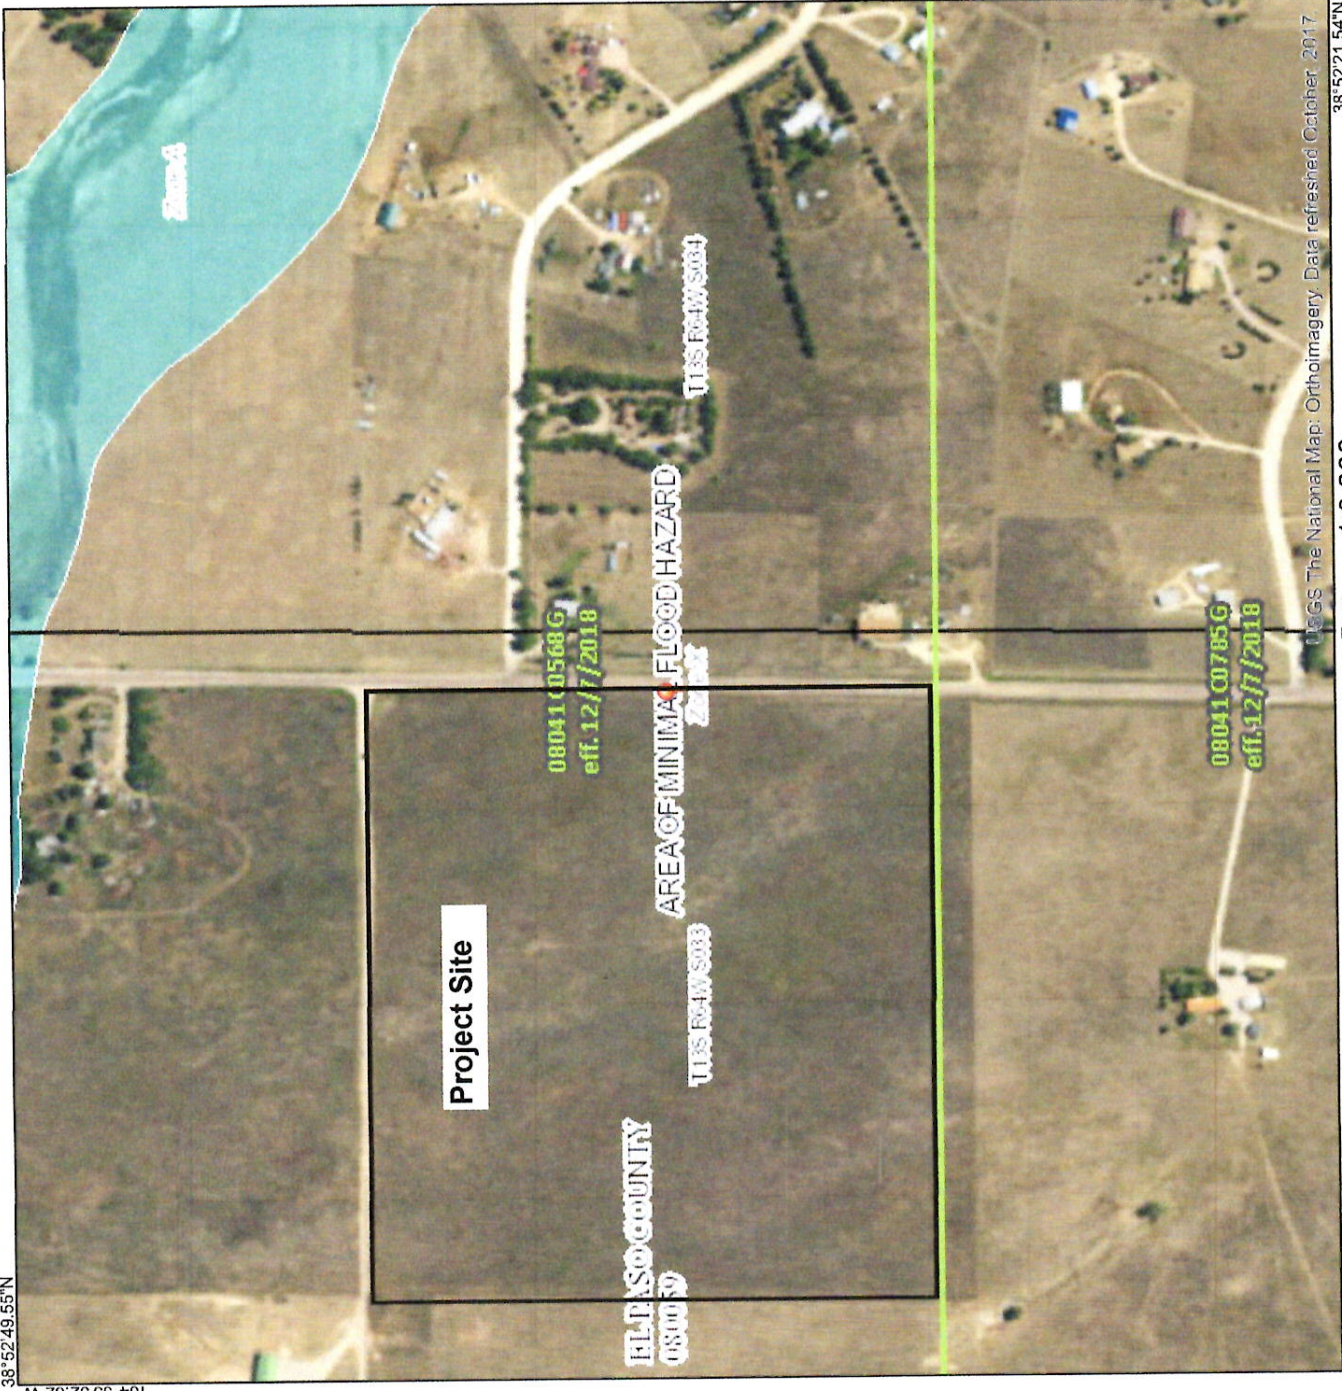
National Flood Hazard Layer FIRMette

- The flood hazard information is derived directly from the authoritative NFHL web services provided by FEMA. This map was exported on 4/25/2019 at 12:54:03 PM and does not reflect changes or amendments subsequent to this date and time. The NFHL and effective information may change or become superseded by new data over time.

The Project Site was evaluated for geologic hazards that may impact development. Hazards identified in the El Paso County Land Development Code including: Mining, wildfire, highwater table or polluted water, landfills, fill areas, contamination; airports and major utility facilities, and landslides were not identified on the Project Site. The National Flood Hazard map delineated the Property and surrounding area an “area of Minimal Flood Hazard” (FEMA 2018). The Project Site is not located in a flood plain (Figure 8).

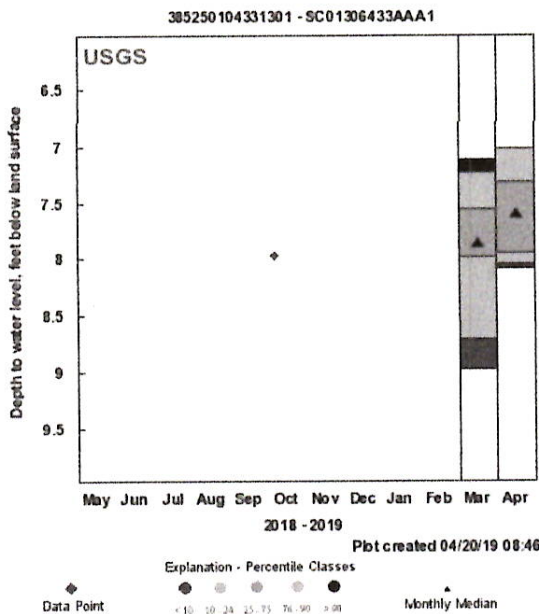
Site Statistics

Most recent data value: 7.97 on 10/2/2018
Period of Record Monthly Statistics for 385250104331301
Depth to water level, feet below land surface
All Approved Continuous & Periodic Data Used In Analysis
 Note: Highlighted values in the table indicate closest statistic to the most recent data value.

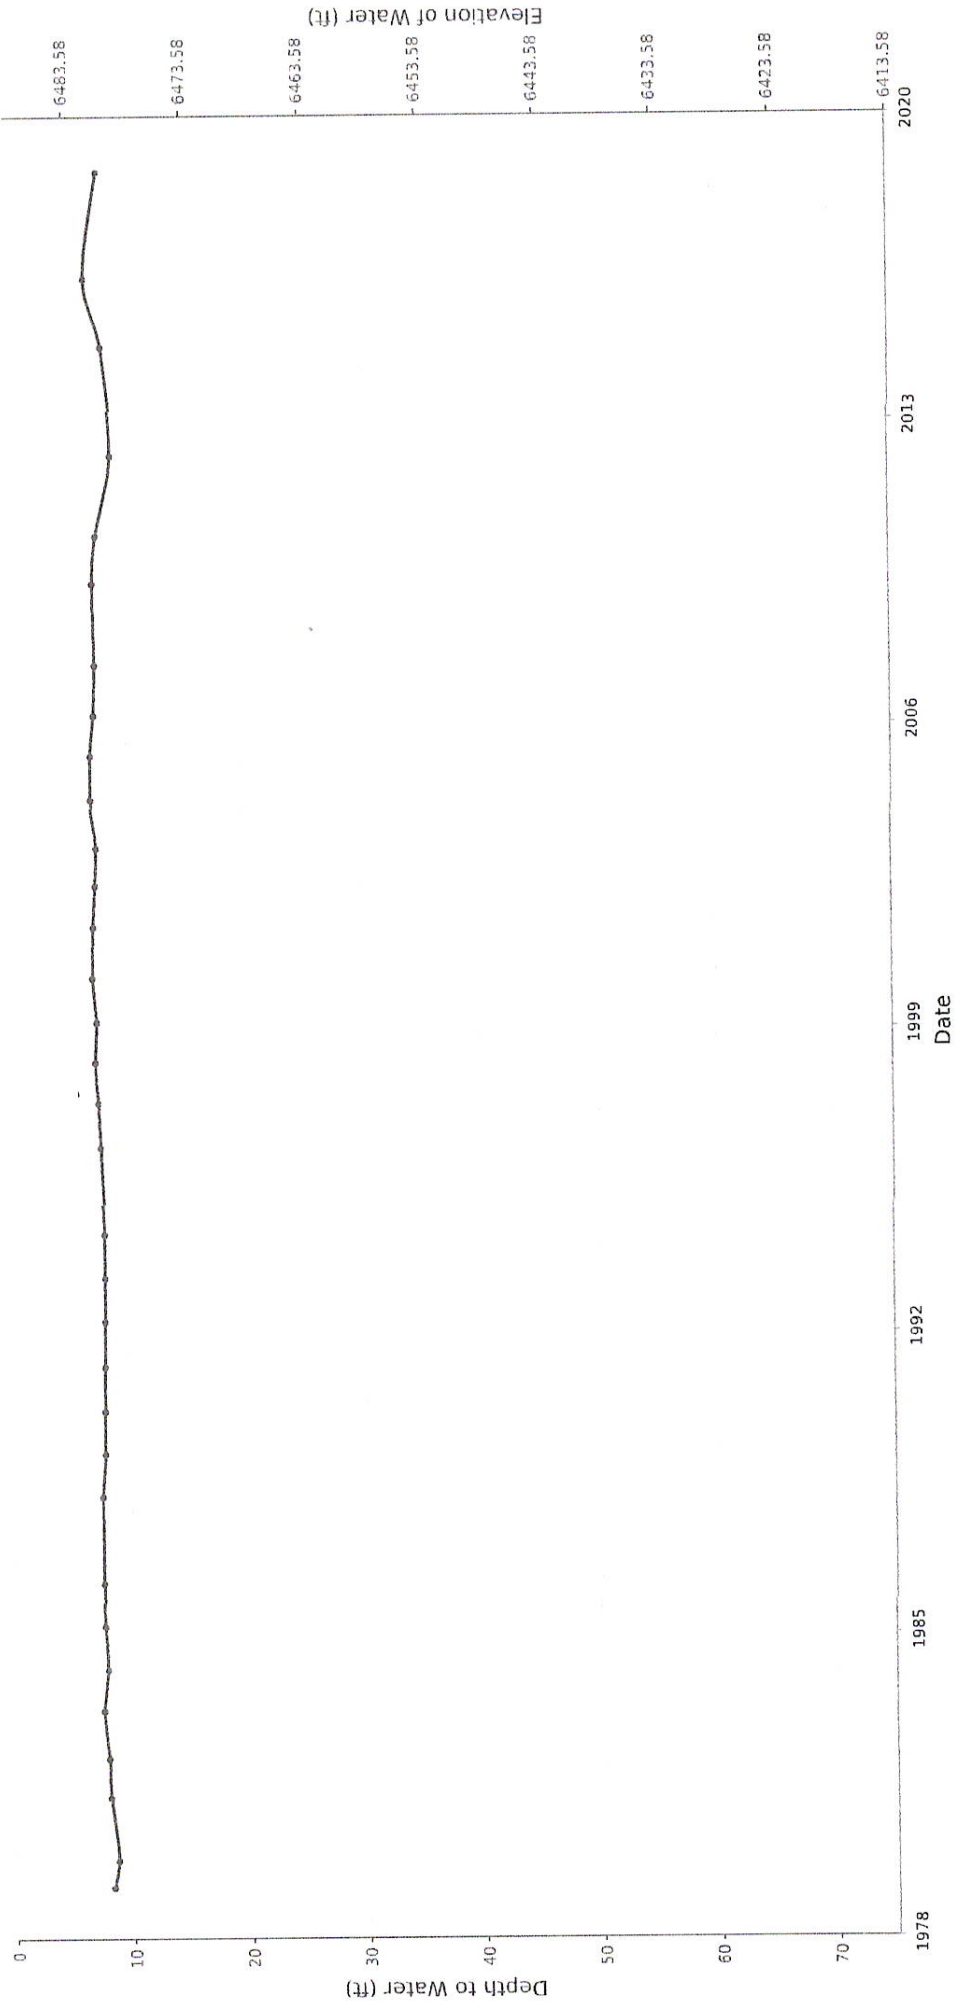
SC01306433AAA1

Highest WL	Date of Highest WL	Lowest WL	Date of Lowest WL
6.78	04/21/16	8.97	03/27/12
