Wyoming Estates Preliminary Plan

Compilation of Soils, Geology, and OWTS

Soils and Geology
And Wastewater Treatment System
Evaluation

For
Wyoming Estates
3050 N. Curtis Road
Final

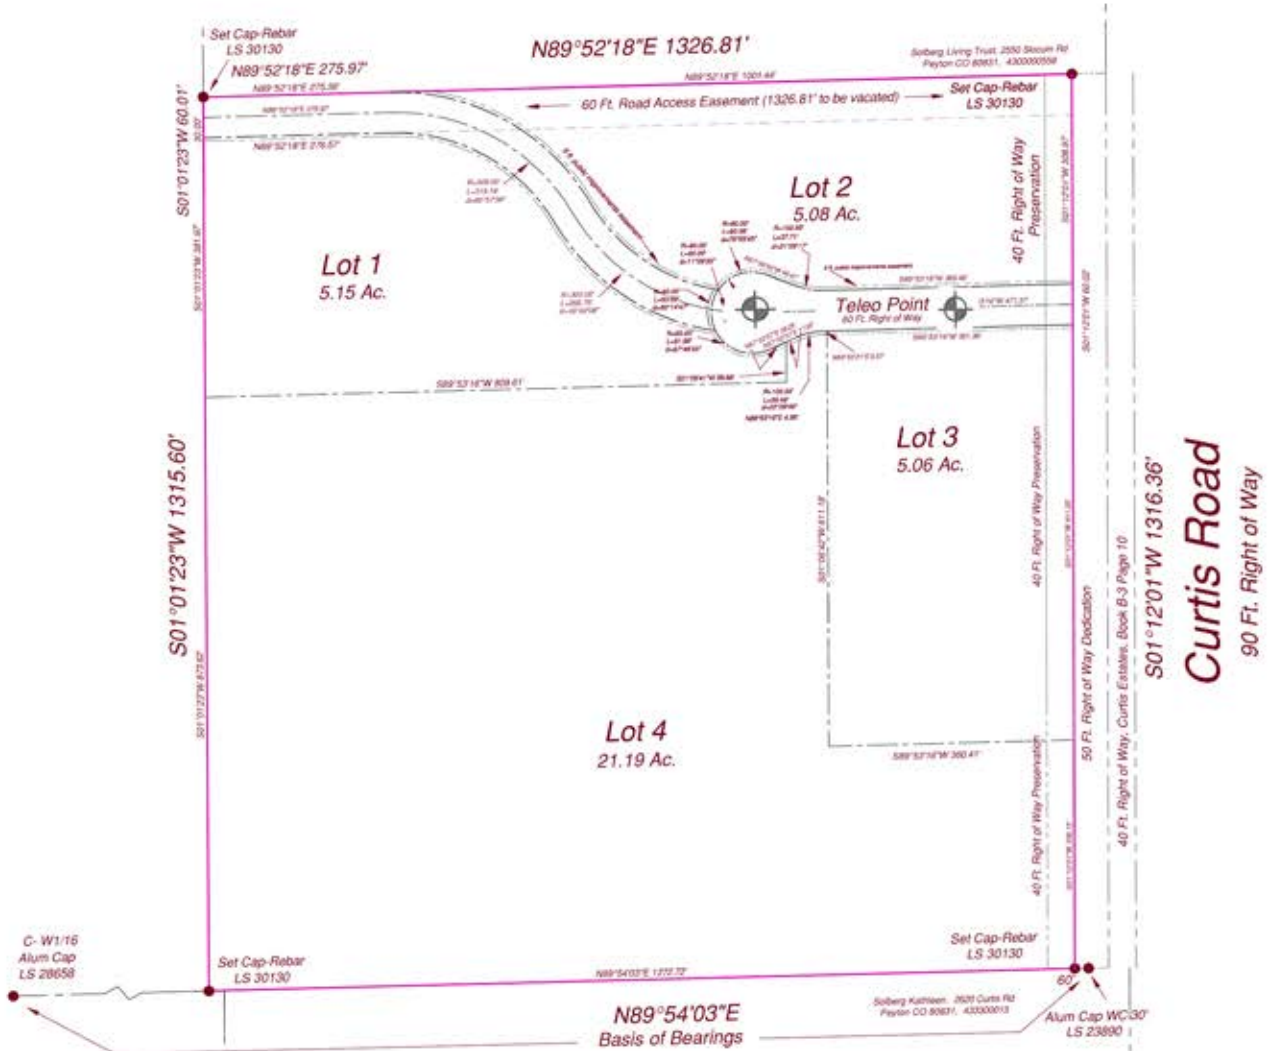
FIGURE 7
Pavement Design Test Pit Locations

Approximate Backhoe Test Pit Excavation

Two test holes were evaluated for a proposed gravel roadway for pavement design (Raiper, 2019 Figure 7). Soil samples were collected for testing which included sieve analysis and Atterberg limits in addition to determining resistance values (R-values). The results are summarized in Table 2.

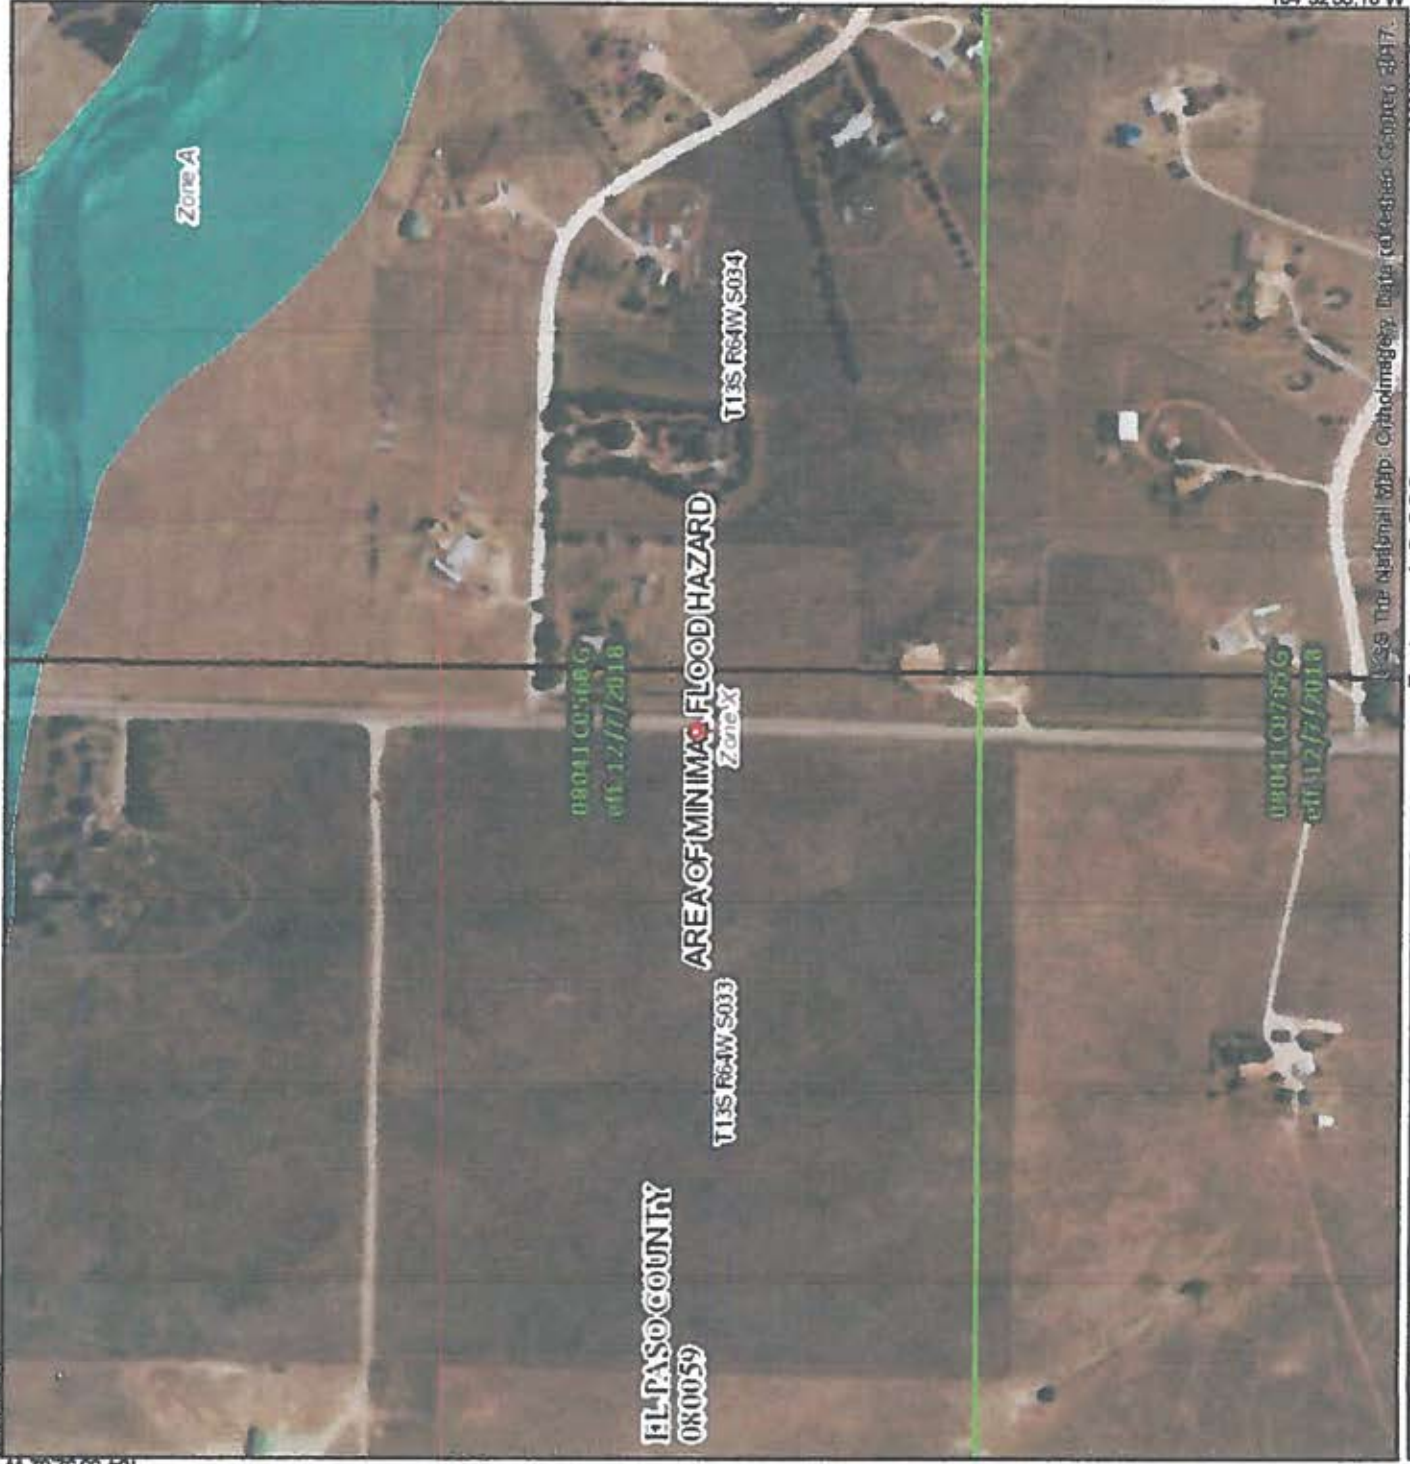
National Flood Hazard Layer FIRMette Figure 8

The flood hazard information is derived directly from the authoritative NFHL web services provided by FEMA. This map was exported on 4/25/2019 at 12:54:03 PM and does not reflect changes or amendments subsequent to this date and time. The NFHL and effective information may change or become superseded by new data over time.
