Wyoming Estates Preliminary Plan

Filings #1 and #2

Compilation of Soils, Geology, and OWTS

Soils and Geology
And Wastewater Treatment System
Evaluation

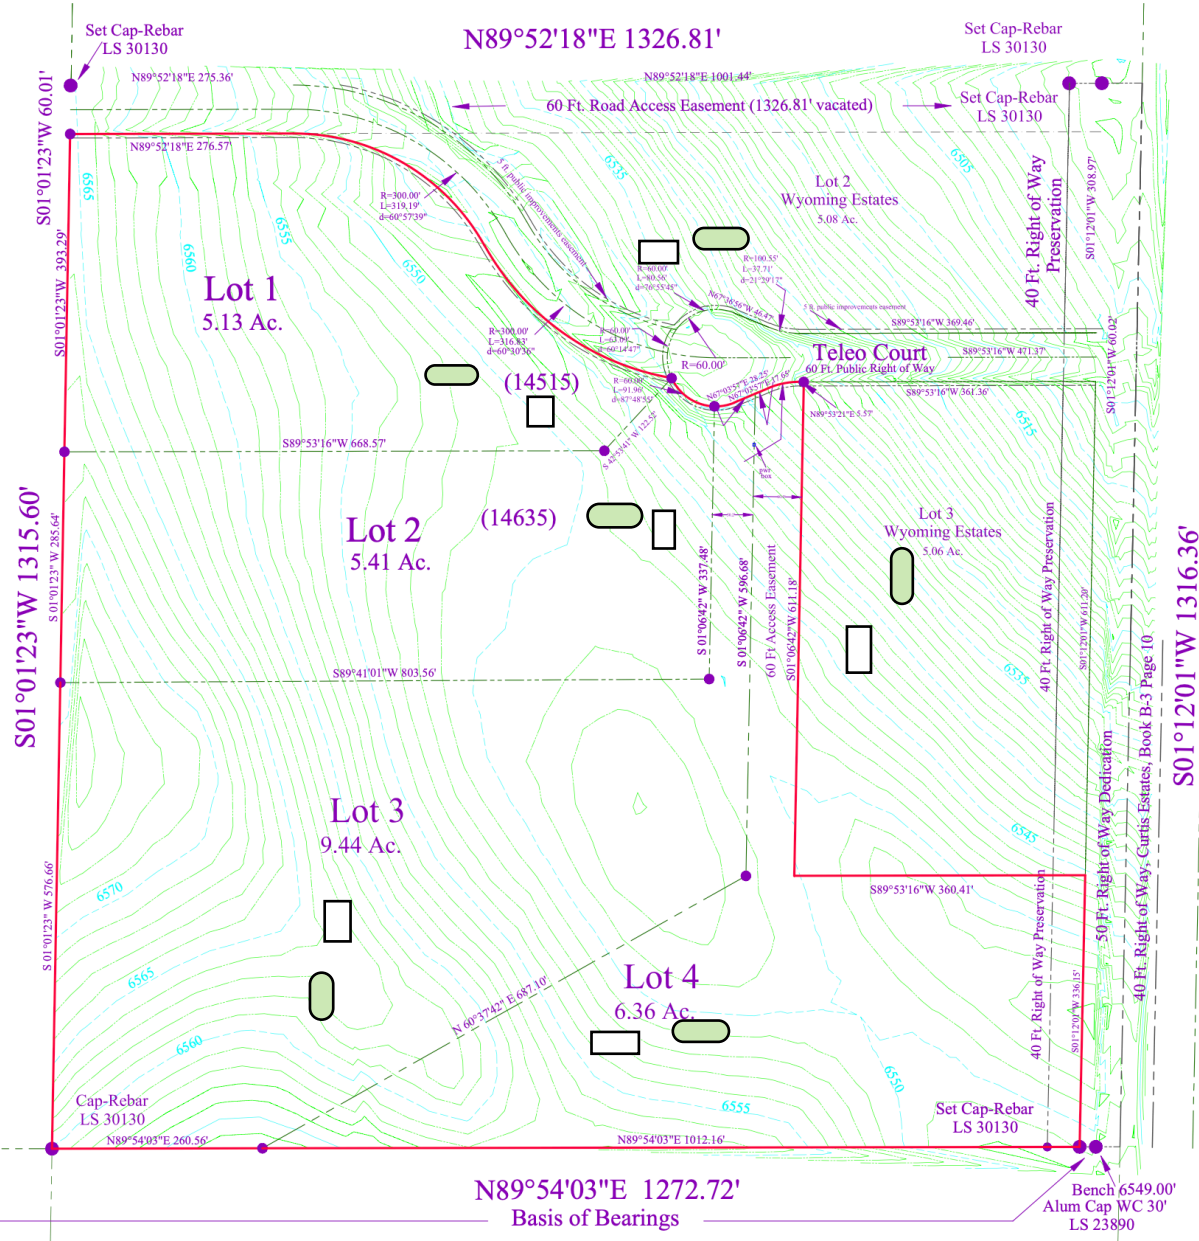
You are required to show alternate OWTS locations for each lot in addition to what is depicted here.

Existing/ proposed house location
-

Existing/ proposed OWTS location

Scale 1 inch = 100 feet
Units of Measure: U.S. Survey Foot

The following reports have been compiled from engineers evaluating the soils and geology for Wyoming Estates Filing 1 and 2 (a minor subdivision and preliminary plan). The project site was originally 3050 Curtis Rd, a 40 acre site which was approved for a minor subdivision called Wyoming Estates in January 2022. The additional information provided here is the soils tests for Onsite Wastewater Treatment Systems for Filing #2 (Preliminary Plan), which is comprised of the final 2 lots (a re-plat of Filing 1, lot 4). See the map on the following page.

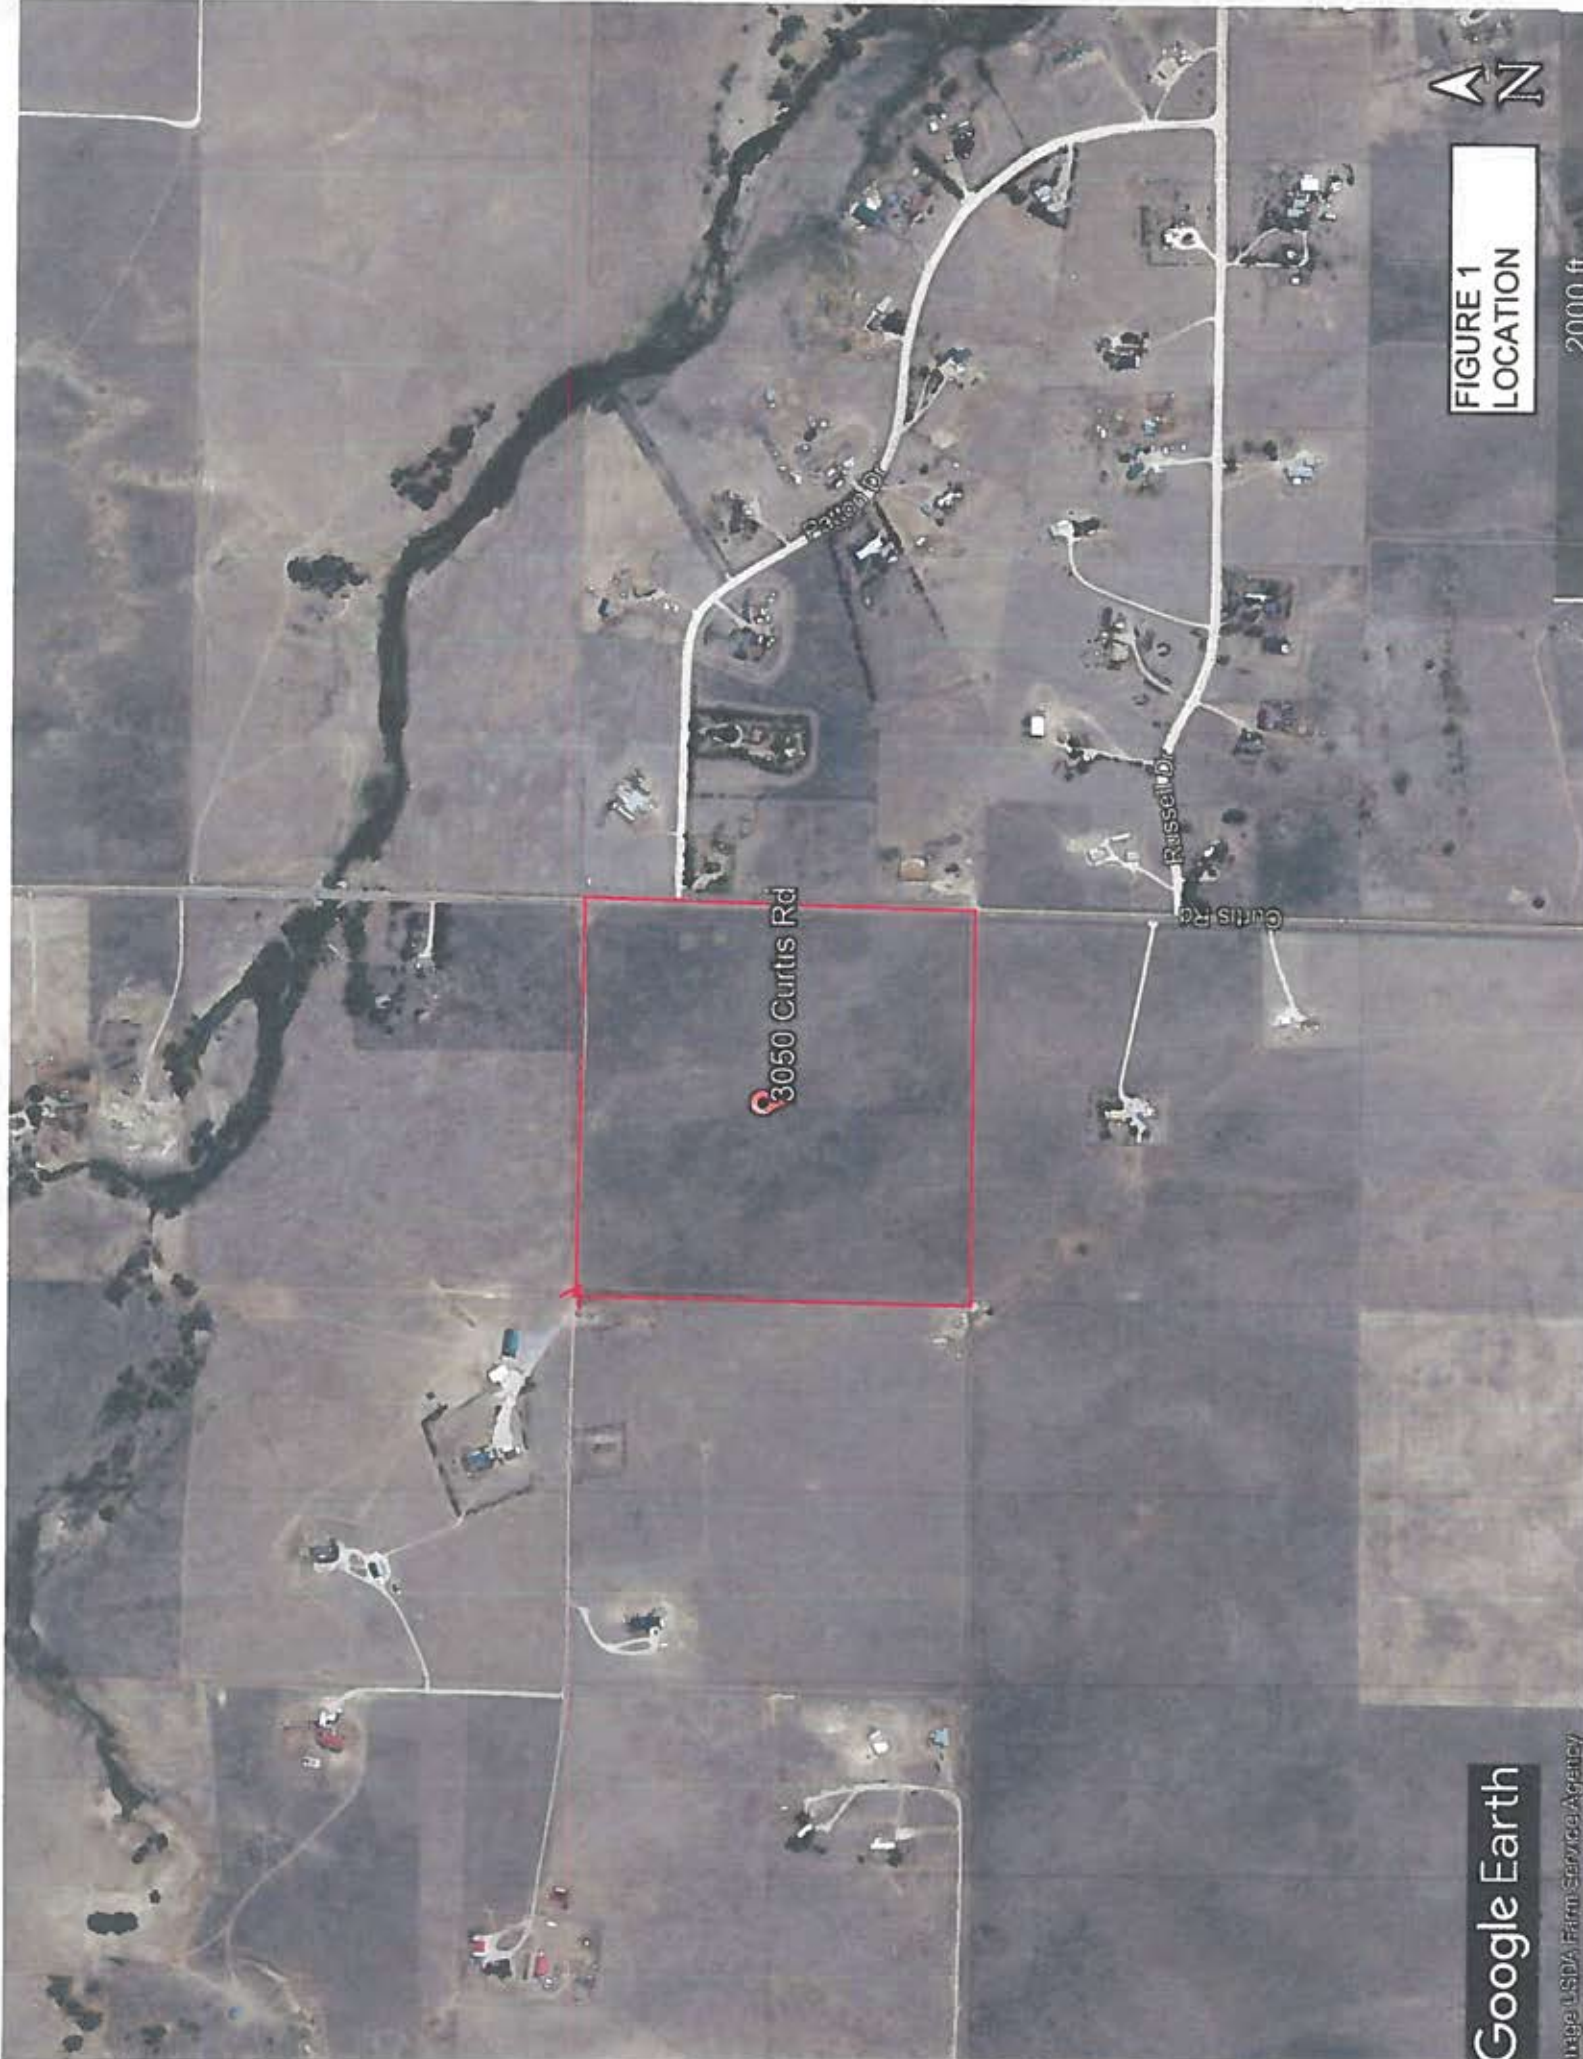
**FIGURE 1
LOCATION**

Wyoming Estates

The following presents Soils and Geology for the proposed Wyoming Estates Minor Subdivision (Project Site) located in the SE ¼ of the NE ¼ of Section 33, Township 13 South, Range 64 West of the 6th P.M. in the County of El Paso (Figure 1).

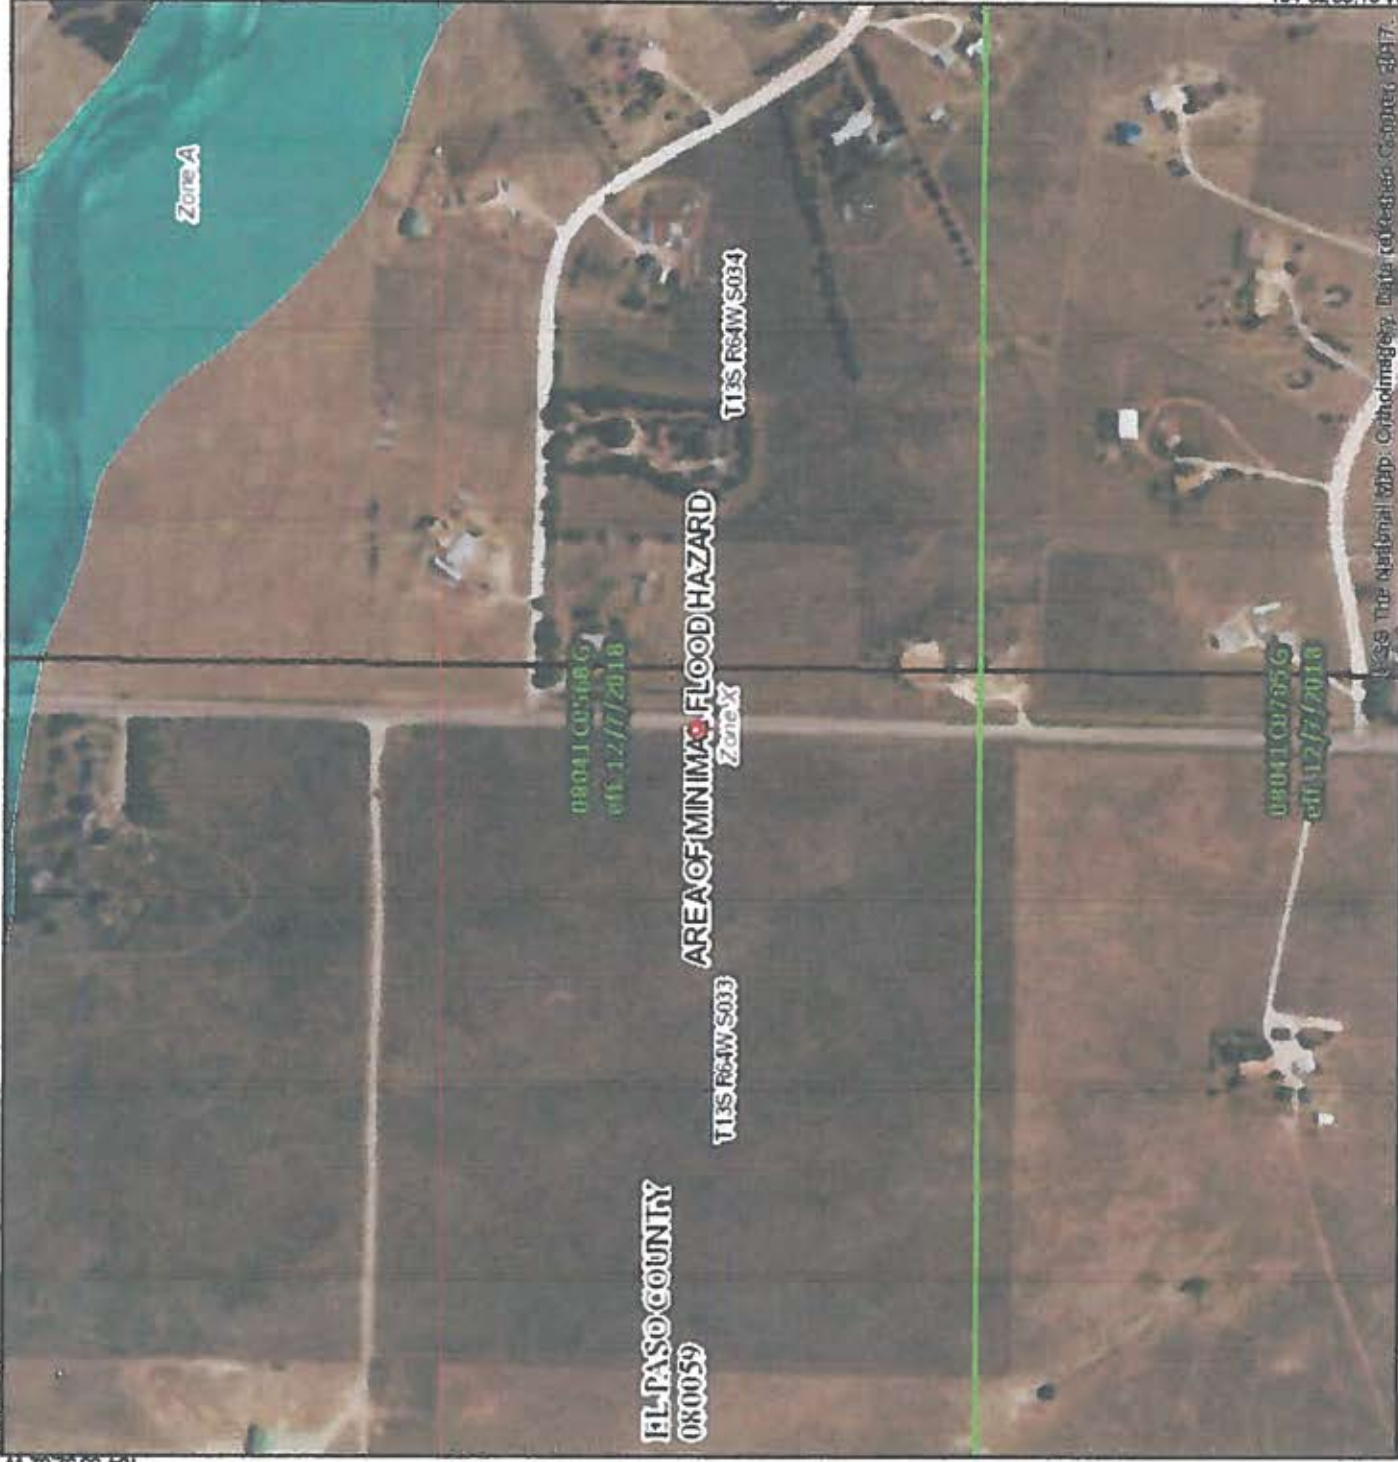
National Flood Hazard Layer FIRMette Figure 8

The flood hazard information is derived directly from the authoritative NFHL web services provided by FEMA. This map was exported on 4/25/2019 at 12:54:03 PM and does not reflect changes or amendments subsequent to this date and time. The NFHL and effective information may change or become superseded by new data over time.

The Project Site was evaluated for geologic hazards that may impact development. Hazards identified in the El Paso County Land Development Code including: Mining, wildfire, highwater table or polluted water, landfills, fill areas, contamination; airports and major utility facilities, and landslides were not identified on the Project Site. The National Flood Hazard map delineated the Property and surrounding area an "area of Minimal Flood Hazard" (FEMA 2018). The Project Site is not located in a flood plain (Figure 8).

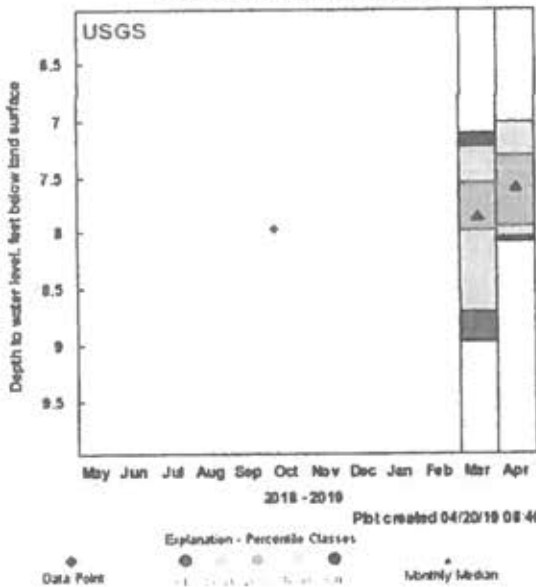
385250104331301 - 8C01306433AAA1

Most recent data value: 7.97 on 10/2/2018
 Period of Record Monthly Statistics for 385250104331301
 Depth to water level, feet below land surface
 All **Approved** Continuous & Periodic Data Used In Analysis
 Note: Highlighted values in the table indicate closest statistic to the most recent data value.

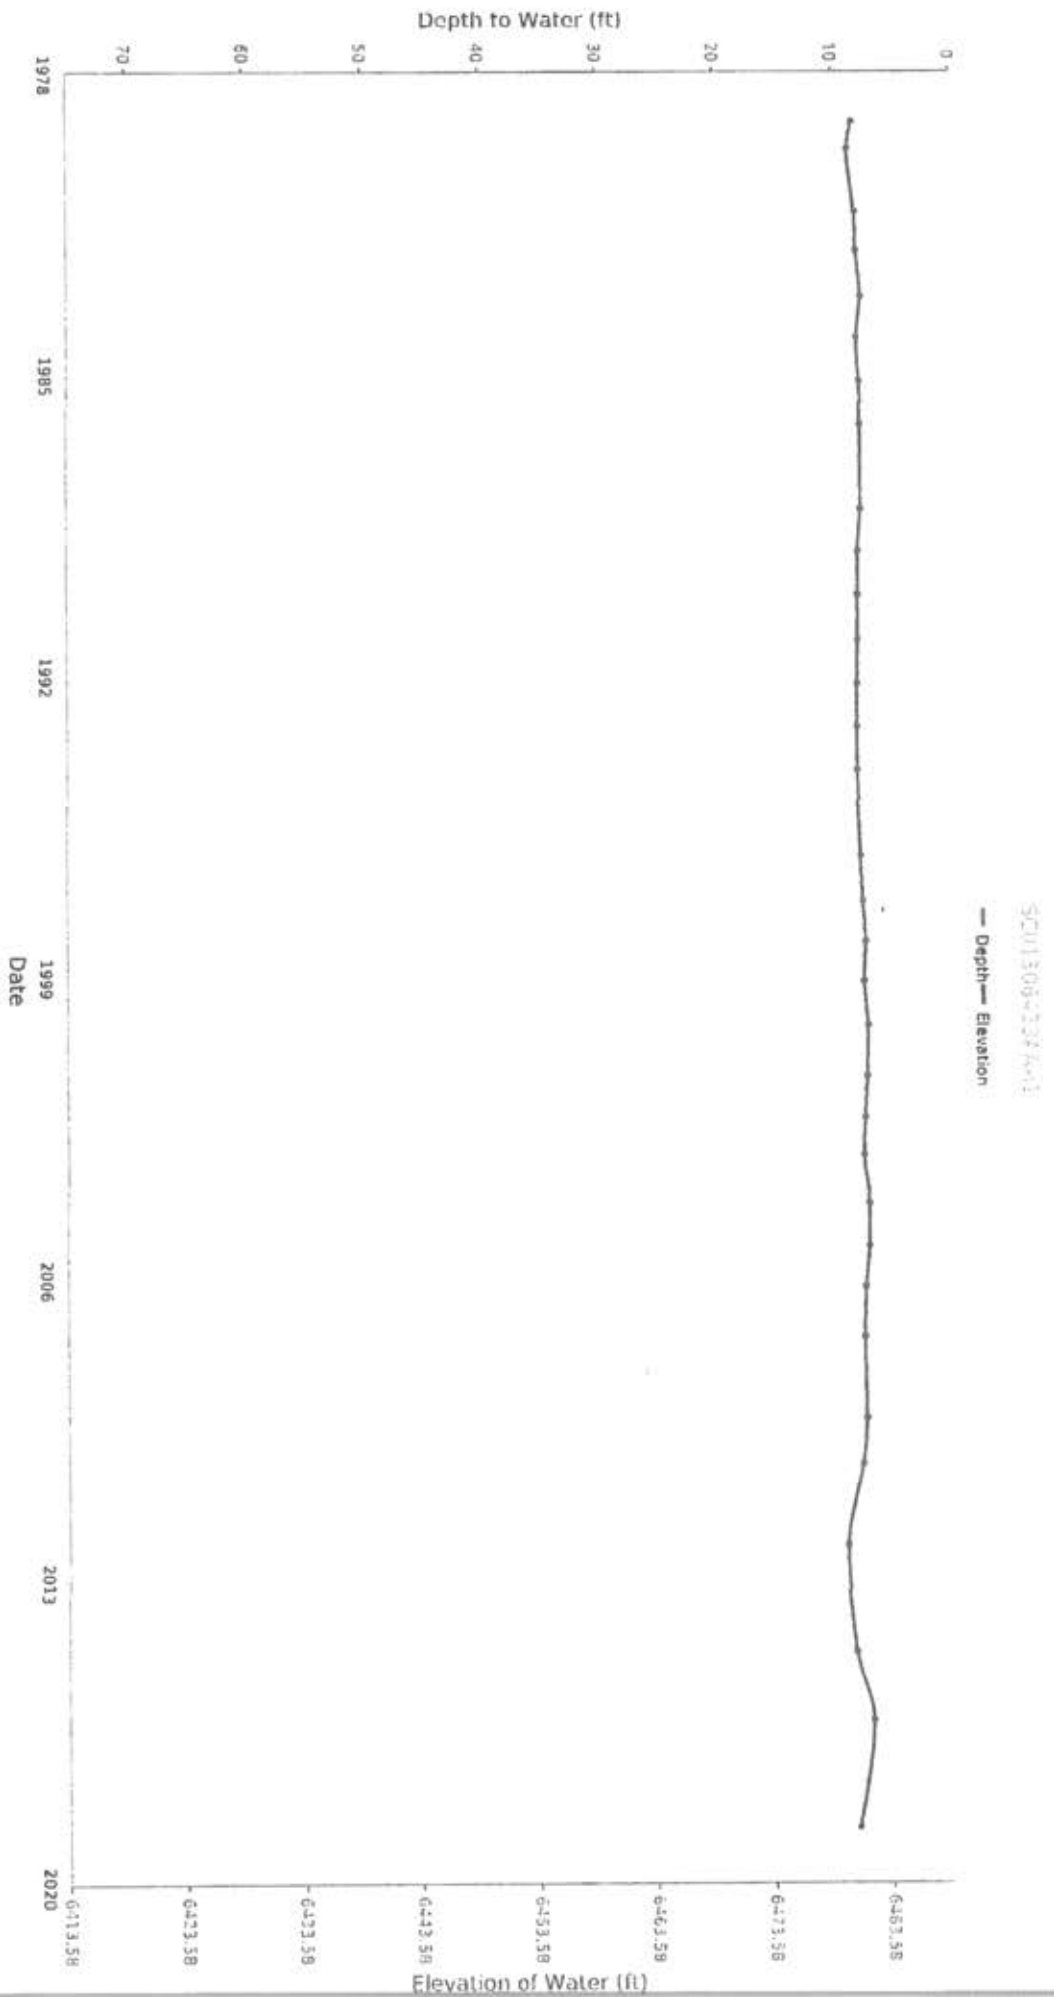
Depth to water level, feet below land surface
 Approved Periodic Water Level Values

Begin Date	End Date	Number of Values
03/14/79	10/02/18	37

Highest WL	Date of Highest WL	Lowest WL	Date of Lowest WL
6.78	04/21/16	8.97	03/27/12
