SOILS, GEOLOGY AND WASTEWATER STUDY

**Southeast corner of Old Ranch Rd and Otero Ave
Lots 1 and 2, Spring Crest Sub Amended
El Paso County, Colorado**

JOB NO. 184689

**November 8, 2021
Amended April 18, 2024**

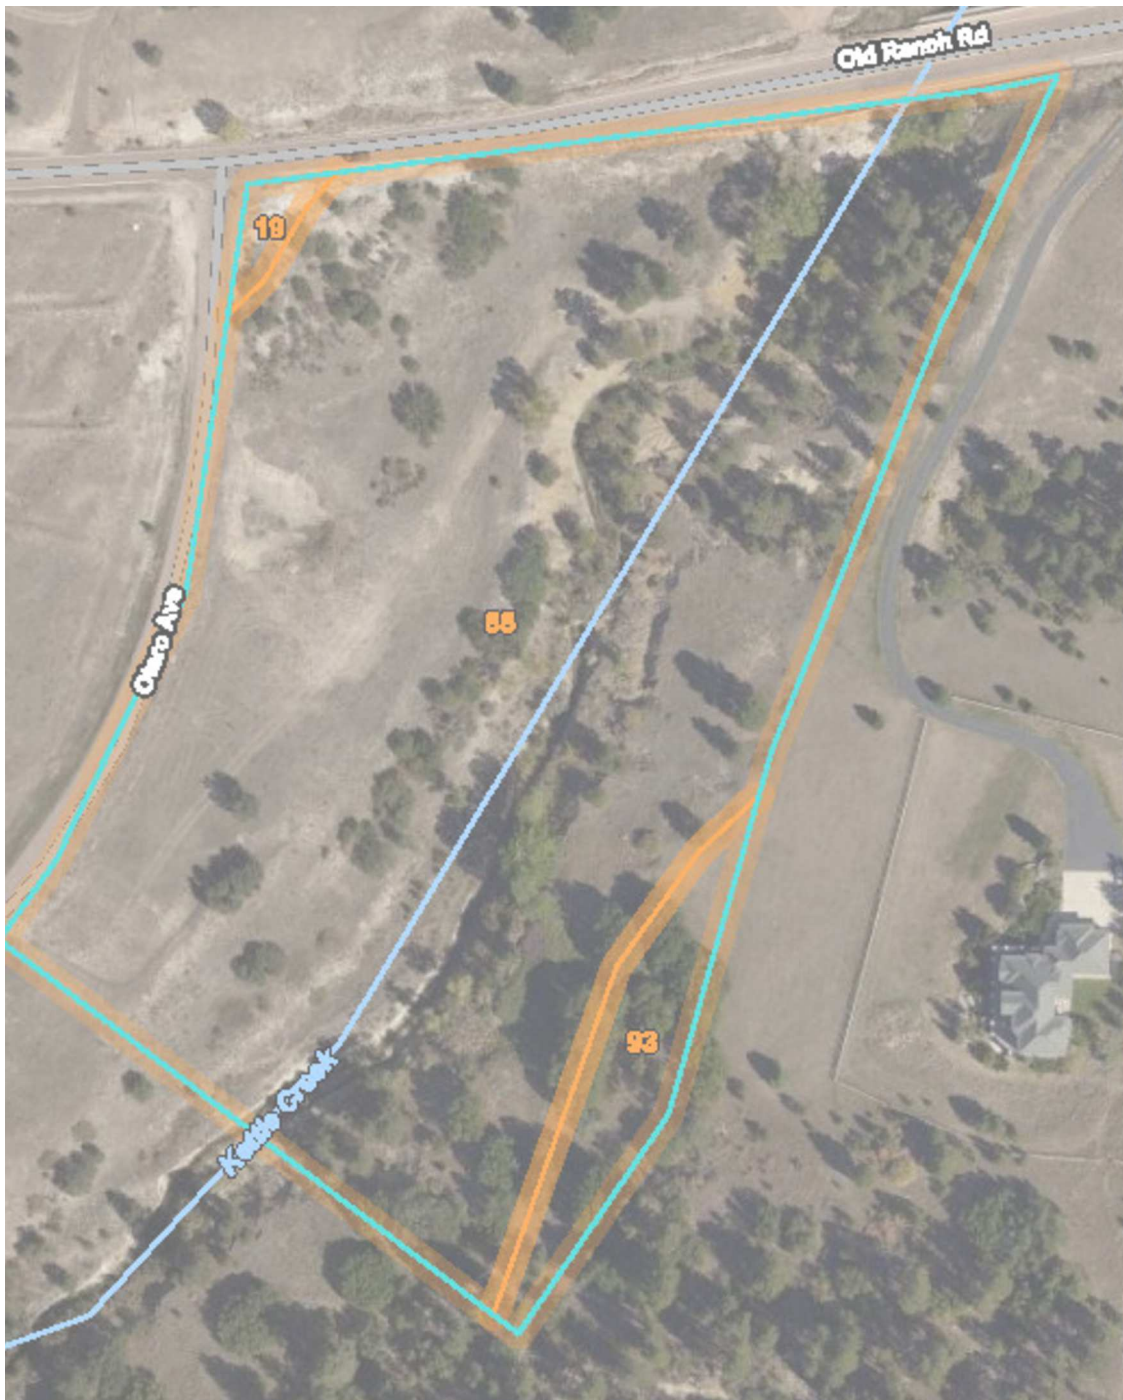
FIG No. 3

- 19 - Columbine gravelly loamy sand, 0 to 3 percent slopes
- 85 - Stapleton-Bernal sandy loams, 3 to 20 percent slopes
- 93 - Tomah-Crowfoot complex, 8 to 15 percent slopes

The USDA Soil Survey Map is presented in Figure 3.

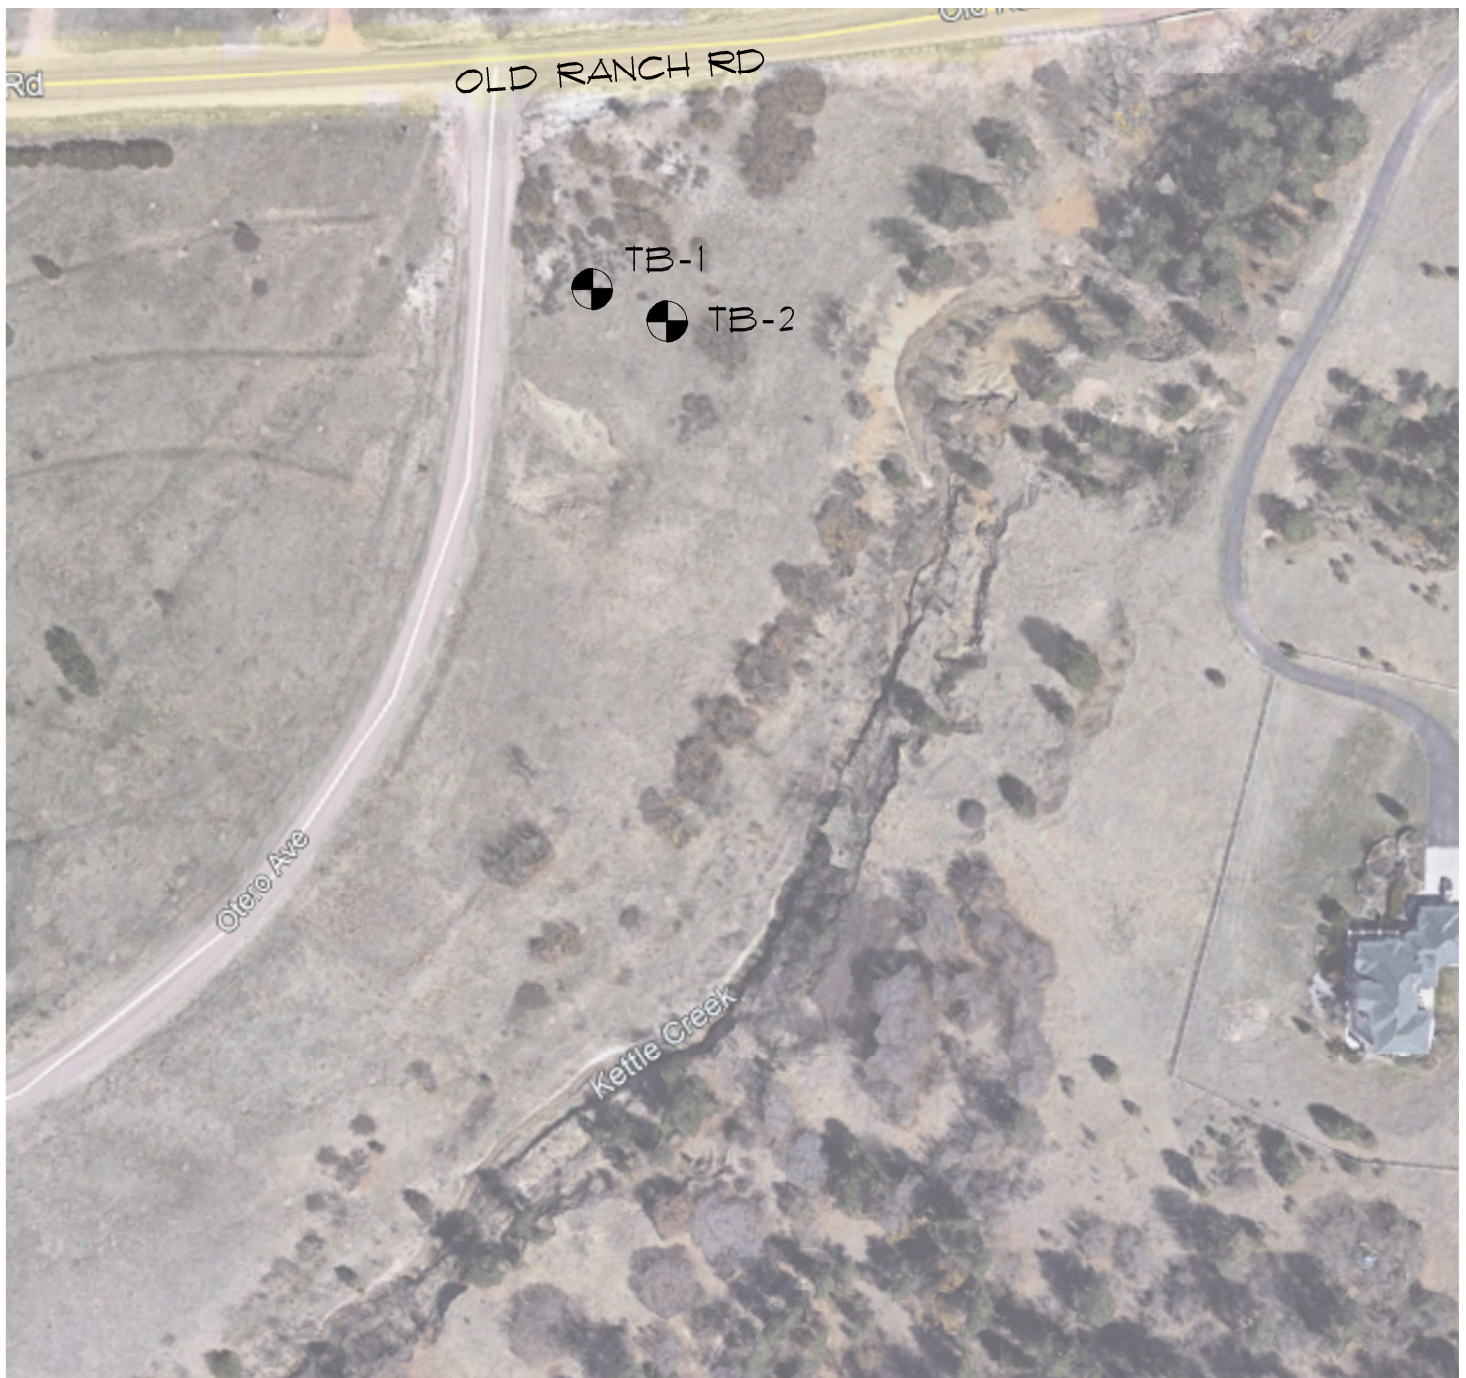
FIG No. 2

GPS COORDINATES:
 TB-1: 38.980146, -104.786592
 TB-2: 38.980218, -104.786710
 ACCURACY +/- 20 FEET

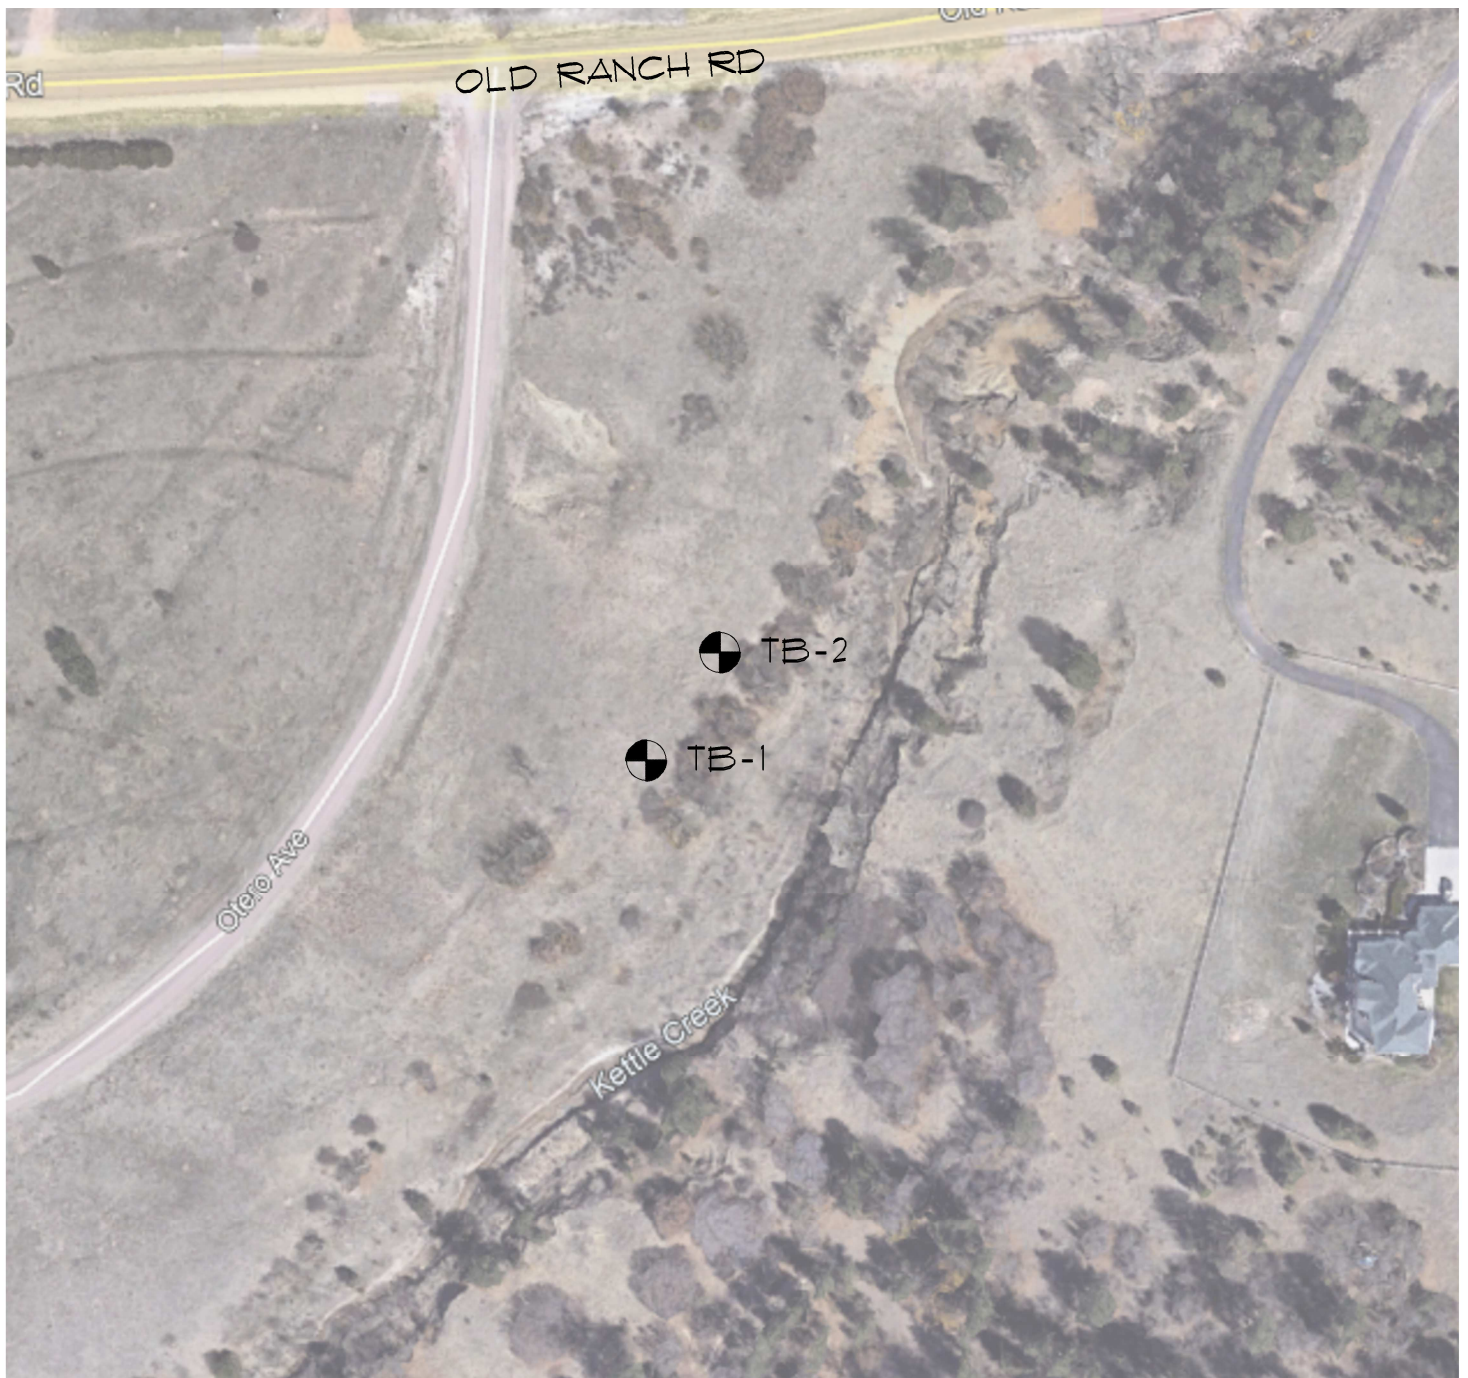
FIG No. 2

GPS COORIDNATES:
 TB-1: 38.979325, -104.786569
 TB-2: 38.979495, -104.786515
 ACCURACY +/- 20 FEET
