Re: Drainage Compliance Letter for Proposed Les Schwab Tire Center on Lot 1 – Meridian Crossing Filing Number 1A

This drainage conformance letter has been prepared for Lot 1 - Meridian Crossing Filing Number 1A located in the Southeast Quarter of Section 32, Township 12 South, Range 64 West of City of Falcon, County of El Paso, State of Colorado. The purpose of this letter is to demonstrate that the proposed drainage for the tire center site conforms to the current *El Paso County Drainage Criteria Manual Volumes 1 and 2, Urban Drainage and Flood Control District Criteria Manual*, and the approved *the Final Drainage Report – Meridian Crossing* prepared by Springs Engineering, Inc. Dated July 2008. Runoff coefficient and volume calculations have been performed for the subject site and these calculations are attached herein.

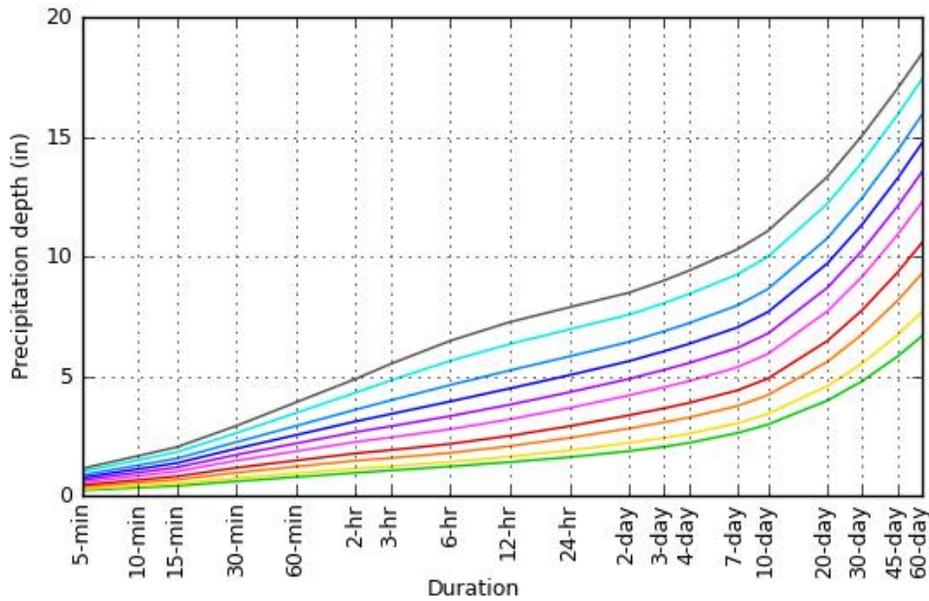
PDS-based depth-duration-frequency (DDF) curves
 Latitude: 38.9352°, Longitude: -104.6120°

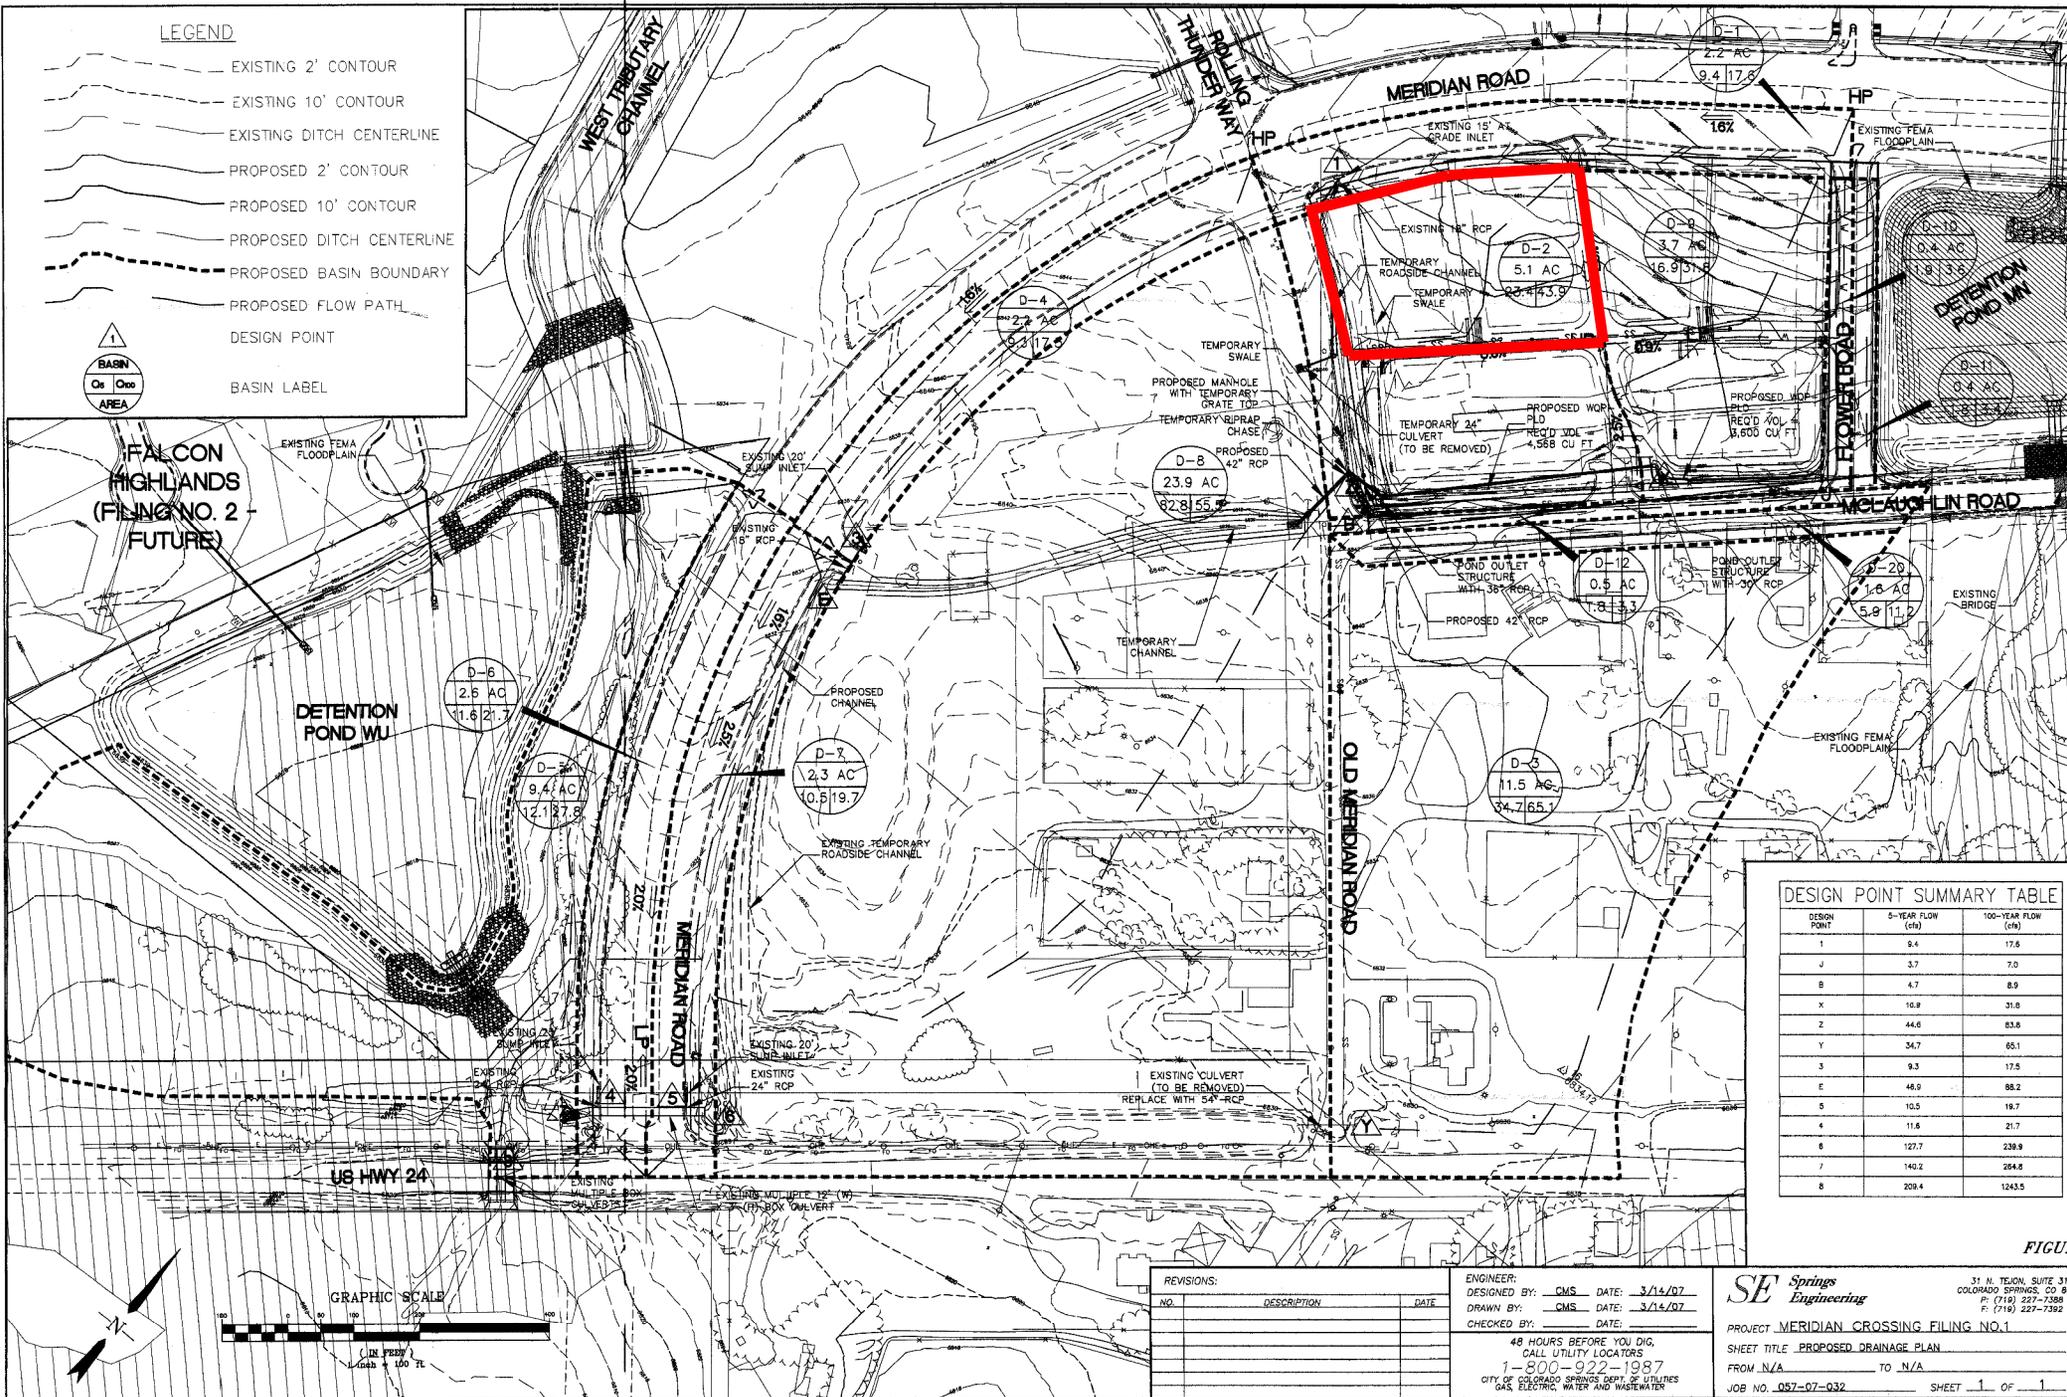
FROM APPROVED MASTER DRAINAGE REPORT MERIDIAN CROSSING FILING No. 1

DESIGN POINT SUMMARY TABLE

DESIGN POINT	5-YEAR FLOW (cfs)	100-YEAR FLOW (cfs)
1	9.4	17.6
J	3.7	7.0
B	4.7	8.9
X	10.9	31.0
Z	44.6	83.8
Y	34.7	65.1
3	9.3	17.5
E	46.9	88.2
5	10.5	19.7
4	11.6	21.7
6	127.7	239.9
7	140.2	264.6
8	208.4	1243.5

The project site is located within existing basin D-2 of the *Final Drainage Report – Meridian Crossing*. The current runoff surface drains to an existing water quality pond on the southeast side of Lot 5. The existing condition of the pond is dirt and has lost much of its vegetation. This pond will need to be re-vegetated as part of this project. Flows are then conveyed into the existing storm sewer at the southern end of basin D-2 which traverses underneath Old Meridian Road and discharges into the existing detention pond WU. The planned 5-year and 100-year runoff values for Basin D-2 from the *Final Drainage Report – Meridian Crossing* are 23.4cfs and 43.9cfs, respectively. Since the proposed developed acreage in this report is located entirely within existing Basin D-2 from *Final Drainage Report – Meridian Crossing*, we can use the Rational Method to calculate the existing runoff values for the site as 12.0cfs for the 5-year and 22.3cfs for the 100-year (see below).

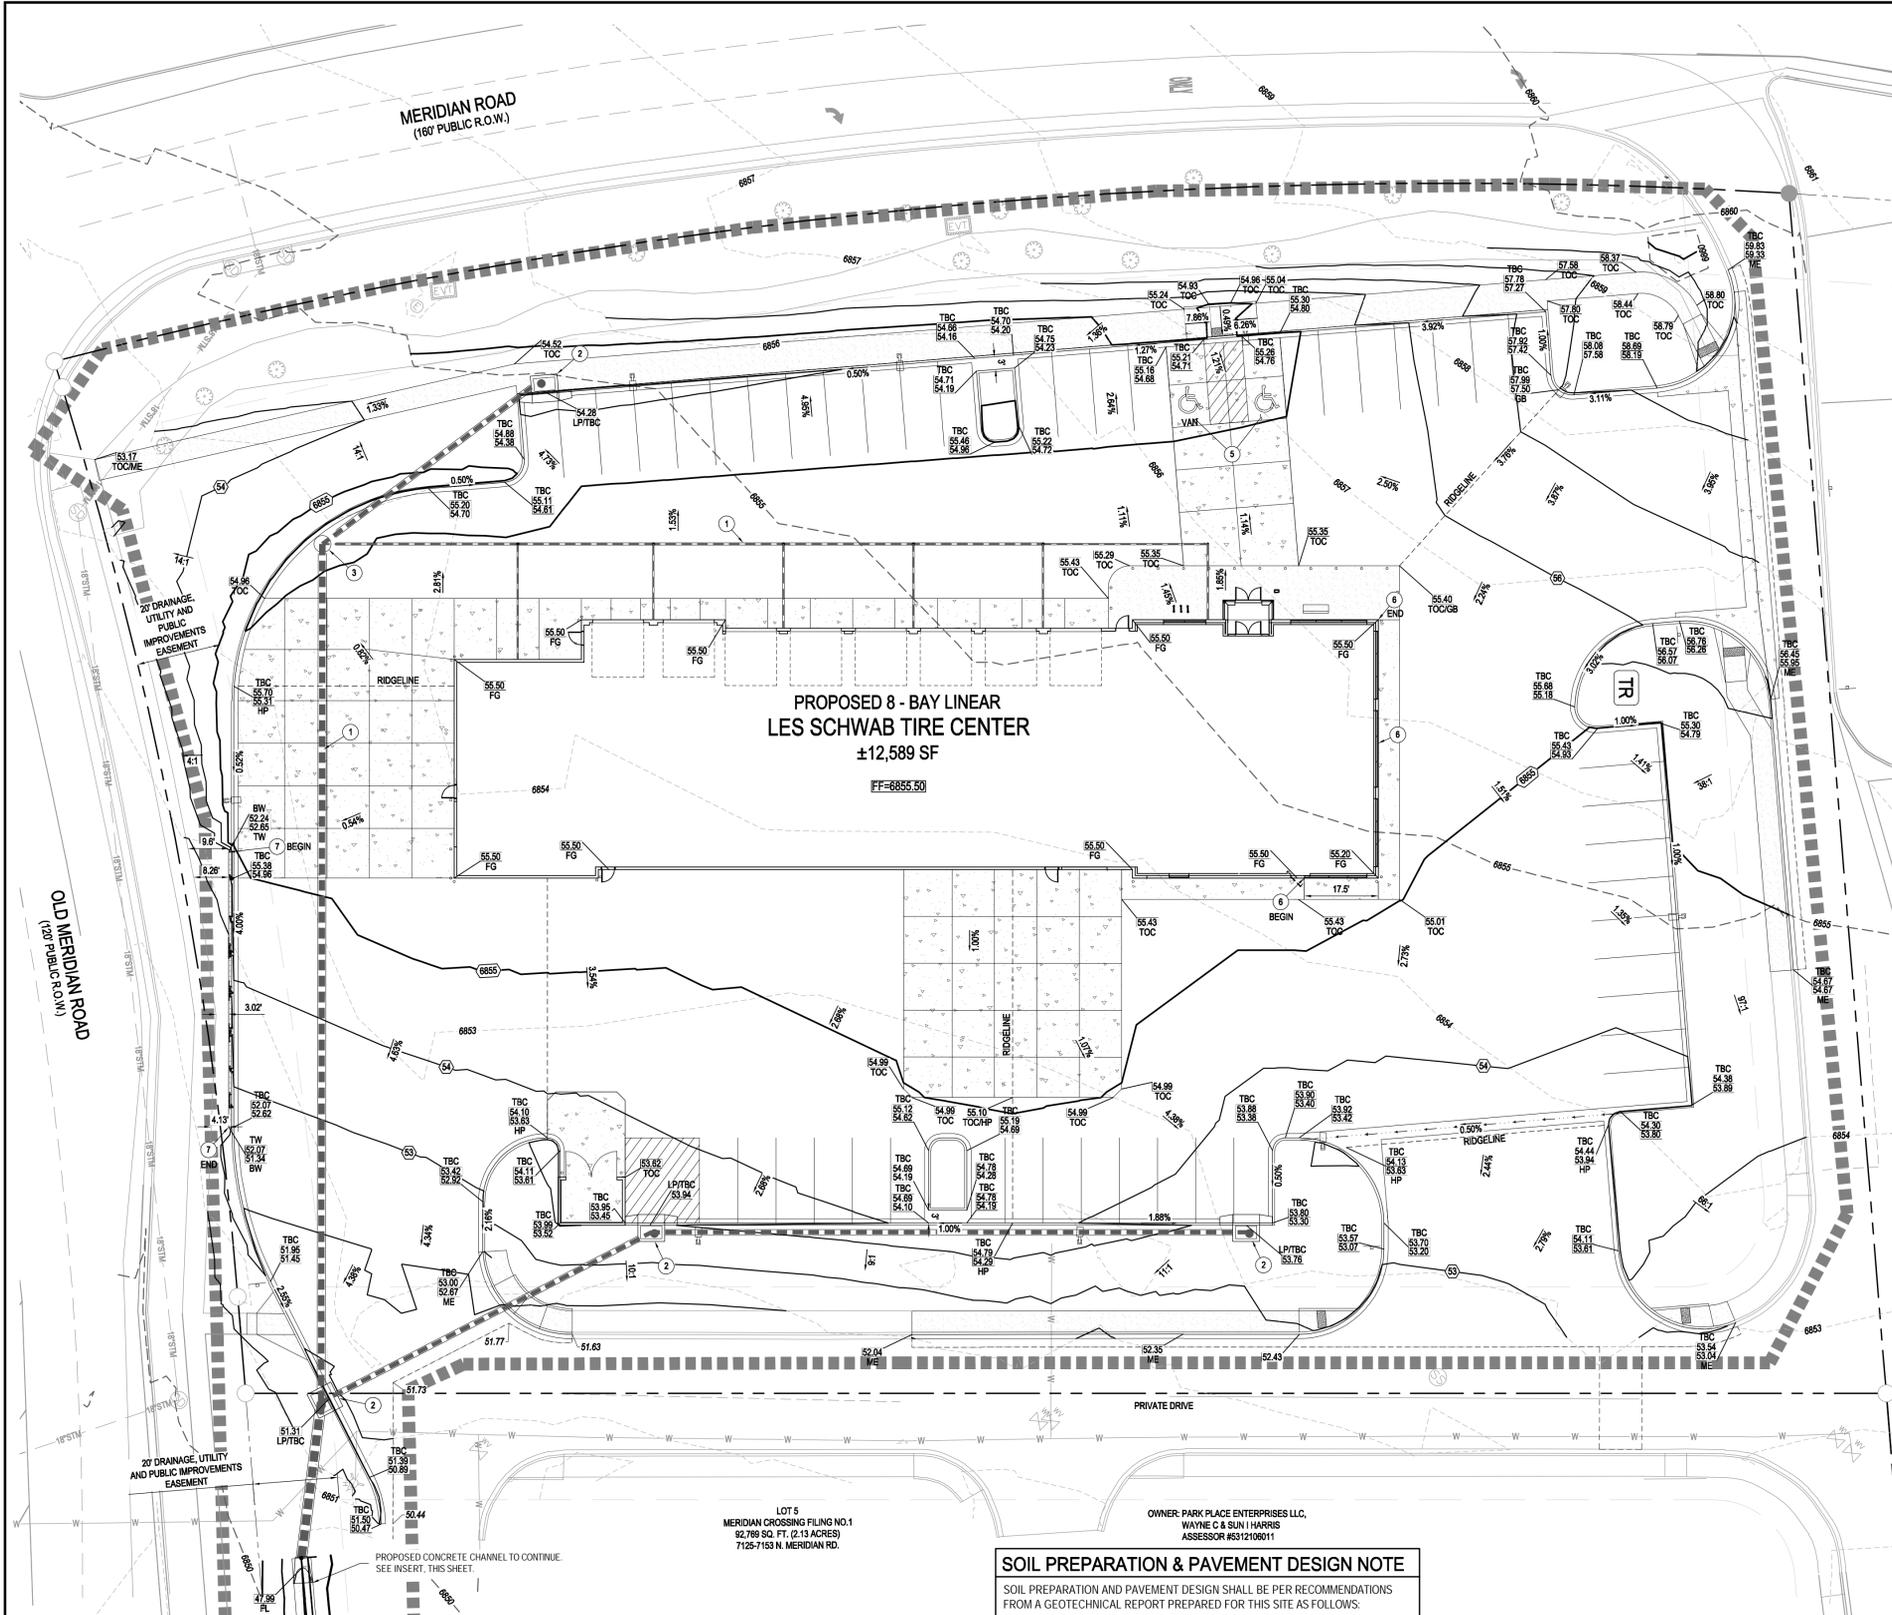
**PROPOSED 8 - BAY LINEAR
LES SCHWAB TIRE CENTER
±12,589 SF**

FF=6855.50
