ENTECH
ENGINEERING, INC.

Re: Geologic Hazard Additional Borings
Springs at Waterview East (Trails at Aspen Ridge)
South Powers and Bradley Road
Colorado Springs, Colorado

**SOIL, GEOLOGY, AND GEOLOGIC HAZARD
SPRINGS AT WATERVIEW EAST
SOUTH POWERS BOULEVARD AND BRADLEY ROAD
EL PASO COUNTY, COLORADO**

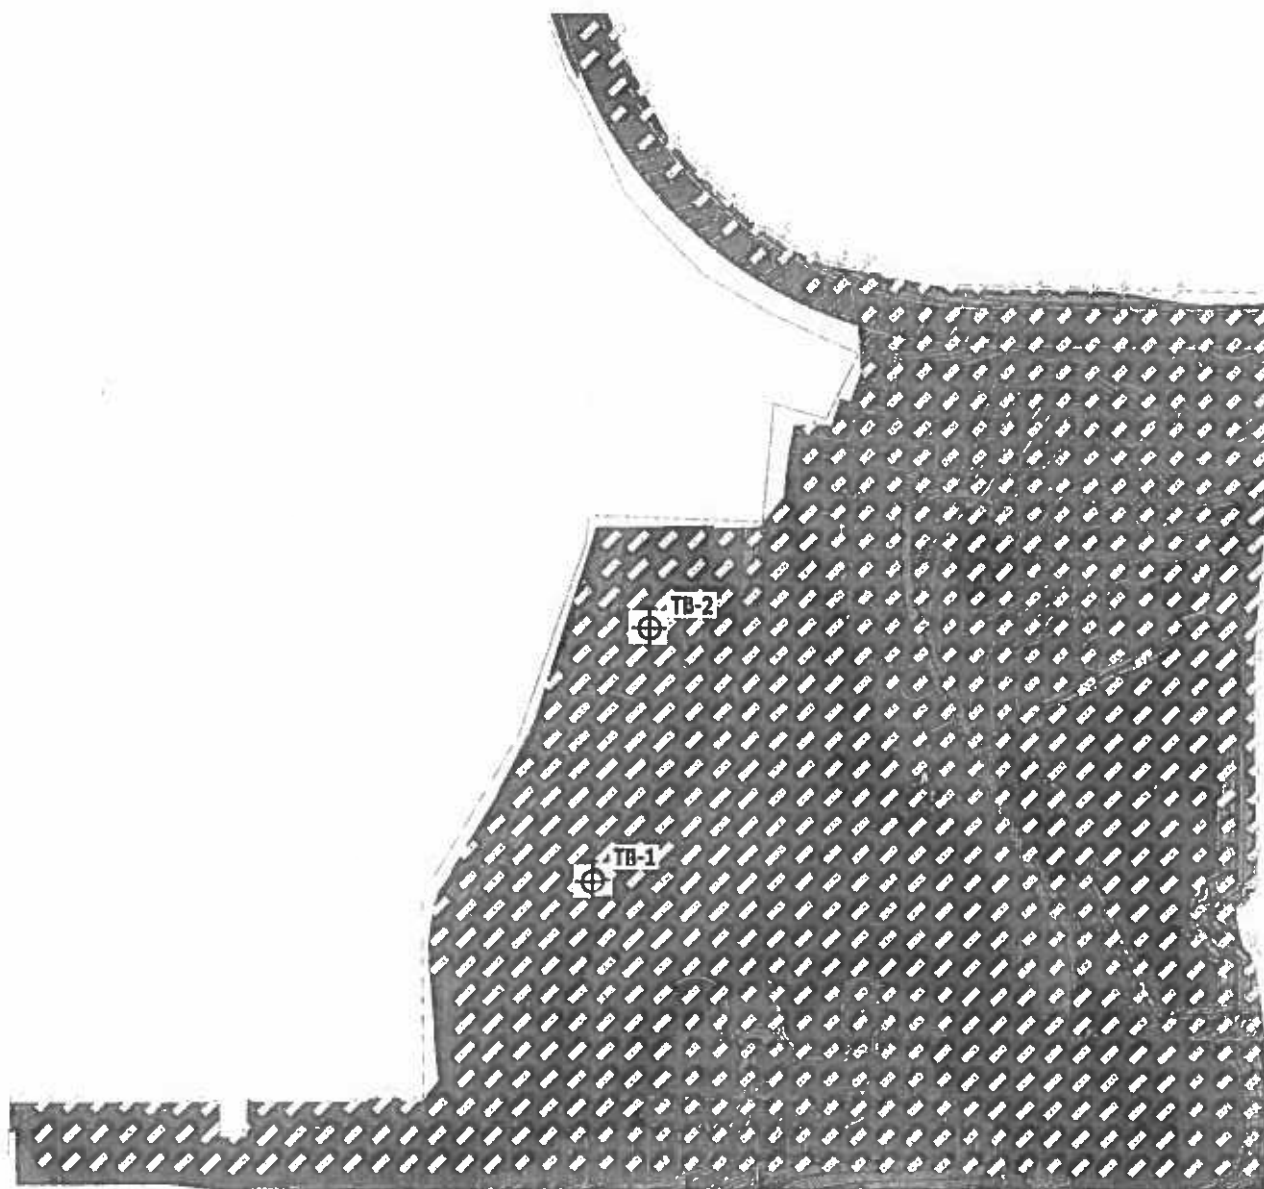
TB-2 - APPROXIMATE TEST BORING LOCATION AND NUMBER

CGS recommended additional investigation on the site in areas where significant cuts are proposed. Entech drilled four additional borings on August 7, 2019. Test Boring locations are shown on Figure 1. Test Boring Nos. 1 – 3 were drilled in areas of deep cuts, and Test Boring No. 4 was placed in an area of significant fill. Groundwater was not encountered during drilling or subsequent to drilling. The test borings were drilled to depths of 20 to 40 feet. Soils encountered in these borings consisted of predominantly sandy clay soils with underlying claystone and shale bedrock. The bedrock underlying the site is the Pierre Shale Formation of Cretaceous Age, which typically has a moderate to high expansion potential.
