Revised January 18, 2021
Revised October 14, 2020
August 14, 2020
Project No: 19-3028

SUBSURFACE INVESTIGATION AND SOILS REPORT AND ONSITE WASTEWATER TREATMENT SYSTEM SIZING

17055 Red Barn Road, Peyton,
El Paso County, Colorado

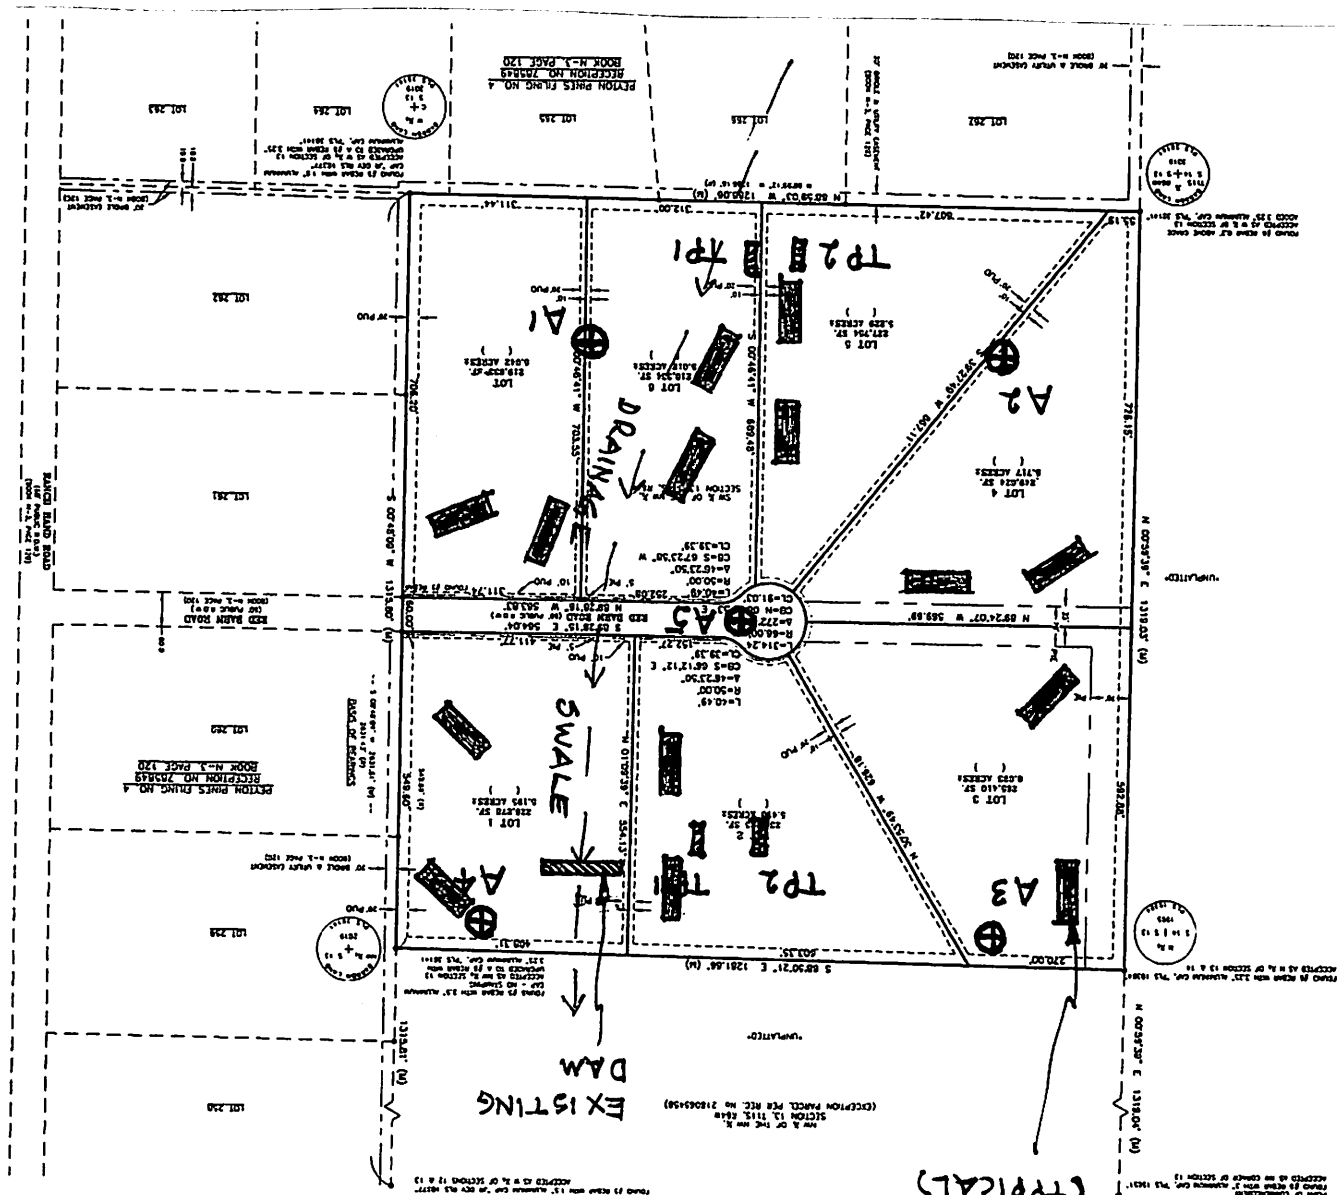
Name: OWENS
 Project No.: 19-3028
 17055 Red Barn Road, Peyton, El Paso County, Colorado.

PINE VIEW ESTATES
 THE SOUTHWEST QUARTER OF THE NORTHWEST QUARTER
 SECTION 13, TOWNSHIP 11 SOUTH, RANGE 64 WEST OF THE 6TH P.M.
 COUNTY OF EL PASO, STATE OF COLORADO

21' x 100' ±
 POTENTIAL OWTS
 ACCEPTABLE LOCATION
 (TYPICAL)

SCALE: 1" = 333'
 666 999 1332
