**SOIL, GEOLOGY, & GEOLOGIC HAZARD STUDY
SADDLEHORN RANCH – FILING NO. 3
CURTIS ROAD & JUDGE ORR ROAD
EL PASO COUNTY, COLORADO**

November 15, 2022

Entech Job No. 222005
AAprojects/2022/222005 countysoil/geo

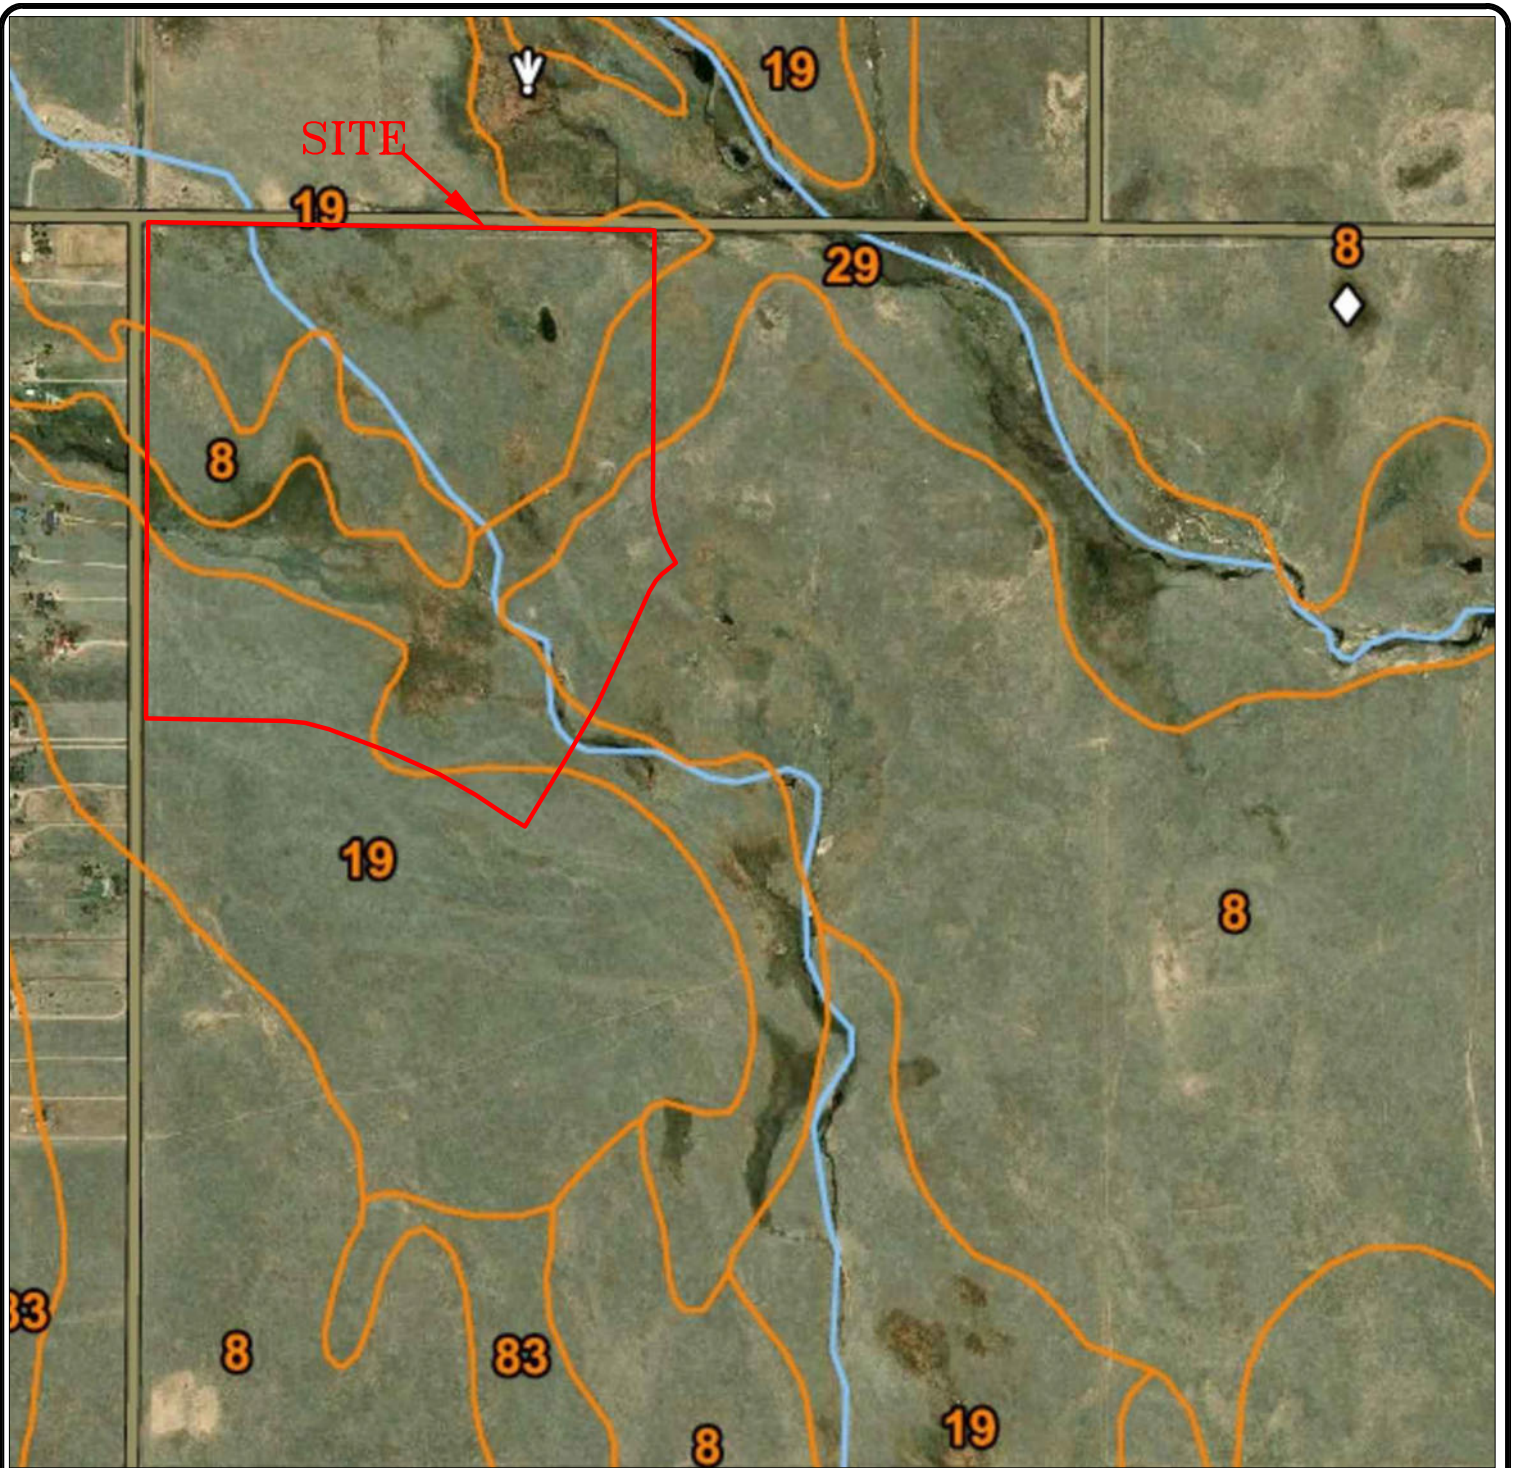
FIG NO.:
 4

SOIL SURVEY MAP
 SADDLEHORN RANCH FILING NO. 3
 CURTIS ROAD AND JUDGE ORR ROAD
 EL PASO COUNTY, CO.
 FOR: WILLIAM GUMAN AND ASSOCIATES, LTD
